**CONSOLIDATED SEWER MAINTENANCE DISTRICT  
CONDITION ASSESSMENT PROGRAM REPORT  
PROJECT NO. Y0TV1112B**

**CONDITION ASSESSMENT REPORT  
LOS ANGELES COUNTY PUBLIC WORKS  
CONSOLIDATED SEWER MAINTENANCE DISTRICT**

PROJECT NAME: Y0TV1112B	PROJECT MGR:	Eric Liu
PROJECT DATE: 06/26/13	CONTACT NO:	(626) 300-3369
SUP. DISTRICT(s): 5	MAP PAGE(S):	2017, 2018, 2070, 2071
Report By: Jonathan Gonzalez	Report Date:	09/06/18

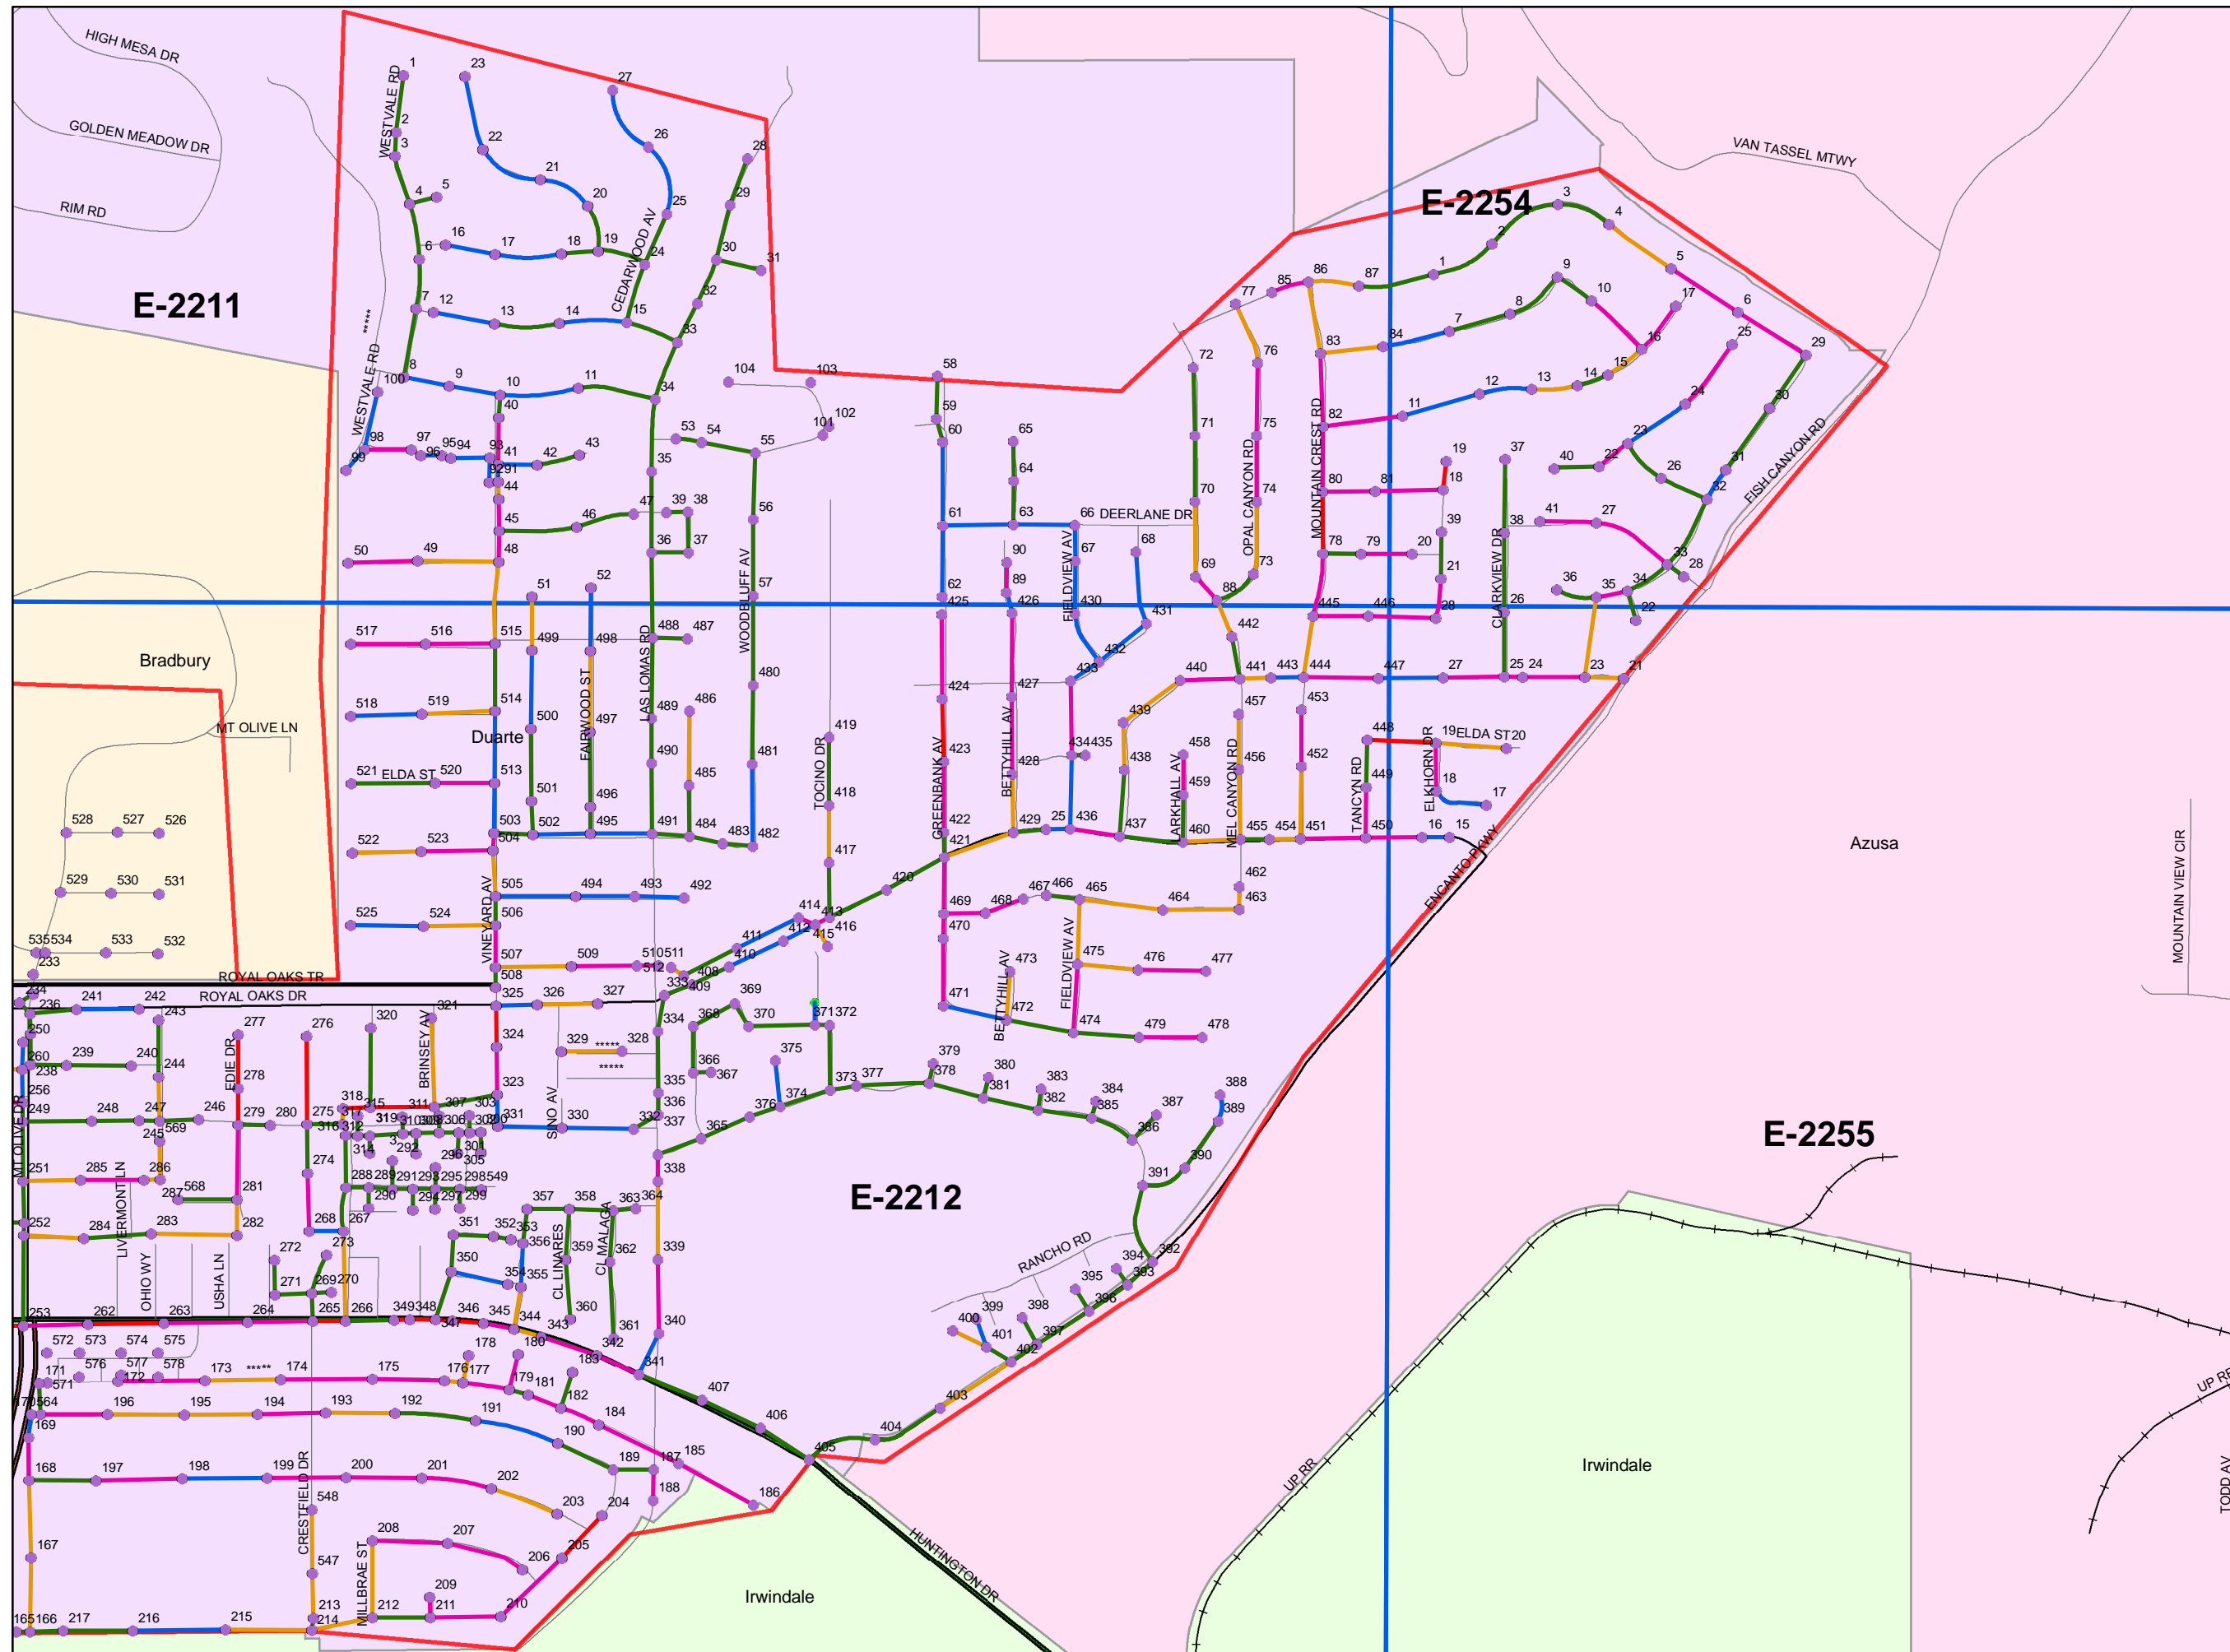
### QUICK MAINTENANCE RATING

A color-coded map showing the quick maintenance rating for each pipe segment is provided in Enclosure 2.

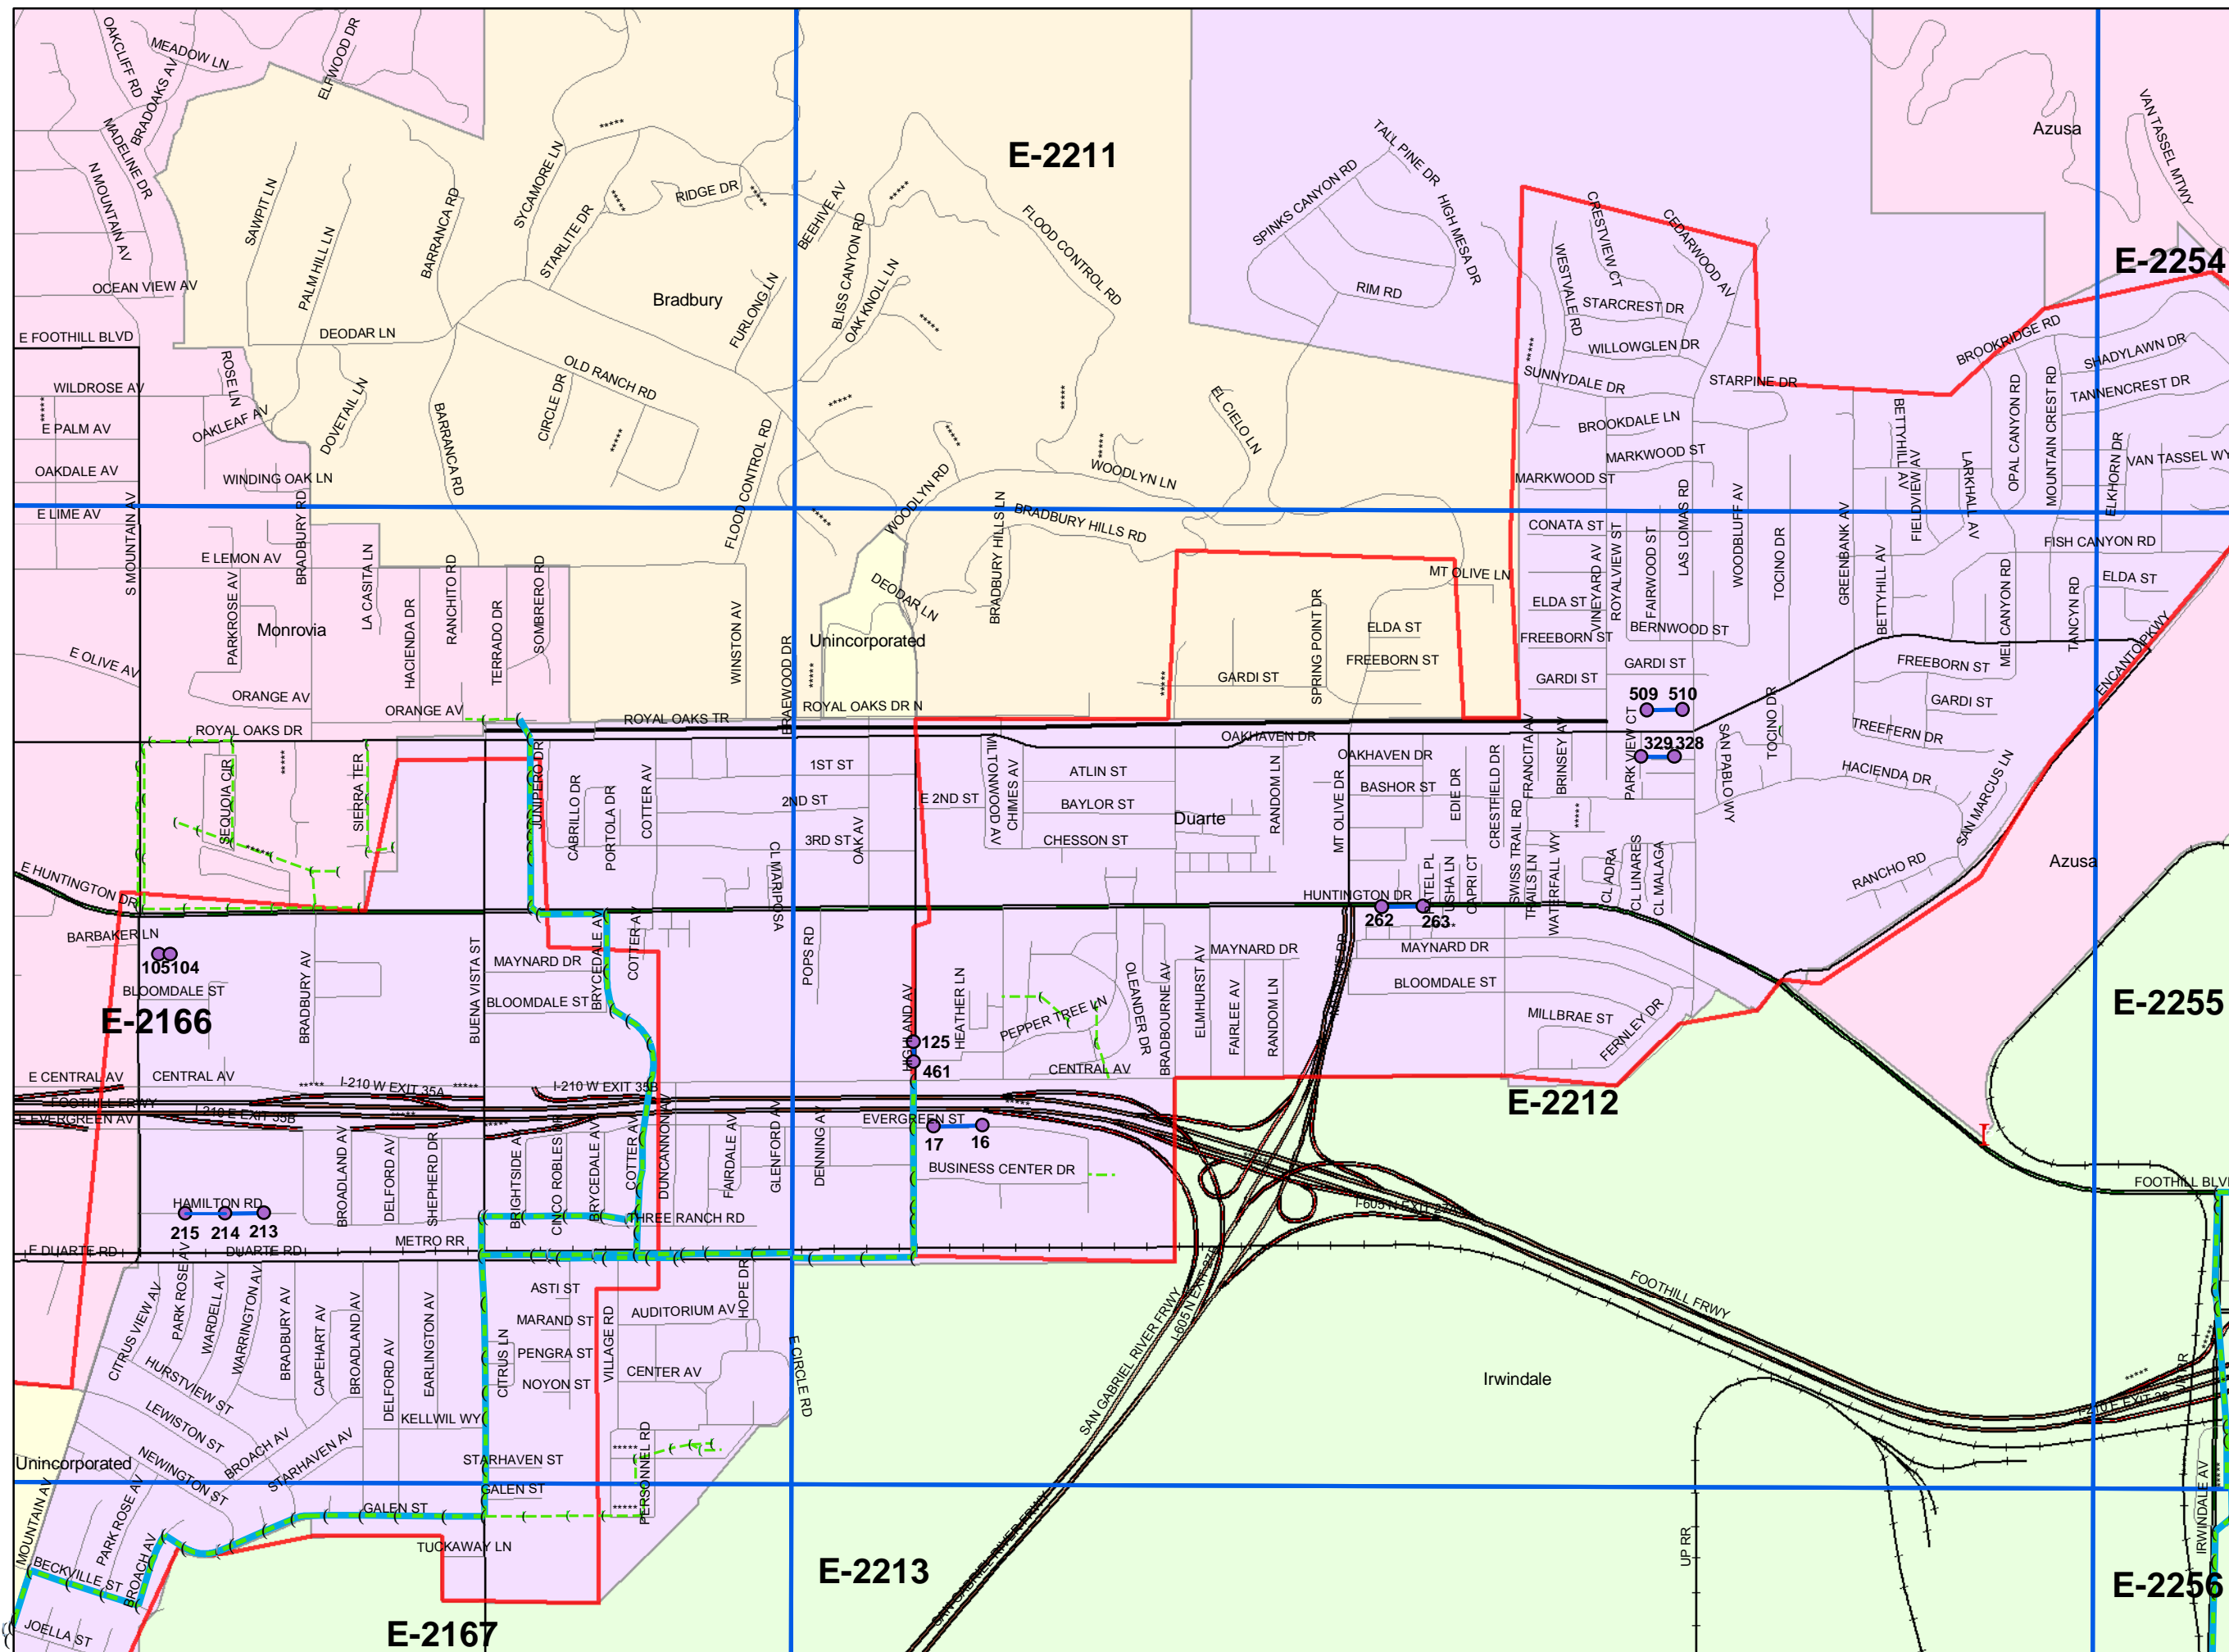
### HIGH WATER LEVEL

Our inspection revealed that approximately 99.2 percent of the system televised has adequate capacity. Approximately 0.8 percent of the segments inspected exhibited visual signs associated with high water levels. The capacity of the sewer pipe can be determined by analyzing several PACP codes, including Water Level, Water Mark, and miscellaneous remarks, which indicate the camera was underwater or there were sags in the line. A sewer pipe is considered at capacity when 50 percent of the diameter of the sewer pipe is full of water. However, there are conditions in which the Water Level or Water Mark has reached 50 percent or greater due to heavy flows in adjoining pipes, a temporary stoppage caused by debris in the sewer lines, or a sag in the line. Therefore, additional review of these pipe segments was conducted to determine if any capacity issues exist.

All sewer pipes where the Water Level, Water Mark, and miscellaneous remarks of camera underwater or sags in the line are at or above 50 percent capacity have been listed and analyzed on the High Water Level Table in Enclosure 2. The nature of these high water level conditions is also summarized on this table.

A map showing the sewer lines with high water levels is provided in Enclosure 2.

<b>ITEM NO.</b>	<b>QMR</b>	<b>START MH</b>	<b>END MH</b>	<b>STREET</b>	<b>OBSERVATION: LOCATION</b>	<b>CAPACITY</b>	<b>CORRECTIVE ACTION</b>
1	5143	2166-0214	2166-0215	HAMILTON RD	Water mark (70%)	YES	Hydrojet
2	4421	2212-0461	2212-TRNK	HIGHLAND AV	Water mark (55%)	YES	Hydrojet
3	4234	2212-0510	2212-0509	EASEMENT	Sag	YES	Hydrojet
4	4131	2212-0329	2212-0329A	EASEMENT	Water mark (60%)	NO	Hydrojet
5	4131	2212-0263A	2212-0263	HUNTINGTON DR	Water level (50%): 80'-129'	NO	Hydrojet
6	4122	2212-0017	2212-TRNK	EVERGREEN AV	Water level (50%): 105'-111'	NO	Hydrojet
7	4122	2166-0105	2166-0104	EASEMENT	Water mark (60%)	YES	Hydrojet

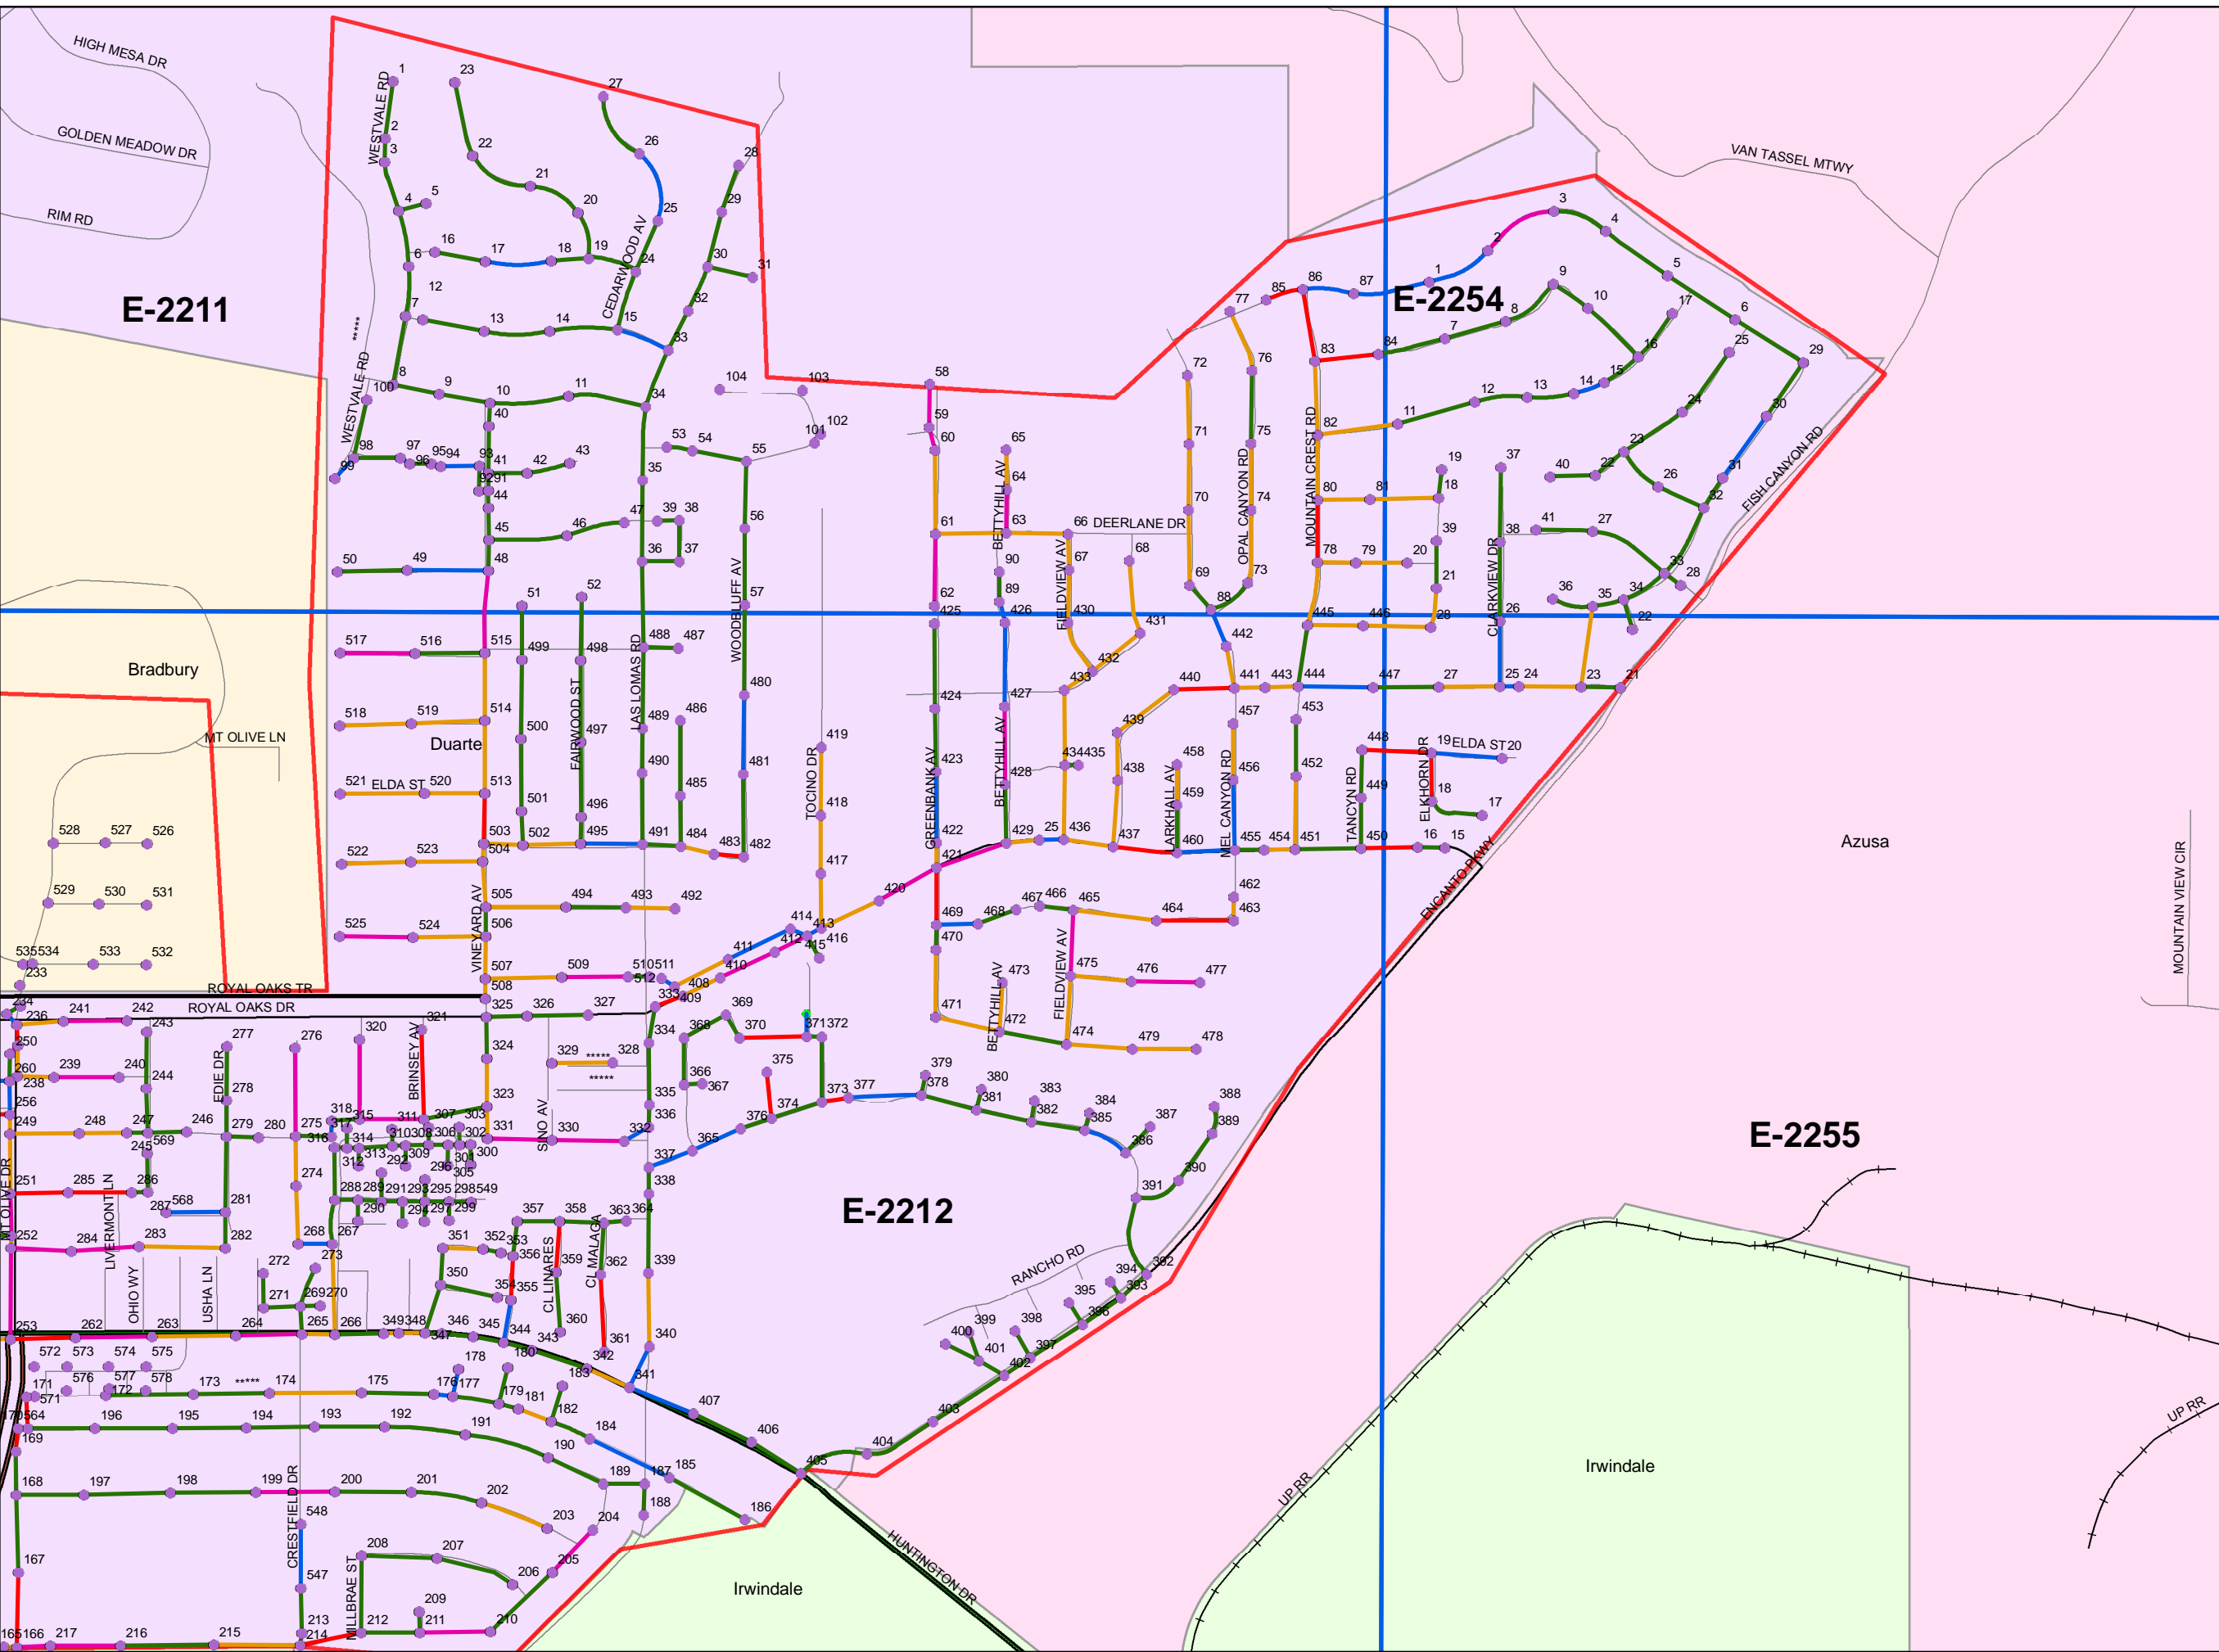
### QUICK STRUCTURAL RATING

Our inspection revealed that approximately 80.8 percent of the inspected pipe segments within the City were free of severe structural defects. The remaining 19.2 percent of the inspected pipe segments had a PACP structural grade of 4 or 5 as indicated in the Quick Structural Rating Table shown below. These segments have been placed on a priority list based on the severity and the need for action. For items 1 through 150 in the Quick Structural Rating Report Priority List (Enclosure 3), which warrant a corrective action, the proposed corrective action will be programmed in the next 24 months as part of the ongoing Accumulative Capital Outlay Program.

A color-coded map showing the Quick Structural Rating for each pipe segment is located in Enclosure 3.
