# COUNTY OF LOS ANGELES

**CONSOLIDATED SEWER MAINTENANCE DISTRICT  
CONDITION ASSESSMENT PROGRAM REPORT  
PROJECT NO. Y0TV1314B2**

**CONDITION ASSESSMENT REPORT  
LOS ANGELES COUNTY PUBLIC WORKS  
CONSOLIDATED SEWER MAINTENANCE DISTRICT**

PROJECT NAME:	Y0TV1314B2	PROJECT MGR:	Eric Liu
PROJECT DATE:	7/23/14	CONTACT NO:	(626) 300-3369
SUP. DISTRICT(s):	5	MAP PAGE(S):	1796 & 1797
Report By:	Hanna Kebede & Clement Khong	Report Date:	1/7/2019

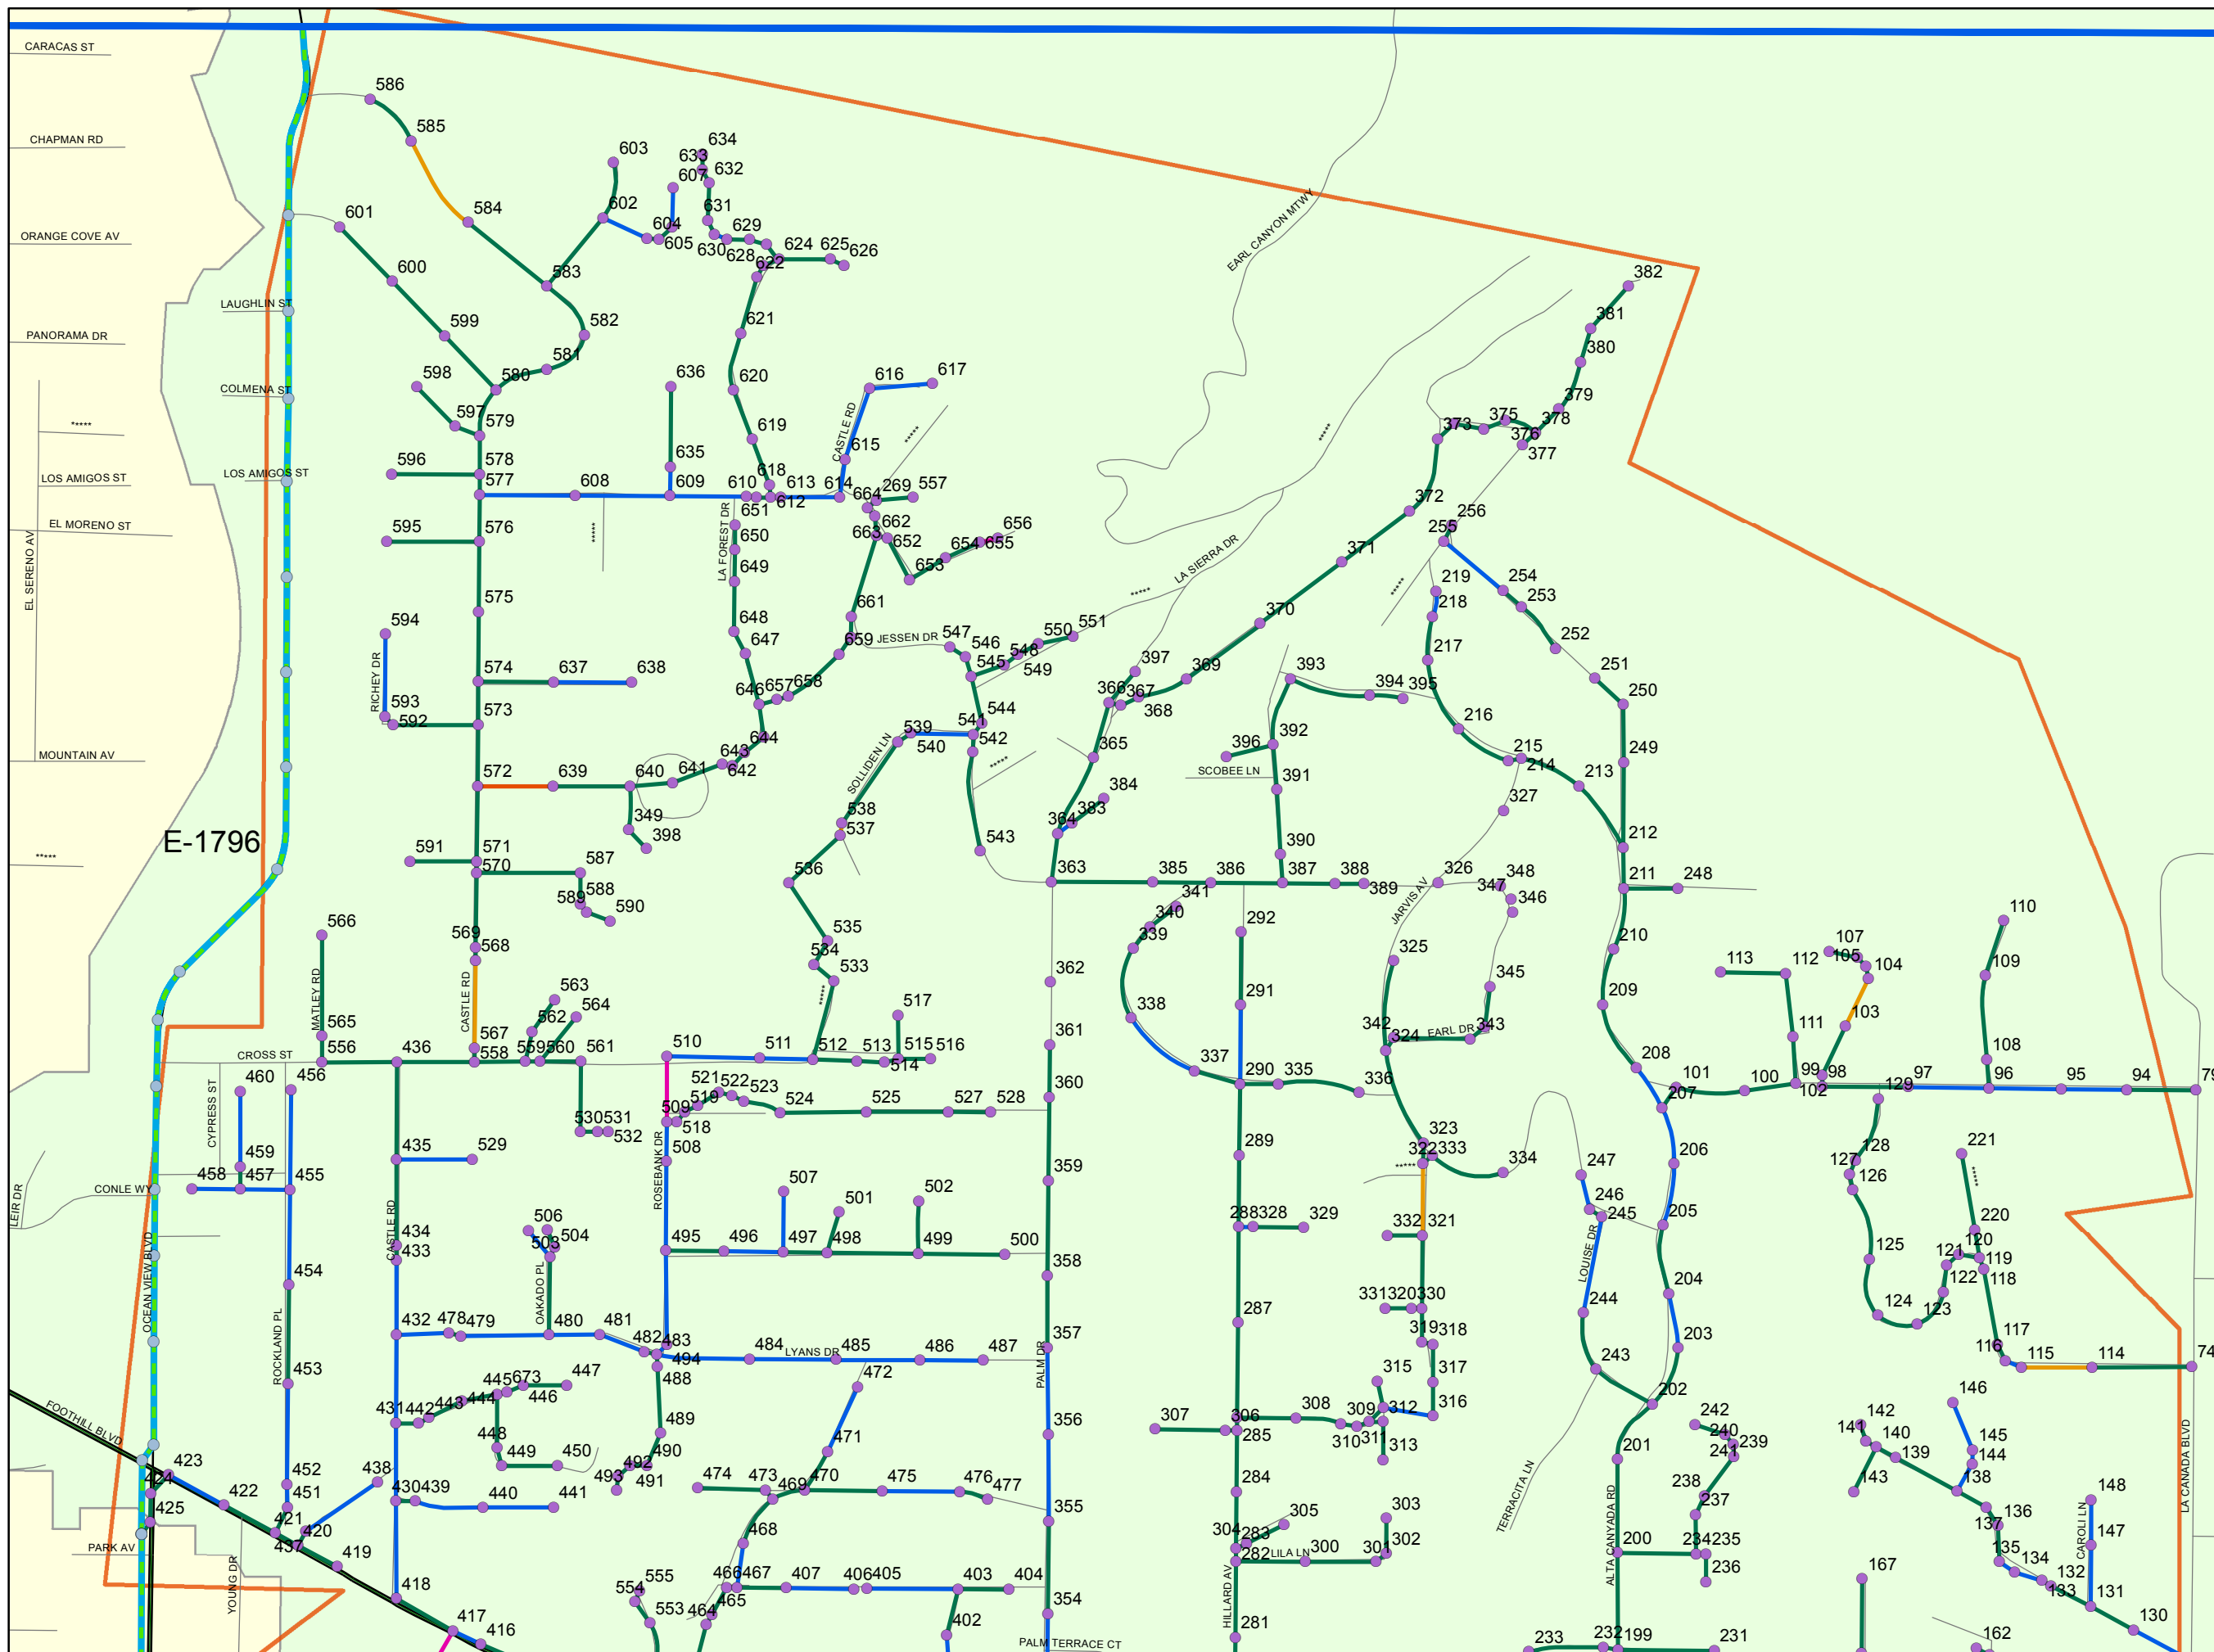
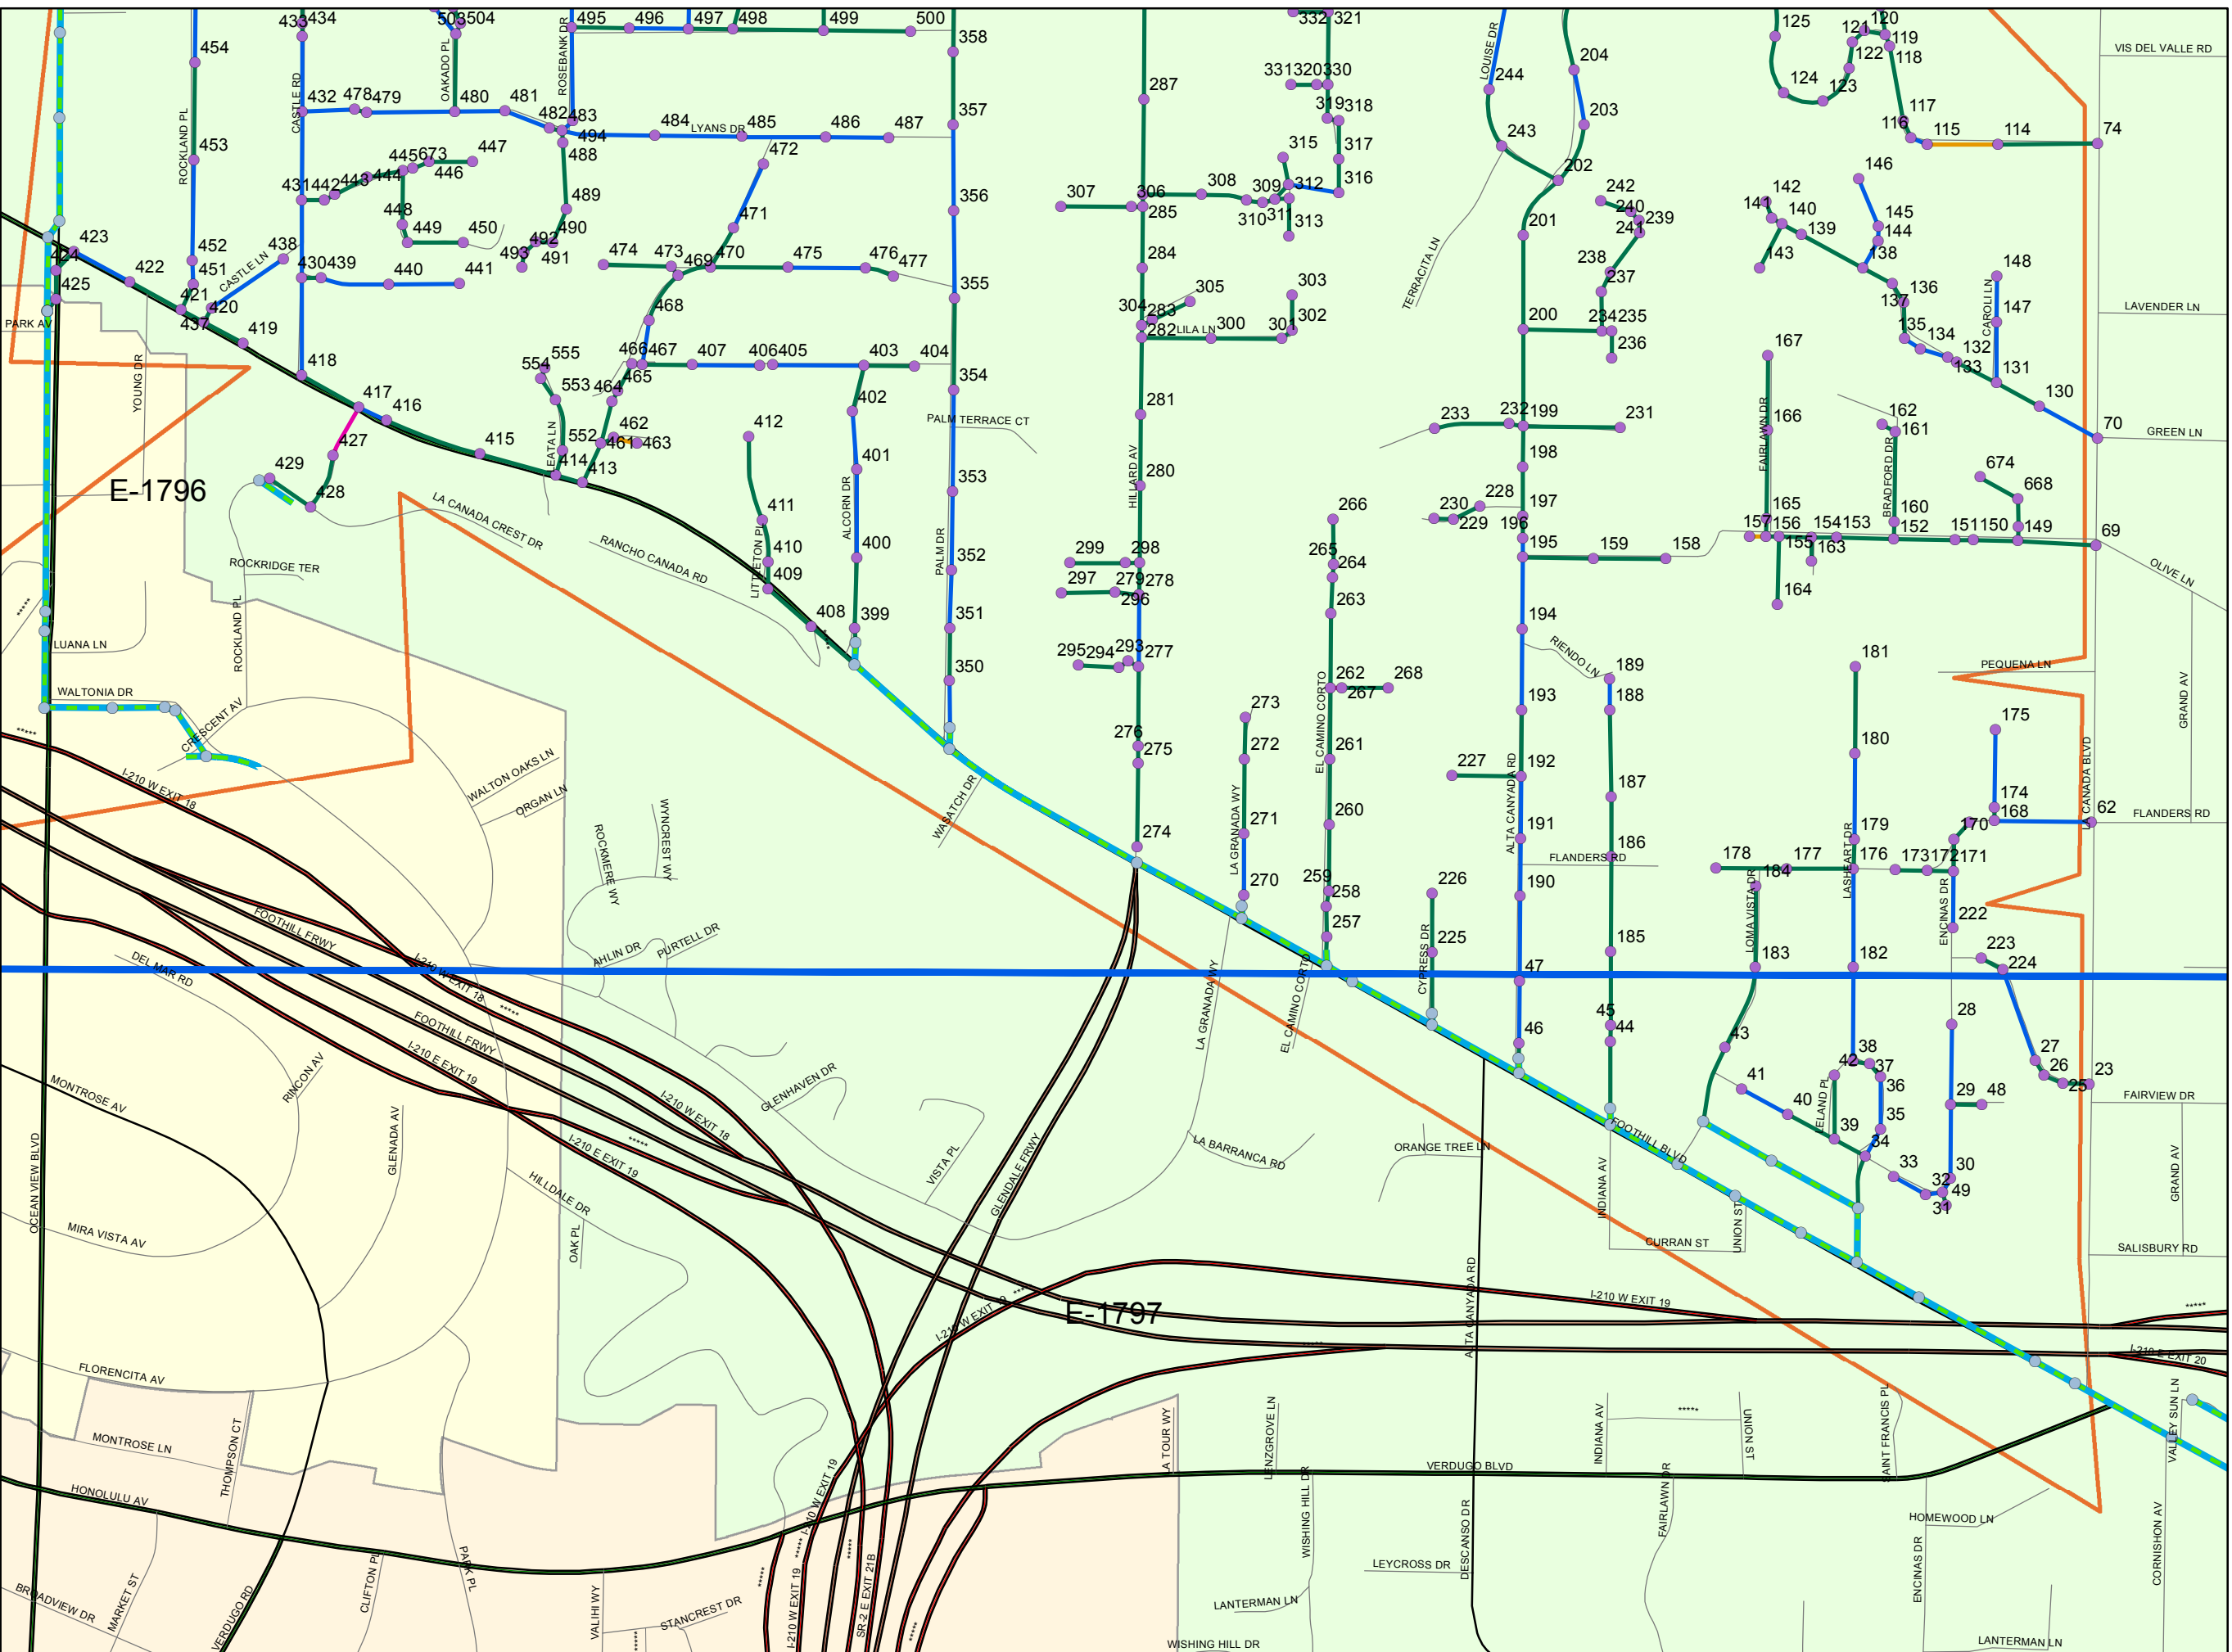
### QUICK MAINTENANCE RATING (QMR)

Our inspection revealed that approximately 97.7 percent of the system televised in your City as part of Project No. Y0TV1314B2 was free of significant blockages or restrictions that would impede sewer flows. The remaining 2.3 percent of the pipe segments within the City had a PACP maintenance grade of 3, 4, or 5 as indicated in the Quick Maintenance Rating Table shown below. These segments have been incorporated into our periodic cleaning schedule with corrective action taken.

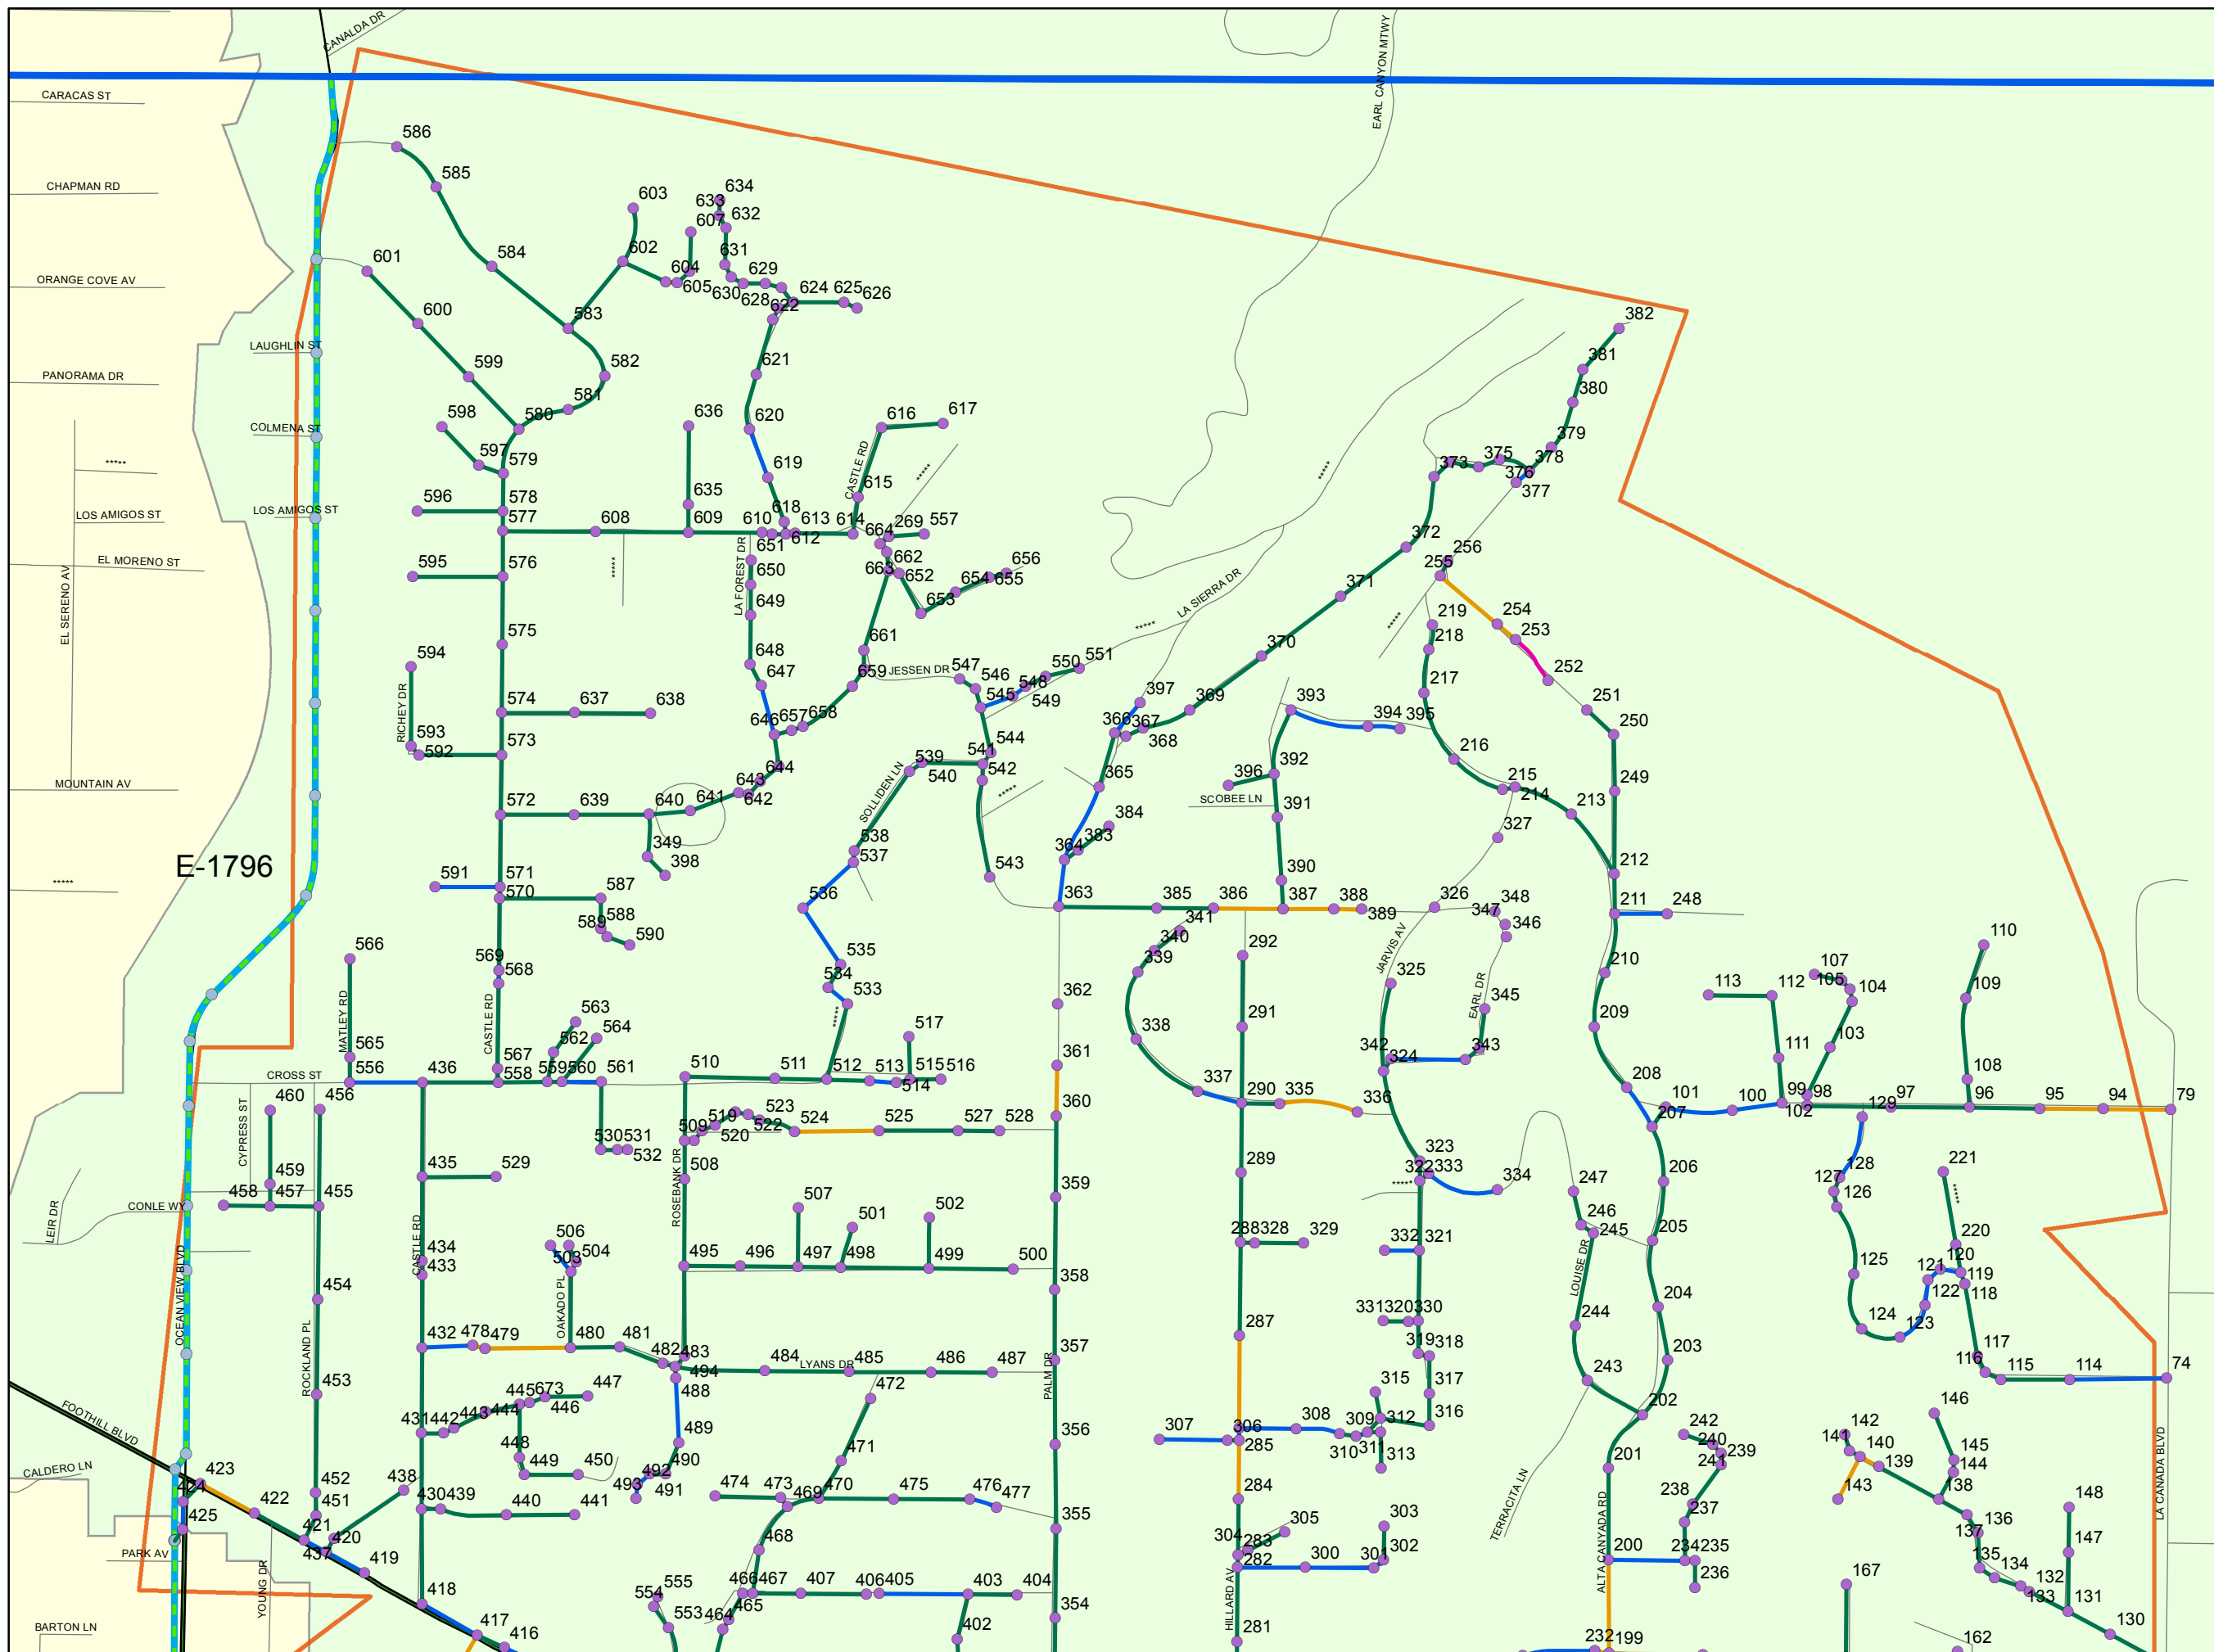
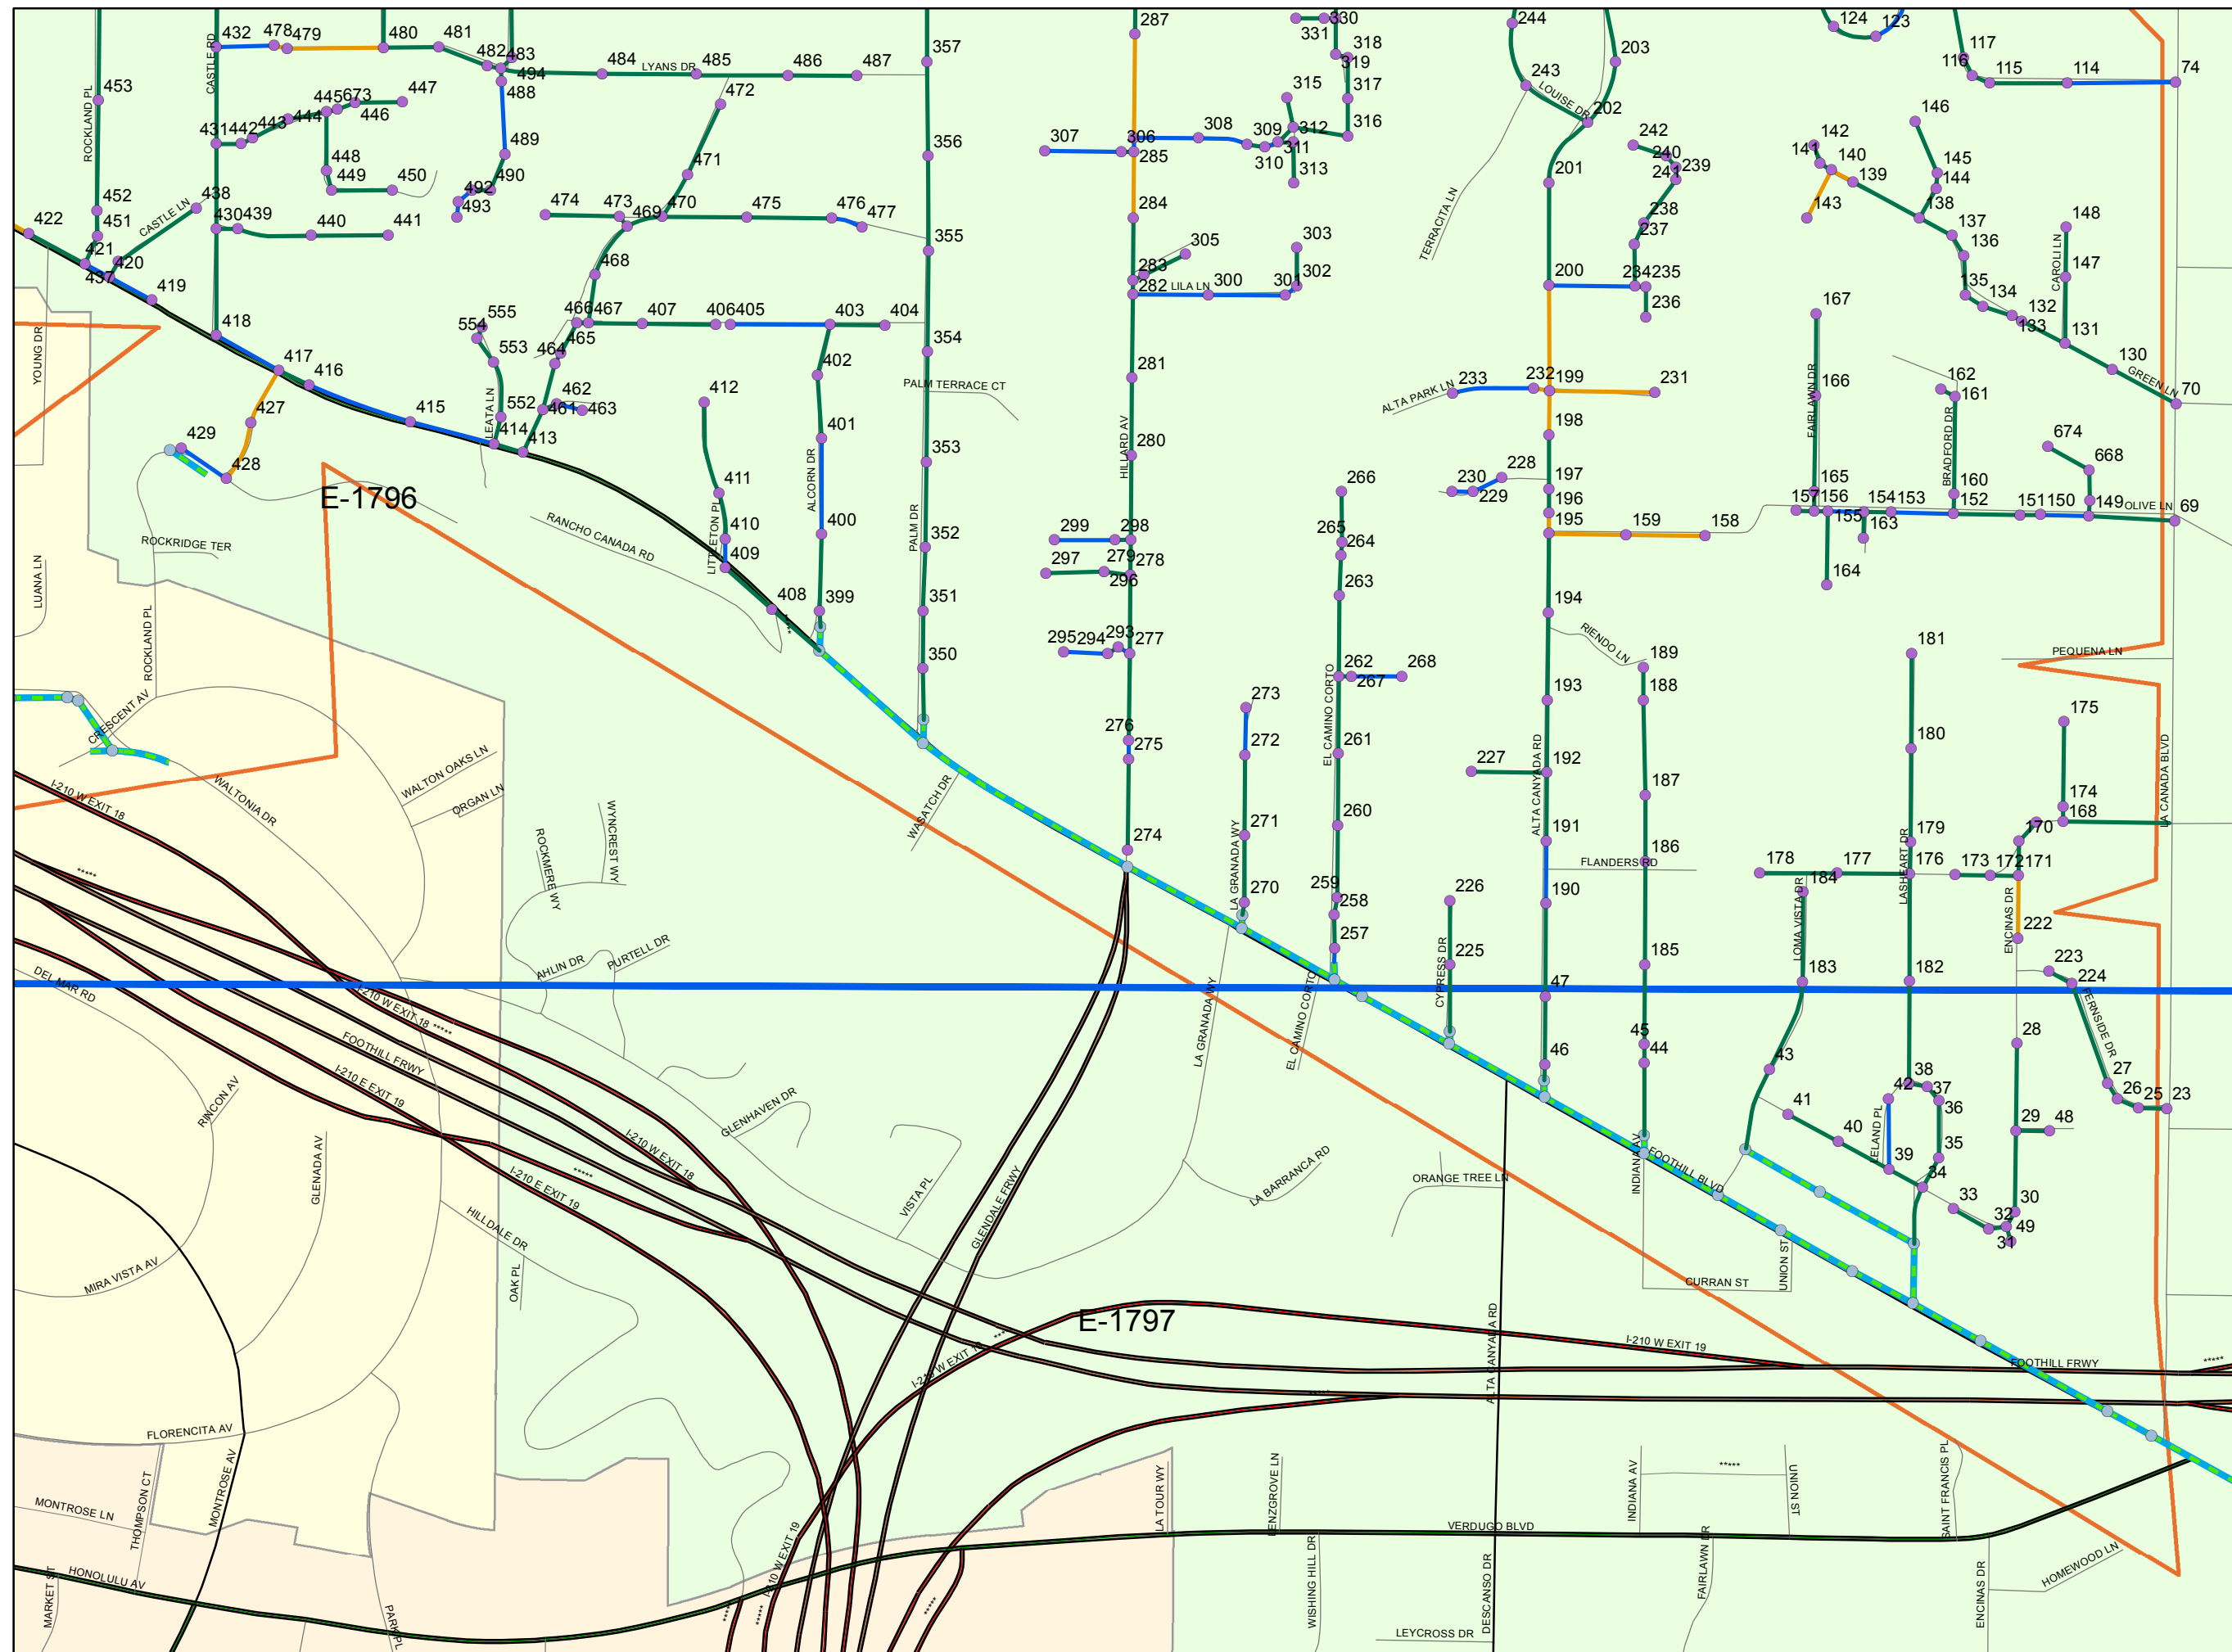
QUICK  
STRUCTURAL  
RATING  
(QSR)

Our inspection revealed that approximately 99.7 percent of the inspected pipe segments within the City were free of severe structural defects. The remaining 0.3 percent of the inspected pipe segments had a PACP structural grade of 4 or 5 as indicated in the Quick Structural Rating Table shown below. These segments have been placed on a priority list based on the severity and the need for action. Item 1 in the Quick Structural Rating Report Priority List (Enclosure 3), will be programmed in the next 24 months into the ongoing Accumulative Capital Outlay Program. We have determined that corrective action is required on item 2.

ITEM NO.	START MH	END MH	STREET	OBSERVATION	PROPOSED CORRECTIVE ACTION
1	1796-0605	1796-0604	ALLEY	Broken	Lining
2	1796-0253	1796-0252	LINDA VISTA DR	Fracture	No action needed*
