### **CONSOLIDATED SEWER MAINTENANCE DISTRICT SERVICES TO THE CITY OF LAKEWOOD**

**ENCLOSURE 2**  
**QUICK MAINTENANCE RATING REPORT PRIORITY LIST**  
**CITY OF LAKEWOOD**

Infrastructure Inspection Reports  
for Grades 4 and 5

# Periodics Report for City of Lakewood

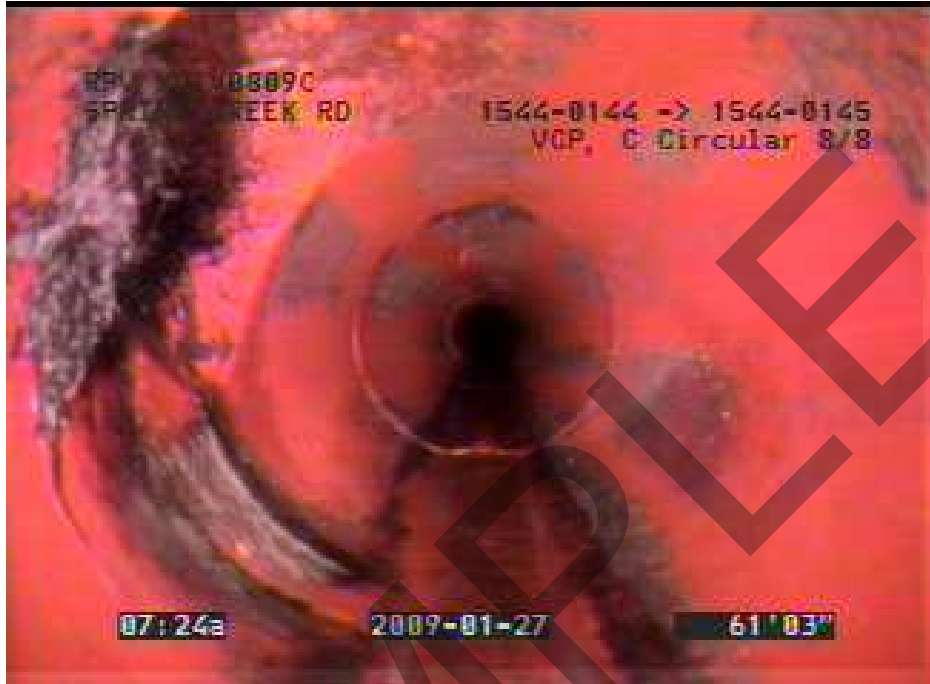
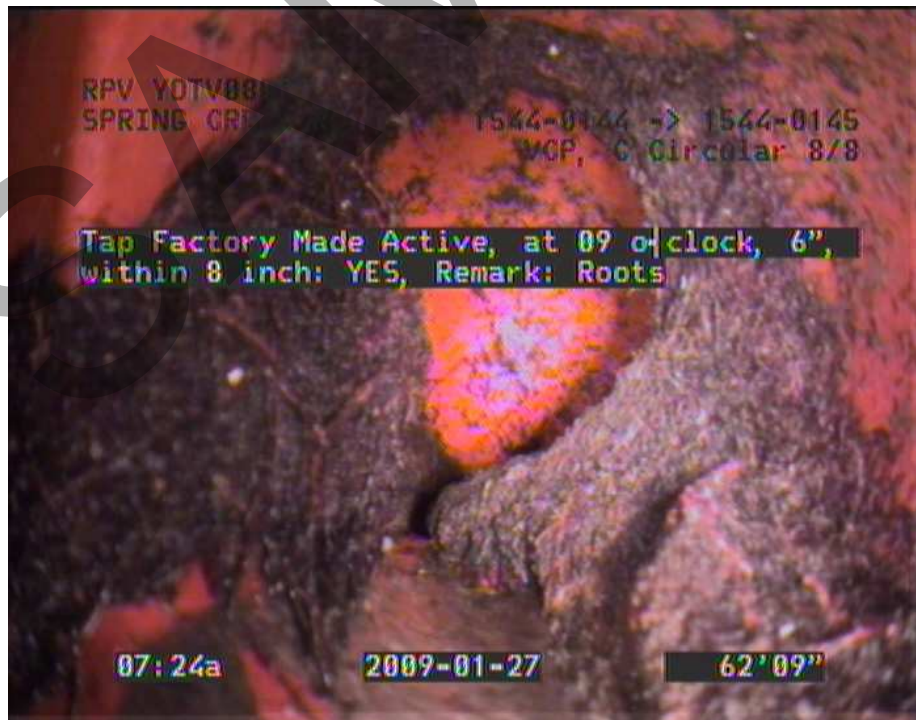
XXXX  
Roots at Lateral Connection

Since the CCTV inspection, the sewer mainline has been cleaned and blockages from root growth have been removed; however, the root blockage in your sewer lateral is still present. As the property owner, you are responsible for the entire length of the sewer lateral, which includes the portion that extends beyond the property line into the public right of way. We request that you contact a qualified plumbing contractor to service your sewer lateral within 90 days to remove roots and any other obstructions that may cause a sewage backup.

For your reference, we have enclosed photos of your lateral connection showing the presence of the root blockage. Also enclosed are some literature on ways of minimizing sewer overflows and damage to your home.
