DEPARTMENT OF PUBLIC WORKS

CONSOLIDATED SEWER MAINTENANCE DISTRICT CONDITION ASSESSMENT PROGRAM REPORT PROJECT Y0TV0506F

**CONDITION ASSESSMENT REPORT
COUNTY OF LOS ANGELES DEPARTMENT OF PUBLIC WORKS
CONSOLIDATED SEWER MAINTENANCE DISTRICT**

As part of the Sewer Condition Assessment Program, the County of Los Angeles Department of Public Works Consolidated Sewer Maintenance District has completed the closed-circuit television (CCTV) inspection of 76,591 feet or approximately 10.5 percent of the City of Rancho Palos Verdes' sewer system.

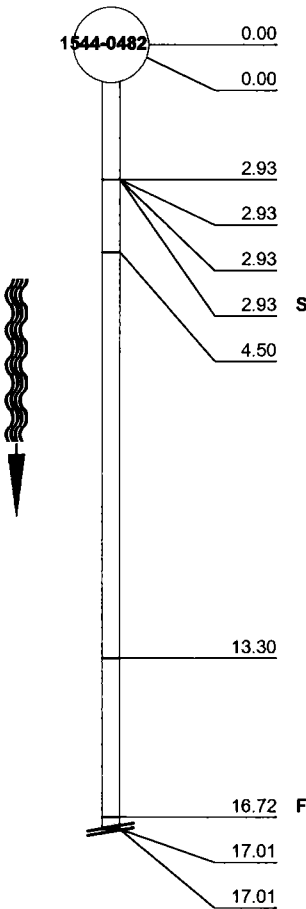
Comment: **Broken pipe**
 Location details: **Whitehorn Dr**

1:50	position	observation	MPEG	photo	grade
	0.00	Manhole	00:01:33		
	0.00	General Observation, Remark: Start Segment	00:01:37		
	2.93	Water Level, 5 % of cross sectional area	00:02:11		
	2.93	Water Mark, 20 % of cross sectional area	00:02:12		
	2.93	Crack Multiple, from 07 to 05 o'clock, within 8 inch: YES, Remark: roots	00:02:16		
	2.93 S1	Roots Fine Joint, from 08 to 04 o'clock, within 8 inch: YES, start	00:02:23		
	4.50	Fracture Multiple, from 07 to 10 o'clock, within 8 inch: YES	00:03:06	370a, b	
	13.30	Crack Multiple, from 08 to 04 o'clock, within 8 inch: YES	00:03:55		
	16.72 F1	Roots Fine Joint, from 08 to 04 o'clock, within 8 inch: YES, end			
	17.01	Broken Void Visible, from 07 to 05 o'clock, within 8 inch: YES	00:04:22	372a, b	
	17.01	Survey Abandoned, Remark: Pipe broken camera blocked	00:06:07	373a

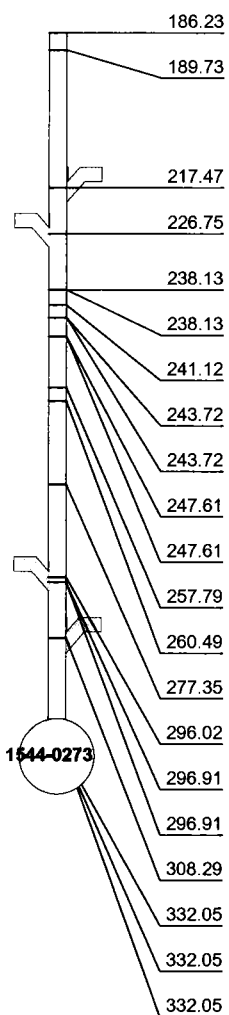
Comment: **cracks ,roots**

1:465	position	observation	MPEG	photo	grade
	<u>186.23</u>	Roots Fine Joint, from 01 to 03 o'clock, within 8 inch: YES	00:13:06		
	<u>189.73</u>	Crack Multiple, from 11 to 04 o'clock, within 8 inch: YES	00:13:23		
	<u>217.47</u>	Tap Factory Made Active, at 10 o'clock, 6", within 8 inch: YES	00:14:25		
	<u>226.75</u>	Tap Factory Made Active, at 02 o'clock, 6", within 8 inch: YES	00:15:01		
	<u>238.13</u>	Crack Circumferential, from 10 to 01 o'clock, within 8 inch: YES	00:15:44		
	<u>238.13</u>	Roots Fine Joint, from 03 to 08 o'clock, within 8 inch: YES	00:15:48		
	<u>241.12</u>	Roots Fine Joint, from 09 to 03 o'clock, within 8 inch: YES	00:16:23		
	<u>243.72</u>	Roots Fine Joint, from 09 to 03 o'clock, within 8 inch: YES	00:16:48		
	<u>243.72</u>	Crack Circumferential, from 08 to 11 o'clock, within 8 inch: YES	00:16:52		
	<u>247.61</u>	Roots Fine Joint, from 12 to 01 o'clock, within 8 inch: YES	00:17:12

<u>247.61</u>	Crack Circumferential, from 09 to 10 o'clock, within 8 inch: YES	00:17:14		
	<u>257.79</u>	Roots Fine Joint, from 09 to 04 o'clock, within 8 inch: YES	00:17:40		
	<u>260.49</u>	Crack Multiple, from 08 to 12 o'clock, within 8 inch: YES	00:17:49		
	<u>277.35</u>	Roots Fine Joint, from 12 to 03 o'clock, within 8 inch: YES	00:18:27		
	<u>296.02</u>	Tap Factory Made Active, at 02 o'clock, 6", within 8 inch: YES	00:19:10		
	<u>296.91</u>	Crack Multiple, from 08 to 02 o'clock, within 8 inch: YES	00:19:27		
	<u>296.91</u>	Roots Fine Joint, at 03 o'clock, within 8 inch: YES	00:19:34		
	<u>308.29</u>	Tap Factory Made Active, at 10 o'clock, 6", within 8 inch: YES, Remark: ROOTS	00:20:03	137a	
	<u>332.05</u>	General Observation, Remark: End of Segment	00:21:23		
	<u>332.05</u>	General Observation, Remark: Materials found- VCP	00:21:26		
	<u>332.05</u>	Manhole	00:21:39

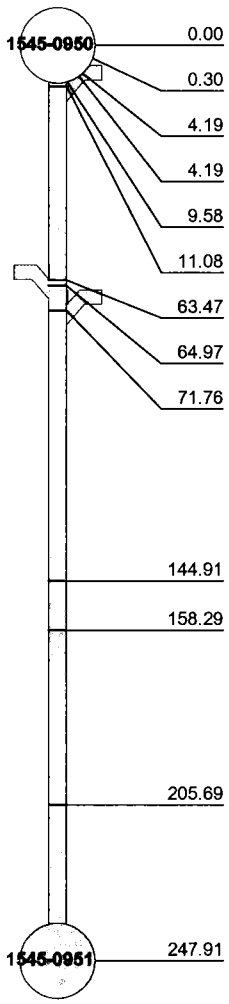
Comment: **Cracks and Roots**
 Location details: **Fawnskin**

144.91	Roots Fine Joint, from 03 to 05 o'clock, within 8 inch: YES	00:07:10		
	158.29	Crack Spiral, from 09 to 12 o'clock, within 8 inch: YES	00:07:58	1258a

205.69	Crack Spiral, from 09 to 11 o'clock, within 8 inch: YES	00:09:27		
	247.91	Manhole, Remark: End of Segment Material found-VCP	00:11:22

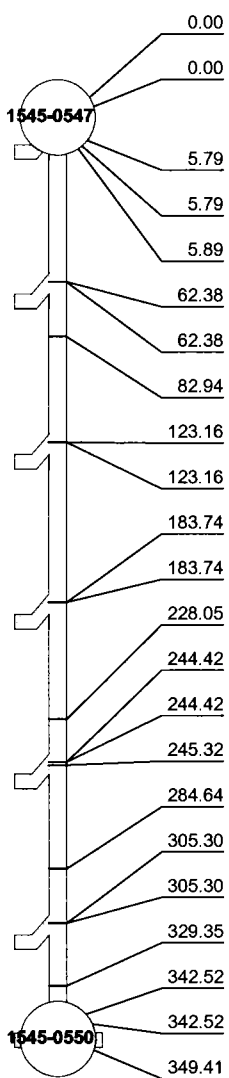
329.35	Roots Fine Joint, at 09 o'clock, within 8 inch: YES	00:15:13		
	342.52	Tap Factory Made Active, at 02 o'clock, 6", within 8 inch: YES, Remark: Roots	00:15:37

342.52	Roots Fine Lateral, from 03 to 09 o'clock, within 8 inch: YES	00:15:43		
	349.41	Manhole, Remark: End of Segment Material found-VCP	00:16:36

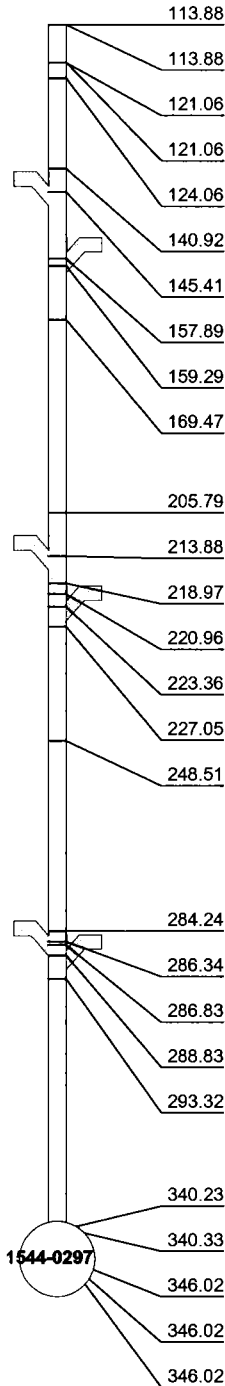
340.23	Fracture Multiple, from 04 to 08 o'clock, within 8 inch: YES	00:28:17	44a, b	
	340.33	Fracture Spiral, from 02 to 09 o'clock, within 8 inch: YES	00:28:58	45a, b

346.02	General Observation, Remark: End of Segment	00:29:39		
	346.02	General Observation, Remark: Materials found- VCP	00:29:40		
	346.02	Manhole	00:29:56

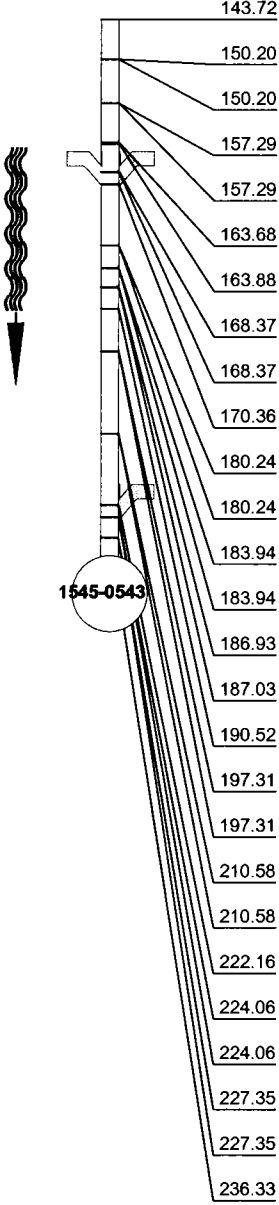
<u>180.24</u>	Crack Multiple, from 08 to 04 o'clock, within 8 inch: YES, Remark: Roots	00:18:05	2470a	
	<u>180.24</u>	Roots Fine Joint, from 08 to 04 o'clock, within 8 inch: YES	00:18:10		
	<u>183.94</u>	Crack Spiral, from 07 to 11 o'clock, within 8 inch: YES, Remark: Roots	00:18:27	2472a	
	<u>183.94</u>	Roots Fine Joint, from 07 to 10 o'clock, within 8 inch: YES	00:18:44		
	<u>186.93</u>	Crack Multiple, from 08 to 11 o'clock, within 8 inch: YES, Remark: Roots	00:19:00	2474a	
	<u>187.03</u>	Roots Fine Joint, from 08 to 04 o'clock, within 8 inch: YES	00:19:14		
	<u>190.52</u>	Crack Multiple, from 07 to 11 o'clock, within 8 inch: YES	00:19:30	2476a	
	<u>197.31</u>	Crack Multiple, from 09 to 03 o'clock, within 8 inch: YES, Remark: Roots	00:20:03	2477a	
	<u>197.31</u>	Roots Fine Joint, from 08 to 04 o'clock, within 8 inch: YES	00:20:10		
	<u>210.58</u>	Crack Multiple, from 08 to 04 o'clock, within 8 inch: YES, Remark: Roots	00:20:41

<u>210.58</u>	Roots Fine Joint, from 08 to 04 o'clock, within 8 inch: YES	00:20:46		
	<u>222.16</u>	Tap Factory Made Active, at 10 o'clock, 4", within 8 inch: YES	00:21:11		
	<u>224.06</u>	Crack Multiple, from 08 to 04 o'clock, within 8 inch: YES, Remark: Roots	00:21:25	2482a	
	<u>224.06</u>	Roots Fine Joint, from 10 to 02 o'clock, within 8 inch: YES	00:21:46		
	<u>227.35</u>	Crack Multiple, from 01 to 09 o'clock, within 8 inch: YES, Remark: Roots	00:22:24	2484a	
	<u>227.35</u>	Roots Fine Joint, from 10 to 02 o'clock, within 8 inch: YES	00:22:30		
	<u>236.33</u>	Manhole, Remark: End of Segment Material found-VCP	00:23:23

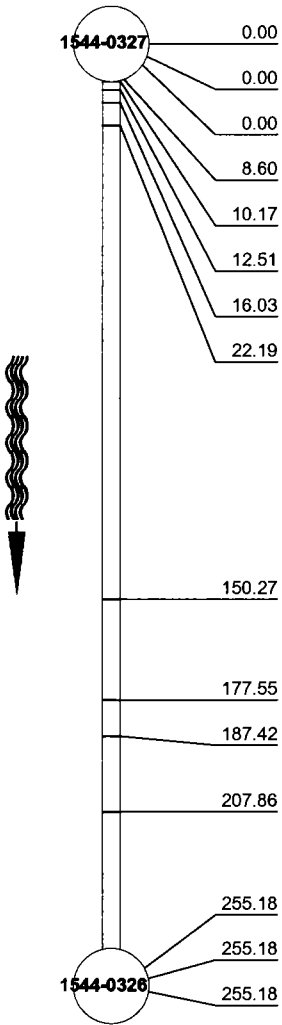
207.86	Crack Circumferential, from 10 to 02 o'clock, within 8 inch: YES	00:10:27		
	255.18	General Observation, Remark: End Segment	00:12:06		
	255.18	General Observation, Remark: pipe material found VCP	00:12:07

255.18	Manhole	00:12:22

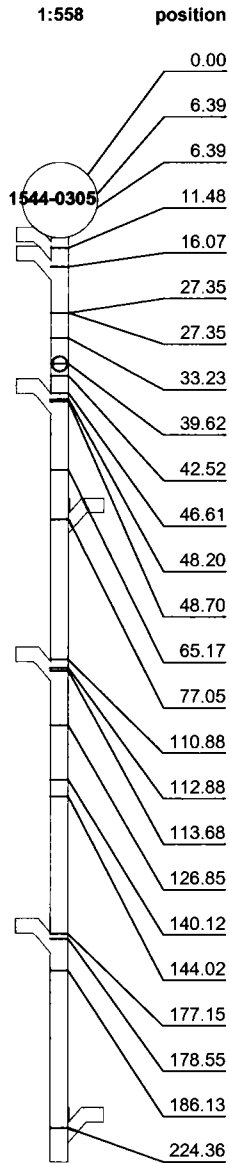
178.55	Tap Factory Made Active, at 02 o'clock, 6", within 8 inch: YES	00:10:36		
	186.13	Crack Longitudinal, at 08 o'clock, within 8 inch: YES	00:10:59	436a

224.36	Tap Factory Made Active, at 10 o'clock, 10", within 8 inch: YES	00:12:13

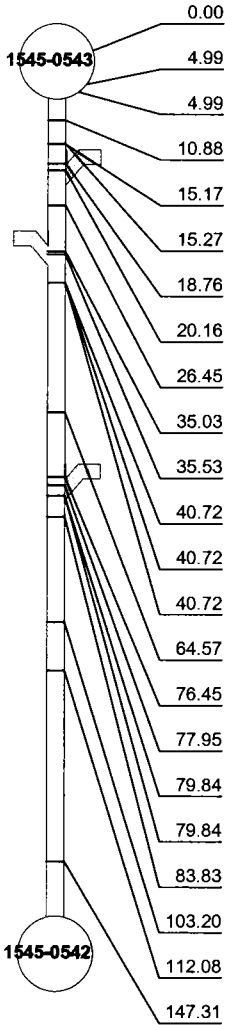
103.20	Roots Fine Joint, from 11 to 02 o'clock, within 8 inch: YES	00:09:34		
	112.08	Crack Multiple, from 08 to 04 o'clock, within 8 inch: YES	00:11:24

147.31	Crack Multiple, from 10 to 02 o'clock, within 8 inch: YES	00:13:06

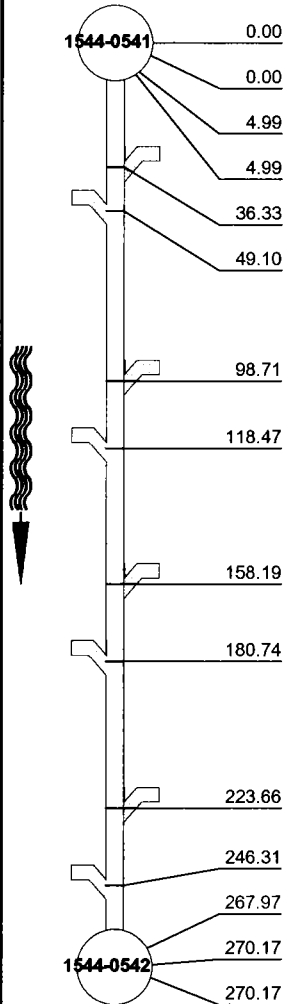
267.97	Hole, from 04 to 06 o'clock, within 8 inch: NO, Remark: at manhole	00:10:26	461a	S 4
	270.17	General Observation, Remark: End of Segment Material found-VCP	00:11:10

270.17	Manhole	00:11:31
