CONSOLIDATED SEWER MAINTENANCE DISTRICT CONDITION ASSESSMENT PROGRAM REPORT CITY OF SANTA FE SPRINGS

**CONDITION ASSESSMENT REPORT
COUNTY OF LOS ANGELES DEPARTMENT OF PUBLIC WORKS
CONSOLIDATED SEWER MAINTENANCE DISTRICT**

PROJECT NAME:	Y0TV1011B	PROJECT MGR:	Hanna Kebede
PROJECT DATE:	02/03/11	CONTACT NO:	(626) 300-3388
SUP. DISTRICT(s):	1	MAP PAGE(S):	2025,2026
Report By:	May Hong	Report Date:	01/07/16

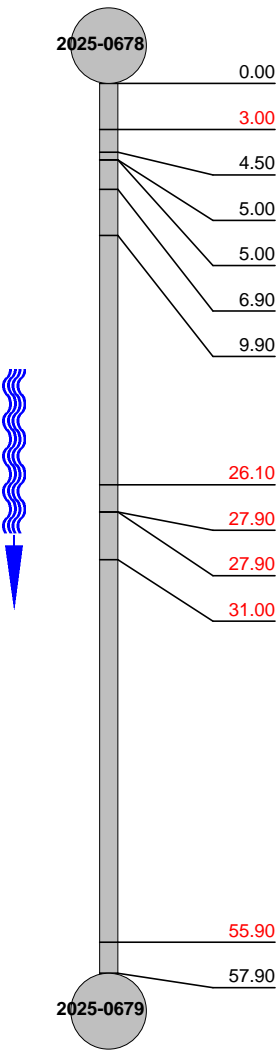
0.00	AMH	Manhole, within 8 inch: NO, Remarks: 2025-0678	
	3.00	S1 CM	Crack Multiple, from 7 to 5 o'clock, within 8 inch: YES, Start	(Struct) 3
	4.50	TFA	Tap Factory Active, at 3 o'clock, 6", within 8 inch: NO
