# COUNTY OF LOS ANGELES

## DEPARTMENT OF PUBLIC WORKS

**CONSOLIDATED SEWER MAINTENANCE DISTRICT  
CONDITION ASSESSMENT PROGRAM REPORT  
PROJECT NO. Y0TV1112C**

**CONDITION ASSESSMENT REPORT  
LOS ANGELES COUNTY PUBLIC WORKS  
CONSOLIDATED SEWER MAINTENANCE DISTRICT**

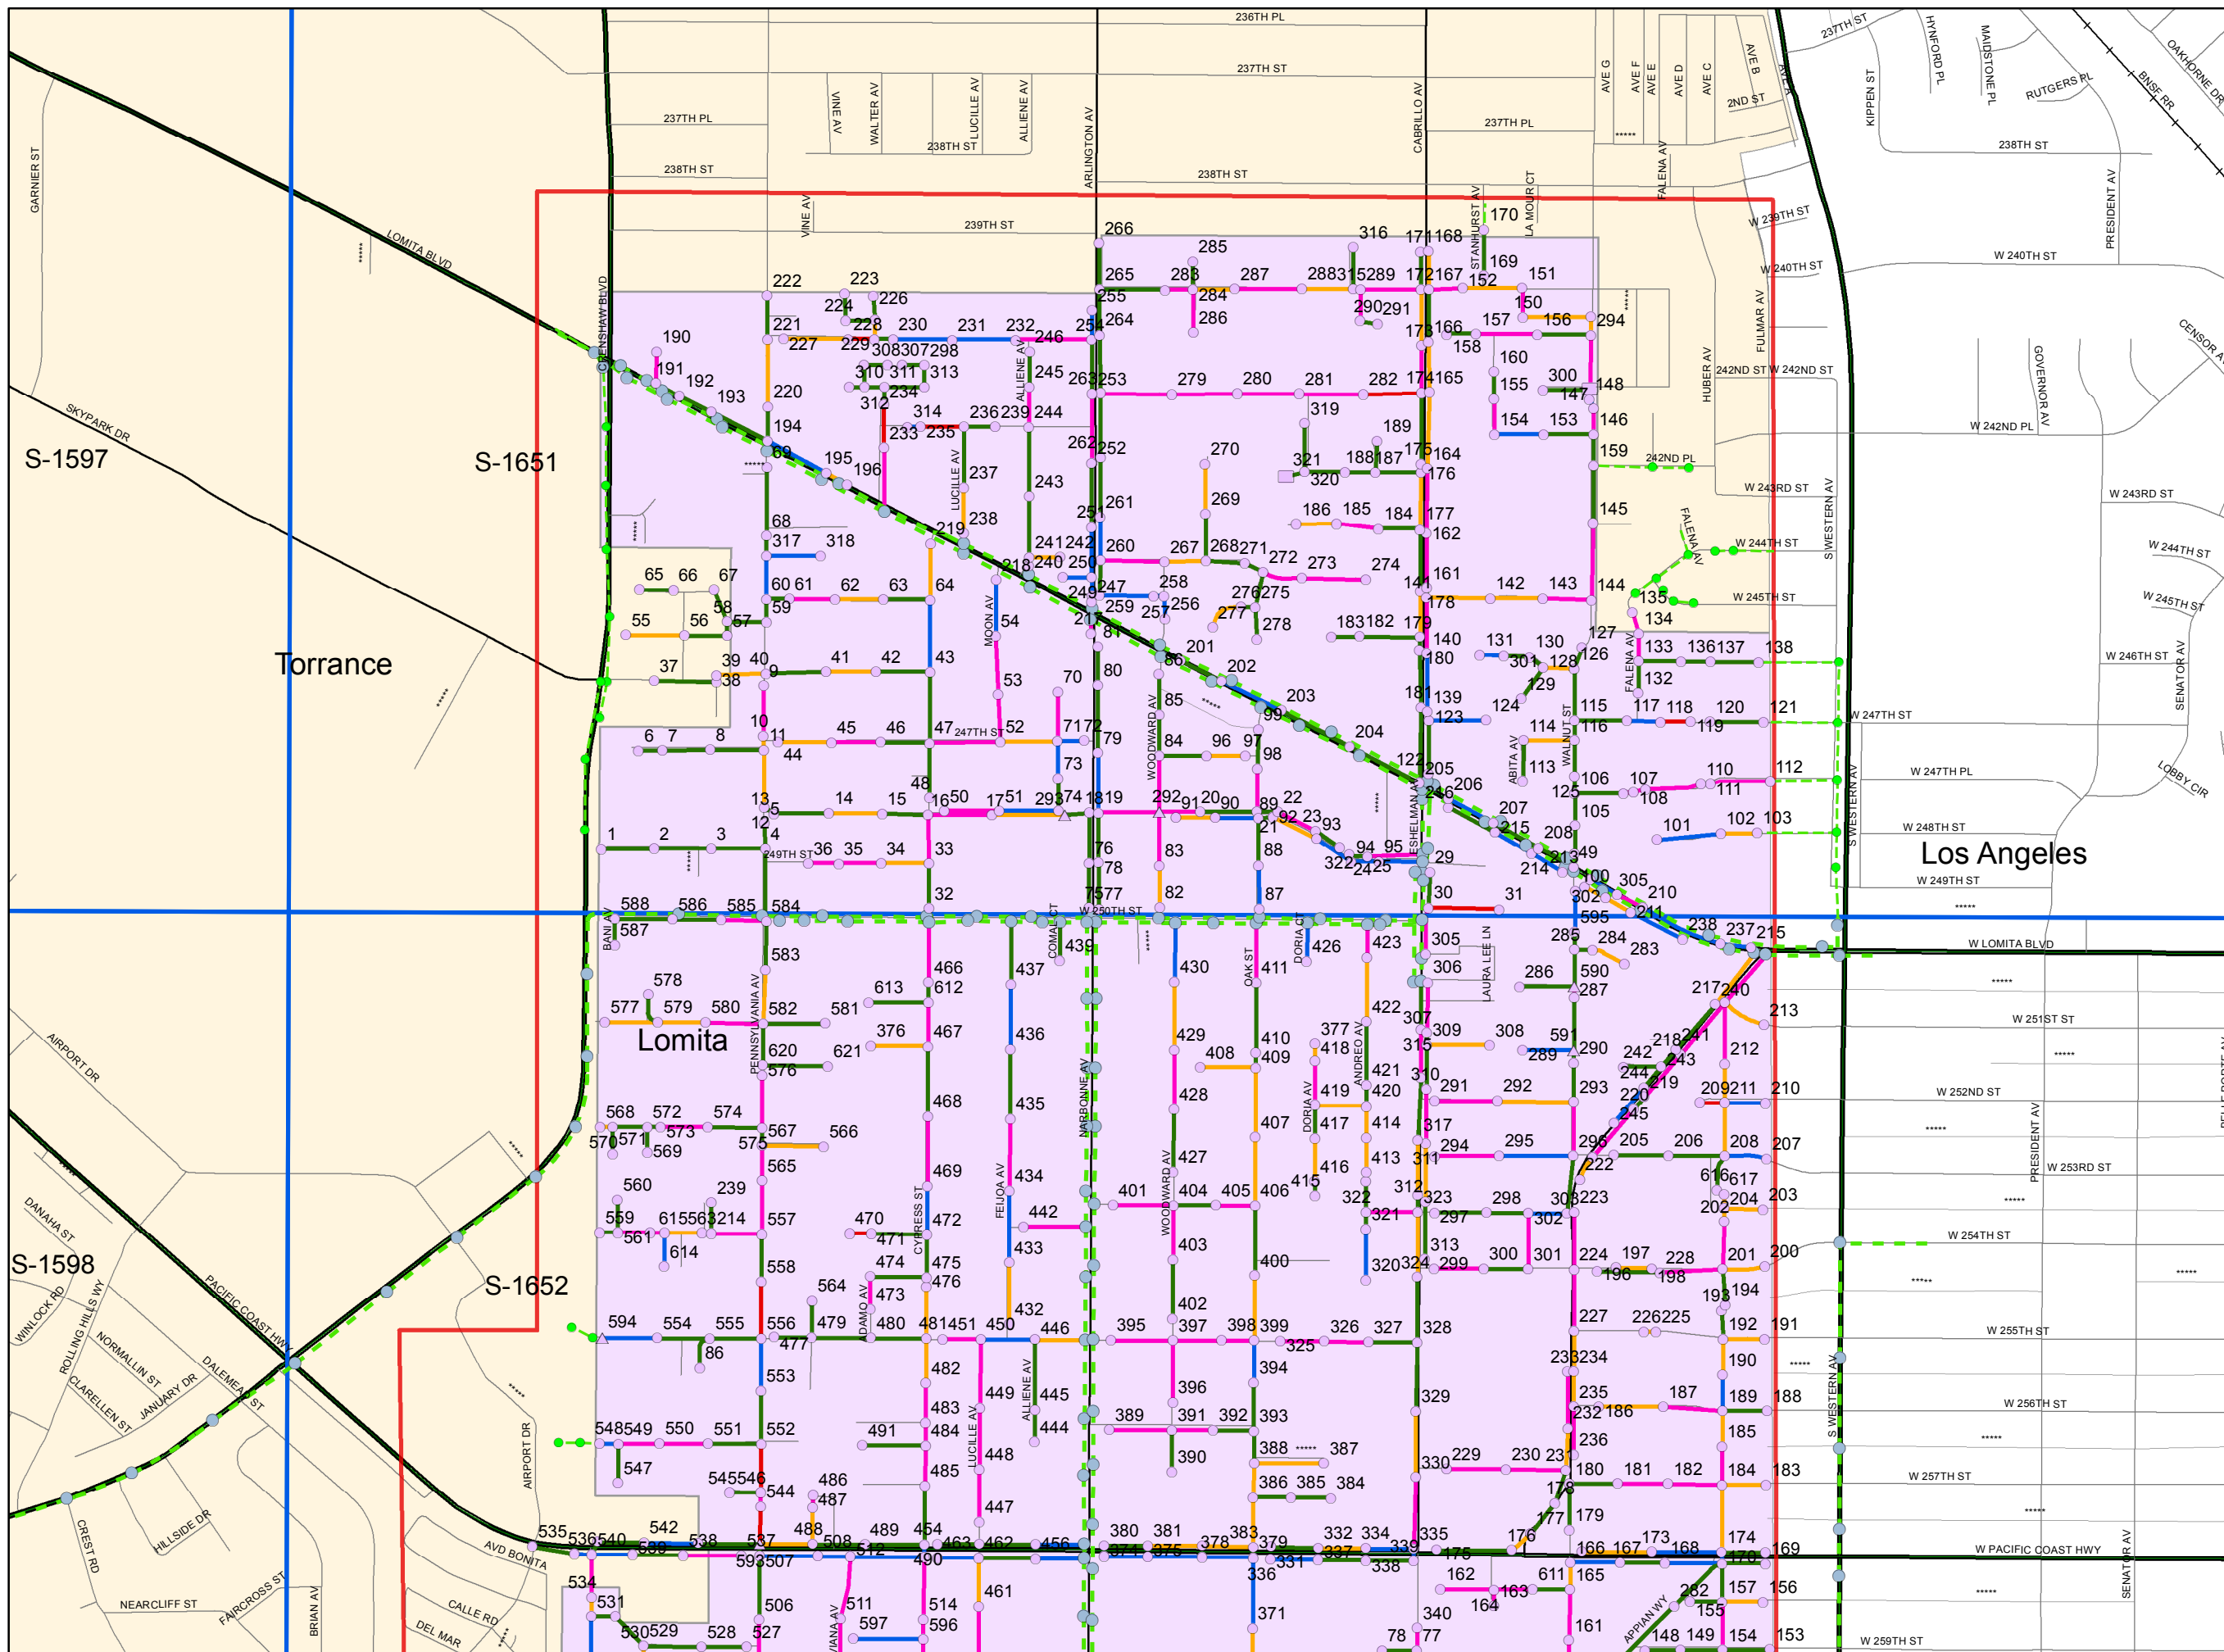
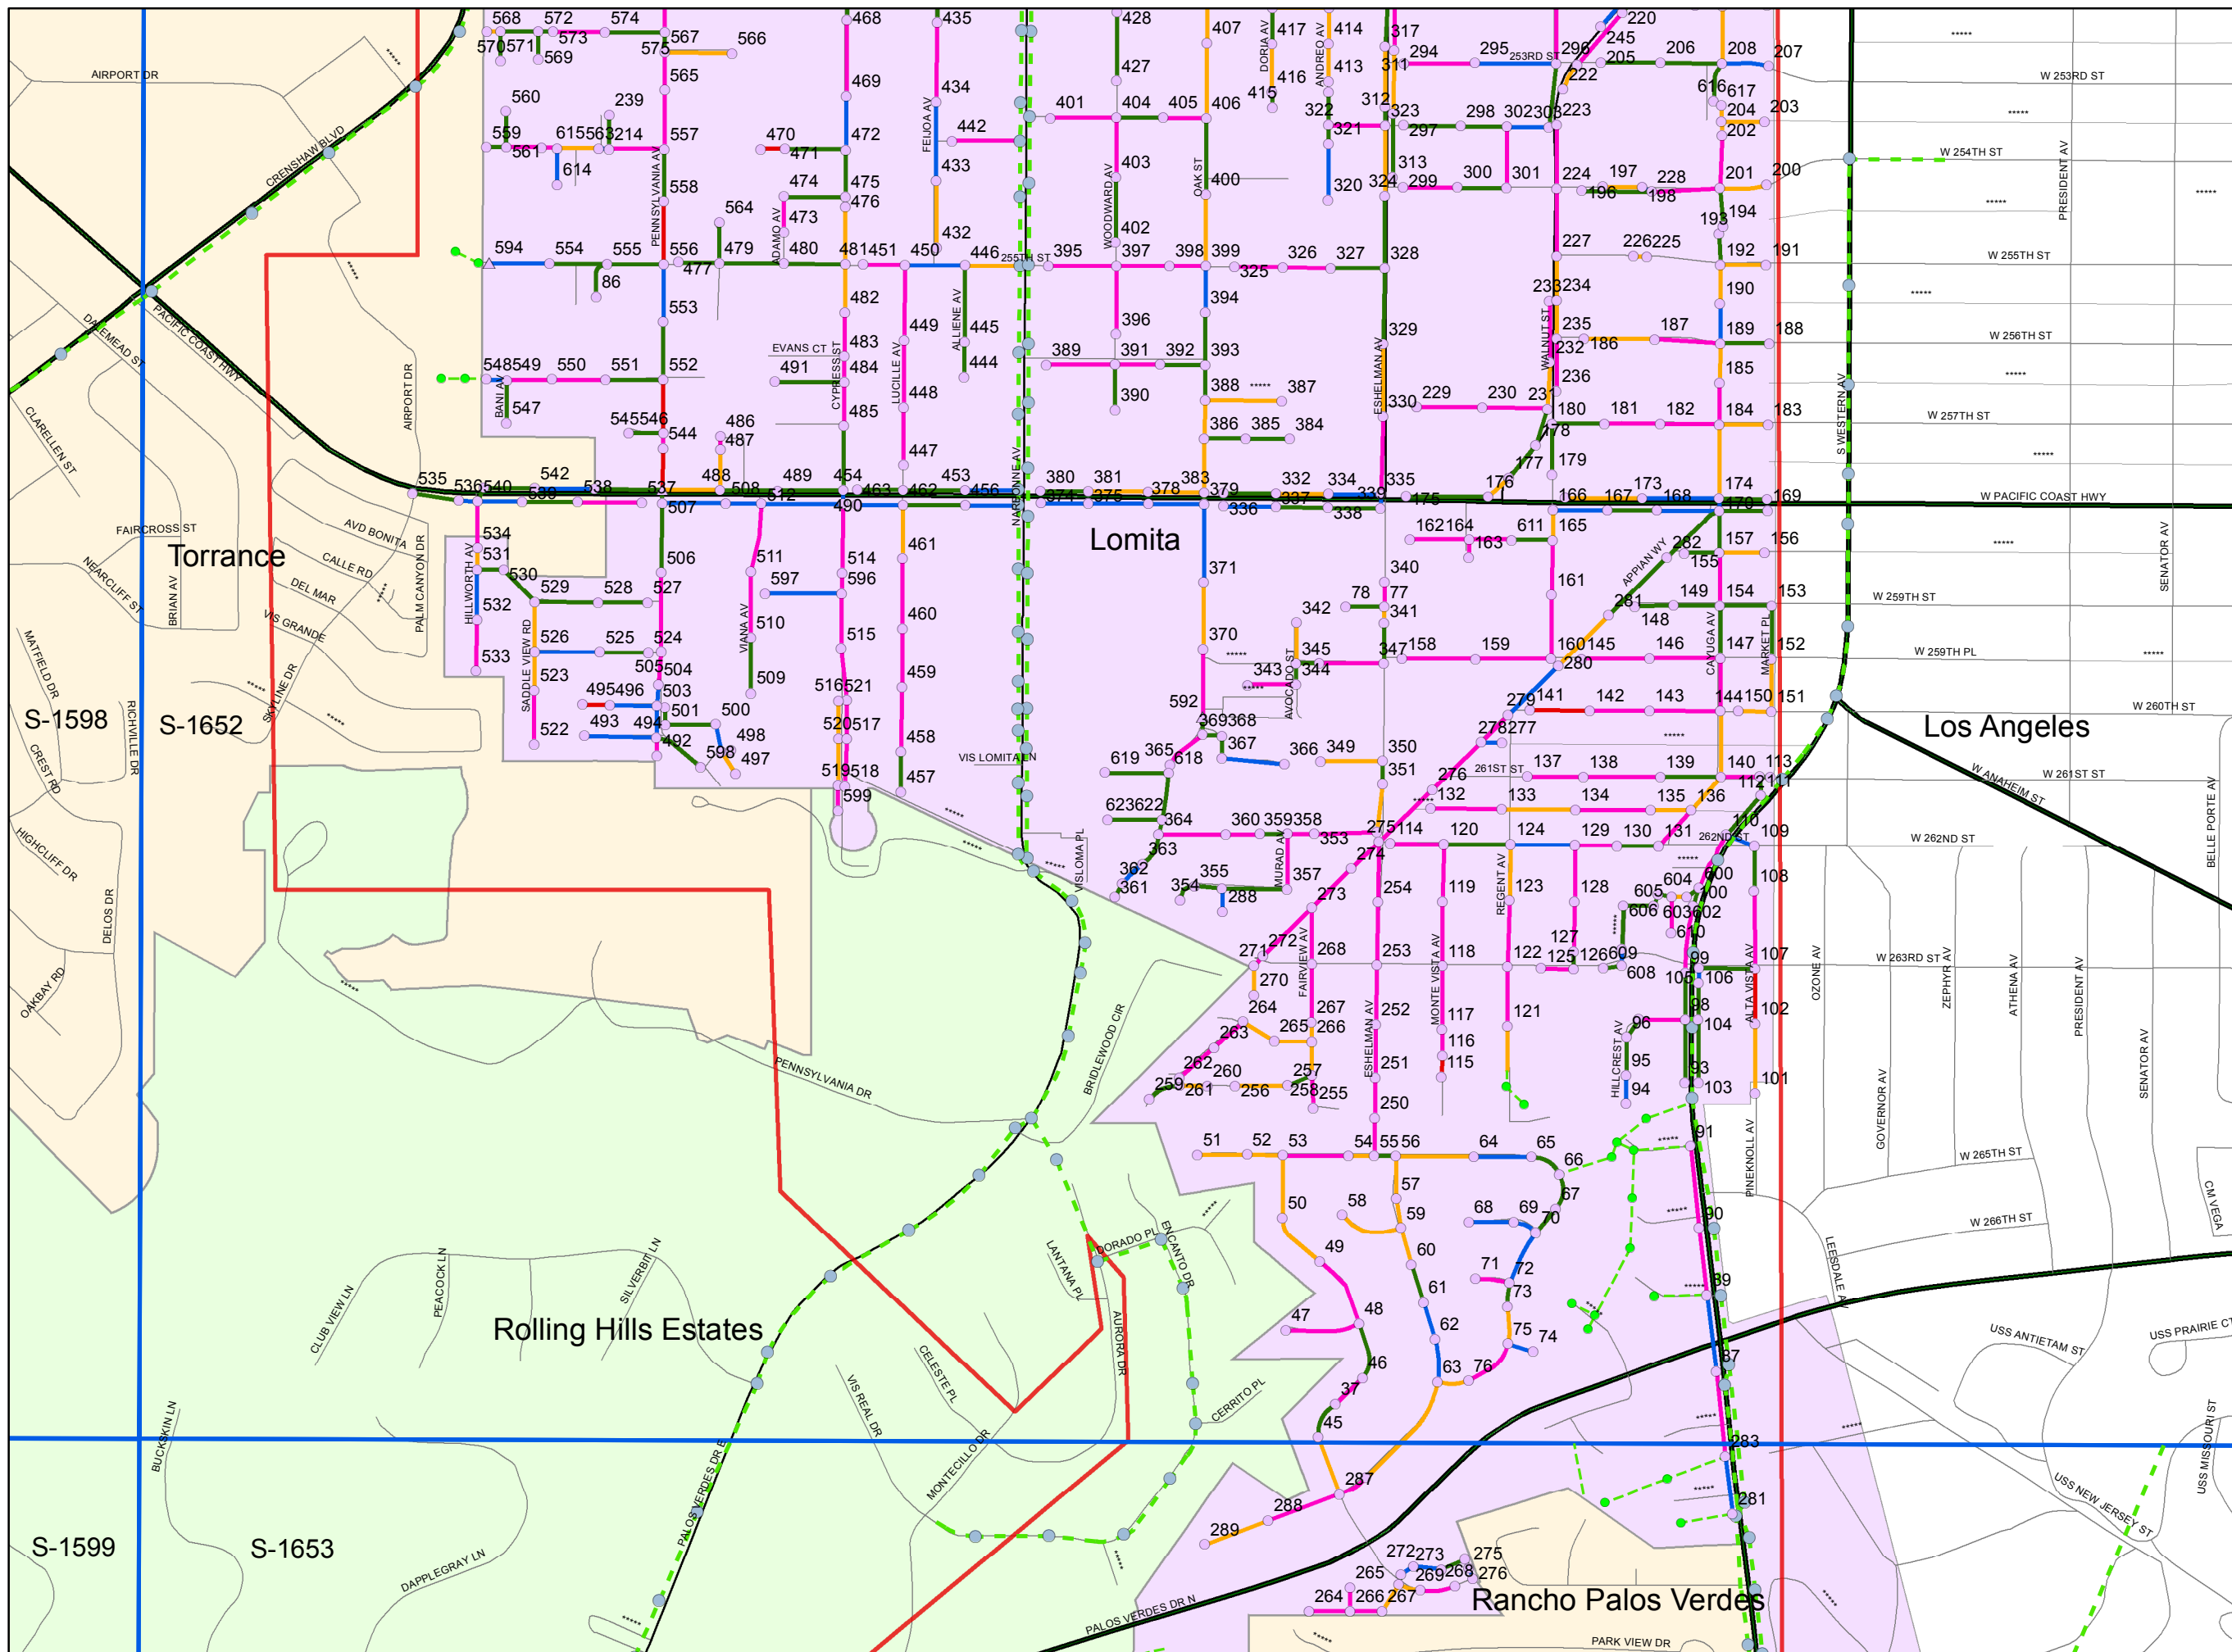
QUICK  
MAINTENANCE  
RATING  
(QMR)

Our inspection revealed that approximately 50.6 percent of the system televised in your City as part of Project No. Y0TV1112C was free of significant blockages or restrictions that would impede sewer flows. The remaining 49.4 percent of the pipe segments within the City had a PACP maintenance grade of 3, 4, or 5 as indicated in the Quick Maintenance Rating Table shown below. These segments have been incorporated into our periodic cleaning schedule with corrective action taken.

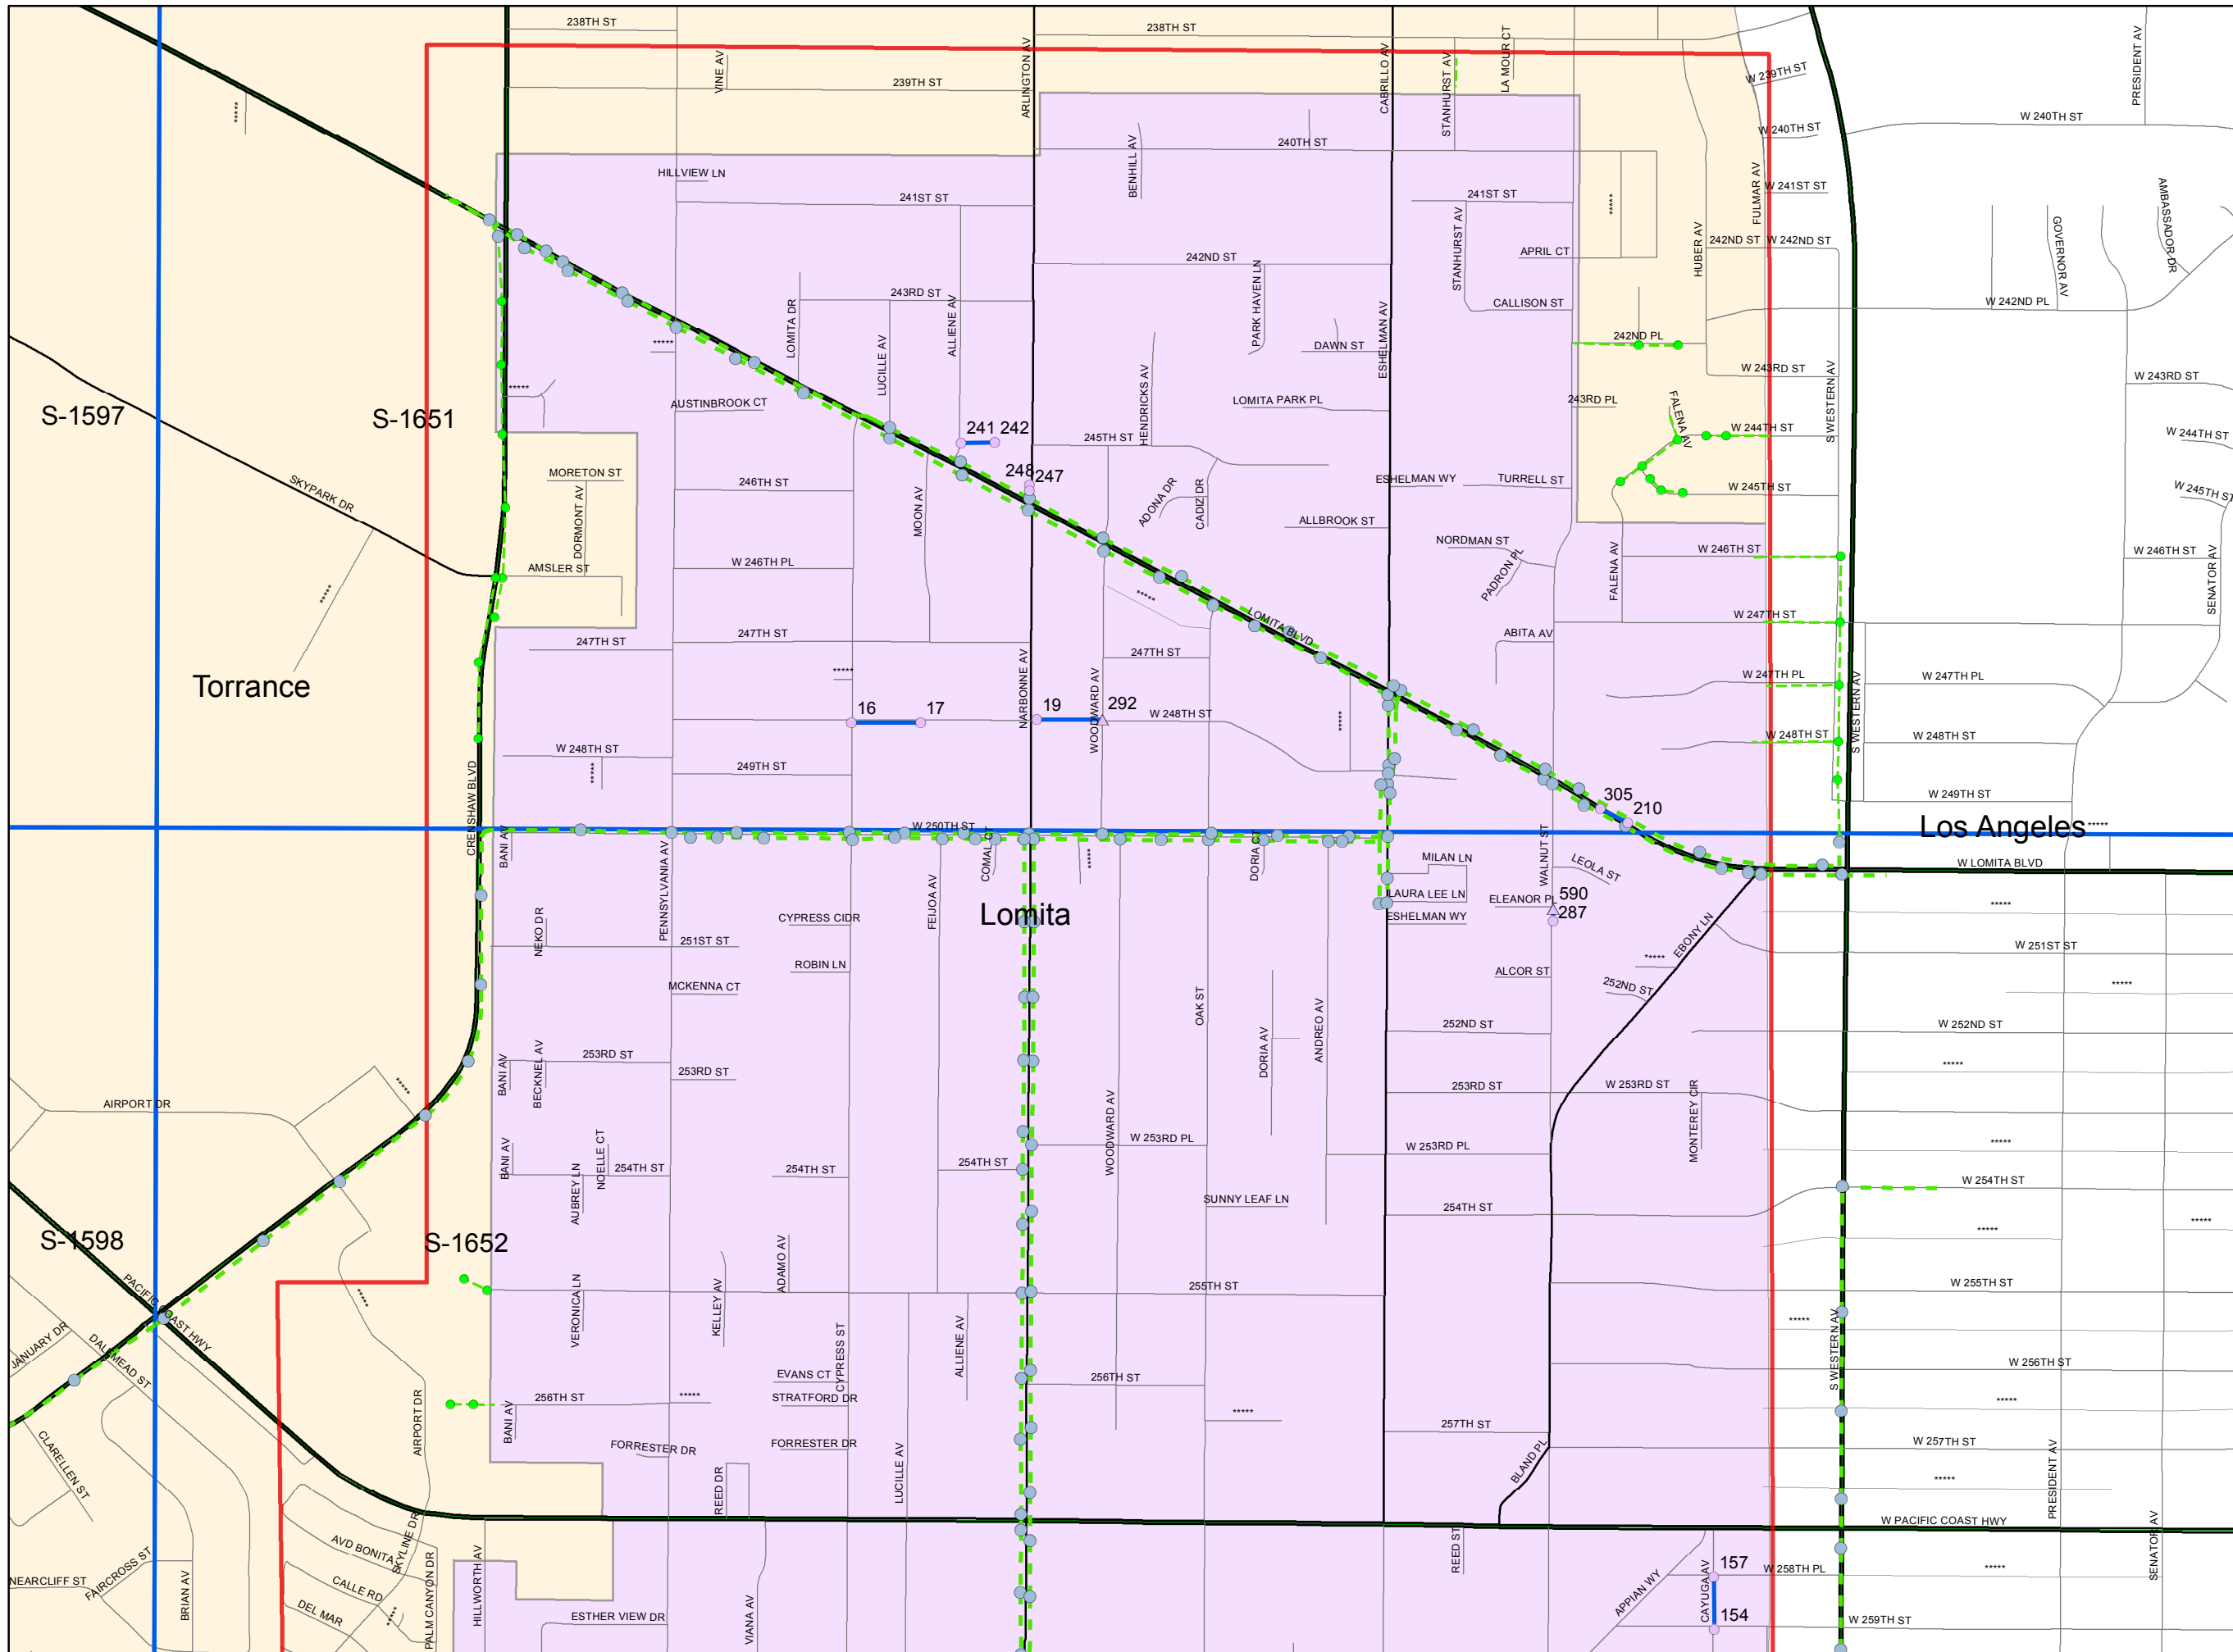
**HIGH WATER LEVEL**

Our inspection revealed that approximately 99.2 percent of the system televised has adequate capacity. Approximately 0.8 percent of the segments inspected exhibited visual signs associated with high water levels. The capacity of the sewer pipe can be determined by analyzing several PACP codes, including Water Level, Water Mark, and miscellaneous remarks, which indicate the camera was underwater or there were sags in the line. A sewer pipe is considered at capacity when 50 percent of the diameter of the sewer pipe is full of water. However, there are conditions in which the Water Level or Water Mark has reached 50 percent or greater due to heavy flows in adjoining pipes, a temporary stoppage caused by debris in the sewer lines, or a sag in the line. Therefore, additional review of these pipe segments was conducted to determine if any capacity issues exist.

| <b>ITEM NO.</b> | <b>QMR</b> | <b>START MH</b> | <b>END MH</b> | <b>STREET</b> | <b>OBSERVATION</b> | <b>CORRECTIVE ACTION TAKEN<br/>(DATE COMPLETED)</b> |
| 1 | 4A00 | 1651-0019 | 1651-0292 | 248TH ST | High water (219' to 311' ) | Rodder (7/2/2015) |
| 2 | 4221 | 1651-0248 | 1651-0247 | NARBONNE AV | Water mark: 60% | Rodder (7/6/2015) |
| 3 | 4121 | 1651-0305 | 1651-0210 | LOMITA BV | Water mark: 50% | No maintenance action needed. |
| 4 | 4111 | 1652-0154 | 1652-0157 | CAYUGA AV | Water mark: 50% | No maintenance action needed. |
| 5 | 4100 | 1651-0016 | 1651-0017 | 248TH ST | Sag (60%): 4'-16' | No maintenance action needed. |
| 6 | 4100 | 1652-0287 | 1652-0590 | WALNUT ST | Water mark: 50% | No maintenance action needed. |
| 7 | 3122 | 1652-0242 | 1650-0241 | ALLEY | Sag (50%): 2'-8' | No maintenance action needed. |

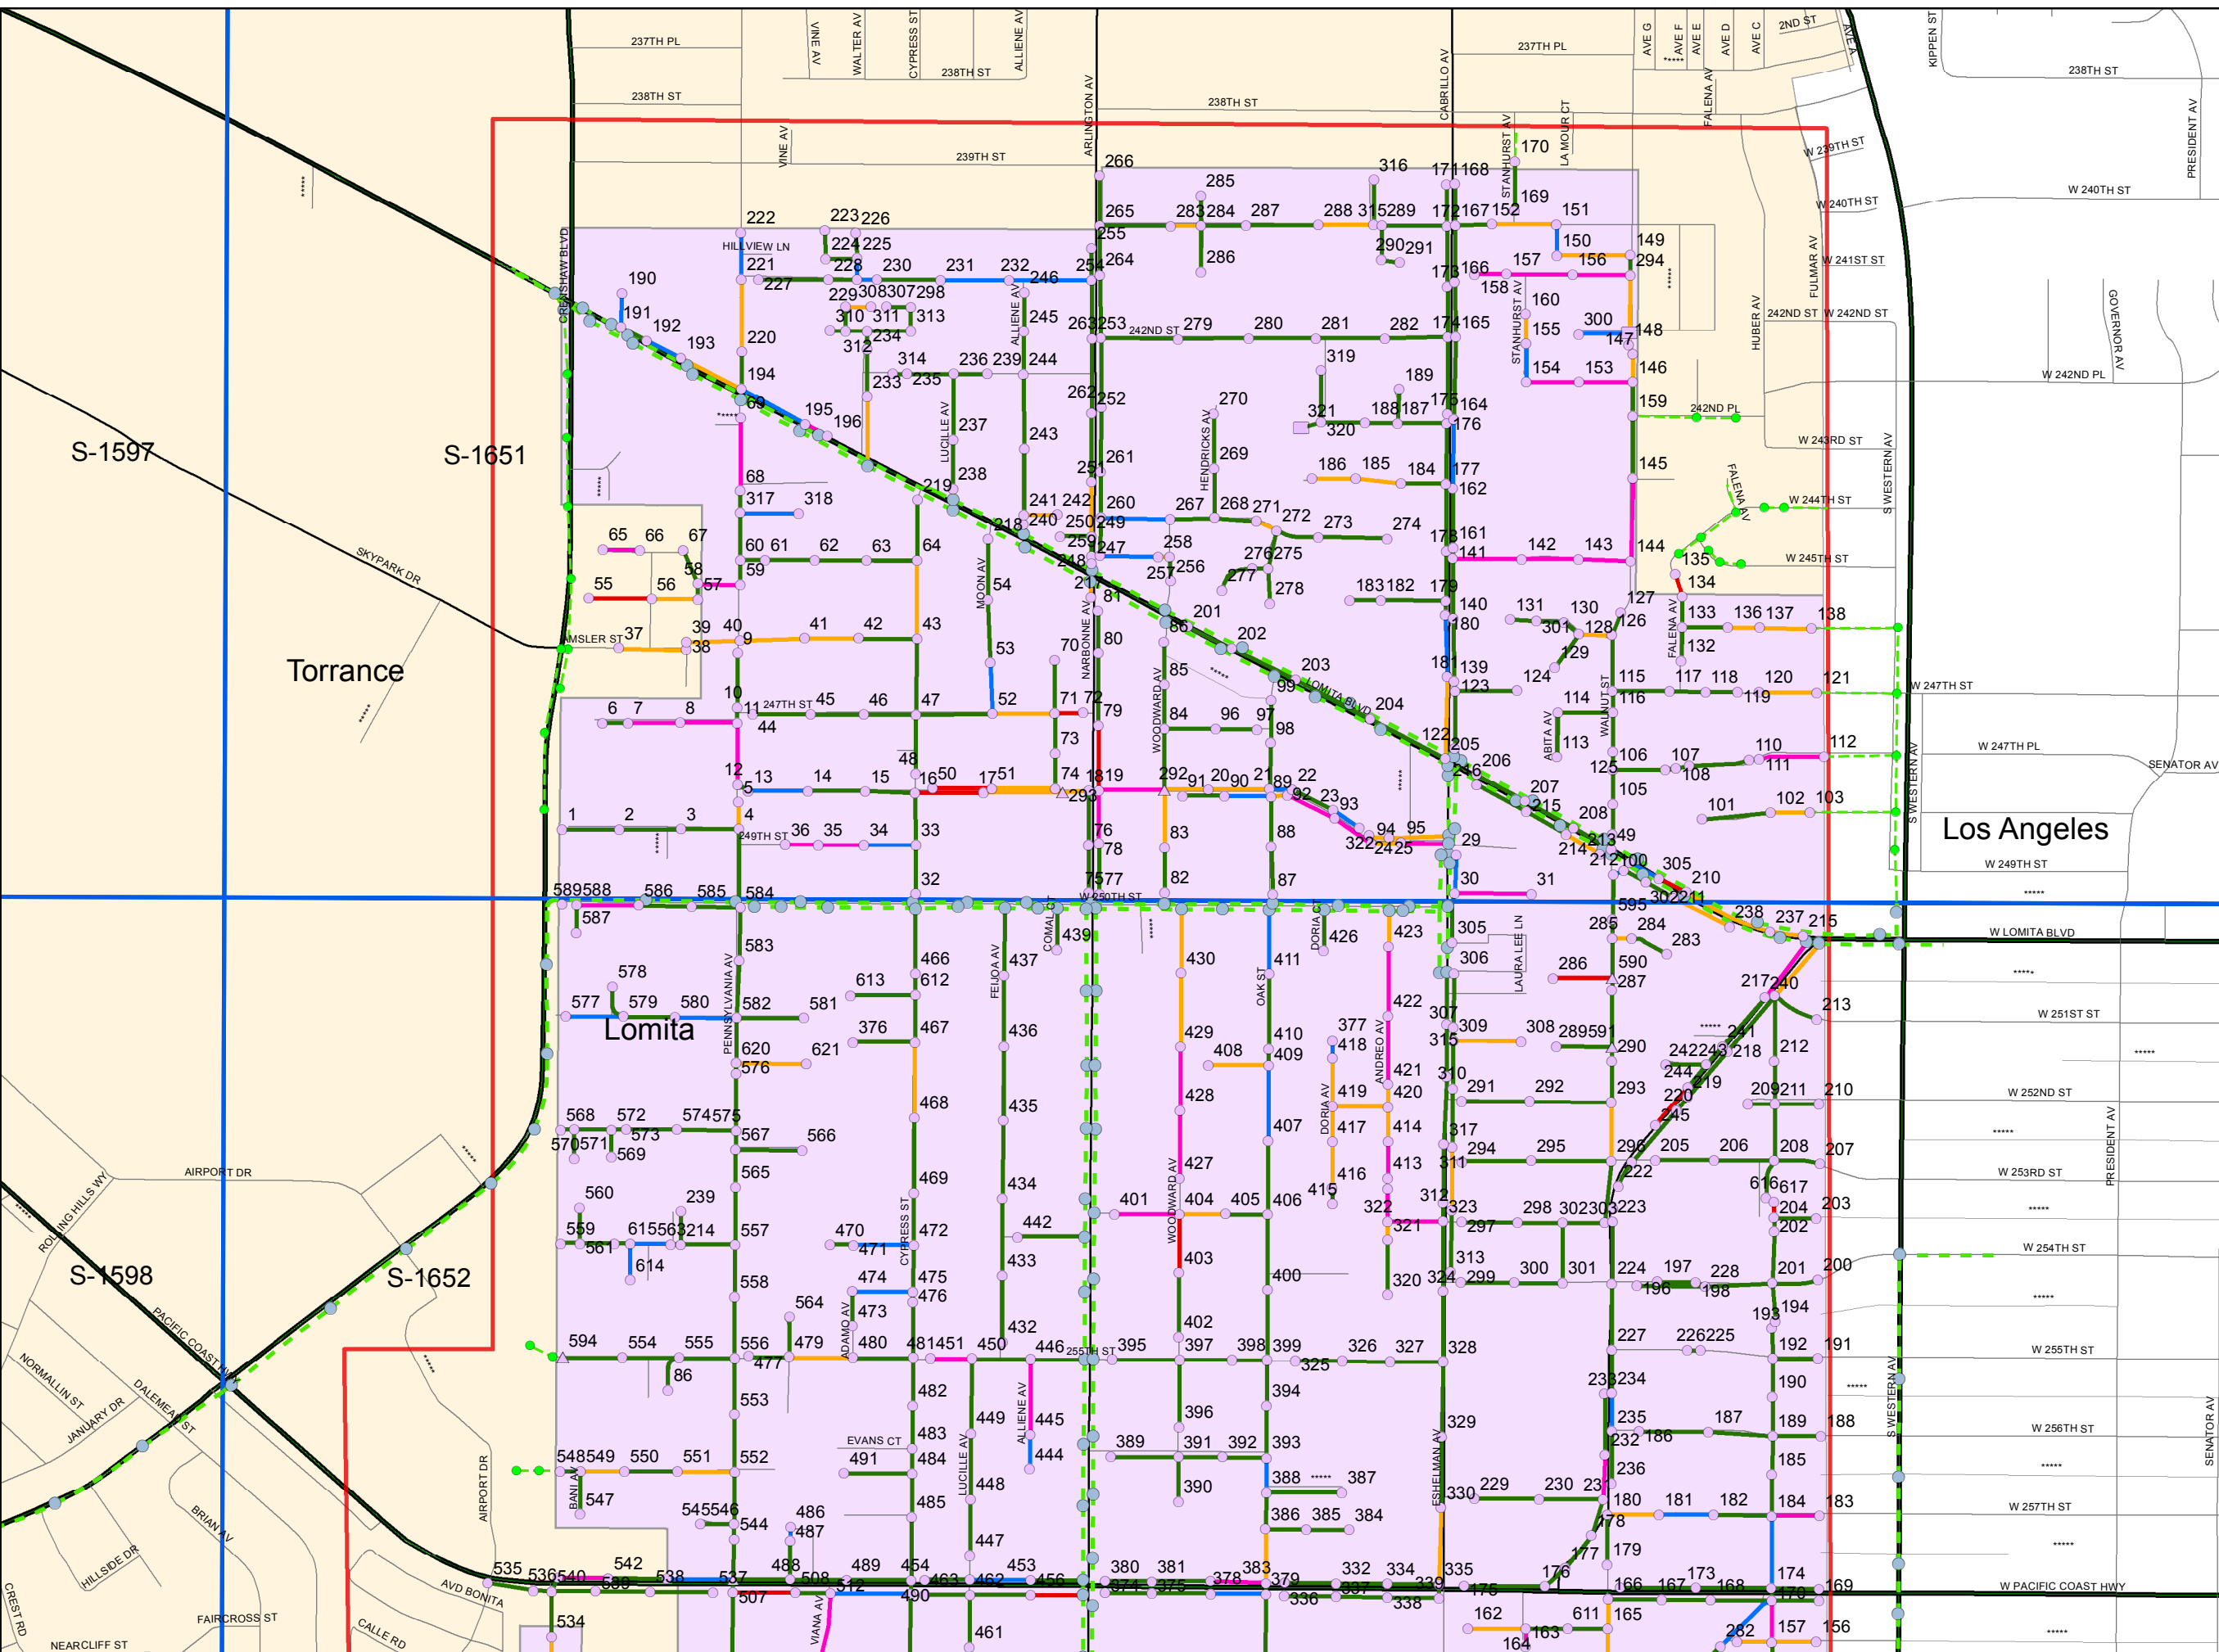
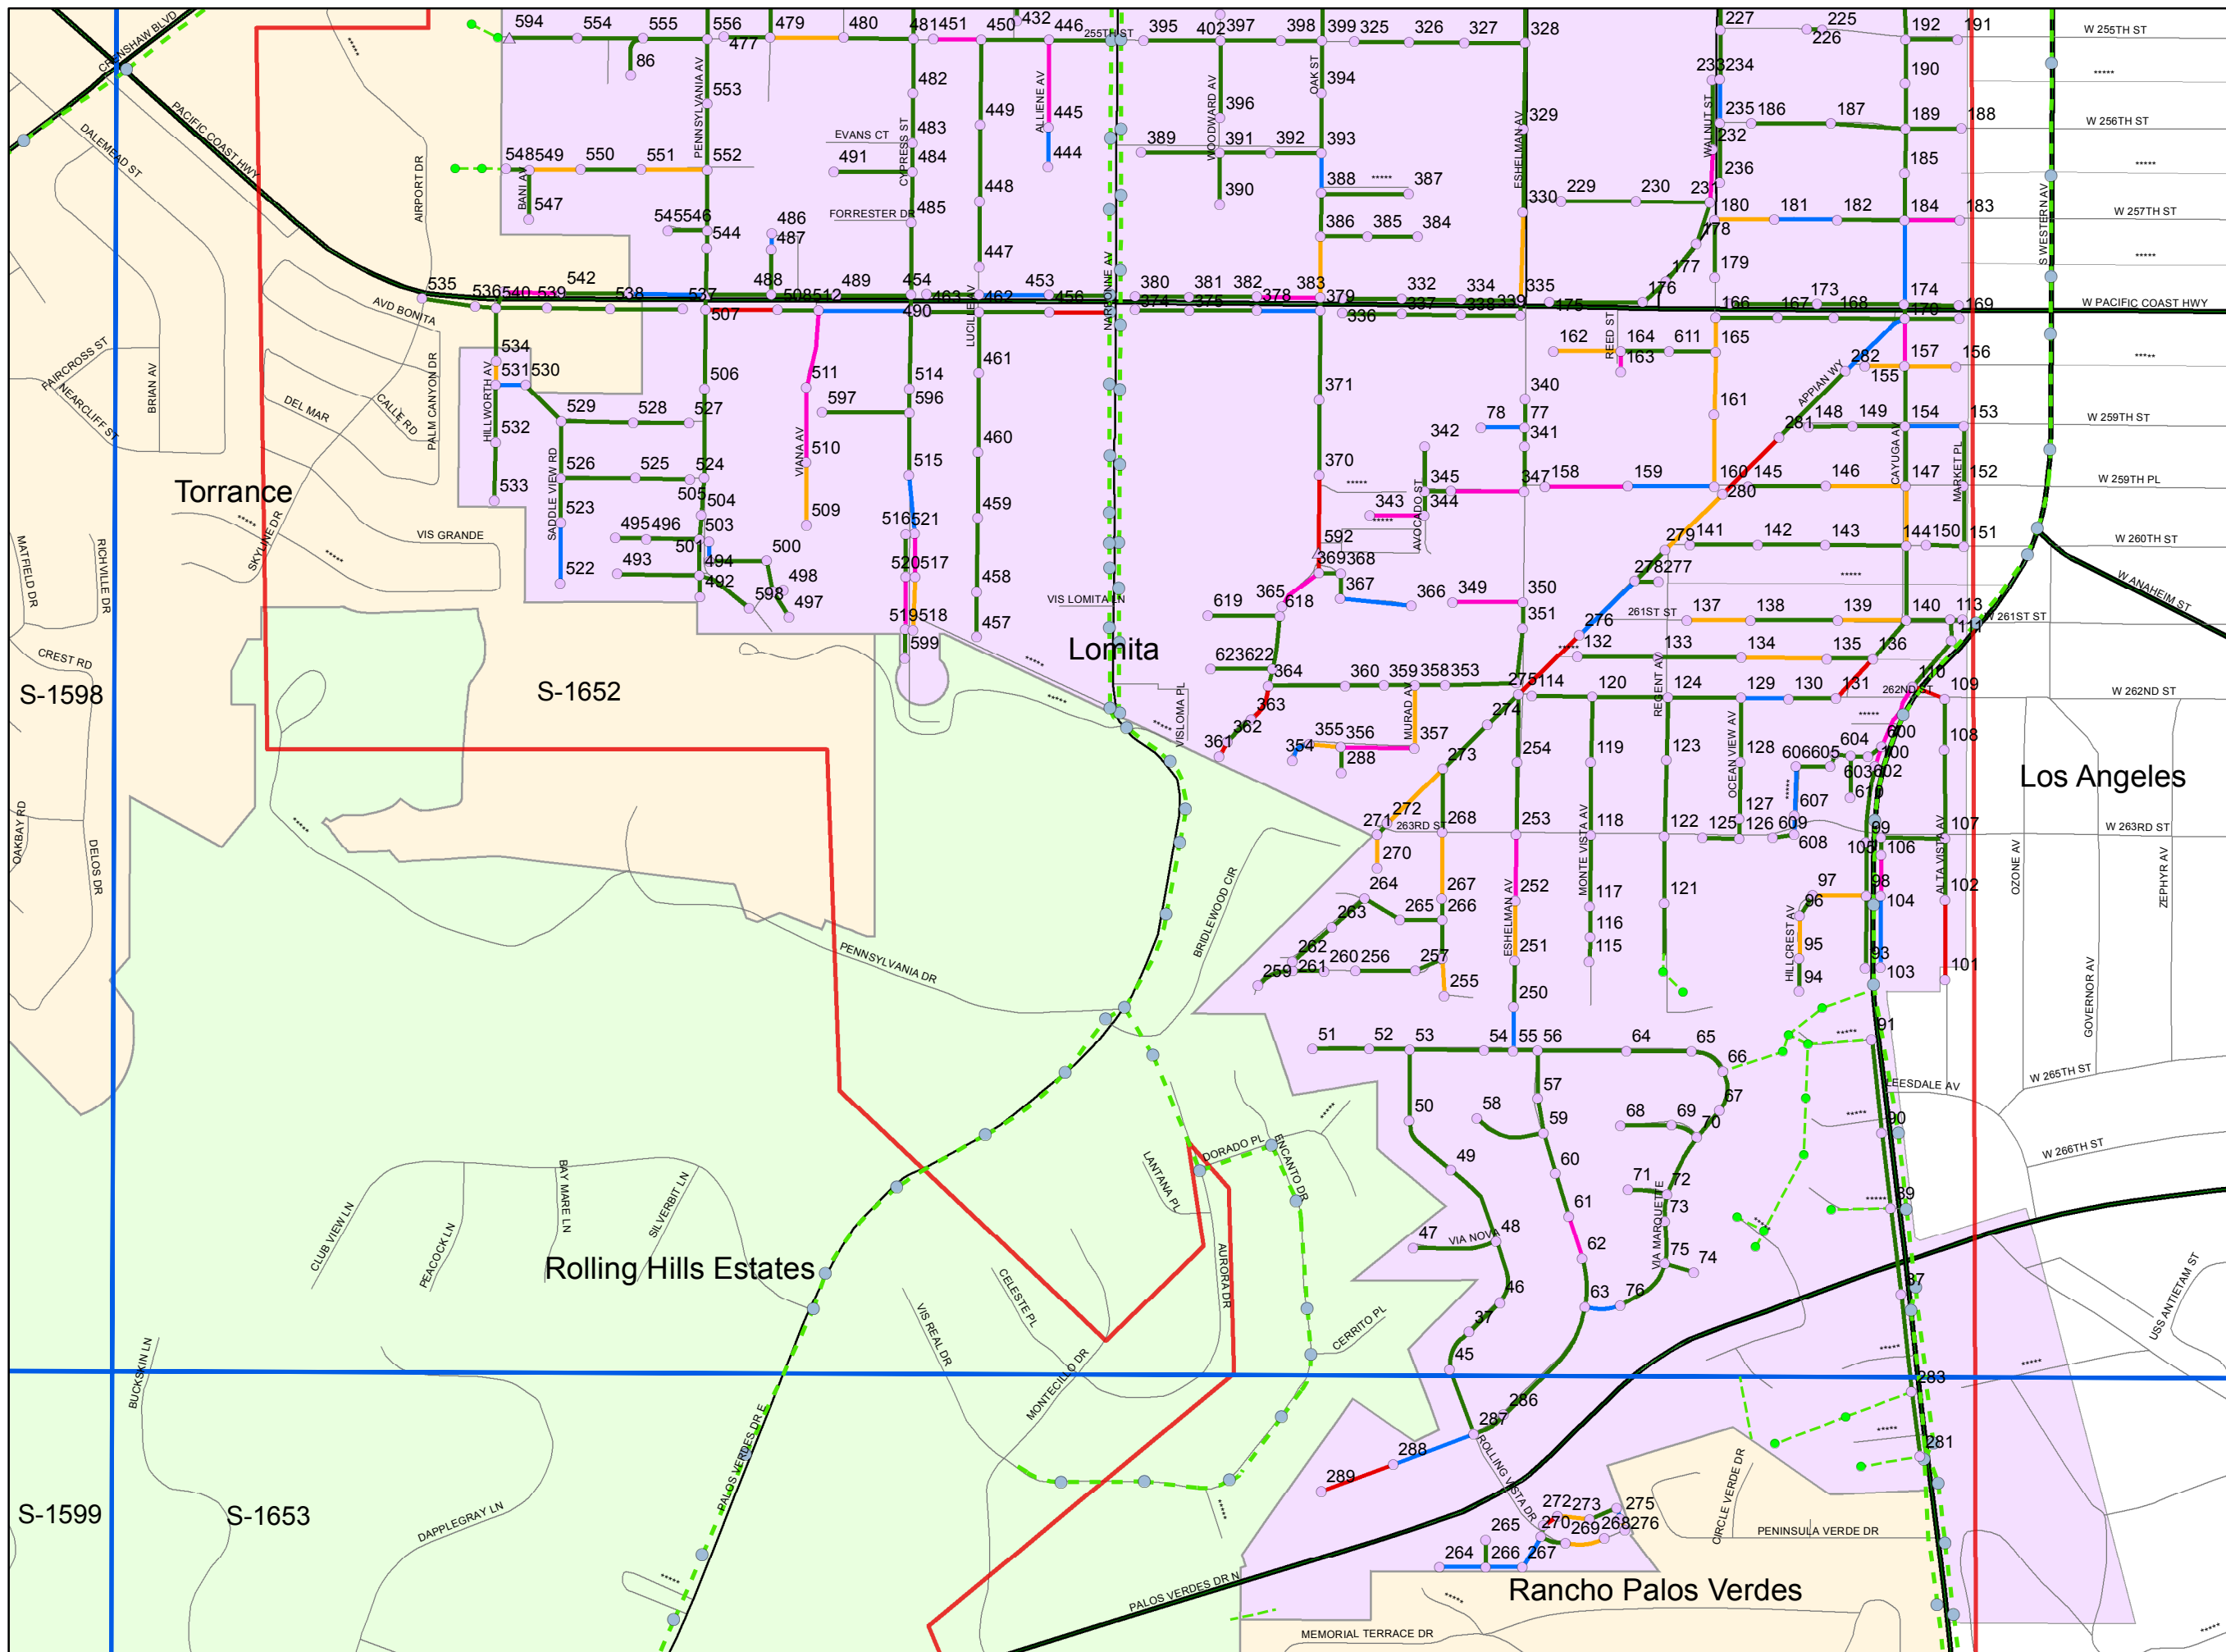
**QUICK  
STRUCTURAL  
RATING  
(QSR)**

Our inspection revealed that approximately 89.5 percent of the inspected pipe segments within the City were free of severe structural defects. The remaining 10.5 percent of the inspected pipe segments had a PACP structural grade of 4 or 5 as indicated in the Quick Structural Rating Table shown below. These segments have been placed on a priority list based on the severity and the need for action. For items 1 through 89 in the Quick Structural Rating Report Priority List (Enclosure 3), which warrant a corrective action, the proposed corrective action will be programmed in the next 24 months as part of the ongoing Accumulative Capital Outlay Program.
