**CONSOLIDATED SEWER MAINTENANCE DISTRICT
CONDITION ASSESSMENT PROGRAM REPORT
PROJECT Y0TV0506E**

**CONDITION ASSESSMENT REPORT
COUNTY OF LOS ANGELES DEPARTMENT OF PUBLIC WORKS
CONSOLIDATED SEWER MAINTENANCE DISTRICT**

PROJECT NAME:	Y0TV0506E	PROJECT MGR:	Kari Eskridge
PROJECT DATE:	05/10/06-09/15/06	CONTACT NO:	(626) 300-3390
SUP DISTRICT(s):	1	MAP PAGE(S):	2260, 2261, 2304
Report By:	Phyo Kyaw	Report Date:	10/08/09

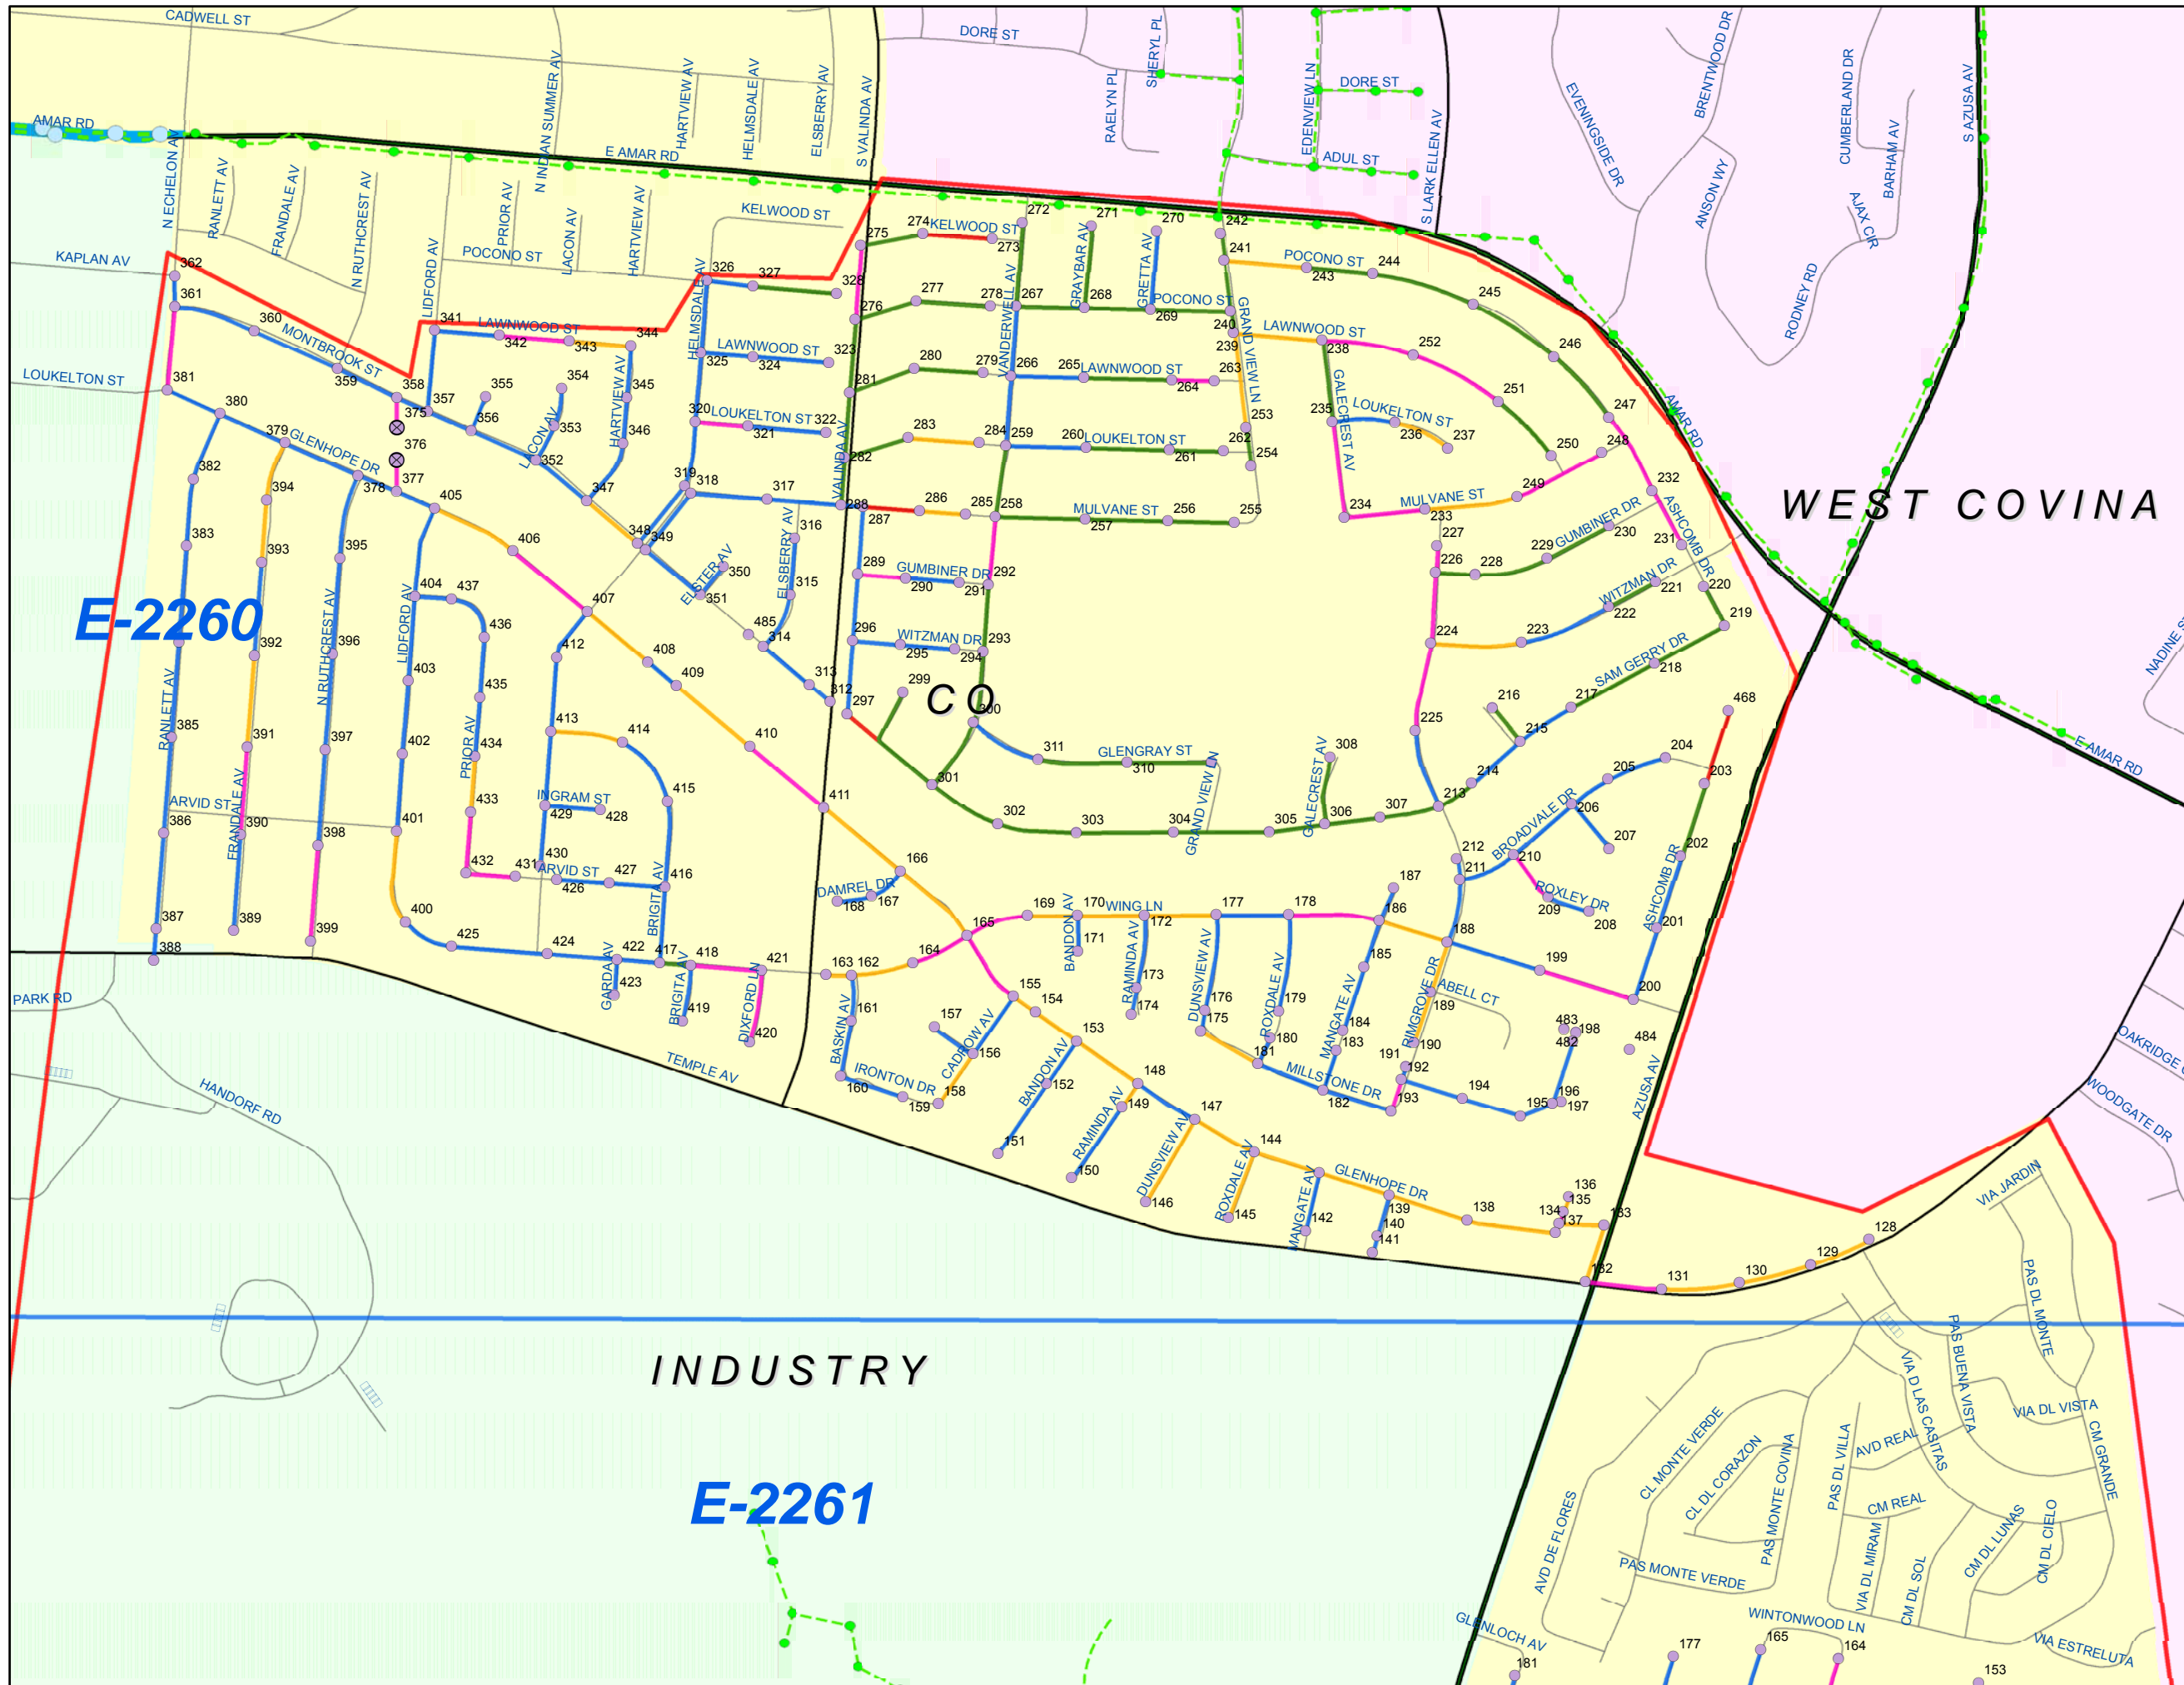
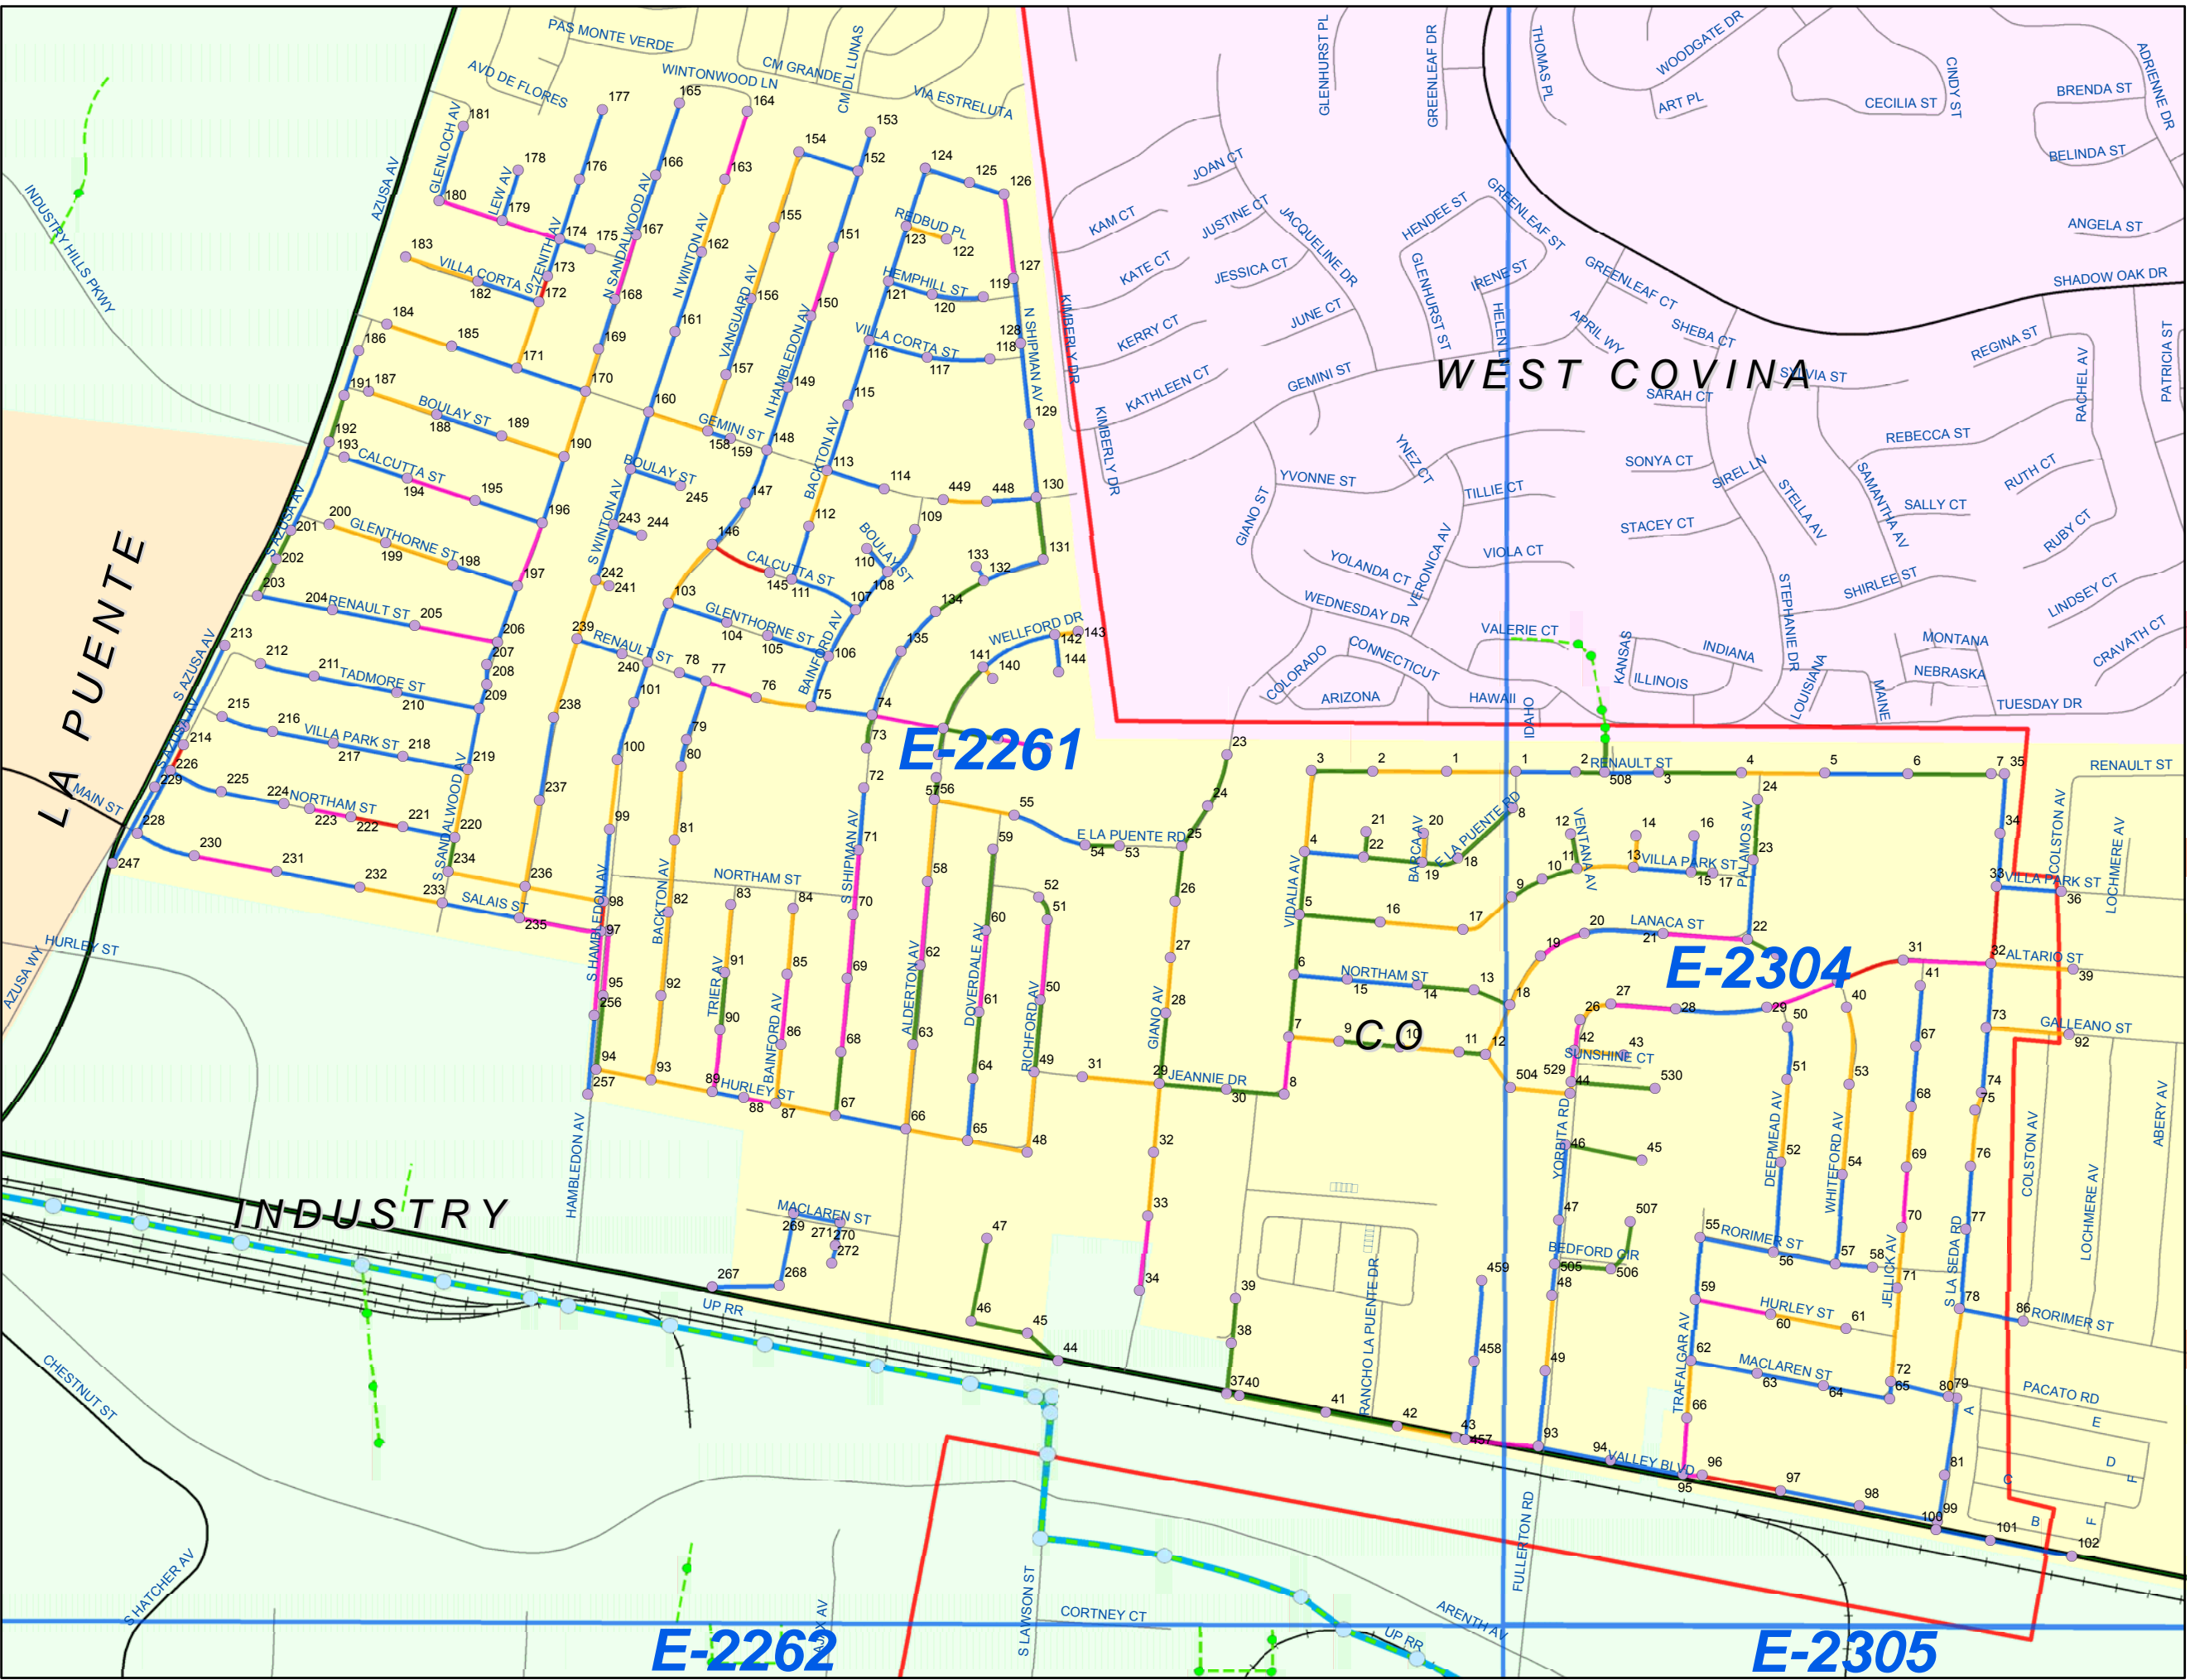
QUICK MAINTENANCE RATING (QMR)

Our inspection revealed that approximately 85.8 percent of the system televised was free of blockages or restrictions that would impede sewer flows. However, the remaining 14.2 percent of the inspected pipe segments within the Unincorporated County of Los Angeles area had a PACP maintenance grade of 4 or 5 as indicated in the Quick Maintenance Rating Table shown below. These segments have been incorporated into our routine cleaning schedule with corrective action taken as noted on the Quick Maintenance Rating Report Priority List (Enclosure 2). Also included is a color-coded map showing the quick maintenance rating for each pipe segment.

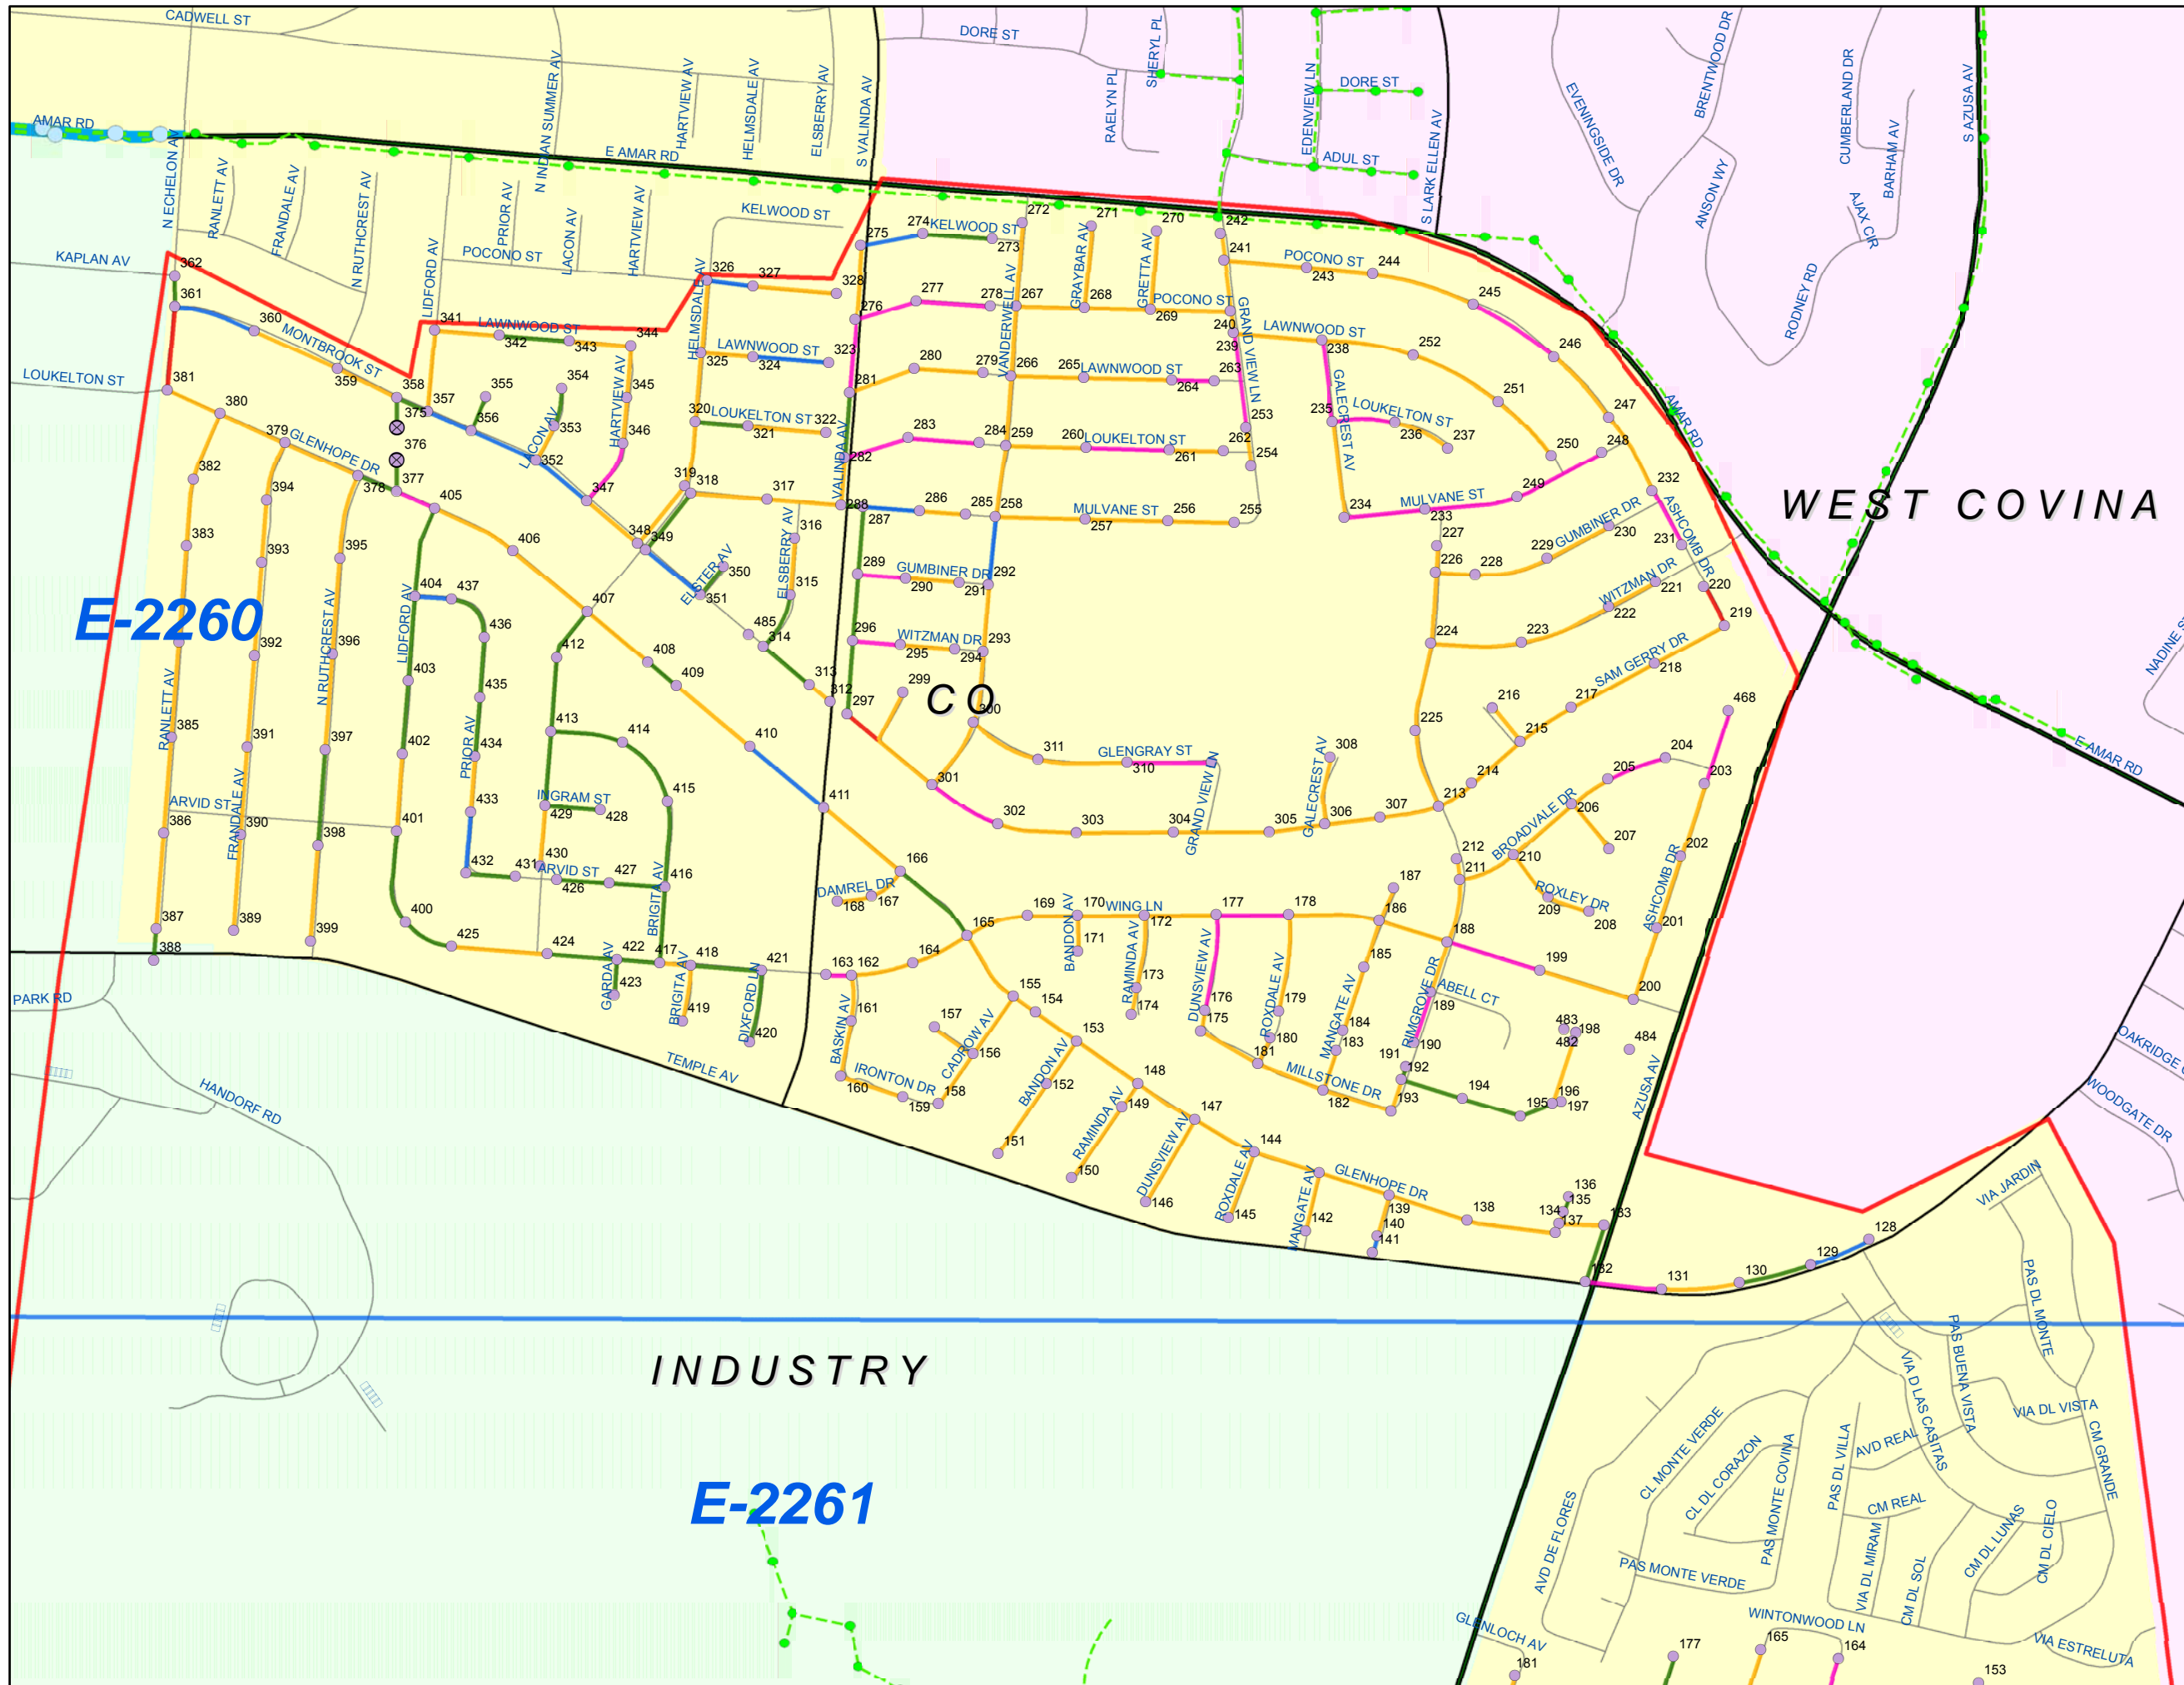
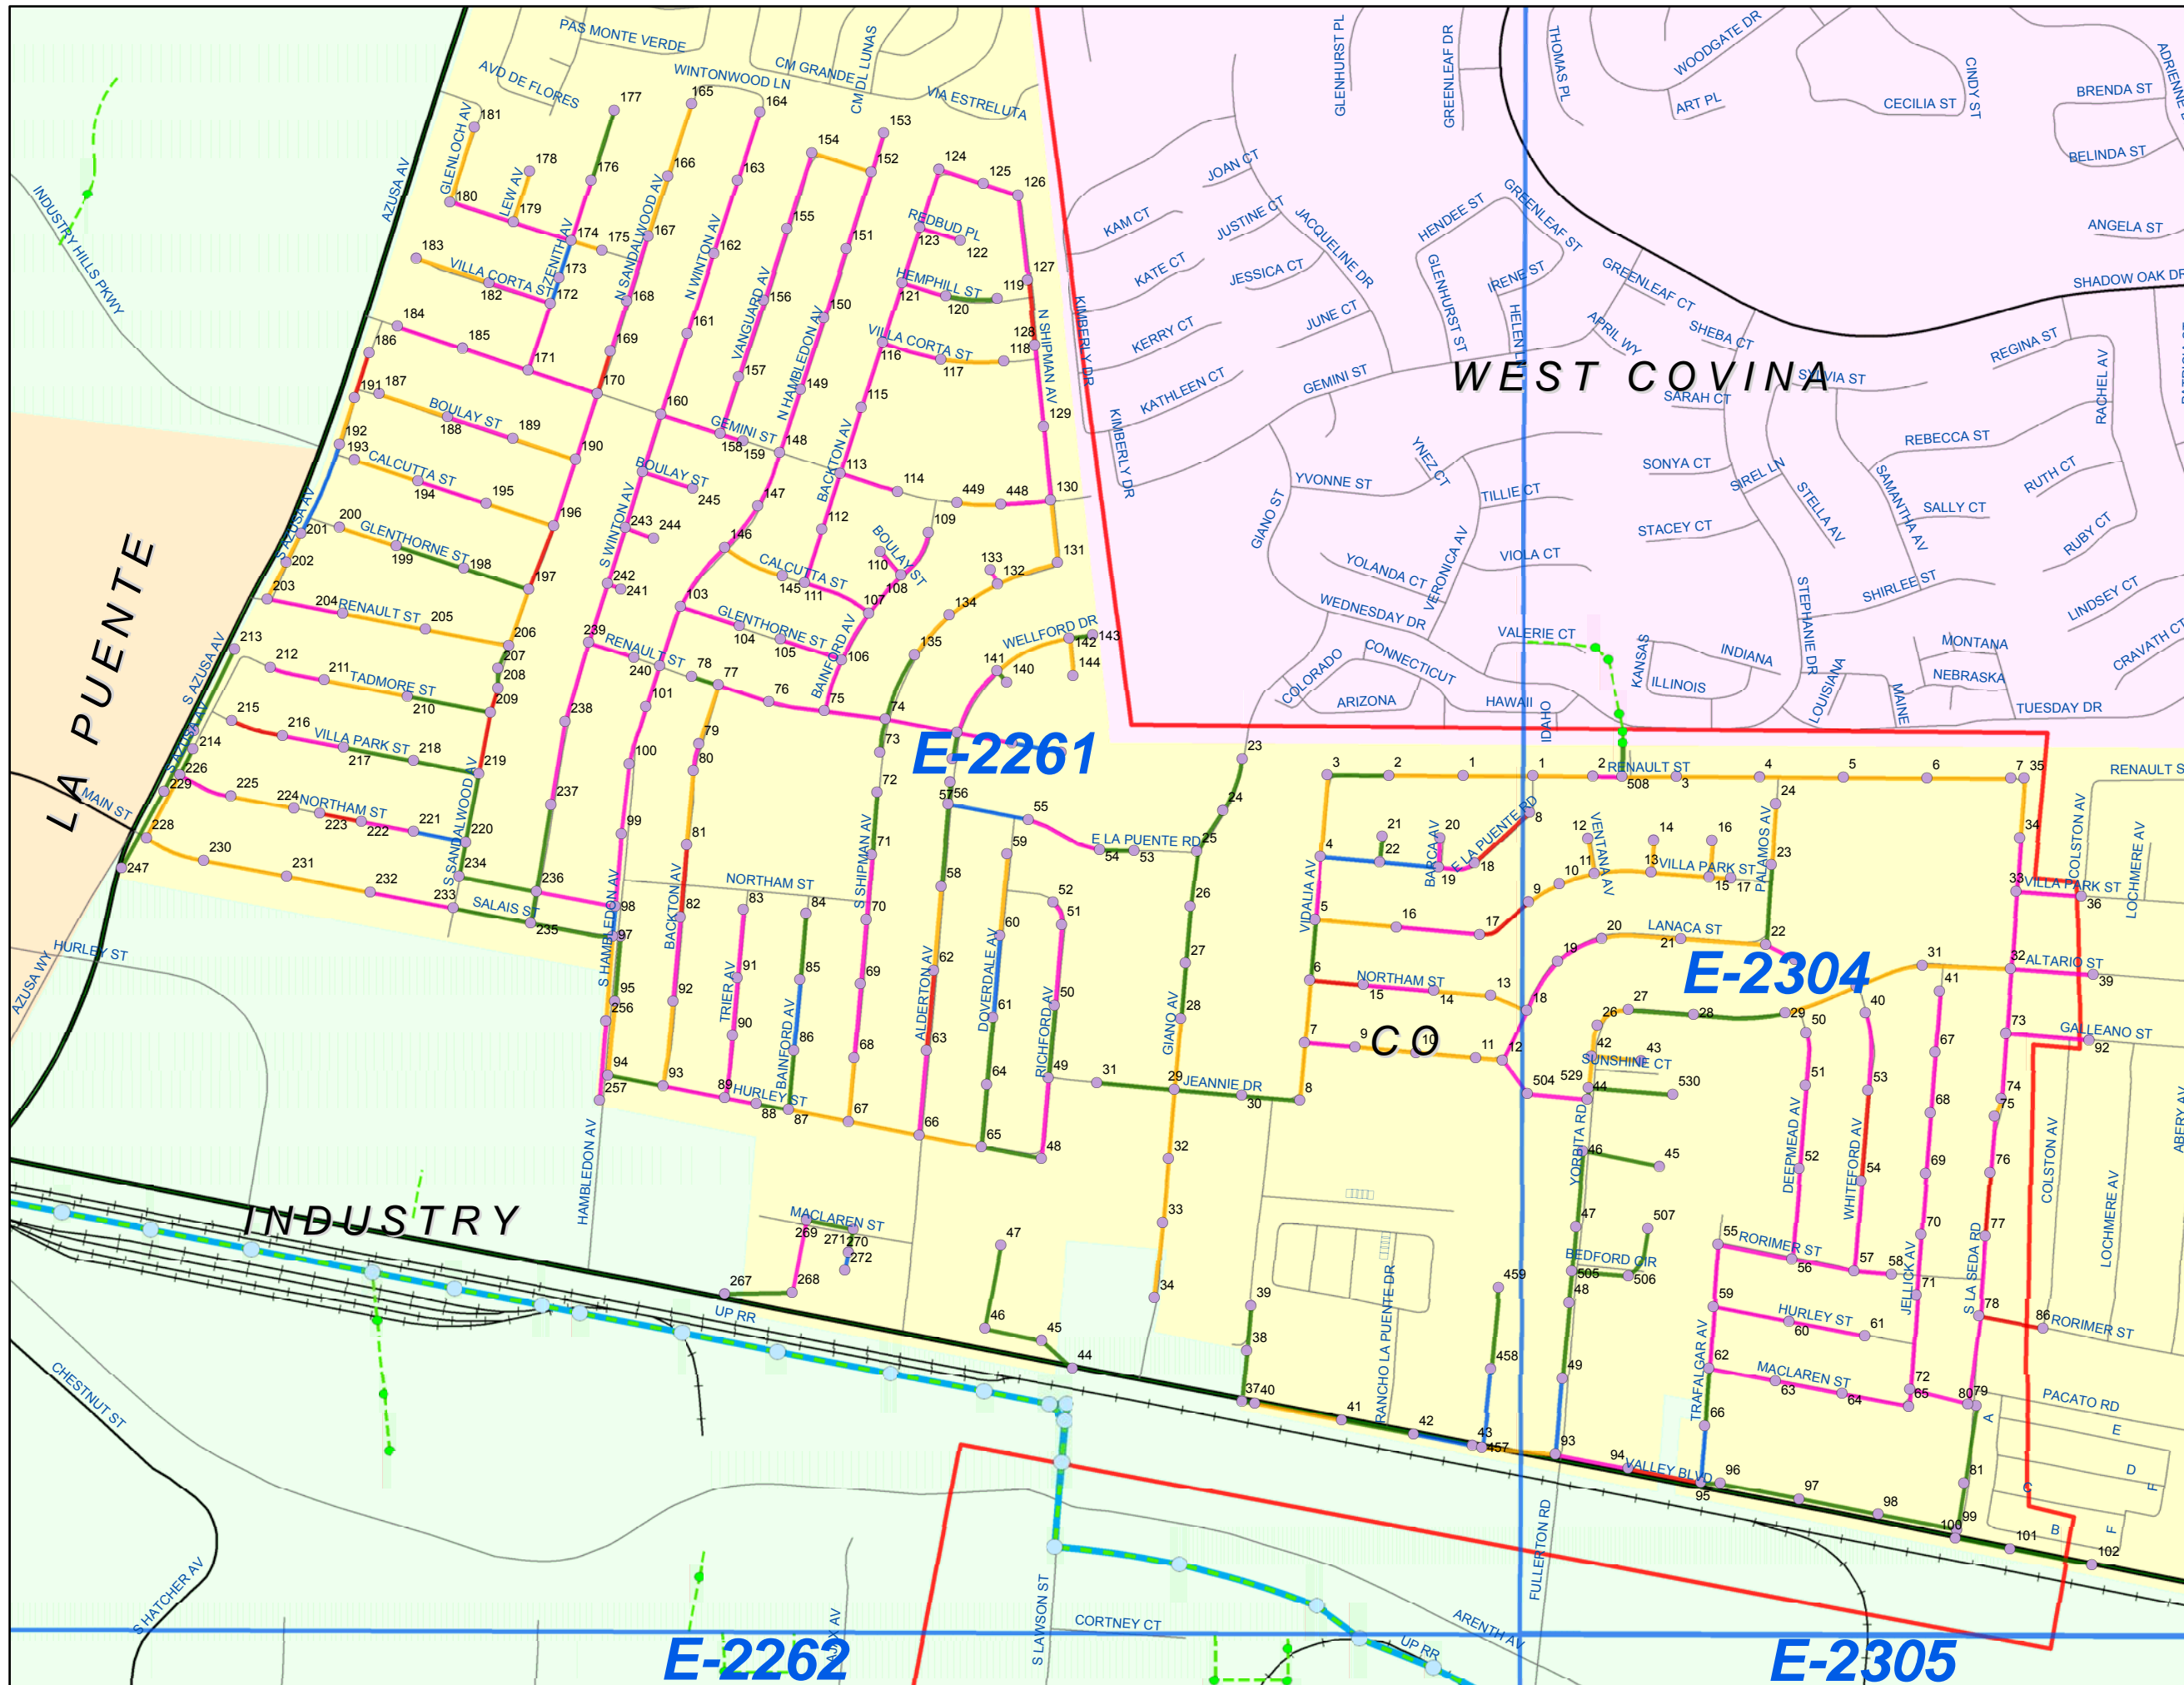
QUICK STRUCTURAL RATING (QSR)

Our inspection revealed that approximately 67.6 percent of the inspected pipe segments within the Unincorporated County of Los Angeles were free of severe structural defects. However, the remaining 32.4 percent of the inspected pipe segments had a PACP structural grade of 4 or 5 as indicated in the Quick Structural Rating Table shown below. These segments have been placed on a priority list based on the severity and the need for action. For Items 1 through 200 in the Quick Structural Rating Report Priority List (Enclosure 3) which require a corrective action, the proposed corrective method will be scheduled in the next 24 months as part of the ongoing Accumulative Capital Outlay Project. A color-coded map showing the Quick Structural Rating for each pipe segment is located in Enclosure 3. Copies of the actual inspection report for these 200 segments are included in Enclosure 4.
