**CONSOLIDATED SEWER MAINTENANCE DISTRICT
CONDITION ASSESSMENT PROGRAM REPORT
PROJECT Y0TV0607C**

**CONDITION ASSESSMENT REPORT
COUNTY OF LOS ANGELES DEPARTMENT OF PUBLIC WORKS
CONSOLIDATED SEWER MAINTENANCE DISTRICT**

PROJECT NAME:	Y0TV0607C	PROJECT MGR:	Kari Eskridge
PROJECT DATE:	02/01/07 □ 06/04/07	CONTACT NO:	(626) 300-3390
SUP. DISTRICT(s):	1	MAP PAGE(S):	1970,1971,2023,2024 □ 2076
Report By:	Phyo Kyaw	Report Date:	06/01/09

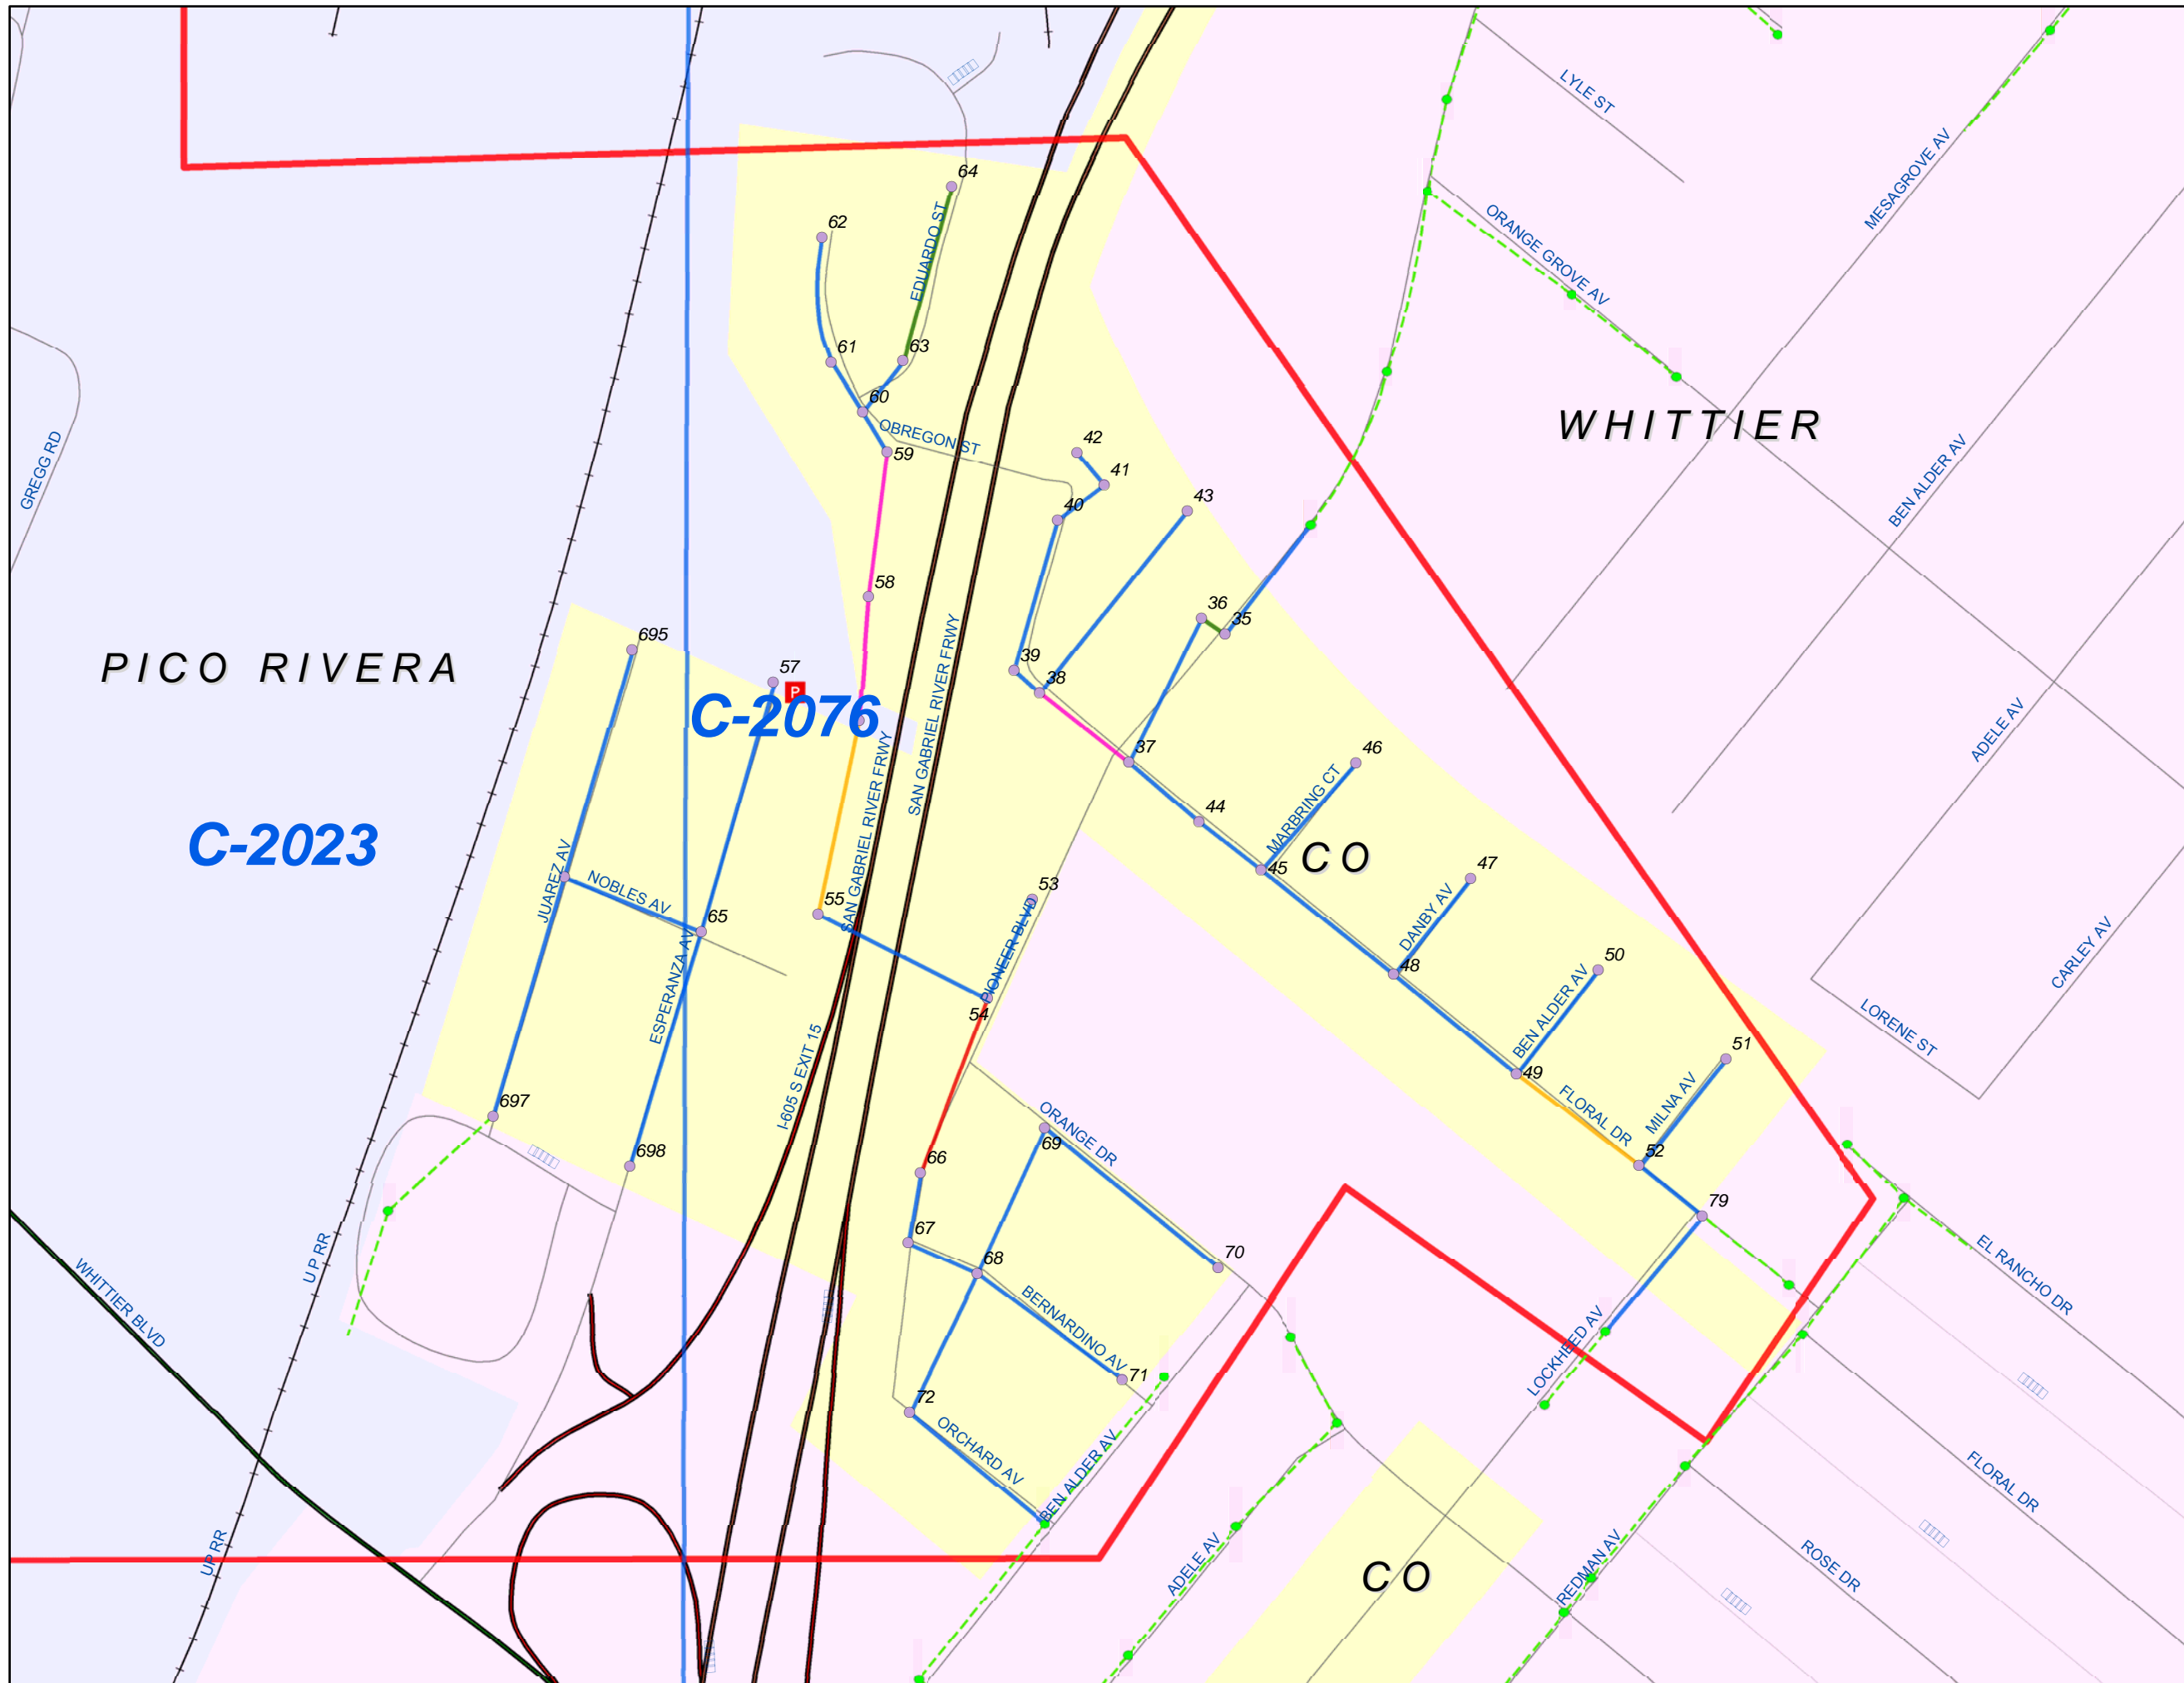
QUICK MAINTENANCE RATING (QMR)

Item No.	QMR	Start MH	End MH	Street	Observation	Corrective Action Taken
1	5321	2076-0054	2076-0066	PIONEER BV	Sag	Hydrojet (Completed 3/25/09)
2	4131	2076-0059	2076-0058	ALLEY by OBREGON and 605 FWY	Deposits; roots	Hydrojet (Completed 4/2/09)
3	4121	2076-0038	2076-0037	OBREGON ST	Broken and multiple fractures with soil visible and roots ball	Emergency Project (Point Repair) by SMD Central Yard: Completed November 2008
4	4121	2076-0058	2076-0056	ALLEY by OBREGON and 605 FWY	Roots	Rodder (Completed 3/31/09)

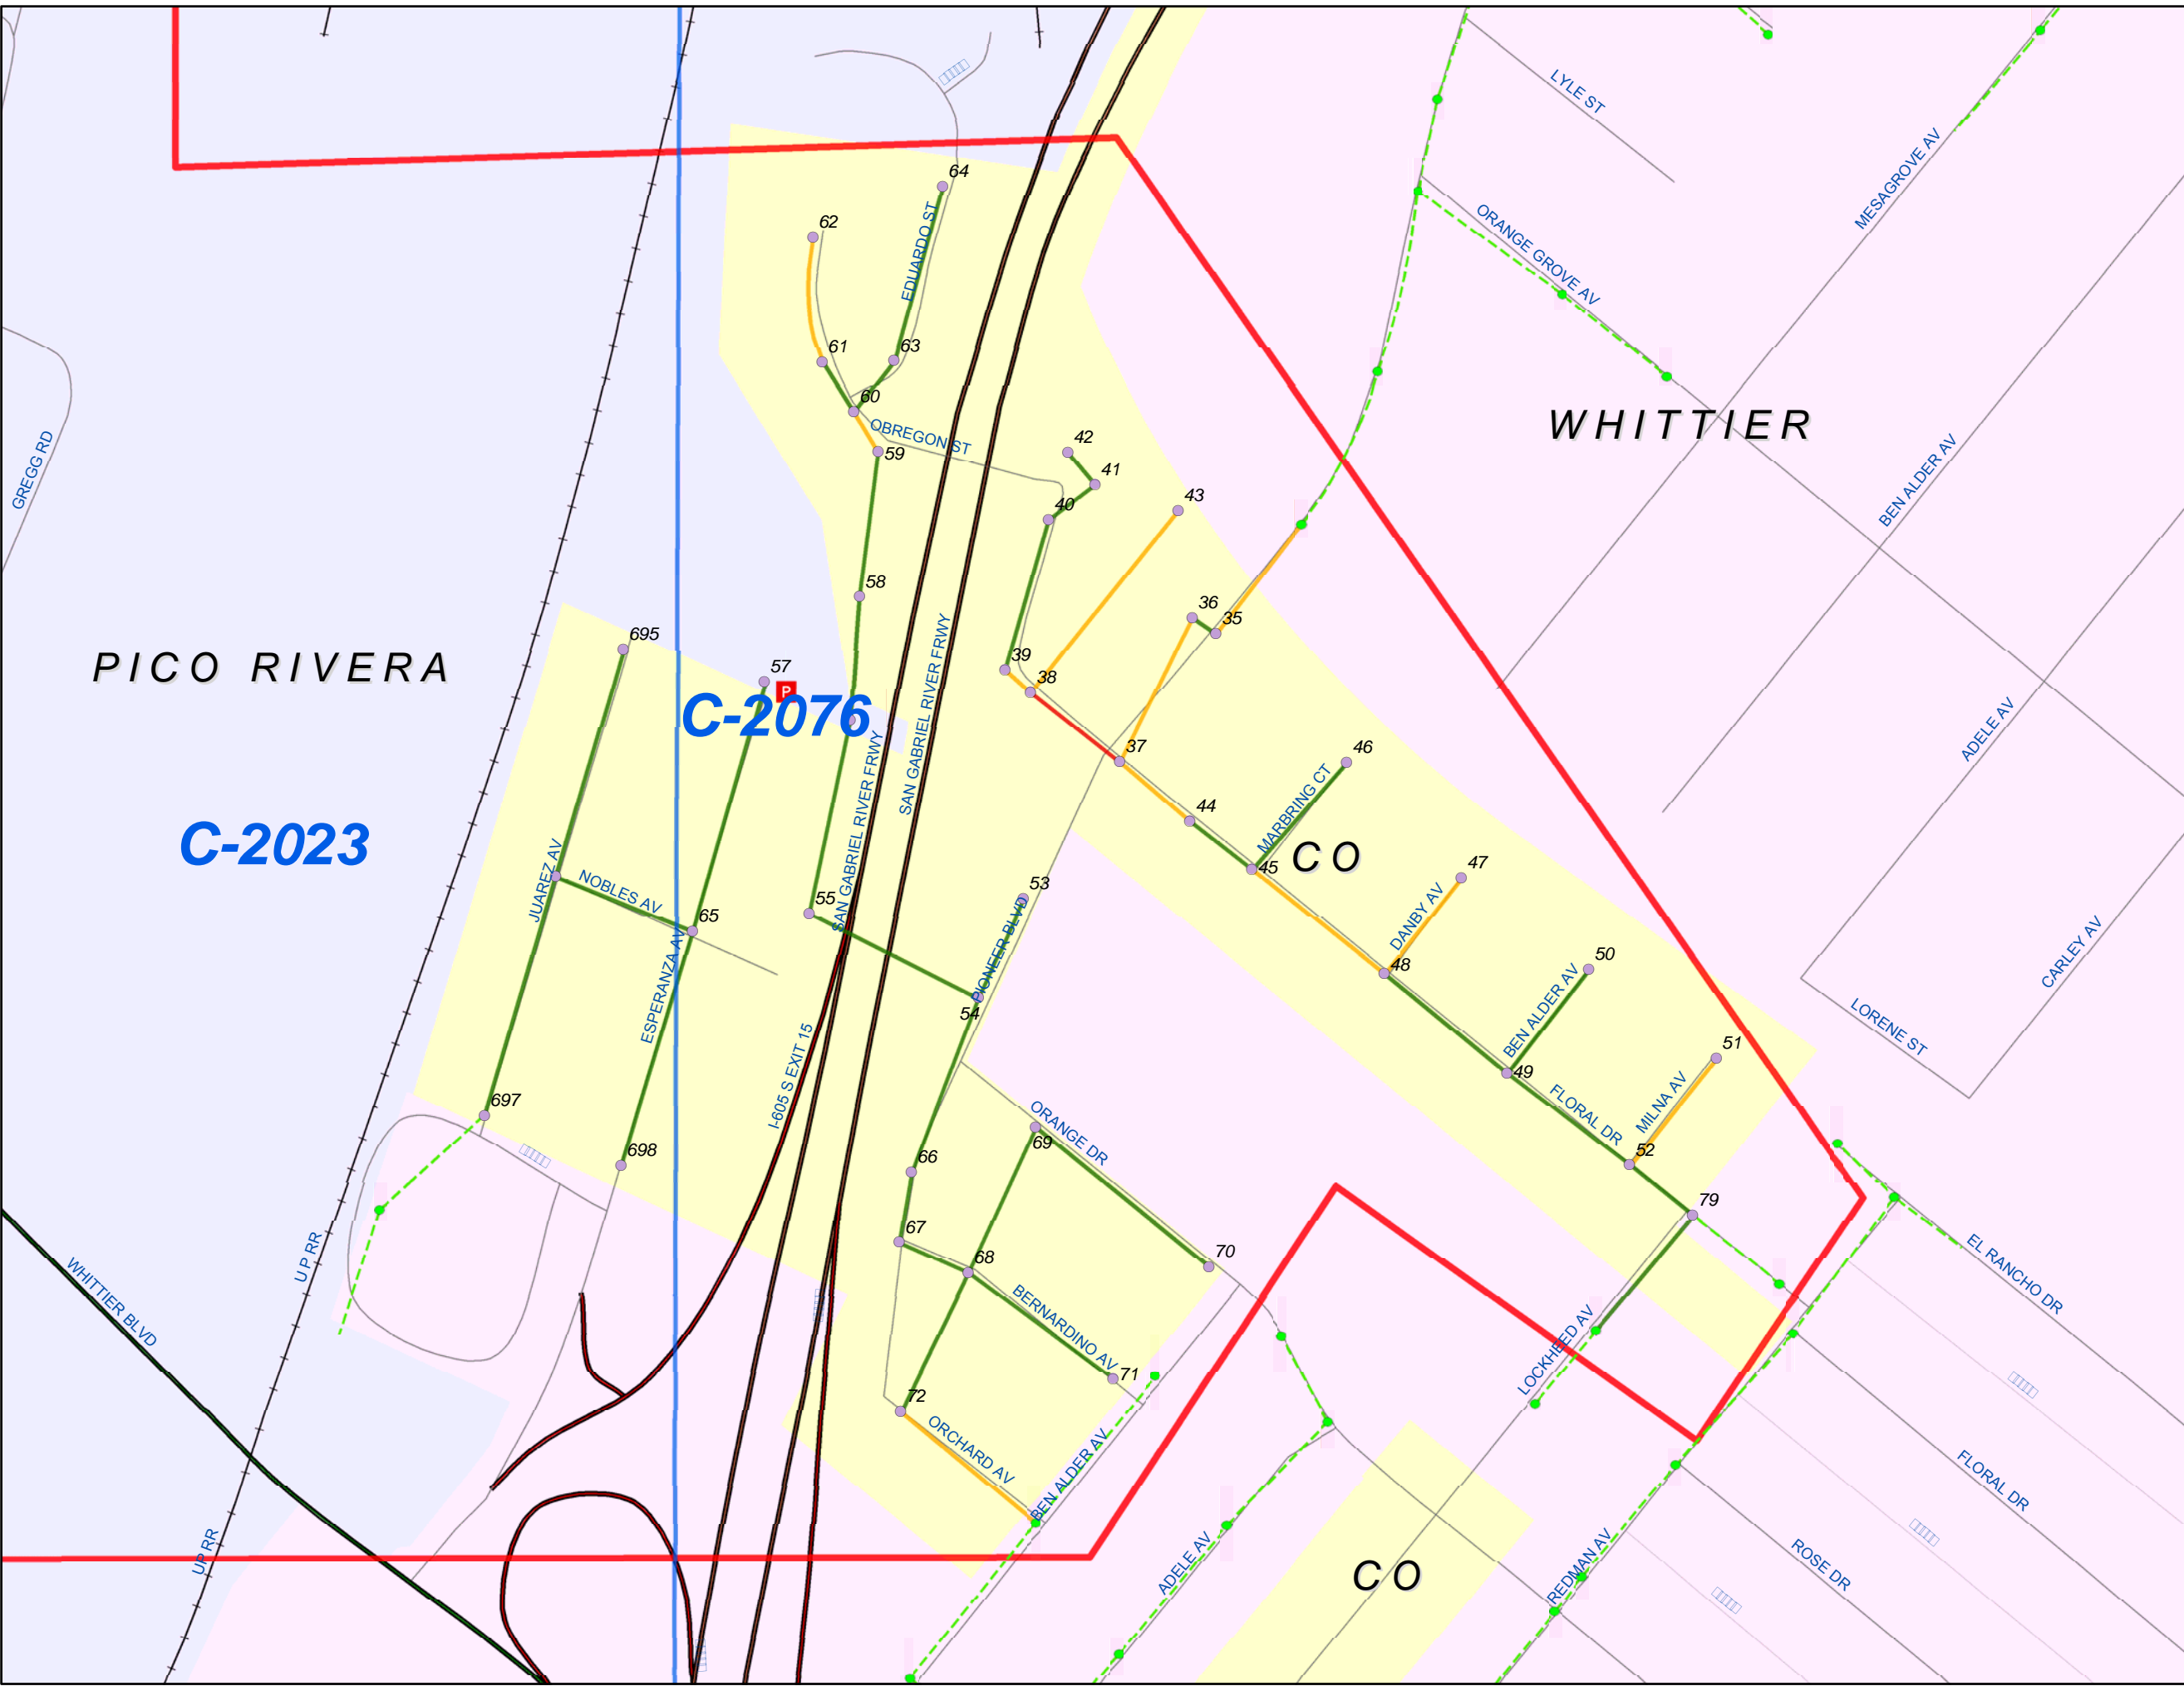
QUICK STRUCTURAL RATING (QSR)

Item No.	QSR	Start MH	End MH	Street	Observation: Location	Proposed Corrective Method	Length of Repair (FT)
1	5300	2076-0037	2076-0038	OBERGON ST	Broken and multiple fractures with soil visible: 11'	Emergency Project (Point Repair) by SMD Central Yard: Completed November 2008
