**CONSOLIDATED SEWER MAINTENANCE DISTRICT
CONDITION ASSESSMENT PROGRAM REPORT
UNINCORPORATED COUNTY**

**CONDITION ASSESSMENT REPORT
LOS ANGELES COUNTY PUBLIC WORKS
CONSOLIDATED SEWER MAINTENANCE DISTRICT**

PROJECT NAME:	Y0TV0910B	PROJECT MGR:	Kari Eskridge
PROJECT DATE:	5/5/10	CONTACT NO:	(626) 300-3390
SUP. DISTRICT(S):	1 & 4	MAP PAGE(S):	2079, 2080, 2129, 2130
Report By:	Eric Liu	Report Date:	1/7/19

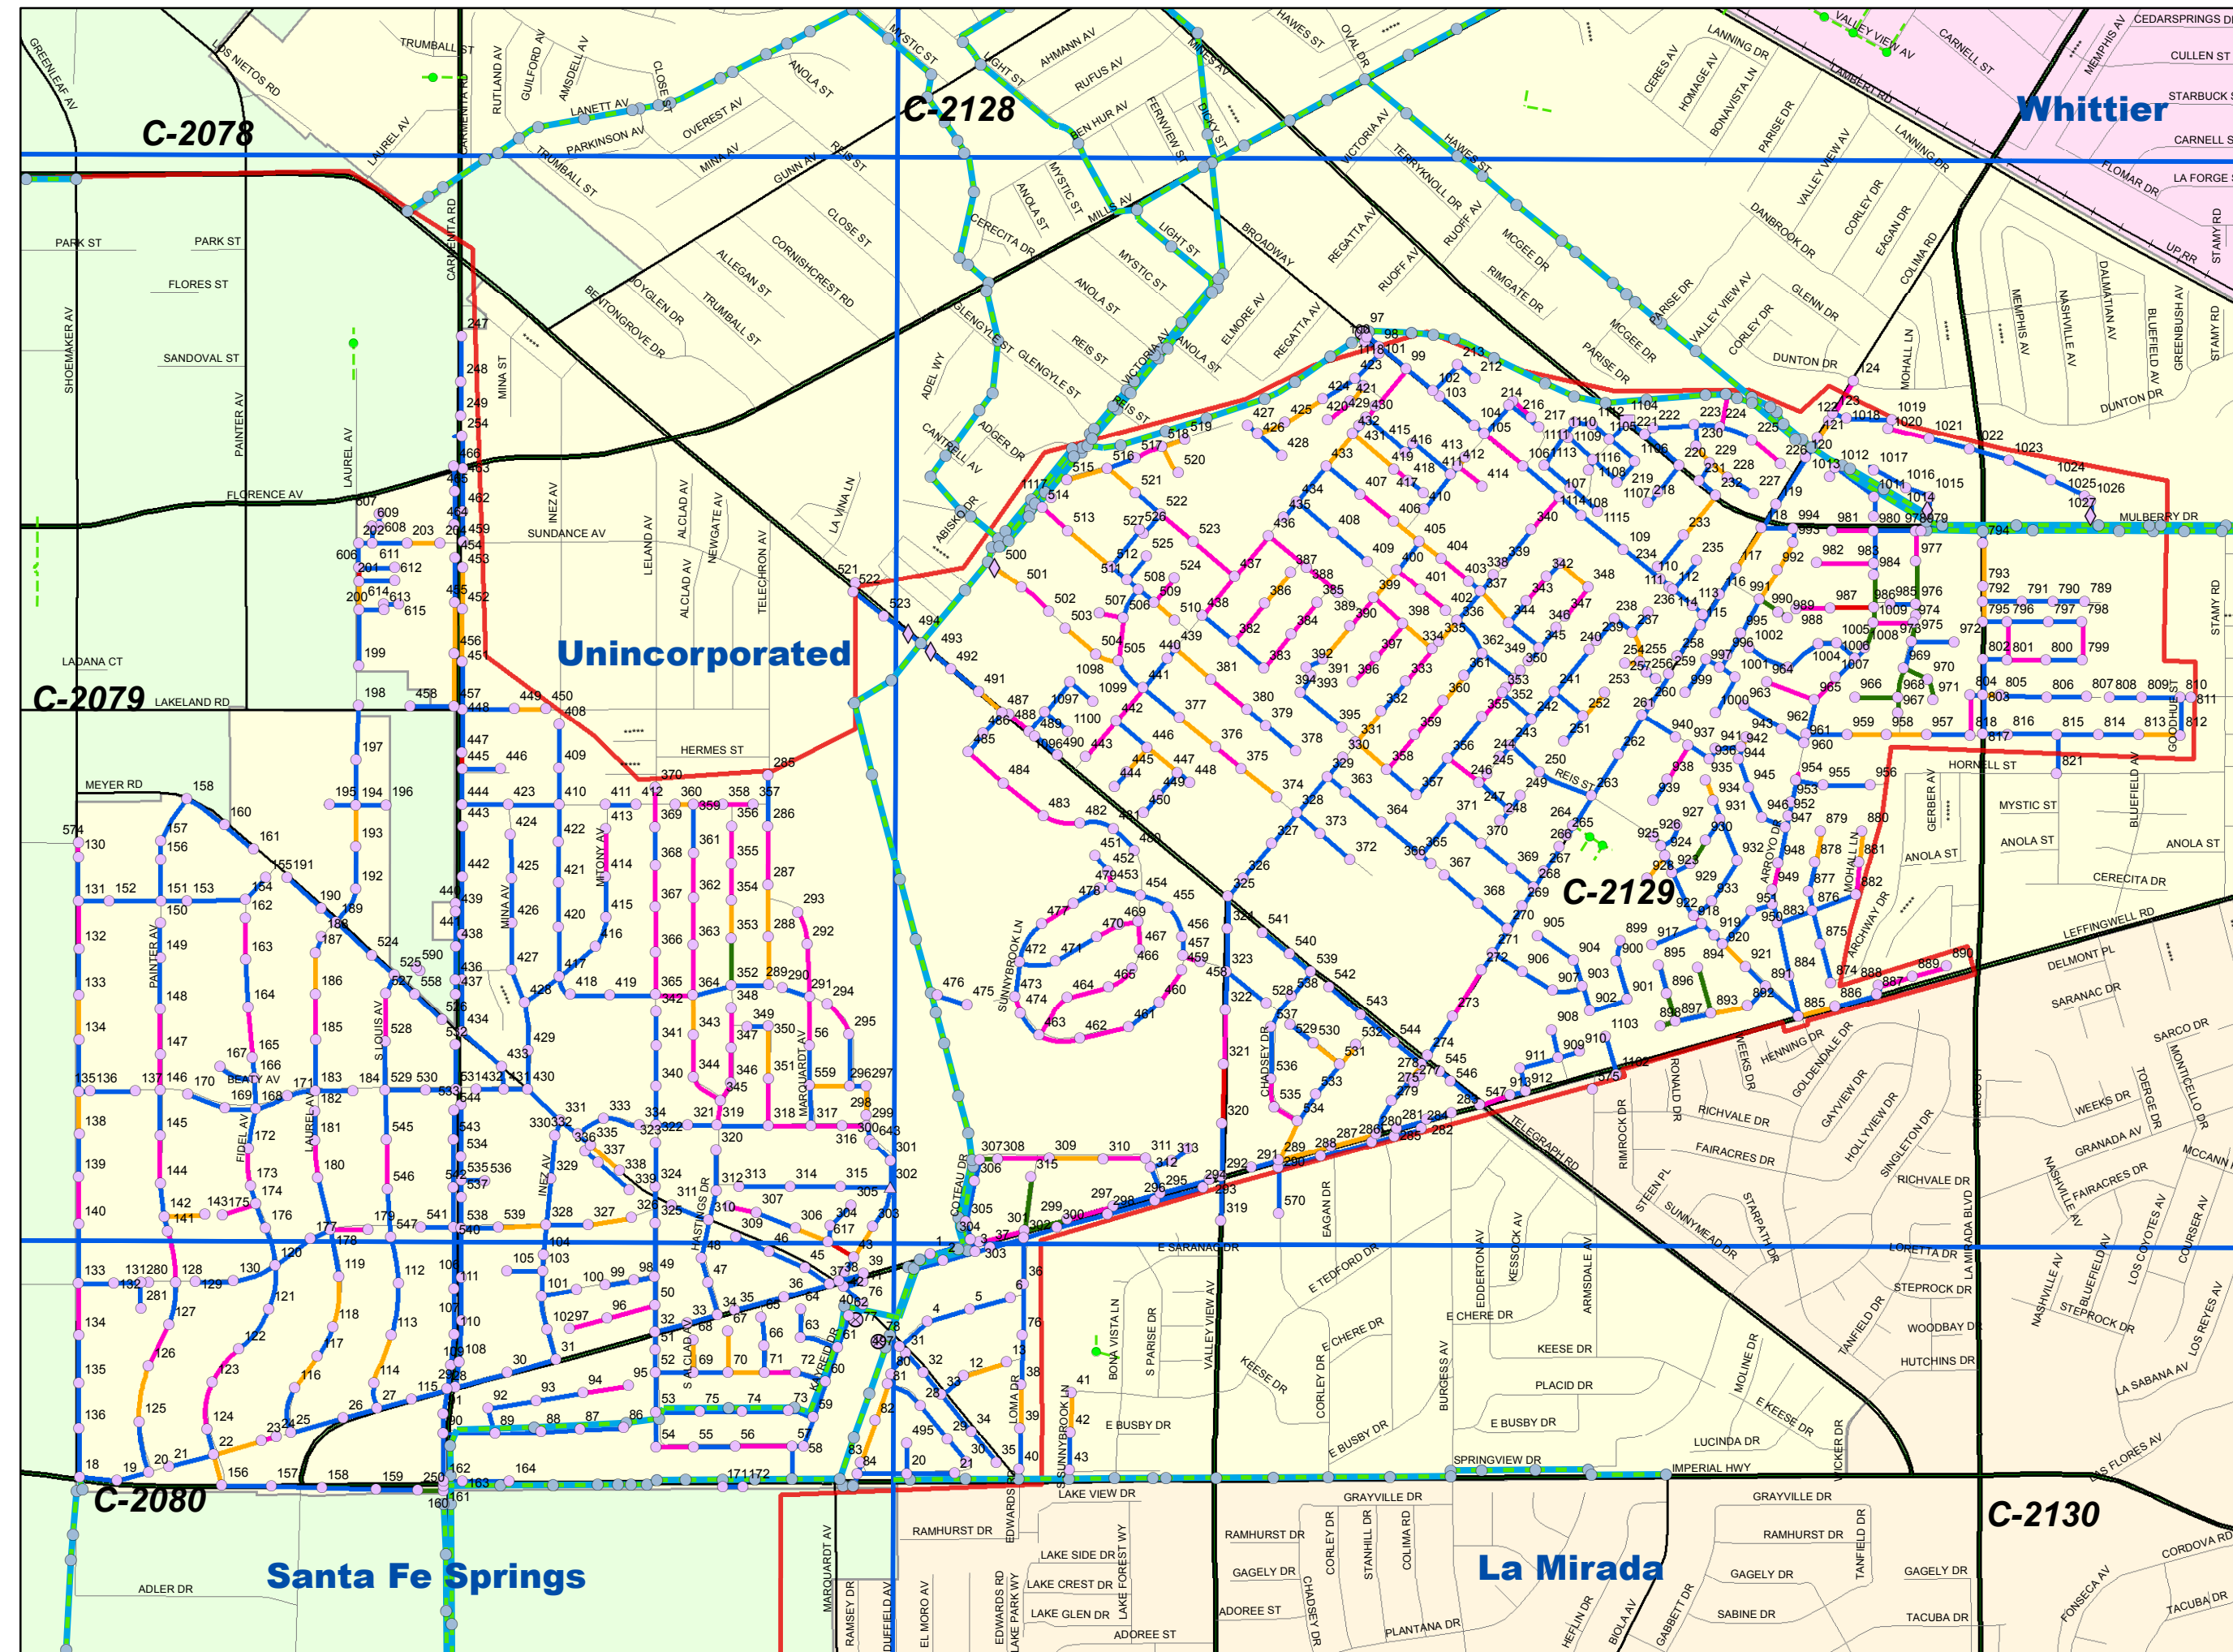
QUICK
MAINTENANCE
RATING
(QMR)

Our inspection revealed that approximately 67.5 percent of the system televised in unincorporated County as part of Project No. Y0TV0910B was free of significant blockages or restrictions that would impede sewer flows. However, the remaining 32.5 percent of the pipe segments within the unincorporated County had a PACP maintenance grade of 3, 4, or 5 as indicated in the Quick Maintenance Rating Table shown below. These segments have been incorporated into our routine cleaning schedule with corrective action taken.

A color-coded map showing the quick maintenance rating for each pipe segment is provided in Enclosure 2.

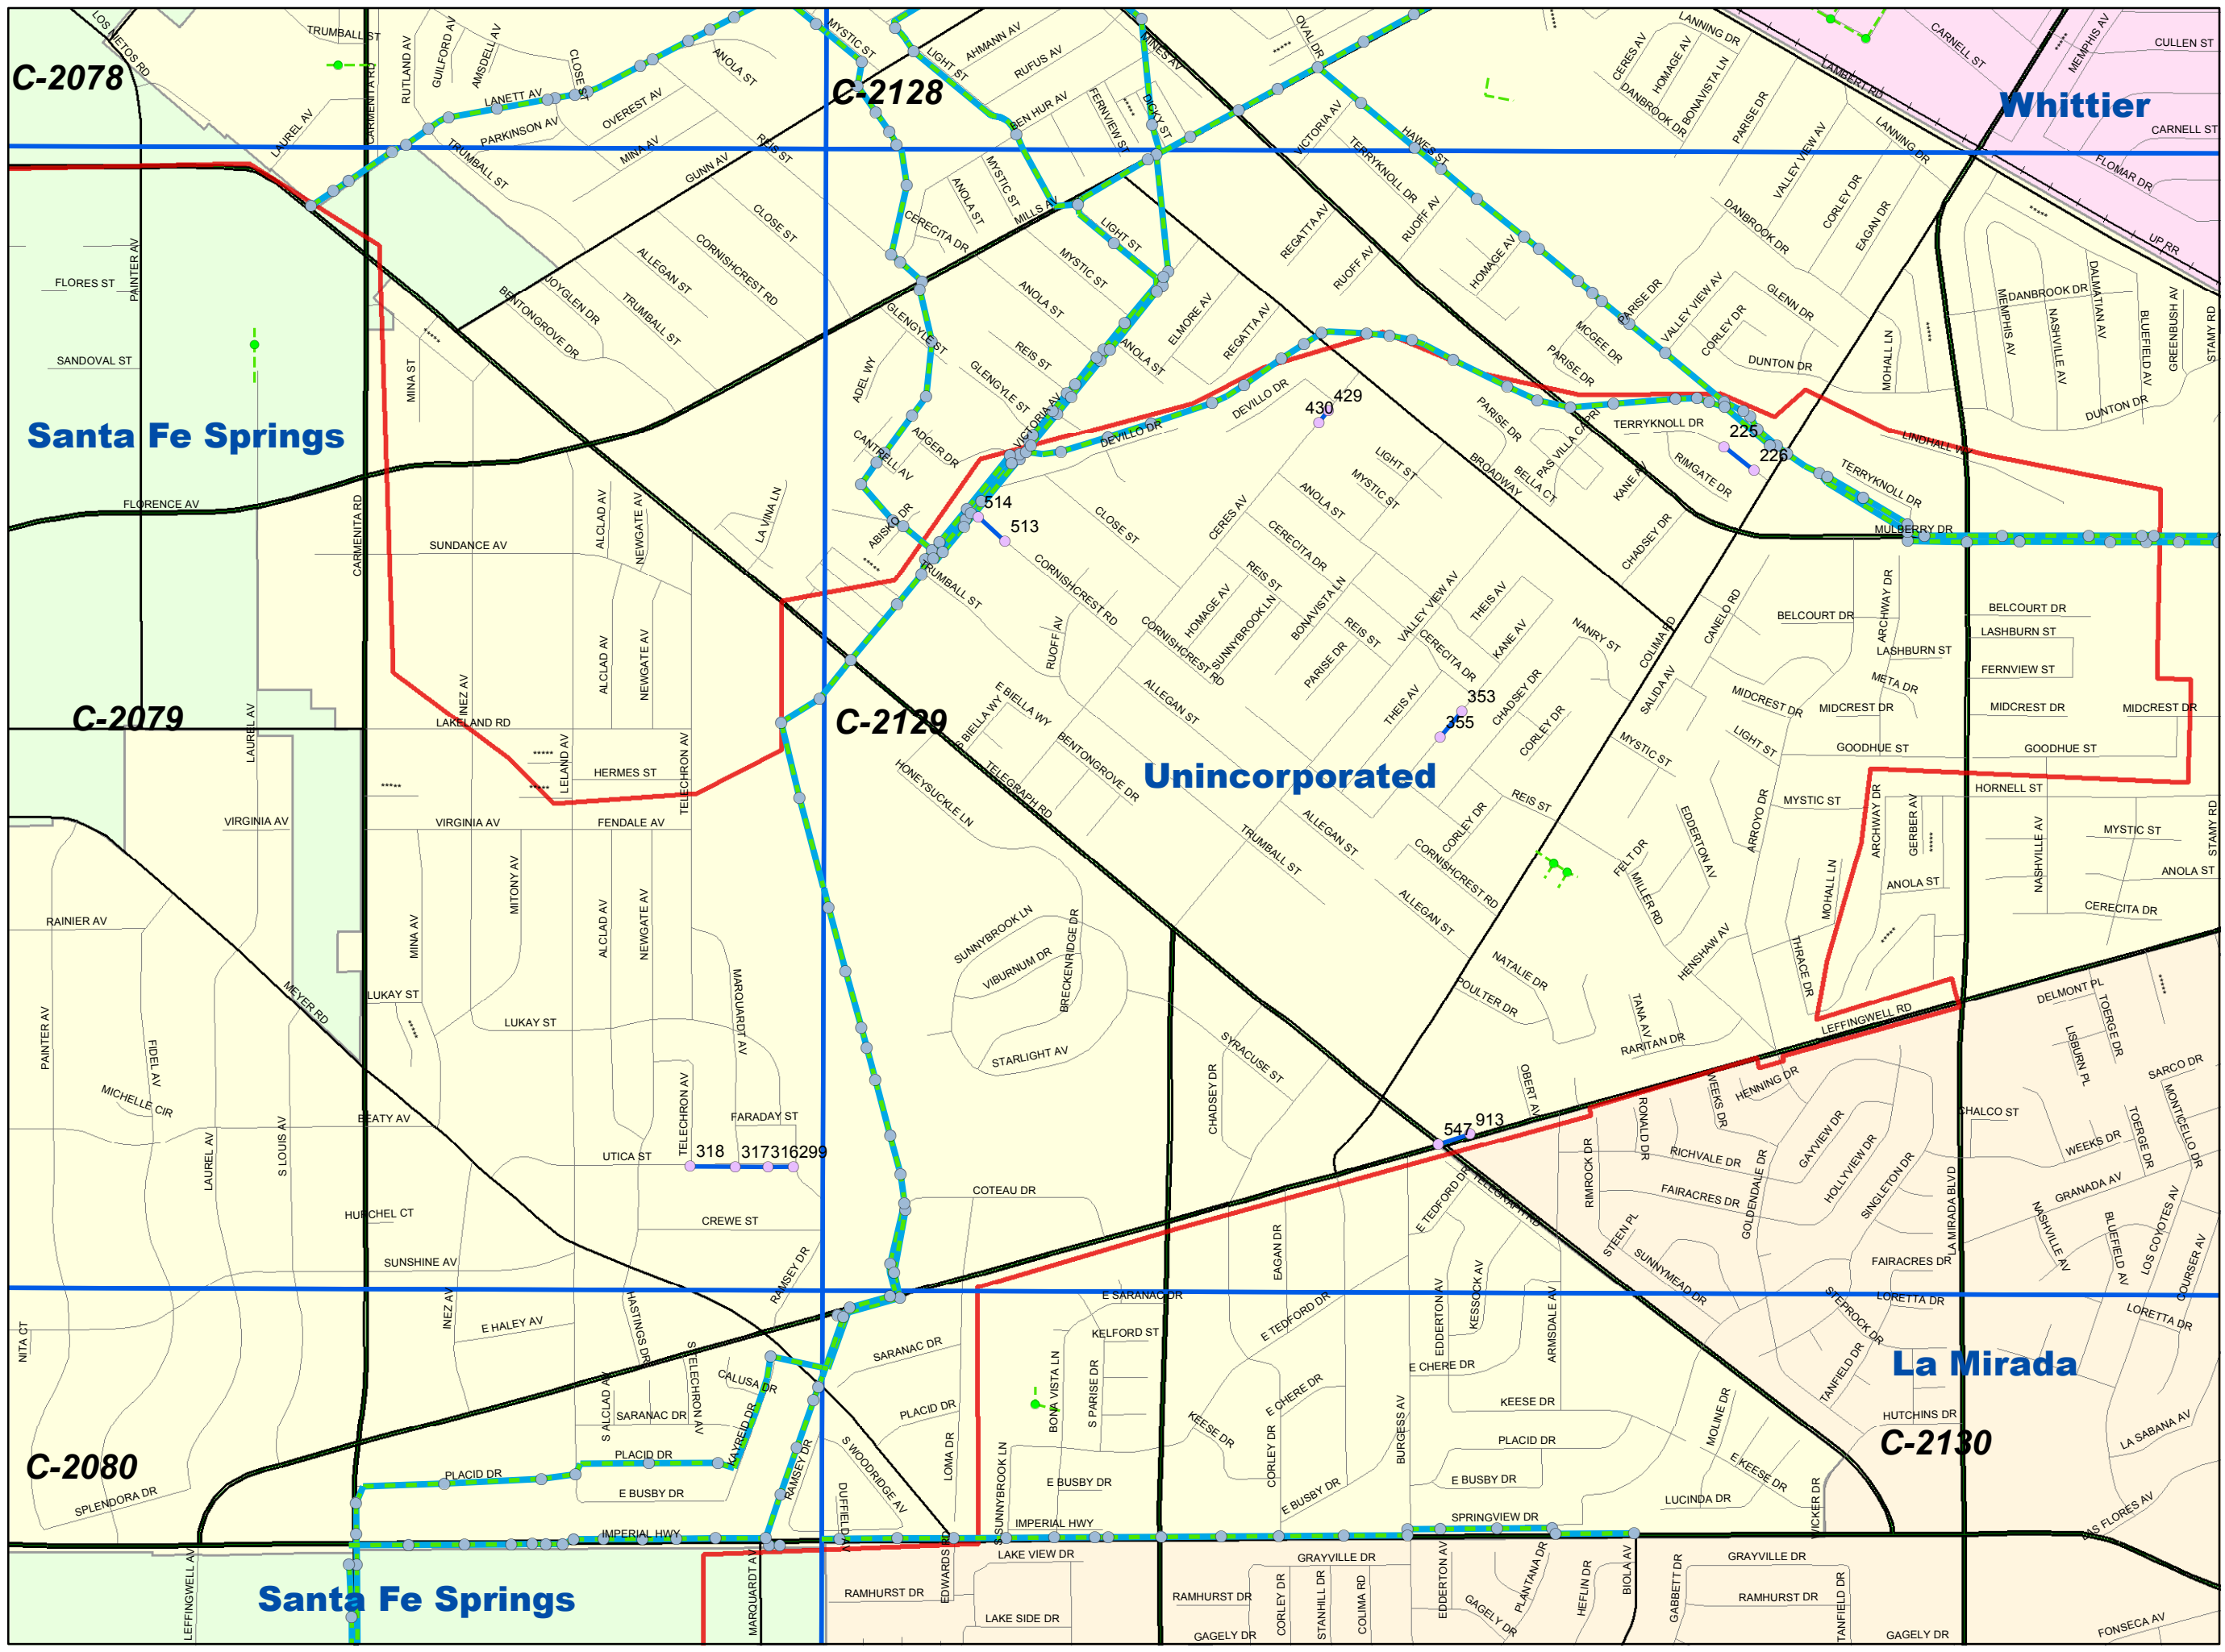
HIGH WATER LEVELS

Our inspection revealed that approximately 99 percent of the system televised has adequate capacity. Approximately 1 percent of the segments inspected exhibited visual signs associated with high water levels. The capacity of the sewer pipe can be determined by analyzing several PACP codes, including Water Level, Water Mark, and miscellaneous remarks, which indicate the camera was underwater or there were sags in the line. A sewer pipe is considered at capacity when 50 percent of the diameter of the sewer pipe is full of water. However, there are conditions in which the Water Level or Water Mark has reached 50 percent or greater due to heavy flows in adjoining pipes, a temporary stoppage caused by debris in the sewer lines, or a sag in the line. Therefore, additional review of these pipe segments was conducted to determine if any capacity issues exist.

All sewer pipes where the Water Level, Water Mark, and miscellaneous remarks of camera underwater or sags in the line are at or above 50 percent capacity have been listed and analyzed on the High Water Level Table in Enclosure 2. The nature of these high water level conditions is also summarized on this table.

A map showing the sewer lines with high water levels is provided in Enclosure 2.

ITEM NO.	QMR	START MH	END MH	STREET	OBSERVATION: LOCATION	CAPACITY	CORRECTIVE ACTION
1	4A3B	2079-0317	2079-0318	UTICA ST	Camera under water	NO	Rodder
2	463A	2079-0316	2079-0317	UTICA ST	Camera under water	NO	Rodder
3	453C	2129-0513	2129-0514	CORNISHCREST RD	Camera under water	NO	Rodder
4	442A	2079-0299	2079-0316	UTICA ST	Camera under water	NO	Rodder
5	4336	2129-0429	2129-0430	CERES AV	Sag	NO	Rodder
6	4235	2129-0353	2129-0355	KANE AV	Sag	NO	Rodder
7	4231	2129-0225	2129-0226	TERRYKNOLL DR	Sag	NO	Rodder
8	4225	2129-0547	2129-0913	LEFFINGWELL RD	Camera under water	NO	Rodder
9	3221	2129-0514	2129-TRNK	VICTORIA AV	Sag	NO	No maintenance action needed

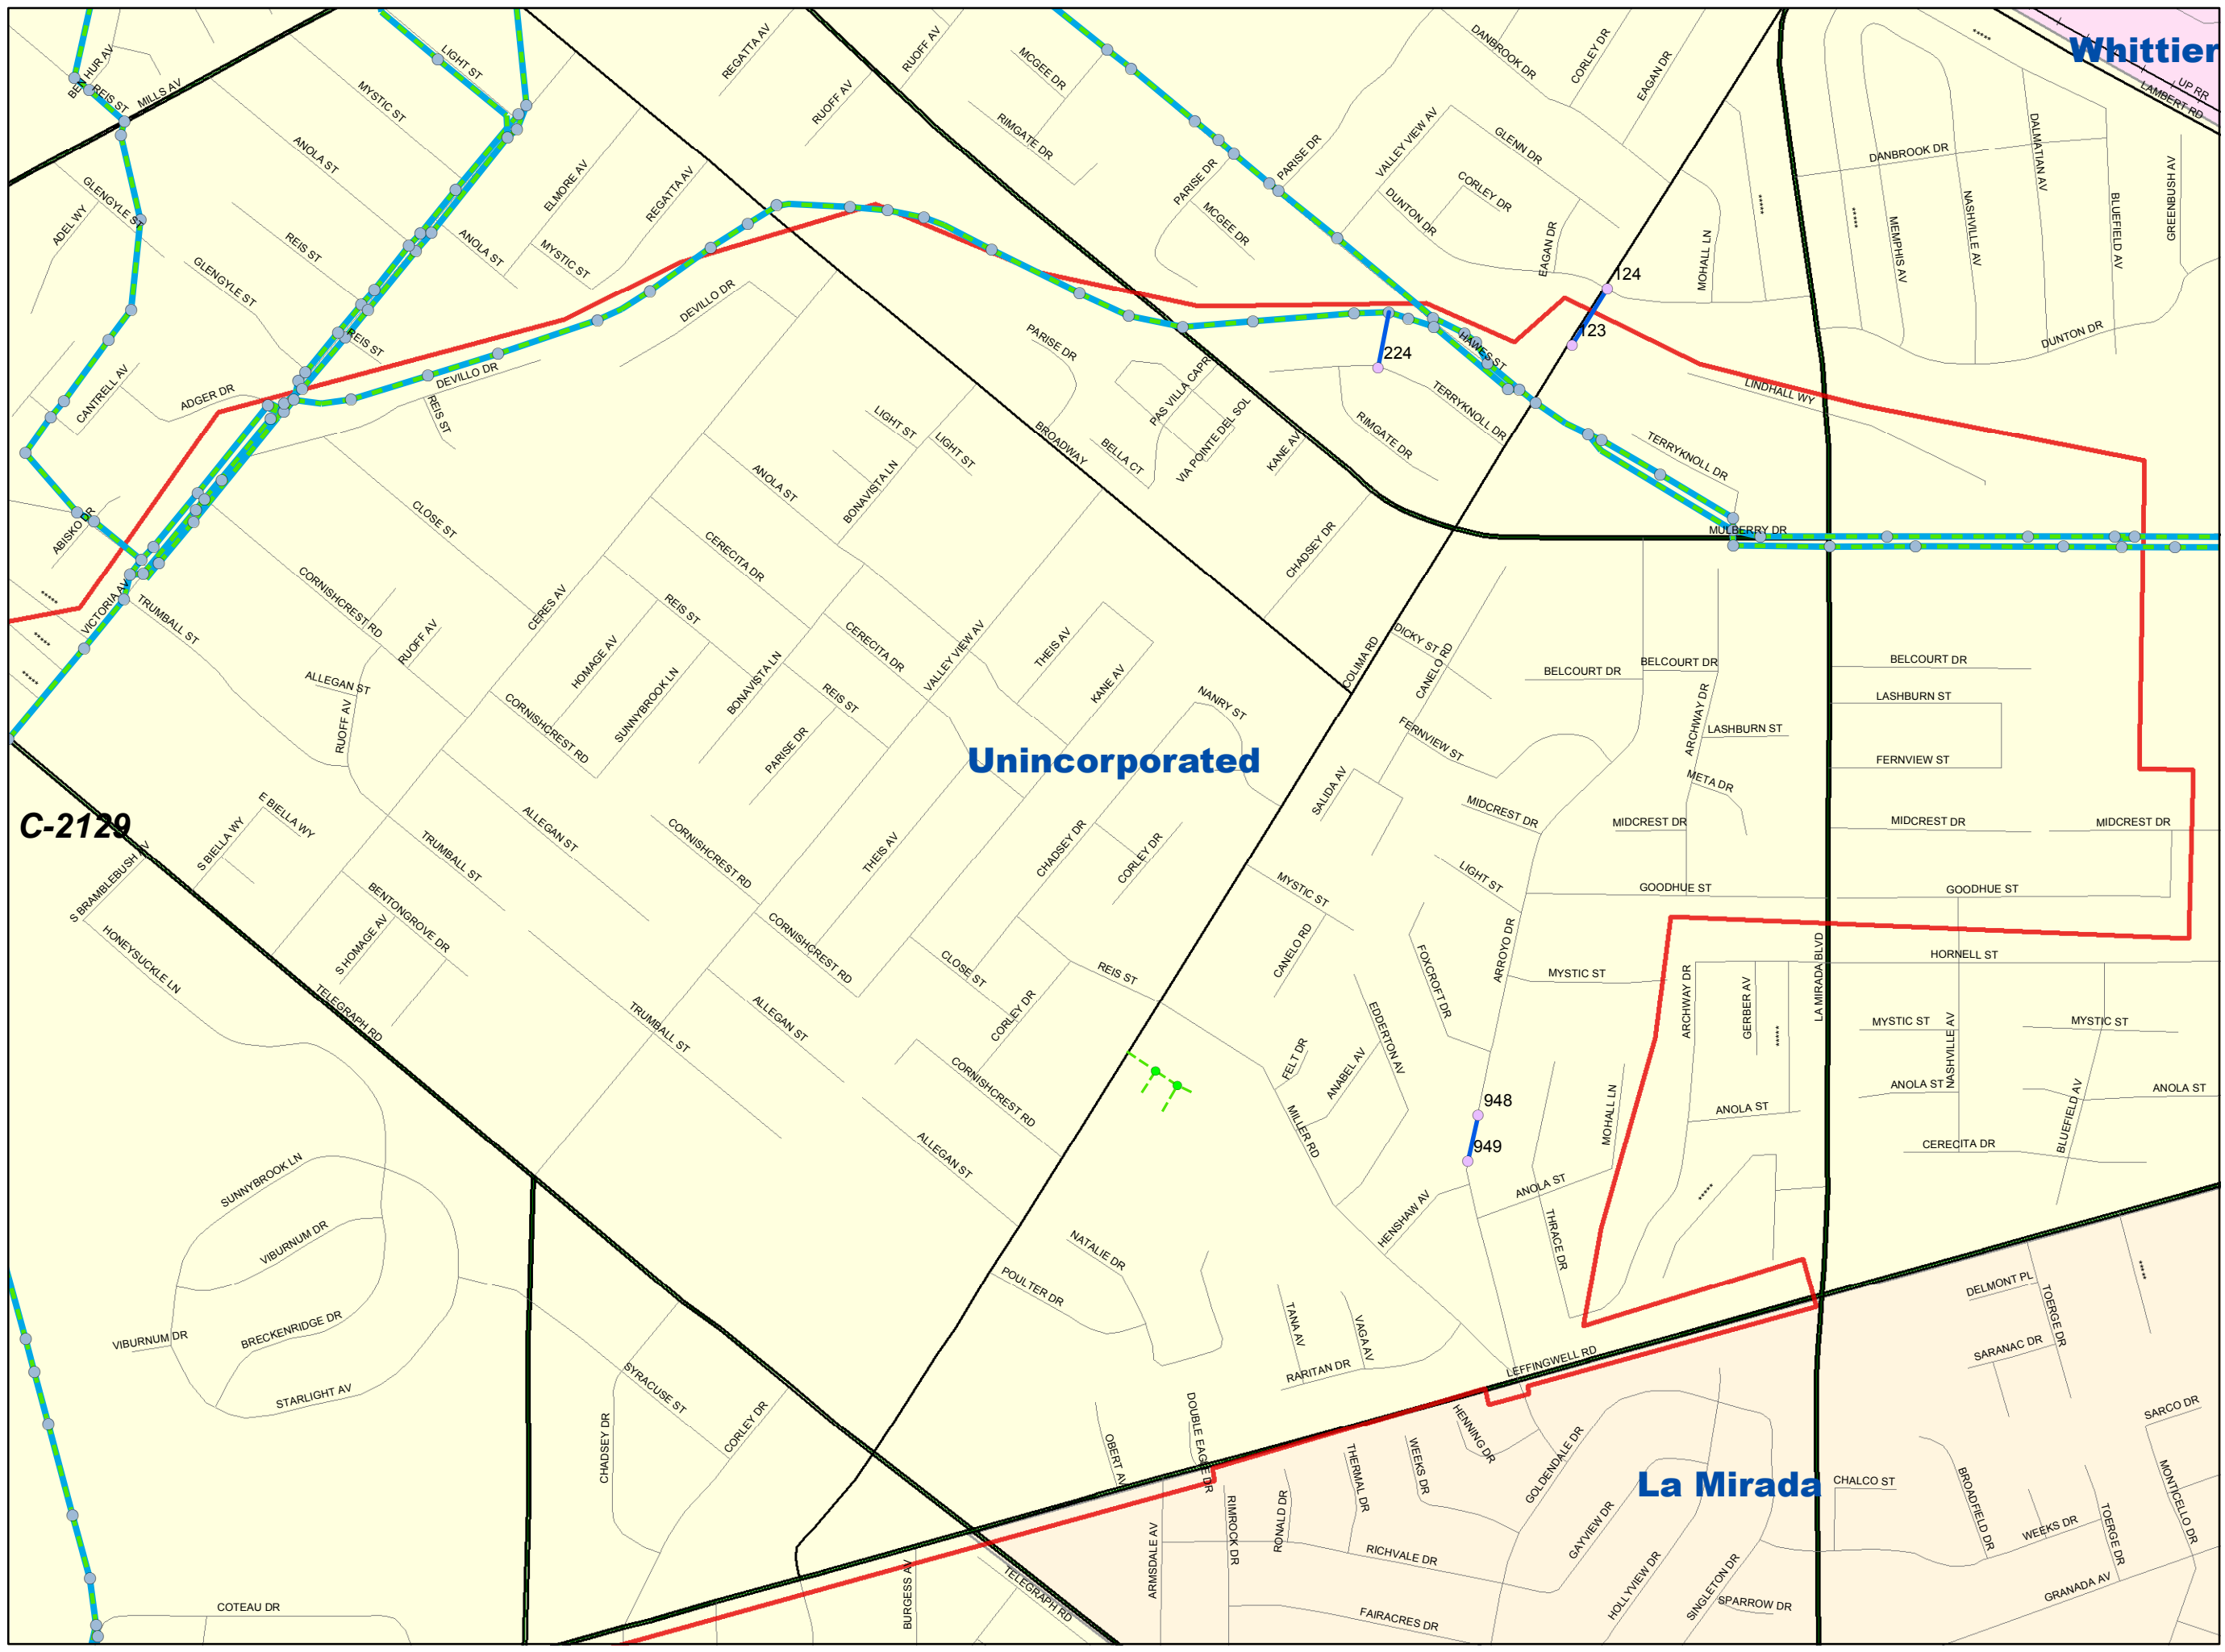
INFILTRATION

Our inspection revealed that approximately 0.3 percent of the system in unincorporated County as part of Project No. Y0TV0910B has infiltration within the pipe segments. Infiltration is the ingress of groundwater into the sewers through a defect or porous area of the pipe wall. All sewer pipes where infiltration was found are listed on the Infiltration Table in Enclosure 2. This table also provides the proposed corrective action for these impacted sewer segments. If a corrective action is proposed, the work will be programmed in the next 24 months as part of our ongoing Accumulative Capital Outlay Program.

A map showing the sewer lines with infiltration is provided in Enclosure 2.

ITEM NO.	QMR	START MH	END MH	STREET	OBSERVATION	PROPOSED CORRECTIVE METHOD	LENGTH OF REPAIR (FT)
1	412A	2129-0224	2129-TRNK		Infiltration runner: 45'	Infiltration is minimum. No action needed.	
2	4432	2129-0123	2129-0124	COLIMA RD	Infiltration runner: 49', 53', 57'	Infiltration is minimum. No action needed.	
3	4122	2129-0948	2129-0949	ARROYO DR	Infiltration dripper: 249'	Infiltration is minimum. No action needed.

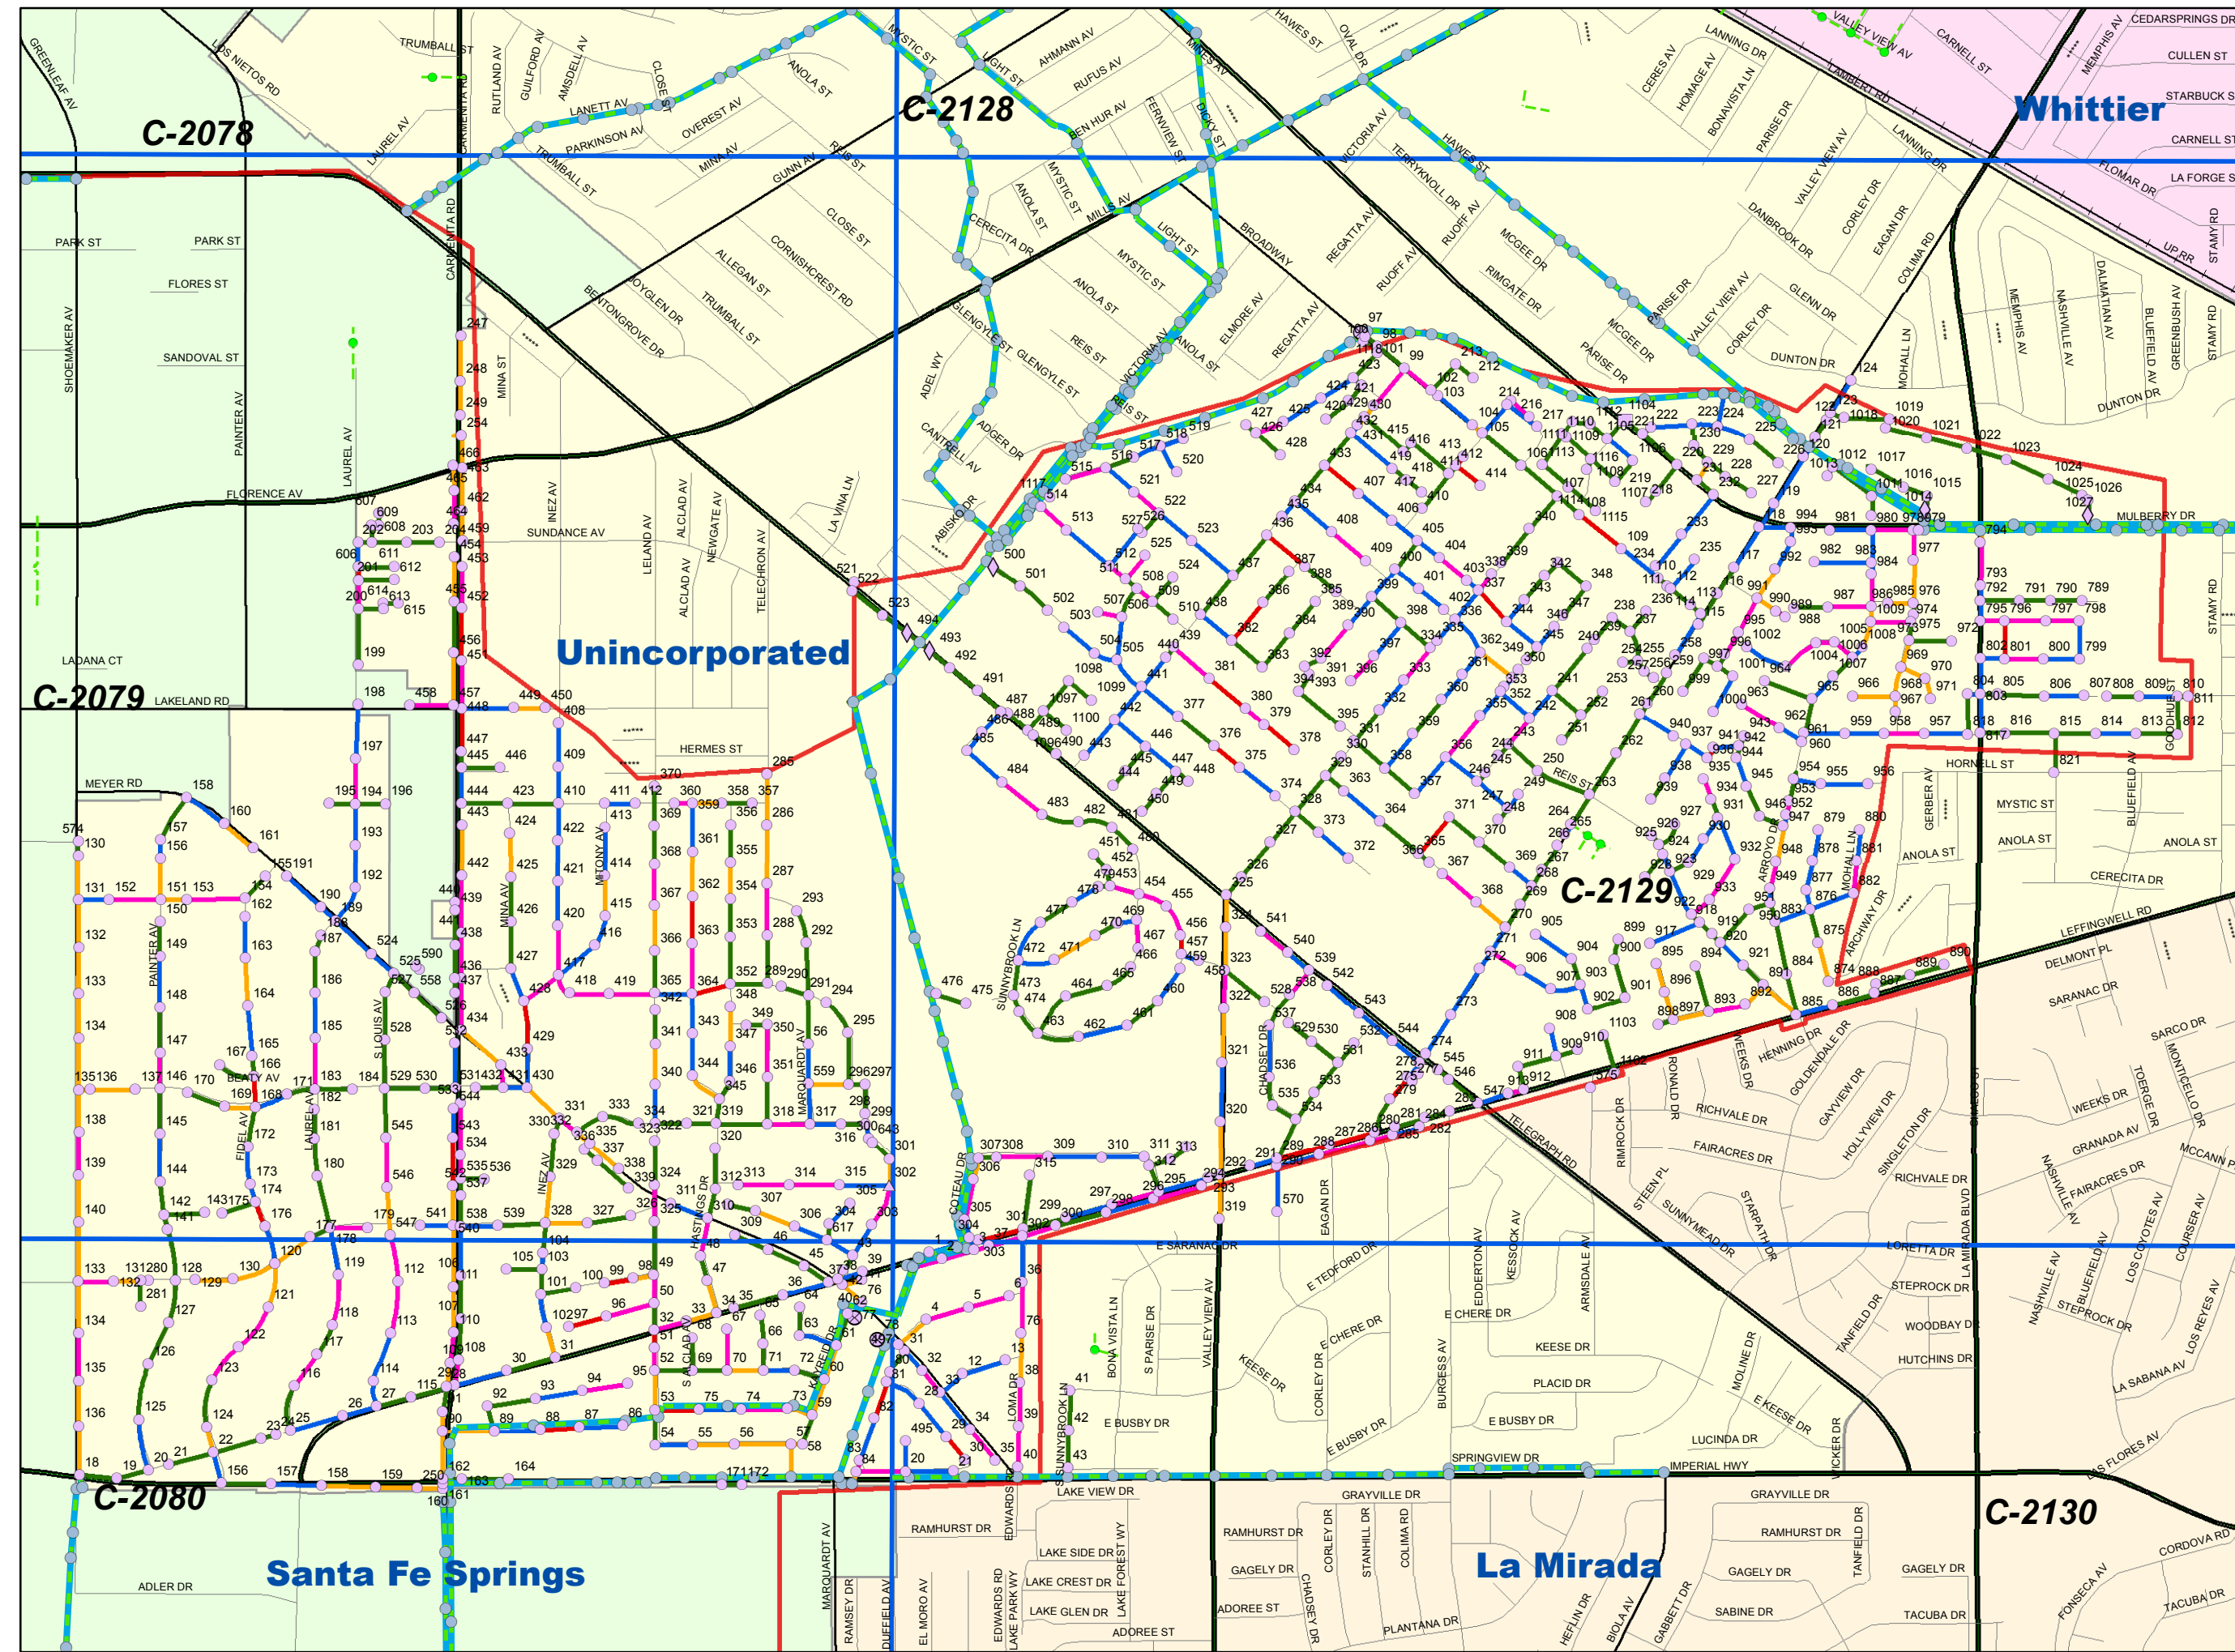
QUICK
STRUCTURAL
RATING
(QSR)

Our inspection revealed that approximately 80.8 percent of the inspected pipe segments within unincorporated County were free of severe structural defects. However, the remaining 19.2 percent of the inspected pipe segments had a PACP structural grade of 4 or 5 as indicated in the Quick Structural Rating Table shown below. These segments have been placed on a priority list based on the severity and the need for action. For items 1 through 171 in the Quick Structural Rating Report Priority List (Enclosure 3), which warrant a corrective action, the proposed corrective action will be programmed in the next 24 months as part of the ongoing Accumulative Capital Outlay Program.

A color-coded map showing the Quick Structural Rating for each pipe segment is located in Enclosure 3.
