**CONSOLIDATED SEWER MAINTENANCE DISTRICT
CONDITION ASSESSMENT PROGRAM REPORT
PROJECT Y0TV0910A**

**CONDITION ASSESSMENT REPORT
COUNTY OF LOS ANGELES DEPARTMENT OF PUBLIC WORKS
CONSOLIDATED SEWER MAINTENANCE DISTRICT**

PROJECT NAME:	Y0TV910A	PROJECT MGR:	Eric Liu
PROJECT DATE:	07/23/10	CONTACT NO:	(626) 300-3369
SUP. DISTRICT(s):	1 & 4	MAP PAGE(S):	1654,1709,1753,1754 1808 &1809
Report By:	Hanna Kebede	Report Date:	05/13/2013

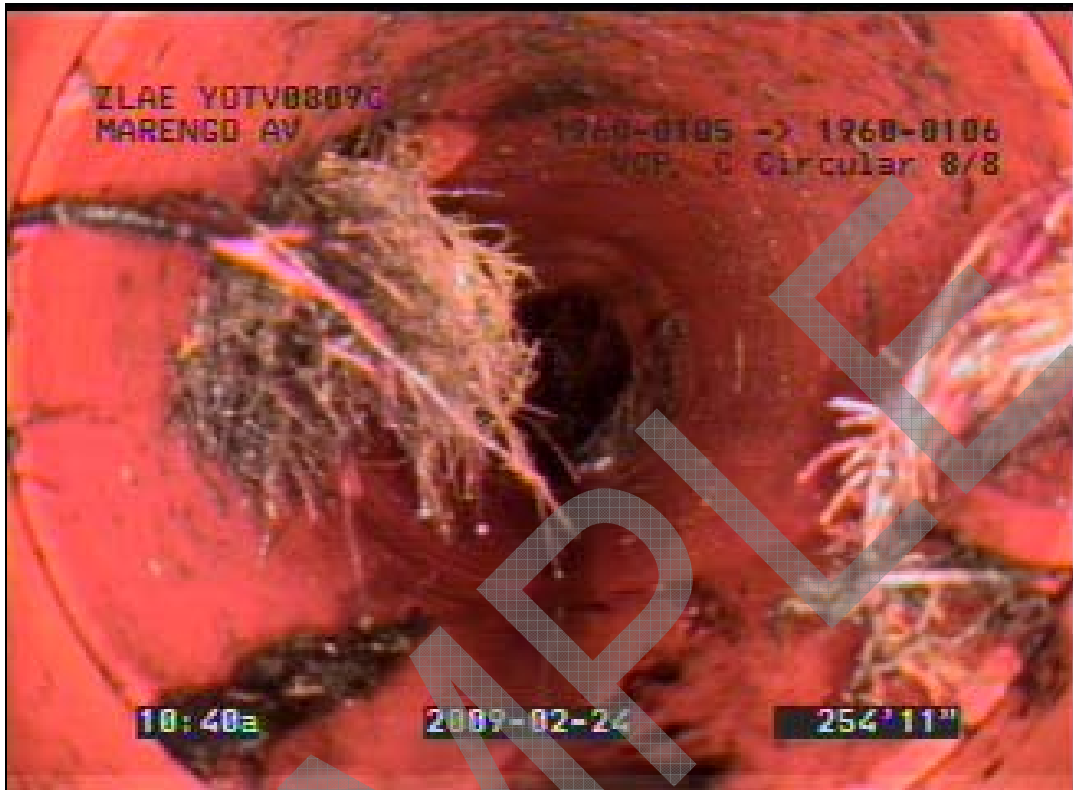
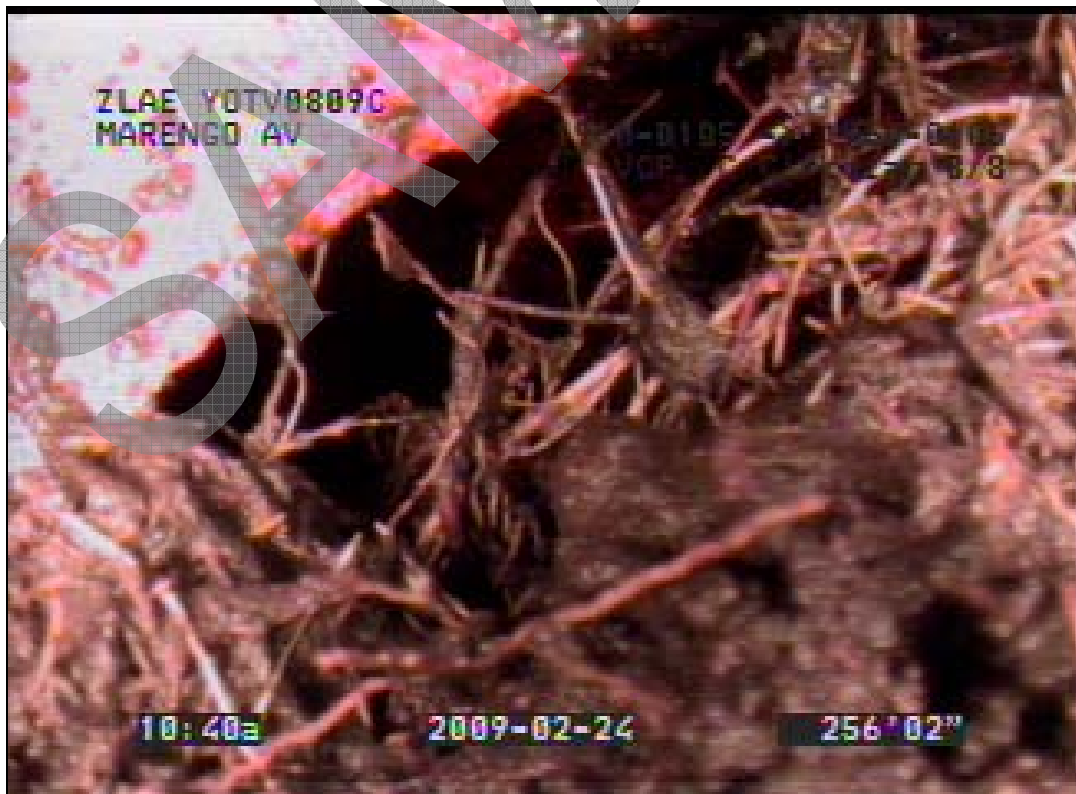
3476 MARENGO AVE
ALTADENA
Roots at Lateral Connection

For your reference, we have enclosed photos of your lateral connection showing the presence of the root blockage. Also enclosed are some literature on ways of minimizing sewer overflows and damage to your home.

your sewer lateral within 90 days to remove roots and any other obstructions that may cause a sewage backup. Failure to do so may result in future overflows and subject you to civil prosecution, reimbursement costs, and fines up to \$1,000. Reference 20.24.160 Violation - Penalty; 20.24.170 Continued violations; 20.32.690 Reimbursement for repairs and maintenance following violations.
