**CONSOLIDATED SEWER MAINTENANCE DISTRICT
CONDITION ASSESSMENT PROGRAM REPORT
UNINCORPORATED COUNTY**

**CONDITION ASSESSMENT REPORT
COUNTY OF LOS ANGELES DEPARTMENT OF PUBLIC WORKS
CONSOLIDATED SEWER MAINTENANCE DISTRICT**

PROJECT NAME:	Y0TV0910D	PROJECT MGR:	Eric Liu
PROJECT DATE:	1/31/11	CONTACT NO:	(626) 300-3369
SUP. DISTRICT(S):	2	MAP PAGE(S):	1481, 1482, 1534, 1535, 1587, 1588, 1589, 1592, 1642, 1646
Report By:	Eric Liu	Report Date:	9/6/18

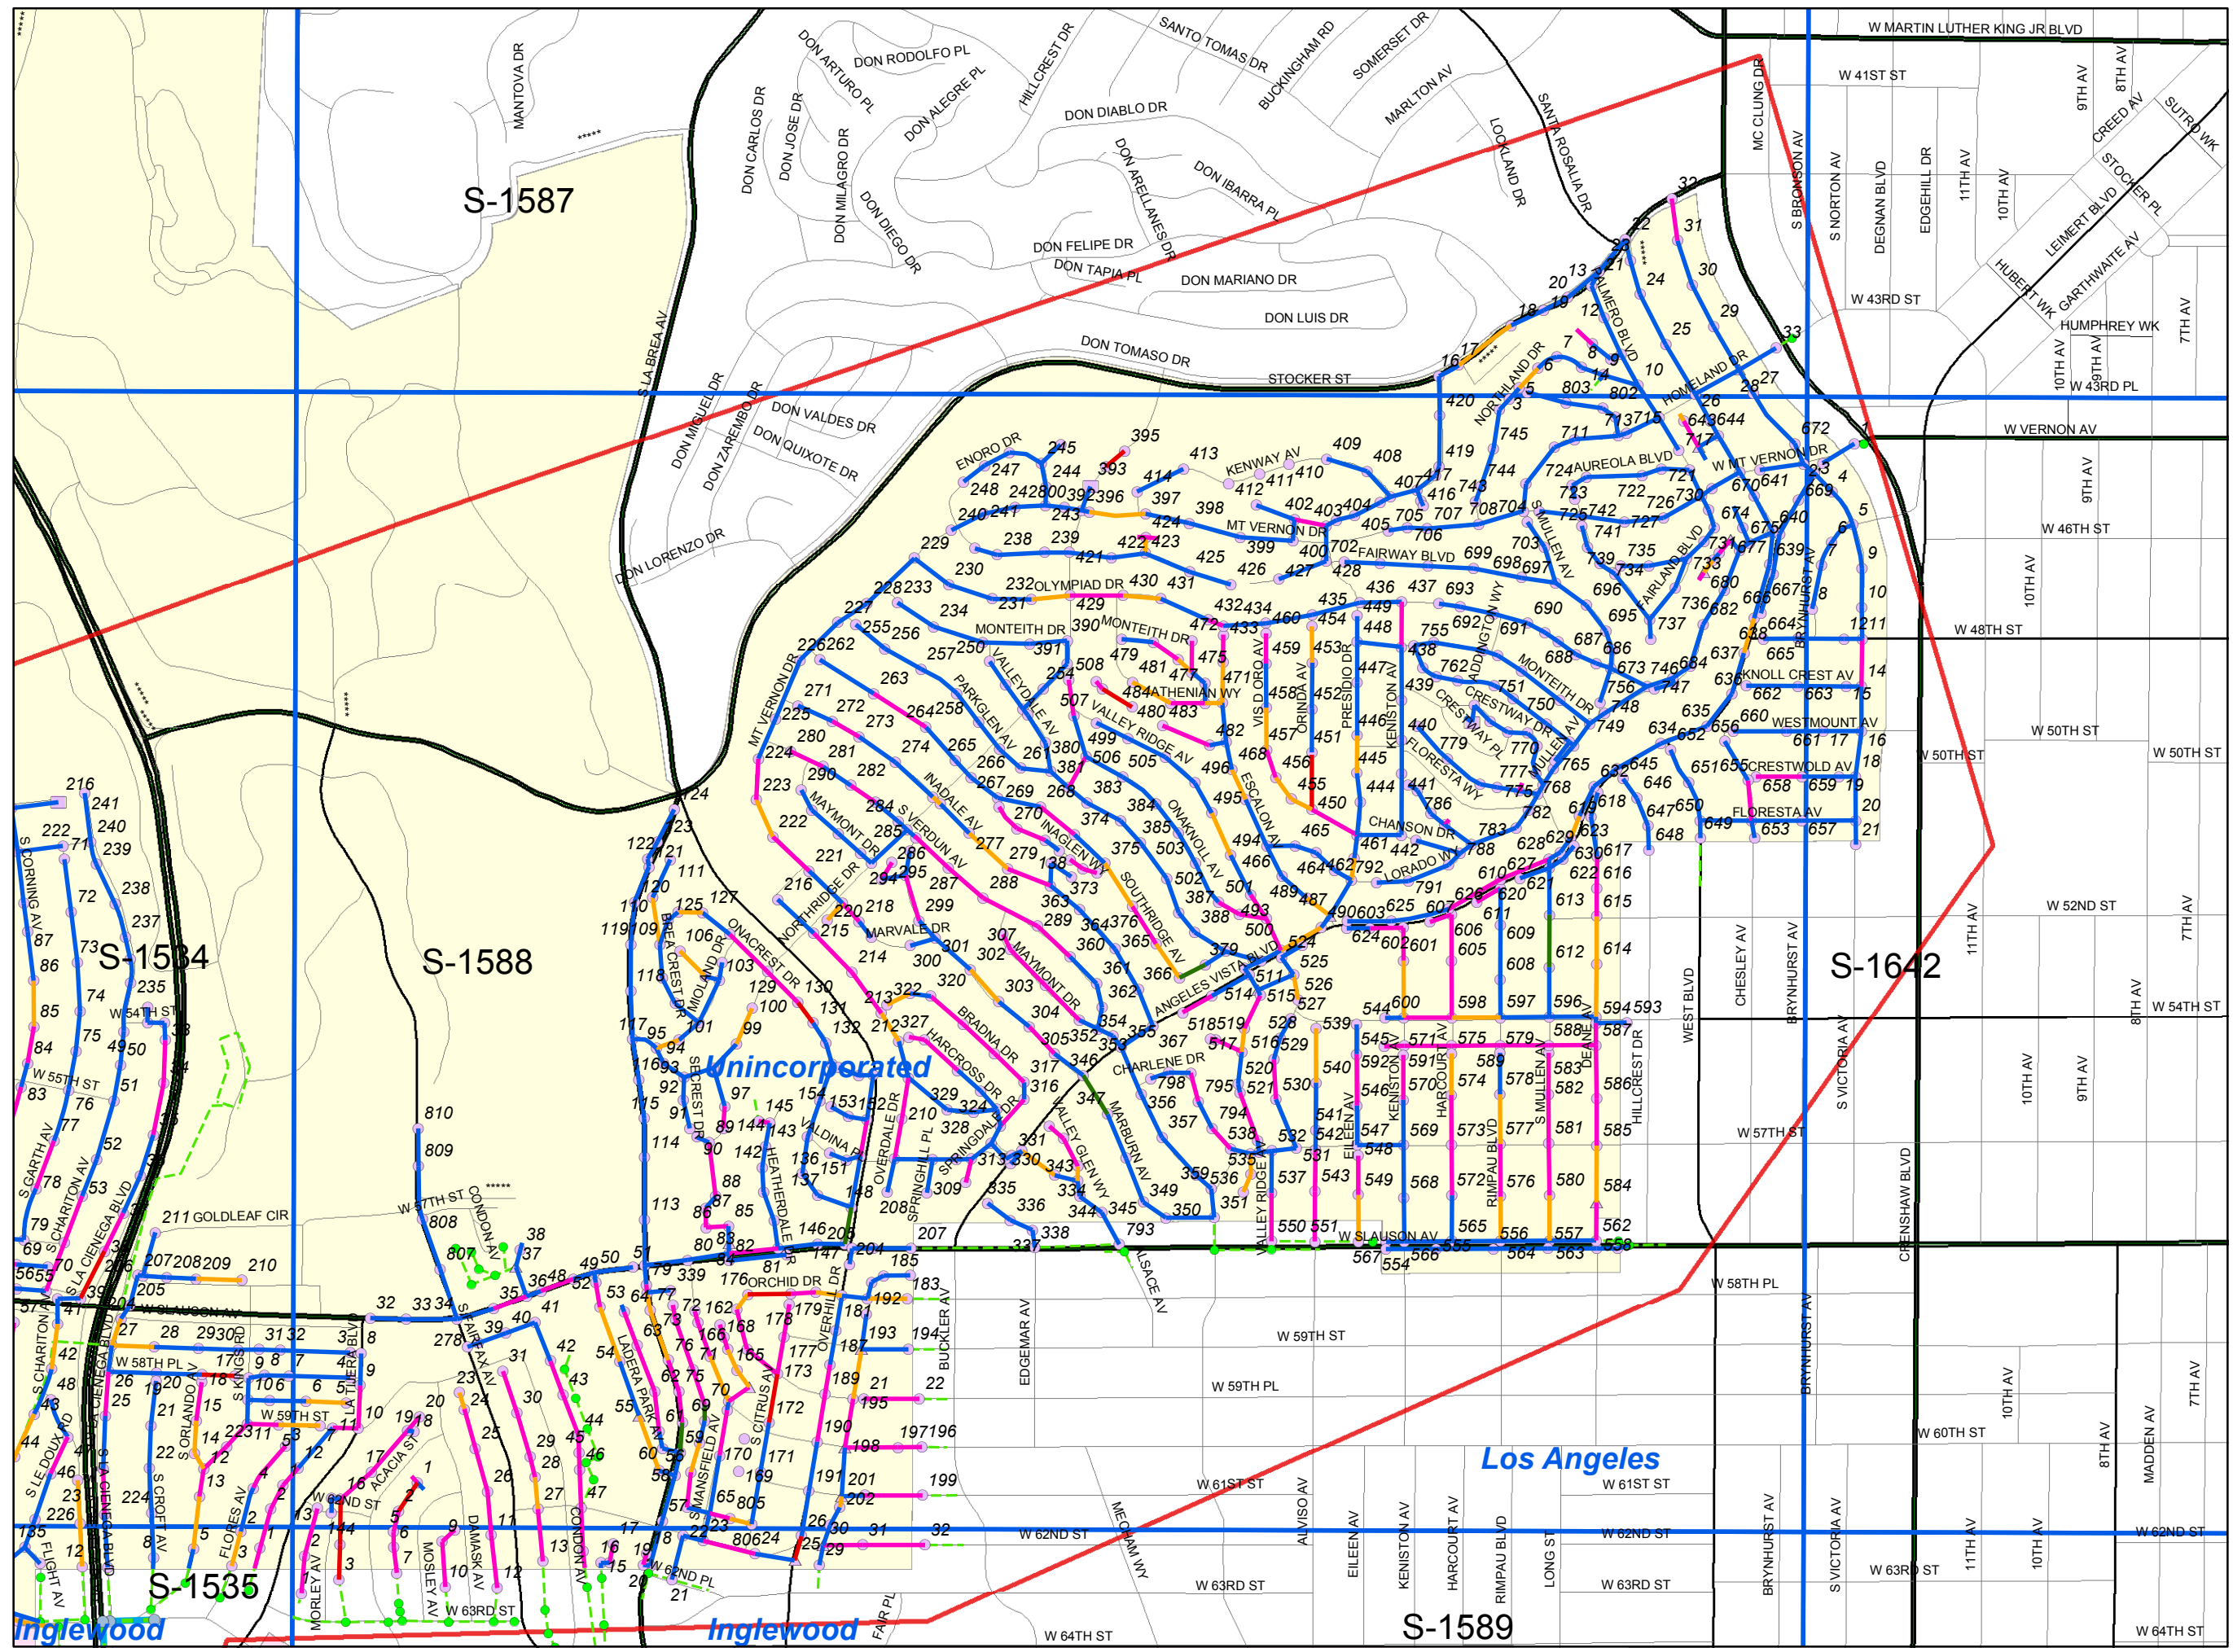
QUICK
MAINTENANCE
RATING
(QMR)

Our inspection revealed that approximately 68.7 percent of the system televised in unincorporated County as part of Project No. Y0TV0910D was free of significant blockages or restrictions that would impede sewer flows. However, the remaining 31.3 percent of the pipe segments within the unincorporated County had a PACP maintenance grade of 3, 4, or 5 as indicated in the Quick Maintenance Rating Table shown below. These segments have been incorporated into our routine cleaning schedule with corrective action taken.

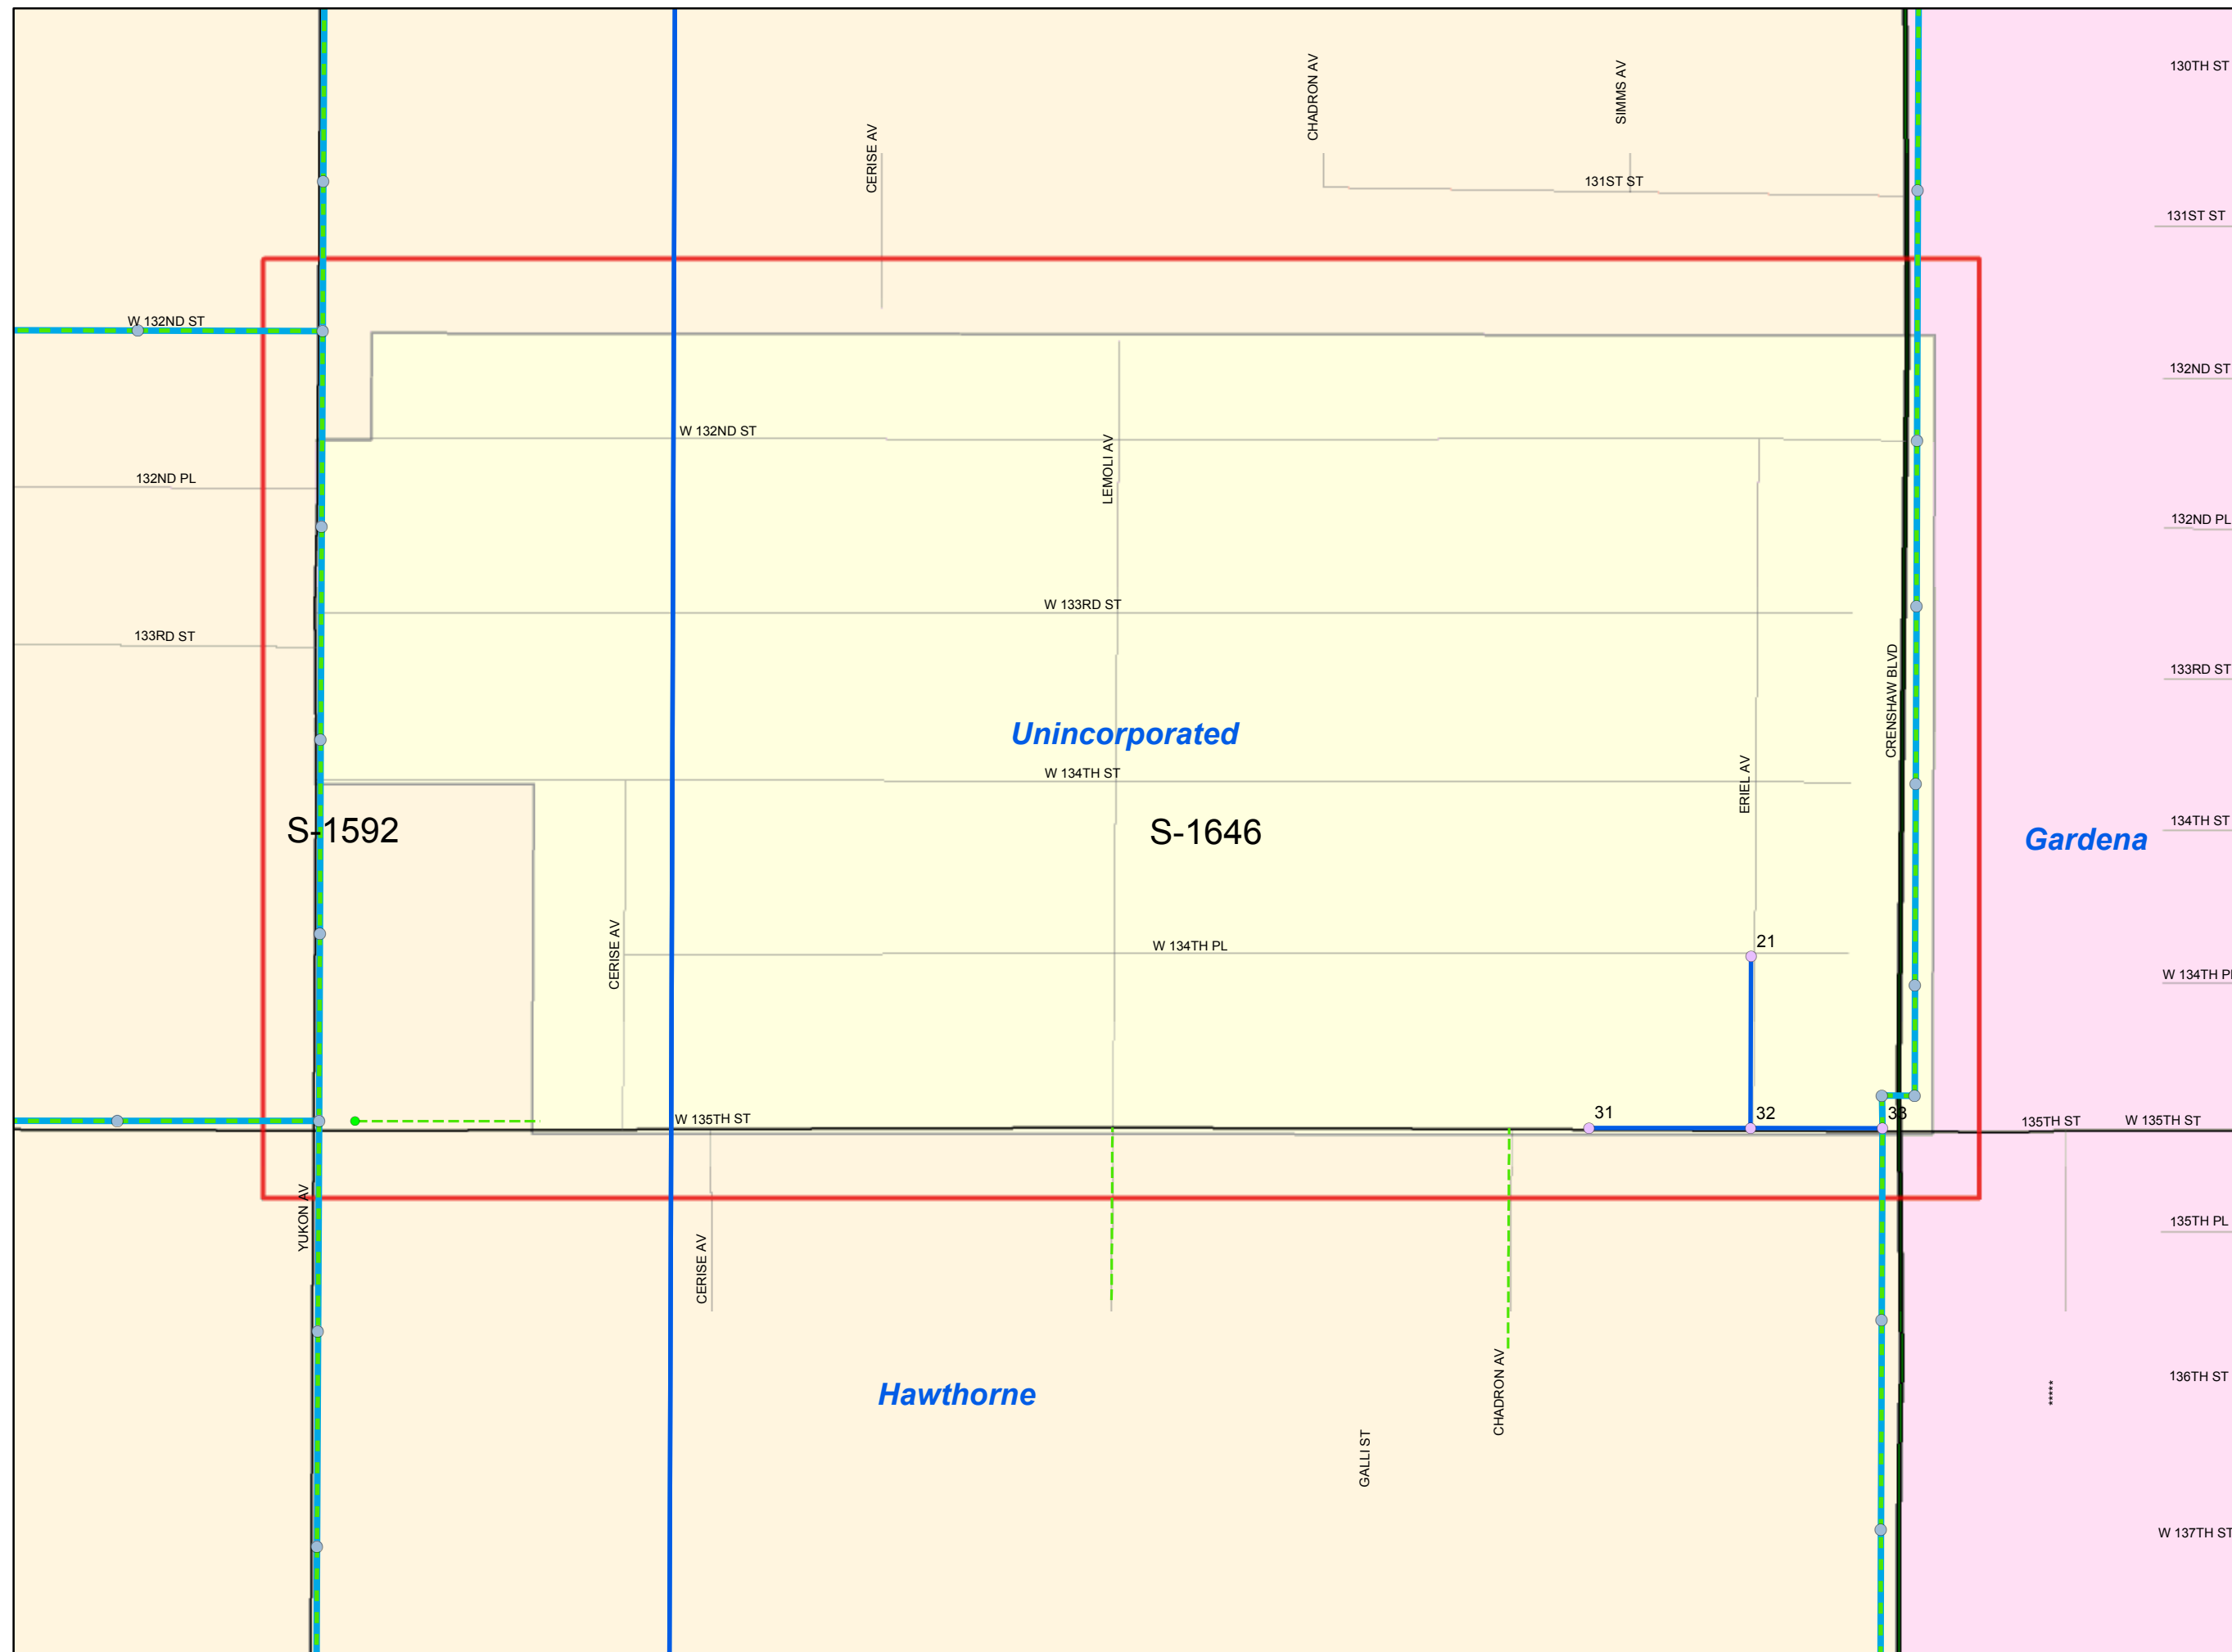
HIGH WATER LEVEL

Our inspection revealed that approximately 99.2 percent of the system televised has adequate capacity. Approximately 0.8 percent of the segments inspected exhibited visual signs associated with high water levels. The capacity of the sewer pipe can be determined by analyzing several PACP codes, including Water Level, Water Mark, and miscellaneous remarks, which indicate the camera was underwater or there were sags in the line. A sewer pipe is considered at capacity when 50 percent of the diameter of the sewer pipe is full of water. However, there are conditions in which the Water Level or Water Mark has reached 50 percent or greater due to heavy flows in adjoining pipes, a temporary stoppage caused by debris in the sewer lines, or a sag in the line. Therefore, additional review of these pipe segments was conducted to determine if any capacity issues exist.

ITEM NO.	QMR	START MH	END MH	STREET	OBSERVATION: LOCATION	CAPACITY	CORRECTIVE ACTION
1	5141	1534-0038	1534-0039	LA CIENEGA BV	Camera under water	NO	Hydrojet
2	4132	1588-0048	1588-0049	SLAUSON AV	Camera under water; Sag	NO	Hydrojet
3	4131	1588-0053	1588-0052	LA DERA PARK AV	Camera under water	NO	Hydrojet
4	4131	1588-0079	1588-0078	LA BREA AV	Camera under water	NO	Hydrojet
5	4100	1646-0021	1646-0032	ERIEL AV	High flow	YES	Hydrojet
6	4100	1646-0032	1646-0031	135TH ST	High flow	YES	Hydrojet
7	4100	1646-0033	1646-0032	135TH ST	High flow	YES	Hydrojet
8	3122	1588-0053	1588-0054	LA DERA PARK AV	Sag	NO	Hydrojet
9	3122	1588-0462	1588-0461	PRESIDIO DR	Sag	NO	Hydrojet
10	3122	1588-0490	1588-0491	ANGELES VISTA BV	Sag	NO	Hydrojet
11	3121	1534-0204	1534-0027	LA CIENEGA BV	Sag	NO	Hydrojet

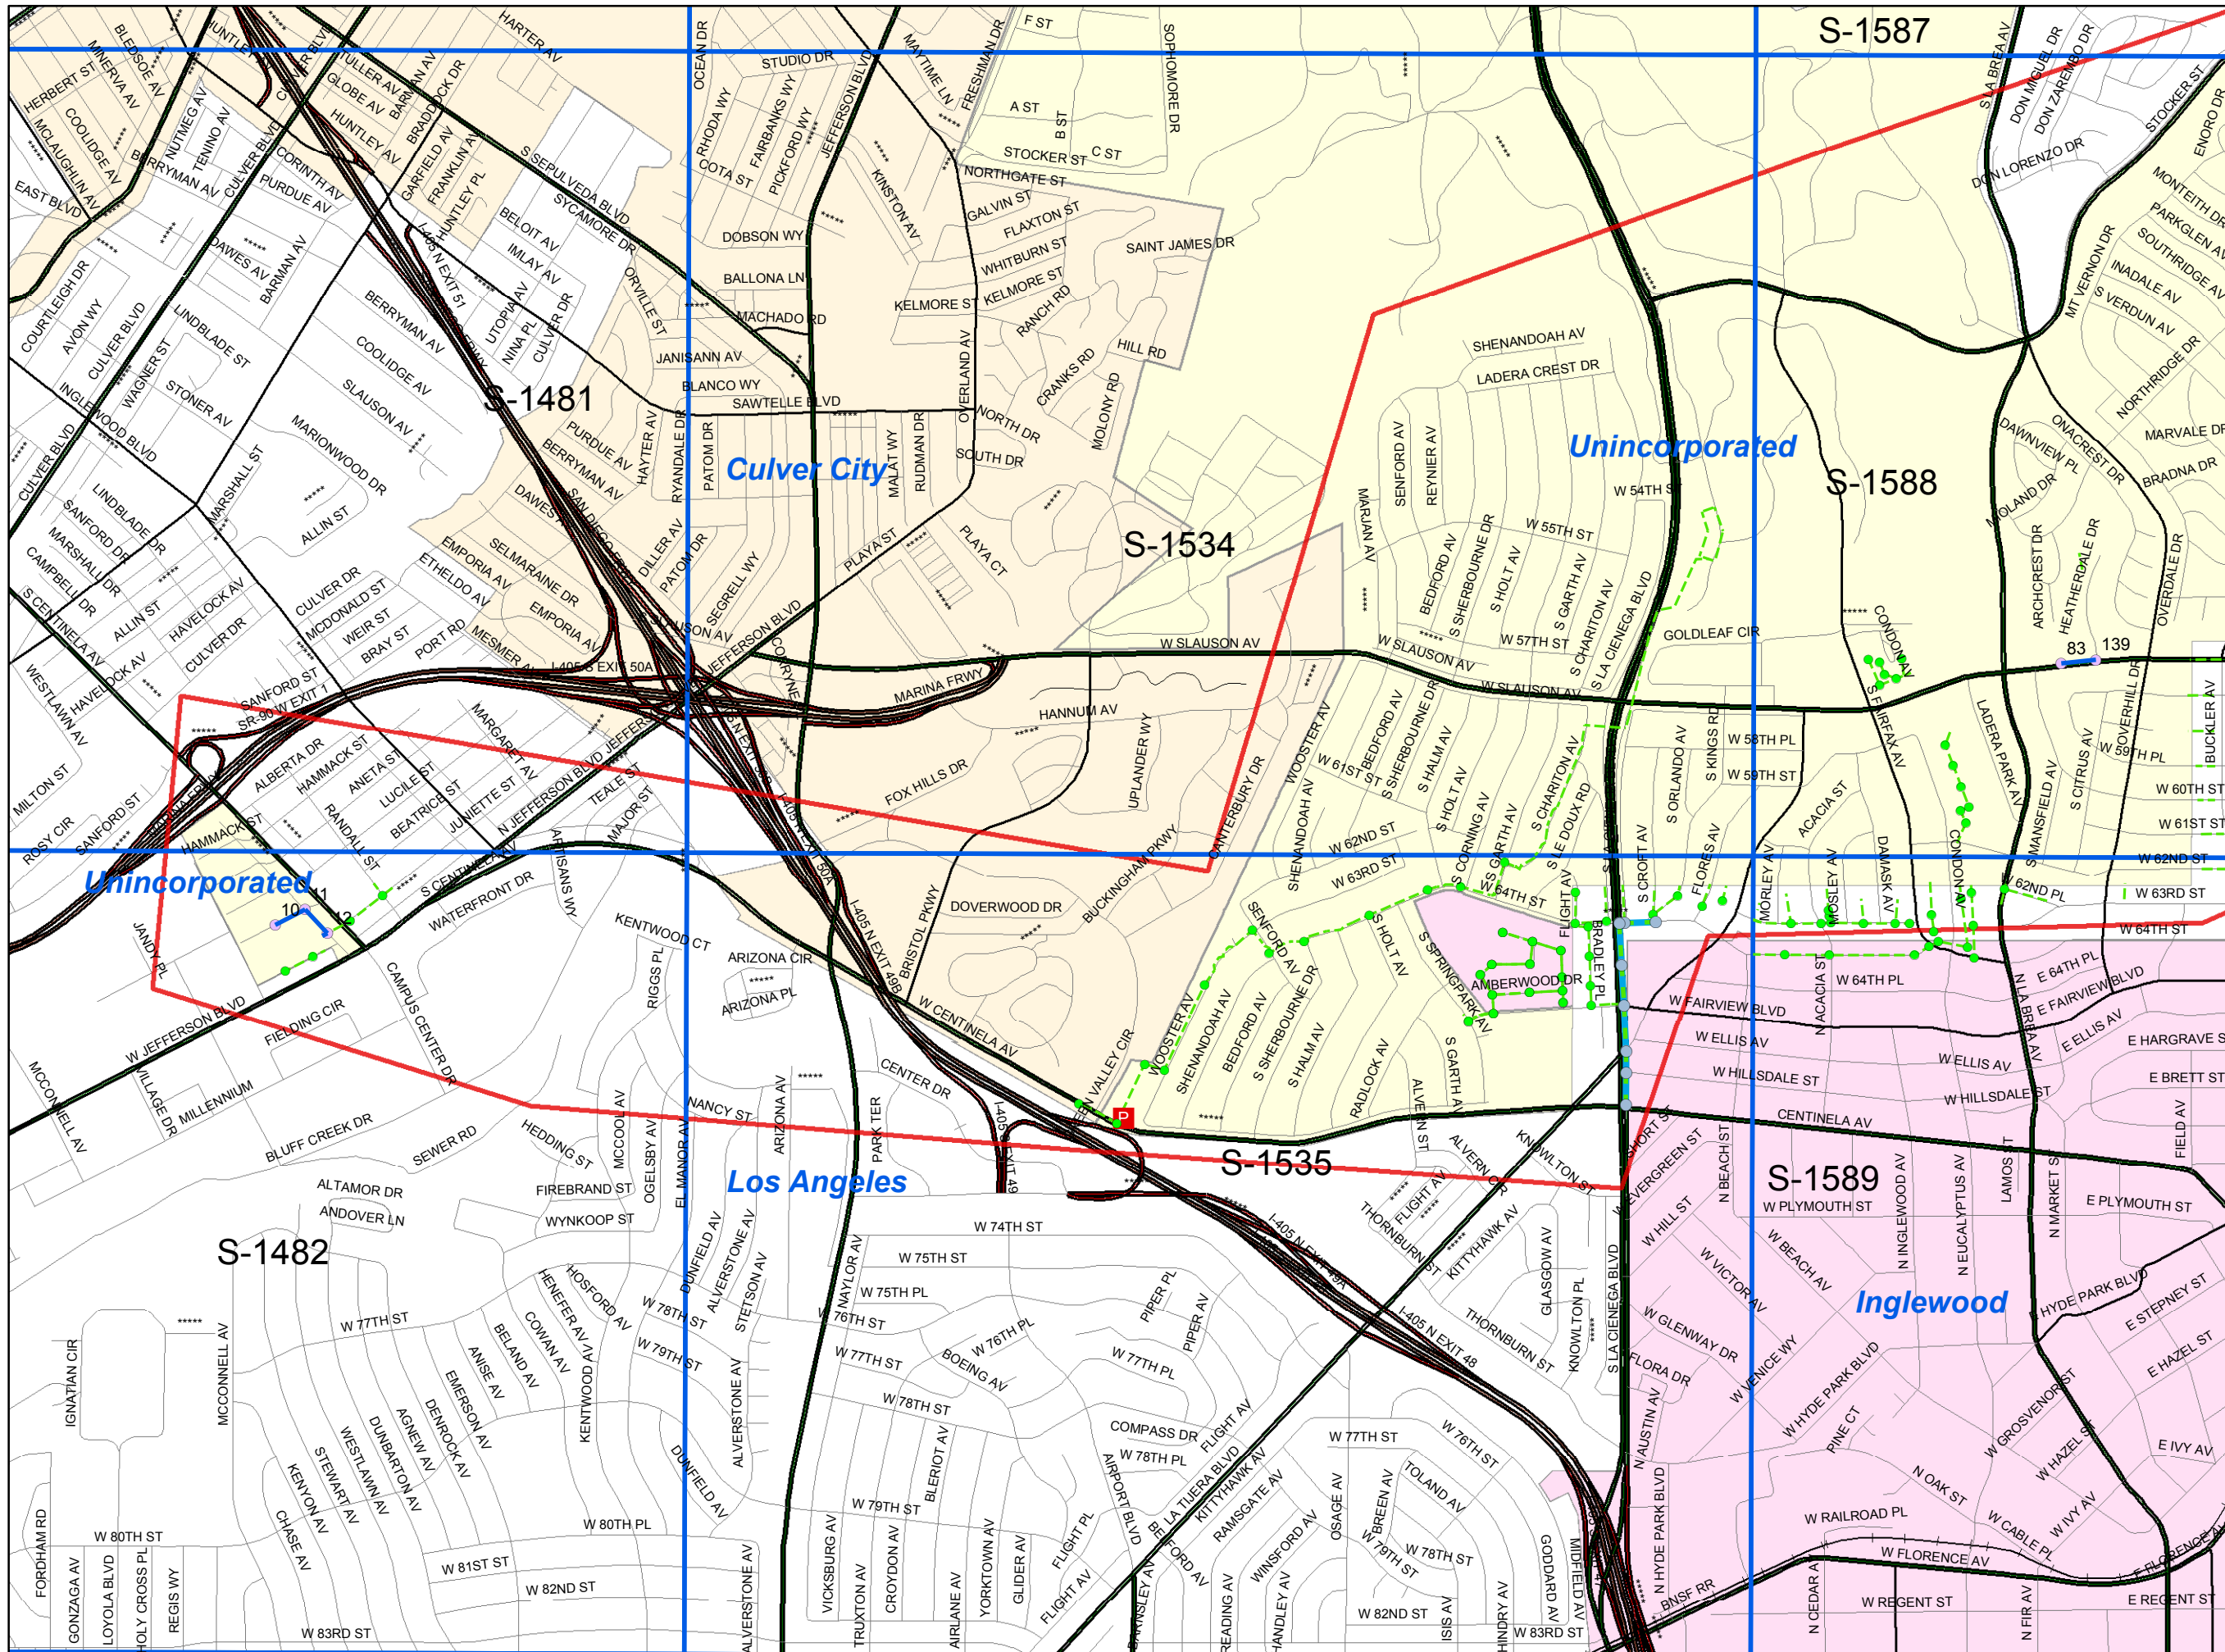
INFILTRATION

Our inspection revealed that approximately 0.2 percent of the system in unincorporated County as part of Project No. Y0TV0910D has infiltration within the pipe segments. Infiltration is the ingress of groundwater into the sewers through a defect or porous area of the pipe wall. All sewer pipes where infiltration was found are listed on the Infiltration Table in Enclosure 2. This table also provides the proposed corrective action for these impacted sewer segments. If a corrective action is proposed, the work will be programmed in the next 24 months as part of our ongoing Accumulative Capital Outlay Program.

ITEM NO.	QMR	START MH	END MH	STREET	OBSERVATION	PROPOSED CORRECTIVE METHOD	LENGTH OF REPAIR (FT)
1	4235	1482-0010	1482-0011	BEATRICE ST	Infiltration dripper: 33', 223'; Infiltration runner: 214'	Infiltration is minimum. No action needed.	
2	4121	1482-0012	1482-WEST	JUNIETTE ST	Infiltration runner: 37'	Infiltration is minimum. No action needed.	
3	4121	1588-0083	1588-0139	SLAUSON AV	Infiltration runner: 314'	Infiltration is minimum. No action needed.

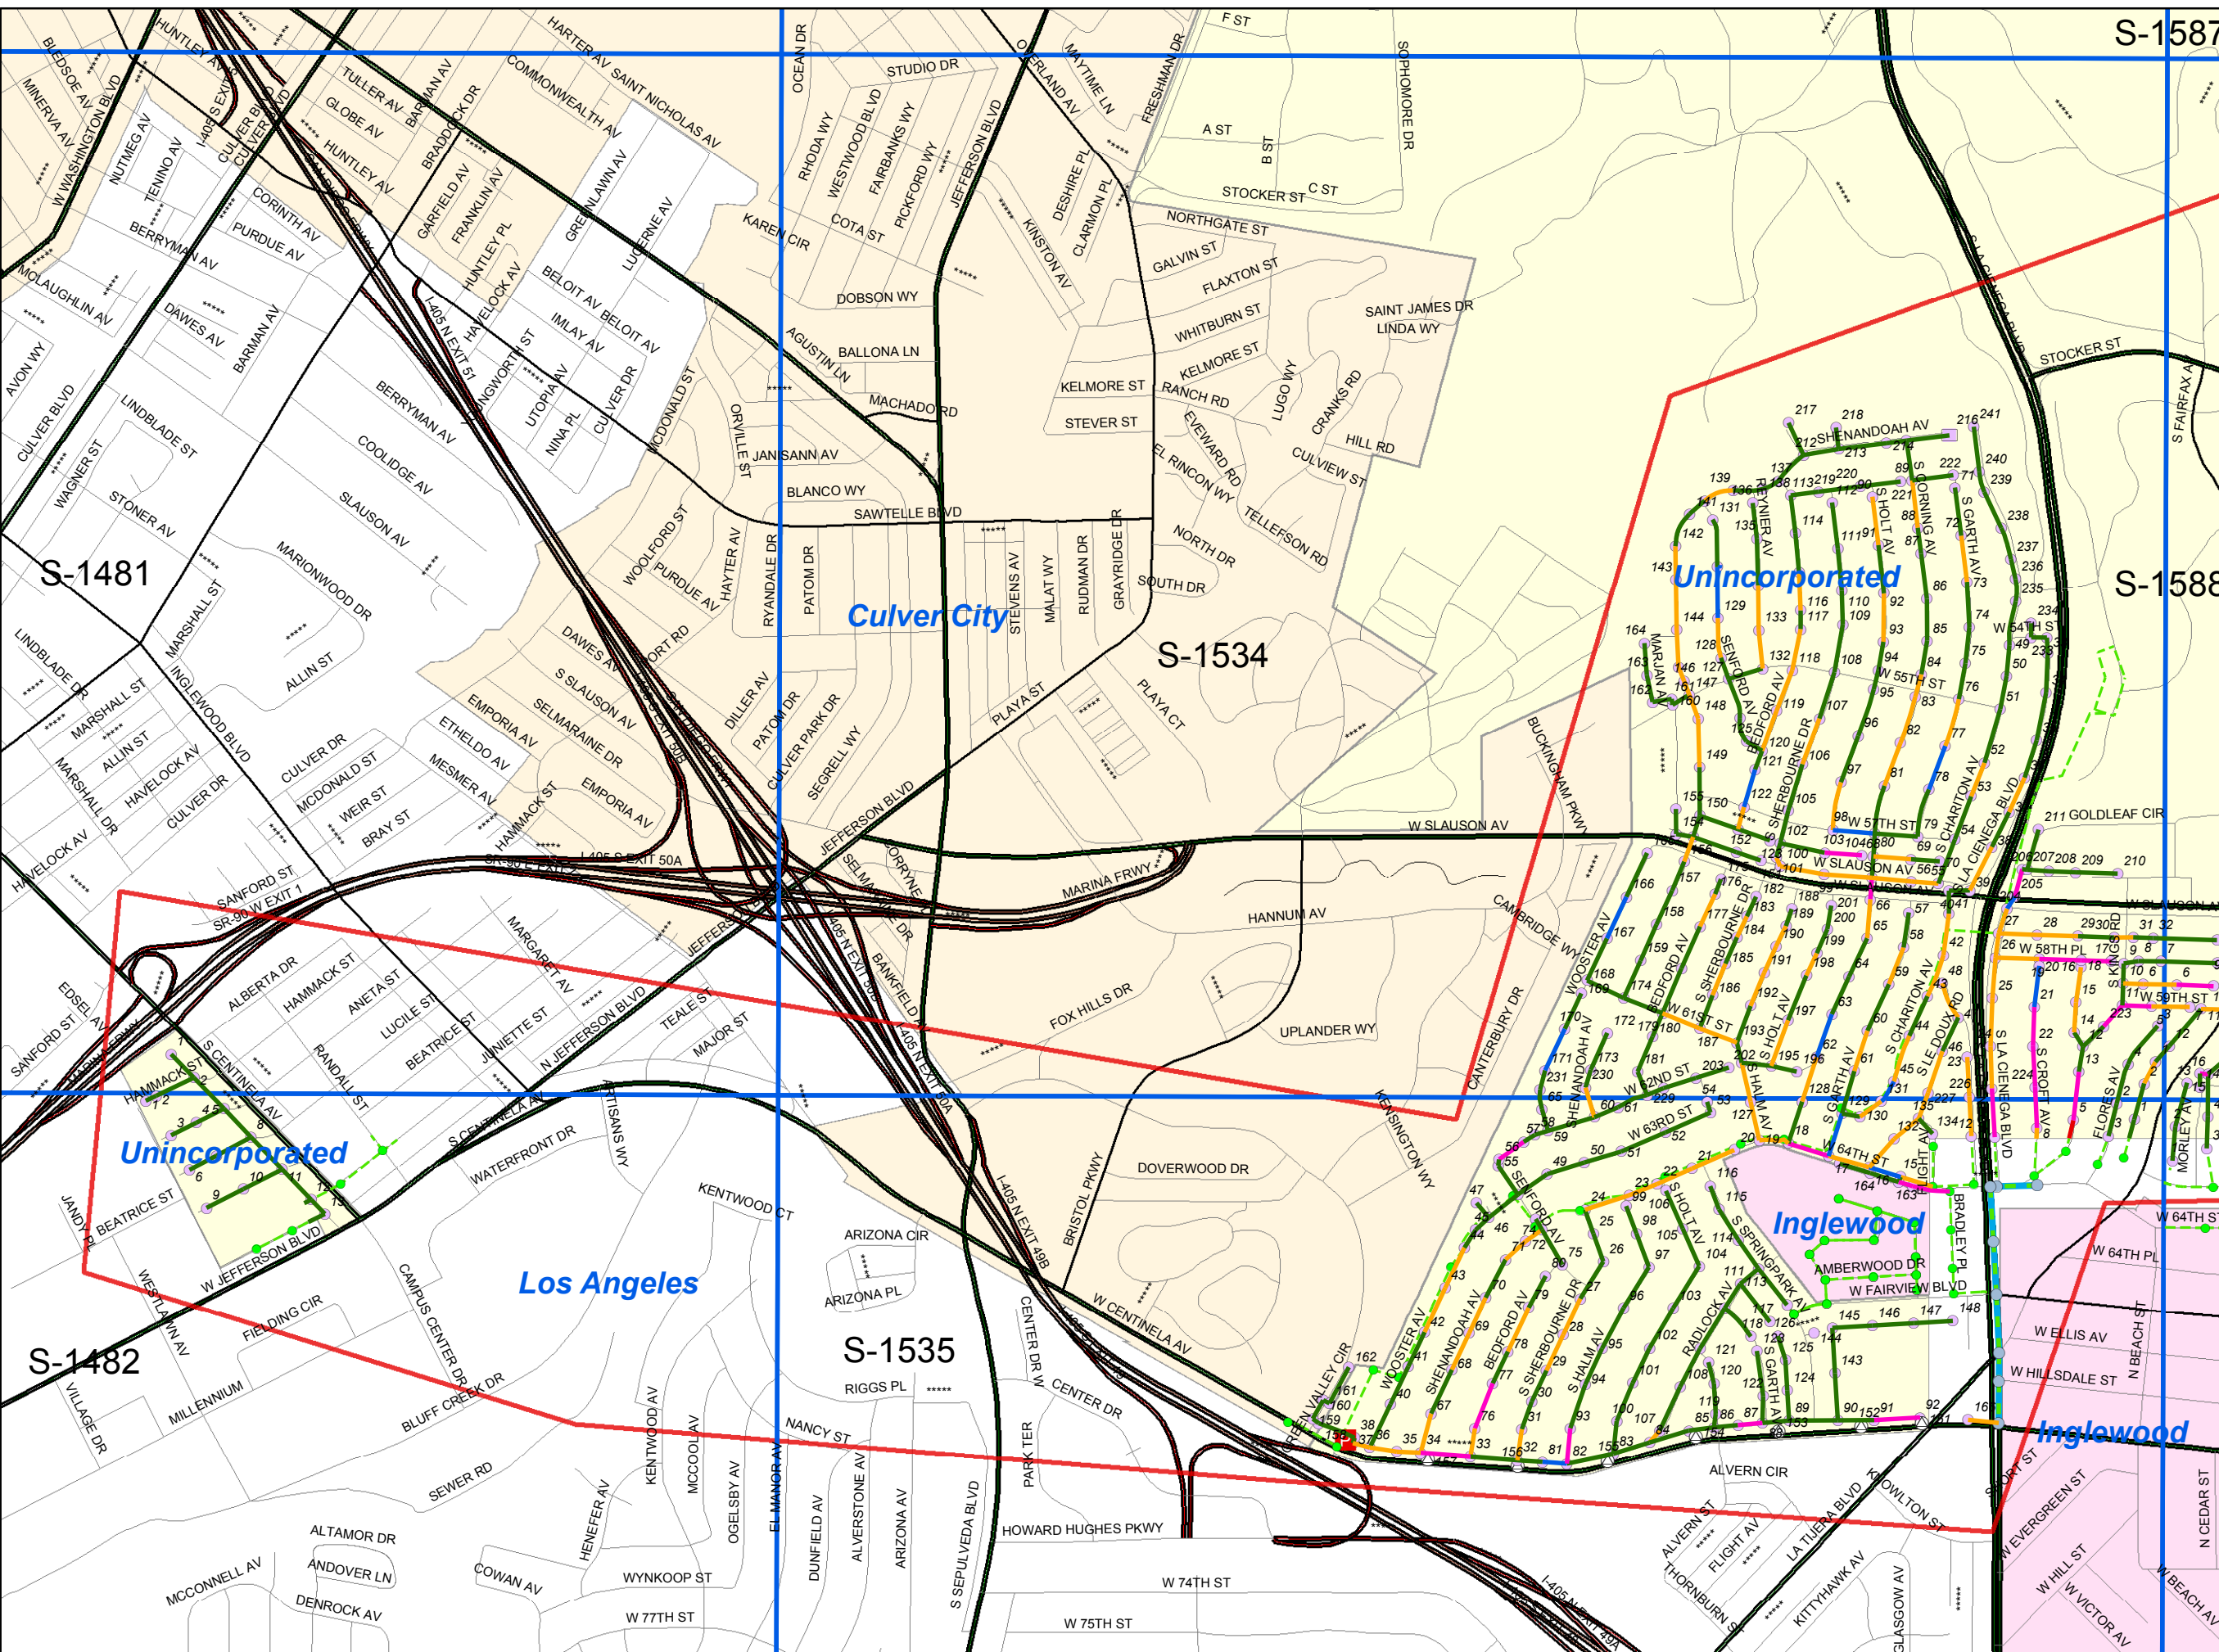
QUICK
STRUCTURAL
RATING
(QSR)

Our inspection revealed that approximately 91.8 percent of the inspected pipe segments within unincorporated County were free of severe structural defects. However, the remaining 8.2 percent of the inspected pipe segments had a PACP structural grade of 4 or 5 as indicated in the Quick Structural Rating Table shown below. These segments have been placed on a priority list based on the severity and the need for action. For items 1 through 112 in the Quick Structural Rating Report Priority List (Enclosure 3), which warrant a corrective action, the proposed corrective action will be programmed in the next 24 months as part of the ongoing Accumulative Capital Outlay Program.
