July 17, 2024  
(2023-005.07)

**Re: *Devil's Gate Reservoir Restoration Project – Phase 3 Restoration Qualitative Monitoring Conducted on April 23, 2024***

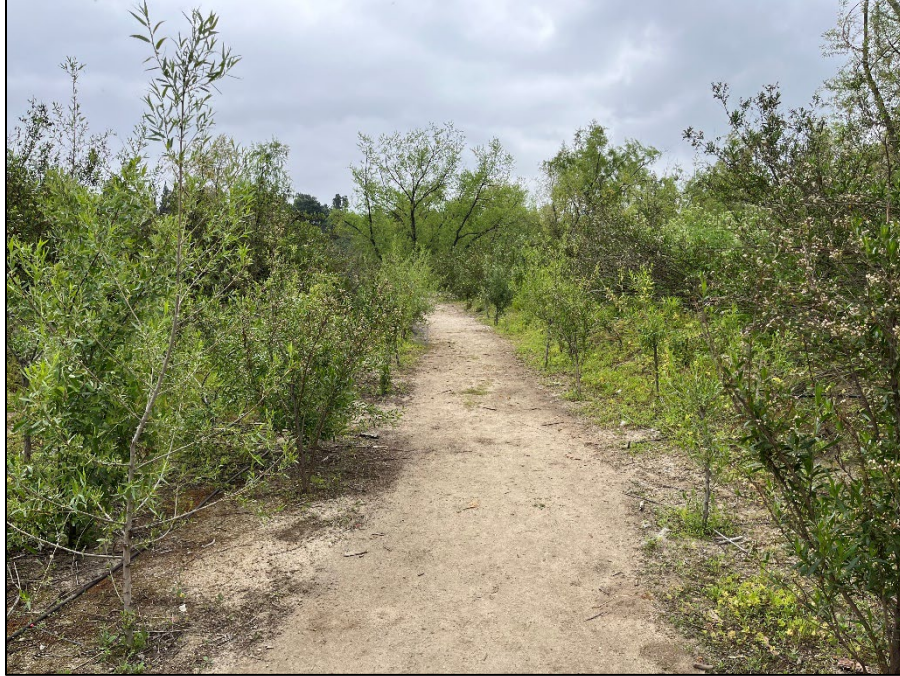
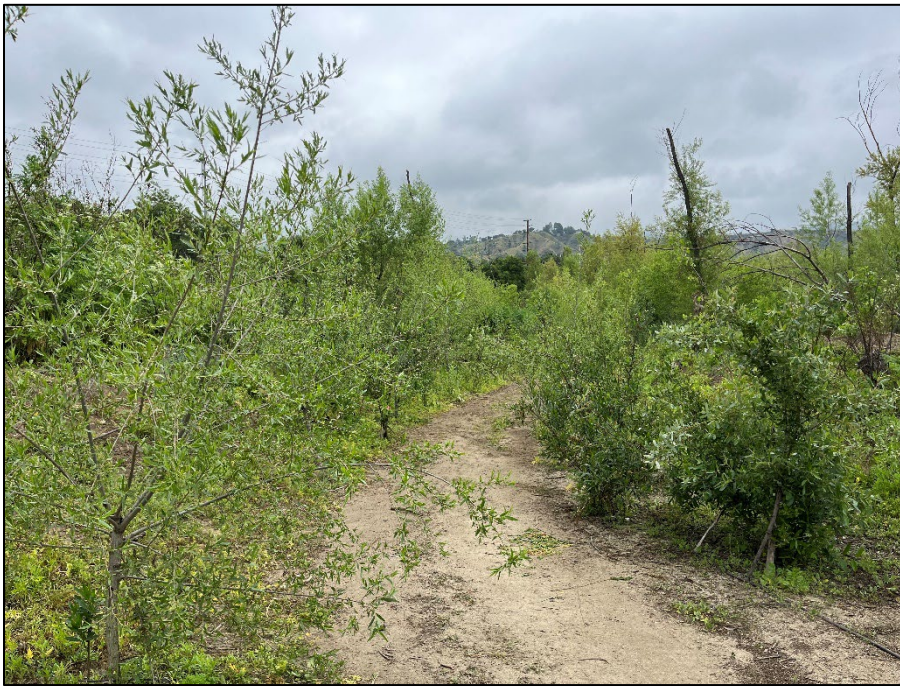
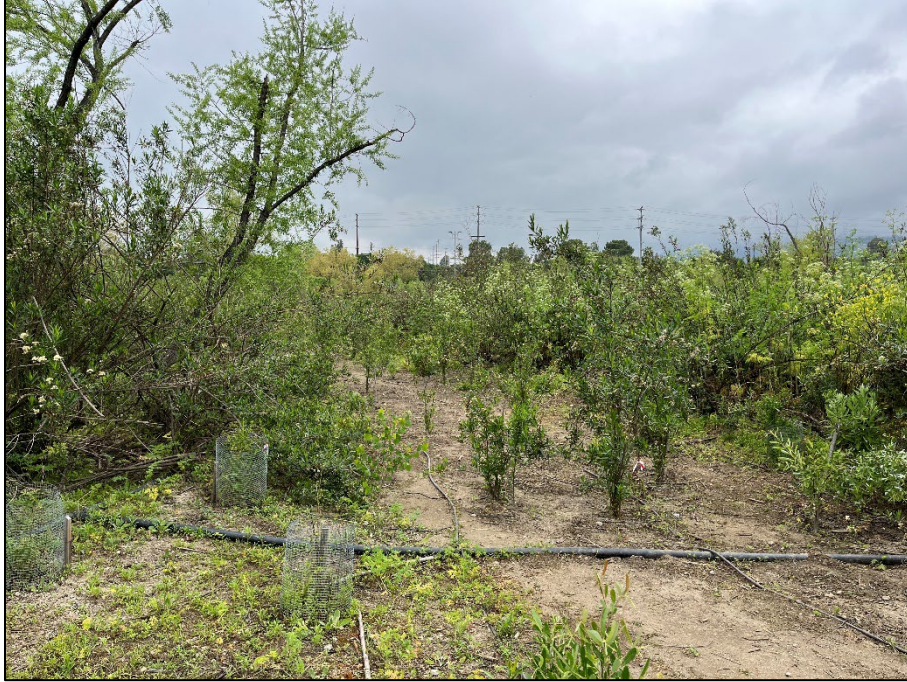
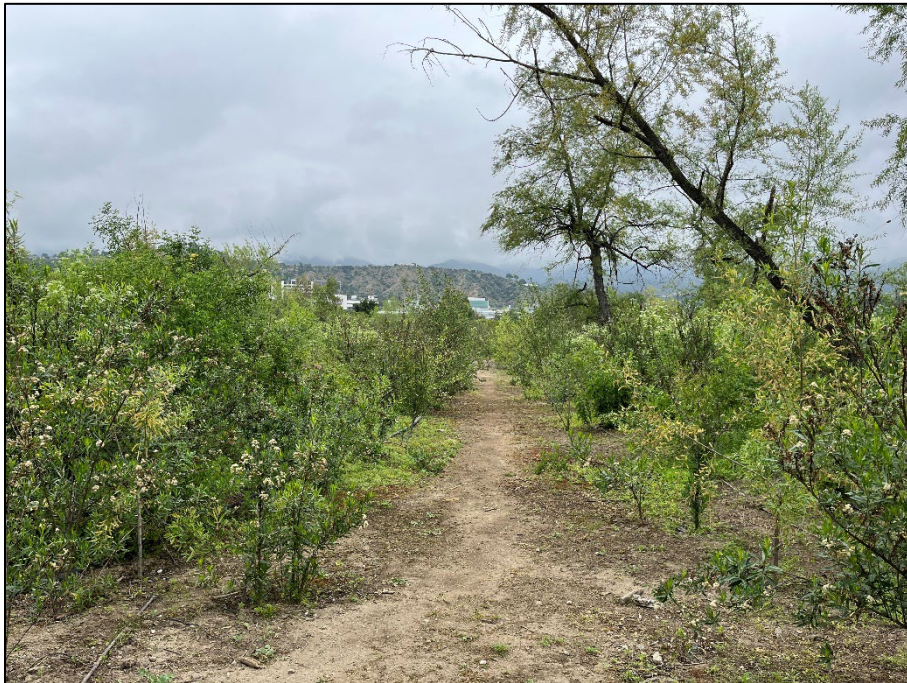
The overall health of the container plants in DG-4 WOUS and DG-4 WOUS Connections was noted as being good. Approximately 5 percent of the container plants and stakes in DG-4 WOUS and DG-4 WOUS Connections were noted as showing signs of stress and a negligible amount were noted as being dead or missing. This is approximately 5 percent less than the percentage of plants that were showing stress during the previous monitoring visit. Stress may be occurring as a result of 1) transplant shock, 2) herbivory by rabbits or other wildlife, 3) competition from nonnative and invasive weeds, 4) misplaced emitters, or 5) recreational traffic through the mitigation areas. During the monitoring visit, the Fremont's cottonwoods (*Populus fremontii*) and willows (*Salix* spp.) were no longer showing signs of seasonal dieback. Formal mortality counts will be taken for DG-4 WOUS and DG-4 WOUS Connections during the 2024 quantitative monitoring and will be included in the 2024 annual reporting. The majority of the recently planted mulefat (*Baccharis salicifolia*) and willow stakes were noted as showing signs of new growth. Some of the container plants were noted as lacking well defined basins and should have their basins properly constructed and/or repaired. The installation of plants in the DG-4 WOUS and DG-4 WOUS Connections mitigation areas appears to have been completed successfully. The current issues identified during the monitoring visit are not expected to have an effect on the continued growth of the plants in the mitigation area. Photos 1 through 4 in Appendix B document the mitigation areas during the monitoring visit.

Nonnative weed cover in DG-4 WOUS and DG-4 WOUS Connections was estimated at approximately 5 to 10 percent, which is approximately 15 percent lower than what was observed during the previous monitoring visit. Nonnative species observed included black mustard (*Brassica nigra*), poison hemlock (*Conium maculatum*), petty spurge (*Euphorbia peplus*), perennial pepperweed (*Lepidium latifolium*). Most of the nonnative weeds observed in these mitigation areas were just starting to germinate; however, some were observed going to flower. In addition, some of the mitigation areas adjacent to DG-4 WOUS and DG-4 WOUS Connections have weeds that are going to flower that should be removed before they go to seed. As weed abatement continues in the mitigation areas, it is anticipated that the seed bank of nonnative and invasive weeds will decrease. It should be noted that active bird nests are preventing weed abatement from occurring in portions of this mitigation area. Work will resume in these areas once the nests have fledged or have been deemed inactive by a qualified avian biologist.

Photo 1. Overview DG-4 WOUS & WOUS Connections

Photo 2. Overview DG-4 WOUS & WOUS Connections

Photo 3. Overview DG-4 WOUS & WOUS Connections

Photo 4. Overview DG-4 WOUS & WOUS Connections

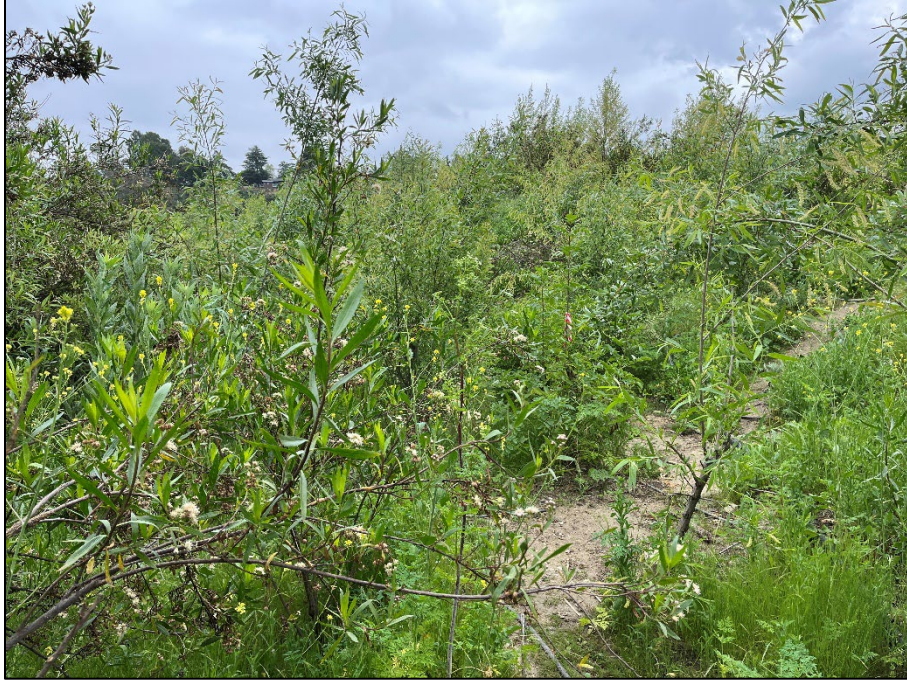
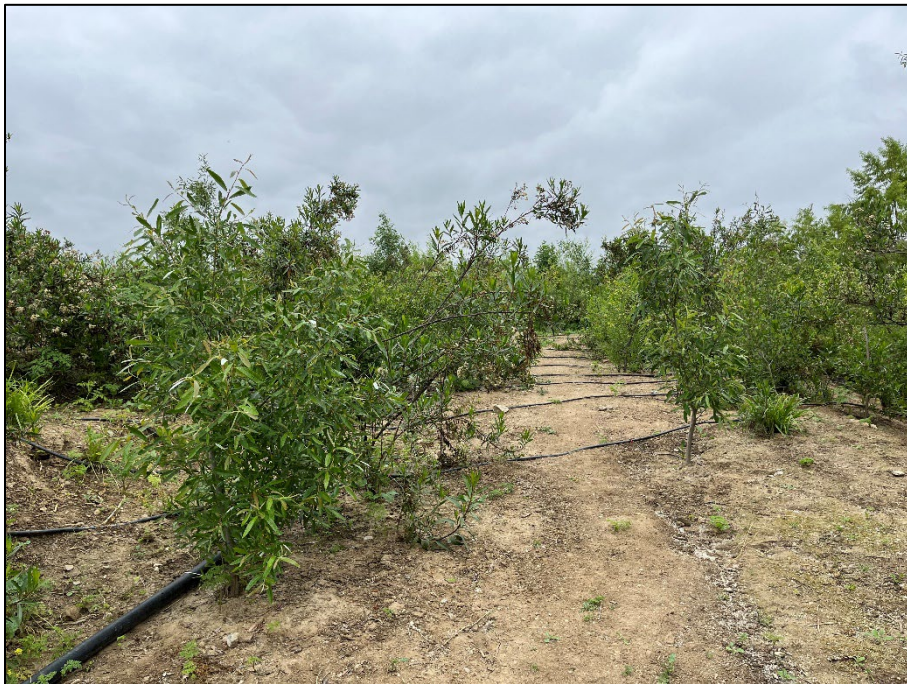
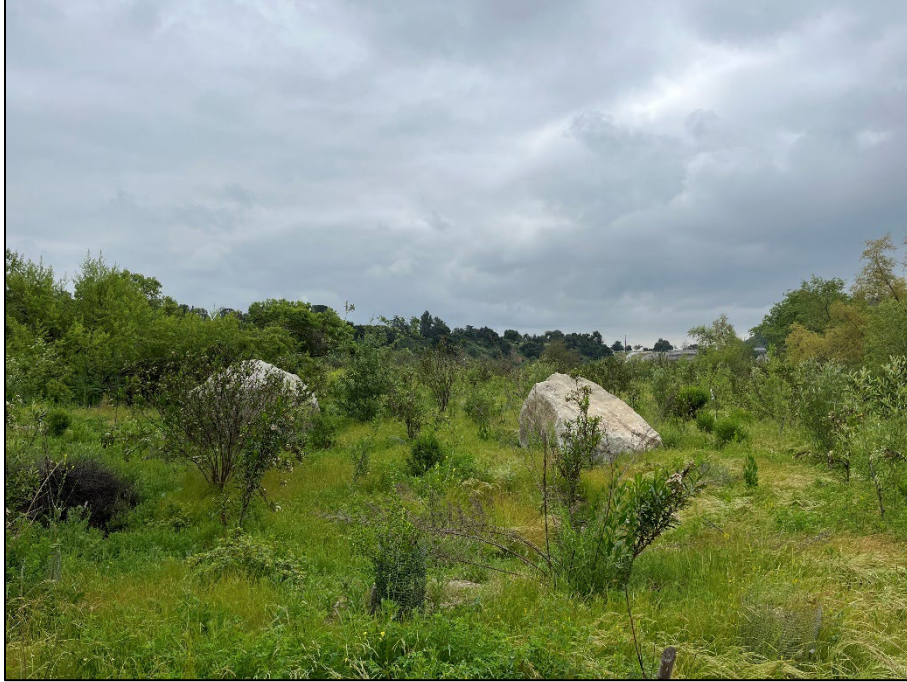
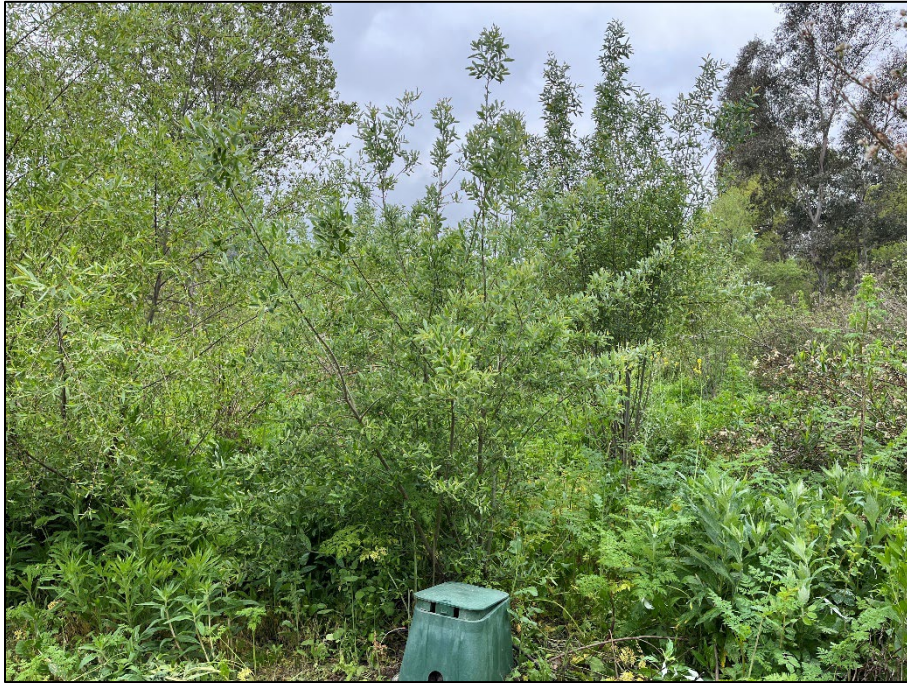
The overall health of the container plants in DG-4A was noted as being good. Approximately 5 to 10 percent of the container plants and stakes in DG-4A were noted as showing signs of stress and a negligible amount were noted as being dead or missing. This is approximately the same percentage of plants that were showing stress during the previous monitoring visit. This included the remaining container plants from the first installation and the replacement container plants that were installed to replace the container plants and stakes planted in the middle section of DG-4A that appeared to be dead or in a condition unlikely to recover during previous monitoring visits. Stress may be occurring due to similar reasons described for DG-4 WOUS and DG-4 WOUS Connections. Formal mortality counts will be taken for DG-4A during the 2024 quantitative monitoring and will be included in the 2024 annual reporting. The majority of the recently planted mulefat and willow stakes were noted as showing signs of new growth. Some of the container plants were noted as lacking well defined basins and should have their basins properly constructed and/or repaired. The installation of plants in the DG-4A mitigation area appears to have been completed successfully and the installation of the replacement container plants should increase native cover. The current issues identified during the monitoring visit are not expected to have an effect on the continued growth of the plants in the mitigation area. Photos 5 through 8 in Appendix B document the mitigation area during the monitoring visit.

Nonnative weed cover in the DG-4A mitigation area ranged from approximately 5 to 25 percent during the monitoring visit, depending on the section of DG-4A, which is approximately 5 to 10 percent less than

what was observed during the previous monitoring visit. Nonnative species observed included black mustard, red brome (*Bromus madritensis*), tocalote (*Centaurea melitensis*), poison hemlock, perennial pepperweed, and annual yellow sweetclover (*Melilotus indicus*). Many of the nonnative weeds observed in this mitigation area, including black mustard and poison hemlock were going to flower and should be removed before they go to seed. In addition, some of the mitigation areas adjacent to DG-4A have weeds that are going to flower that should be removed before they go to seed. As weed abatement continues in the mitigation areas, it is anticipated that the seed bank of nonnative and invasive weeds will decrease; however, perennial pepperweed easily resprouts from rhizomatous roots that can be difficult to fully remove with hand tools. It should be noted that active bird nests are preventing weed abatement from occurring in portions of this mitigation area. Work will resume in these areas once the nests have fledged or have been deemed inactive by a qualified avian biologist.

Photo 5. Overview DG-4A

Photo 6. Overview DG-4A

Photo 7: Overview DG-4A

Photo 8: Overview DG-4A

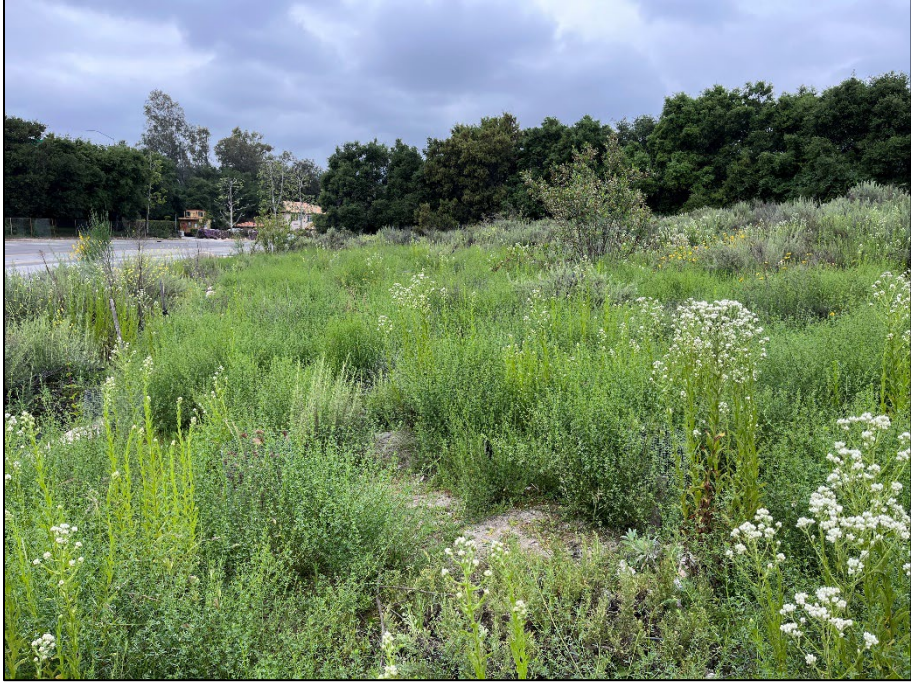
The overall health of the container plants in the Tire Wash mitigation area was noted as being good. Approximately 5 percent of the container plants were noted as showing varied levels of stress, which is approximately 5 percent lower than the percentage of plants that were showing stress during the previous monitoring visit. This included the remaining container plants from the first installation and the replacement container plants that were installed to replace the container plants that were either missing or appeared to be dead or in a condition unlikely to recover during previous monitoring visits. Most of the stress was observed on the recently installed container plants. Stress may be occurring due to similar reasons described for DG-4 WOUS and DG-4 WOUS Connections. The irrigation was found to be functioning properly for this mitigation area. Formal mortality counts will be taken for the Tire Wash during the 2024 quantitative monitoring and will be included in the 2024 annual reporting. Some of the container plants were noted as lacking well defined basins and should have their basins properly constructed and/or repaired. The installation of plants in the Tire Wash mitigation area appears to have been completed successfully. The current issues identified during the monitoring visit are not expected to have an effect on the continued growth of the plants in the mitigation area. Photo 9 in Appendix B documents the mitigation area during the monitoring visit.

Nonnative weed cover in the Tire Wash mitigation area was estimated at approximately 2 percent, which is approximately 1 percent higher than the percentage of nonnative cover that was observed during the previous monitoring visit. Nonnative species observed included black mustard and red-stemmed filaree (*Erodium cicutarium*). Most of the nonnative weeds observed in this mitigation area were just starting to germinate; however, some of the black mustard was observed to be in flower. As weed abatement continues in the mitigation areas, it is anticipated that the seed bank of nonnative and invasive weeds will decrease.

Photo 9: Overview Tire Wash

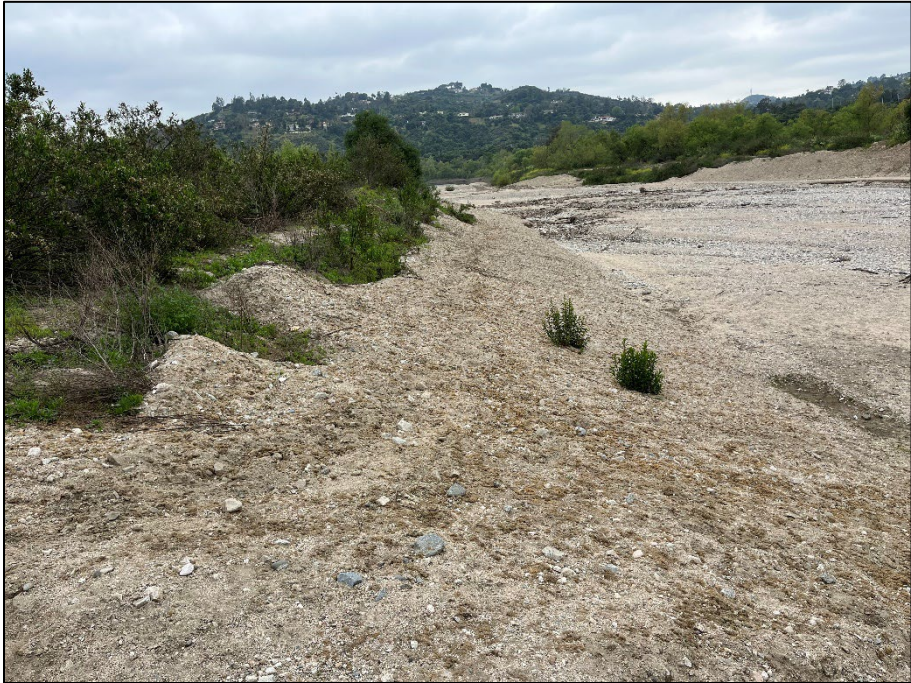
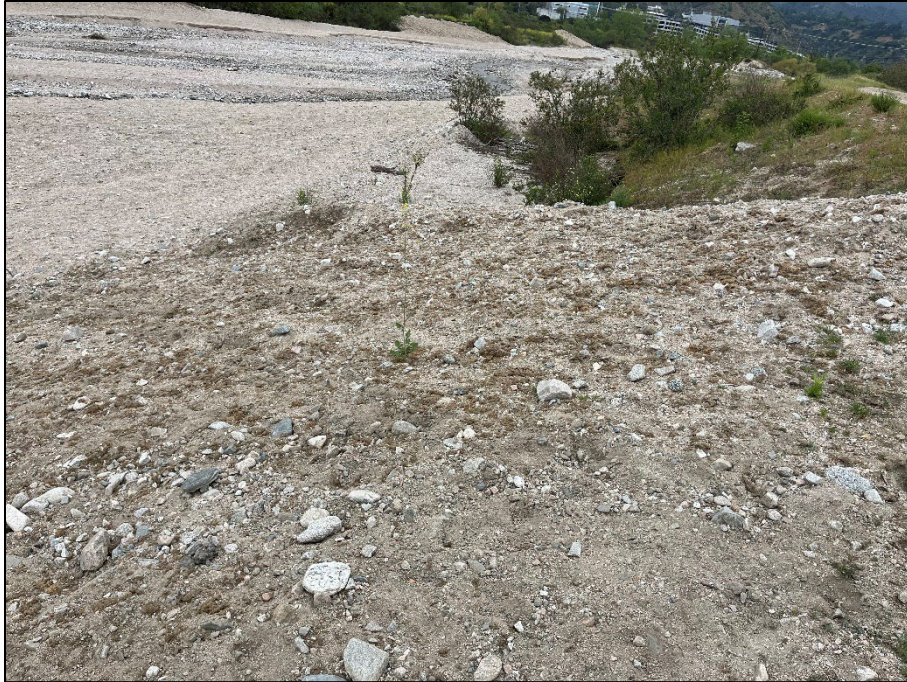
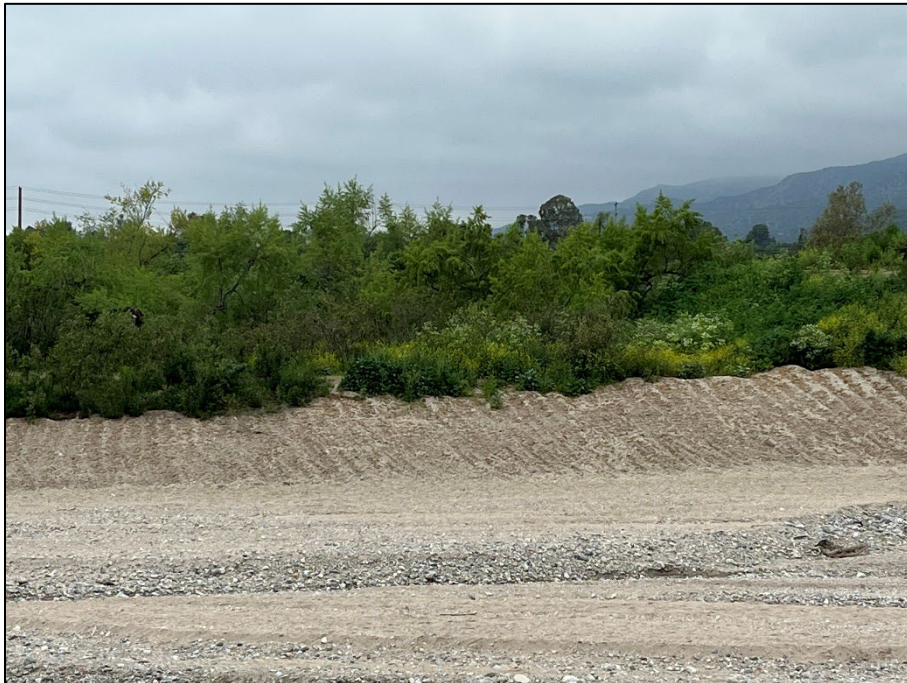
Container plants were not installed on the Side Slopes or in Flint Wash, but these areas were seeded with native plant species. Native plant growth was noted throughout the Side Slopes and Flint Wash, likely both from natural recruitment and from seeding. Portions of the Side Slopes that were previously noted as having significant erosion that occurred as a result of heavy rainfall during the 2023 wet season and following the tropical storm that occurred in late August 2023 were noted as having been repaired during previous monitoring visits and were included in the supplemental seeding effort initiated in November of 2023. During the monitoring visit, the recently hydroseeded portions of the Side Slopes where previous erosion had occurred showed very minimal germination. Lack of germination on these portions of the Side Slopes could be due to lack of soil nutrients, lack of organic matter, and/or incorrect compaction levels. Native plants such as California sagebrush, mugwort, coyote bush (*Baccharis pilularis*), mulefat, Canada horseweed, telegraph weed, annual lupine (*Lupinus bicolor*), and black willow (*Salix gooddingii*) were observed sprouting on the Side Slopes and in Flint Wash. Overall native cover was estimated to be approximately 35 to 40 percent during the monitoring visit; however, the portions of the Side Slopes that were recently repaired and hydroseeded were noted as having very low cover. A portion of the Side Slopes near the southwestern extent of DG-2 WOUS that was noted as having significant erosion during the previous monitoring visit was still present and had not been repaired. Photos 10 through 12 in Appendix B document the Side Slopes during the monitoring visit.

Nonnative weed cover on the Side Slopes and Flint Wash was estimated at approximately 10 to 15 percent overall, which is approximately 5 percent higher than the level of weed cover that was observed during the previous monitoring visit. It should also be noted that the middle to southern section of the Side Slopes on the west side and Flint Wash had a higher level of nonnative weed cover that was estimated at approximately 25 to 30%. Nonnative species observed on the Side Slopes and Flint Wash included black mustard, poison hemlock, rattail six weeks grass (*Festuca myuros*), perennial pepperweed, and annual yellow sweetclover. Most of the nonnative weeds observed in this mitigation area were just starting to germinate; however, some were starting to flower and will soon go to seed. These areas should be weeded prior to seed production. As weed abatement continues in the mitigation areas, it is anticipated that the seed bank of nonnative and invasive weeds will decrease; however, perennial pepperweed easily resprouts from rhizomatous roots that can be difficult to fully remove with hand tools.

Photo 10: Overview Side Slopes

Photo 11: Overview Side Slopes

Photo 12: Overview Side Slopes

Portions of the Side Slopes that were previously noted as having significant erosion that occurred as a result of heavy rainfall during the 2023 wet season and following the tropical storm that occurred in late August 2023 were noted as having been repaired during previous monitoring visits and were included in the supplemental seeding effort which was completed in November of 2023. Some additional erosion was observed at the toe of the Side Slopes in these areas and has the potential to worsen. In addition, one area of severe erosion that was noted on the eastern Side Slopes at the southwestern extent of DG-2 WOUS during the previous monitoring visit was still present and had not been repaired. As more perennial plants become established on the Side Slopes, erosion should become less of an issue; however, action will need to be taken to repair the damage caused by the erosion and measures should be taken to

reduce damage from erosion in the future. In addition, if the supplemental seeding effort does not produce germination on the previously eroded Side Slopes, adaptive management techniques will likely be warranted. During future monitoring events, erosion should continue to be monitored in all planted areas and if warranted, erosion Best Management Practices should be installed in appropriate areas. This may only require the installation of straw wattles at select sites to prevent existing rills from becoming larger.
