February 5, 2021  
2018-047.016

Mr. Mark Gim  
Los Angeles County Public Works  
900 South Fremont Avenue, 9th Floor  
Alhambra, California 91803

**Re: *Devil's Gate Reservoir Restoration Project – Phase 1 Restoration Qualitative Monitoring Conducted on January 13, 2021***

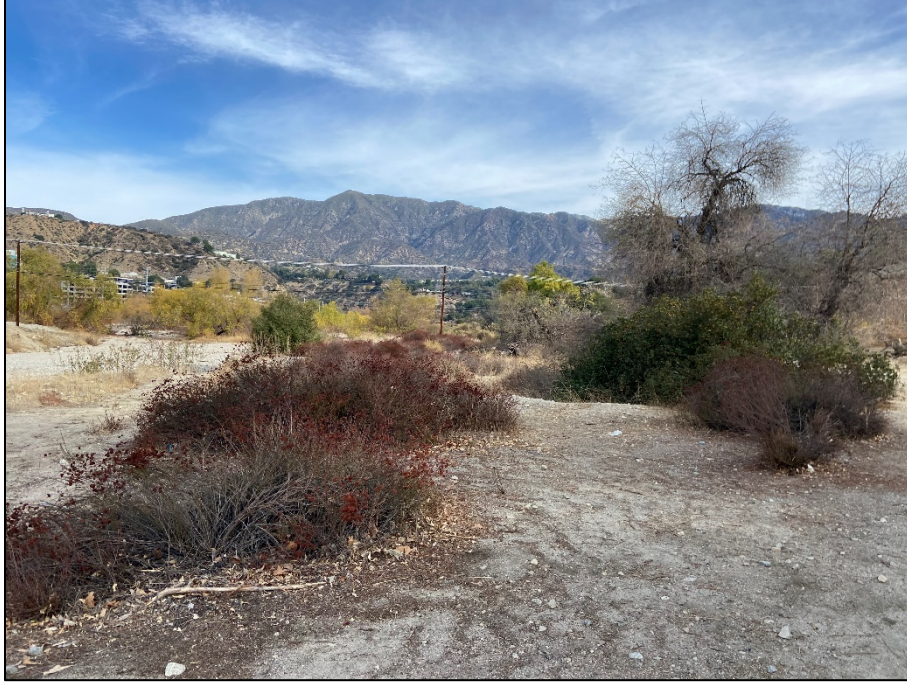
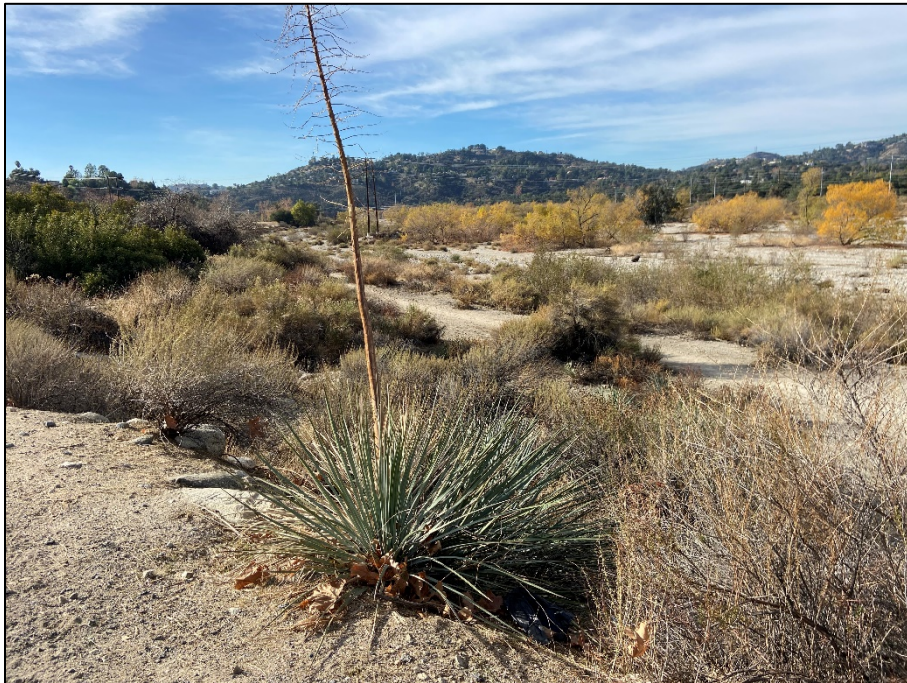
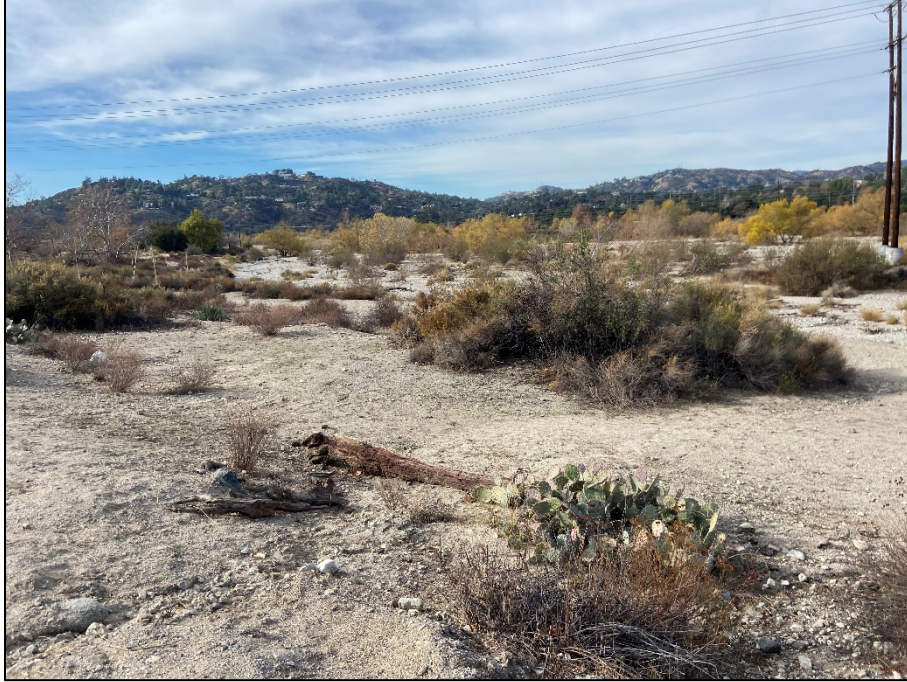
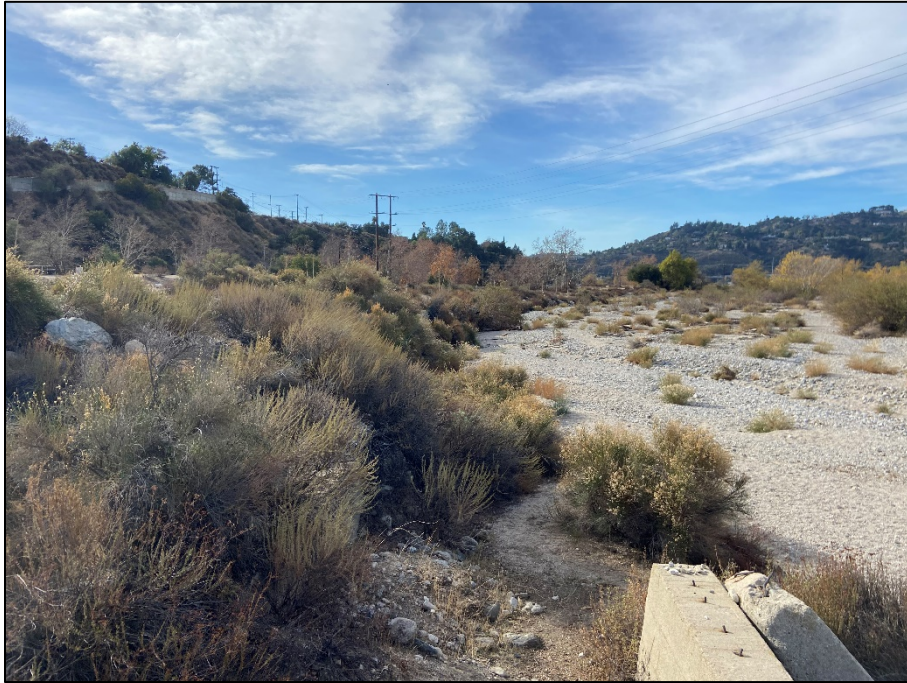
Container plants were not installed in the DG-1 or DG-1 WOUS mitigation areas, but these areas were seeded with native plant species. Native plant growth was noted throughout the DG-1 and DG-1 WOUS mitigation areas, likely both from natural recruitment and from seeding; however, germination was observed to be very minimal in the majority of these mitigation areas. Portions of DG-1 WOUS were noted as being scoured during the wet season and had minimal plant growth. Most native annuals were noted as being dead for the season. Native plants such as mulefat (*Baccharis salicifolia*), California buckwheat (*Eriogonum fasciculatum*), common sand aster (*Corethrogyne filaginifolia*), and scale broom (*Lepidospartum squamatum*) were observed sprouting in the DG-1 and DG-1 WOUS mitigation areas. In addition, dodder (*Cuscuta sp.*) was observed growing on some of the shrubs in this mitigation area, which could lead to future decline of these shrubs; however, the dodder was noted as being mostly dead for the season. Photos 1 through 4 in Attachment B document the mitigation area during the monitoring visit.

Nonnative weed cover in DG-1 and DG-1 WOUS was estimated at approximately <1 percent, if the dead annual weeds are excluded, which is approximately the same level of weed cover that was observed during the previous qualitative monitoring event. Nonnative species observed in DG-1 and DG-1 WOUS included black mustard (*Brassica nigra*), red brome (*Bromus madritensis ssp. rubens*), cheatgrass (*Bromus tectorum*), tocalote (*Centaurea melitensis*), and Mediterranean grass (*Schismus barbatus*); however, most individuals were observed to be dead for the season.

Photo 1: Overview Mitigation Area DG-1

Photo 2: Overview Mitigation Area DG-1

Photo 3: Overview Mitigation Area DG-1

Photo 4: Overview Mitigation Area DG-1 WOUS

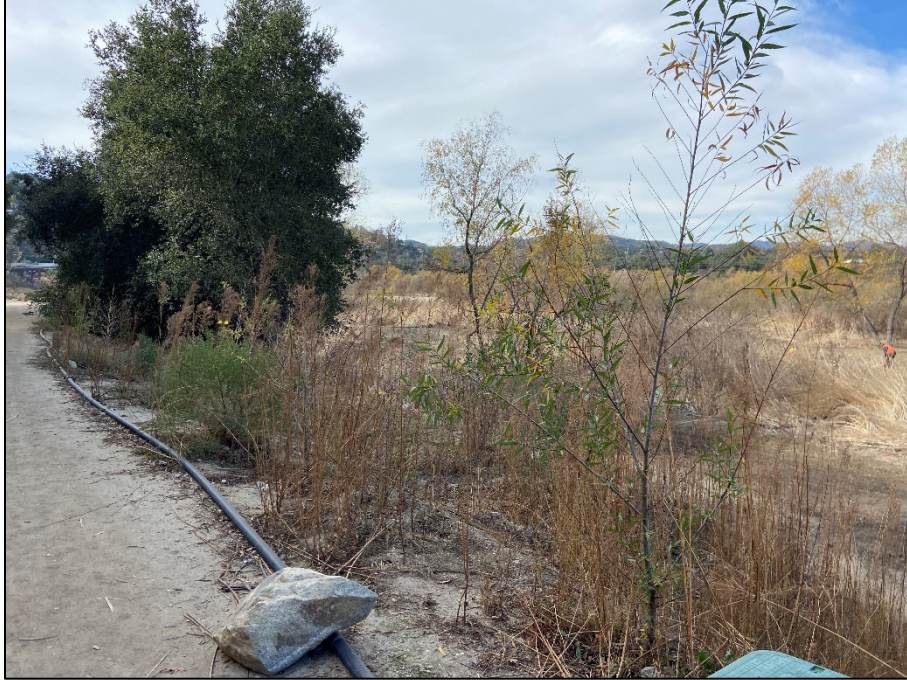
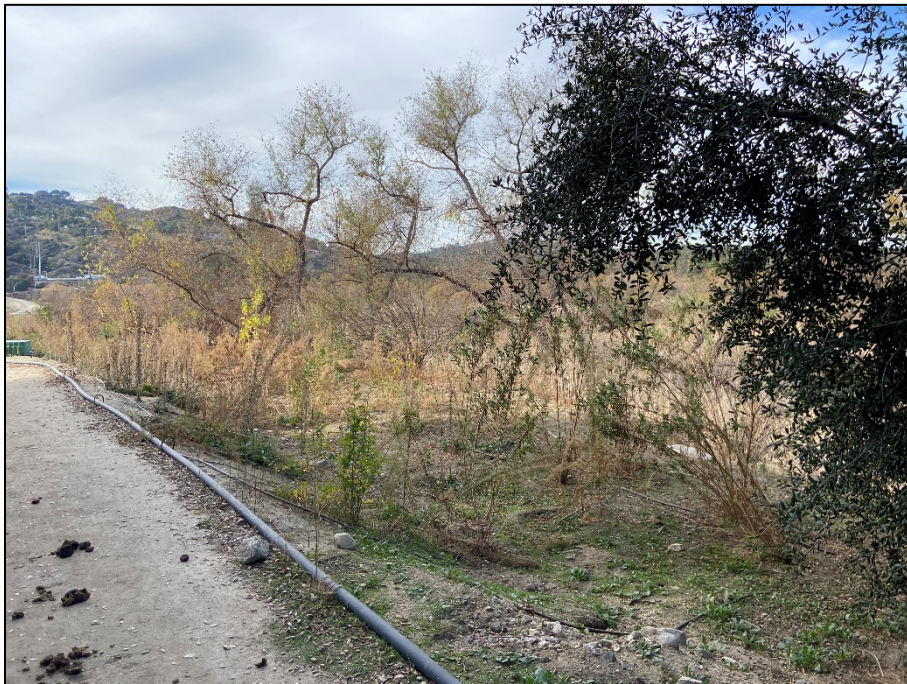
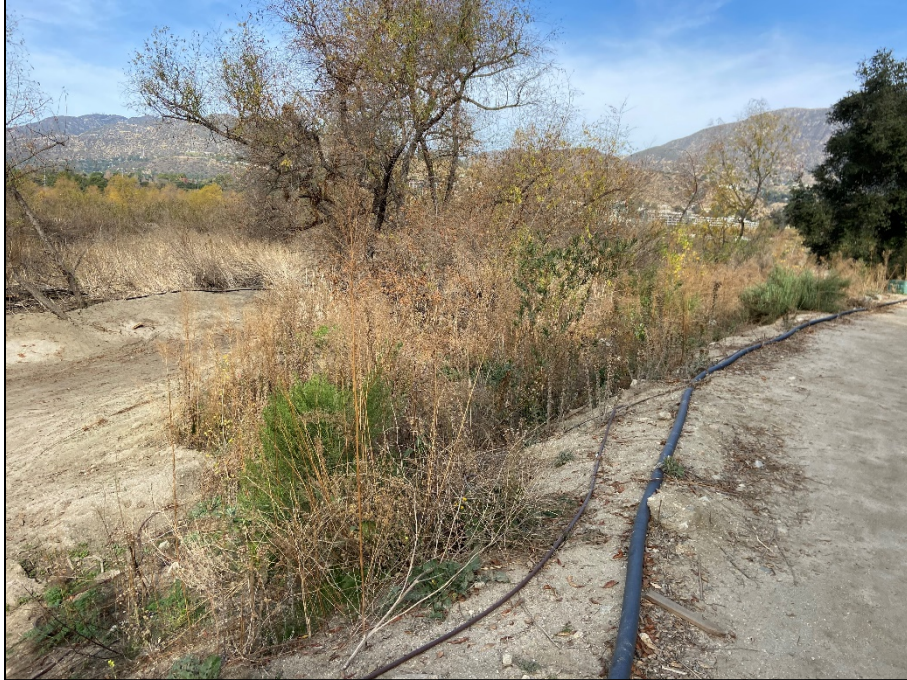
The overall health of the container plants in DG-2A was noted as being good. Only minimal stress was observed, and the majority of the remaining container plants are becoming well established. Approximately 10 percent of all container plants were showing varied levels of stress, which is the same percentage of plants that were showing stress during the previous qualitative monitoring event. Stress

may be occurring as a result of 1) herbivory by rabbits or other wildlife or 2) competition from nonnative and invasive weeds. There were no additional container plants noted as being missing or dead. Formal mortality counts were taken for DG-2A during the quantitative monitoring and will be included in the annual reporting. The willow species (*Salix sp.*) and Fremont's cottonwoods (*Populus fremontii*) in the mitigation areas were showing signs of seasonal dieback. Some of the planting basins were observed to have minor erosion and should be repaired. The installation of plants in the DG-2A mitigation area appears to have been completed successfully. The current issues identified during the monitoring visit are not expected to have an effect on the continued growth of the plants in the mitigation area. Photos 5 through 7 in Attachment B document the mitigation area during the monitoring visit.

Nonnative weed cover in DG-2A was estimated at approximately 10 to 15 percent, which is approximately 5 percent more than the level of weed cover that was observed during the previous qualitative monitoring event. Nonnative species observed in DG-2A included black mustard, poison hemlock (*Conium maculatum*), perennial pepperweed (*Lepidium latifolium*), and white horehound (*Marrubium vulgare*). While nonnative annuals were observed to be mostly dead, new germination of nonnative weeds was also observed.

Photo 5: Overview Mitigation Area DG-2A

Photo 6: Overview Mitigation Area DG-2A

Photo 7: Overview Mitigation Area DG-2A

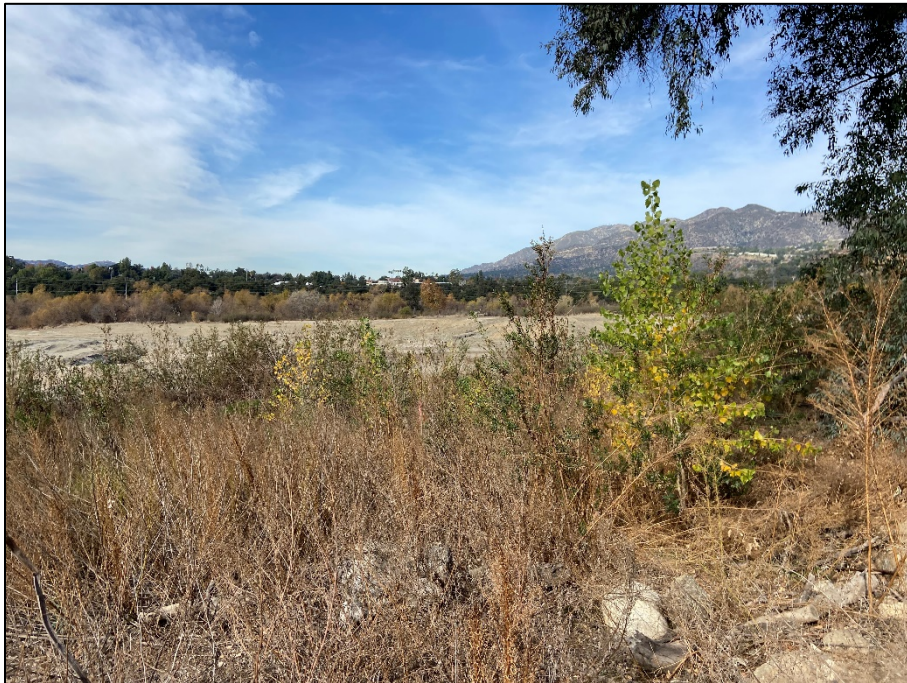
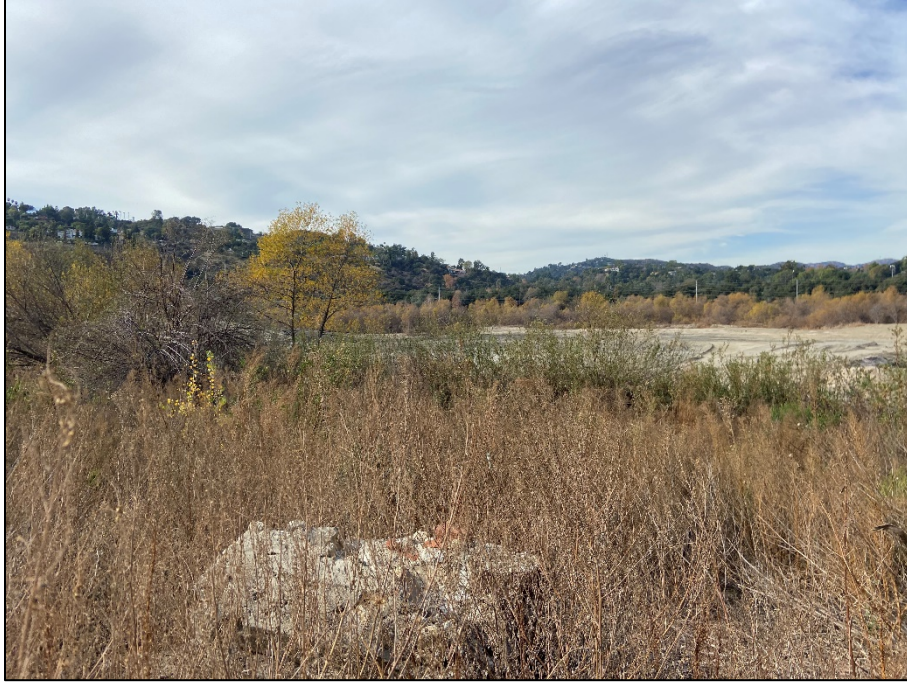
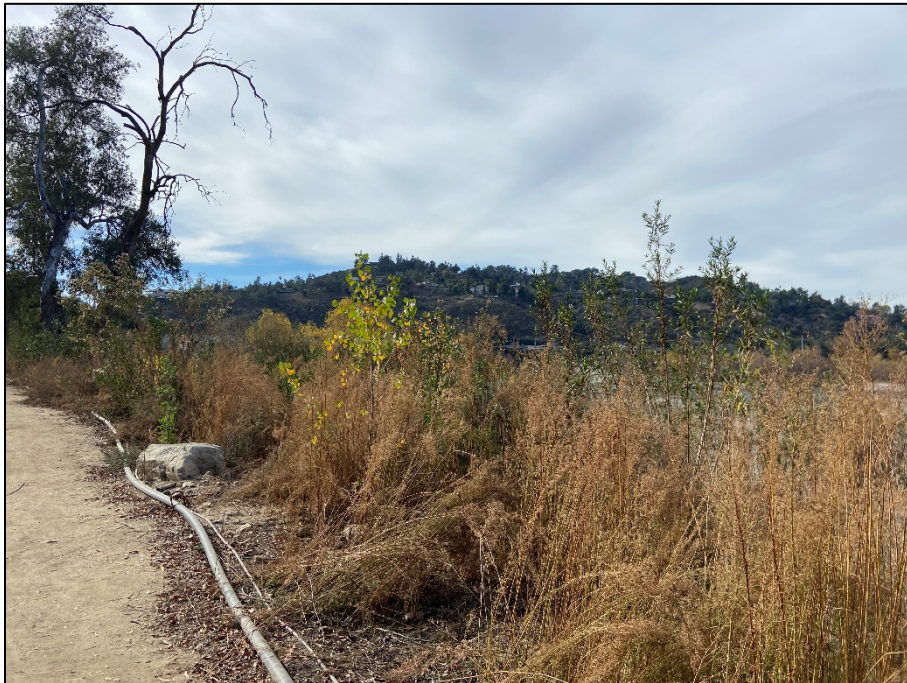
The overall health of the container plants in DG-2B was noted as being good. Approximately 10 percent of all container plants were showing varied levels of stress, which is the same percentage of plants that were showing stress during the previous qualitative monitoring event. Stress was likely due to the same reasons as those described for DG-2A. In addition, insect galls were observed on several of the willow species. Formal mortality counts were taken for DG-2B during the quantitative monitoring and will be included in the annual reporting. Similar to DG-2A, the willow species and Fremont's cottonwoods were showing signs of seasonal dieback. Some of the planting basins were observed to have minor erosion and should be repaired. The installation of the plants in the DG-2B mitigation area appears to have been successfully completed. The current issues identified during the monitoring visit are not expected to have an effect on the continued growth of plants in the mitigation area. Photos 8 through 10 in Attachment B document the mitigation area during the monitoring visit.

Native plant growth was noted throughout the DG-2B mitigation area, likely both from natural recruitment and from seeding. Native plants such as mugwort, mulefat, telegraph weed, and stinging nettle were observed sprouting in the DG-2B mitigation area. In addition, dodder was observed growing on some of the shrub and tree species in this mitigation area which could lead to future decline of these shrubs; however, the dodder was observed to be mostly dead for the season.

Nonnative weed cover in DG-2B was estimated at approximately 10 percent, if the dead annual weeds are excluded, which is approximately 5 percent more than what was observed during the previous qualitative

Photo 8: Overview Mitigation Area DG-2B

Photo 9: Overview Mitigation Area DG-2B

Photo 10: Overview Mitigation Area DG-2B

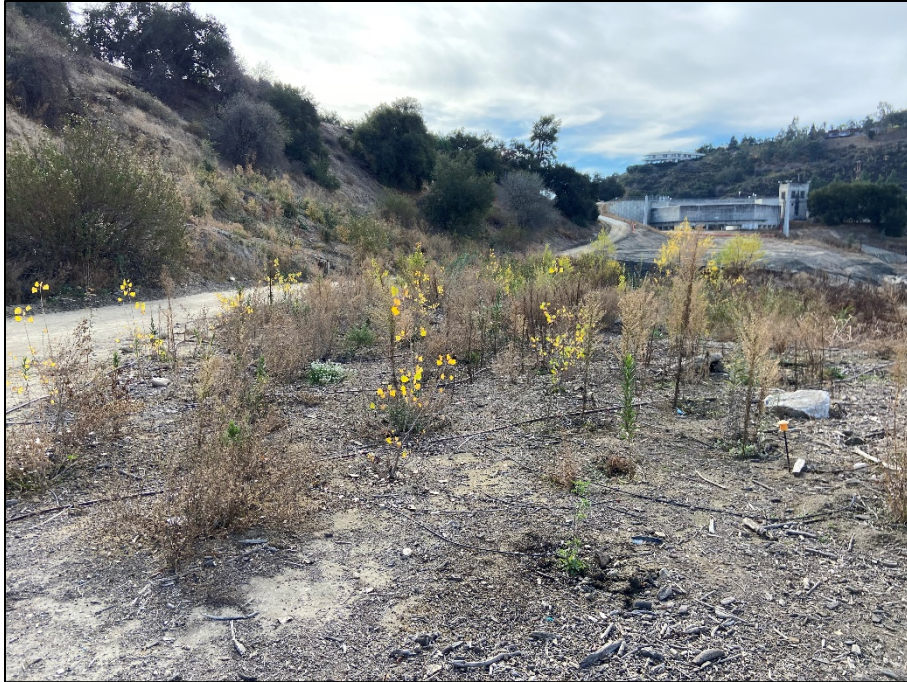
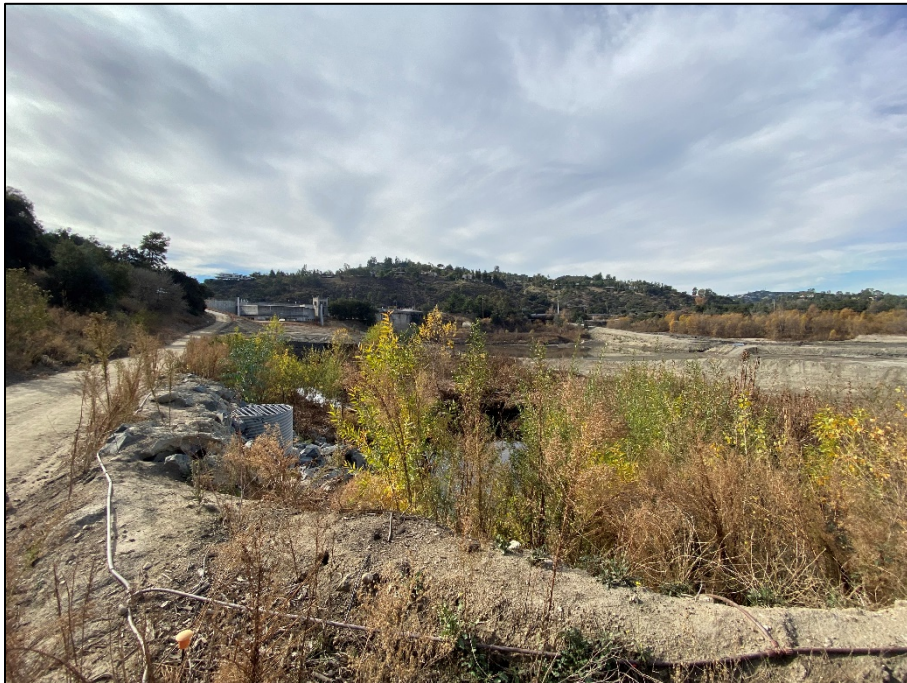
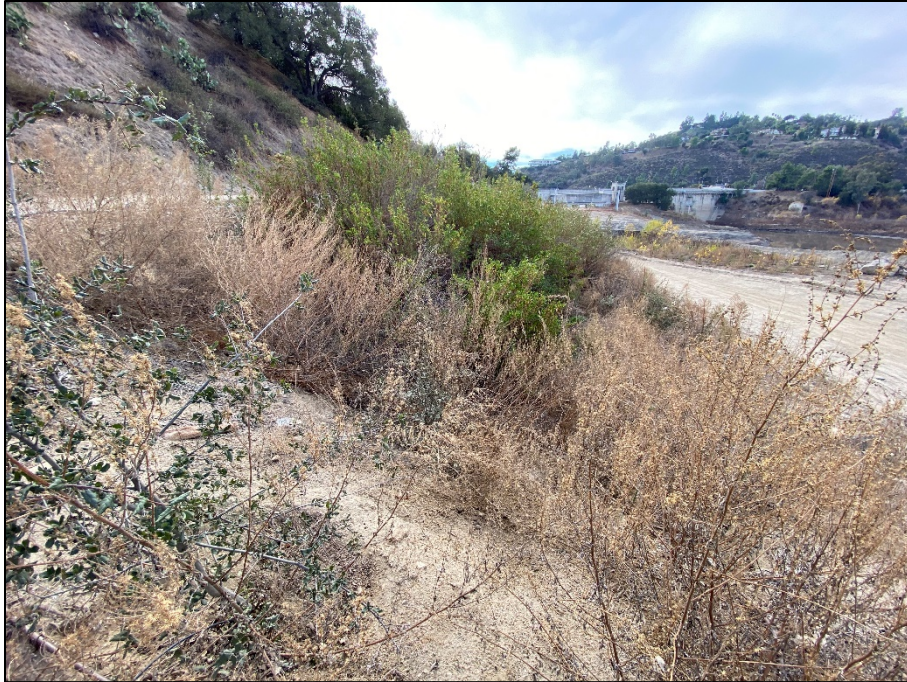
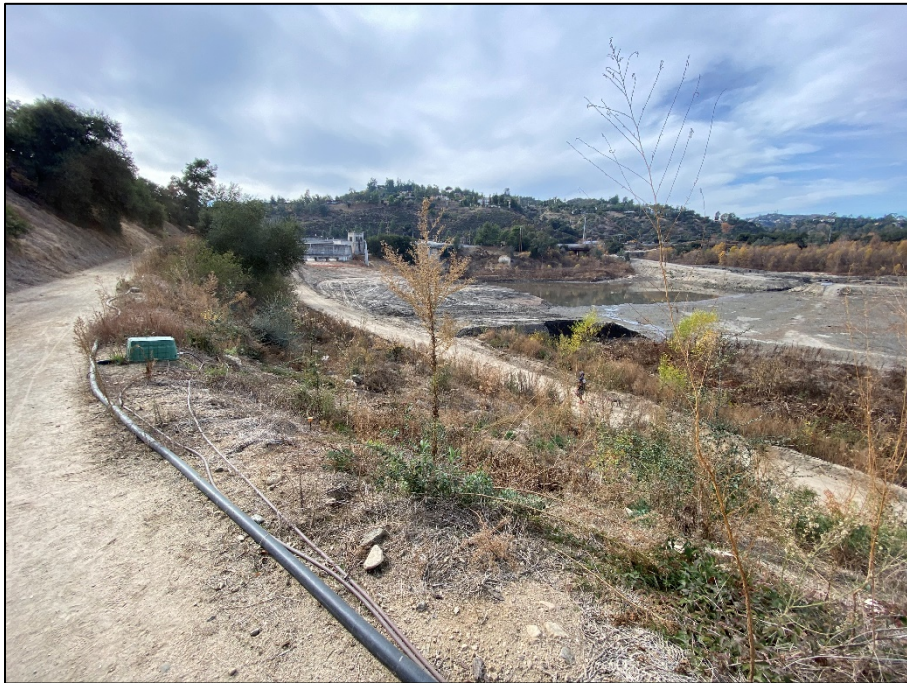
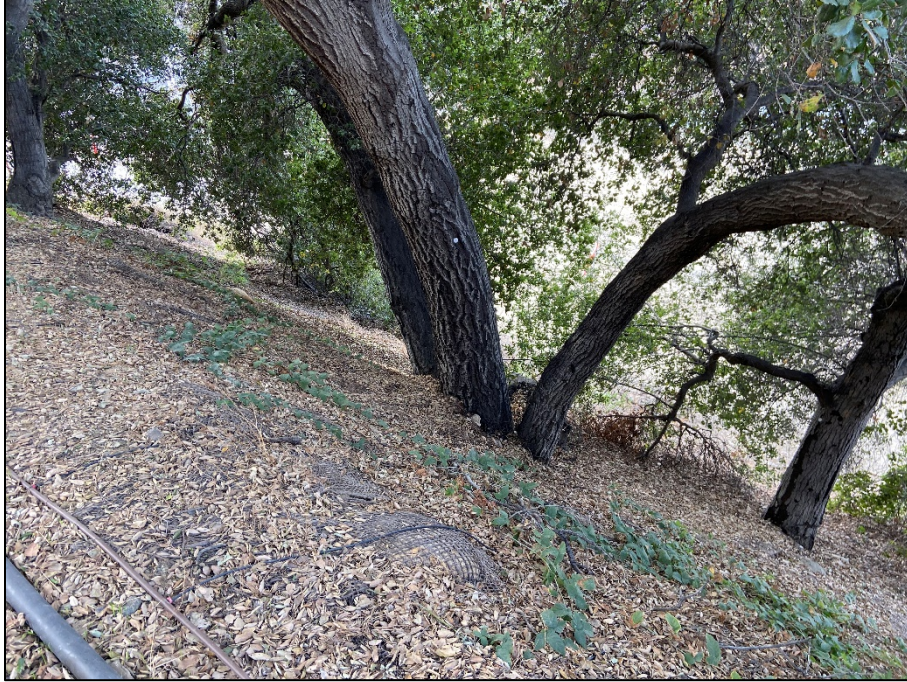
The overall health of the container plants in DG-3A was noted as being good. Approximately 10 percent of the container plants in the Coast Live Oak Woodland portions of DG-3A were noted as showing varied levels of stress, which is five percent less than the percentage of container plants that were showing stress during the previous qualitative monitoring event; however, six more coast live oak containers were observed to be dead or in a condition unlikely to survive. Approximately 5 to 10 percent of the container plants in the Mulefat Thickets portions of DG-3A were noted as showing varied levels of stress, which is approximately the same number of container plants that were showing stress during the previous qualitative monitoring event. Formal mortality counts were taken for DG-3A during the quantitative monitoring and will be included in the annual reporting. The types of stress the plants were exhibiting are the same as those described for the plants in DG-2A. However, erosion is also a problem in some areas of DG-3A. Some of the planting basins were observed to have minor erosion and should be repaired. In addition, the heavy water and debris flows noted during previous monitoring visits have contributed to plant mortality and stress in this mitigation area. Similar to DG-2A, the container planted willow species and Fremont's cottonwoods were exhibiting seasonal dieback; however, the planted willow and mulefat cuttings were observed to be sprouting vigorously. During the monitoring visit, the planted coast live oak (*Quercus agrifolia*) acorns were inspected for survivorship and health. Approximately 20 germinated coast live oak acorns appear to still be present in DG-3A. The majority of the germinated acorns appear to be in good health; however, several appeared to be showing signs of drought stress. The installation of the plants in the DG-3A mitigation area appears to have been completed successfully. The current issues noted during the monitoring are not expected to have a negative effect on the continued growth of the plants in the mitigation area. Photos 11 through 15 in Attachment B document the mitigation area during the monitoring visit.

Nonnative weed cover in DG-3A was estimated at approximately 5 to 10 percent, if the dead annual weeds are excluded, which is the same percent of nonnative cover that was observed during the previous qualitative monitoring event. Nonnative species observed in DG-3A included black mustard, poison hemlock, perennial pepperweed, sweet alyssum (*Lobularia maritima*), tree tobacco (*Nicotiana glauca*), wild radish (*Raphanus sativus*), and castor bean (*Ricinus communis*).

Minor erosion to planting basins was observed throughout the Phase 1 mitigation areas, likely from recent storm events. In addition, severe erosion in DG-3A near Altadena Drain was observed. Recent rainfall has

created a channel that flows to the south of Altadena Drain before connecting to the reservoir where severe berm erosion has occurred. Erosion to the upper slope in DG-3A was also observed. Due to the steepness of the slope in the Coast Live Oak Woodland portion of the DG-3A mitigation area, erosion will likely continue to be somewhat of an issue in this area; however, jute nettings are currently in place on the slope and will help to lessen the severity of erosion issues. As native cover increases in this area, erosion issues should lessen. The severity of the erosion should continue to be monitored in all planted areas and if warranted, erosion Best Management Practices (BMPs) should be installed in appropriate areas. This may only require the installation of straw wattles at select sites to prevent existing rills from becoming larger. However, until more native perennial plants become established in these areas, there is the potential that intense rainfall may create additional erosion problems.

Photo 11: Overview Mitigation Area DG-3A Altadena Drain

Photo 12: Overview Mitigation Area DG-3A Altadena Drain

Photo 13: Overview Mitigation Area DG-3A Oak Woodland

Photo 14: Overview Mitigation Area DG-3A Oak Woodland

Photo 15: Overview Mitigation Area DG-3A Oak Woodland

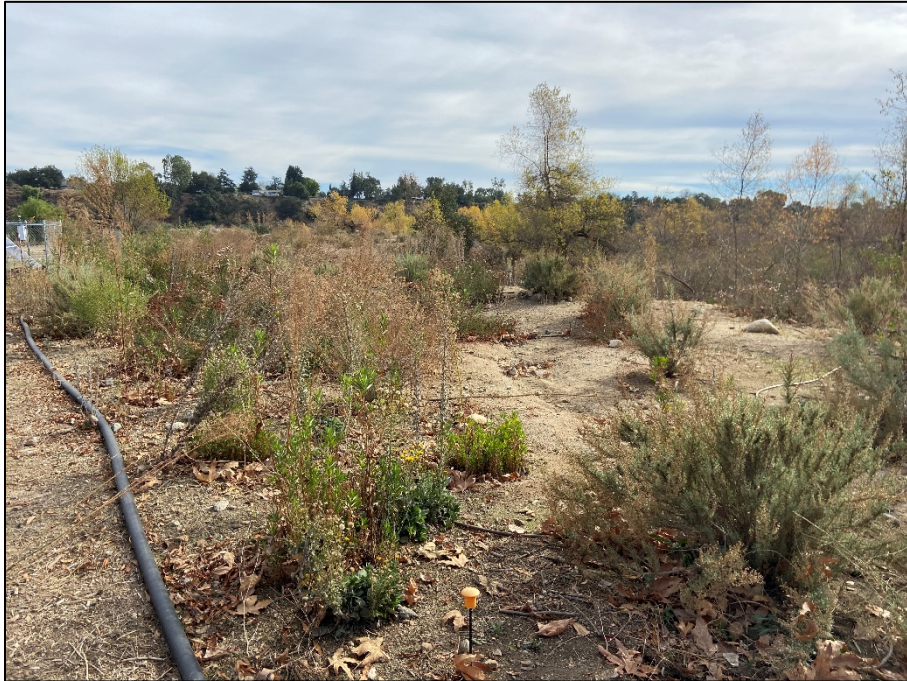
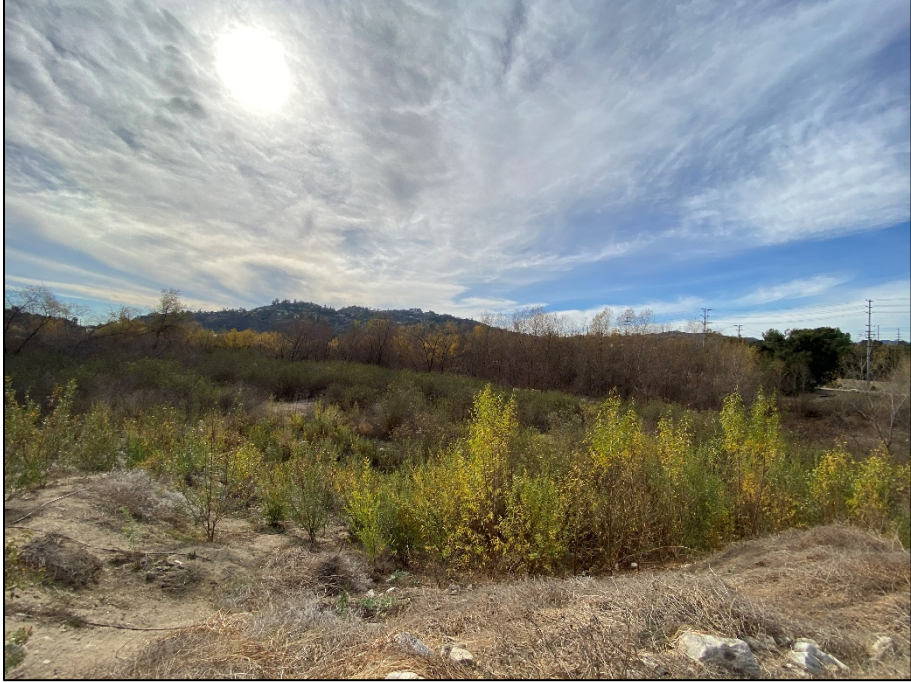
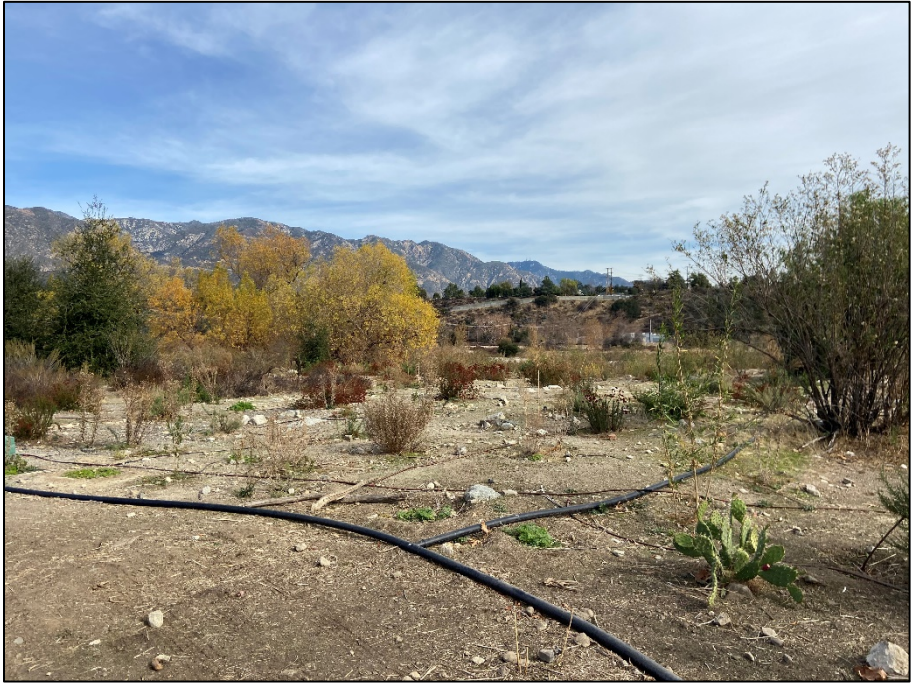
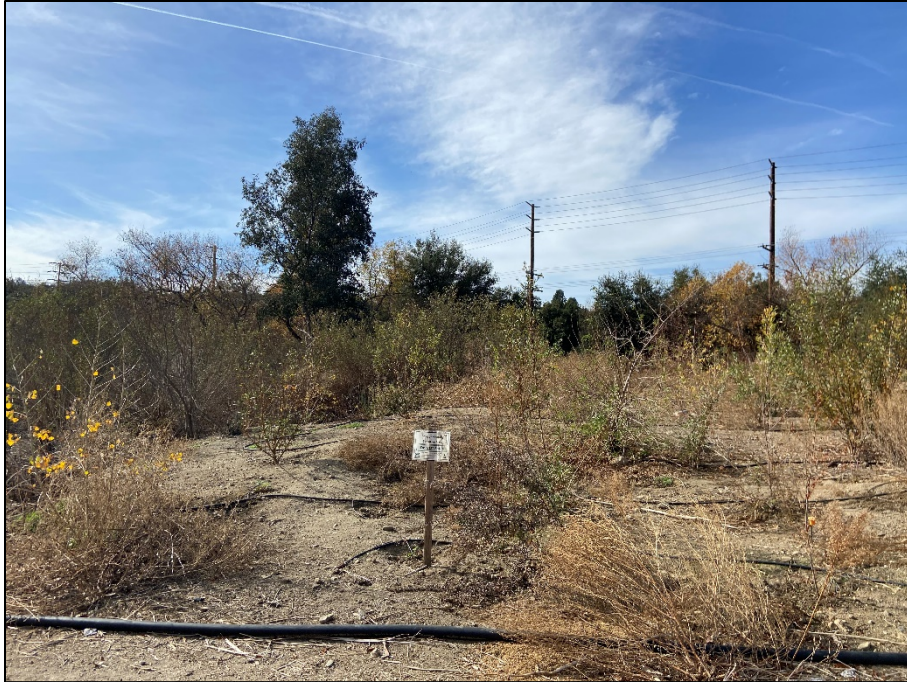
The overall health of the container plants in mitigation area DG-4 was noted as being good. Approximately 10 to 15 percent of container plants in the coastal sage scrub portions of DG-4 were showing varied levels of stress which is the same as the percentage of plants showing stress during the previous qualitative monitoring event. Approximately 10 to 15 percent of container plants in the riparian portions of DG-4 were showing varied levels of stress, which is five percent less than the percentage of container plants that were showing stress during the previous qualitative monitoring visit. The stress appears to be mostly due to the same reasons described in DG-2A. Many plants that appeared to be stressed during previous qualitative monitoring events, due to high temperatures and drought stress, appeared to be recovering. In addition, the 300-foot buffer around a least Bell's vireo (*Vireo bellii pusillus*) nest that affected middle portions of DG-4 has been removed; however, weed proliferation in this area prior to buffer removal likely contributed to plant stress and mortality. For most portions of DG-4, only a negligible number of container plants were noted as being missing or dead. Formal mortality counts were taken for DG-4 during the quantitative monitoring and will be included in the annual reporting. The container planted willow species and Fremont's cottonwood were showing signs of seasonal dieback; however, the planted willow and mulefat cuttings were also observed to be sprouting vigorously. Some of the planting basins were observed to have minor erosion and should be repaired. The installation of plants in the DG-4 mitigation area appears to have been completed successfully and the issues noted during the monitoring are not expected to have an impact on the continued growth of the plants. Photos 16 through 19 in Attachment B document the mitigation area during the monitoring visit.

Nonnative weed cover in DG-4 was estimated at approximately 10 to 15 percent for most areas, which is approximately 5 to 10 percent more than what was observed during the previous qualitative monitoring event. It should be noted that portions of DG-4 that are adjacent to weed infested portions of Phase 2 (i.e., DG-4A) were observed to have new germination of perennial pepperweed. Nonnative species observed in DG-4 included black mustard, poison hemlock, perennial pepperweed, and white horehound. Nonnative weed cover, especially perennial pepperweed, is a significant problem in portions of the DG-4 mitigation area. Because perennial pepperweed can produce dense colonies through seed germination and underground rhizomes (rhizomatous roots), removal of this species without the use of systemic herbicide is very difficult.

Photo 16: Overview Mitigation Area DG-4

Photo 17: Overview Mitigation Area DG-4

Photo 18: Overview Mitigation Area DG-4

Photo 19: Overview Mitigation Area DG-4

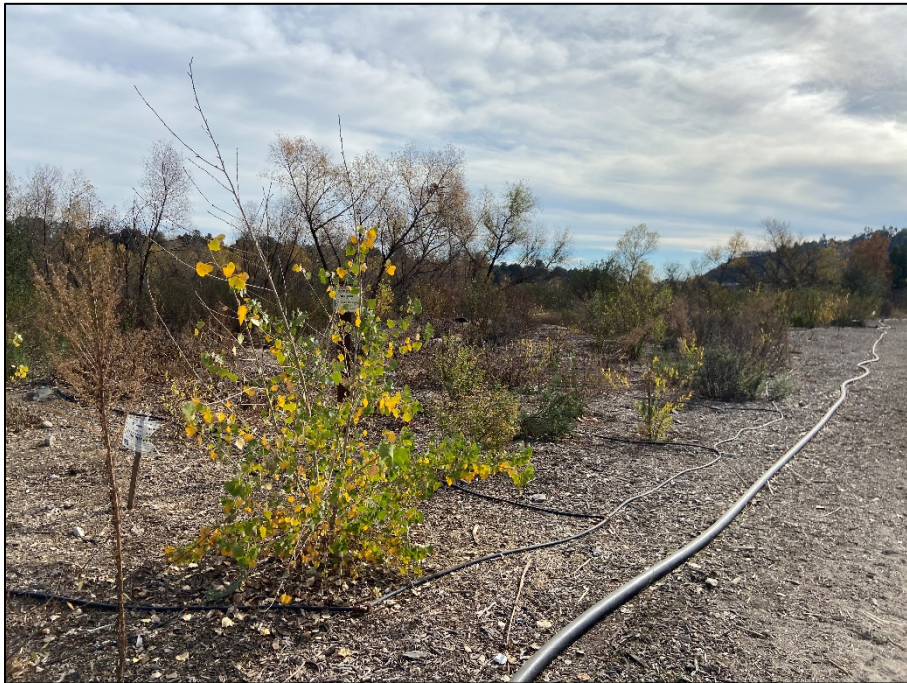
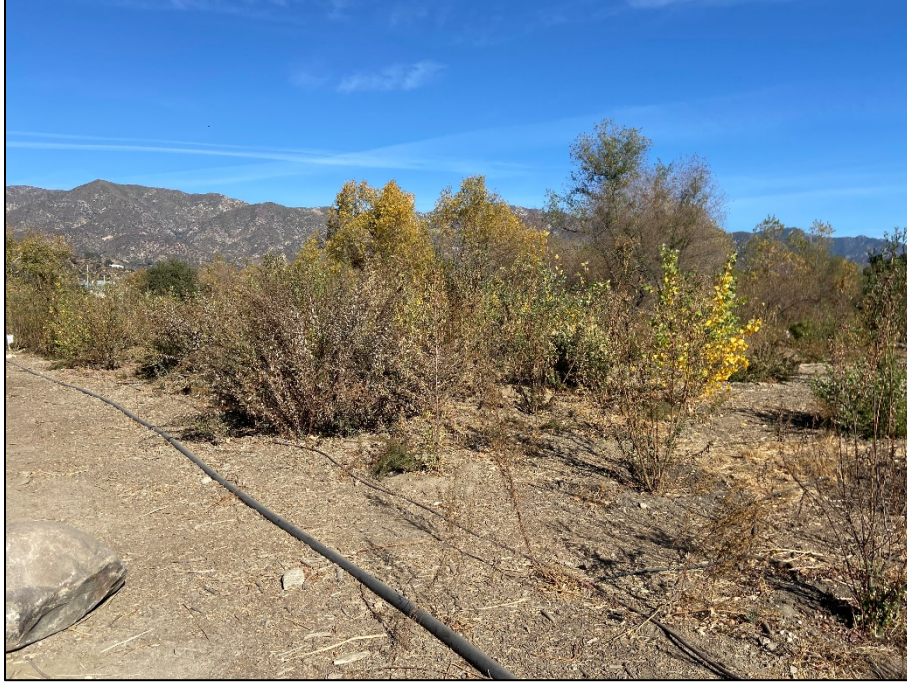
The overall health of the container plants in mitigation area DG-4B was noted as being good and this mitigation area is becoming well established. Approximately 5 to 10 percent of all container plants were noted as showing varied levels of stress, which is approximately the same percentage of plants that were showing stress during the previous qualitative monitoring visit. The types of stress the plants were exhibiting are the same as those described for the plants in DG-2A. A negligible number of container

plants were noted as being missing or dead. Formal mortality counts were taken for DG-4B during the quantitative monitoring and will be included in the annual reporting. Similar to DG-4, the container planted willow species and Fremont's cottonwoods were showing signs of seasonal dieback. Some of the planting basins were observed to have minor erosion and should be repaired. The installation of plants in the DG-4B mitigation area appears to have been completed successfully and the issues noted during the monitoring are not expected to have an impact on the continued growth of the plants. Photos 20 and 21 in Attachment B document the mitigation area during the monitoring visit.

Nonnative weed cover in DG-4B was estimated to be approximately 5 percent, which is the same percentage of nonnative cover that was observed during the previous qualitative monitoring event. Most nonnative annuals were observed to be dead for the season; however, some new germination was observed. Nonnative species observed in DG-4B included black mustard, poison hemlock, white horehound, and perennial pepperweed.

Photo 20: Overview Mitigation Area DG-4B

Photo 21: Overview Mitigation Area DG-4B

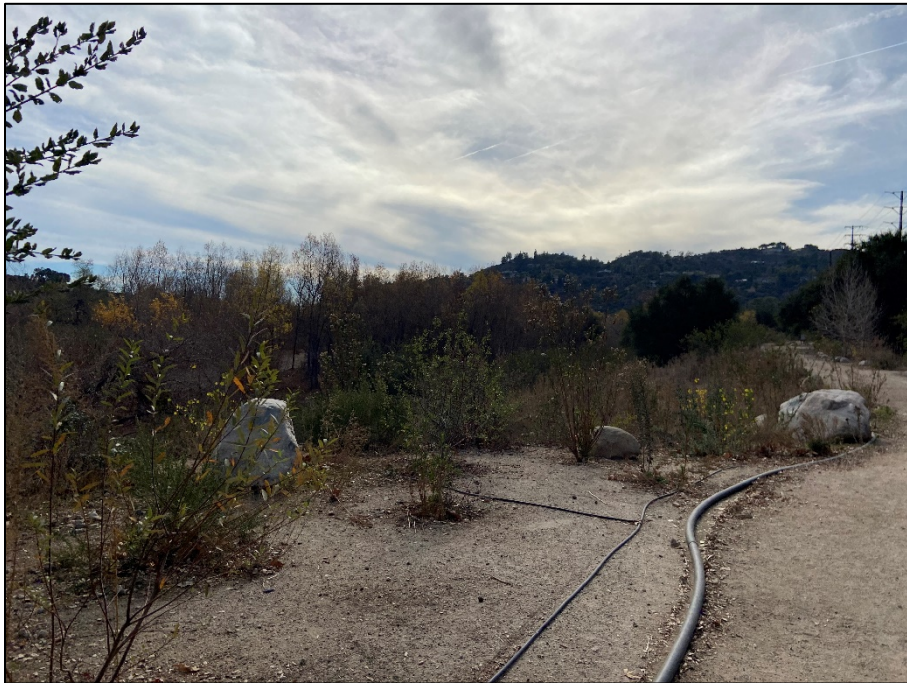
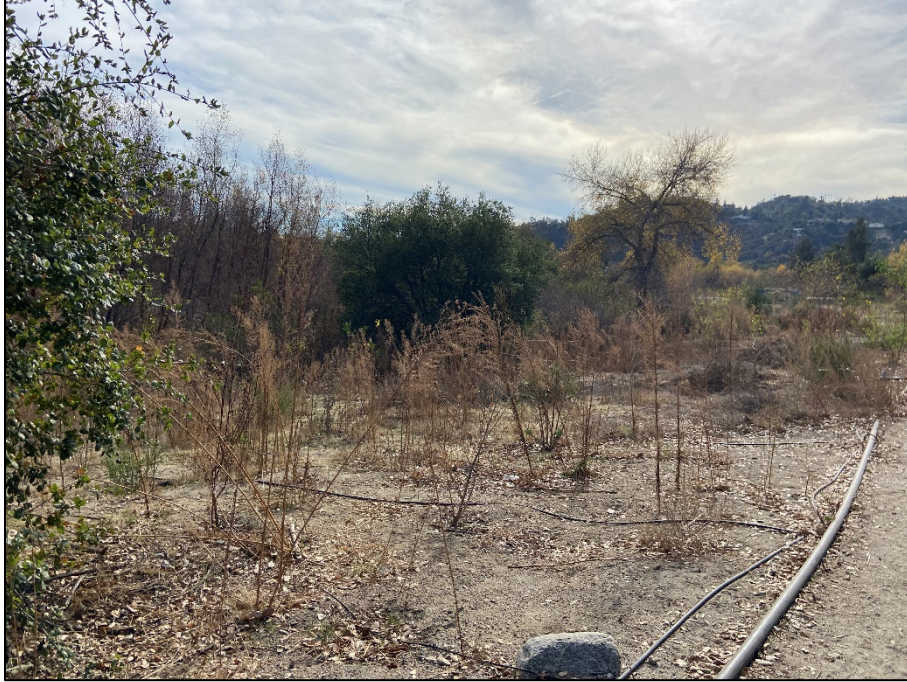
The overall health of the container plants in mitigation area DG-4C was noted as being good. Approximately 10 percent of all container plants were noted as showing varied levels of stress, which is approximately 5 percent less than the percentage of plants that were showing stress during the previous qualitative monitoring event. The types of stress the plants were exhibiting are the same as those described for the plants in DG-2A. A negligible number of container plants were noted as being missing or dead. Formal mortality counts were taken for DG-4C during the quantitative monitoring and will be included in the annual reporting. Similar to DG-4, the container planted willow species and Fremont's cottonwood were showing signs of seasonal dieback. Some of the planting basins were observed to have minor erosion and should be repaired. The installation of plants in the DG-4C mitigation area appears to have been completed successfully and the issues noted during the monitoring are not expected to have an impact on the continued growth of the plants. Photos 22 and 23 in Attachment B document the mitigation area during the monitoring visit.

Nonnative weed cover in DG-4C was estimated at approximately 5 to 10 percent, which is approximately 5 percent higher than the level of nonnative cover that was observed during the previous qualitative monitoring event. Nonnative species observed in DG-4C included black mustard, poison hemlock, perennial pepperweed, and white horehound.

Photo 22: Overview Mitigation Area DG-4C

Photo 23: Overview Mitigation Area DG-4C

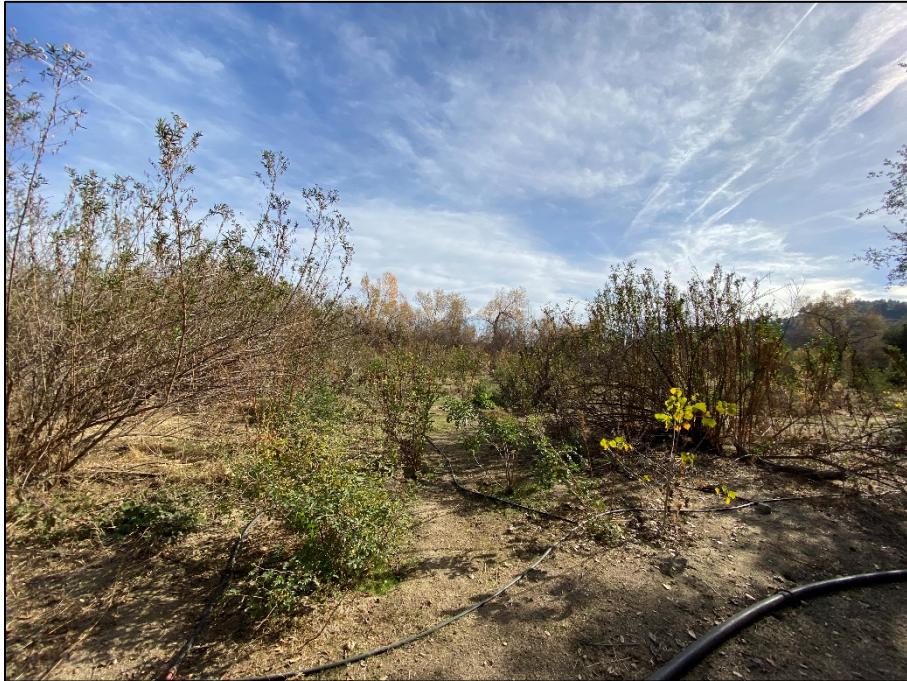
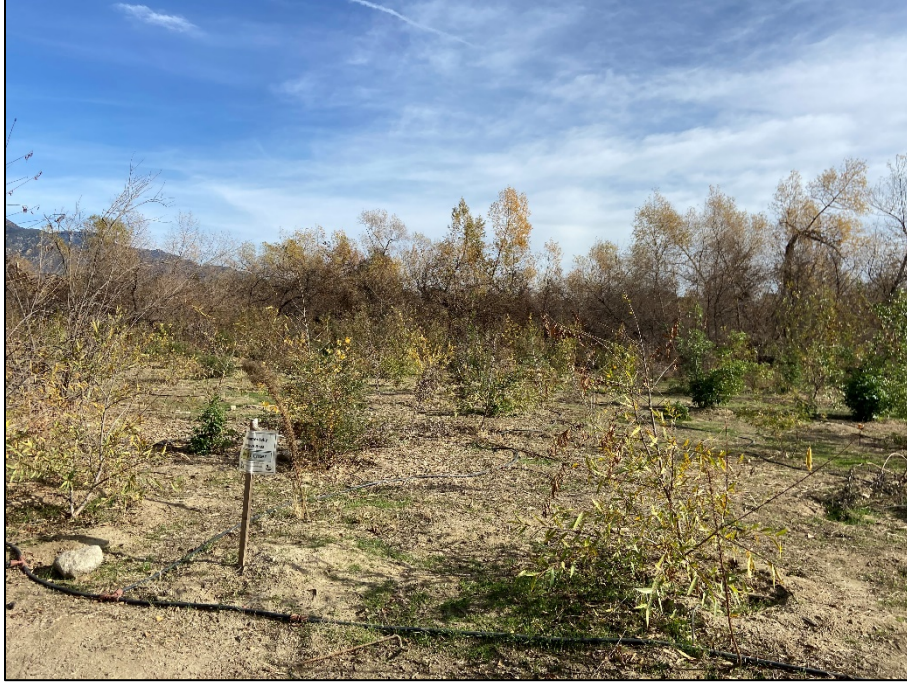
The overall health of the container plants in the DG-5 mitigation area was noted as being good. Approximately 10 to 15 percent of all container plants were noted as showing varied levels of stress, which is approximately five percent less than the percentage of plants that were showing stress during the previous qualitative monitoring event. While the 300-foot buffer around a least Bell's vireo nest that affected all of DG-5 has been removed, weed proliferation in this area prior to buffer removal likely contributed to plant stress and mortality. Gopher herbivory is also a significant problem in DG-5 and accounts for the majority of the missing container plants. In addition, gopher activity has increased the level of basin degradation and many basins need repair. Formal mortality counts were taken for DG-5 during the quantitative monitoring and will be included in the annual reporting. Similar to DG-4, the container planted willow species and Fremont's cottonwoods were showing signs of seasonal dieback. Some of the planting basins were observed to have minor erosion and should be repaired. The installation of plants in the DG-5 mitigation area appears to have been completed successfully and the issues noted during the monitoring are not expected to have a negative impact on the continued growth of the plants. Photos 24 and 25 in Attachment B document the mitigation area during the monitoring visit.

Nonnative weed cover in DG-5 was estimated at approximately 5 to 10 percent, which is the same percent of nonnative weed cover that was observed during the previous qualitative monitoring event. Nonnative species observed in DG-5 included wild oat (*Avena fatua*), black mustard, poison hemlock, common barley (*Hordeum vulgare*), perennial pepperweed, and white horehound.

Photo 24: Overview Mitigation Area DG-5

Photo 25: Overview Mitigation Area DG-5

Rabbit herbivory of container plants was observed in the Phase 1 mitigation areas. California rose, California buckwheat, and basket rush (*Juncus textilis*) appeared to be the most affected by herbivory. In addition, gopher herbivory of container plants was observed in DG-5. Minor herbivory generally will not kill the plants, but continued monitoring should be conducted during future visits to determine the level of the herbivory isn't such that plants are dying. If browsing by rabbits or other animals begins to worsen, caging around affected and/or favored container plants may be warranted. In addition, below grade gopher traps should be installed at DG-5 to remove the gophers from this area.
