Devil's Gate Reservoir Restoration Project First Quarter Compliance Report Activities Occurring Between January 2019 and March 2019

Appendix A: Construction Monitoring Logs

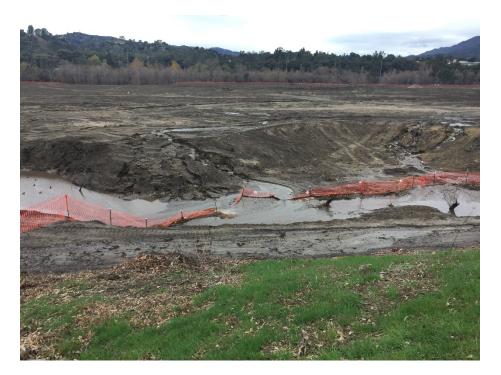
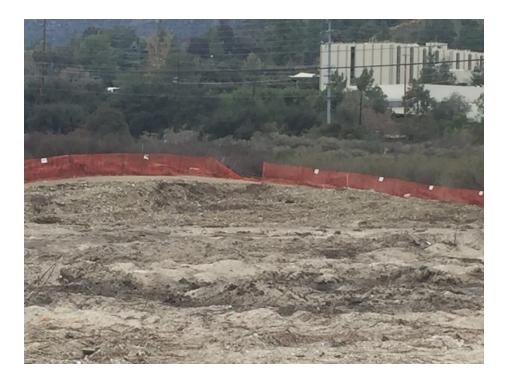
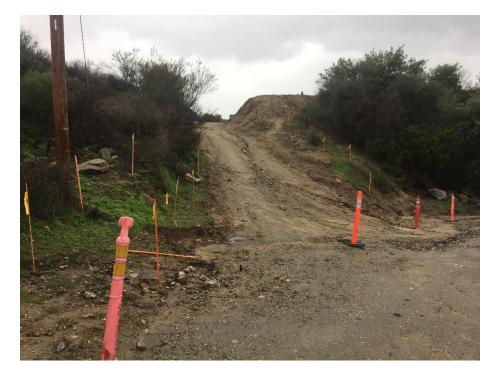
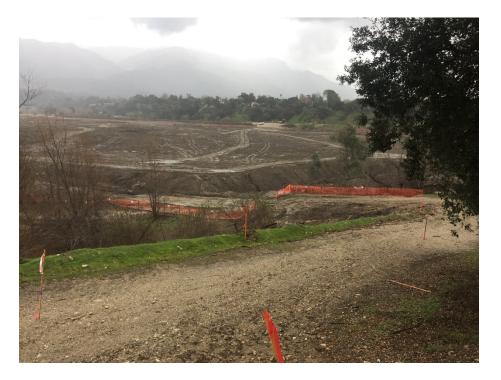
1200 onsite for 2x weekly site visit. No construction activities taking place due to rain. Areas where fence is damaged noted. Several 10+ ESA signs retrieved from trail/reservoir. Overall no major issues on-site. All vegetation has been removed, only small amounts of twig debris and dirt piles remain. 1400 left site.

Fix damaged fencing in NW corner and near Alta Dena Drain. Replace ESA signs with something weather proof.

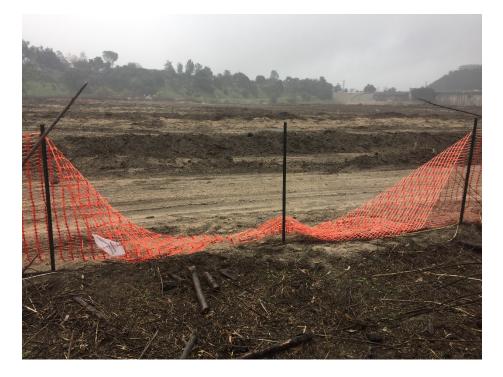
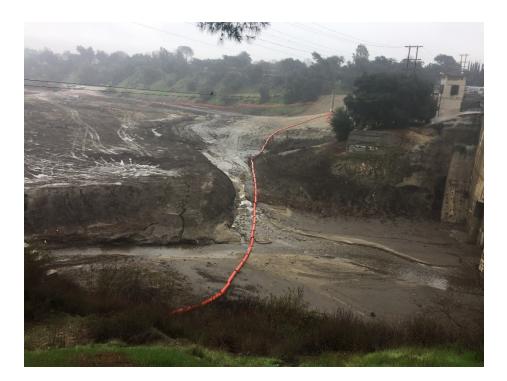
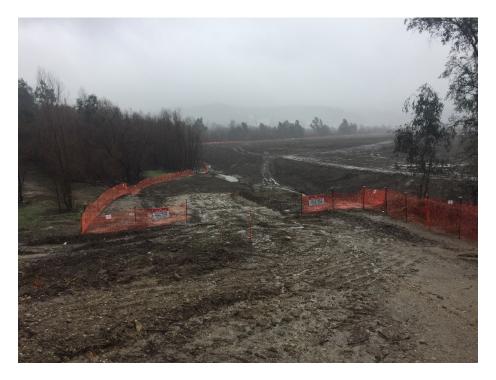
1140 arrived on site for 2nd of twice weekly site visits. Openings in fence noted along southwest side. 1330 left site, no bio issues observed. Minor fence repairs needed.

Minor fence repairs needed.

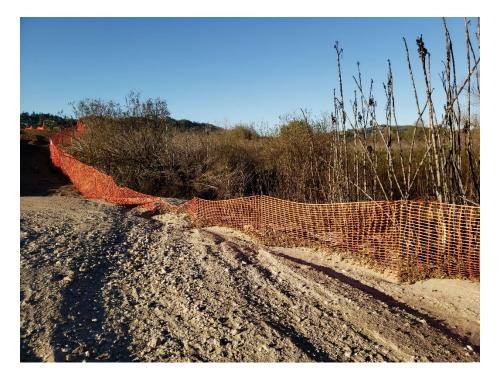
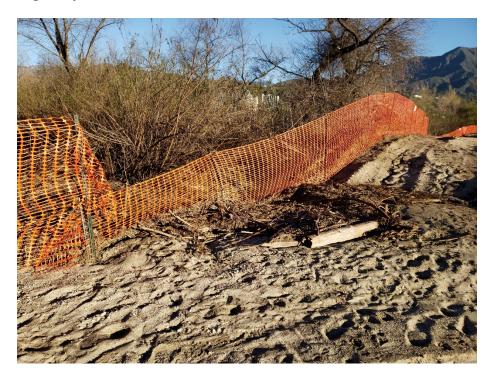
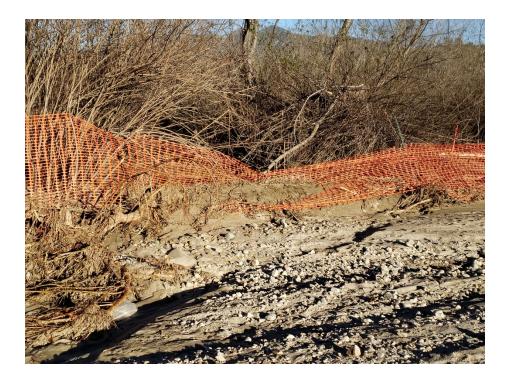
Project signs along fence have washed out of sediment removal area.

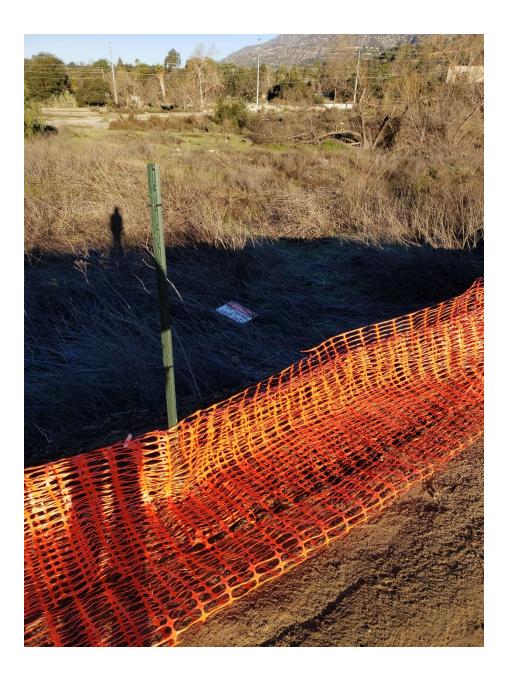
Log Entry #5 Photo A

Fence completely washed out along west side toward southern end.

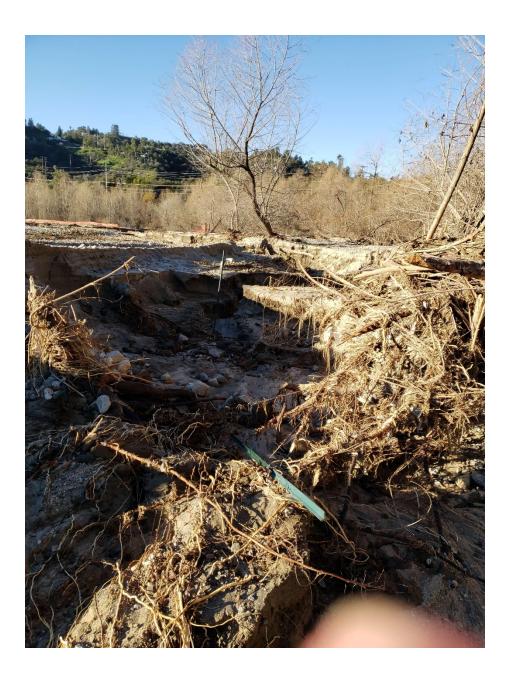
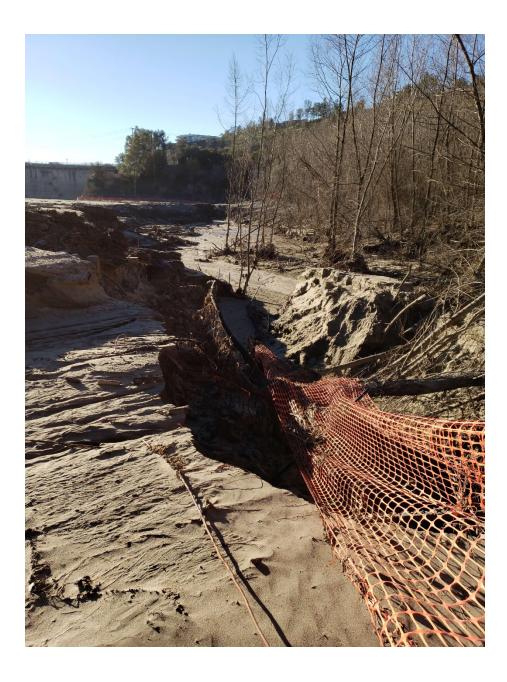
Multiple areas of downed fence, particularly on western boundary. A major section along the southwestern boundary is missing/washed out and is in need of replacement. Appears to be in same state as site check on Wednesday.

Fence is need of repair/replacement.

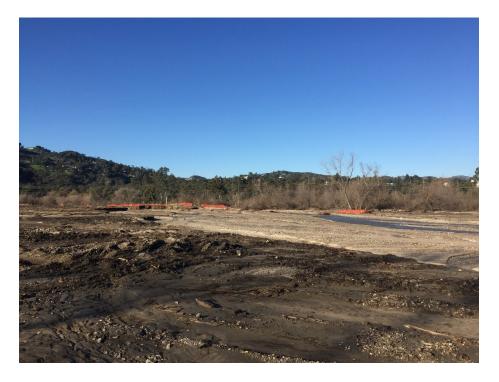
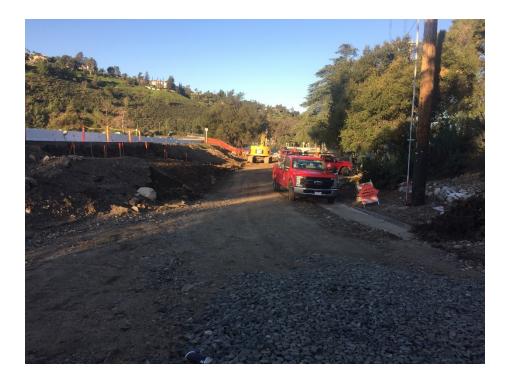
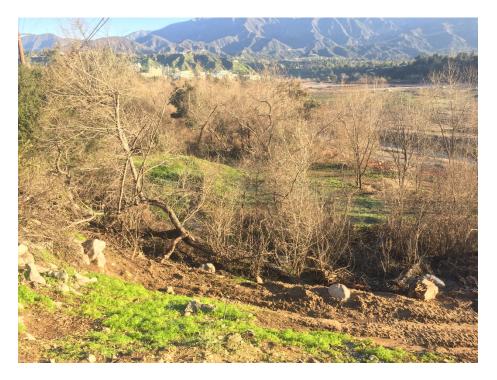
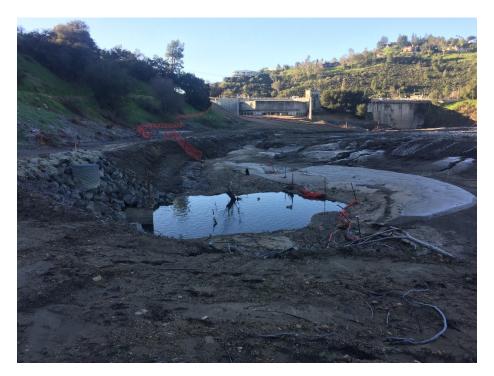
0735 Arrived on site for biweekly LBVI site check. Breaks in fence due to rain flows. Maintenance crew working on small fence repairs. No bio issues observed. Trained 3 new Griffith employees. 0900 Left project site.

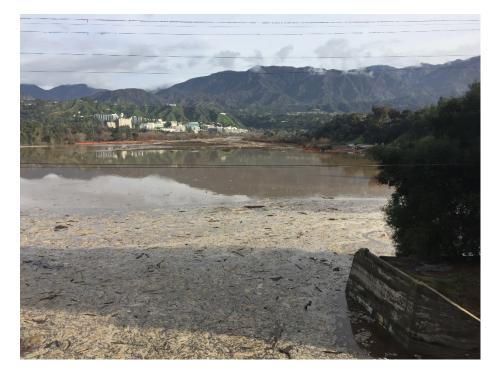
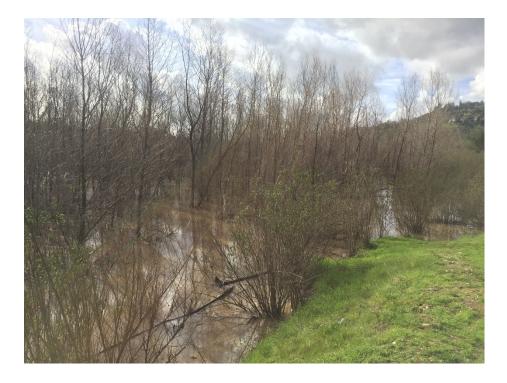
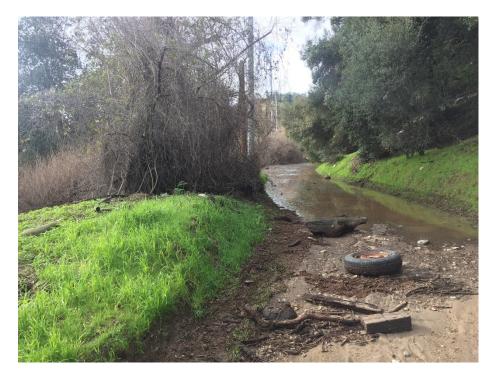
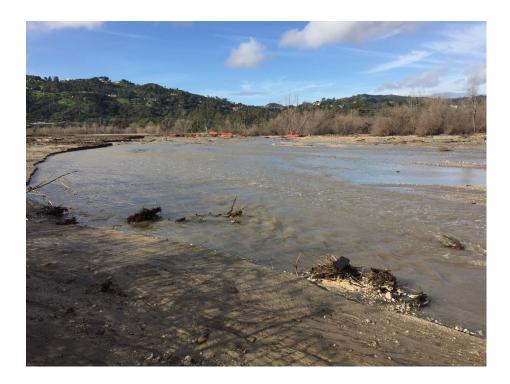
Heavy flow and inundatation at dam. And southern end of project site. No biological issues observed. Several areas of downed fence due to water flows.

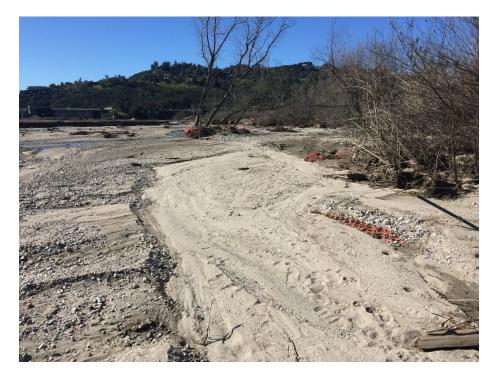
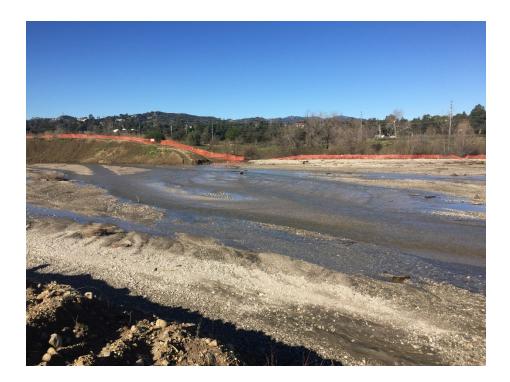
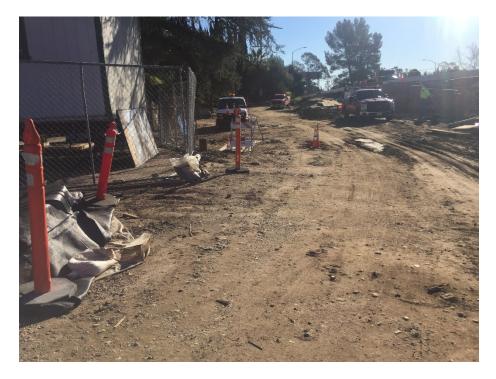
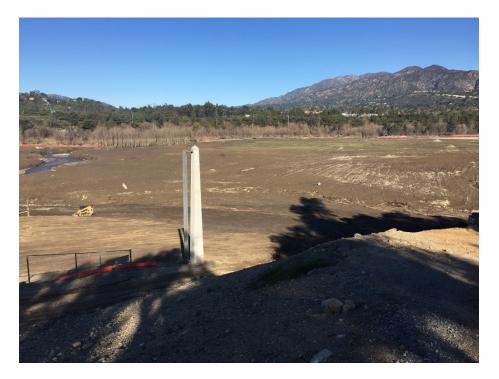
0830 arrived on site, inspected site. No noncompliance issues observed. County clearing debris from behind trash rack. No bio issues observed, no LBVI observed. Will need to fix fence prior to project initiation.

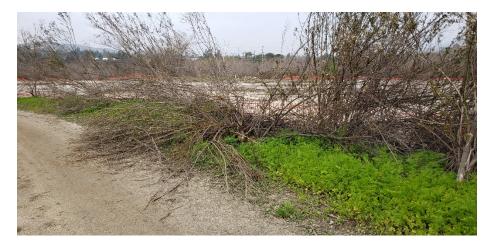
Log Entry #1 Photo A

Observed a few mulefat plants had branches that appeared damaged/broken and pushed over along mid-east side of project in restoration area. This was not observed yesterday during restoration monitoring. The Nature's Image crew was careful and avoided damaging mulefat while pulling weeds. The damaged mulefat is likely non-project related.
