September 3, 2024  
(2023-005.07)

**Re: *Devil's Gate Reservoir Restoration Project – Phase 3 Restoration Qualitative Monitoring Conducted on June 17, 2024***

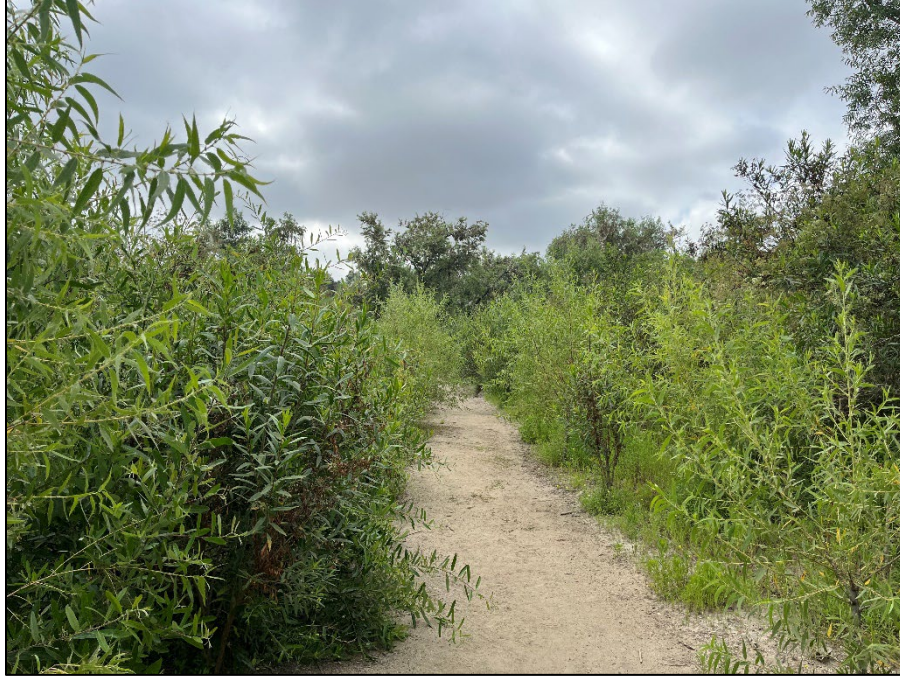
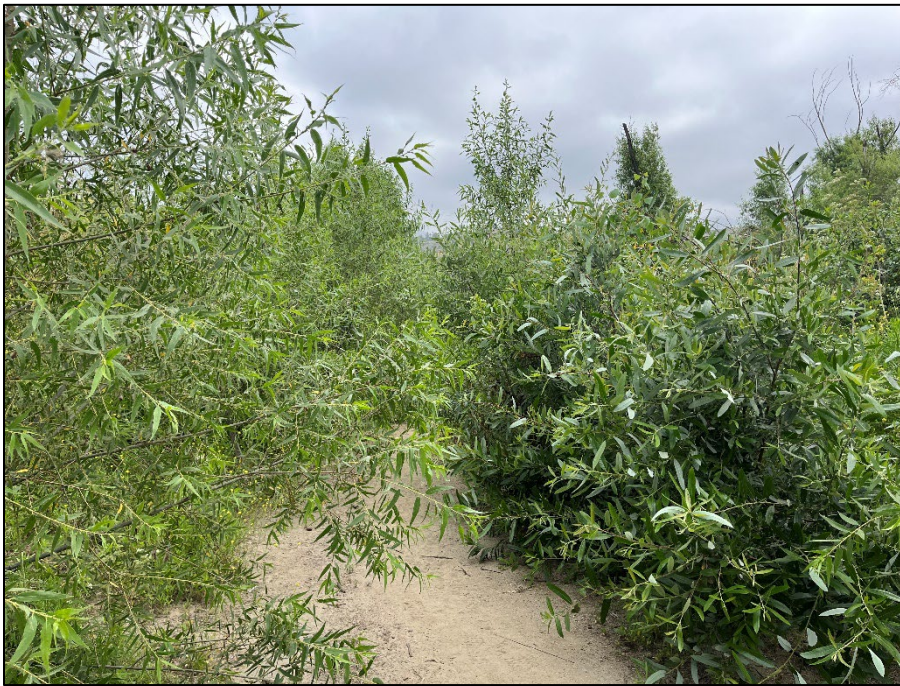
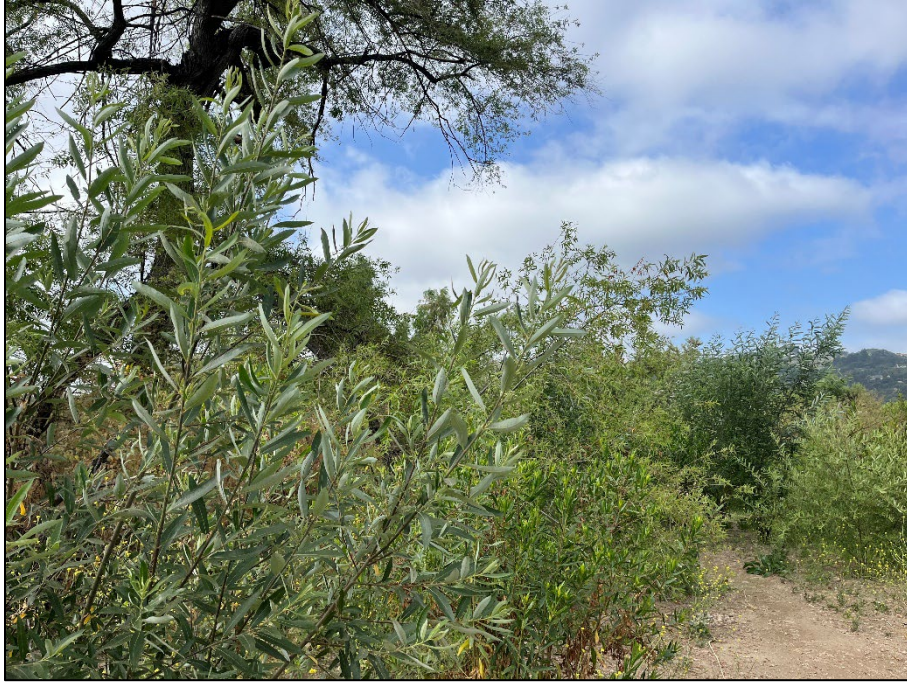
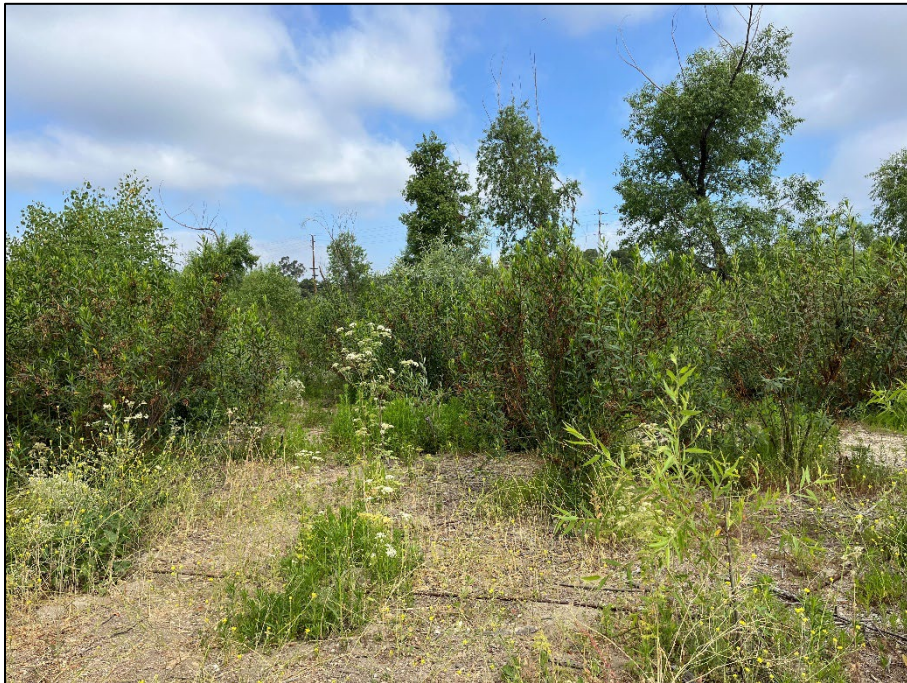
The overall health of the container plants in DG-4 WOUS and DG-4 WOUS Connections was noted as being good. Approximately 5 percent of the container plants and stakes in DG-4 WOUS and DG-4 WOUS Connections were noted as showing signs of stress and a negligible amount were noted as being dead or missing. This is approximately the same percentage of plants that were showing stress during the previous monitoring visit. Stress may be occurring as a result of 1) transplant shock, 2) herbivory by rabbits or other wildlife, 3) competition from nonnative and invasive weeds, 4) misplaced emitters, or 5) recreational traffic through the mitigation areas. During the monitoring visit, Fremont's cottonwoods (*Populus fremontii*) and willows (*Salix* spp.) were no longer showing signs of seasonal dieback. Formal mortality counts will be taken for DG-4 WOUS and DG-4 WOUS Connections during the 2024 quantitative monitoring and will be included in the 2024 annual reporting. The majority of the recently planted mulefat (*Baccharis salicifolia*) and willow stakes were noted as showing signs of new growth. Some of the container plants were noted as lacking well defined basins and should have their basins properly constructed and/or repaired. The installation of plants in the DG-4 WOUS and DG-4 WOUS Connections mitigation areas appears to have been completed successfully. The current issues identified during the monitoring visit are not expected to have an effect on the continued growth of the plants in the mitigation area. Photos 1 through 4 in Appendix B document the mitigation areas during the monitoring visit.

Photo 1. Overview DG-4 WOUS & WOUS Connections

Photo 2. Overview DG-4 WOUS & WOUS Connections

Photo 3. Overview DG-4 WOUS & WOUS Connections

Photo 4. Overview DG-4 WOUS & WOUS Connections

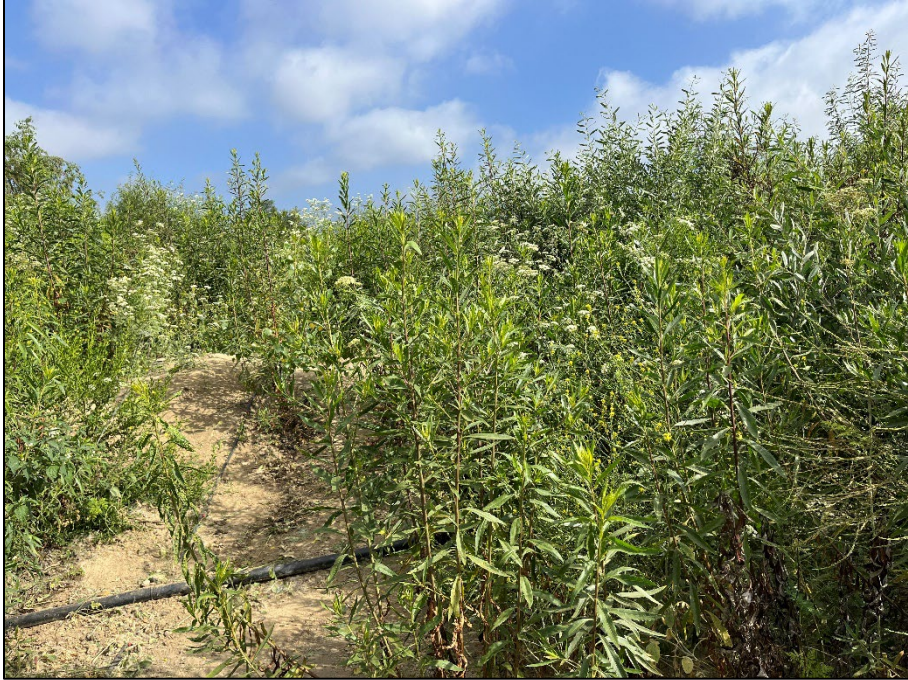
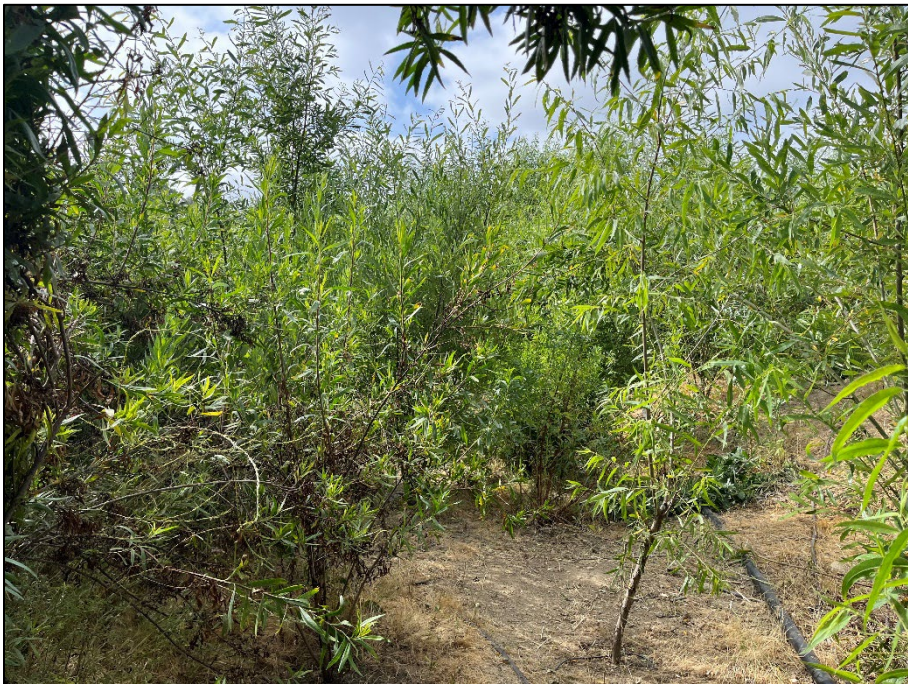
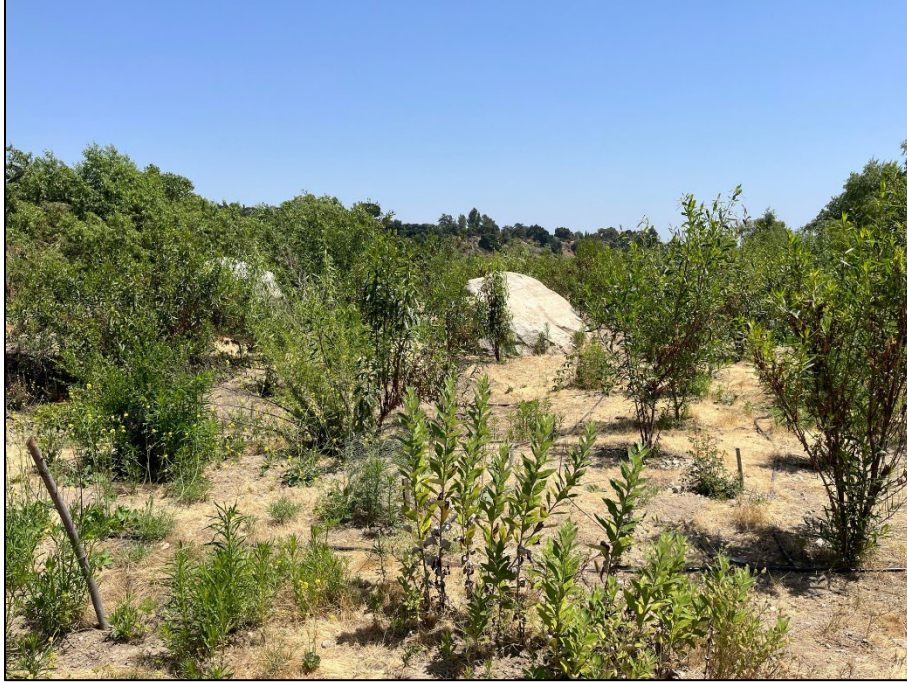
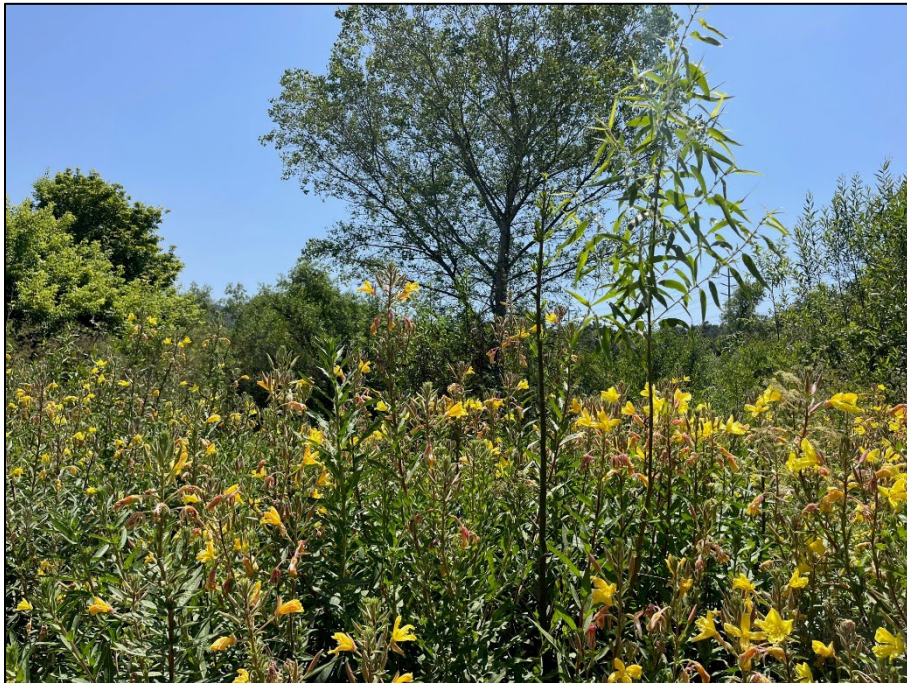
The overall health of the container plants in DG-4A was noted as being good and this mitigation area is becoming well established. Approximately 5 percent of the container plants and stakes in DG-4A were noted as showing signs of stress and a negligible amount were noted as being dead or missing. Approximately the same percentage of plants were showing signs of stress during the previous monitoring visit. This included the remaining container plants from the first installation and the replacement container plants that were installed to replace the container plants and stakes planted in the middle section of DG-4A that appeared to be dead or in a condition unlikely to recover during previous monitoring visits. Stress may be occurring due to similar reasons described for DG-4 WOUS and DG-4 WOUS Connections. Formal mortality counts will be taken for DG-4A during the 2024 quantitative monitoring and will be included in the 2024 annual reporting. The majority of the recently planted mulefat and willow stakes were noted as showing signs of new growth. Some of the container plants were noted as lacking well defined basins and should have their basins properly constructed and/or repaired. The installation of plants in the DG-4A mitigation area appears to have been completed successfully and the installation of the replacement container plants should increase native cover. The current issues identified during the monitoring visit are not expected to have an effect on the continued growth of the plants in the mitigation area. Photos 5 through 8 in Appendix B document the mitigation area during the monitoring visit.

Photo 5. Overview DG-4A

Photo 6. Overview DG-4A

Photo 7: Overview DG-4A

Photo 8: Overview DG-4A

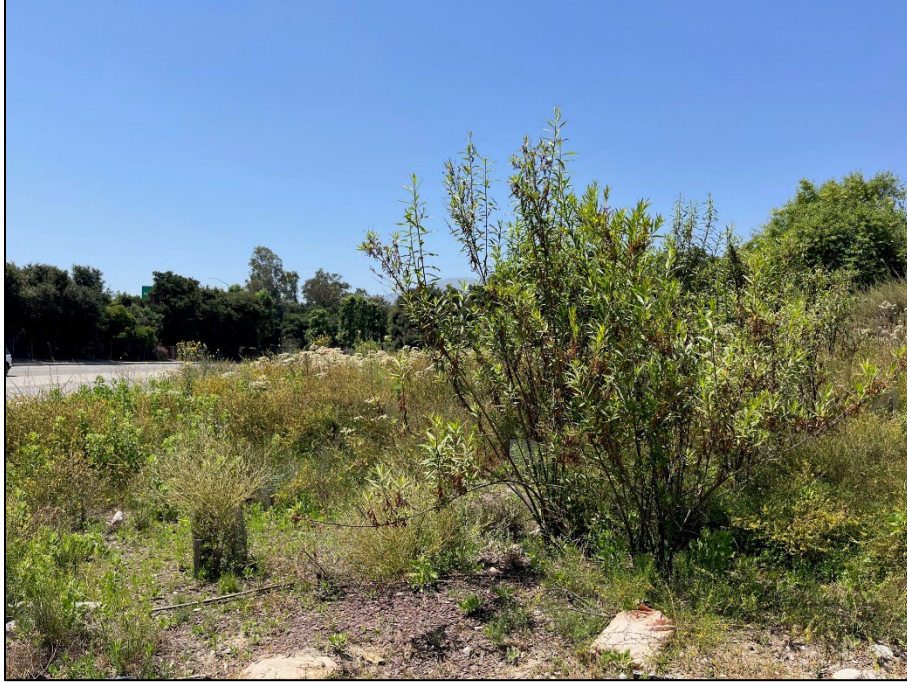
Photo 9: Overview Tire Wash

The overall health of the container plants in the Tire Wash mitigation area was noted as being good. Approximately 5 percent of the container plants were noted as showing varied levels of stress, which is approximately the same percentage of plants that were showing stress during the previous monitoring visit. This included the remaining container plants from the first installation and the replacement container plants that were installed to replace the container plants that were either missing or appeared to be dead or in a condition unlikely to recover during previous monitoring visits. Most of the stress was observed on the recently installed container plants. Stress may be occurring due to similar reasons described for DG-4 WOUS and DG-4 WOUS Connections. In addition, some of the container plants are being smothered by deerweed (*Acmispon glaber*) which is proliferating in this area. The irrigation was found to be functioning properly for this mitigation area. Formal mortality counts will be taken for the Tire Wash during the 2024 quantitative monitoring and will be included in the 2024 annual reporting. Some of the container plants were noted as lacking well defined basins and should have their basins properly constructed and/or repaired. The installation of plants in the Tire Wash mitigation area appears to have been completed successfully. The current issues identified during the monitoring visit are not expected to have an effect on the continued growth of the plants in the mitigation area. Photo 9 in Appendix B documents the mitigation area during the monitoring visit.

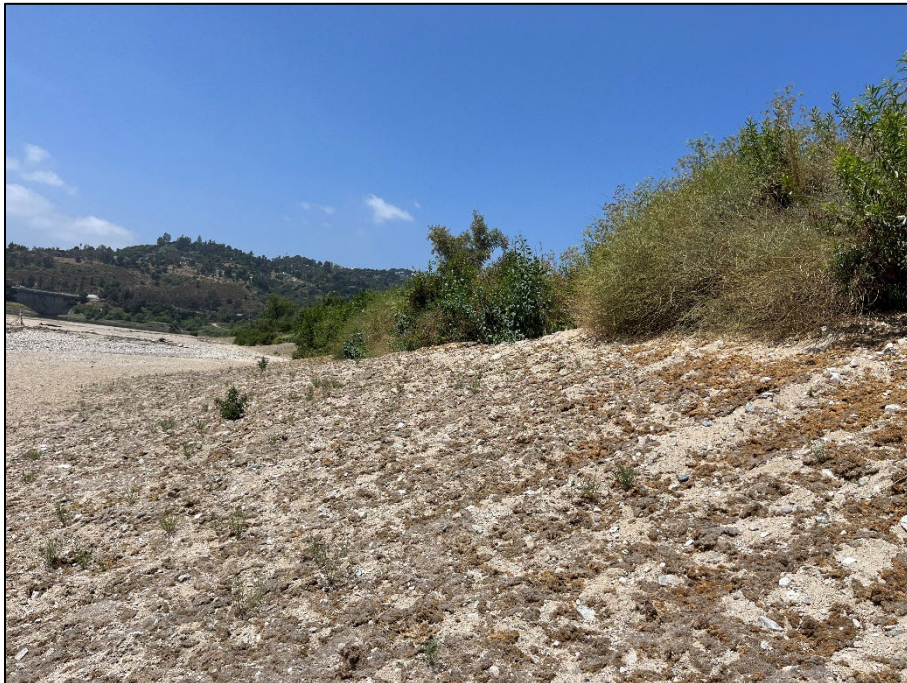
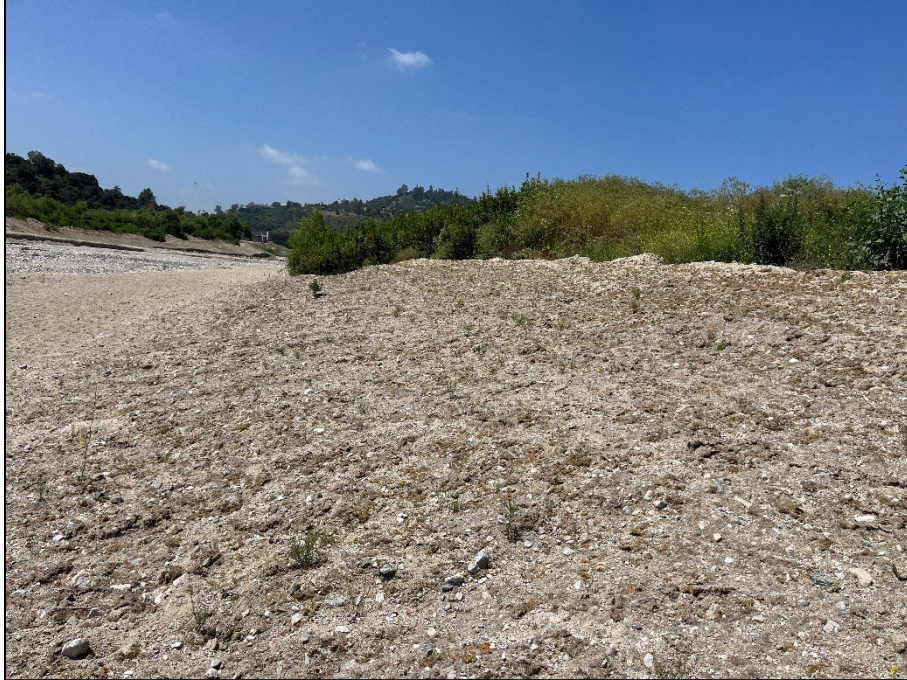
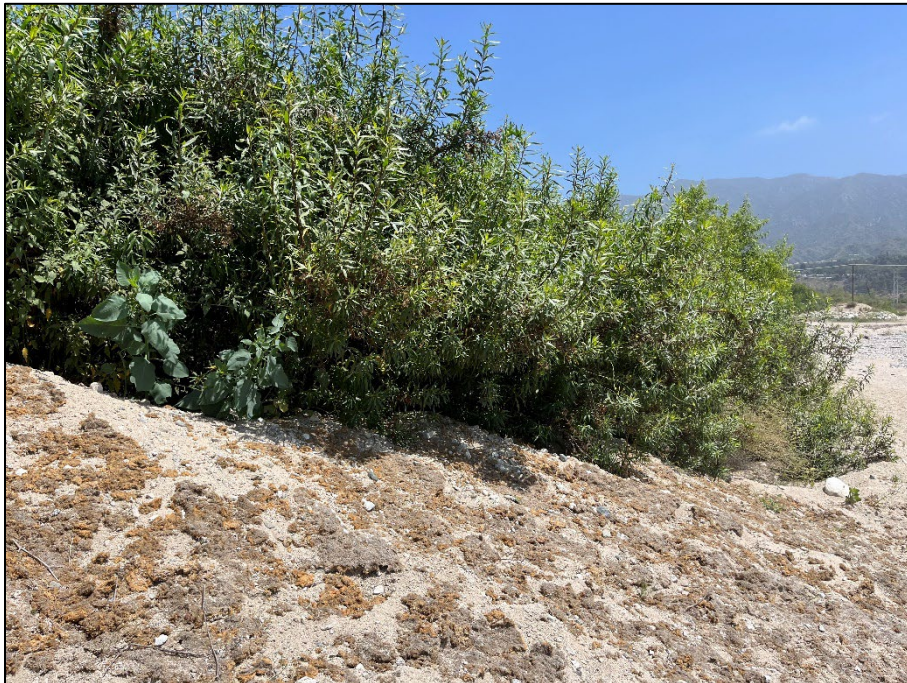
Container plants were not installed on the Side Slopes or in Flint Wash, but these areas were seeded with native plant species. Native plant growth was noted throughout the Side Slopes and Flint Wash, likely both from natural recruitment and from seeding. Portions of the Side Slopes that were previously noted as having significant erosion that occurred as a result of heavy rainfall during the 2023 wet season and following the tropical storm that occurred in late August 2023 were noted as having been repaired during previous monitoring visits and were included in the supplemental seeding effort initiated in November of 2023. During the monitoring visit, the recently hydroseeded portions of the Side Slopes where previous erosion had occurred showed minimal germination; however, germination was observed to be higher in these areas during the June monitoring visit than during previous monitoring visits. Lack of germination on these portions of the Side Slopes could be due to lack of soil nutrients, lack of organic matter, and/or incorrect compaction levels. Native plants such as common yarrow (*Achillea millefolium*), deerweed, annual bursage, mugwort, mulefat, Canada horseweed, telegraph weed, stinging annual lupine (*Lupinus hirsutissimus*), grape-soda lupine (*Lupinus excubitus*), black willow (*Salix gooddingii*), and rough cocklebur (*Xanthium strumarium*) were observed sprouting on the Side Slopes and in Flint Wash. Overall native cover was estimated to be approximately 40 percent during the monitoring visit; however, the portions of the Side Slopes that were recently repaired and hydroseeded were noted as having very low cover. A portion of the Side Slopes near the southwestern extent of DG-2 WOUS that was noted as having significant erosion during the previous monitoring visit was still present and had not been repaired. Photos 10 through 12 in Appendix B document the Side Slopes during the monitoring visit.

Nonnative weed cover on the Side Slopes and Flint Wash was estimated at approximately 15 to 20 percent overall, which is approximately 5 percent lower than the level of weed cover that was observed during the previous monitoring visit. It should also be noted that the middle to southern section of the Side Slopes on the west side and Flint Wash had a higher level of nonnative weed cover that was estimated at approximately 30 to 40 percent. Nonnative species observed on the Side Slopes and Flint Wash included black mustard, poison hemlock, perennial pepperweed, Indian plantain (*Plantago arenaria*), and wild radish (*Raphanus sativus*). Most of the nonnative weeds observed in this mitigation area were just starting to germinate; however, some were starting to flower and will soon go to seed. These areas should be weeded prior to seed production. As weed abatement continues in the mitigation areas, it is anticipated that the seed bank of nonnative and invasive weeds will decrease; however, perennial pepperweed easily resprouts from rhizomatous roots that can be difficult to fully remove with hand tools.

Photo 10: Overview Side Slopes

Photo 11: Overview Side Slopes

Photo 12: Overview Side Slopes

observed at the toe of the Side Slopes in these areas and has the potential to worsen. In addition, one area of severe erosion that was noted on the eastern Side Slopes at the southwestern extent of DG-2 WOUS during the previous monitoring visit was still present and had not been repaired. As more perennial plants become established on the Side Slopes, erosion should become less of an issue; however, action will need to be taken to repair the damage caused by the erosion and measures should be taken to reduce damage from erosion in the future. In addition, if the supplemental seeding effort does not produce germination on the previously eroded Side Slopes, adaptive management techniques will likely be warranted. During future monitoring events, erosion should continue to be monitored in all planted areas and if warranted, erosion Best Management Practices should be installed in appropriate areas. This may only require the installation of straw wattles at select sites to prevent existing rills from becoming larger.
