July 18, 2024
(2023-005.07)

Re: *Devil's Gate Reservoir Restoration Project – Phase 3 Restoration Qualitative Monitoring Conducted on May 15, 2024*

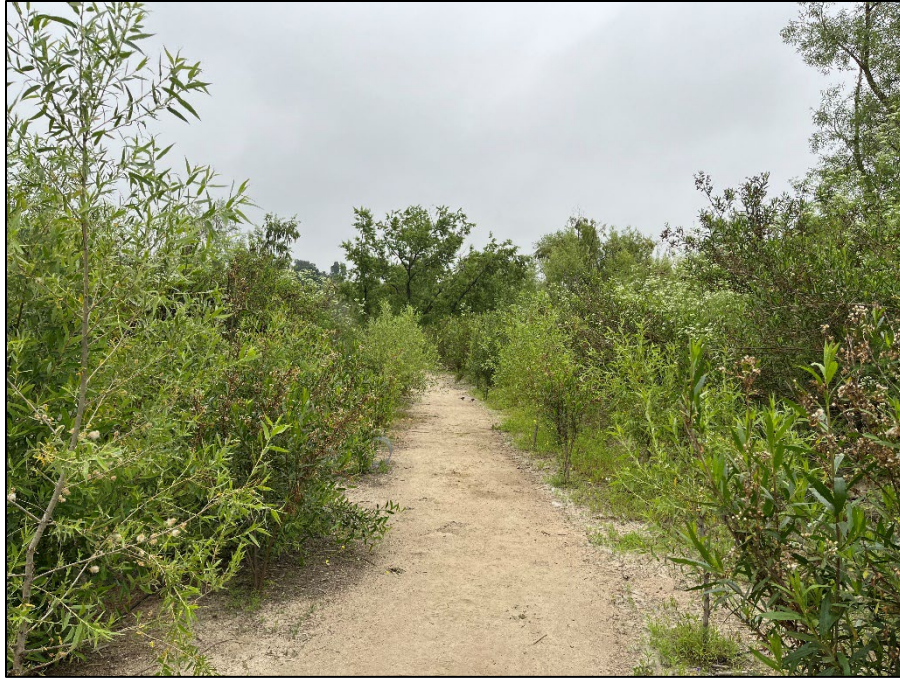
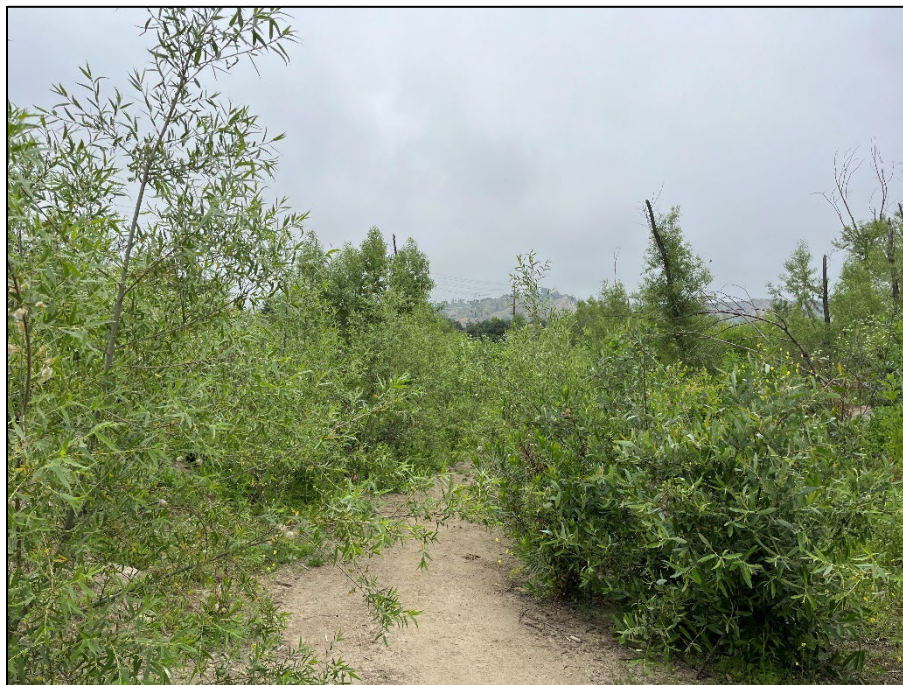
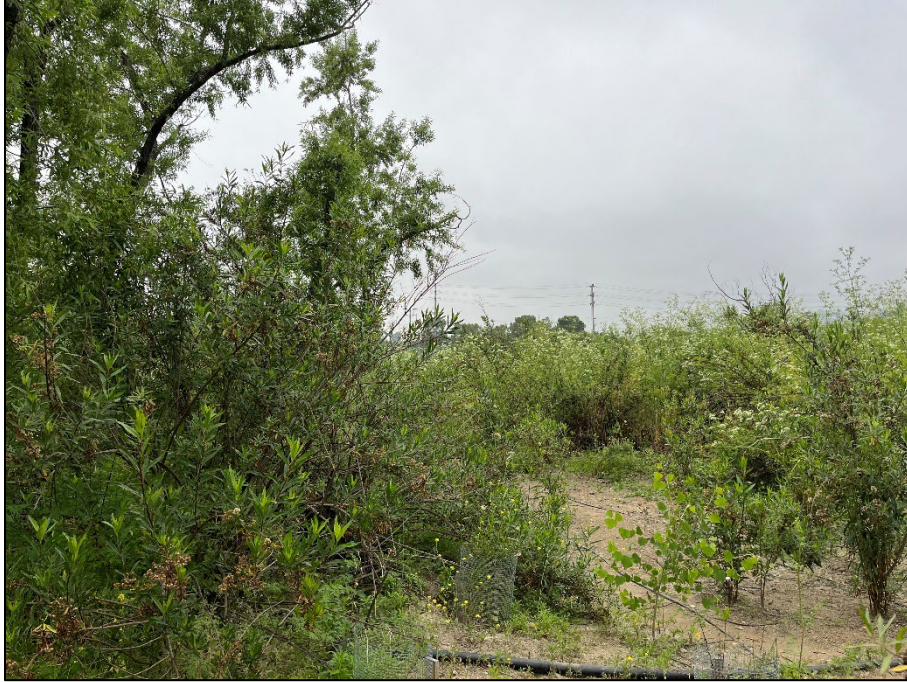
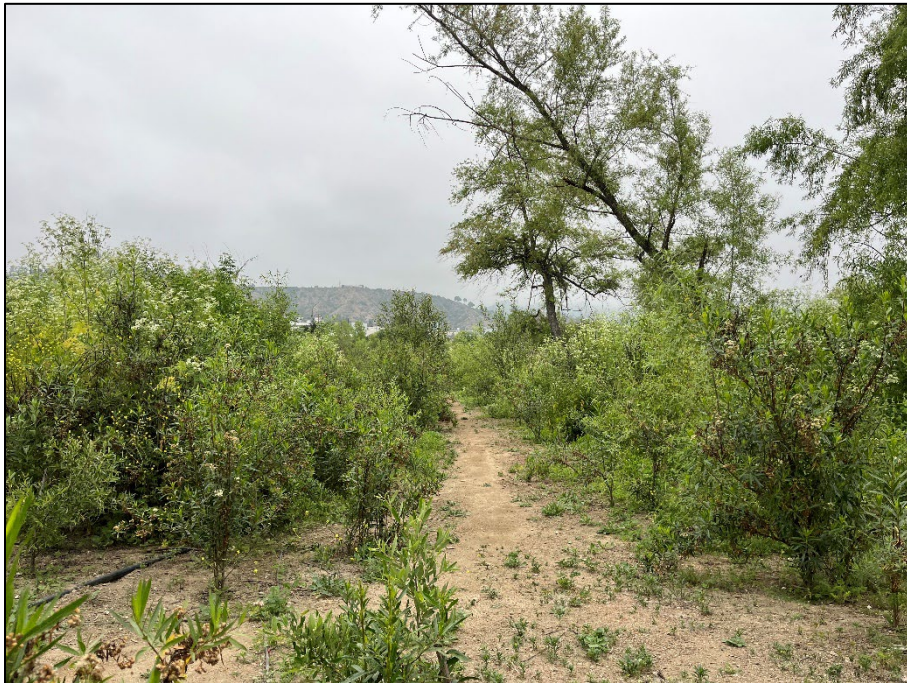
Photo 1. Overview DG-4 WOUS & WOUS Connections

The overall health of the container plants in DG-4 WOUS and DG-4 WOUS Connections was noted as being good. Approximately 5 percent of the container plants and stakes in DG-4 WOUS and DG-4 WOUS Connections were noted as showing signs of stress and a negligible amount were noted as being dead or missing. This is approximately the same percentage of plants that were showing stress during the previous monitoring visit. Stress may be occurring as a result of 1) transplant shock, 2) herbivory by rabbits or other wildlife, 3) competition from nonnative and invasive weeds, 4) misplaced emitters, or 5) recreational traffic through the mitigation areas. During the monitoring visit, Fremont's cottonwoods (*Populus fremontii*) and willows (*Salix* spp.) were no longer showing signs of seasonal dieback. Formal mortality counts will be taken for DG-4 WOUS and DG-4 WOUS Connections during the 2024 quantitative monitoring and will be included in the 2024 annual reporting. The majority of the recently planted mulefat (*Baccharis salicifolia*) and willow stakes were noted as showing signs of new growth. Some of the container plants were noted as lacking well defined basins and should have their basins properly constructed and/or repaired. The installation of plants in the DG-4 WOUS and DG-4 WOUS Connections mitigation areas appears to have been completed successfully. The current issues identified during the monitoring visit are not expected to have an effect on the continued growth of the plants in the mitigation area. Photos 1 through 4 in Appendix B document the mitigation areas during the monitoring visit.

Nonnative weed cover in DG-4 WOUS and DG-4 WOUS Connections was estimated at approximately 10 to 15 percent, which is approximately 5 percent higher than what was observed during the previous monitoring visit. Nonnative species observed included black mustard (*Brassica nigra*), poison hemlock (*Conium maculatum*), perennial pepperweed (*Lepidium latifolium*), wild radish (*Raphanus sativus*), and dwarf nettle (*Urtica urens*). Most of the nonnative weeds observed in these mitigation areas were just starting to germinate; however, some were observed going to flower. In addition, some of the mitigation areas adjacent to DG-4 WOUS and DG-4 WOUS Connections have weeds that are going to flower that should be removed before they go to seed. As weed abatement continues in the mitigation areas, it is anticipated that the seed bank of nonnative and invasive weeds will decrease. It should be noted that active bird nests are preventing weed abatement from occurring in portions of this mitigation area. Work will resume in these areas once the nests have fledged or have been deemed inactive by a qualified avian biologist.

Nonnative weed cover ranged from approximately 5 percent to 40 percent in the various mitigation areas. During the monitoring visit, some of the weed growth observed within the mitigation areas was mostly vegetative and was not flowering or seeding; however, species that were observed to be in flower should be removed prior to seed production. Regular maintenance and removal of nonnative weeds is of the highest priority for all of the mitigation areas and side slopes to reduce competition between native and

nonnative plants. A focus should be placed on removing the weeds and nonnatives from the basins of each of the container plants and cuttings; however, nonnative weeds just outside of the planting areas can migrate into the planting areas via seed dispersal. Outside of the nesting bird season, a focus should also be made to remove nonnative weeds in areas where least Bell's vireos are likely to nest during the breeding season (i.e., in the vicinity of the least Bell's vireo nest that was active in 2020). Nonnative plants and weeds that have gone to seed should be bagged and removed from the mitigation area. Without the use of herbicides, control of the nonnatives will be extremely difficult so the frequency and level of effort will need to be increased to provide control until the native plants and seedlings have a chance to grow and outcompete the nonnatives. In particular, it is important to maintain long-term perennial pepperweed management to reduce competition and allow native plants to germinate. In addition, dodder should be removed from container plants in the mitigation areas. Although many species of dodder are native, this parasitic plant can be harmful to younger shrubs and trees that are not yet established and can even cause mortality.

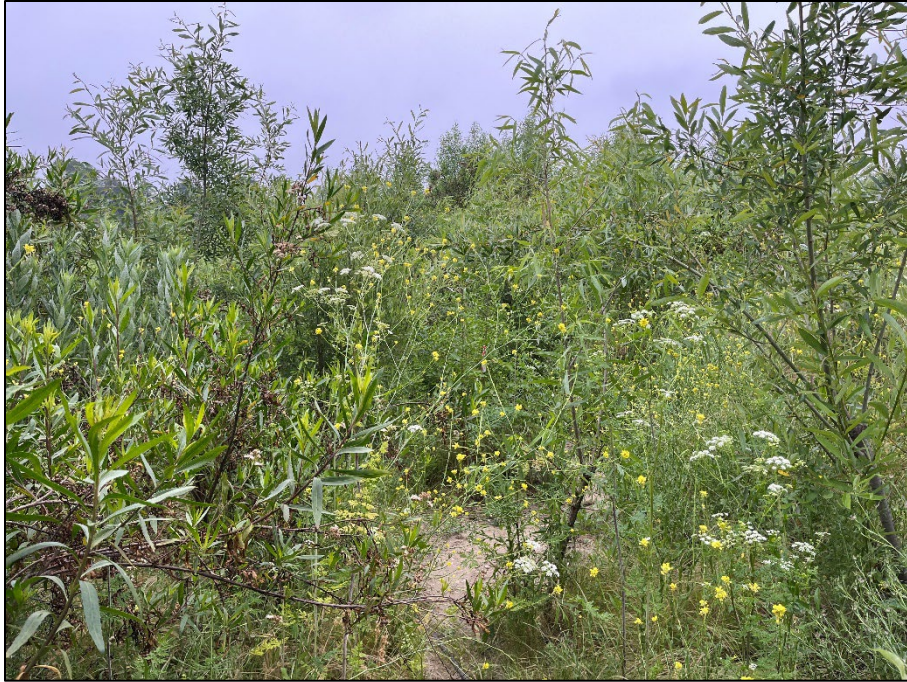
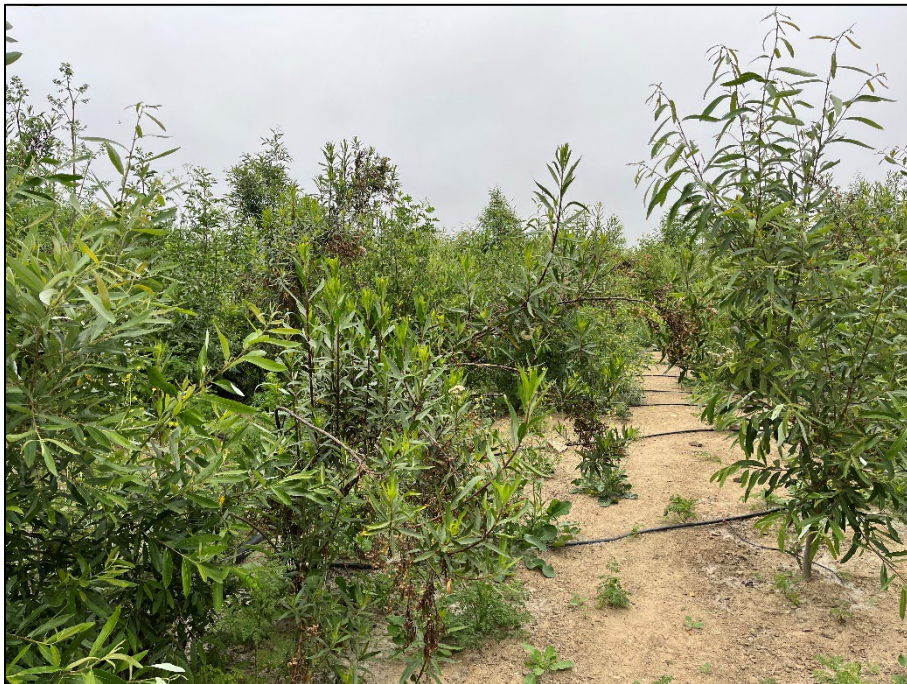
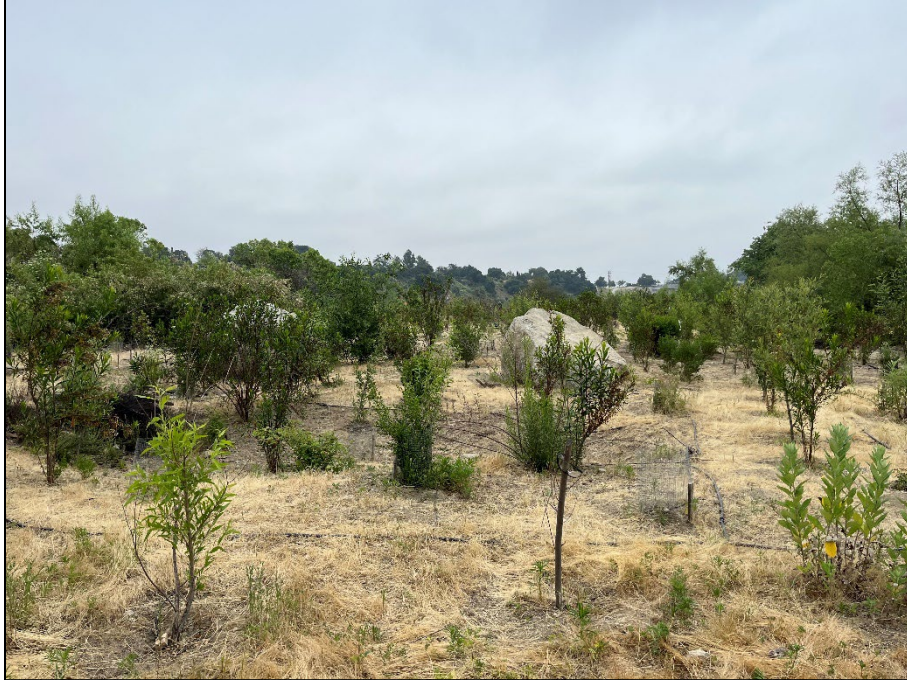
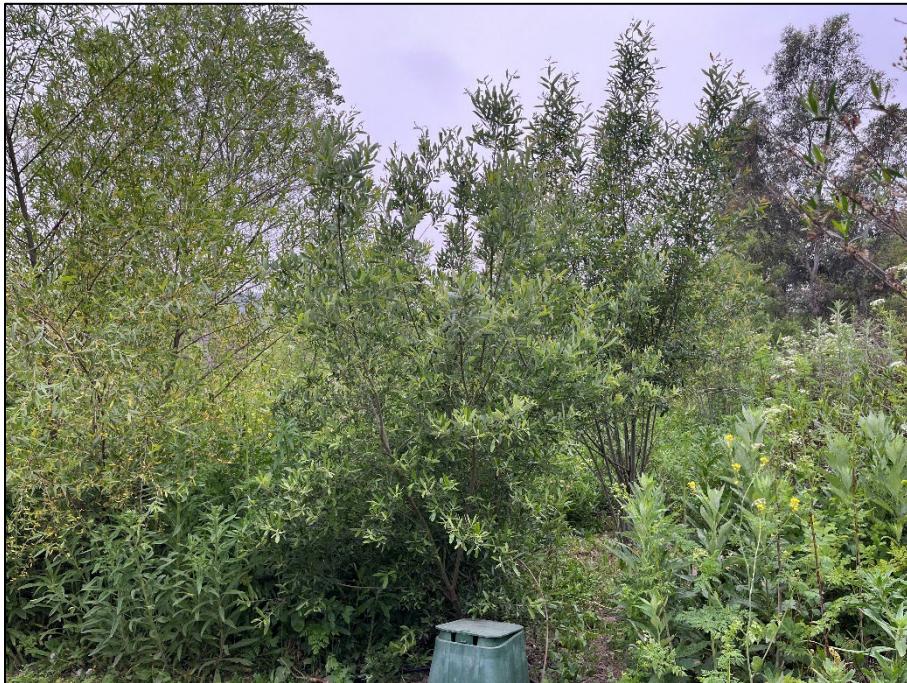
Photo 5. Overview DG-4A

The overall health of the container plants in DG-4A was noted as being good. Approximately 5 percent of the container plants and stakes in DG-4A were noted as showing signs of stress and a negligible amount were noted as being dead or missing. Approximately the same percentage of plants were showing signs of stress during the previous monitoring visit. This included the remaining container plants from the first installation and the replacement container plants that were installed to replace the container plants and stakes planted in the middle section of DG-4A that appeared to be dead or in a condition unlikely to recover during previous monitoring visits. Stress may be occurring due to similar reasons described for DG-4 WOUS and DG-4 WOUS Connections. Formal mortality counts will be taken for DG-4A during the 2024 quantitative monitoring and will be included in the 2024 annual reporting. The majority of the recently planted mulefat and willow stakes were noted as showing signs of new growth. Some of the container plants were noted as lacking well defined basins and should have their basins properly constructed and/or repaired. The installation of plants in the DG-4A mitigation area appears to have been completed successfully and the installation of the replacement container plants should increase native cover. The current issues identified during the monitoring visit are not expected to have an effect on the continued growth of the plants in the mitigation area. Photos 5 through 8 in Appendix B document the mitigation area during the monitoring visit.

Nonnative weed cover in the DG-4A mitigation area ranged from approximately 5 to 30 percent during the monitoring visit, depending on the section of DG-4A, which is approximately 5 percent higher than what was observed during the previous monitoring visit. Nonnative species observed included black

mustard, tocalote (*Centaurea melitensis*), poison hemlock, perennial pepperweed, and annual yellow sweetclover (*Melilotus indicus*). Many of the nonnative weeds observed in this mitigation area, including black mustard and poison hemlock were going to flower and should be removed before they go to seed. In addition, some of the mitigation areas adjacent to DG-4A have weeds that are going to flower that should be removed before they go to seed. As weed abatement continues in the mitigation areas, it is anticipated that the seed bank of nonnative and invasive weeds will decrease; however, perennial pepperweed easily resprouts from rhizomatous roots that can be difficult to fully remove with hand tools. It should be noted that active bird nests are preventing weed abatement from occurring in portions of this mitigation area. Work will resume in these areas once the nests have fledged or have been deemed inactive by a qualified avian biologist.

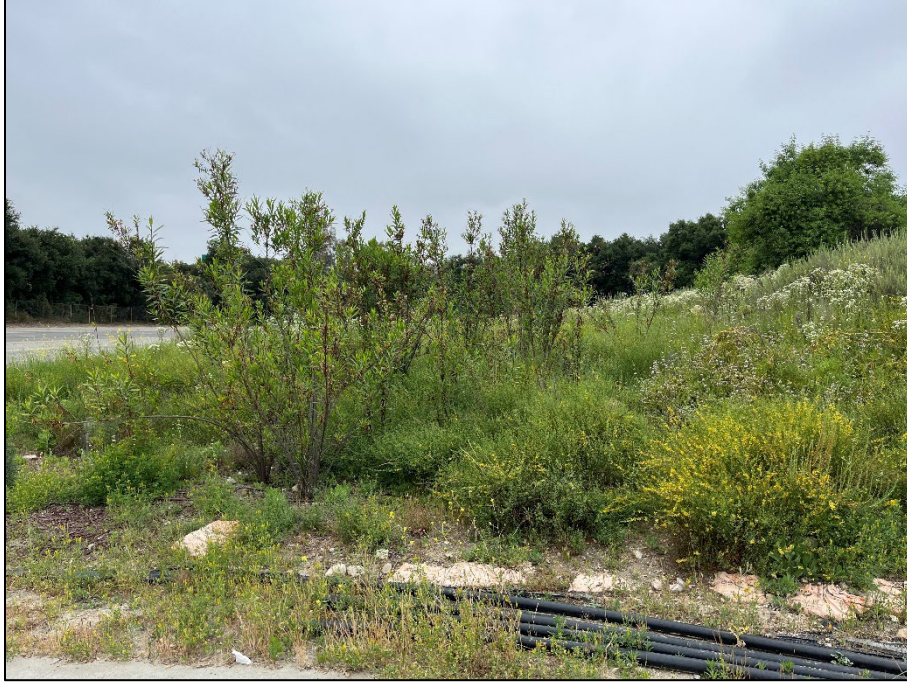
Photo 9: Overview Tire Wash

The overall health of the container plants in the Tire Wash mitigation area was noted as being good. Approximately 5 percent of the container plants were noted as showing varied levels of stress, which is approximately the same percentage of plants that were showing stress during the previous monitoring visit. This included the remaining container plants from the first installation and the replacement container plants that were installed to replace the container plants that were either missing or appeared to be dead or in a condition unlikely to recover during previous monitoring visits. Most of the stress was observed on the recently installed container plants. Stress may be occurring due to similar reasons described for DG-4 WOUS and DG-4 WOUS Connections. The irrigation was found to be functioning properly for this mitigation area. Formal mortality counts will be taken for the Tire Wash during the 2024 quantitative monitoring and will be included in the 2024 annual reporting. Some of the container plants were noted as lacking well defined basins and should have their basins properly constructed and/or repaired. The installation of plants in the Tire Wash mitigation area appears to have been completed successfully. The current issues identified during the monitoring visit are not expected to have an effect on the continued growth of the plants in the mitigation area. Photo 9 in Appendix B documents the mitigation area during the monitoring visit.

Nonnative weed cover in the Tire Wash mitigation area was estimated at approximately 5 percent, which is approximately 3 percent higher than the percentage of nonnative cover that was observed during the previous monitoring visit. Nonnative species observed included black mustard, red-stemmed filaree (*Erodium cicutarium*), and annual yellow sweetclover. Most of the nonnative weeds observed in this mitigation area were just starting to germinate; however, some of the black mustard was observed to be in flower. As weed abatement continues in the mitigation areas, it is anticipated that the seed bank of nonnative and invasive weeds will decrease.

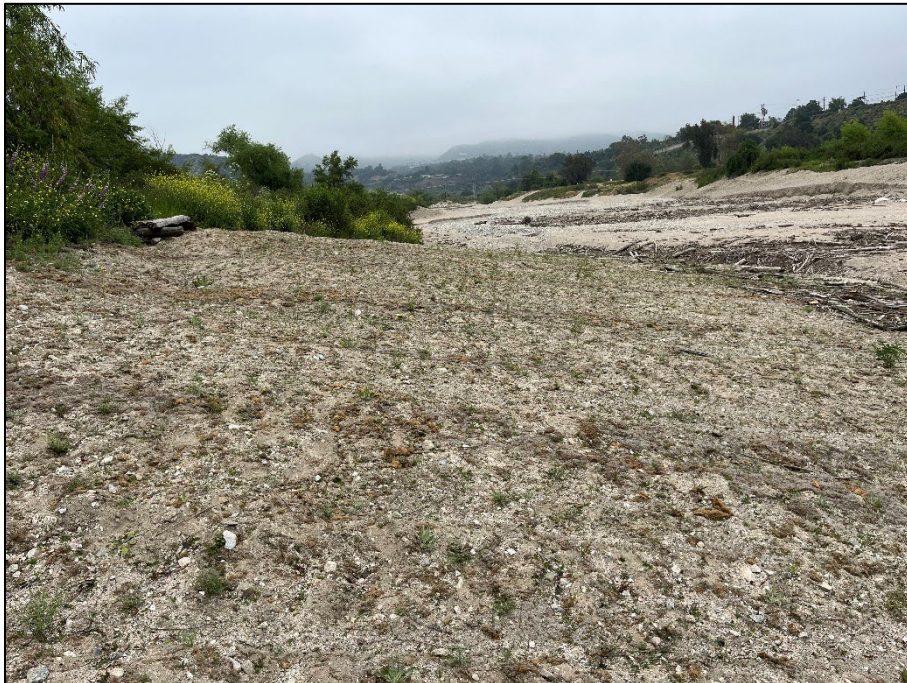
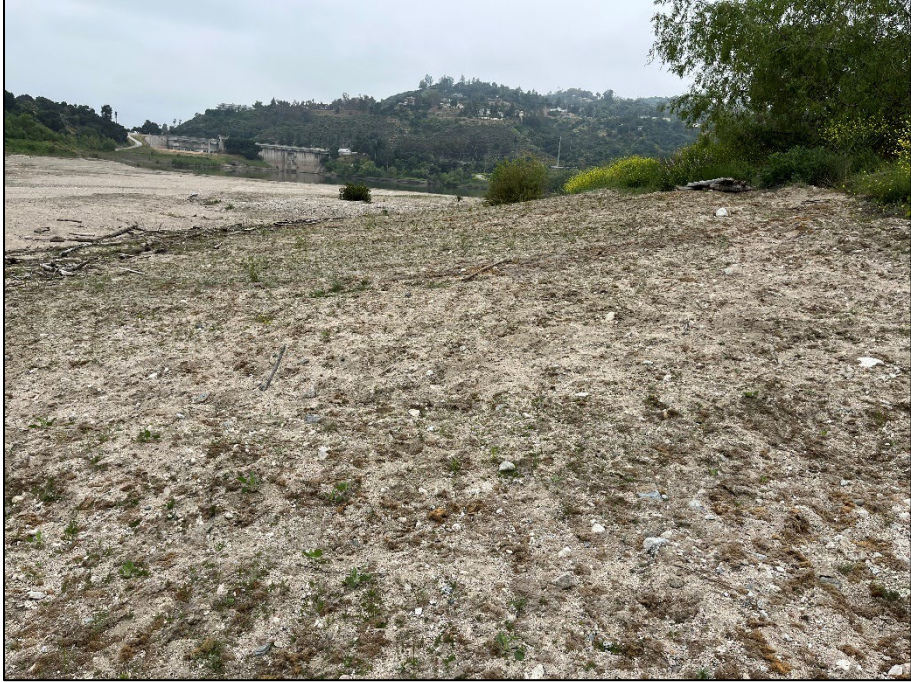
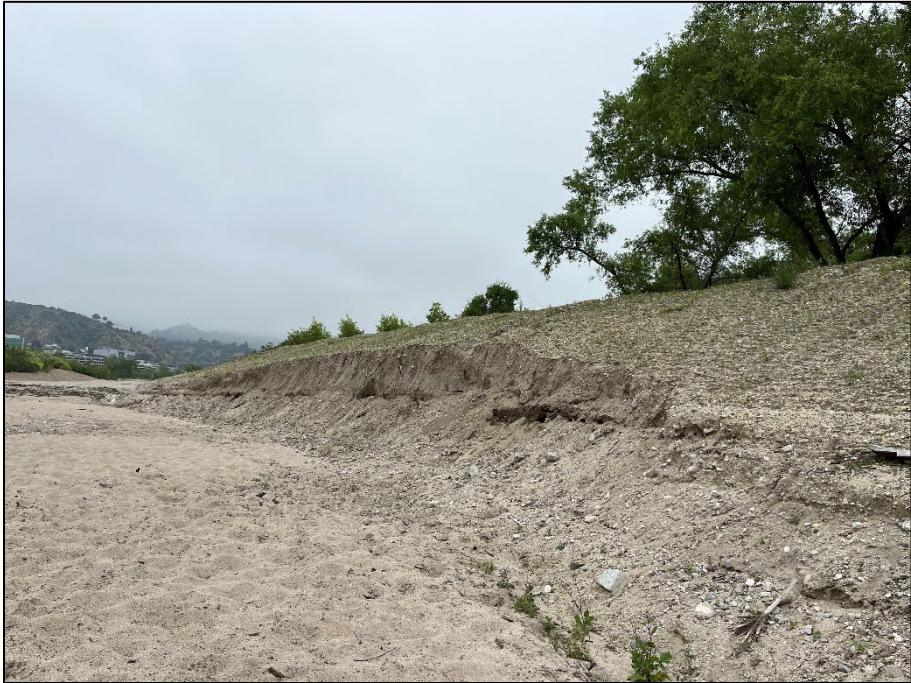
Photo 10: Overview Side Slopes

Container plants were not installed on the Side Slopes or in Flint Wash, but these areas were seeded with native plant species. Native plant growth was noted throughout the Side Slopes and Flint Wash, likely both from natural recruitment and from seeding. Portions of the Side Slopes that were previously noted as having significant erosion that occurred as a result of heavy rainfall during the 2023 wet season and following the tropical storm that occurred in late August 2023 were noted as having been repaired during previous monitoring visits and were included in the supplemental seeding effort initiated in November of 2023. During the monitoring visit, the recently hydroseeded portions of the Side Slopes where previous erosion had occurred showed very minimal germination. Lack of germination on these portions of the Side Slopes could be due to lack of soil nutrients, lack of organic matter, and/or incorrect compaction levels. Native plants such as common yarrow (*Achillea millefolium*), annual bursage (*Ambrosia acanthicarpa*), mugwort, mulefat, California brome (*Bromus sitchensis* var. *carinatus*), Canada horseweed, seep monkey flower (*Erythranthe guttata*), telegraph weed, stinging annual lupine (*Lupinus hirsutissimus*), black willow (*Salix gooddingii*), arroyo willow (*Salix lasiolepis*), and rough cocklebur (*Xanthium strumarium*) were observed sprouting on the Side Slopes and in Flint Wash. Overall native cover was estimated to be approximately 35 to 40 percent during the monitoring visit; however, the portions of the Side Slopes that were recently repaired and hydroseeded were noted as having very low cover. A portion of the Side Slopes near the southwestern extent of DG-2 WOUS that was noted as having significant erosion during the previous monitoring visit was still present and had not been repaired. Photos 10 through 12 in Appendix B document the Side Slopes during the monitoring visit.

Nonnative weed cover on the Side Slopes and Flint Wash was estimated at approximately 20 to 25 percent overall, which is approximately 10 percent higher than the level of weed cover that was observed during the previous monitoring visit. It should also be noted that the middle to southern section of the Side Slopes on the west side and Flint Wash had a higher level of nonnative weed cover that was estimated at approximately 30 to 40 percent. Nonnative species observed on the Side Slopes and Flint Wash included black mustard, poison hemlock, perennial pepperweed, annual yellow sweetclover, and wild radish. Most of the nonnative weeds observed in this mitigation area were just starting to germinate; however, some were starting to flower and will soon go to seed. These areas should be weeded prior to seed production. As weed abatement continues in the mitigation areas, it is anticipated that the seed bank of nonnative and invasive weeds will decrease; however, perennial pepperweed easily resprouts from rhizomatous roots that can be difficult to fully remove with hand tools.

Portions of the Side Slopes that were previously noted as having significant erosion that occurred as a result of heavy rainfall during the 2023 wet season and following the tropical storm that occurred in late August 2023 were noted as having been repaired during previous monitoring visits and were included in the supplemental seeding effort which was completed in November of 2023. Some additional erosion was observed at the toe of the Side Slopes in these areas and has the potential to worsen. In addition, one area of severe erosion that was noted on the eastern Side Slopes at the southwestern extent of DG-2 WOUS during the previous monitoring visit was still present and had not been repaired. As more

perennial plants become established on the Side Slopes, erosion should become less of an issue; however, action will need to be taken to repair the damage caused by the erosion and measures should be taken to reduce damage from erosion in the future. In addition, if the supplemental seeding effort does not produce germination on the previously eroded Side Slopes, adaptive management techniques will likely be warranted. During future monitoring events, erosion should continue to be monitored in all planted areas and if warranted, erosion Best Management Practices should be installed in appropriate areas. This may only require the installation of straw wattles at select sites to prevent existing rills from becoming larger.
