November 19, 2024
(2023-005.07)

Re: *Devil's Gate Reservoir Restoration Project – Phase 3 Restoration Qualitative Monitoring Conducted on October 16, 2024*

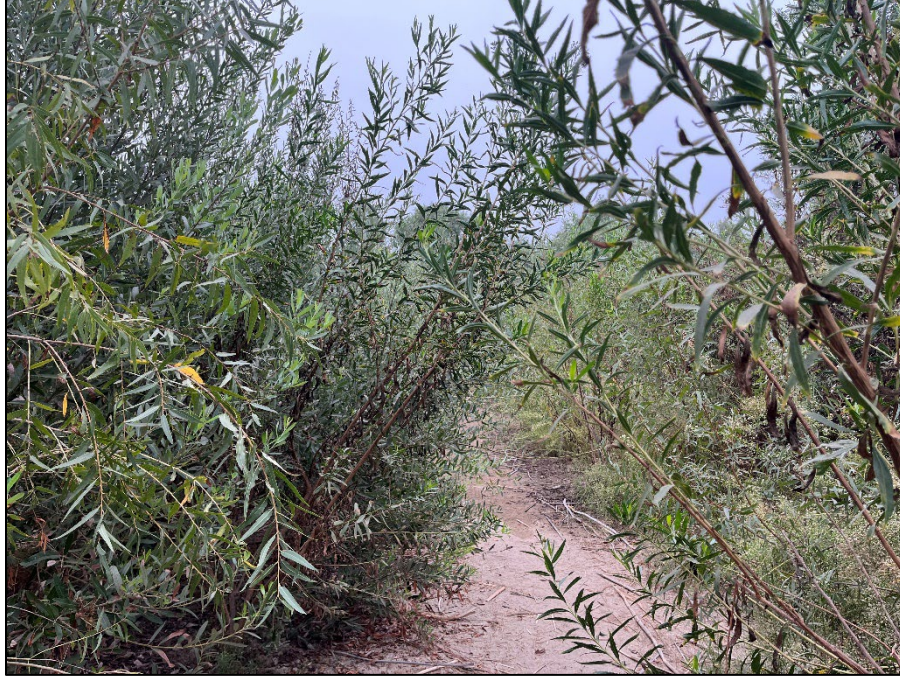
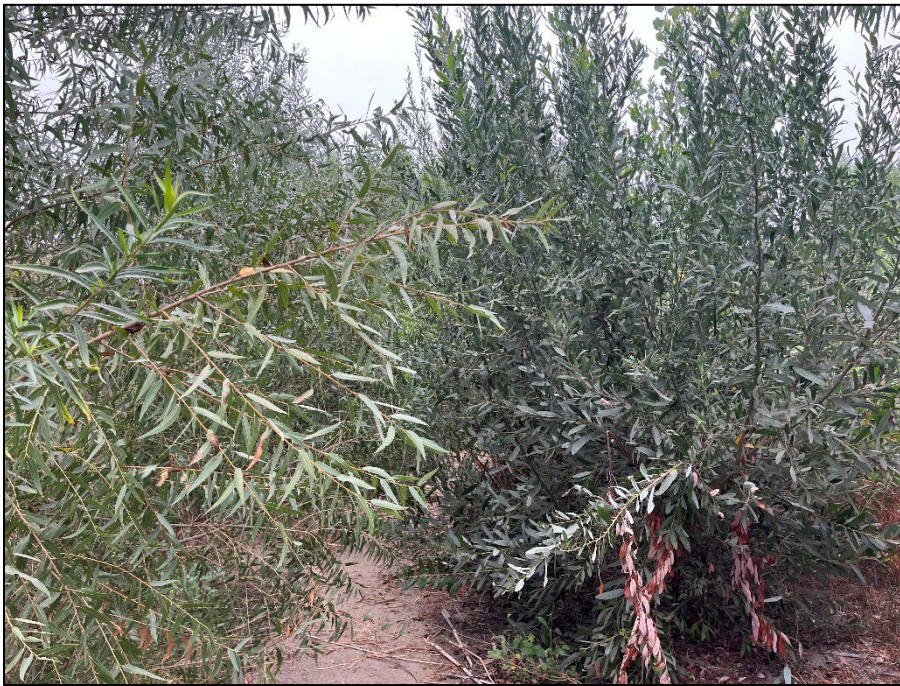
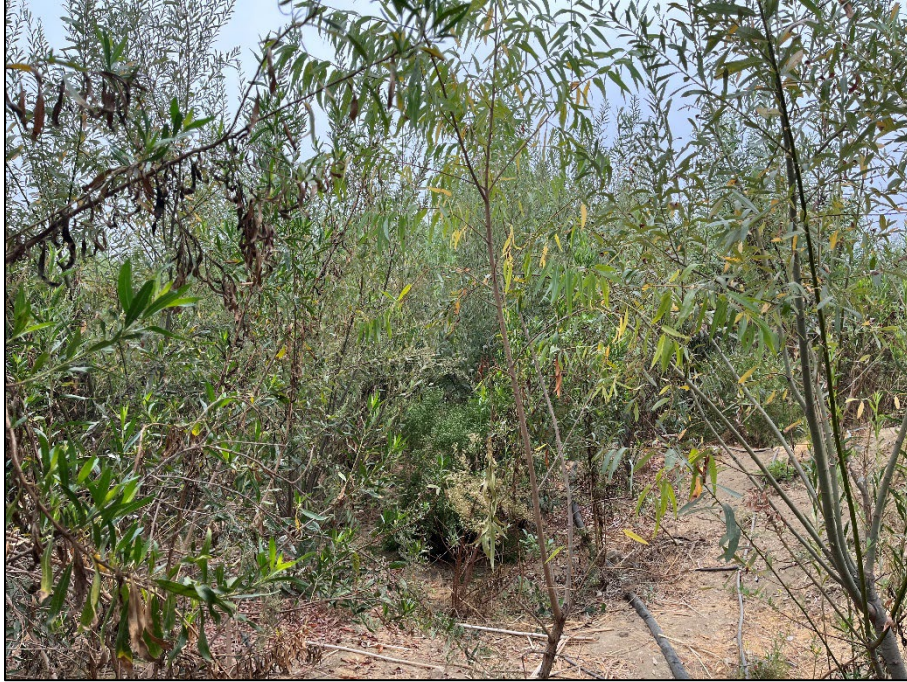
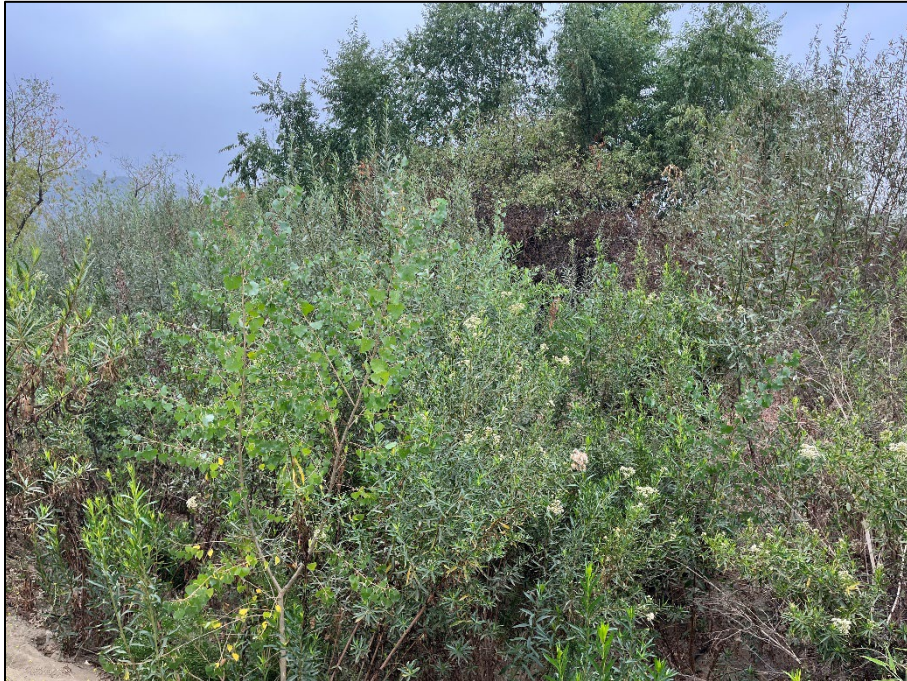
The overall health of the container plants in DG-4 WOUS and DG-4 WOUS Connections was noted as being good. Approximately 5 percent of the container plants and stakes in DG-4 WOUS and DG-4 WOUS Connections were noted as showing signs of stress and a negligible amount were noted as being dead or missing. This is approximately the same percentage of plants that were showing stress during the previous monitoring visit. Stress may be occurring as a result of 1) transplant shock, 2) herbivory by rabbits or other wildlife, 3) competition from nonnative and invasive weeds, 4) misplaced emitters, or 5) recreational traffic through the mitigation areas. The majority of the recently planted mulefat (*Baccharis salicifolia*) and willow stakes were noted as showing signs of new growth. Photos 1 through 4 in Appendix B document the mitigation areas during the monitoring visit.

Photo 1. Overview DG-4 WOUS & WOUS Connections

Photo 2. Overview DG-4 WOUS & WOUS Connections

Photo 3. Overview DG-4 WOUS & WOUS Connections

Photo 4. Overview DG-4 WOUS & WOUS Connections

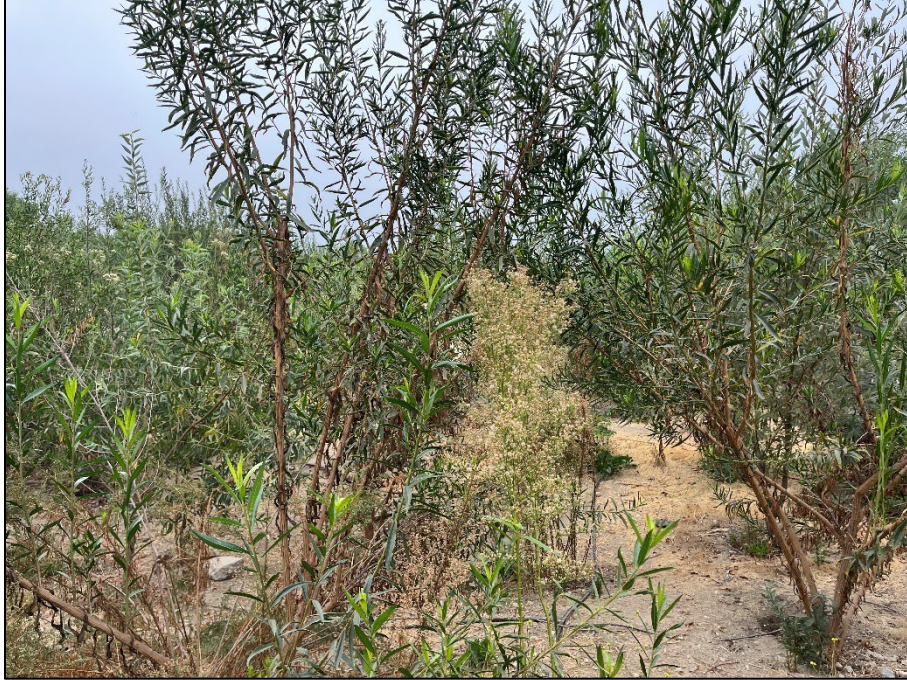
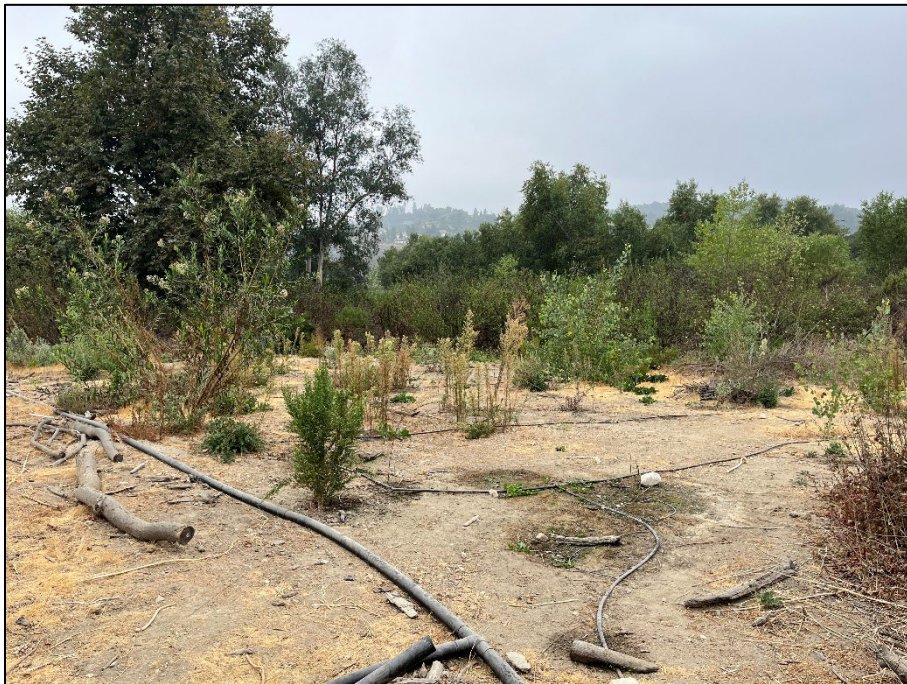
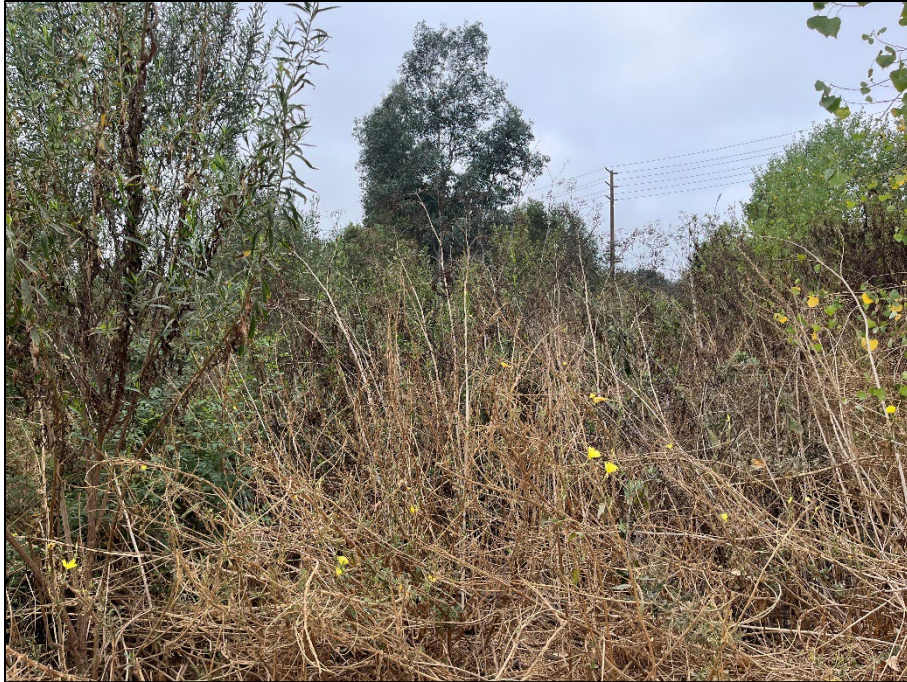
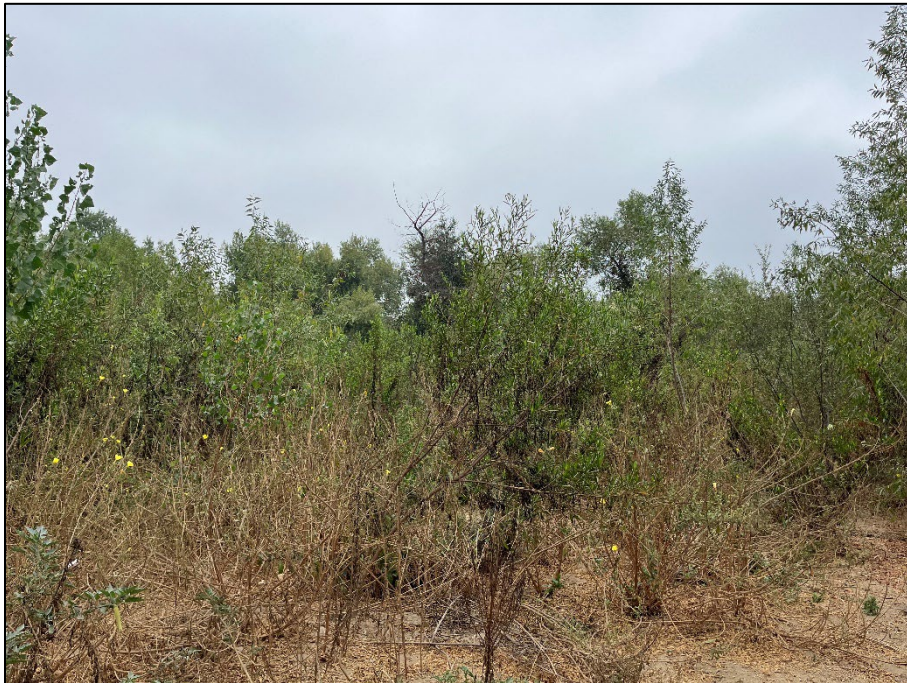
The overall health of the container plants in DG-4A was noted as being good and this mitigation area is becoming well established. Approximately 5 percent of the container plants and stakes in DG-4A were noted as showing signs of stress and a negligible amount were noted as being dead or missing. Approximately the same percentage of plants were showing signs of stress during the previous monitoring visit. This included the remaining container plants from the first installation and the container plants that were installed to replace the container plants and stakes planted in the middle section of DG-4A that appeared to be dead or in a condition unlikely to recover during previous monitoring visits. Stress may be occurring due to similar reasons described for DG-4 WOUS and DG-4 WOUS Connections. The majority of the recently planted mulefat and willow stakes were noted as showing signs of new growth. Some of the container plants were noted as lacking well defined basins and should have their basins properly constructed and/or repaired. Photos 5 through 8 in Appendix B document the mitigation area during the monitoring visit.

Photo 5. Overview DG-4A

Photo 6. Overview DG-4A

Photo 7: Overview DG-4A

Photo 8: Overview DG-4A

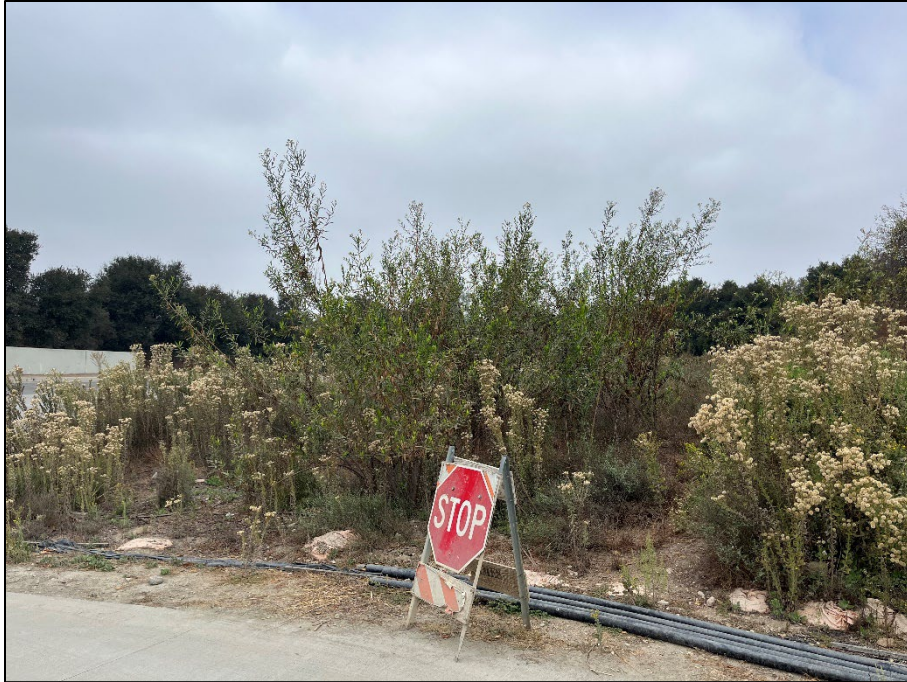
The overall health of the container plants in the Tire Wash mitigation area was noted as being good. Approximately 5 percent of the container plants were noted as showing varied levels of stress, which is approximately the same percentage of plants that were showing stress during the previous monitoring visit. This included the remaining container plants from the first installation and the replacement container plants that were installed to replace the container plants that were either missing or appeared to be dead or in a condition unlikely to recover during previous monitoring visits. Most of the stress was observed on the recently installed container plants. Stress may be occurring due to similar reasons described for DG-4 WOUS and DG-4 WOUS Connections. In addition, some of the container plants are being smothered by deerweed (*Acemison glaber*) which is proliferating in this area. The irrigation was found to be functioning properly for this mitigation area. Photo 9 in Appendix B documents the mitigation area during the monitoring visit.

Photo 9: Overview Tire Wash

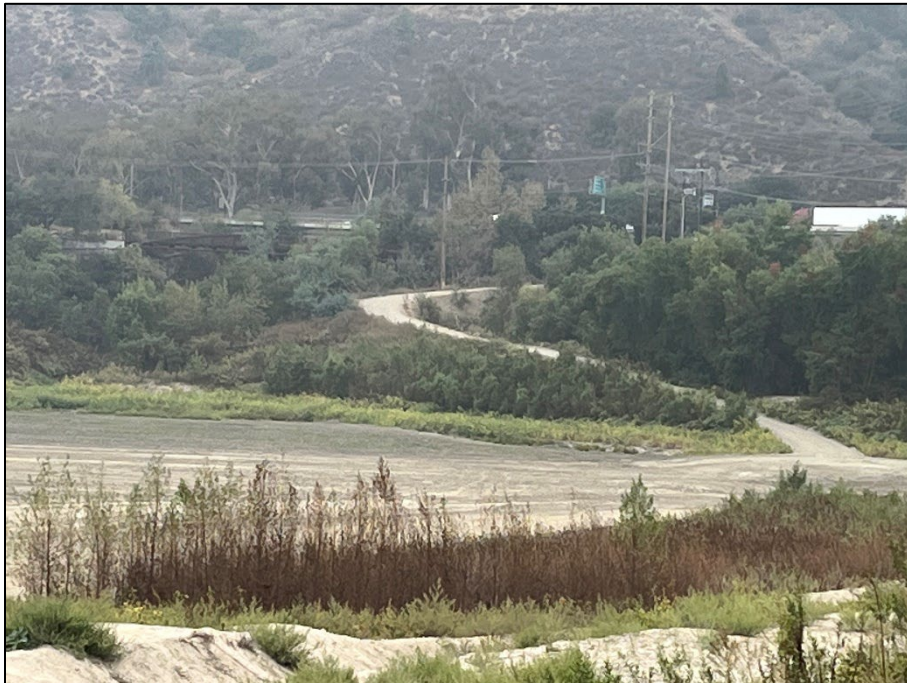
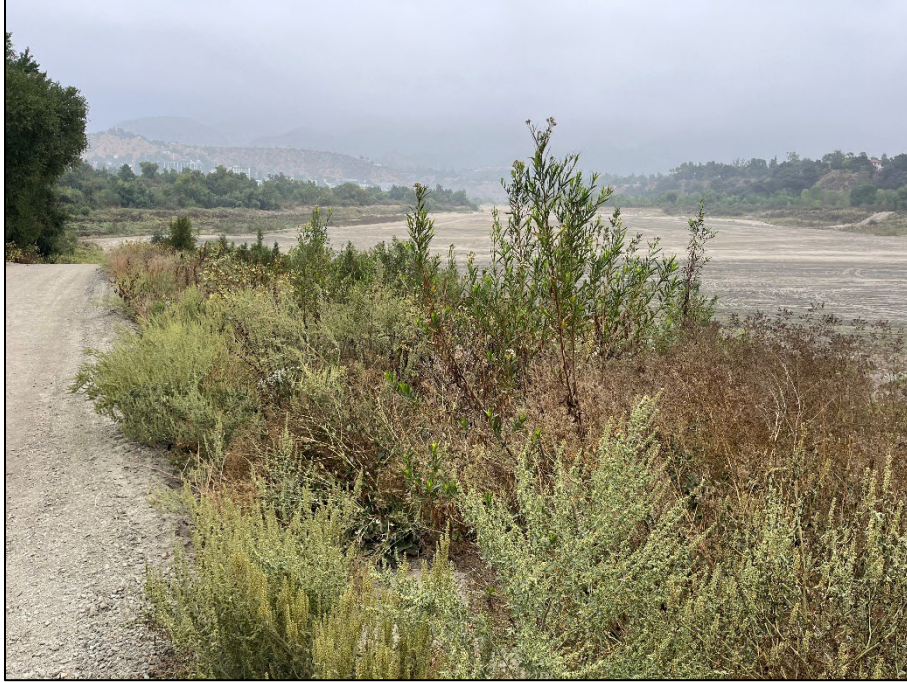
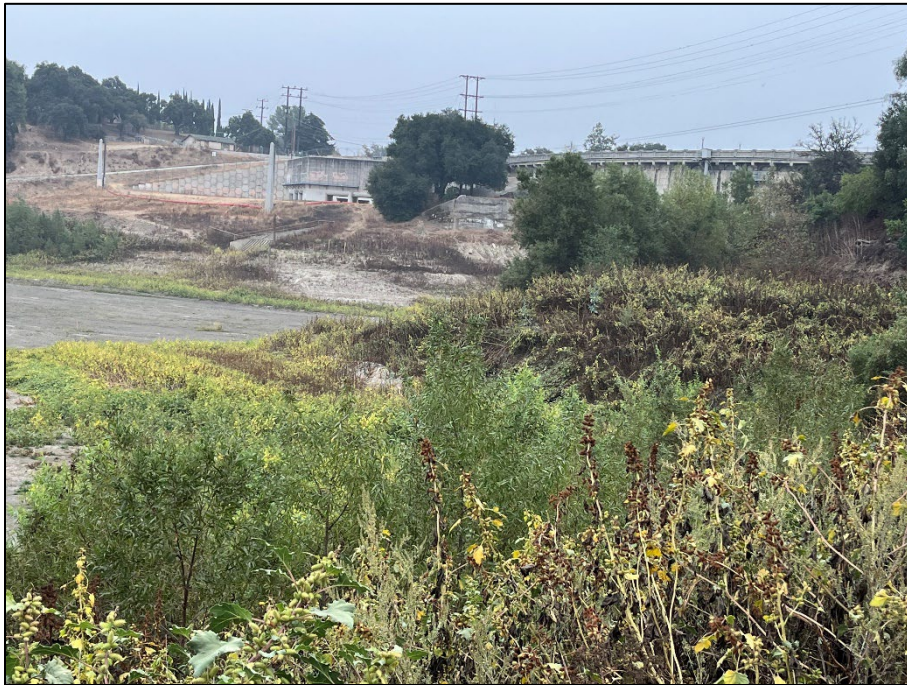
native cover was estimated to be approximately 45 percent during the monitoring visit; however, the portions of the Side Slopes that were recently repaired and hydroseeded were noted as having very low cover. A portion of the Side Slopes near the southwestern extent of DG-2 WOUS that was noted as having significant erosion during the previous monitoring visit was still present and had not been repaired. Photos 10 through 12 in Appendix B document the Side Slopes during the monitoring visit.

Photo 10: Overview Side Slopes

Photo 11: Overview Side Slopes

Photo 12: Overview Side Slopes

Portions of the Side Slopes that were previously noted as having significant erosion that occurred as a result of heavy rainfall during the 2023 wet season and following the tropical storm that occurred in late August 2023 were noted as having been repaired during previous monitoring visits and were included in the supplemental seeding effort which was completed in November of 2023. Some additional erosion was observed at the toe of the Side Slopes in these areas and has the potential to worsen. In addition, one area of severe erosion that was noted on the eastern Side Slopes at the southwestern extent of DG-2 WOUS during the previous monitoring visit was still present and had not been repaired. As more perennial plants become established on the Side Slopes, erosion should become less of an issue; however, action will need to be taken to repair the damage caused by the erosion and measures should be taken to reduce damage from erosion in the future. In addition, if the supplemental seeding effort does not produce germination on the previously eroded Side Slopes, adaptive management techniques will likely be warranted. During future monitoring events, erosion should continue to be monitored in all planted areas and if warranted, erosion Best Management Practices should be installed in appropriate areas. This may only require the installation of straw wattles at select sites to prevent existing rills from becoming larger.
