March 5, 2024  
2023-005.07

**Re: *Devil's Gate Reservoir Restoration Project – Phase 3 Restoration Qualitative Monitoring Conducted on January 30, 2024***

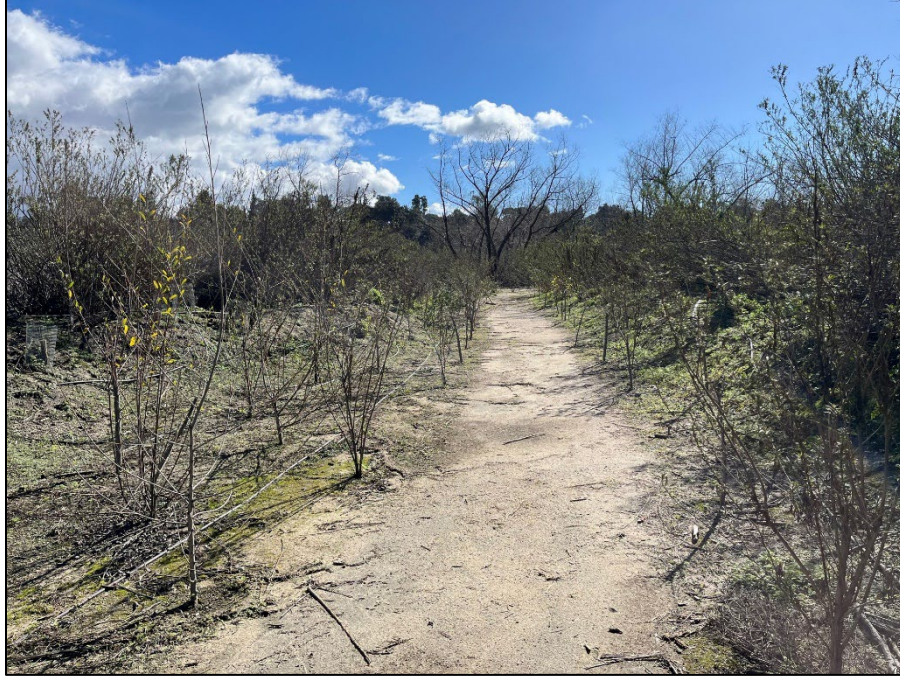
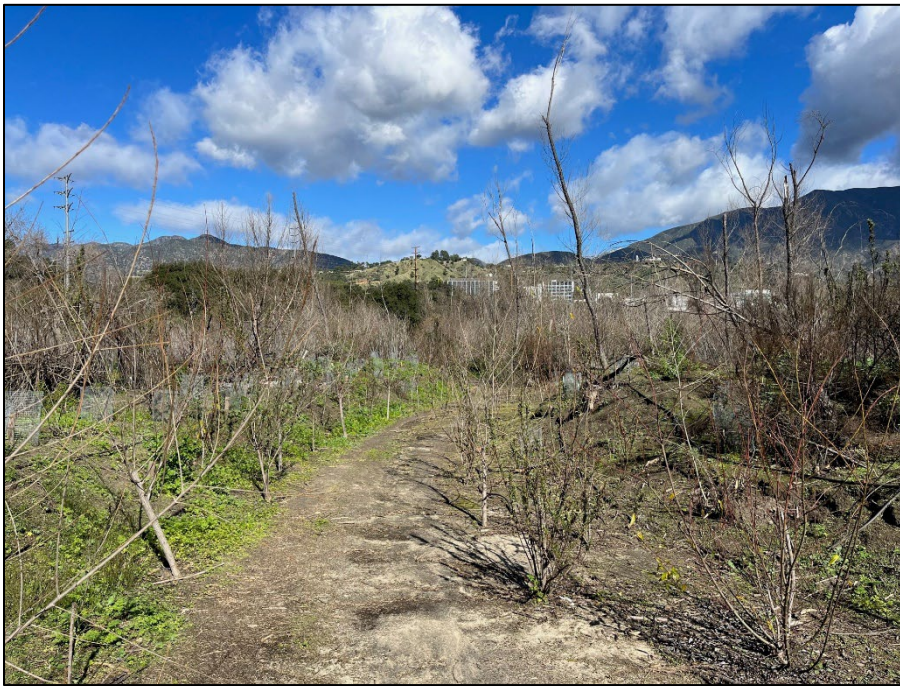
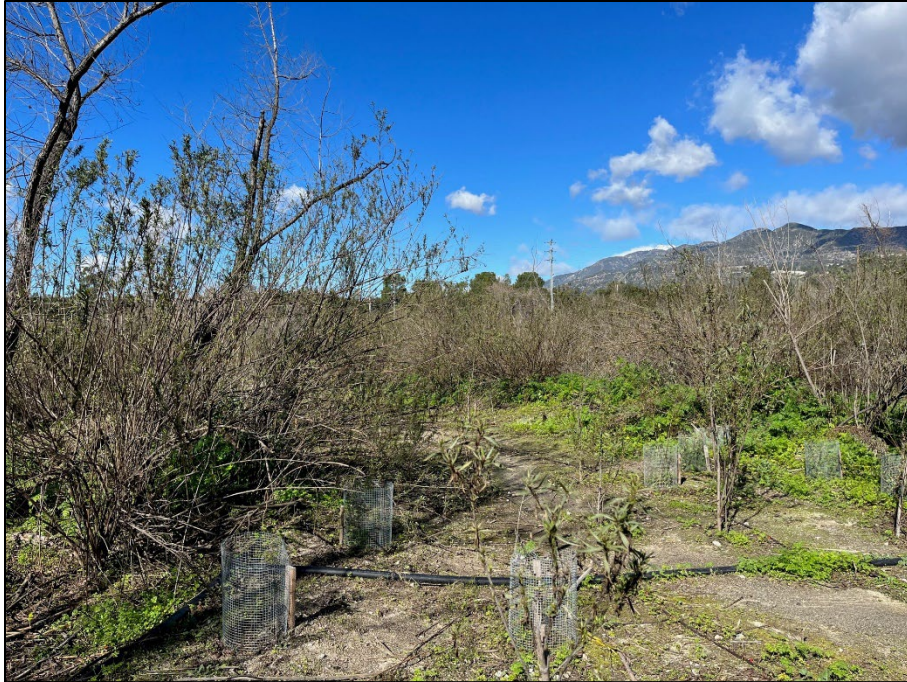
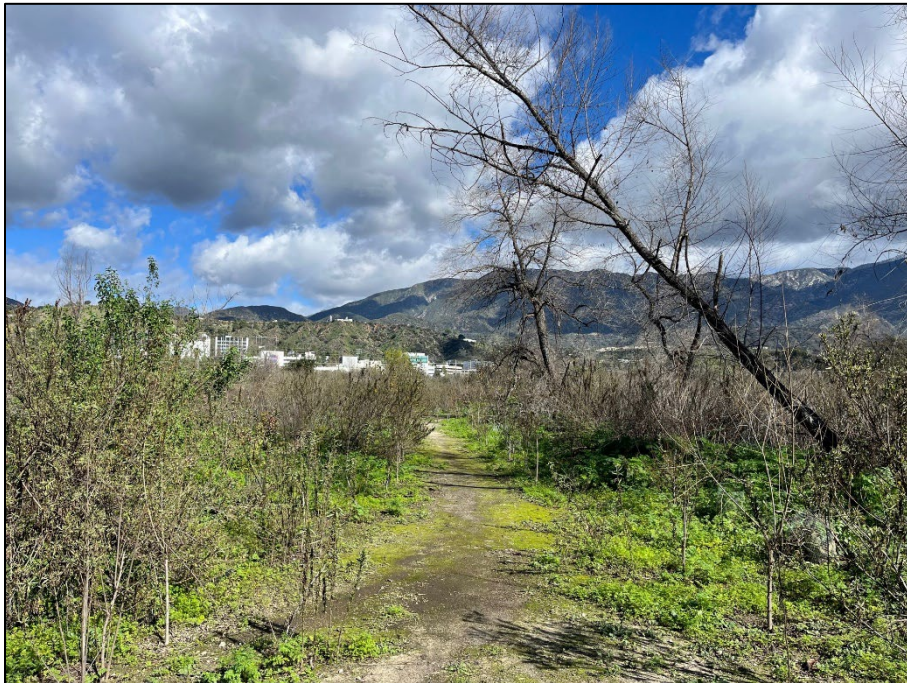
The overall health of the container plants in DG-4 WOUS and DG-4 WOUS Connections was noted as being good; however, some were starting to show signs of seasonal dieback. A negligible percentage of the container plants and stakes in DG-4 WOUS and DG-4 WOUS Connections were noted as showing signs of stress and a negligible amount were noted as being dead or missing. This is slightly lower than the percentage of plants that were showing stress during the previous monitoring visit. Stress may be occurring as a result of 1) transplant shock, 2) herbivory by rabbits or other wildlife, 3) competition from nonnative and invasive weeds, 4) misplaced emitters, or 5) recreational traffic through the mitigation areas. Formal mortality counts will be taken for DG-4 WOUS and DG-4 WOUS Connections during the 2024 quantitative monitoring and will be included in the 2024 annual reporting. The majority of the recently planted mulefat (*Baccharis salicifolia*) and willow (*Salix* spp.) stakes were noted as showing signs of new growth; however, some were starting to show signs of seasonal dieback. Some of the container plants were noted as lacking well defined basins and should have their basins properly constructed and/or repaired. The installation of plants in the DG-4 WOUS and DG-4 WOUS Connections mitigation areas appears to have been completed successfully. The current issues identified during the monitoring visit are not expected to have an effect on the continued growth of the plants in the mitigation area. Photos 1 through 4 in Appendix B document the mitigation areas during the monitoring visit.

Nonnative weed cover in DG-4 WOUS and DG-4 WOUS Connections was estimated at approximately 15 to 20 percent, which is approximately 5 percent higher than what was observed during the previous monitoring visit. Nonnative species observed included black mustard (*Brassica nigra*), poison hemlock (*Conium maculatum*), and wand mullein (*Verbascum virgatum*). Most of the nonnative weeds observed in these mitigation areas were just starting to germinate and were not going to flower or seed. As weed abatement continues in the mitigation areas, it is anticipated that the seed bank of nonnative and invasive weeds will decrease. It should be noted that active bird nests are preventing weed abatement from occurring in portions of this mitigation area. Work will resume in these areas once the nests have fledged or have been deemed inactive by a qualified avian biologist.

Photo 1. Overview DG-4 WOUS & WOUS Connections

Photo 2. Overview DG-4 WOUS & WOUS Connections

Photo 3. Overview DG-4 WOUS & WOUS Connections

Photo 4. Overview DG-4 WOUS & WOUS Connections

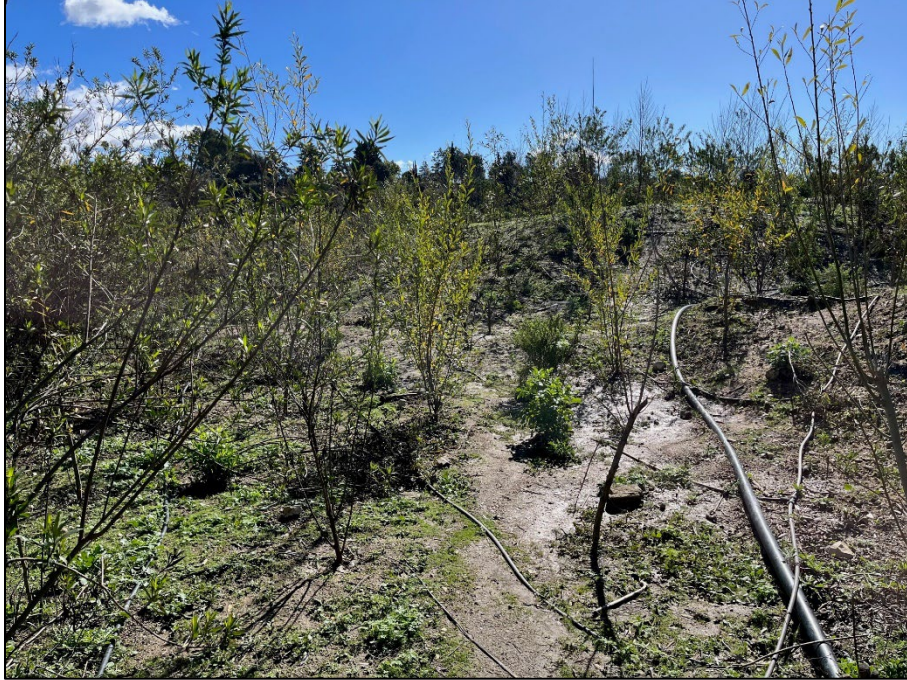
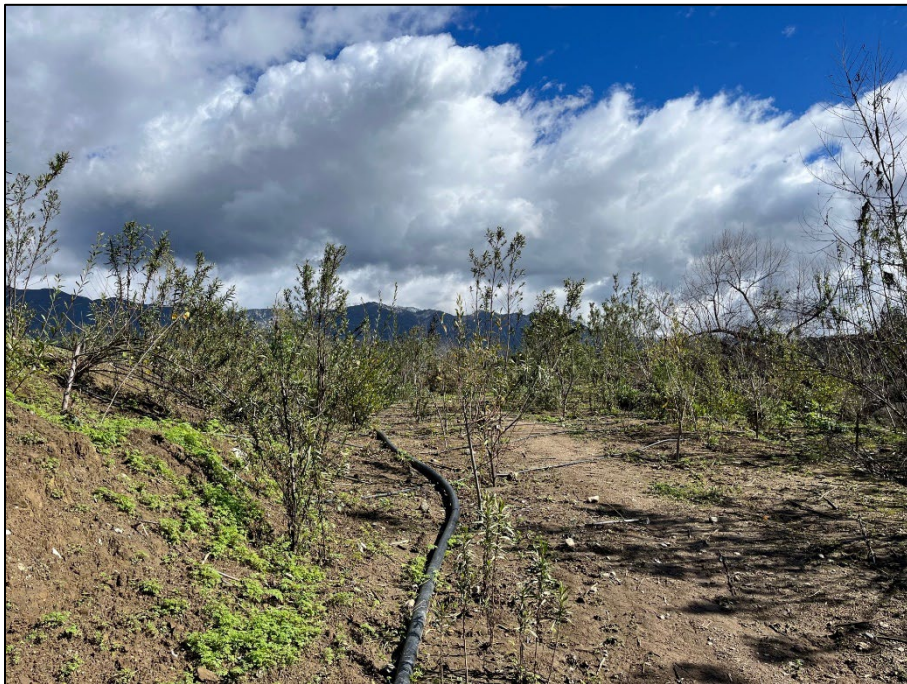
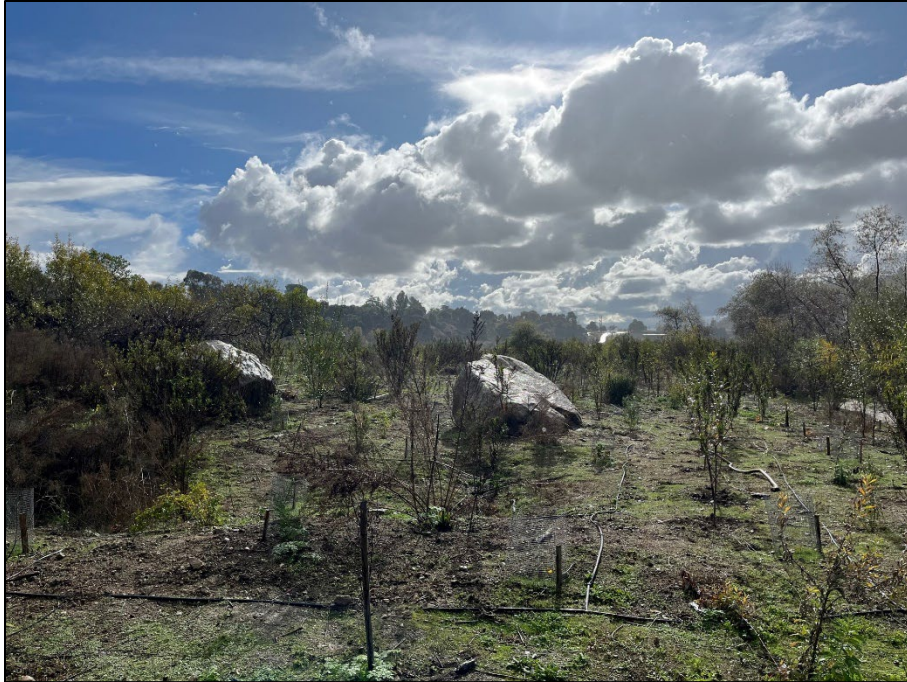
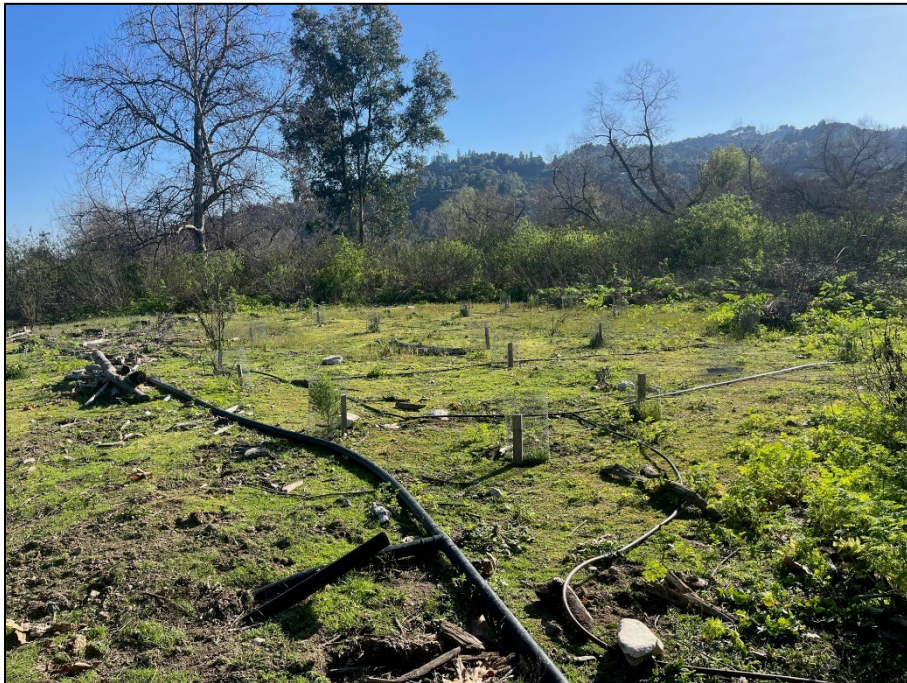
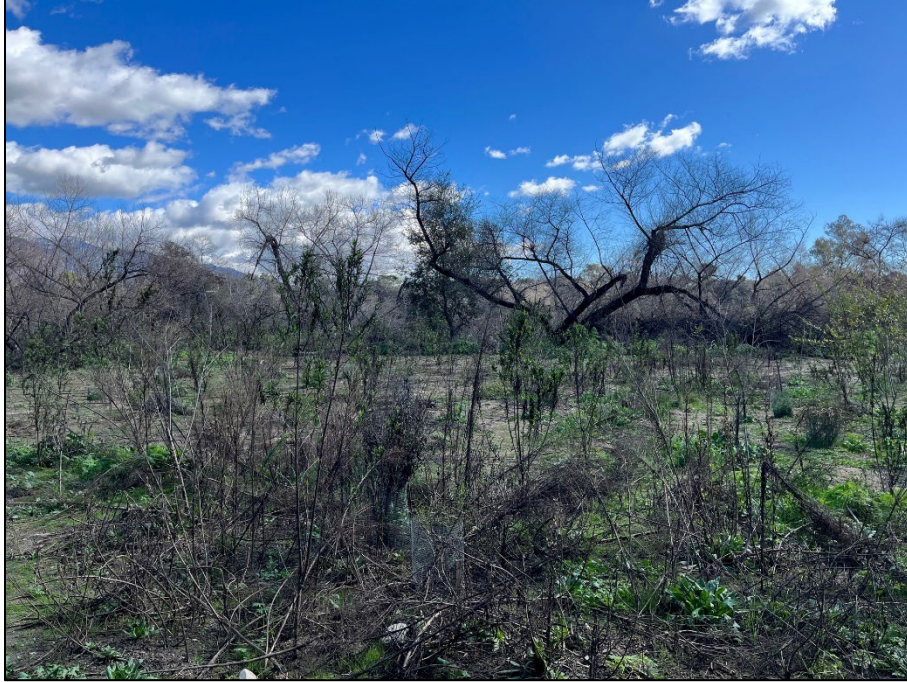
The overall health of the container plants in DG-4A was noted as being good; however, some were starting to show signs of seasonal dieback. Approximately less than 10 percent of the container plants and stakes were noted as showing signs of stress and a negligible amount were noted as being dead or missing. This is approximately the same percentage of plants that were showing stress during the previous monitoring visit. This included the remaining container plants from the first installation and the replacement container plants that were installed to replace the container plants and stakes planted in the middle section of DG-4A that appeared to be dead or in a condition unlikely to recover during previous monitoring visits. Stress may be occurring due to similar reasons described for DG-4 WOUS and DG-4 WOUS Connections. It should also be noted that a portion of DG-4A was inundated for two short periods of time during January and February of 2023; however, the inundation does not appear to have contributed to higher levels of stress or mortality in these areas. Formal mortality counts will be taken for DG-4A during the 2024 quantitative monitoring and will be included in the 2024 annual reporting. Some of the container plants were noted as lacking well defined basins and should have their basins properly constructed and/or repaired. The installation of plants in the DG-4A mitigation area appears to have been completed successfully and the installation of the replacement container plants should increase native cover. The current issues identified during the monitoring visit are not expected to have an effect on the continued growth of the plants in the mitigation area. Photos 5 through 9 in Appendix B document the mitigation area during the monitoring visit.

Nonnative weed cover in the DG-4A mitigation area ranged from approximately 10 to 20 percent during the monitoring visit which is approximately 5 percent higher than what was observed during the previous monitoring visit. Nonnative species observed included black mustard, poison hemlock, and perennial pepperweed (*Lepidium latifolium*). Most of the nonnative weeds observed in this mitigation area were just starting to germinate. As weed abatement continues in the mitigation areas, it is anticipated that the seed bank of nonnative and invasive weeds will decrease; however, perennial pepperweed easily resprouts from rhizomatous roots that can be difficult to fully remove with hand tools.

Photo 5. Overview DG-4A

Photo 6. Overview DG-4A

Photo 7: Overview DG-4A

Photo 8: Overview DG-4A

Photo 9: Overview DG-4A

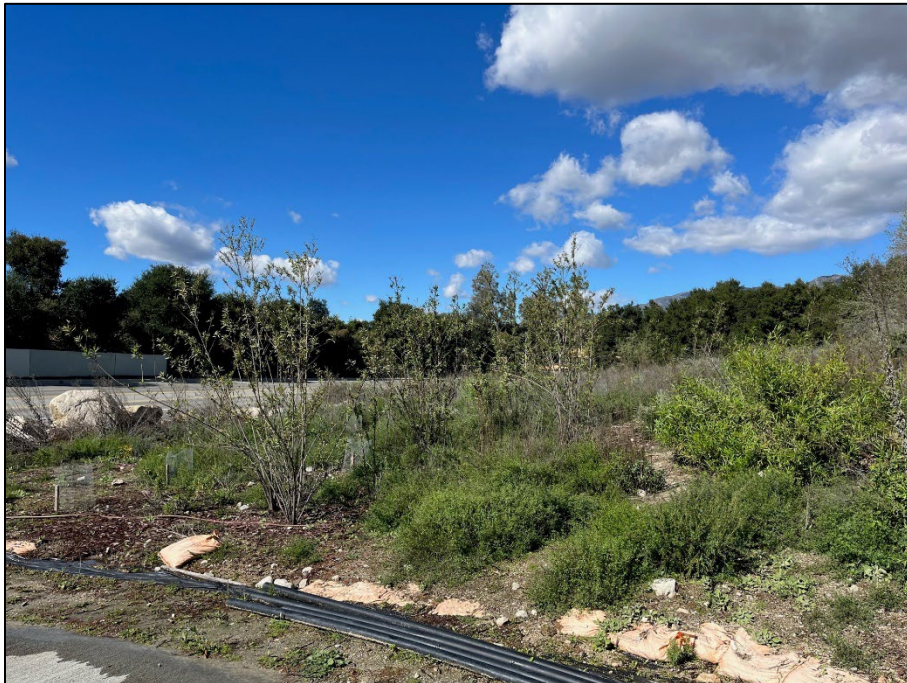
The overall health of the container plants in the Tire Wash mitigation area was noted as being good. Approximately 5 percent of the container plants were noted as showing varied levels of stress, which is approximately the same percentage of plants that were showing stress during the previous monitoring visit. This included the remaining container plants from the first installation and the replacement container plants that were installed to replace the container plants that were either missing or appeared to be dead or in a condition unlikely to recover during previous monitoring visits. Stress may be occurring due to similar reasons described for DG-4 WOUS and DG-4 WOUS Connections. Formal mortality counts will be taken for the Tire Wash during the 2024 quantitative monitoring and will be included in the 2024 annual reporting. Some of the container plants were noted as lacking well defined basins and should have their basins properly constructed and/or repaired. The installation of plants in the Tire Wash mitigation area appears to have been completed successfully. The current issues identified during the monitoring visit are not expected to have an effect on the continued growth of the plants in the mitigation area. Photo 10 in Appendix B documents the mitigation area during the monitoring visit.

Nonnative weed cover in the Tire Wash mitigation area was estimated at approximately 2 percent, which is approximately 3 percent less than the percentage of nonnative cover that was observed during the previous monitoring visit. Nonnative species observed included black mustard and red-stemmed filaree (*Erodium cicutarium*). Most of the nonnative weeds observed in this mitigation area were just starting to germinate. As weed abatement continues in the mitigation areas, it is anticipated that the seed bank of nonnative and invasive weeds will decrease.

Photo 10: Overview Tire Wash

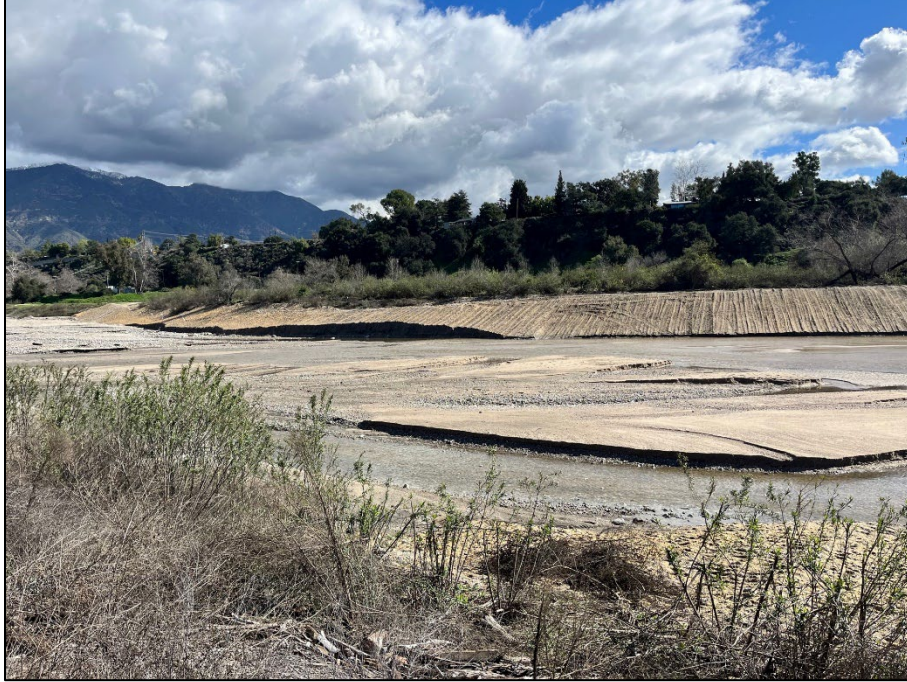
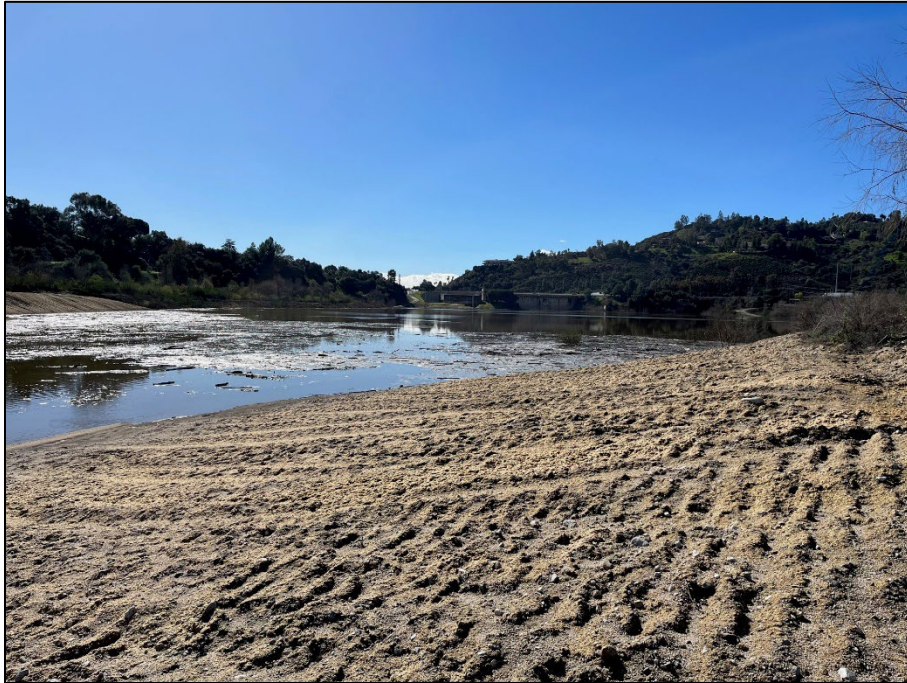
Container plants were not installed on the Side Slopes, but a portion of these areas were seeded with native plant species. Native plant growth was noted throughout the Side Slopes, likely both from natural recruitment and from seeding. Portions of the Side Slopes that were previously noted as having significant erosion that occurred as a result of heavy rainfall during the 2023 wet season and following the tropical storm that occurred in late August 2023 were noted as having been repaired during previous monitoring visits and were included in the supplemental seeding effort which was initiated in November of 2023. As of this monitoring visit, the recently hydroseeded areas showed minimal germination. Native plants such as mulefat, Phacelia, and black willow (*Salix gooddingii*) were observed sprouting on the Side Slopes. The black willow that was sprouting appeared to be coming from natural recruitment. Overall native cover was estimated to be approximately 45 percent during the monitoring visit; however, native cover in the areas without erosion was estimated to be 55 to 60 percent. Photos 11 and 12 in Appendix B document the Side Slopes during the monitoring visit.

Nonnative weed cover on the Side Slopes was estimated at approximately 10 to 15 percent, which is approximately 5 percent higher than the level of weed cover that was observed during the previous monitoring visit and portions of the Side Slopes had evidence of recent weed abatement. Nonnative species observed on the Side Slopes included black mustard, perennial pepperweed, tree tobacco (*Nicotiana glauca*), and castor bean (*Ricinus communis*). Most of the nonnative weeds observed in this mitigation area were just starting to germinate; however, some were starting to flower and will soon go to seed. These areas should be weeded prior to seed production. As weed abatement continues in the mitigation areas, it is anticipated that the seed bank of nonnative and invasive weeds will decrease; however, perennial pepperweed easily resprouts from rhizomatous roots that can be difficult to fully remove with hand tools.

Photo 11: Overview Side Slopes

Photo 12: Overview Side Slopes

Portions of the Side Slopes that were previously noted as having significant erosion that occurred as a result of heavy rainfall during the 2023 wet season and following the tropical storm that occurred in late August 2023 were noted as having been repaired during previous monitoring visits and were included in the supplemental seeding effort which was completed in November of 2023. As more perennial plants become established on the Side Slopes, erosion should become less of an issue; however, action will need to be taken to repair the damage caused by the erosion and measures should be taken to reduce damage from erosion in the future. During future monitoring events, erosion should continue to be monitored in all planted areas and if warranted, erosion Best Management Practices should be installed in appropriate areas. This may only require the installation of straw wattles at select sites to prevent existing rills from becoming larger.
