Re: *Devil's Gate Reservoir Restoration Project – Phase 1 Restoration Qualitative Monitoring Conducted on August 23, 2023*

1.0 INTRODUCTION

Qualitative monitoring was conducted by Carley Adams on August 23, 2023. Field data collected during the monitoring event is provided as Attachment A. This report documents the first biannual qualitative monitoring visit for the Phase 1 mitigation areas.

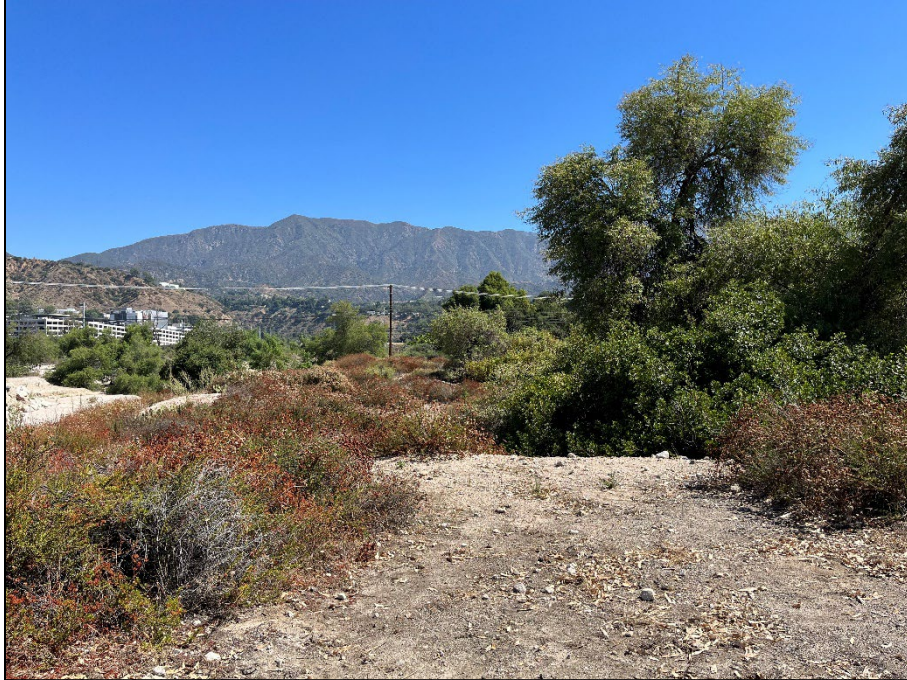
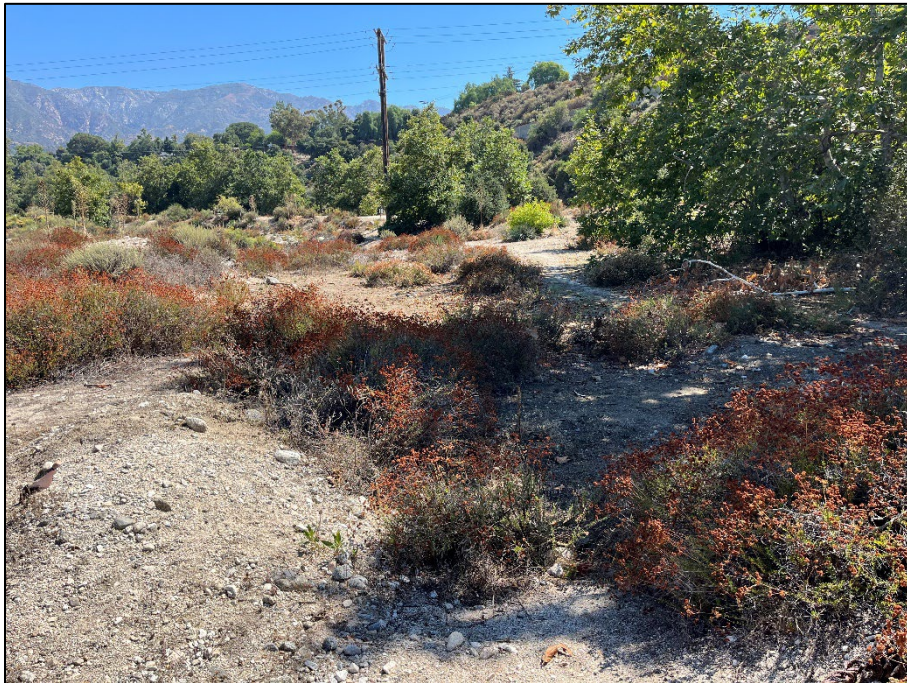
Photo 1: Overview Mitigation Area DG-1

Container plants were not installed in the DG-1 or DG-1 WOUS mitigation areas, but these areas were seeded with native plant species. Native plant growth, including perennials and annuals, was noted throughout the DG-1 and DG-1 WOUS mitigation areas, likely both from natural recruitment and from seeding; however, germination was observed to be minimal in most of these mitigation areas. Portions of DG-1 WOUS were noted as being scoured during the 2020, 2021, 2022, and 2023 wet seasons and had minimal plant growth. Native plants such as annual bursage (*Ambrosia acanthicarpa*), California sagebrush (*Artemisia californica*), mulefat (*Baccharis salicifolia*), common sandaster (*Corethrogyne filaginifolia*), Canada horseweed (*Erigeron canadensis*), California buckwheat (*Eriogonum fasciculatum*), telegraph weed (*Heterotheca grandiflora*), Menzies' goldenbush (*Isocoma menziesii*), scalebroom (*Lepidospartum squamatum*), ladies' tobacco (*Pseudognaphalium californica*), and chia (*Salvia columbariae*) were observed sprouting in the DG-1 and DG-1 WOUS mitigation areas. Native cover for the DG-1 and DG-1 WOUS mitigation areas was estimated to be approximately 60 to 65 percent with some areas having relatively dense cover and other areas being scoured and/or having minimal cover. Photos 1 and 2 in Attachment B document the status of the mitigation areas during the monitoring visit.

Nonnative weed cover in DG-1 and DG-1 WOUS was estimated to be approximately less than one percent, which is approximately nine percent lower than the level of weed cover that was observed during the previous qualitative monitoring event. It should be noted that weed cover in this mitigation area during the summer of 2022 was approximately less than two percent which shows that weed cover in this mitigation area has been consistently low. Black mustard (*Brassica nigra*) was the only nonnative species observed in DG-1 and DG-1 WOUS. Most nonnative weeds were just starting to germinate and had not gone to flower or seed.

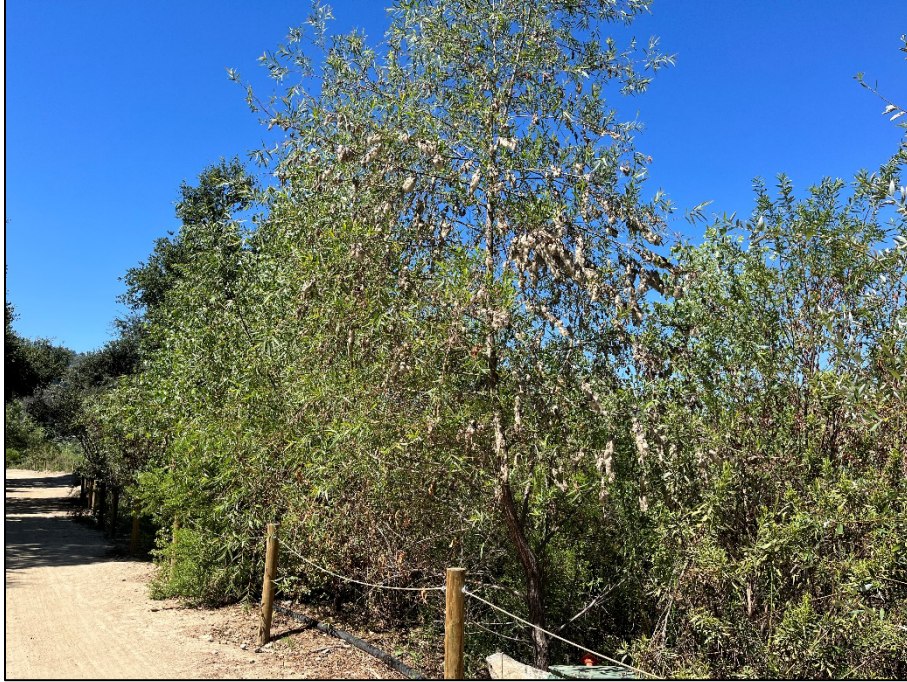
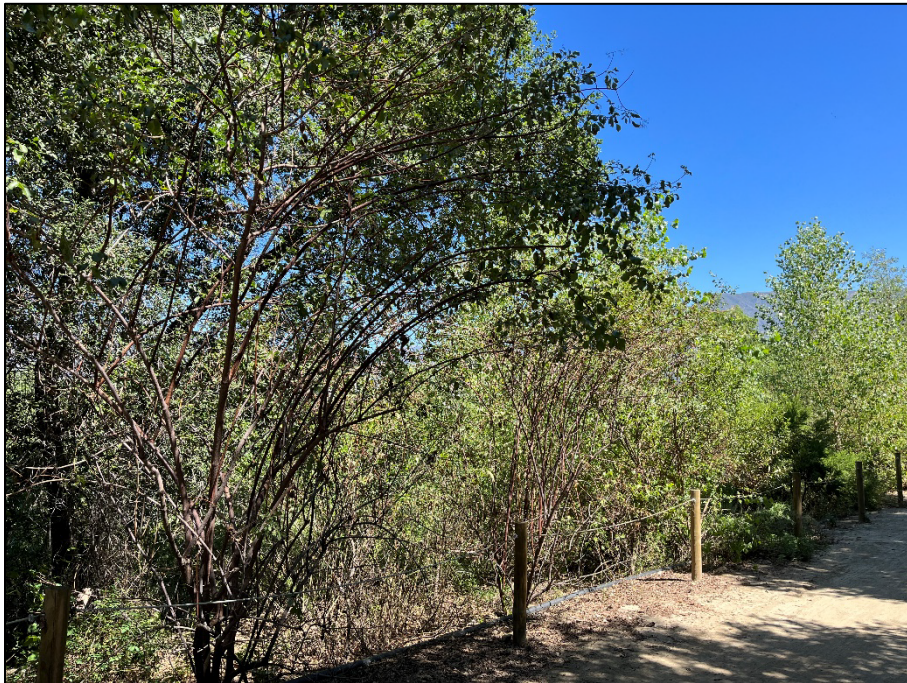
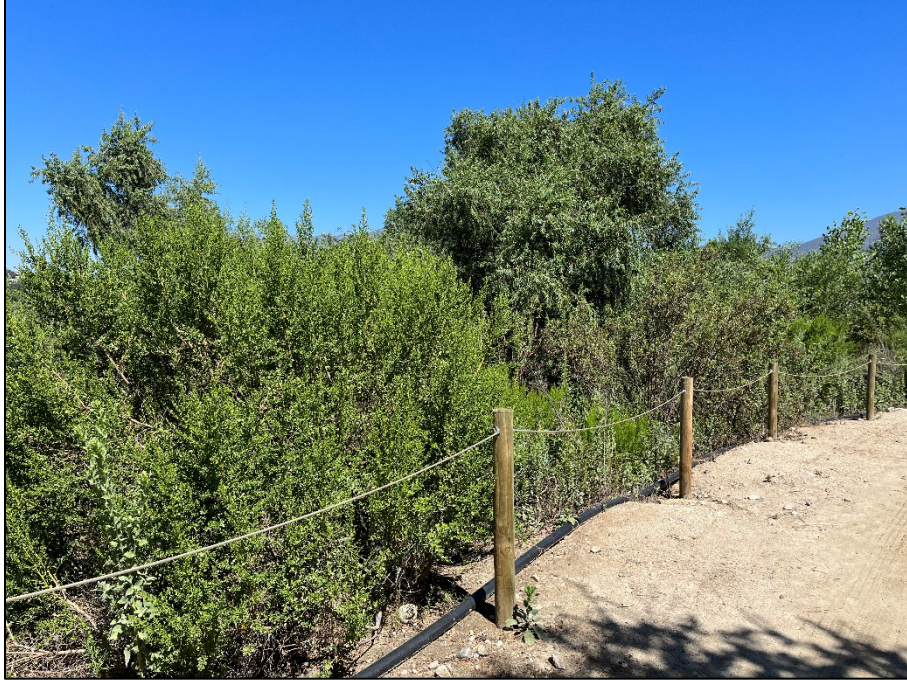
Photo 3: Overview Mitigation Area DG-2A

The overall health of the container plants in DG-2A was noted as being good. Approximately less than five percent of the container plants in DG-2A were noted as showing varied levels of stress, which is approximately the same as the percentage of container plants that were showing stress during the previous qualitative monitoring event. Stress may be occurring as a result of 1) competition from nonnative and invasive weeds, 2) misplaced emitters, or 3) recreational traffic through the mitigation areas. There were no additional container plants noted as being missing or dead. Formal mortality counts were taken for DG-2A during the 2020, 2021, 2022, and 2023 quantitative monitoring events. The willows (*Salix* sp.) and Fremont's cottonwoods (*Populus fremontii*) were no longer showing signs of seasonal dieback. The installation of plants in the DG-2A mitigation area appears to have been completed successfully. The current issues identified during the monitoring visit are not expected to have an effect on the continued growth of the plants in the mitigation area. Photos 3 through 5 in Attachment B document the status of the mitigation area during the monitoring visit.

Native plant growth was noted throughout the DG-2A mitigation area, likely both from natural recruitment and from seeding. Native plants such as annual bursage, mugwort (*Artemisia douglasiana*), tall flatsedge (*Cyperus eragrostis*), Canada horseweed, telegraph weed, ladies' tobacco, and stinging nettle (*Urtica dioica*) were observed sprouting in the DG-2A mitigation area. Native cover for the DG-2A mitigation area was estimated to be 85 percent.

Nonnative weed cover in DG-2A was estimated at approximately one percent, which is approximately the same level of weed cover that was observed during the previous qualitative monitoring event. It should be noted that weed cover in this mitigation area during the summer of 2022 was approximately less than one percent which shows that weed cover in this mitigation area has been consistently low. Nonnative species observed in DG-2A during the monitoring visit included pigweed amaranth (*Amaranthus ablus*), black mustard, and white horehound (*Marrubium vulgare*). Most nonnative weeds were just starting to germinate and had not gone to flower or seed.

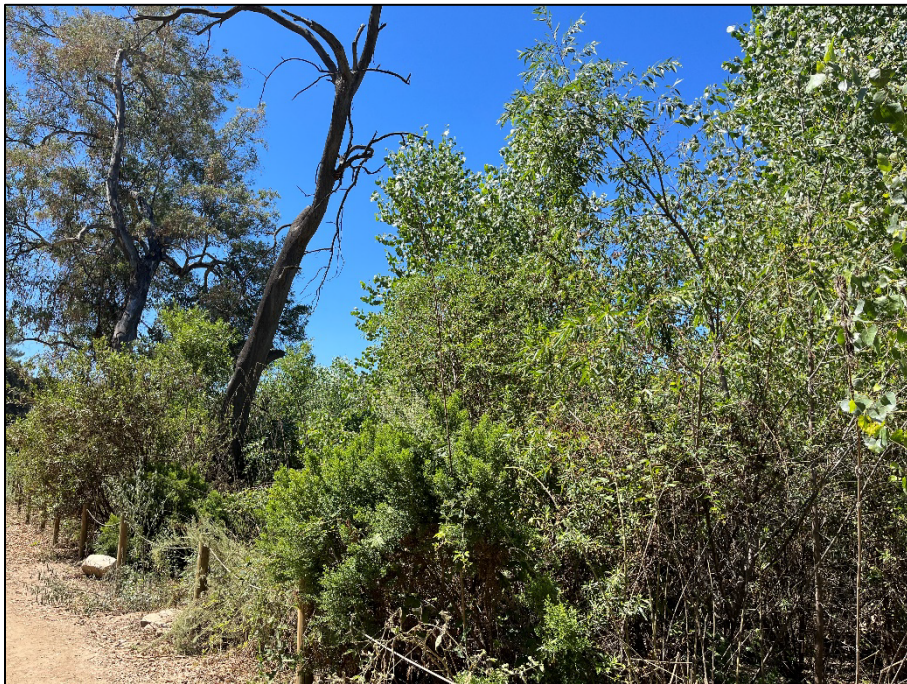
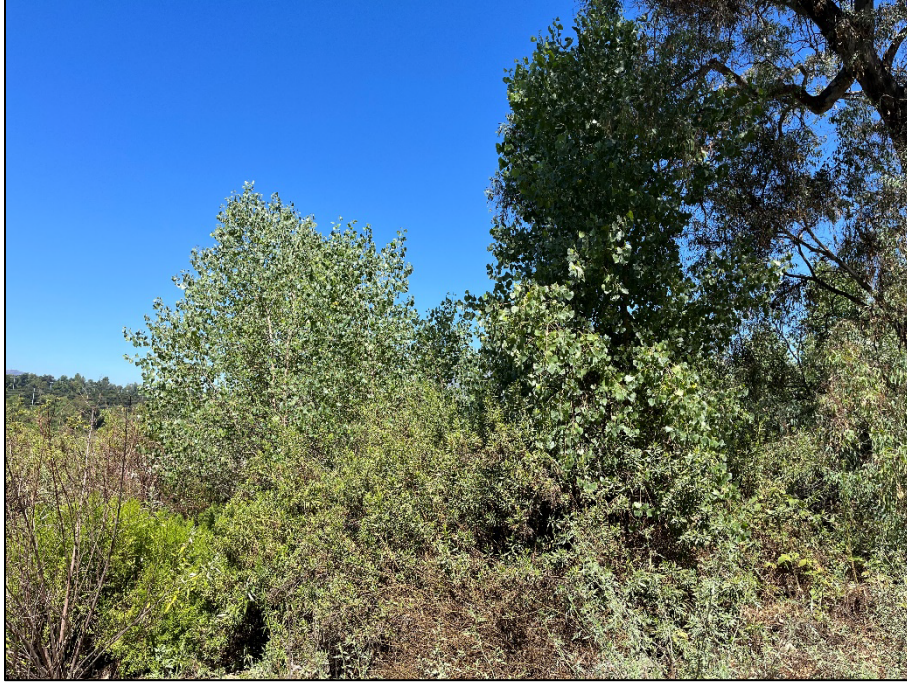
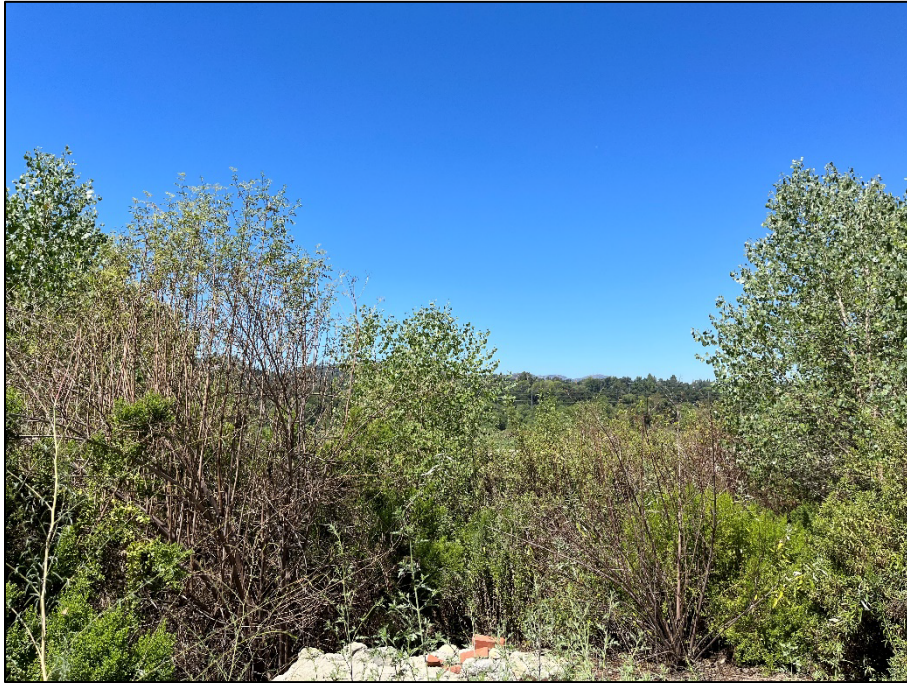
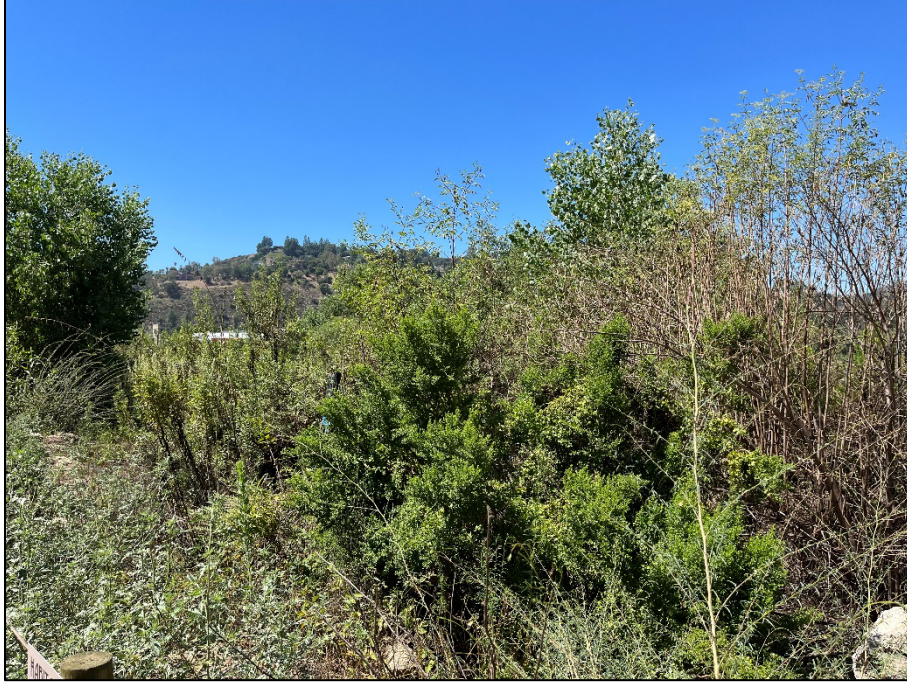
Photo 6: Overview Mitigation Area DG-2B

The overall health of the container plants in DG-2B was noted as being good. Approximately less than five percent of the container plants in DG-2B were noted as showing varied levels of stress, which is approximately the same percentage of container plants that were showing stress during the previous qualitative monitoring event. Stress was likely due to the same reasons as those described for DG-2A. In addition, insect galls were observed on several of the willow species. Formal mortality counts were taken for DG-2B during the 2020, 2021, 2022, and 2023 quantitative monitoring events. Similar to DG-2A, the willows and Fremont's cottonwoods were no longer showing signs of seasonal dieback. The installation of the plants in the DG-2B mitigation area appears to have been successfully completed. The current issues identified during the monitoring visit are not expected to have an effect on the continued growth of plants in the mitigation area. Photos 6 through 9 in Attachment B document the status of the mitigation area during the monitoring visit.

Nonnative weed cover in DG-2B was estimated at approximately two percent, which is approximately one percent higher than the level of nonnative cover that was observed during the previous qualitative monitoring event. It should be noted that weed cover in this mitigation area during the summer of 2022 was approximately less than one percent which shows that weed cover in this mitigation area has been consistently low. Nonnative species observed in DG-2B during the monitoring visit included black mustard and perennial pepperweed (*Lepidium latifolium*). Most nonnative weeds were just starting to germinate and had not gone to flower or seed.

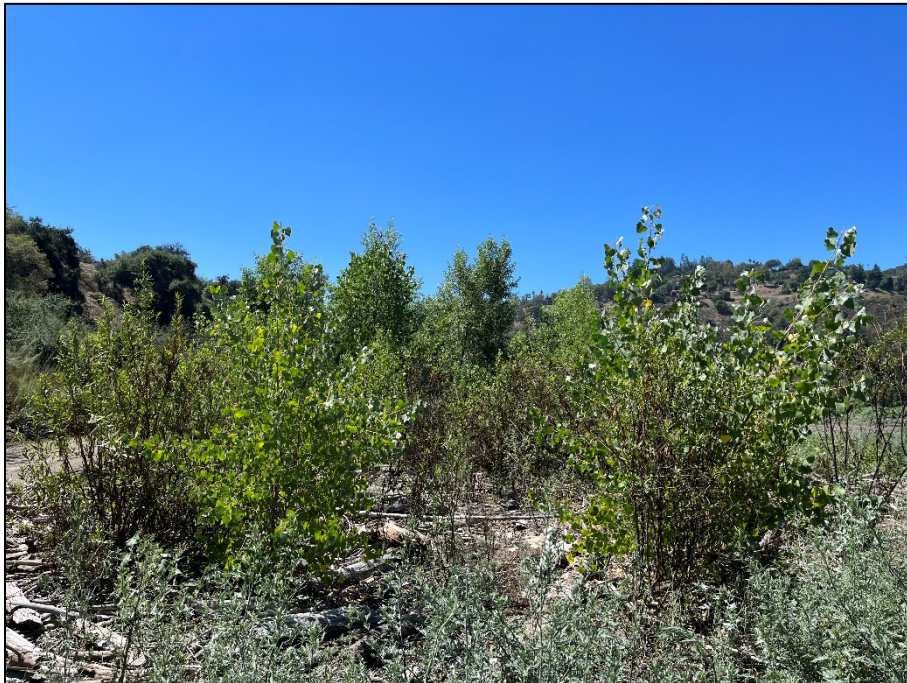
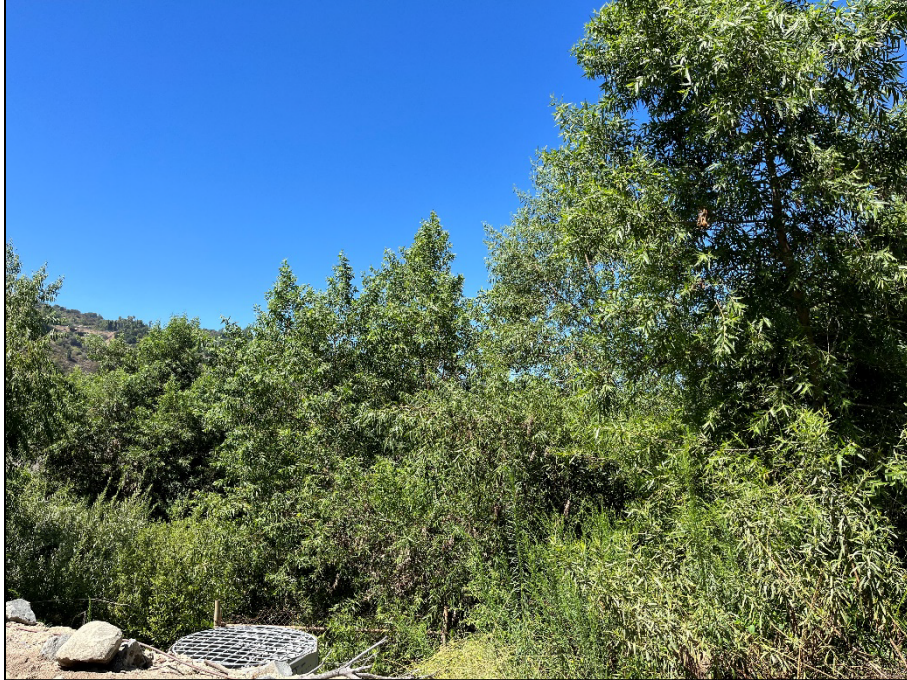
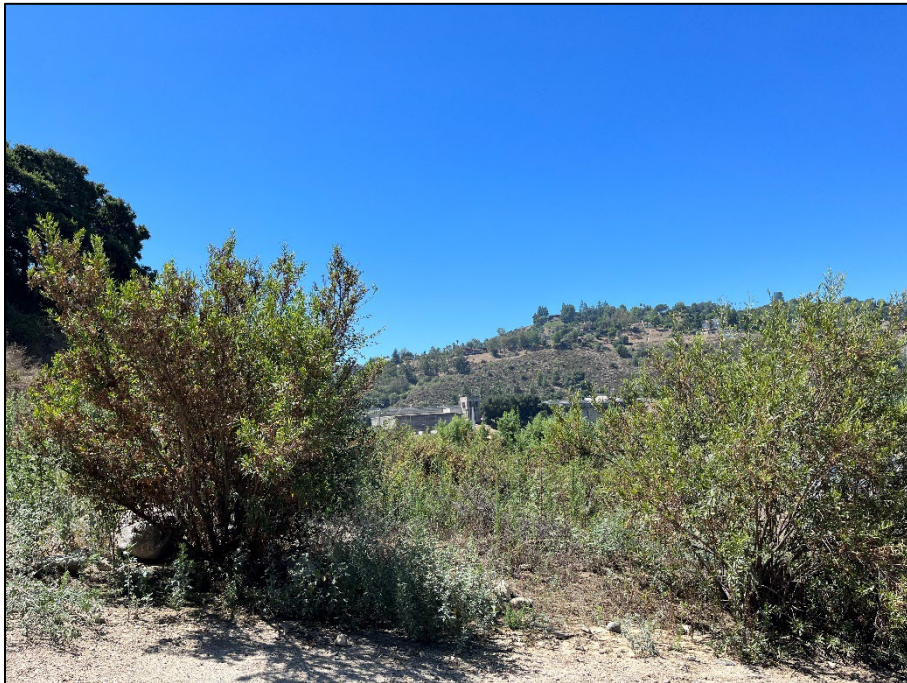
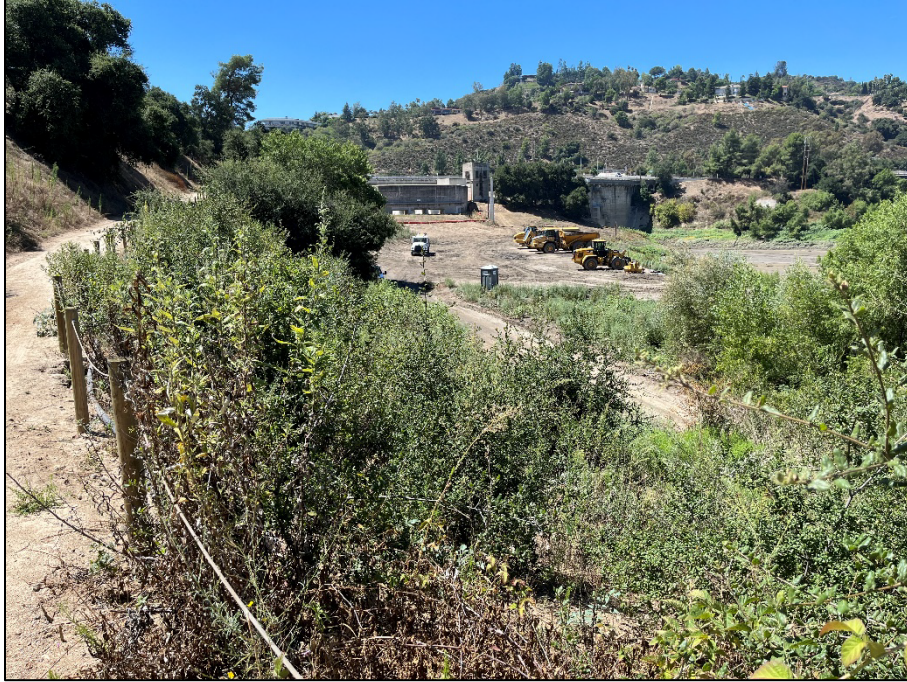
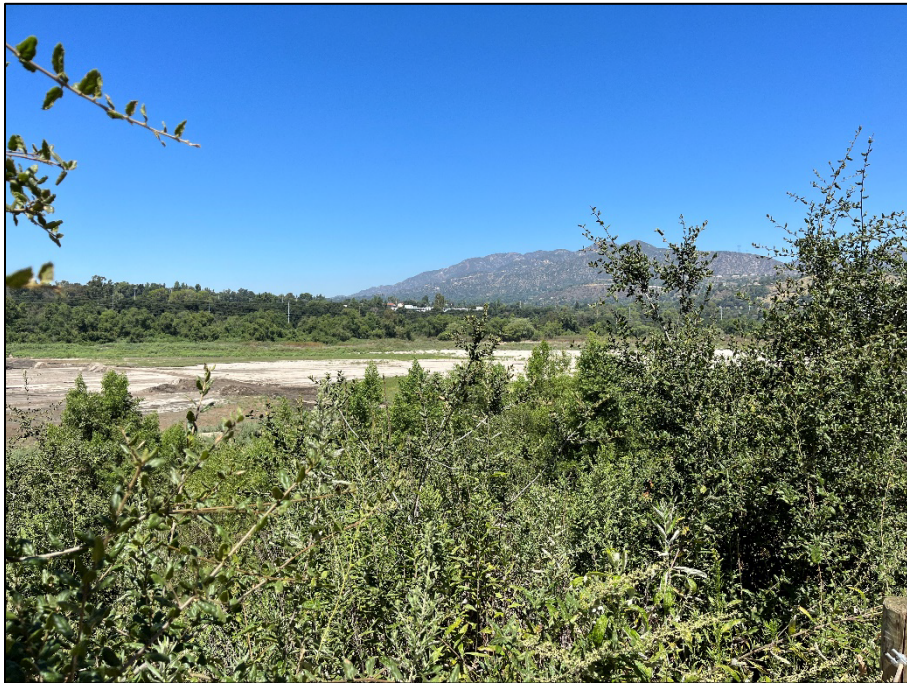
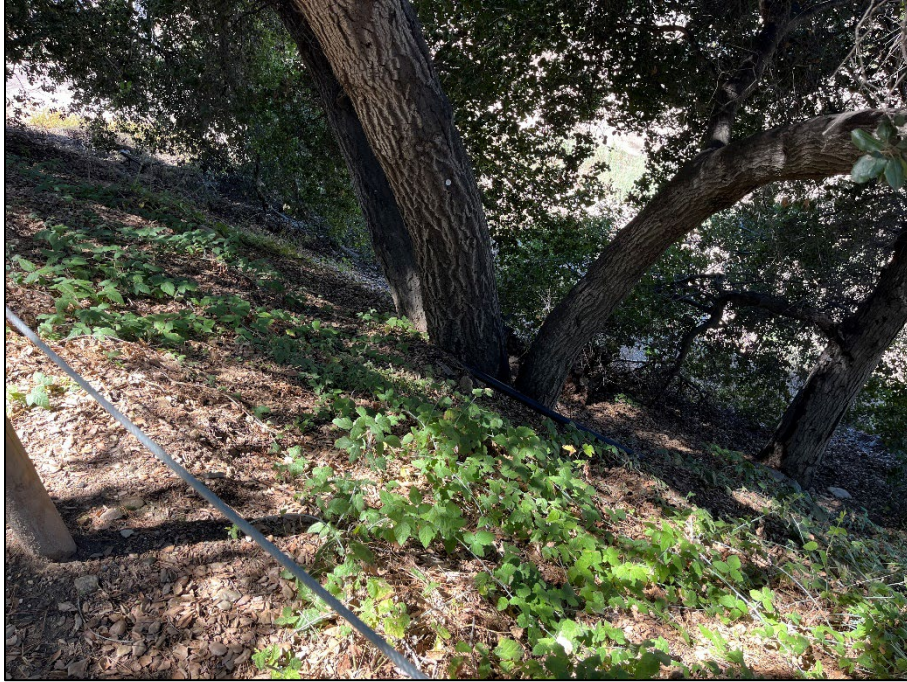
Photo 10: Overview Mitigation Area DG-3A Altadena Drain

The overall health of the container plants in DG-3A was noted as being good. Approximately five percent of the container plants in the coast live oak woodland portions of DG-3A were noted as showing varied levels of stress, which is approximately five percent less than the percentage of container plants that were showing stress during the previous qualitative monitoring event. During the monitoring visit, the planted coast live oak acorns were inspected for survivorship and health. Approximately 20 germinated coast live oak acorns appear to still be present in DG-3A. The majority of the germinated acorns appear to be in good health. During the monitoring, it was noted that an existing coast live oak tree (Tree Tag #39) is continuing to experience branch failure for multiple branches. The cause of the branch failure was unclear.

Approximately 10 percent of the container plants in the mulefat thickets portions of DG-3A were noted as showing varied levels of stress, which is approximately five percent more than the percentage of container plants that were showing stress during the previous qualitative monitoring event. It should also be noted that many of the container plants and stakes installed near Altadena Drain were observed to be thriving. Formal mortality counts were taken for DG-3A during the 2020, 2021, 2022, and 2023 quantitative monitoring events. The types of stress the plants were exhibiting are the same as those described for the plants in DG-2A. However, erosion is also a problem in some areas of DG-3A. In addition, the Mulefat Thickets portions of DG-3A and the lower extent of the Coast Live Oak Woodland portions of DG-3A experienced approximately 16-days of inundation following heavy storm events in January 2023. Following the inundation, many portions of DG-3A had a high level of woody debris within the mitigation area. Most of the container plants and stakes appear to be recovering from the inundation. Some of the planting basins were observed to have varied levels of erosion and should be repaired. The willow and mulefat stakes were observed to be thriving in this mitigation area. The installation of the plants in the DG-3A mitigation area appears to have been completed successfully. The current issues noted during the monitoring are not expected to have an effect on the continued growth of the plants in the mitigation area. Photos 10 through 15 in Attachment B document the status of the mitigation area during the monitoring visit.

Nonnative weed cover in DG-3A was estimated at approximately five percent, which is approximately 10 percent lower than the level of nonnative cover that was observed during the previous qualitative monitoring event. It should be noted that weed cover in this mitigation area during the summer of 2022 was approximately less than one percent which shows that weed cover in this mitigation area has been consistently low. Nonnative species observed in DG-3A included black mustard, perennial pepperweed, and curly dock (*Rumex crispus*). Most nonnative weeds were just starting to germinate and had not gone to flower or seed.

Minor erosion to planting basins was observed throughout the Phase 1 mitigation areas. The severe erosion noted in DG-3A near Altadena Drain during previous monitoring visits did not show any signs of worsening. Due to the steepness of the slope in the coast live oak woodland portion of the DG-3A mitigation area, erosion will likely continue to be somewhat of an issue in this area; however, jute nettings are currently in place on the slope and will help to lessen the severity of erosion issues. As native cover increases in this area, erosion issues should lessen. The severity of the erosion should continue to be monitored in all planted areas and if warranted, erosion Best Management Practices (BMPs) should be installed in appropriate areas. This may only require the installation of straw wattles at select sites to prevent existing rills from becoming larger. However, until more native perennial plants become established in these areas, there is the potential that intense rainfall may create additional erosion problems.

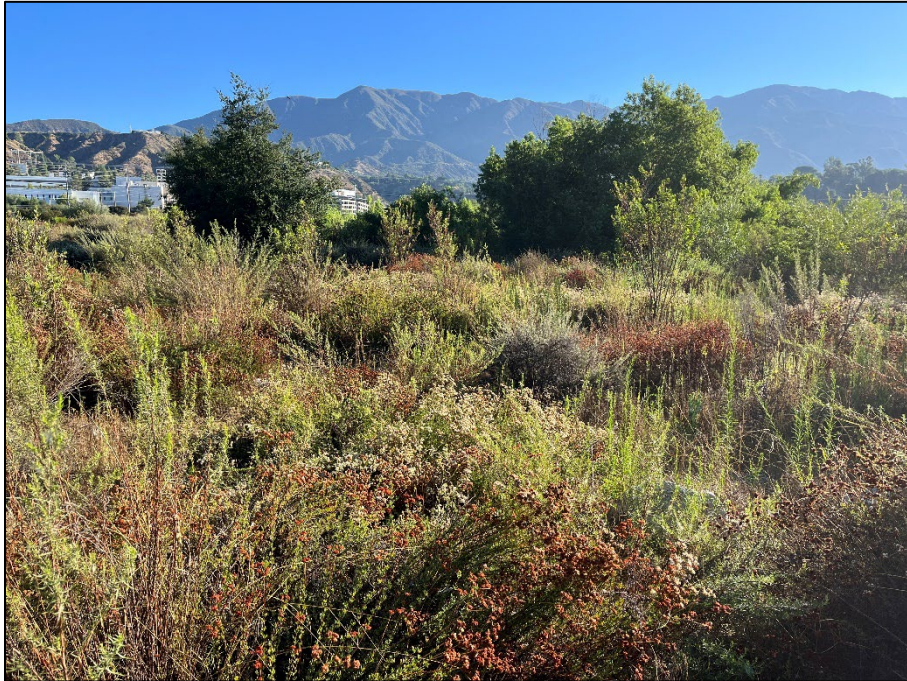
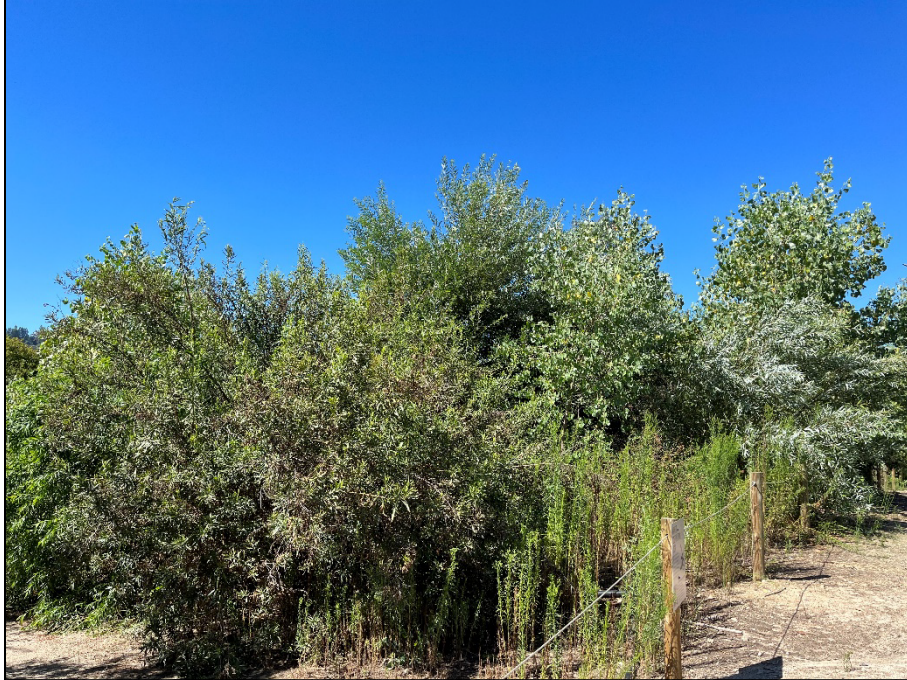
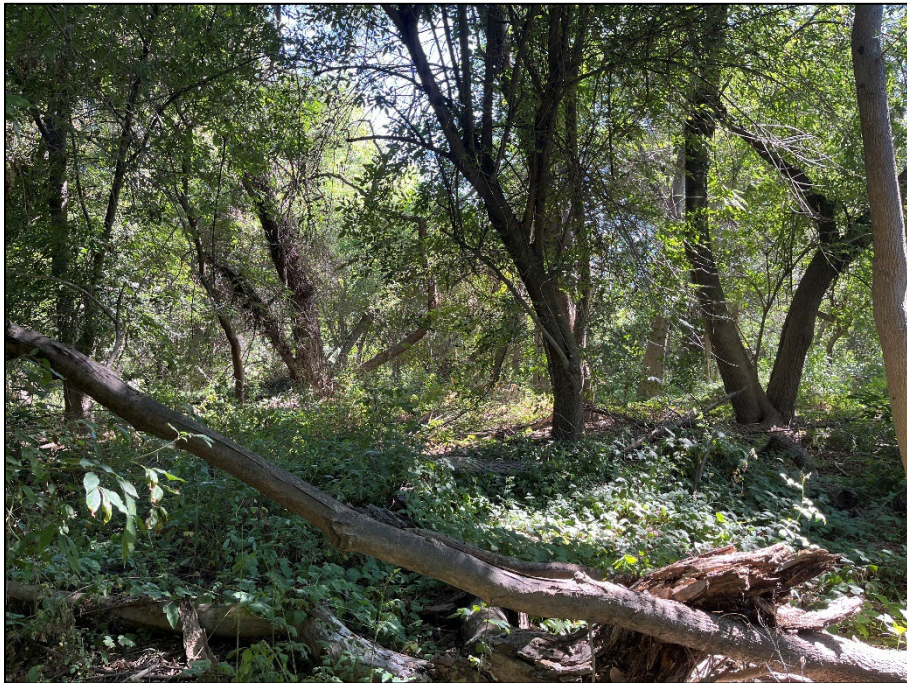
Photo 16: Overview Mitigation Area DG-4 CSS

The overall health of the container plants in mitigation area DG-4 was noted as being good. Approximately five percent of container plants in the coastal sage scrub portions of DG-4 were showing varied levels of stress which is approximately the same percentage of plants showing stress during the previous qualitative monitoring event. Approximately five percent of container plants in most of the riparian portions of DG-4 were showing varied levels of stress, depending on the section of DG-4, which is 5 to 10 percent less than the percentage of plants showing stress during the previous qualitative monitoring event. The causes of stress appear to be mostly due to the same reasons described in DG-2A. In addition, the southern portions of DG-4 experienced approximately 16-days of inundation following heavy storm events in January 2023 and some of the container plants in this area appear dead or in a condition unlikely to recover. For most portions of DG-4 that did not experience inundation, only a negligible number of container plants were noted as being missing or dead. Formal mortality counts were taken for DG-4 during the 2020, 2021, 2022, and 2023 quantitative monitoring events. Similar to DG-2A, the willows and Fremont's cottonwoods were no longer showing signs of seasonal dieback. Some of the planting basins were observed to have minor erosion and should be repaired. The installation of plants in the DG-4 mitigation area appears to have been completed successfully and the issues noted during the monitoring are not expected to have an impact on the continued growth of the plants. Photos 16 through 18 in Attachment B document the status of the mitigation area during the monitoring visit.

Nonnative weed cover in DG-4 was estimated at approximately 10 to 15 percent, which is approximately 10 to 15 percent lower than the percentage of nonnative cover that was observed during the previous qualitative monitoring event. It should be noted that weed cover in this mitigation area during the summer of 2022 was approximately five percent, depending on the area. The minor increase in nonnative weed cover during the summer of 2023 could be due to high levels of precipitation during the 2023 wet

season. In addition, bird nests in DG-4 during the spring and summer of 2022 and 2023 prevented crews from being able to conduct weed abatement activities in some areas. Nonnative species observed in DG-4 included tree of heaven (*Ailanthus altissima*), black mustard, poison hemlock (*Conium maculatum*), perennial pepperweed, white horehound, and German chamomile (*Matricaria chamomilla*). Nonnative weed cover, especially perennial pepperweed, is a significant problem in portions of the DG-4 mitigation area. Because perennial pepperweed can produce dense colonies through seed germination and underground rhizomes (rhizomatous roots), removal of this species without the use of systemic herbicide is very difficult. Some of the nonnative weeds in this mitigation area were starting to produce flowers and or seed and should be removed as soon as the bird nests in this area fledge or are determined to be inactive.

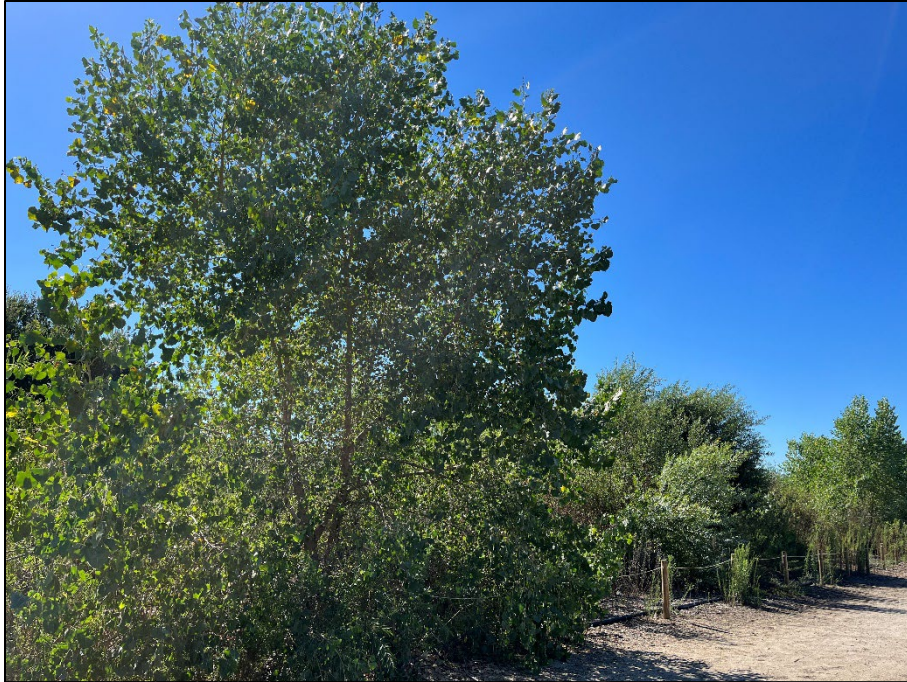
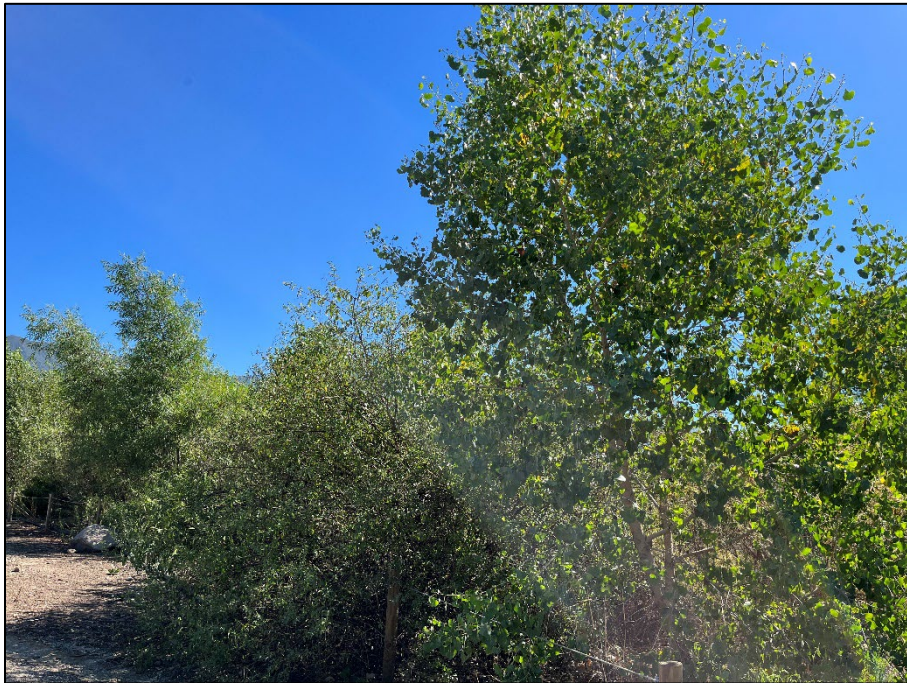
Photo 19: Overview Mitigation Area DG-4B

The overall health of the container plants in mitigation area DG-4B was noted as being good and this mitigation area is becoming well established. Approximately less than five percent of container plants were showing signs of drought stress which is approximately the same percentage of plants that were stressed during the previous qualitative monitoring event. The types of stress the plants were exhibiting are the same as those described for the plants in DG-2A. A negligible number of container plants were noted as being missing or dead. Formal mortality counts were taken for DG-4B during the 2020, 2021, 2022, and 2023 quantitative monitoring events. Some of the planting basins were observed to have minor erosion and should be repaired. The installation of plants in the DG-4B mitigation area appears to have been completed successfully and the issues noted during the monitoring are not expected to have an impact on the continued growth of the plants. Photos 19 and 20 in Attachment B document the current status of the mitigation area during the monitoring visit.

Nonnative weed cover in DG-4B was estimated to be approximately 10 percent, which is approximately the same percentage of nonnative cover that was observed during the previous qualitative monitoring event. It should be noted that weed cover in this mitigation area during the summer of 2022 was approximately less than one percent. The minor increase in nonnative weed cover during the summer of 2023 could be due to high levels of precipitation during the 2023 wet season. Nonnative species observed in DG-4B included black mustard, poison hemlock, and perennial pepperweed. Most nonnative weeds were just starting to germinate and had not gone to flower or seed.

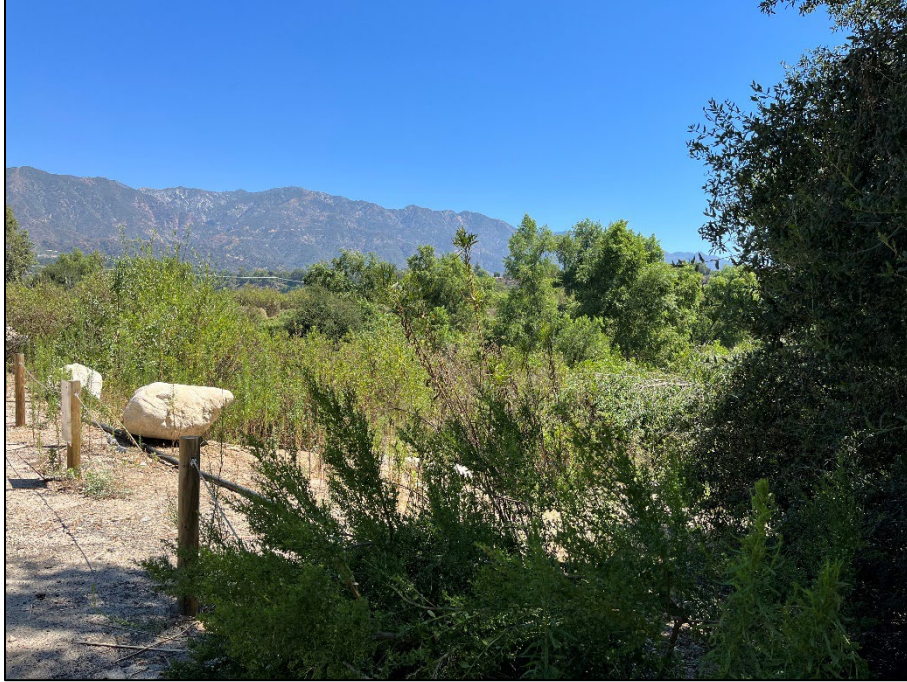
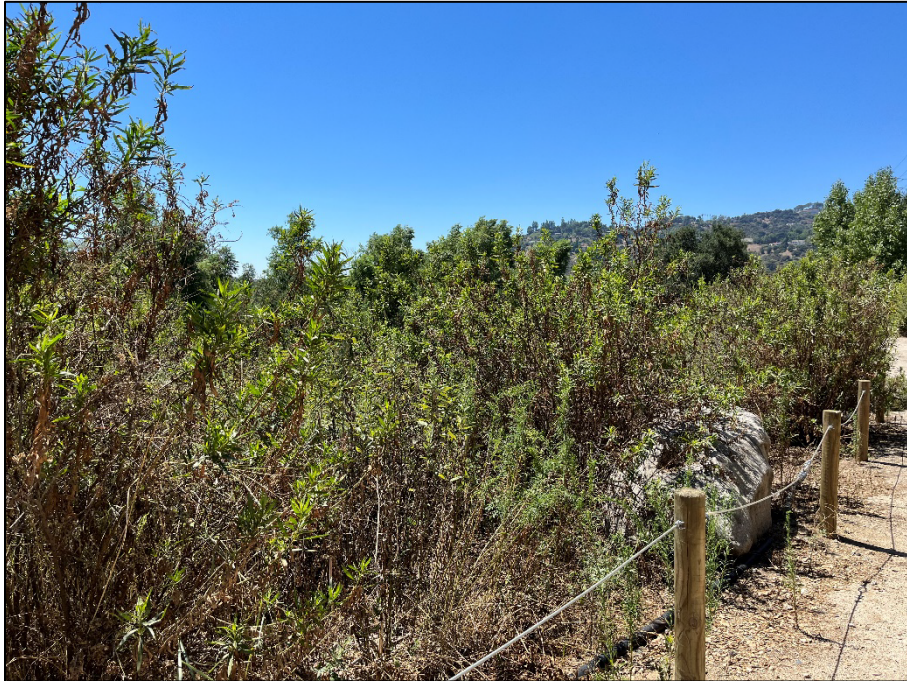
Photo 21: Overview Mitigation Area DG-4C

The overall health of the container plants in mitigation area DG-4C was noted as being good. Approximately five percent of all container plants were noted as showing minor levels of stress, which is approximately the same percentage of plants that were showing stress during the previous qualitative

monitoring event. The types of stress the plants were exhibiting are the same as those described for the plants in DG-2A. A negligible number of container plants were noted as being missing or dead. Formal mortality counts were taken for DG-4C during the 2020, 2021, 2022, 2023 quantitative monitoring events. Similar to DG-2A, the willows and Fremont's cottonwoods were no longer showing signs of seasonal dieback. Some of the planting basins were observed to have minor erosion and should be repaired. The installation of plants in the DG-4C mitigation area appears to have been completed successfully and the issues noted during the monitoring are not expected to have an impact on the continued growth of the plants. Photos 21 and 22 in Attachment B document the status of the mitigation area during the monitoring visit.

Nonnative weed cover in DG-4C was estimated at approximately less than five percent, which is approximately 25 percent lower than the percentage of nonnative cover that was observed during the previous qualitative monitoring event. It should be noted that weed cover in this mitigation area during the summer of 2022 was approximately less than one percent. The minor increase in nonnative cover during the summer of 2023 in this mitigation area is likely due to the increase in precipitation during the 2023 wet season. Nonnative species observed in DG-4C during the monitoring visit included black mustard, wild prickly lettuce (*Lactuca serriola*), and white horehound. Most nonnative weeds were just starting to germinate and had not gone to flower or seed.

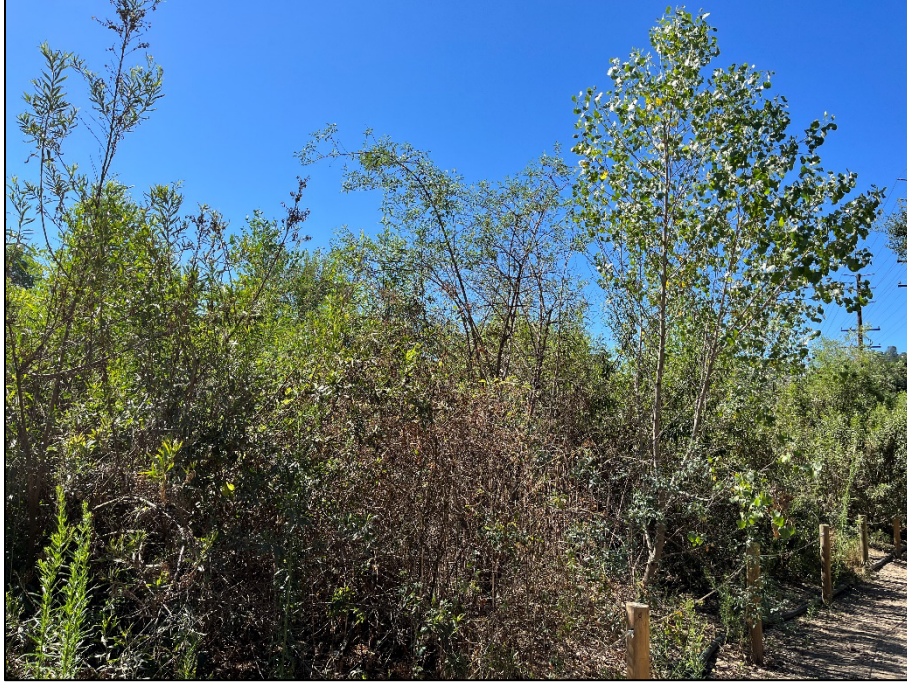
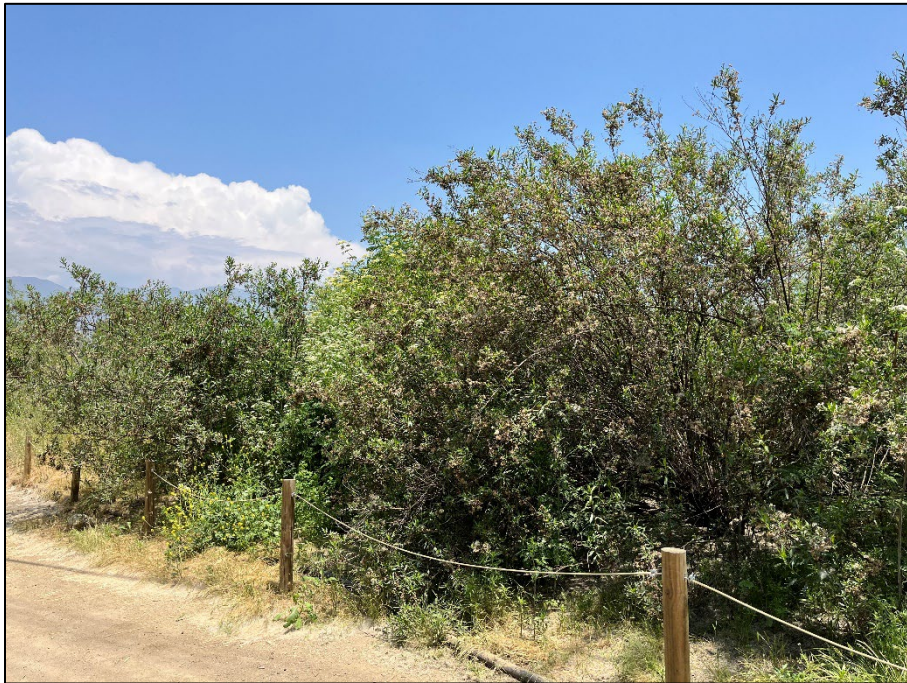
Photo 23: Overview Mitigation Area DG-5

The overall health of the container plants in the DG-5 mitigation area was noted as being good. Approximately less than five percent of all container plants were noted as showing varied levels of stress, which is approximately the same as the percentage of plants that were showing stress during the previous qualitative monitoring event. Formal mortality counts were taken for DG-5 during the 2020, 2021, 2022 and 2023 quantitative monitoring events. Similar to DG-2A, the willows and Fremont's cottonwoods were no longer showing signs of seasonal dieback. Some of the planting basins were observed to have minor erosion and should be repaired. The installation of plants in the DG-5 mitigation area appears to have been completed successfully and the issues noted during the monitoring are not expected to have a negative impact on the continued growth of the plants. Photos 25 and 26 in Attachment B document the status of the mitigation area during the monitoring visit.

Nonnative weed cover in DG-5 was estimated at approximately five percent, which is approximately fifteen percent less than the percentage of nonnative weed cover that was observed during the previous qualitative monitoring event. It should be noted that weed cover in this mitigation area during the

summer of 2022 was approximately less than one percent. The minor increase in nonnative cover during the summer of 2023 in this mitigation area is likely due to the increase in precipitation during the 2023 wet season. Nonnative species observed in DG-5 included black mustard, soft brome (*Bromus hordeaceus*), and poison hemlock. Most nonnative weeds were just starting to germinate and had not gone to flower or seed.
