HYDRAULIC ANALYSIS TECHNICAL ASSESSMENT REPORT

**FOR
ENGINEERED EARTHEN-BOTTOM FLOOD CONTROL CHANNELS
LOCATED WITHIN THE
LOS ANGELES RIVER WATERSHED**

**MAINTAINED AND OPERATED BY THE
LOS ANGELES COUNTY FLOOD CONTROL DISTRICT**

AUGUST 1, 2013

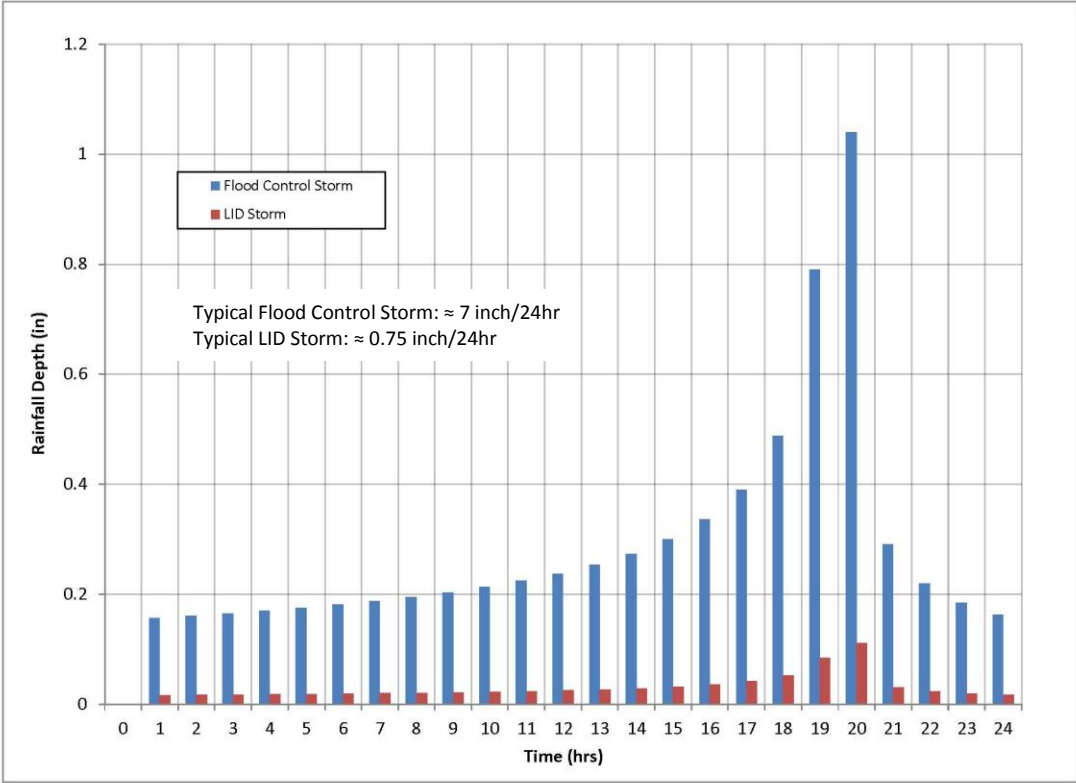
Figure I-3. Typical Flood Control Storm vs LID Storm

While such infiltration requirements are expected to be effective in reducing stream flows during smaller storm events, which may occur potentially multiple times during a single year, the purpose of such requirements is to improve water quality and conserve water, not to significantly reduce the risk of flooding during major storm events. Flood control channels are typically designed to handle much higher stream flows which occur during large storm events. Such storm events (Flood Control Storms) will produce large volumes of runoff, quickly overwhelming these water quality infiltration facilities and rendering them insignificant in their ability to effectively reduce flow rates during the most intense part of a storm. Figure I-3 compares a typical flood Control Storm (7 inches per 24-hour period) and a storm for which low impact development (LID) structures are designed (.75 inches per 24-hour period) (LID Storm).

When these assumptions were applied in the example watershed, the results showed that the volume of only the first 4.5 hours of a Flood Control Storm hydrograph would be captured in the LID/infiltration infrastructure (the duration of a Flood Control Storm is 24 hours). After that point, any remaining volume would not infiltrate and would have to be contained in the flood control channels, as shown in Figure I-3. Thus, while LID/infiltration facilities will reduce storm flows during typical (up to the 85th percentile) storm events, flows from the major storms for which the flood control channels, including the soft bottom reaches, were designed will not be affected. Thus, the presence of LID/infiltration infrastructure would not affect expected stream flow during major storms.

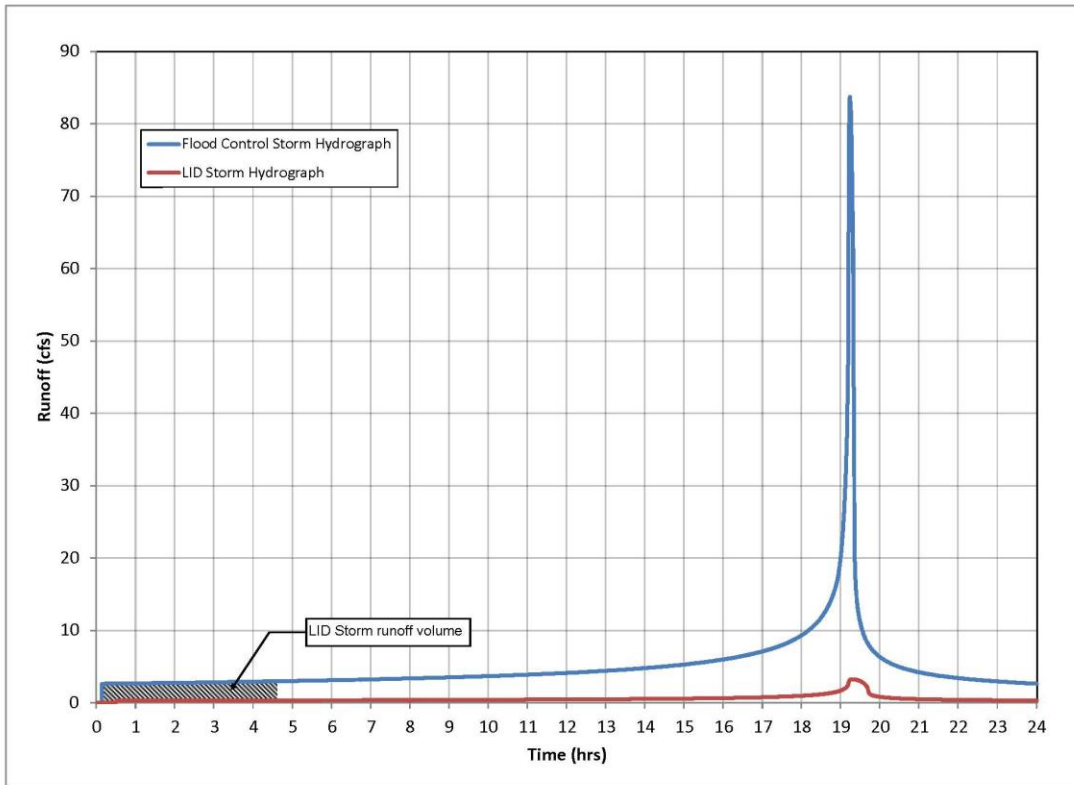
Figure I-4. Example Watershed Runoff Peaks and Volume

To assess the impact of the infiltration requirements set forth in Condition 48, an example watershed was modeled assuming that the entire surface of the watershed was designed to capture flows generated during the 85th percentile storm, which is the standard LID requirement (and which is contained in the current Los Angeles County MS4 permit. This assumption actually overestimates the impact of the infiltration requirements required to be assessed in the Feasibility Study, since those requirements do not apply watershed wide and are being implemented over multiple year time

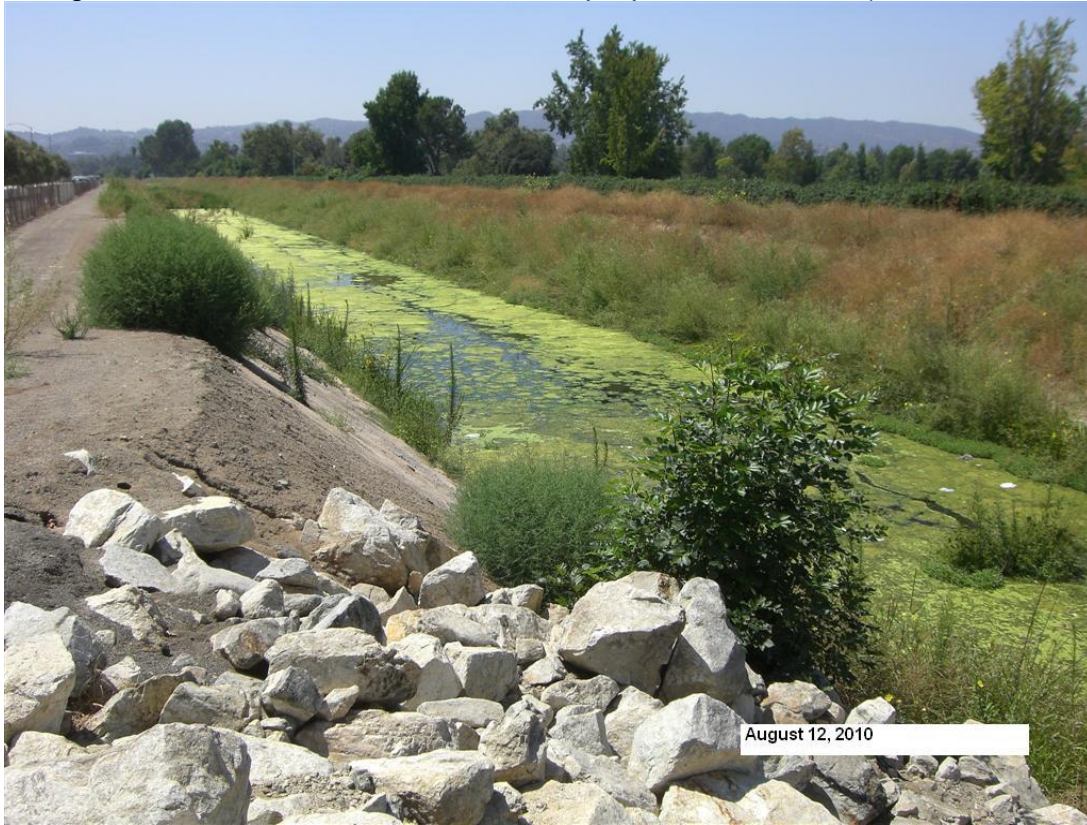
Looking d/s of Sta. 48+75, transition from riprap to soft-bottom (HEC-RAS Model)

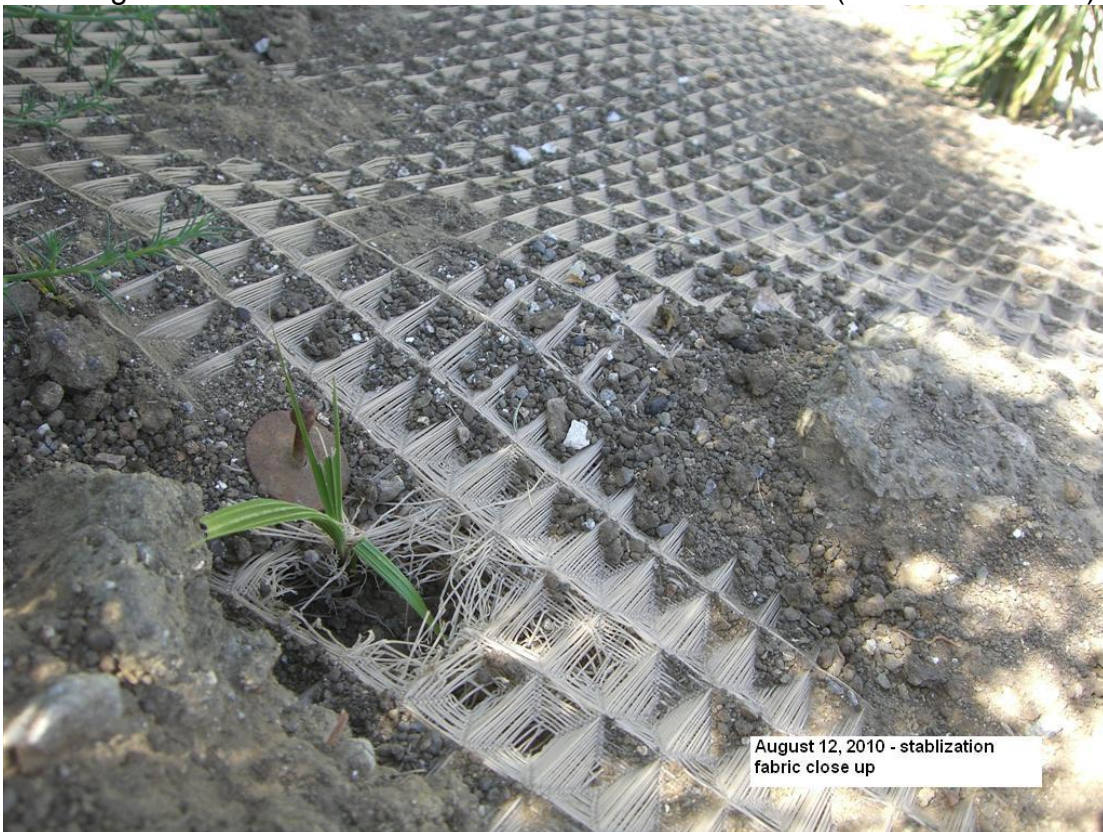
Looking at channel bank stabilization fabric at Sta. 48+25 (HEC-RAS Model)

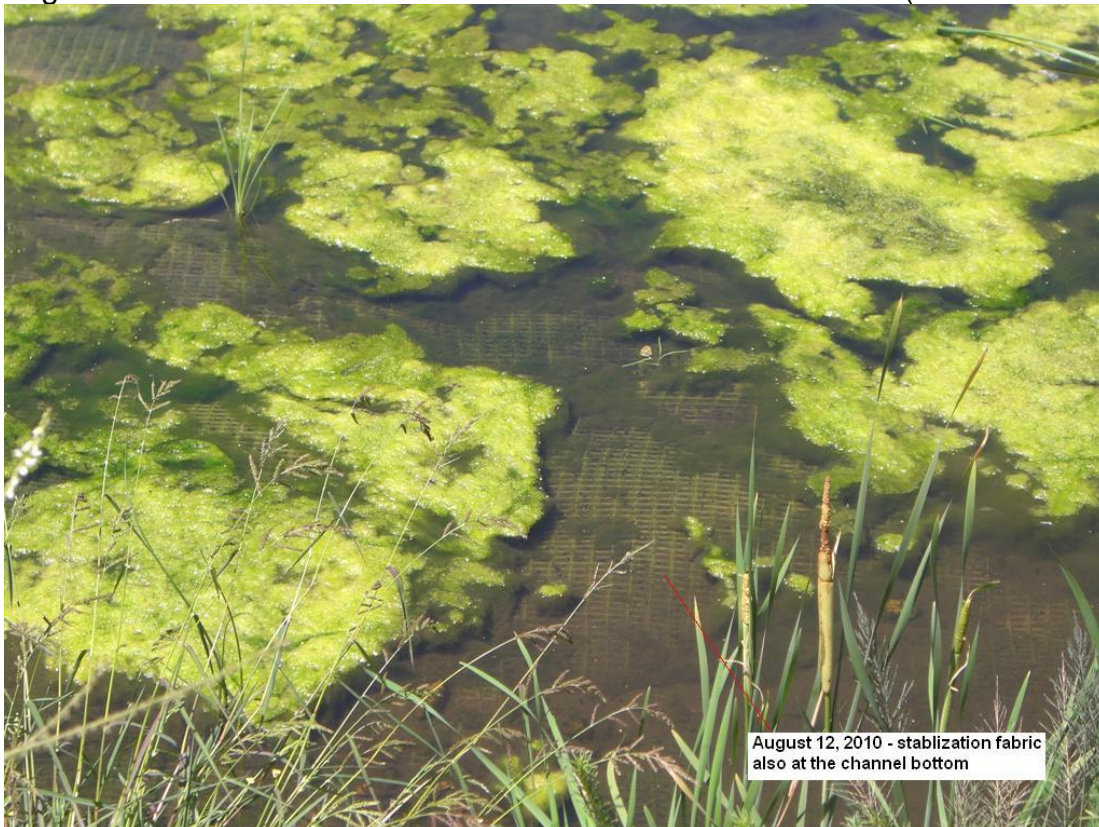
Looking west at stabilization fabric at channel bottom at Sta. 43+00 (HEC-RAS Model)
