**FINAL**  
**BIG TUJUNGA WASH 2001**  
**ANNUAL REPORT**

**LOS ANGELES COUNTY**  
**DEPARTMENT OF PUBLIC WORKS**  
**900 South Fremont Avenue**  
**Alhambra, California 91803-1331**  
**(626) 455-6138**

**CHAMBERS GROUP, INC.**  
**17671 Cowan Avenue, Suite 100**  
**Irvine, California 92614**  
**(949) 261-5414**

**December 2002**

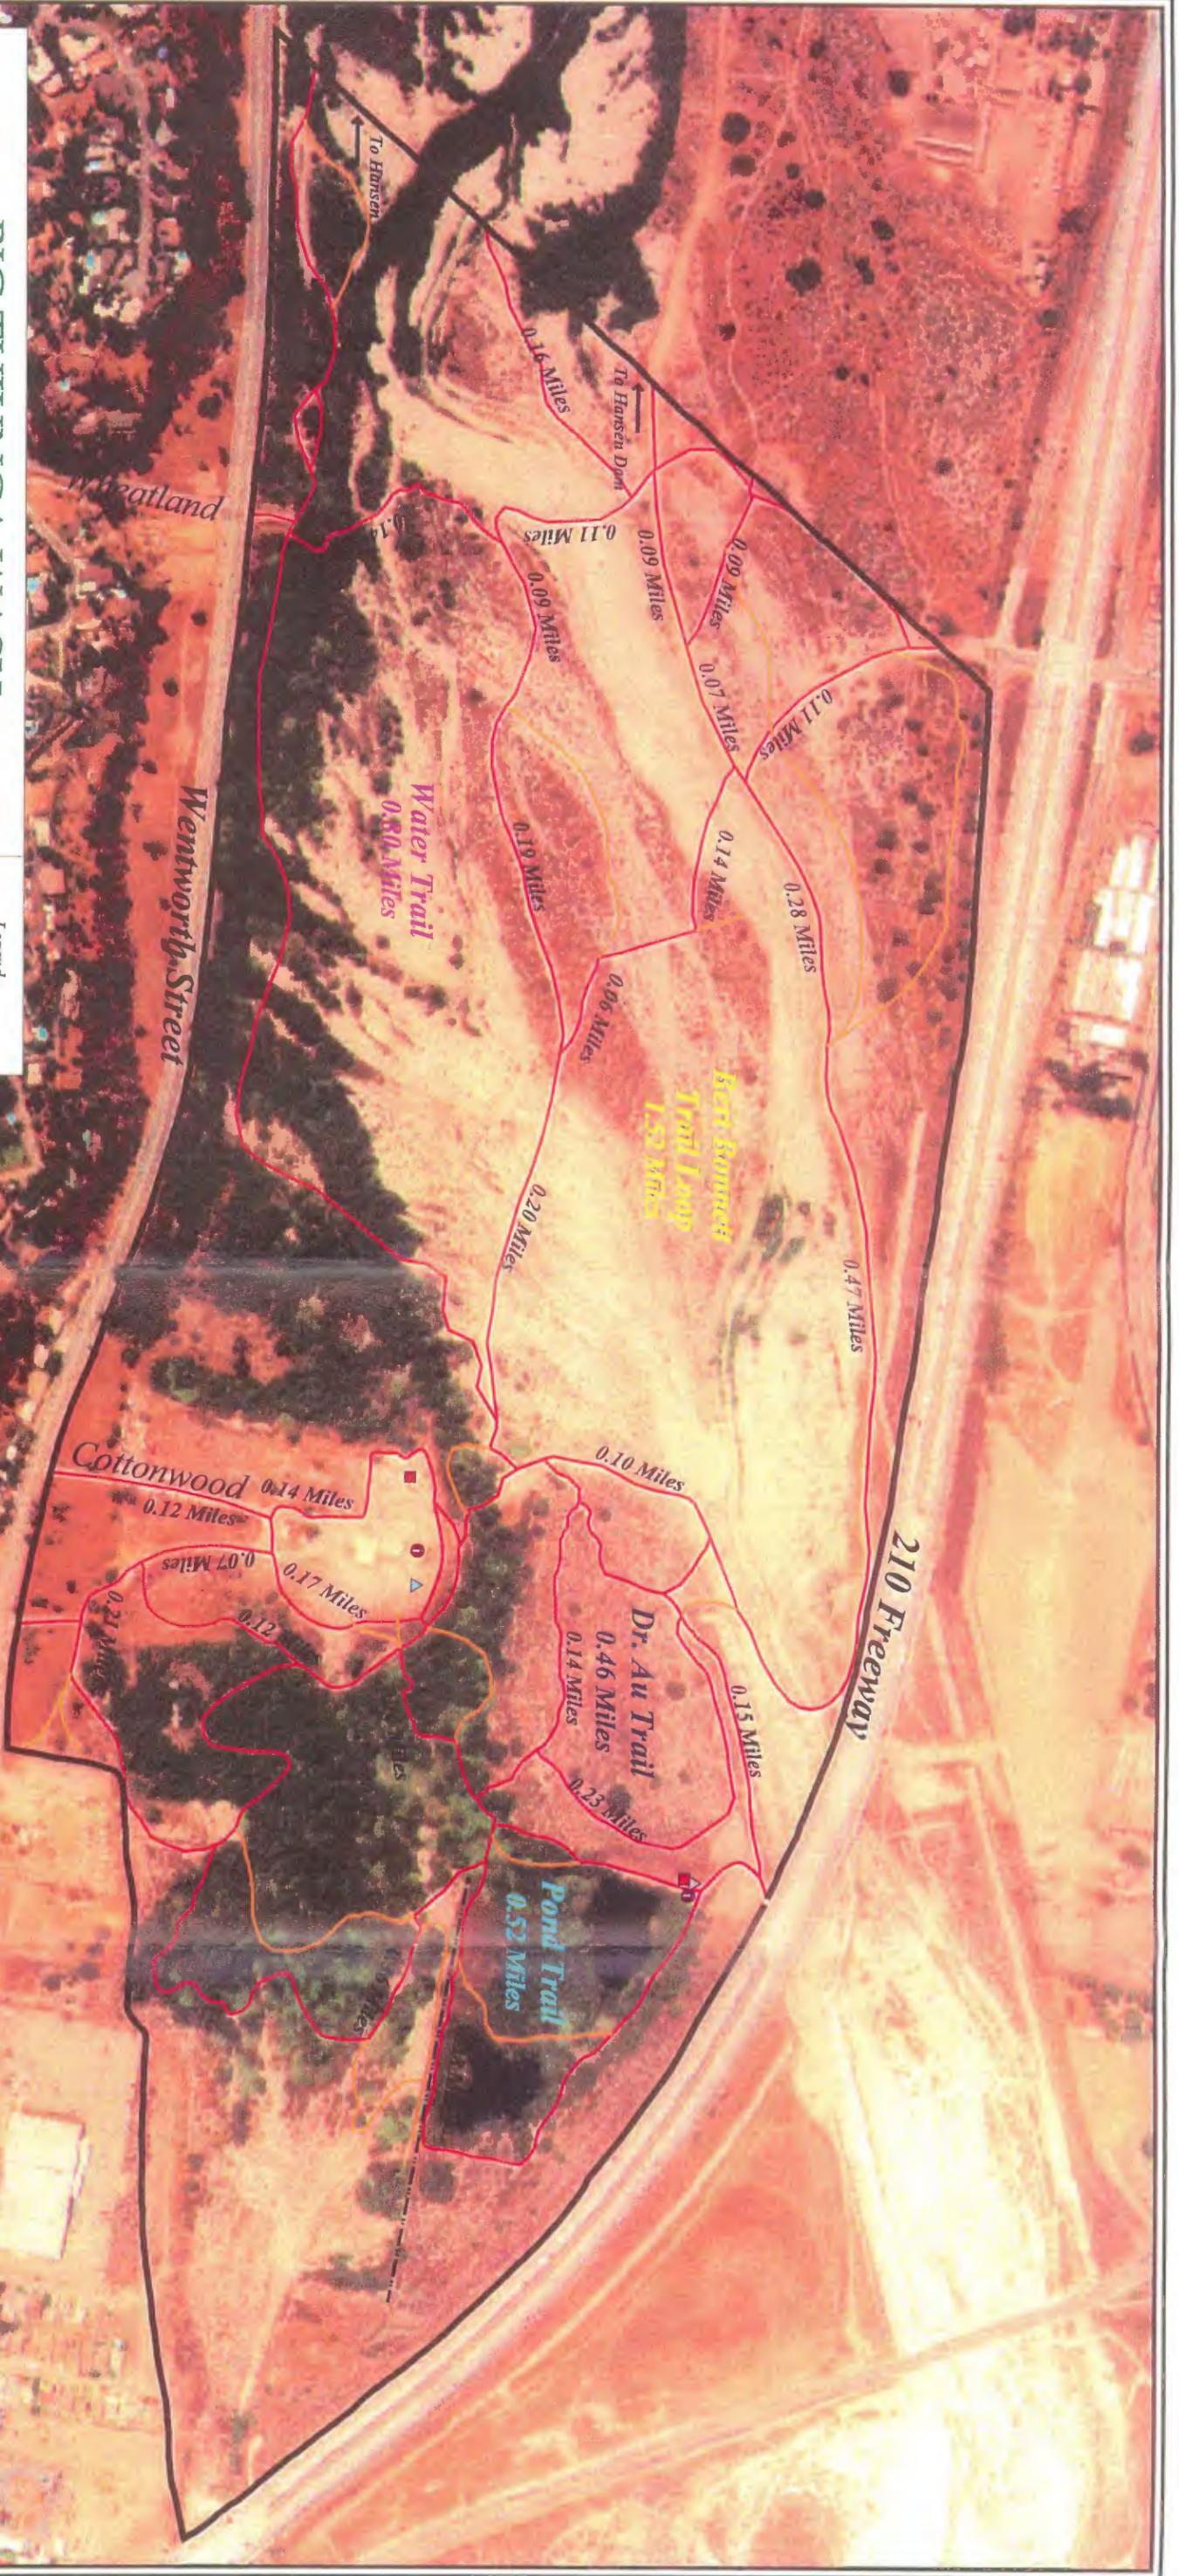
Figure 8-1 Reclaimed and Existing Trails

Figure 8-1 shows the trails map of the Big Tujunga Wash Mitigation Bank. The trails map was overlaid on a 1 inch=200 feet aerial photograph of the site and shows the trails as they exist, trails that are currently present, but that will be closed (reclaimed) during the second year of implementation, and the four designated main trails that serve as safe and scenic recreational trails. The four main trails include the Water Trail, Bert Bonnett Trail Loop, Dr. Au Trail, and Pond Trail.

Only one trail was closed during 2001. This small footpath was situated between the two ponds, causing some damage to the willow plantings in that area. The small, wooden bridge that connected this trail with the Pond Trail was removed from the site. This trail served no purpose other than providing an alternate route to a destination that could be reached by the main trail. It was determined that this path should be closed in order to minimize the impacts on the riparian habitat quality and wildlife species. Large fallen logs, rocks, and other natural debris were strategically placed in order to deter continued use of this trail.

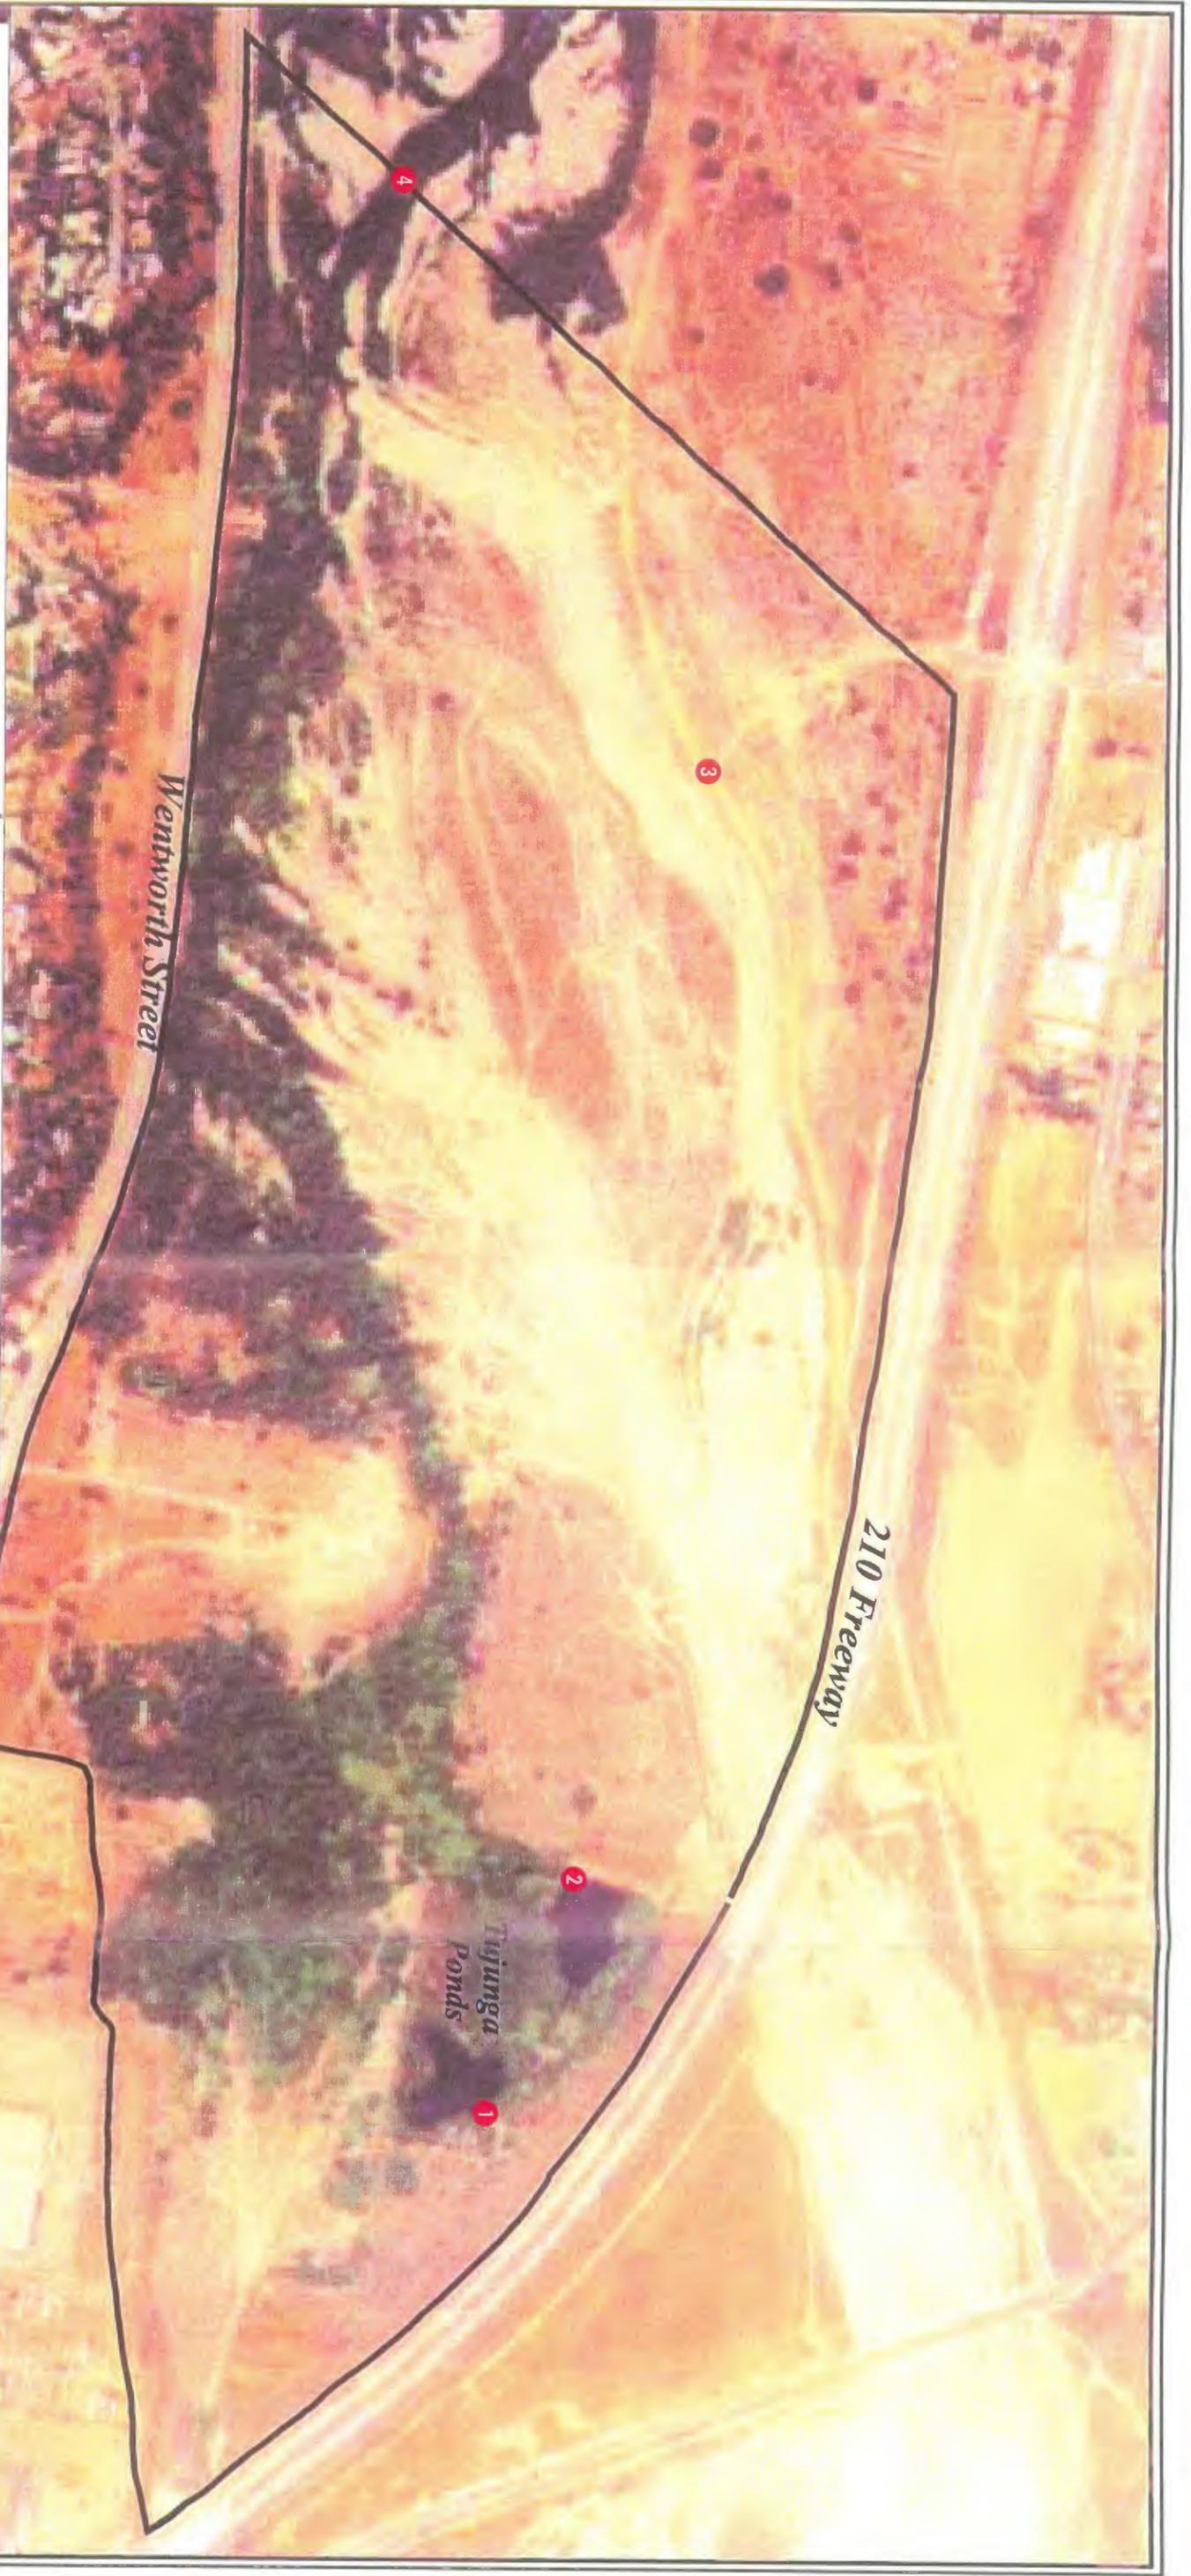
Water quality monitoring sites were permanently established with a Global Positioning System (GPS) at various locations along Haines Canyon Creek and Big Tujunga Wash. Three monitoring sites were located along Haines Canyon Creek. One site was located at the inflow to the Tujunga Ponds; a second site was located at the outflow of the Tujunga Ponds; and the third site was located in Haines Canyon Creek, just before it exits the Mitigation Bank. A fourth water quality monitoring station was also established in Big Tujunga Wash and sampling was performed if flowing water is present during the quarterly sampling visits. Figure 10-1 shows the locations of the four sampling locations.
