# 2021 ANNUAL MONITORING REPORT (YEAR 2)

## DEVIL'S GATE OFF-SITE MITIGATION PROJECT

LOS ANGELES COUNTY, CALIFORNIA

USACE FILE No. SPL-2014-00591

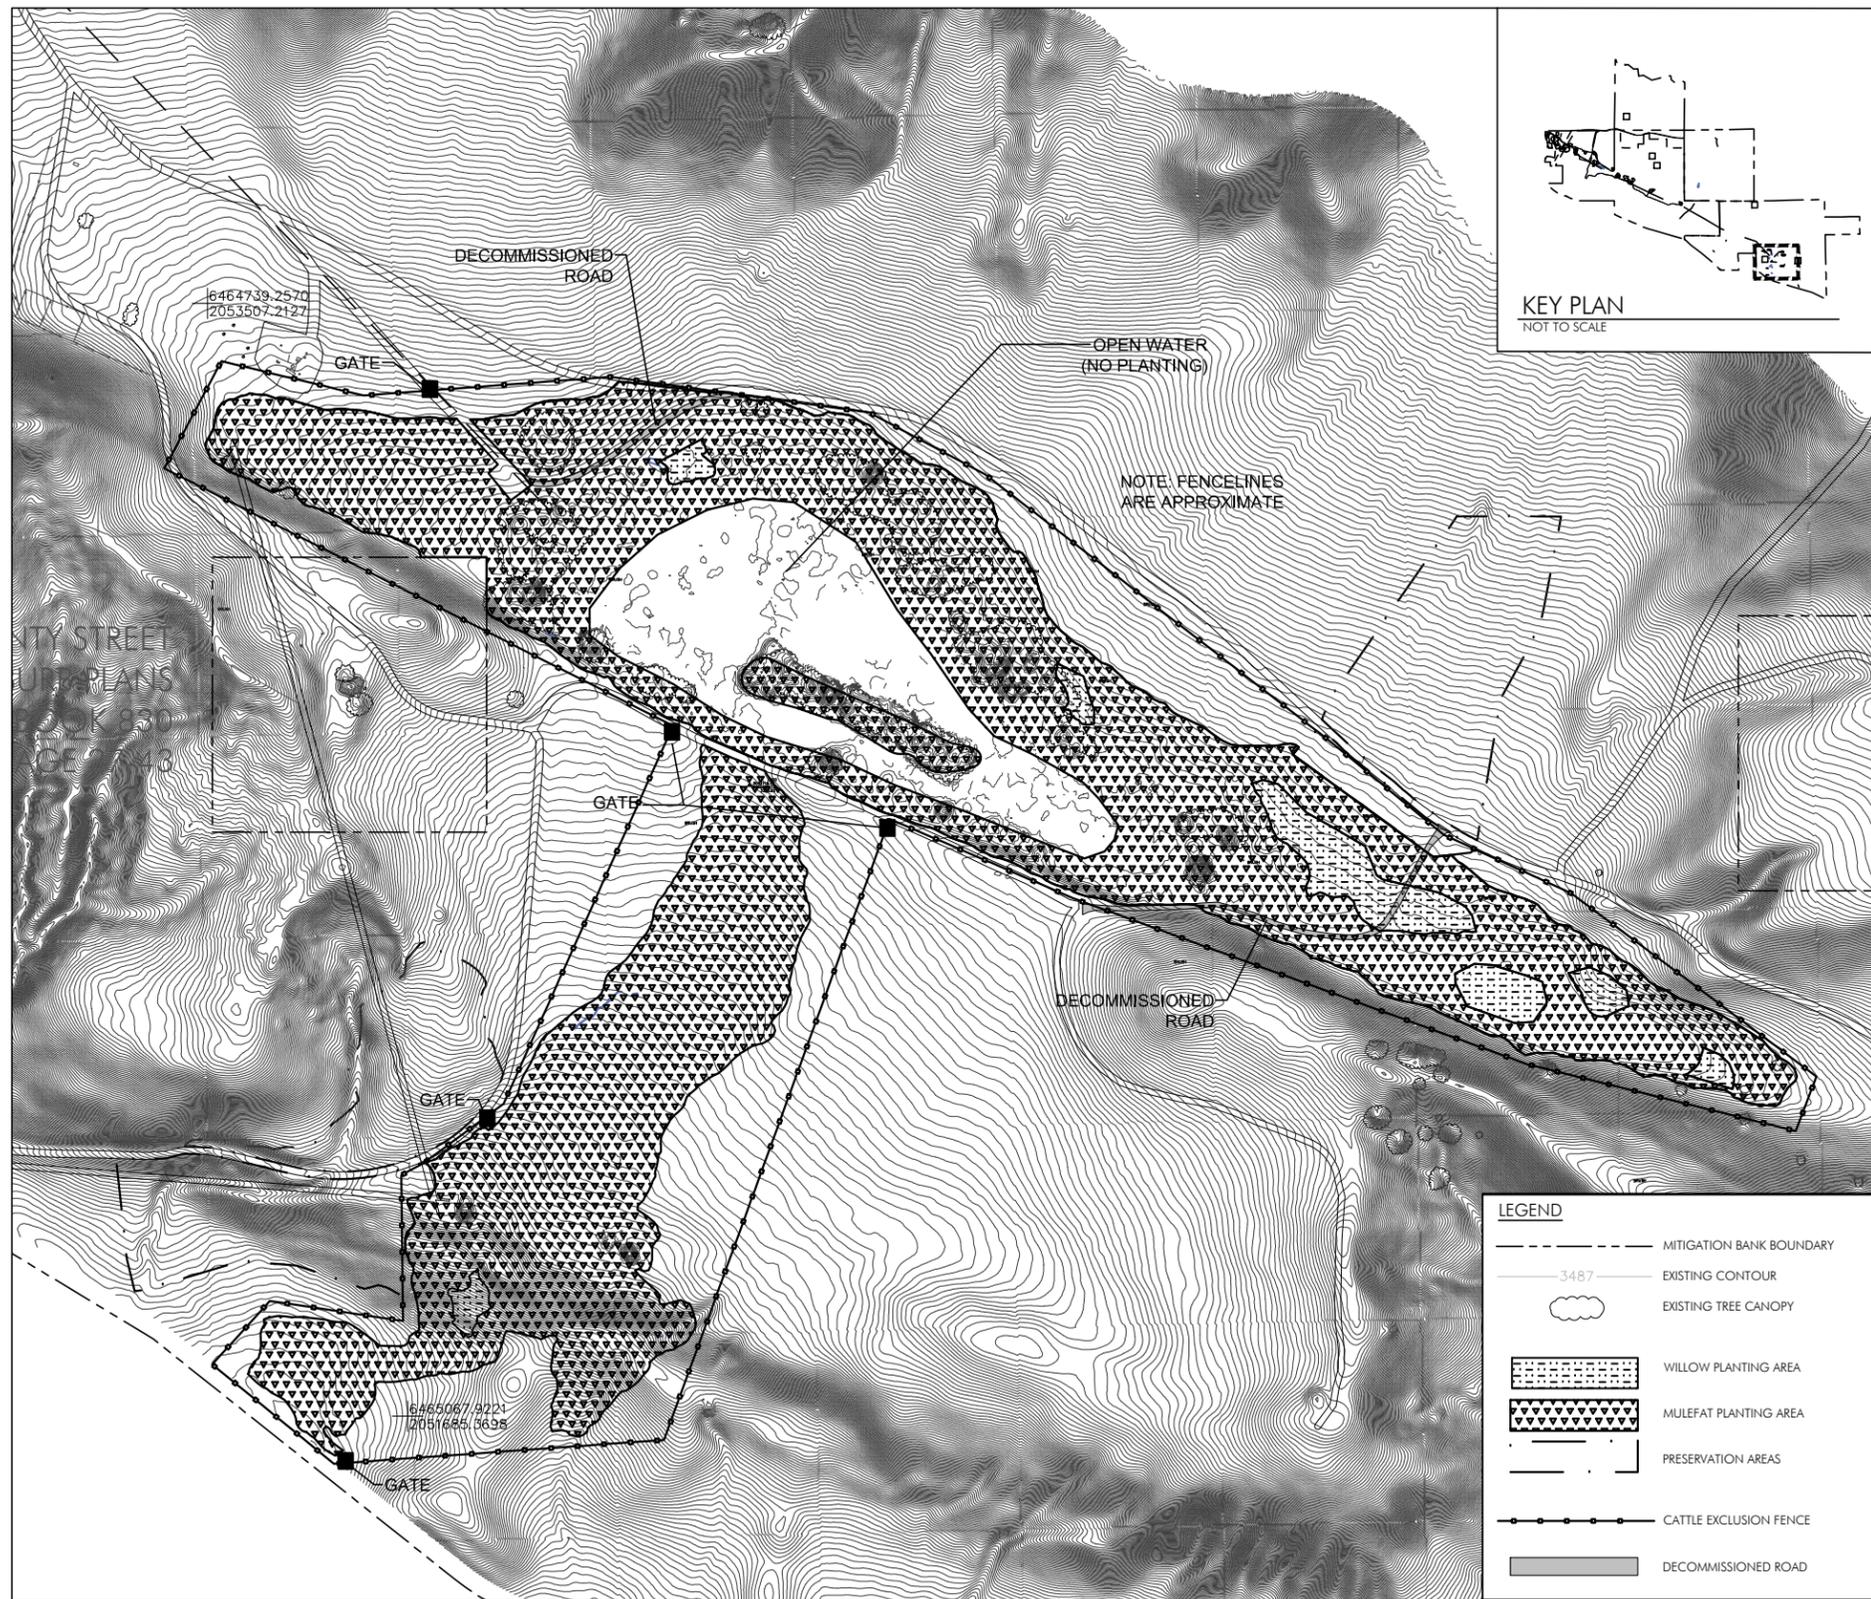
**FIGURE 3: DEVIL'S GATE  
 OFFSITE MITIGATION  
 AS-BUILT PLAN**

The locations of the cattle exclusion fencing, planting areas, and preservation areas are shown in Figure 3.

A wildlife-friendly cattle exclusion fence was installed around the designated planting areas to prevent livestock from grazing on riparian plants. Alignment of the cattle exclusion fencing was adjusted during installation to avoid sensitive habitat while providing full constructability.

Planting areas are within and immediately surrounding areas that previously supported sparse or scattered stands of mulefat, willow, and other riparian species. These areas were planted with 9,338 mulefat live stakes and 1,106 mixed red and arroyo willow live stake plantings to achieve an average density of 500-stems per acre, similar to existing high density mulefat and willow stands within the Mitigation Site. All plantings were live pole cuttings harvested from plants within the Bank to preserve local genetics. Willow plantings were focused in the wettest portion of the Mitigation Site, primarily around Pond D, as well as a few other locations where groundwater seeps were sufficient to support the species; mulefat plantings are therefore more widespread throughout the Mitigation Site. In total, 27.67 acres were planted.

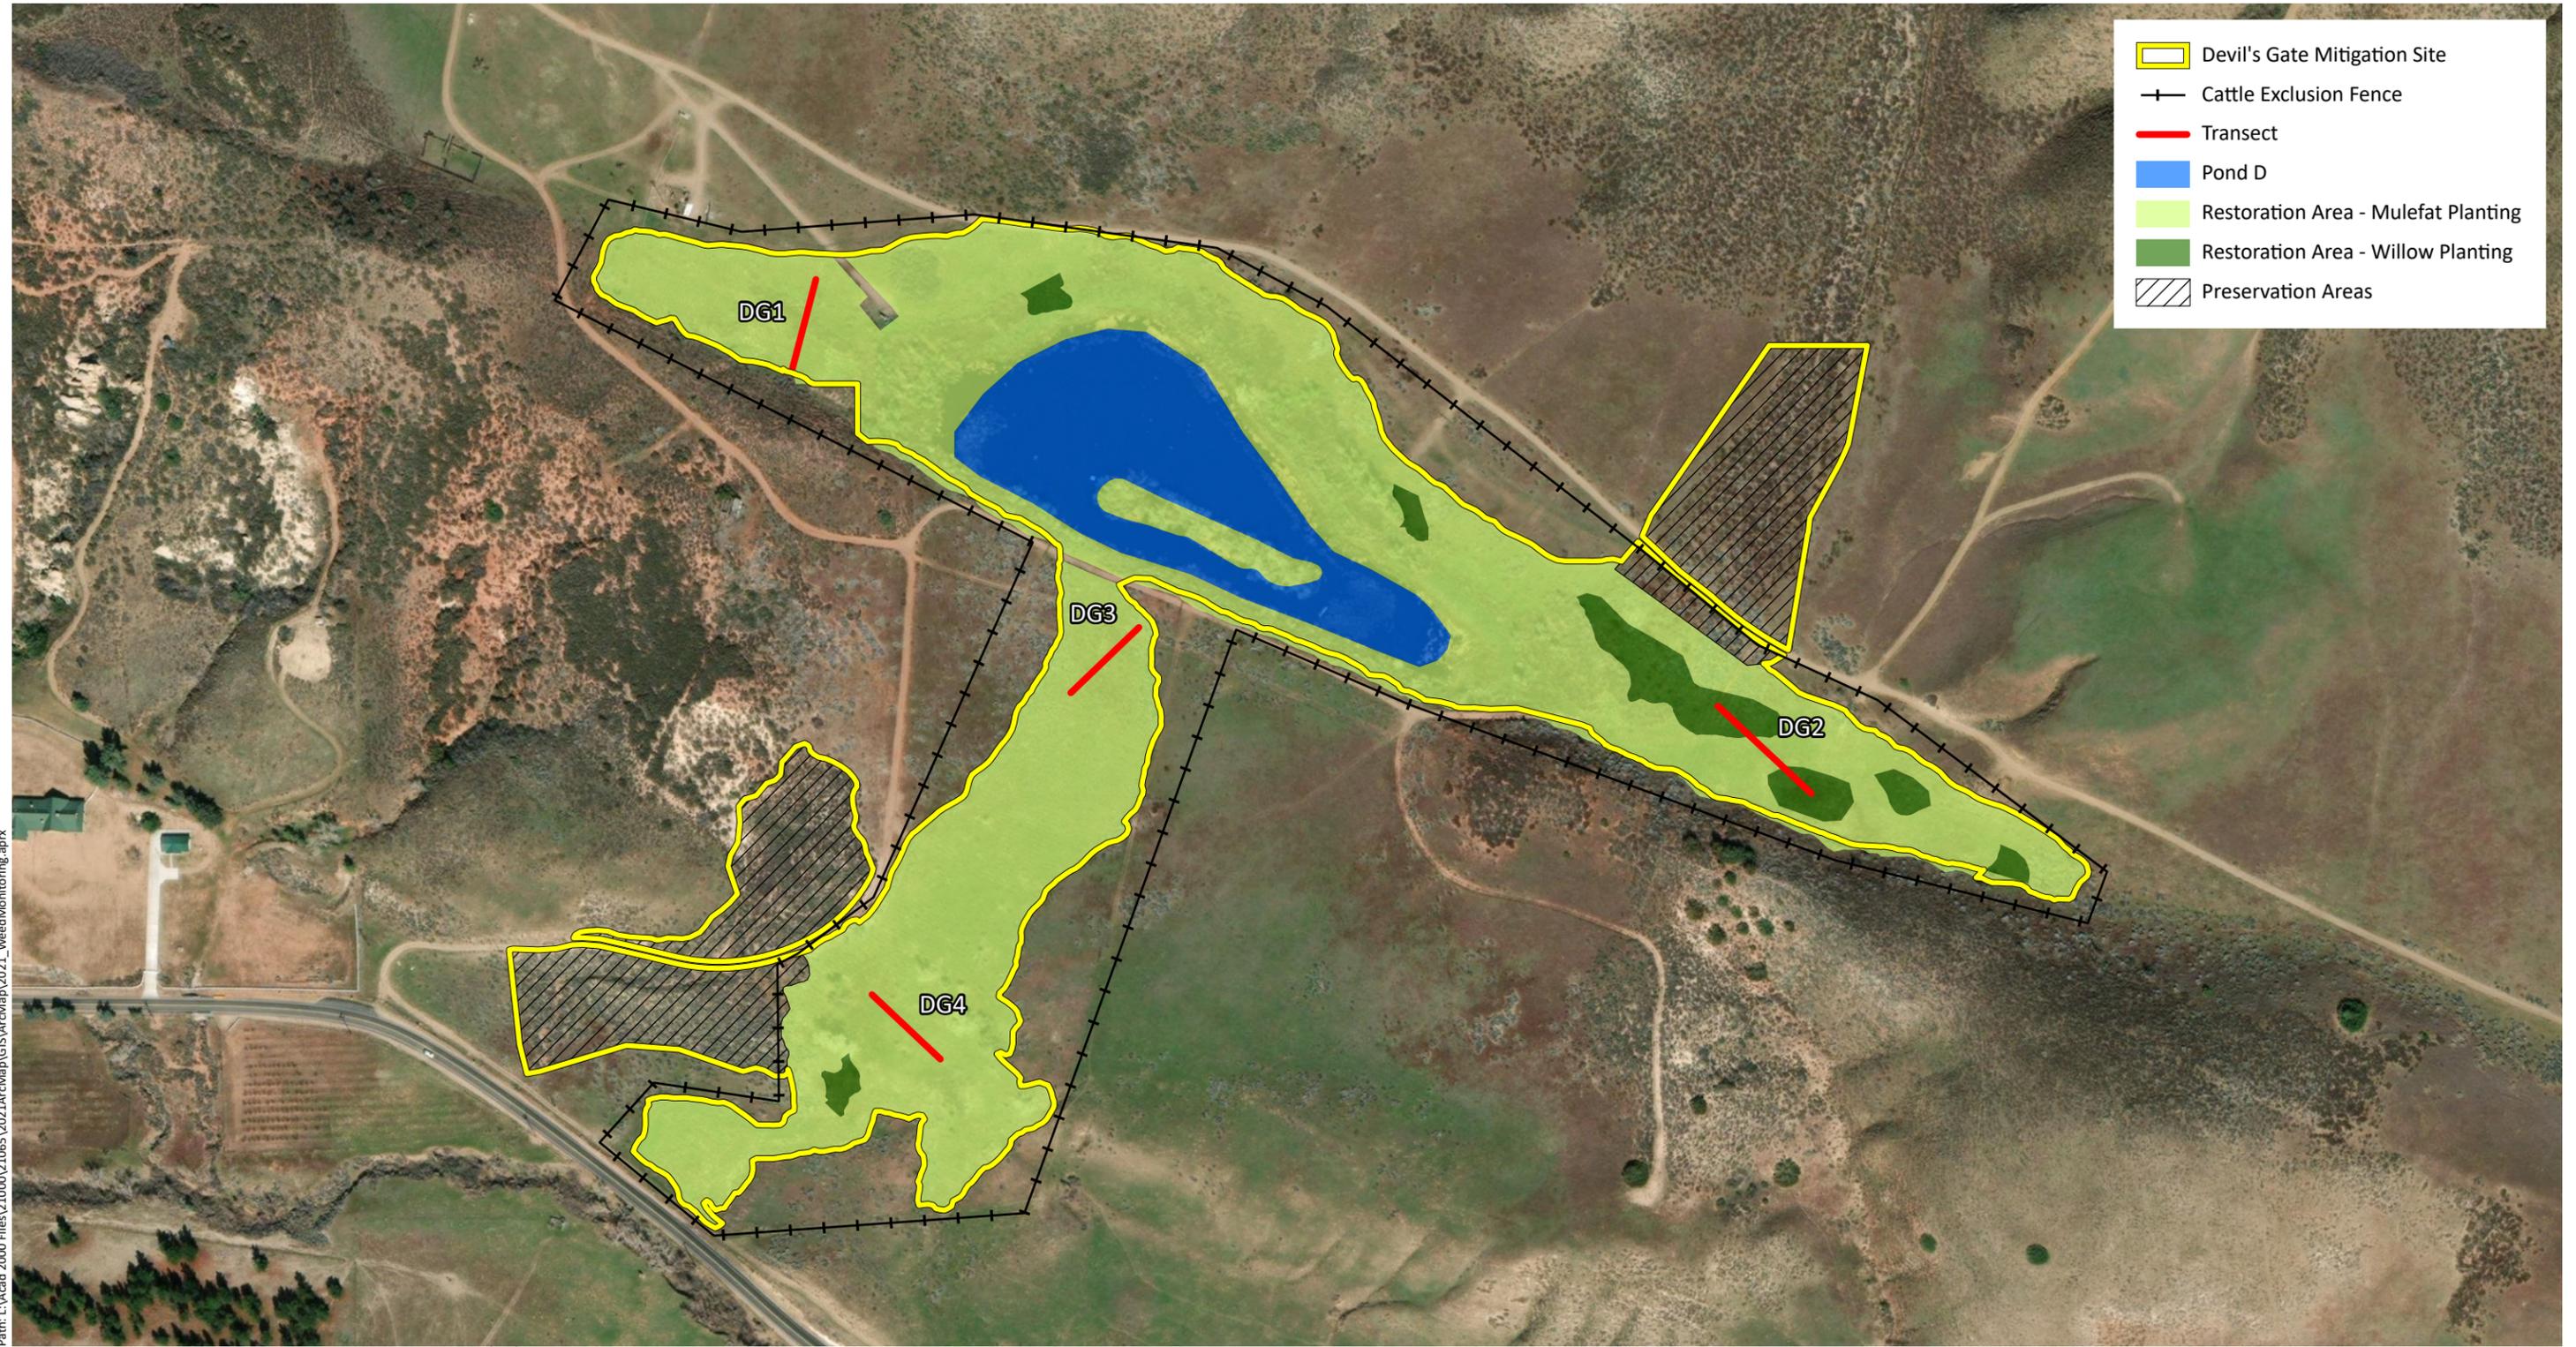
**Figure 4. Mitigation Site Monitoring Locations**

Permanent 50-meter transects were established within planting areas (Figure 4). Transects were permanently marked in the field using T-posts. Global Positioning System (GPS) points were recorded to repeat transect monitoring in future years, and photos were taken at the start and end of each transect. Each 50-meter transect was surveyed by walking a 2.5 meter wide belt transect and recording species and species cover class<sup>1</sup> every 5 meters, resulting in 10 sampling plots per transect. Species and species cover class were recorded within each plot in order to assess the performance standards outlined in Table 1. A photograph was taken of each plot.

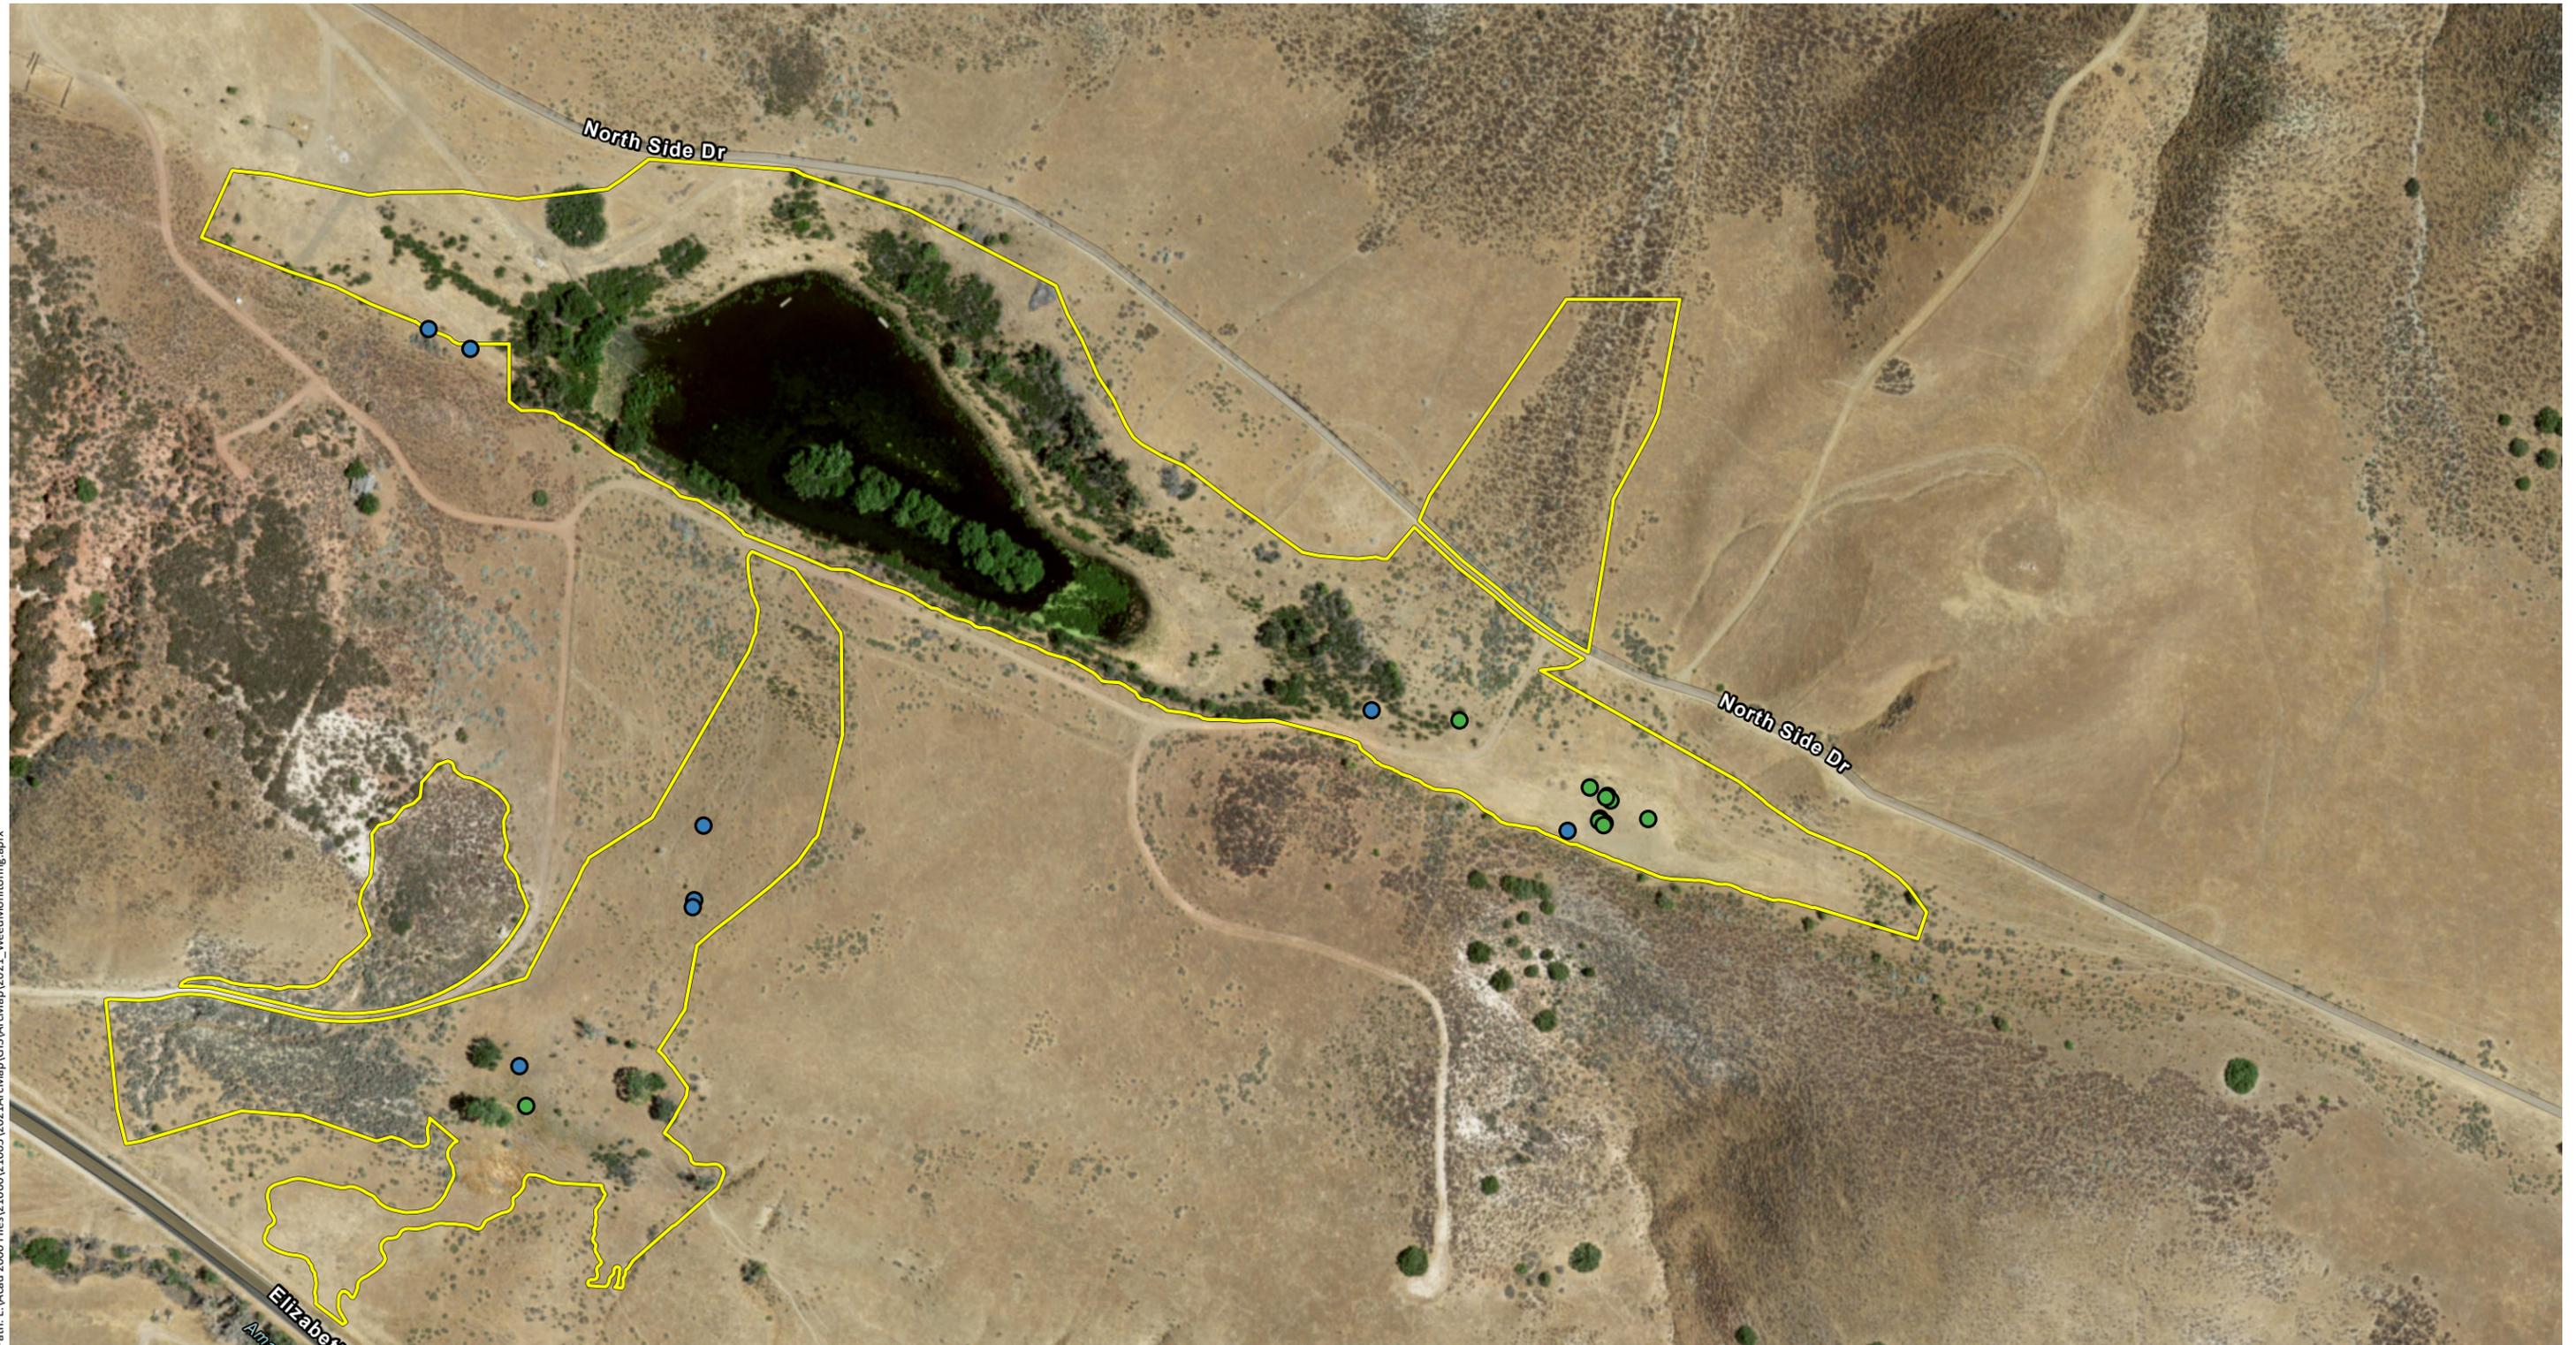
**Figure 5: Mulefat and Willow Mortality Map**

Survivorship for mulefat, willow, and combined was over 99% (Table 4). Annual monitoring survivorship surveys detected minimal amounts of dead mulefat or willow plantings, with only eight dead mulefat and ten dead willows observed. The results of Year 2 mortality mapping are shown in Figure 5.

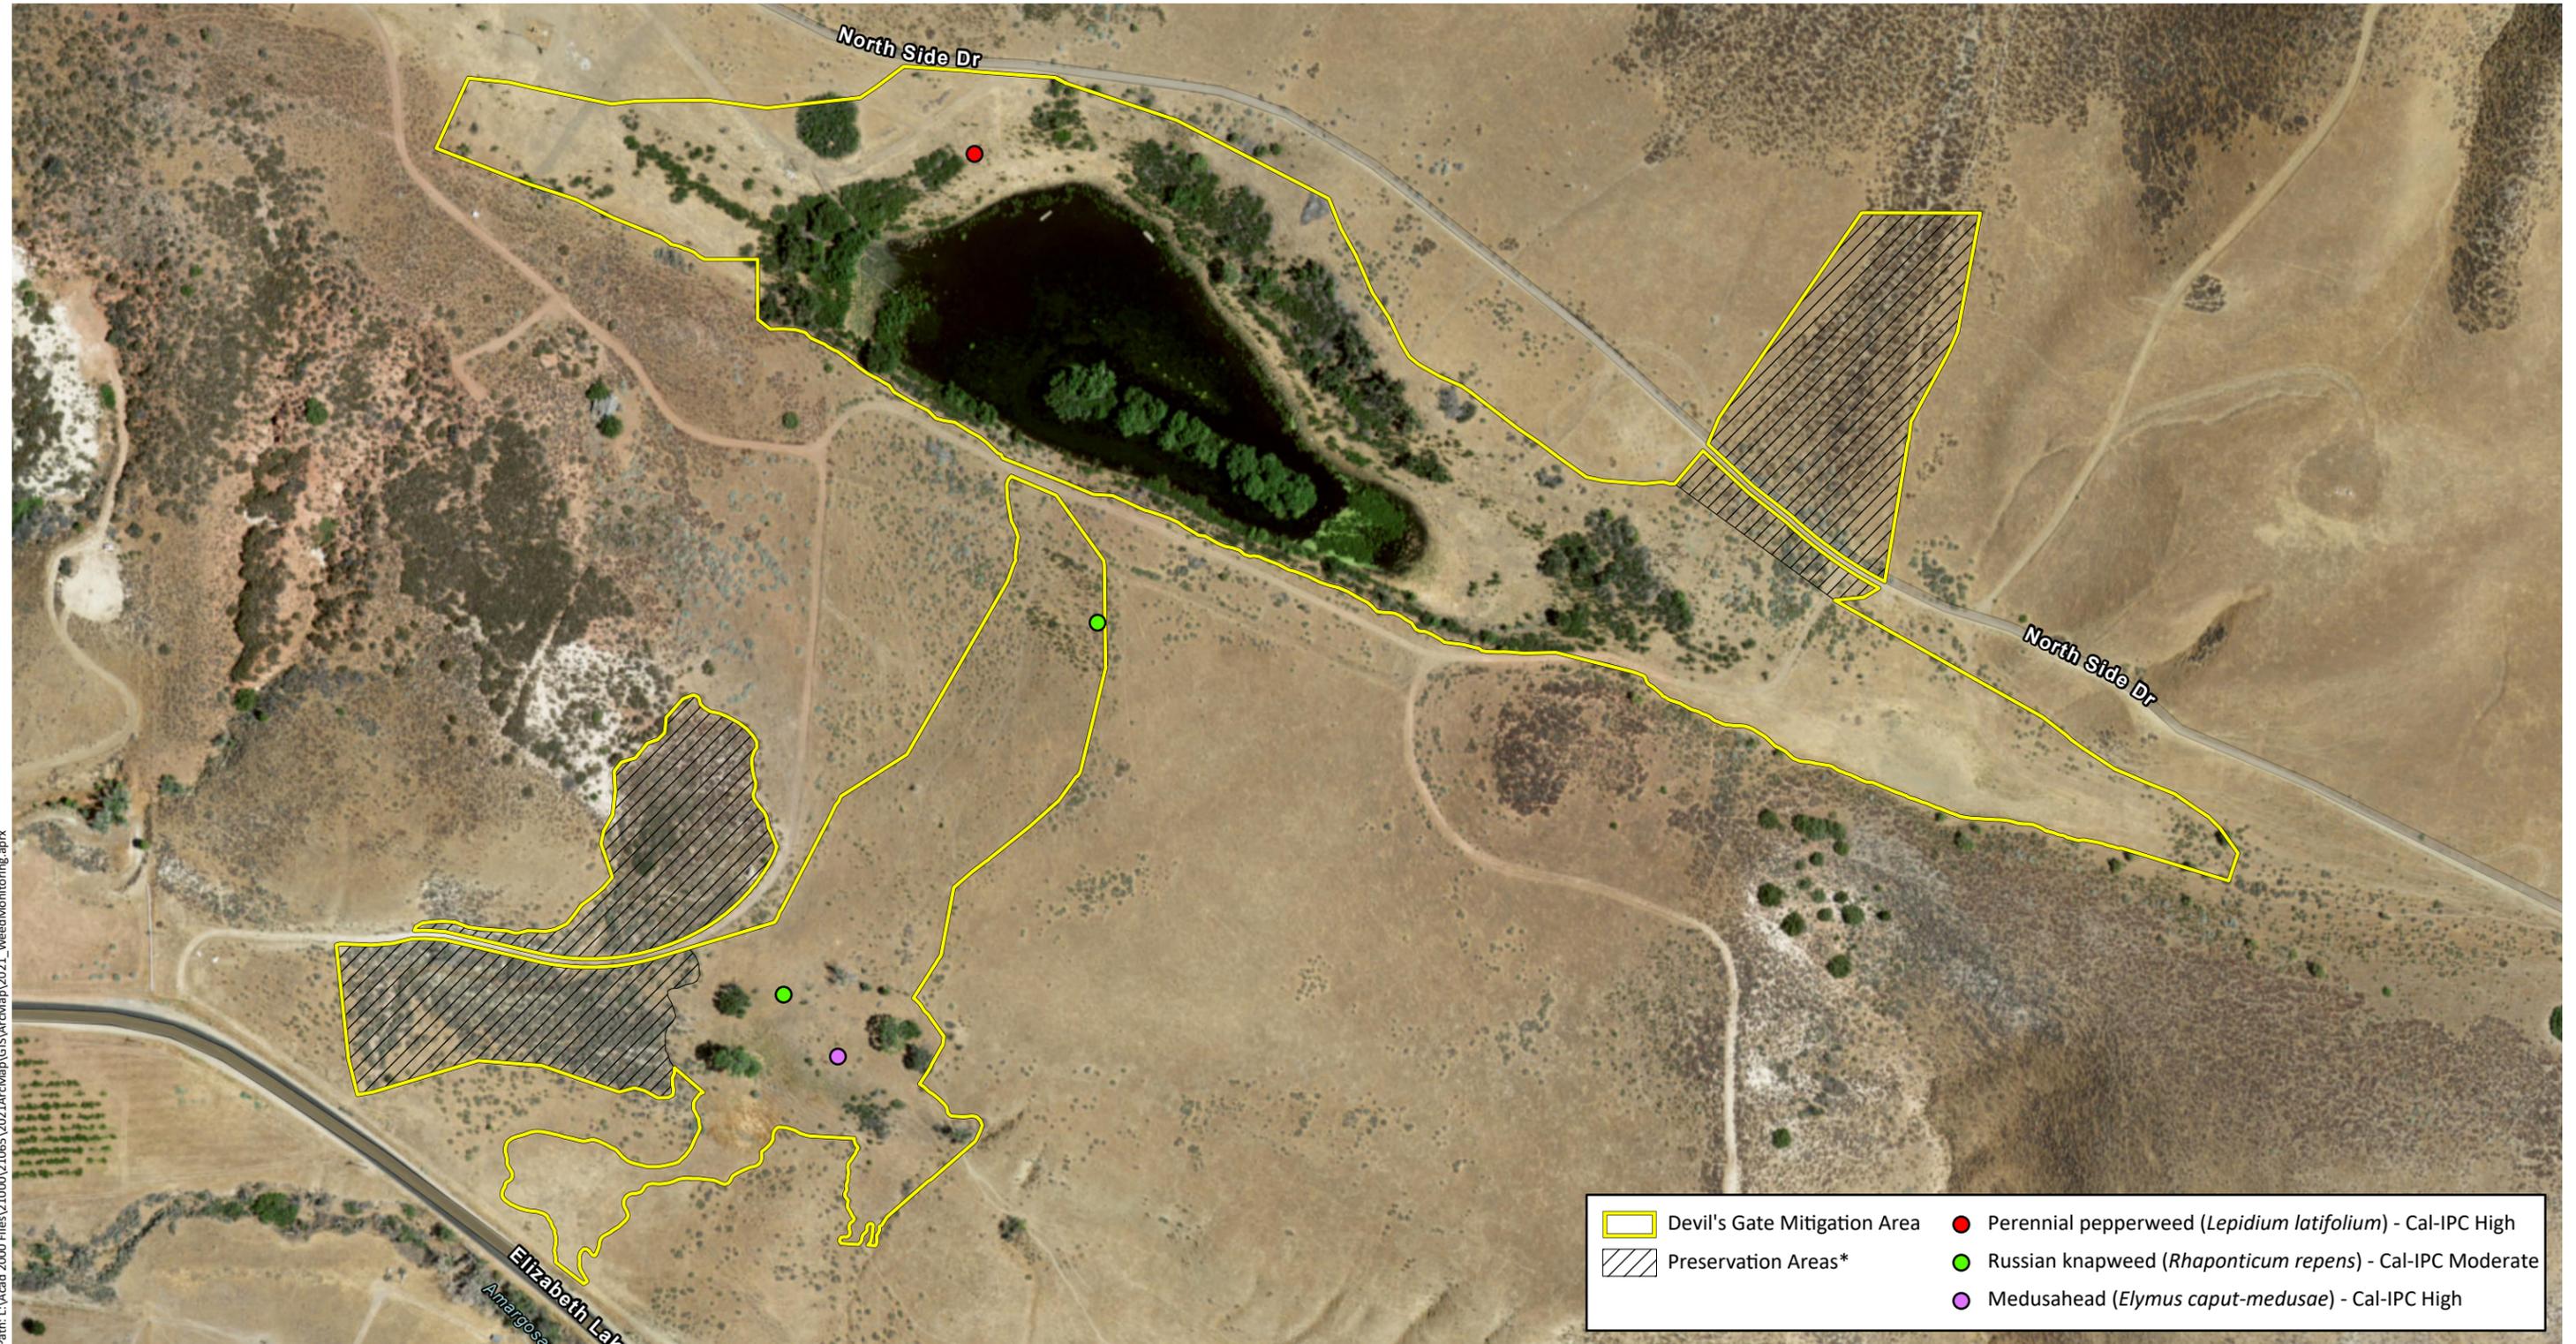
**Figure 6. Target Non-Native Invasive Plants within Mitigation Site Planting Areas**

Three Cal-IPC High grasses are present: red brome, cheatgrass, and medusahead (*Elymus caput-medusae*). Red brome and cheatgrass were the most abundant of the Cal-IPC High species present at the Mitigation Site, and both are locally abundant in the region and within the Bank property. These species are managed within the Mitigation Site to promote the establishment of native species. Conversely, only one medusahead skeleton from the previous season was observed within the Mitigation Site; no new recruitment was observed this year. Medusahead populations are small and localized within the Bank property and are the subject of eradication efforts by Land Veritas staff to prevent recruitment into the Mitigation Site.

Perennial pepperweed, a broad-leaved plant species ranked High by Cal-IPC, was observed at the Mitigation Site this year. Although perennial pepperweed has been documented within the Petersen Ranch Mitigation Bank in the past, this is the first time it has been observed within the Mitigation Site. Given the extent of its presence, the novelty of the observation is likely due to the visual similarity of perennial pepperweed and hairy whitetop (*Lepidium appelianum*), another broad-leaved plant species rated Limited by CAL-IPC, while the two species are in their vegetative stages. Land Veritas staff have been trained or retrained on the identification of these two species and have begun working on controlling populations of perennial pepperweed.

Several occurrences of Russian knapweed (*Rhaponticum repens*; Cal-IPC Moderate) were observed within the Mitigation Site. This species has been targeted for removal and Ranch staff were given specific management and removal directions to ensure this species is controlled utilizing best practices.

The results of the Year 2 target NNIP species mapping are shown on Figure 6.

NNIPs surrounding each planted stake are cleared in the spring and managed throughout the growing season. It is recommended that NNIP treatment within the Mitigation Site continue in conjunction with invasive species treatments across the rest of the Bank Property.

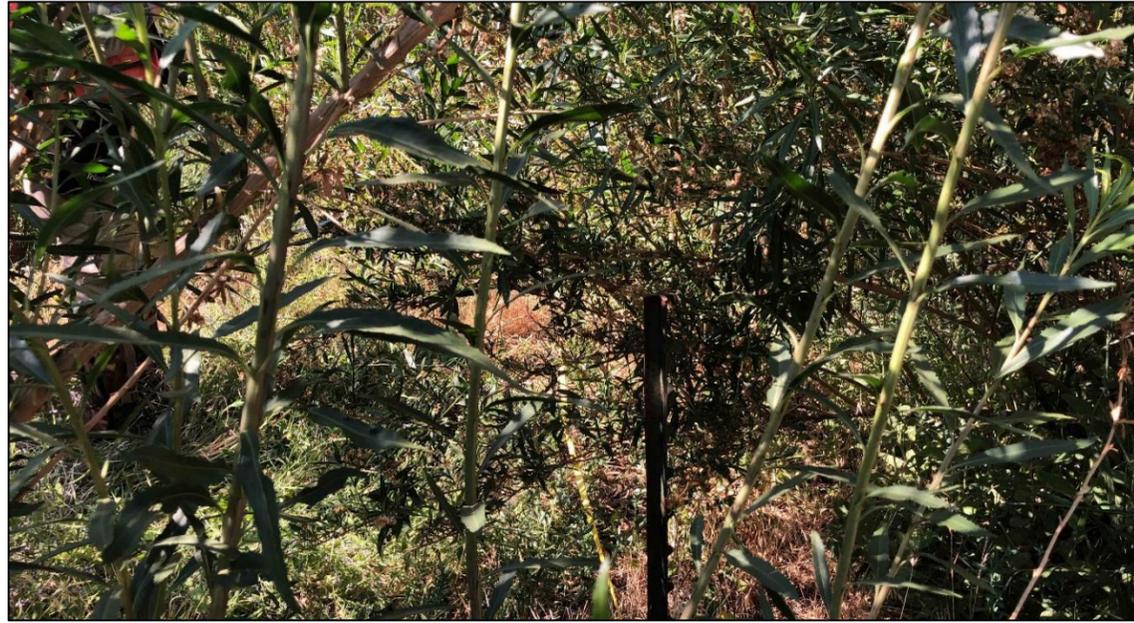
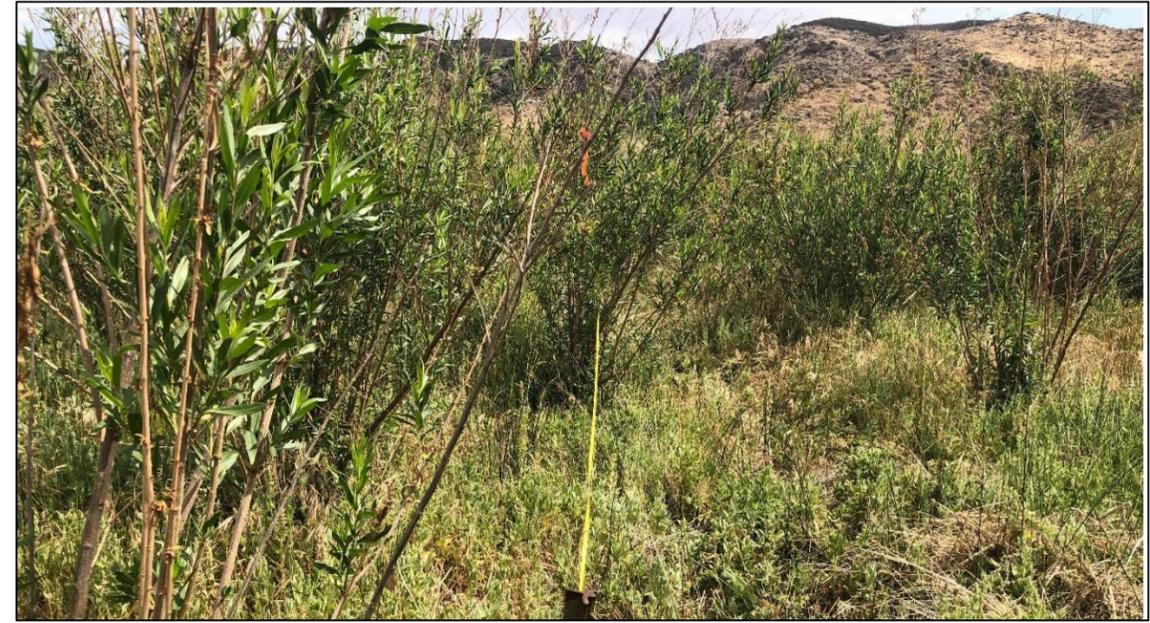
Transect DG1. Taken June 17, 2021.

PERFORMANCE METRIC	DG1	DG2	DG3	DG4	AVERAGE	YEAR 2 PERFORMANCE STANDARD	YEAR 2 PERFORMANCE STANDARD MET?
Mulefat and Willow Total Absolute Cover	48.8%	15.5%	45.8%	22.1%	33.0%	>10%	Yes
Cal-IPC High Cover*	0.0%	0.0%	0.0%	0.0%	0.0%	<10%	Yes

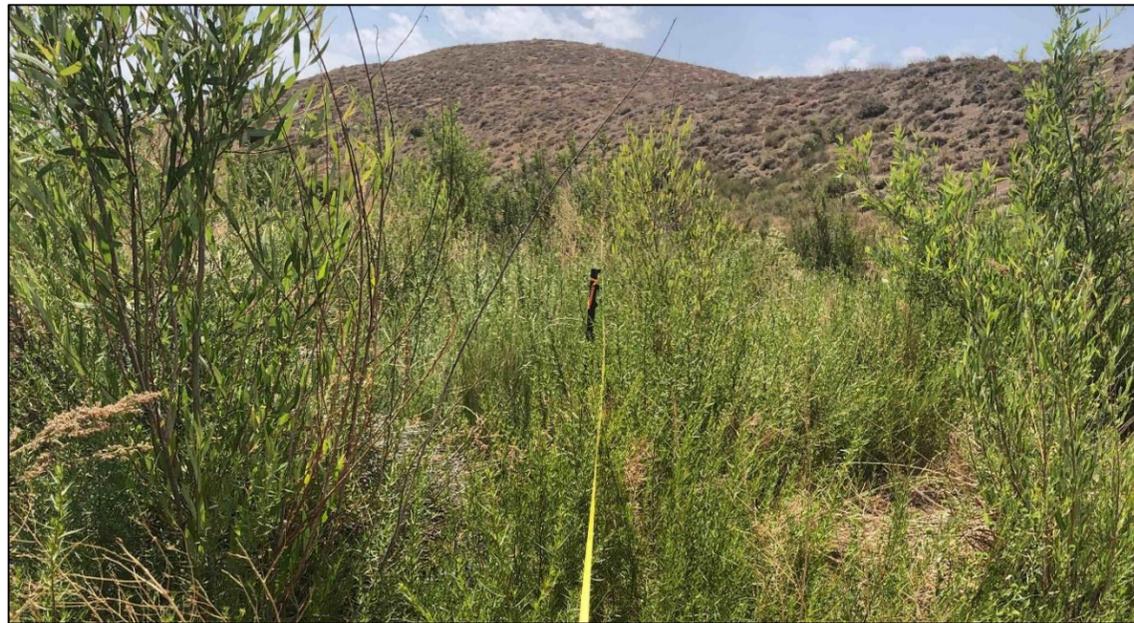
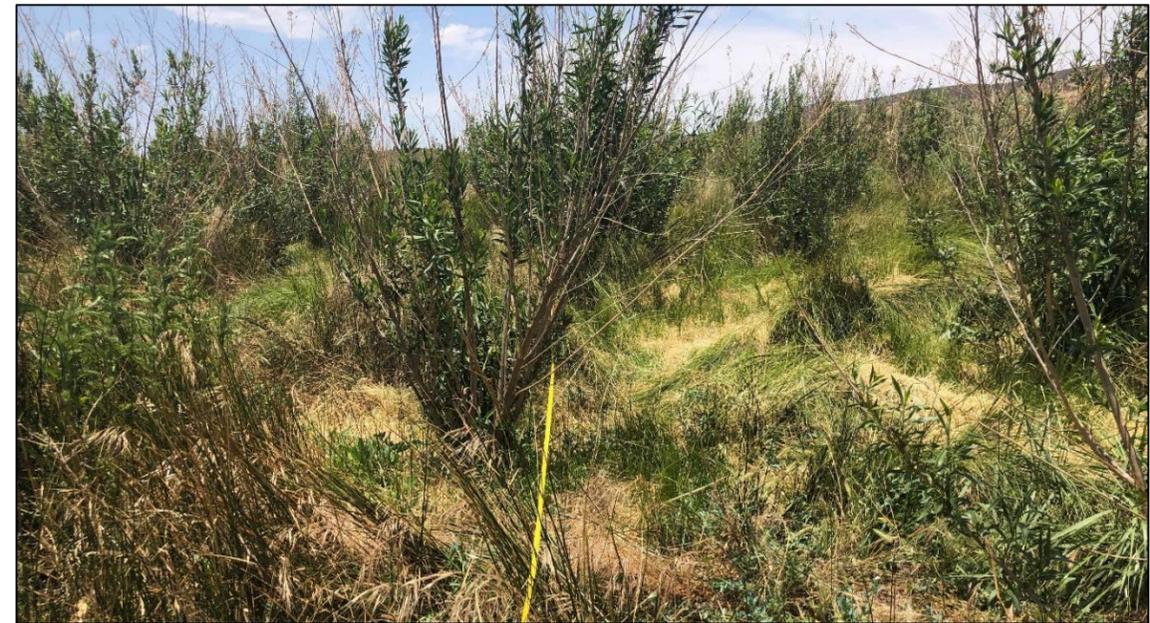
Transect DG2. Taken June 17, 2021.

Though the Mitigation Site is meeting the Year 2 performance standards, the annual monitoring data indicates low cover of mulefat and willow at transects DG2 and DG4. The likely reason for the low cover at DG2 is prolonged ponding, and despite the low cover of mulefat, this transect had the highest willow cover. Additionally, the transect is dominated by native species. Year 2 annual monitoring at DG2 revealed the total absolute cover of native species is 77.0%, with the dominant native species consisting of beardless wild rye (31.0% absolute cover), western vervain (6.6% absolute cover), and red willow (6.5% absolute cover). While DG4 is meeting the Year 2 performance standards, the margin of success is narrow, and the associated portion of the Mitigation Site should be monitored closely in order to ensure successful establishment of installed live stakes. It should be noted that portions of DG4 with lower mulefat cover are dominated by other native perennials including tarragon, gumweed, and foothill needle grass (*Stipa lepida*).
