APPENDIX D – Biological Resources Reports

APPENDIX D 1– Biological Technical Report

**BIOLOGICAL TECHNICAL REPORT FOR THE
DEVIL'S GATE RESERVOIR PROJECT SITE IN
THE CITY OF PASADENA,
LOS ANGELES COUNTY, CALIFORNIA**

November 2010

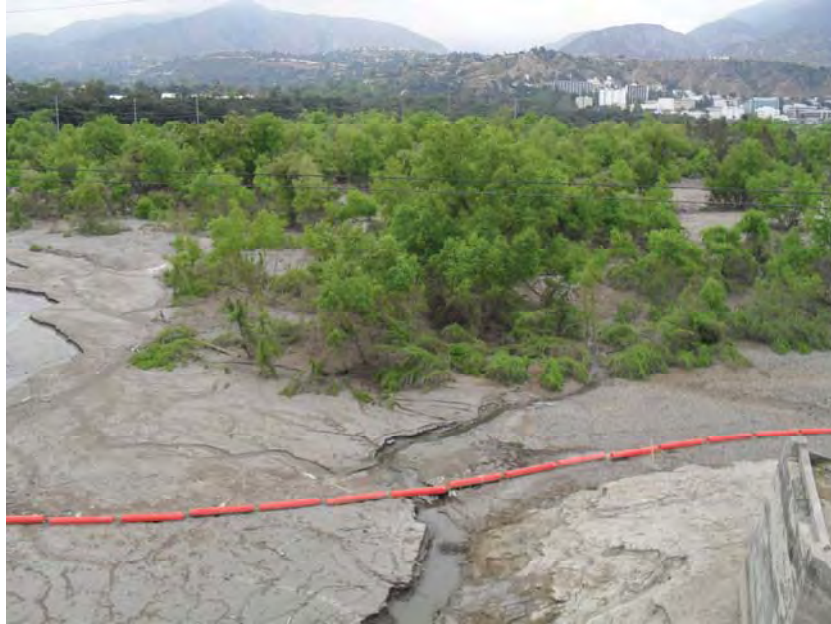
Photo 1: Photo taken looking northwest depicting the Arroyo Seco stream in the Devil's Gate Reservoir directly behind the dam wall. Scoured and Black Willow Series vegetation communities are within the reservoir along the ephemeral stream.

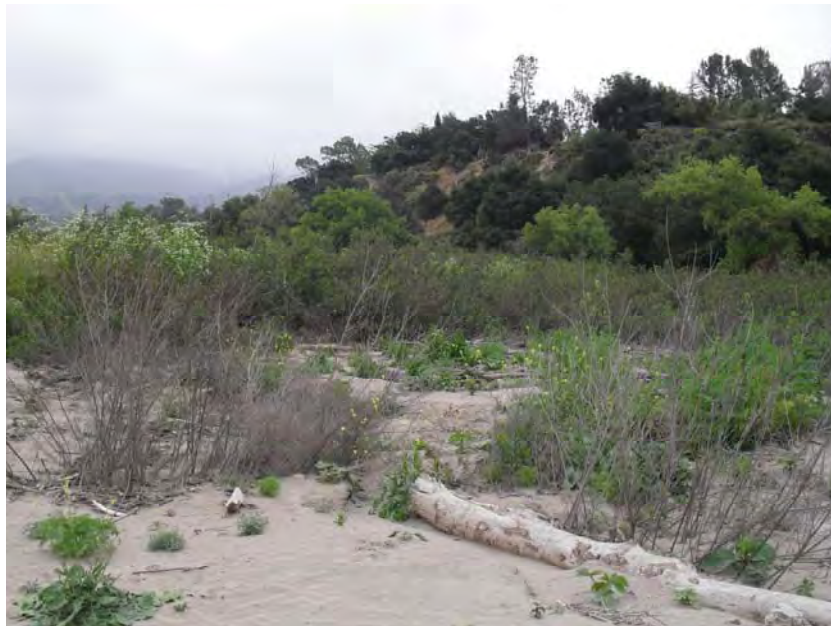
Photo 2: Photo depicts Riparian herbaceous community with Mulefat Scrub behind it and Oak Woodland on the slopes in the background.

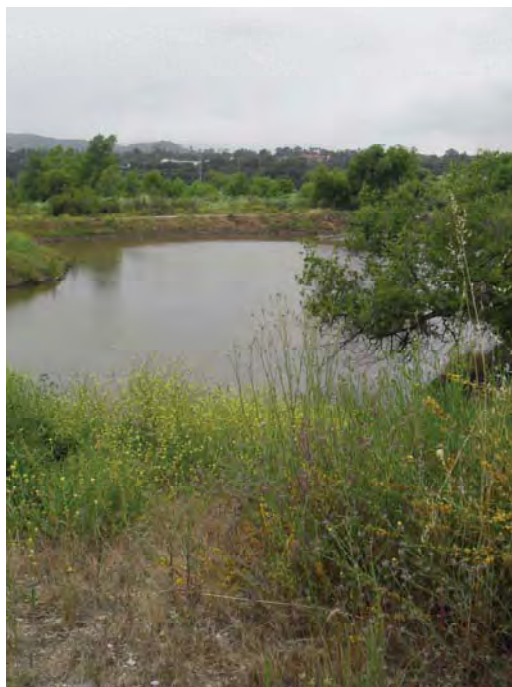
Photo 3: Photo taken looking east depicting one of the many inactive retention basins within the reservoir and Survey Area. This was the only basin that contained water. The water in the basin was a result of rain water and is dry most of the year. The basin is surrounded by disturbed Upland vegetation.

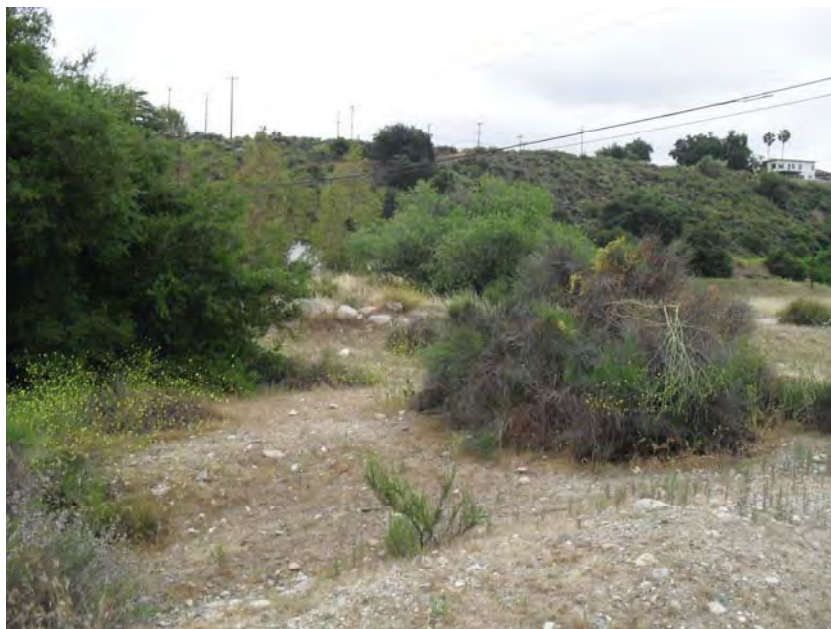
Photo 4: Photo depicting disturbed areas and Coastal Sage Scrub communities. Residential areas border the reservoir on the east.

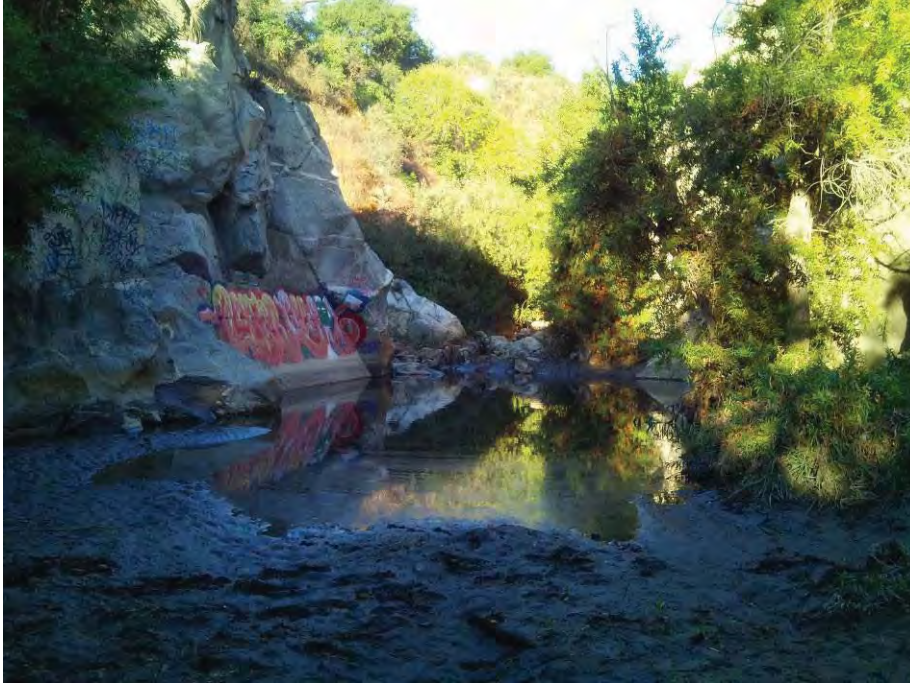
Photo 1. Photo of Area 1 below the dam. This area consisted of isolated pools with sandy substrates and areas with anaerobic conditions. The stream moves through a mature riparian corridor. Photo is facing north.

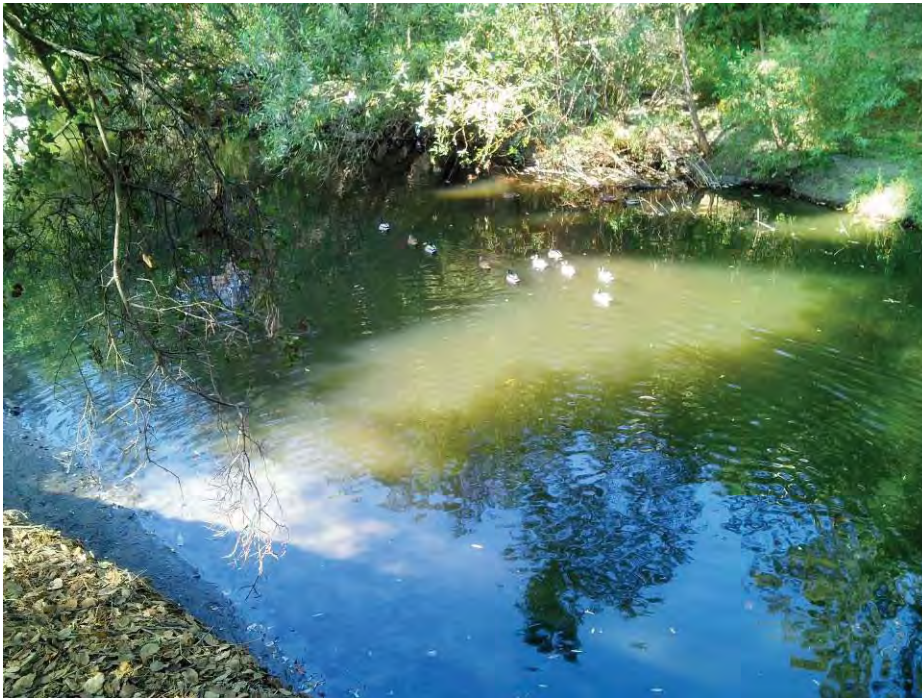
Photo 2. Photo of large pool in Area 2. Sandy and rocky substrates, undercut banks, and vegetative cover were present within the streambed that could provide cover/shelter for fish species. Photo is facing north.

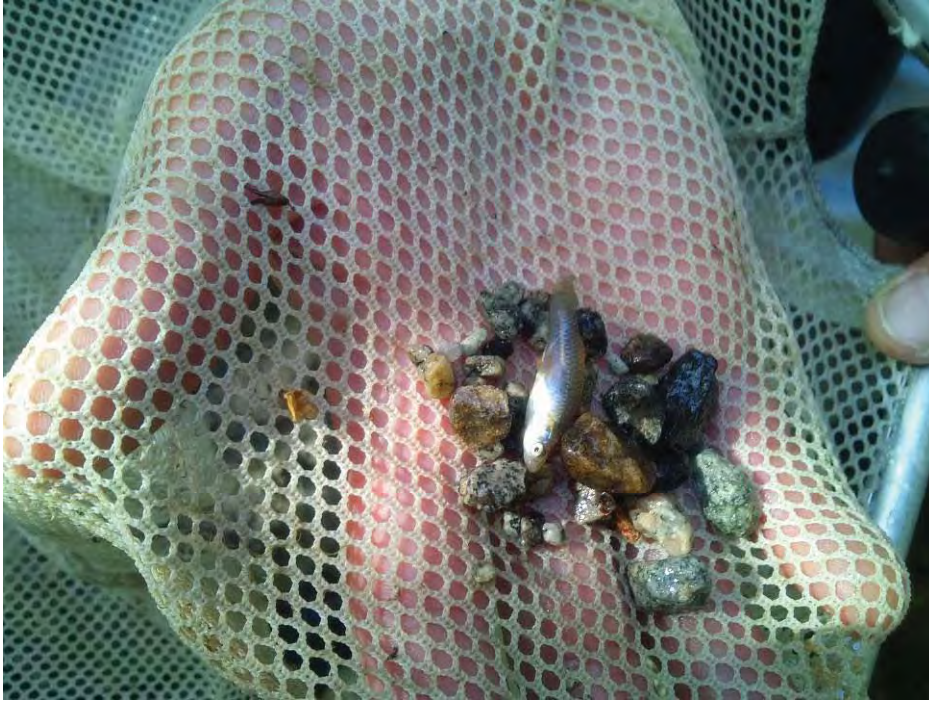
Photo 3. Photo showing mosquito fish observed in Area 2. Approximately 60 mosquito fish were identified during the survey effort. No other fish species were directly observed.

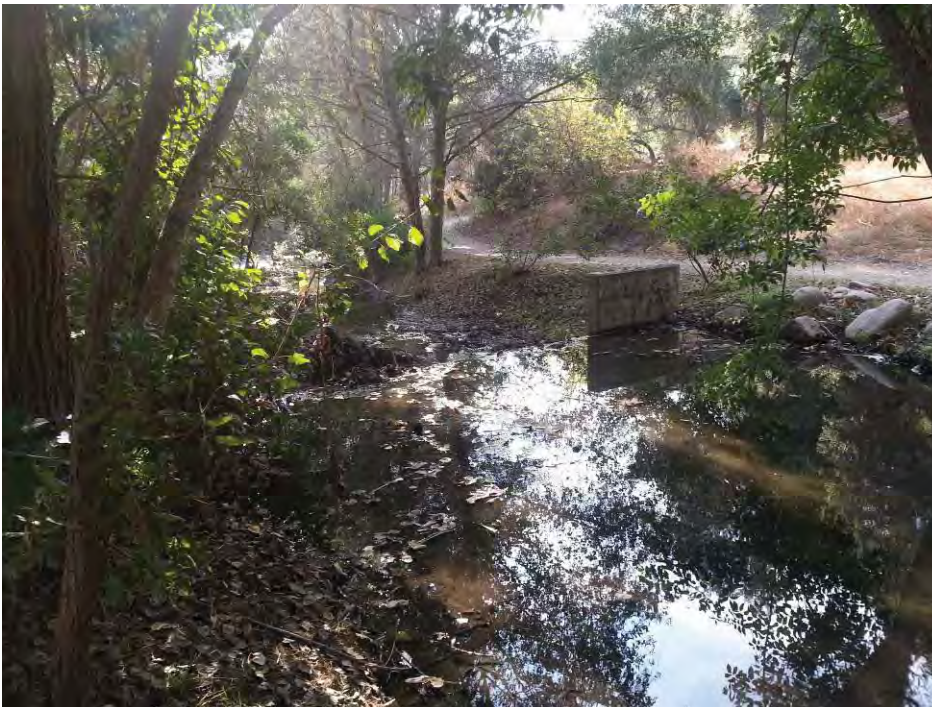
Photo 4. Photo showing Area 3 in the restoration areas. This section of the stream is adjacent to the concrete lined Arroyo Seco Channel. The cement spillover that directs water into the Arroyo Seco is a fish barrier, preventing upstream migration. Photo is facing south.

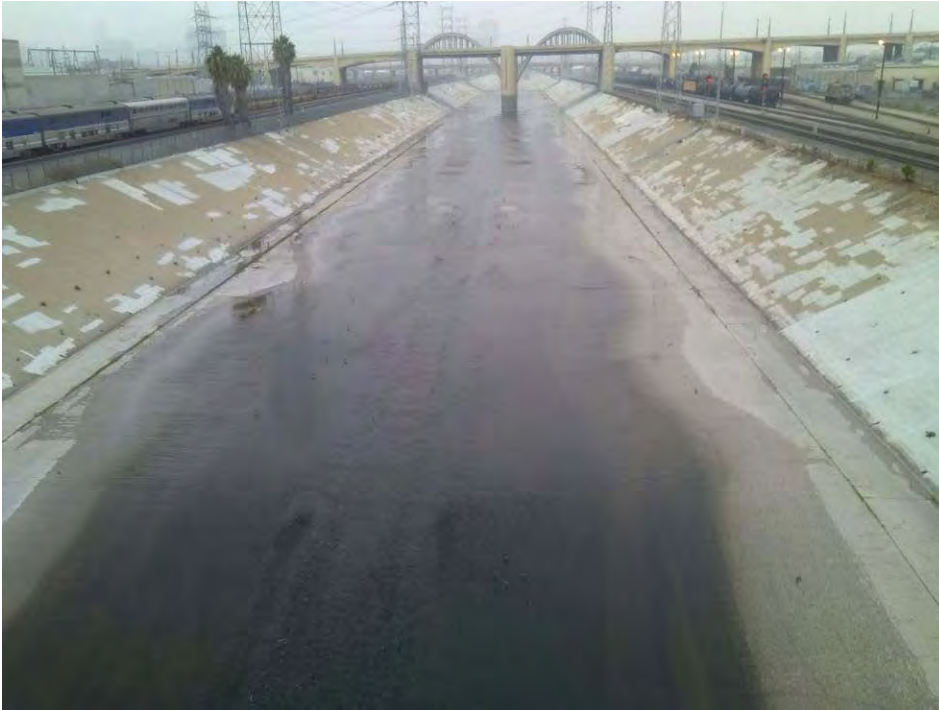
Photo 5. Photo showing Area 4, with little to no suitable shelter/cover for native fish. Photo is facing southwest.

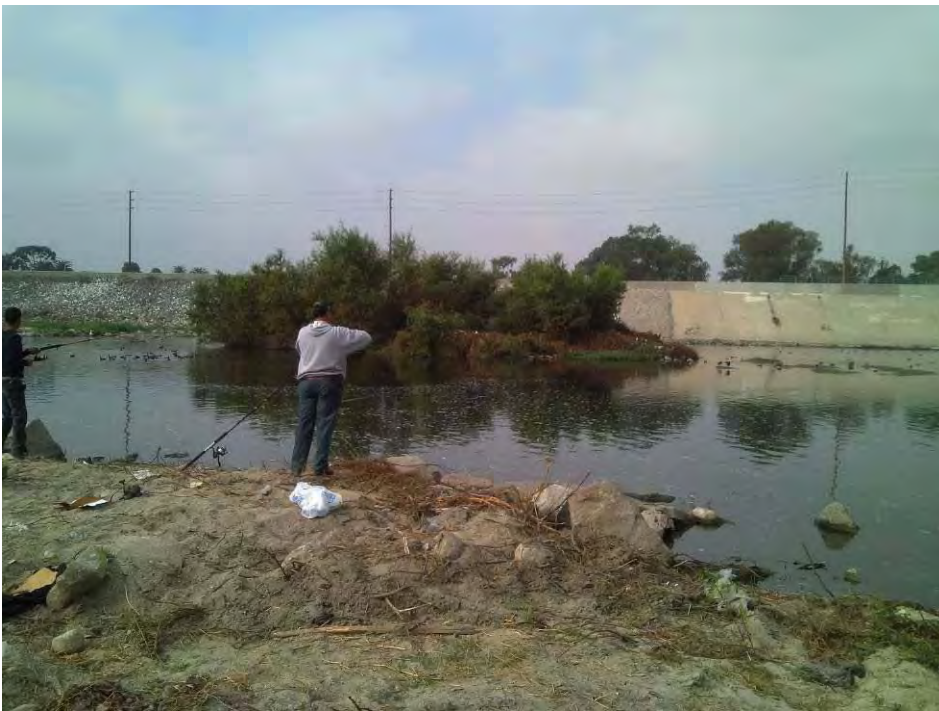
Photo 6. Photo showing Area 5. Area 5 contains suitable habitat for fish. Only non-native fish are expected to survive in this location. Photo is facing west depicting a local angler fishing for common carp.

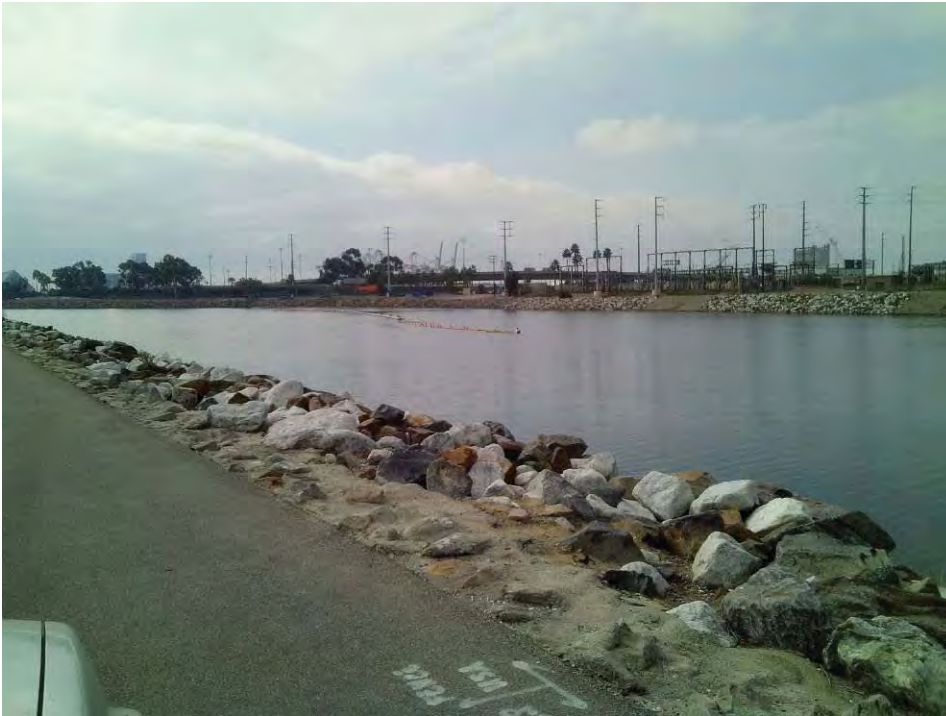
Photo 7. Photo showing Area 6, with suitable fish habitat for species adapted to high saline content waters. Photo is facing south.

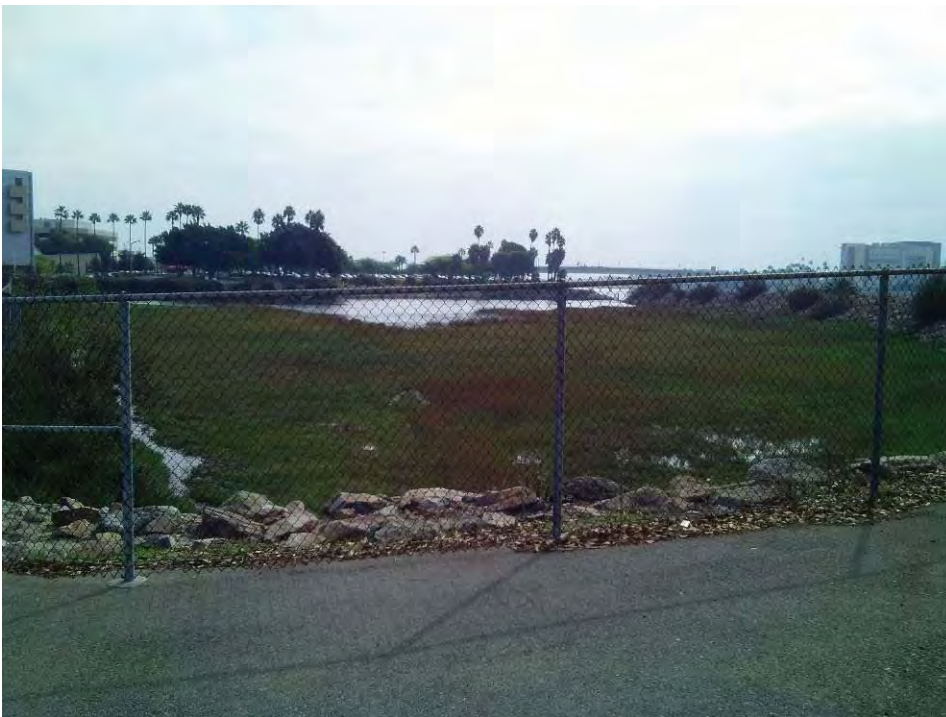
Photo 7. Photo showing an adjacent wetland area to Area 6, which opens to the ocean. This area is known as the Golden Shore Marine Reserve and is a mitigation site for the Rainbow Harbor. Photo is facing southwest.

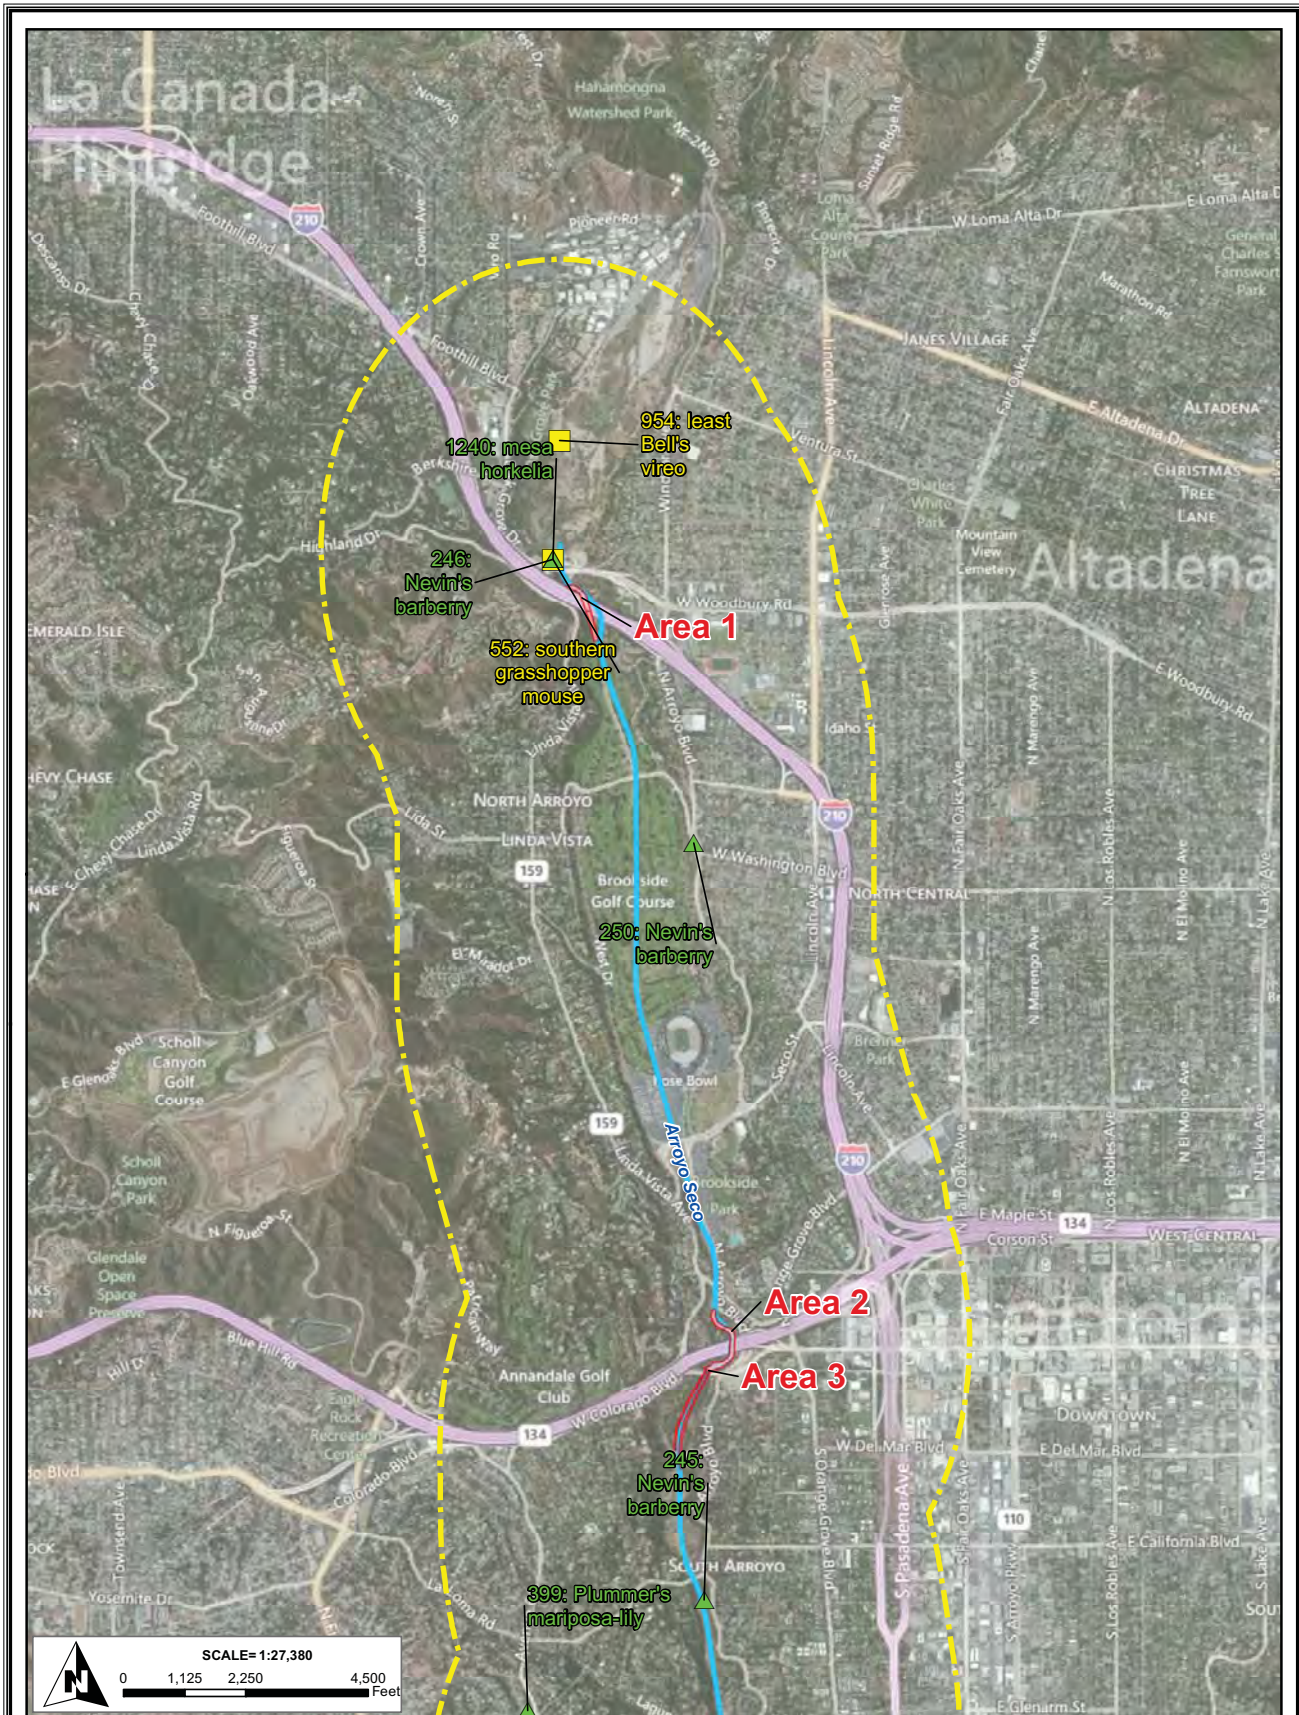
Attachment D
Devil's Gate Sediment Removal Project
CNDB Occurrences and Survey Areas

- Biological Survey Areas
- One-Mile Project Buffer
- CNDB Plant Occurrences
- CNDB Animal Occurrences

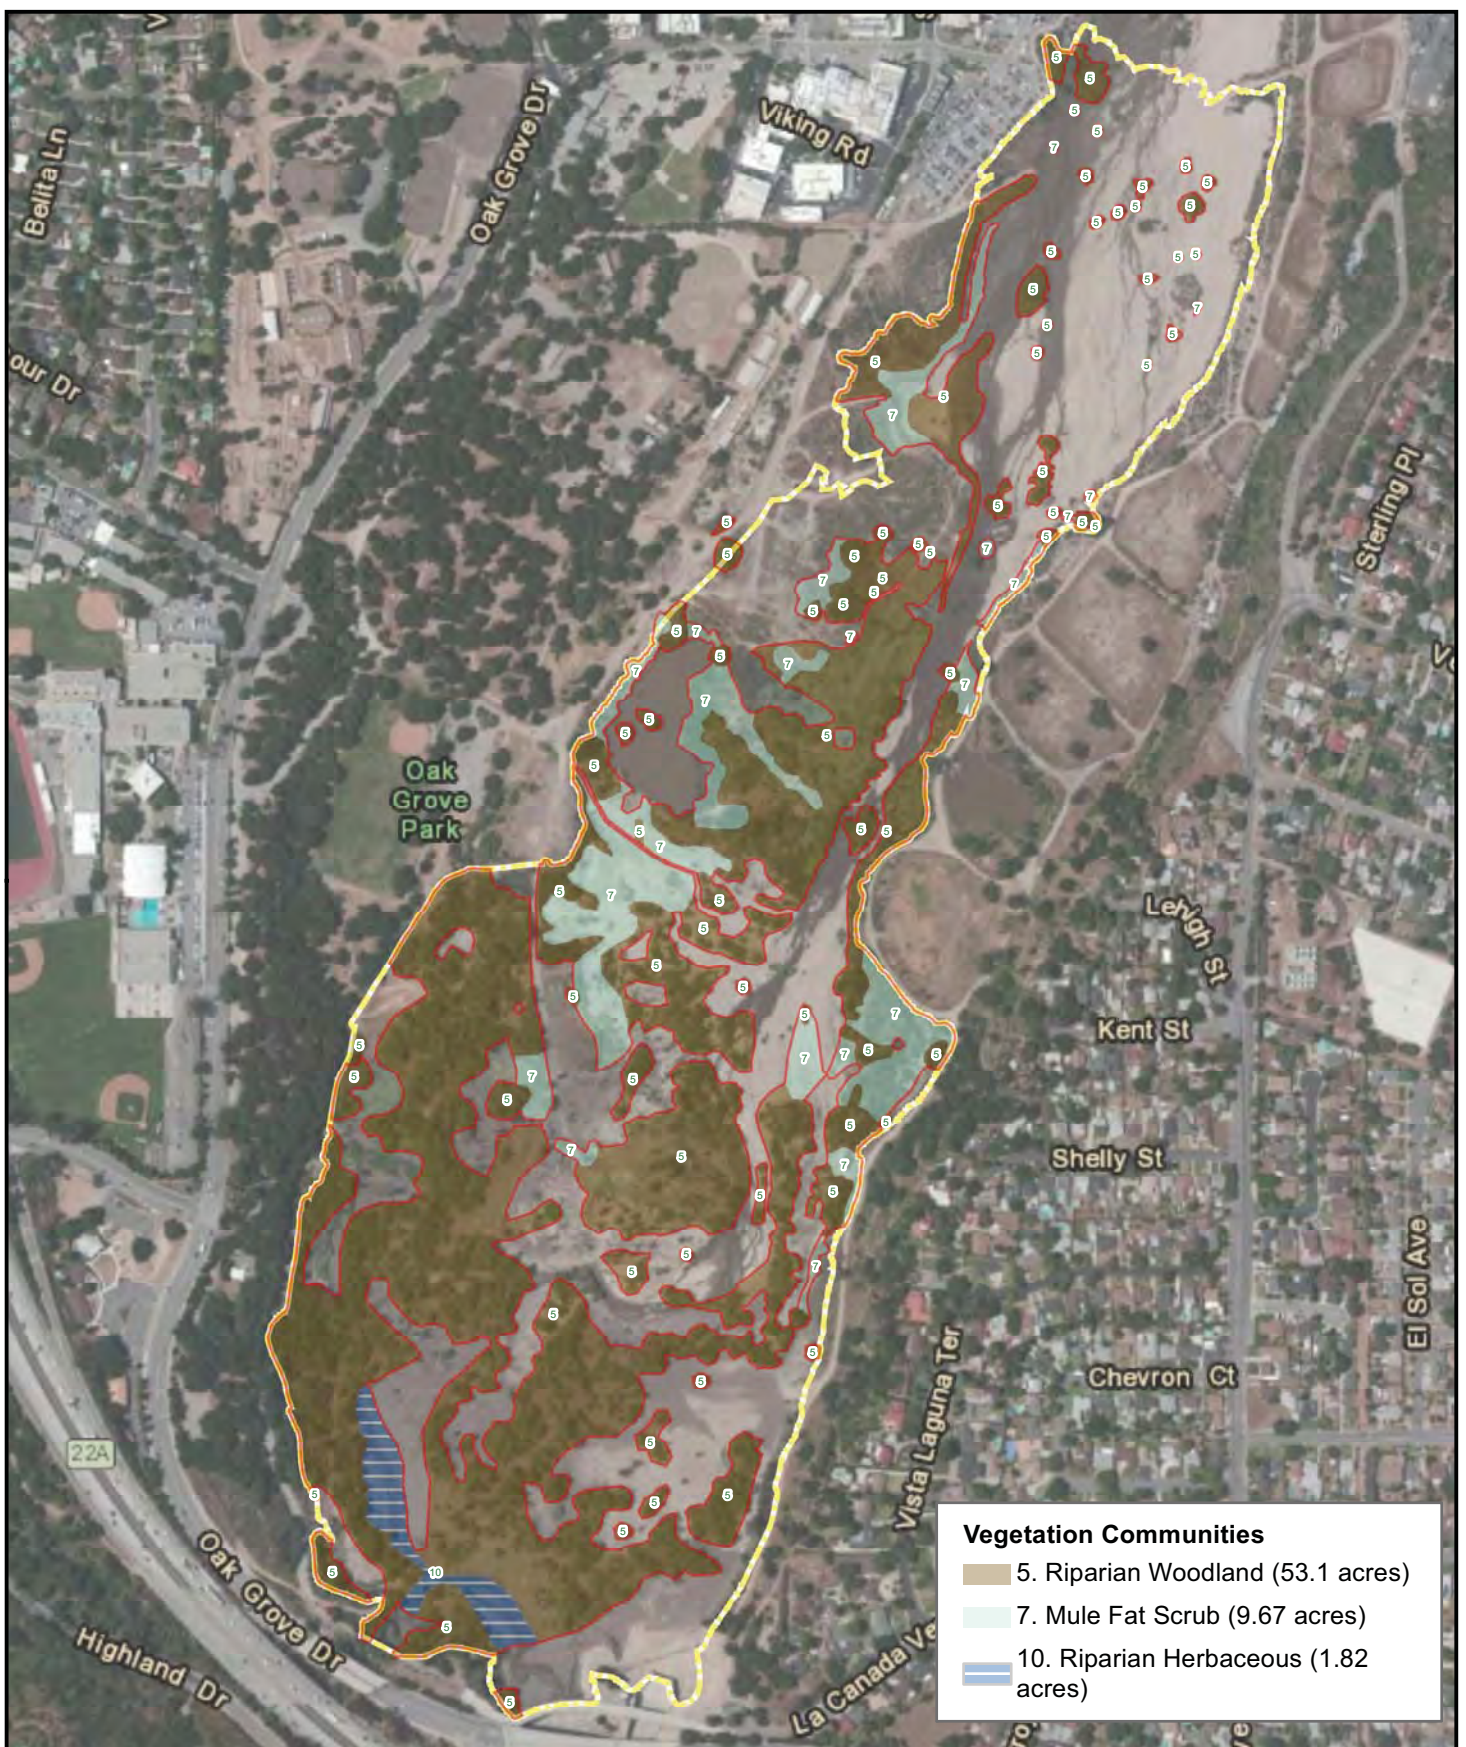
ATTACHMENT 3 – LBVI SURVEY AREA

LBVI Survey Area
 Proposed Project Boundary

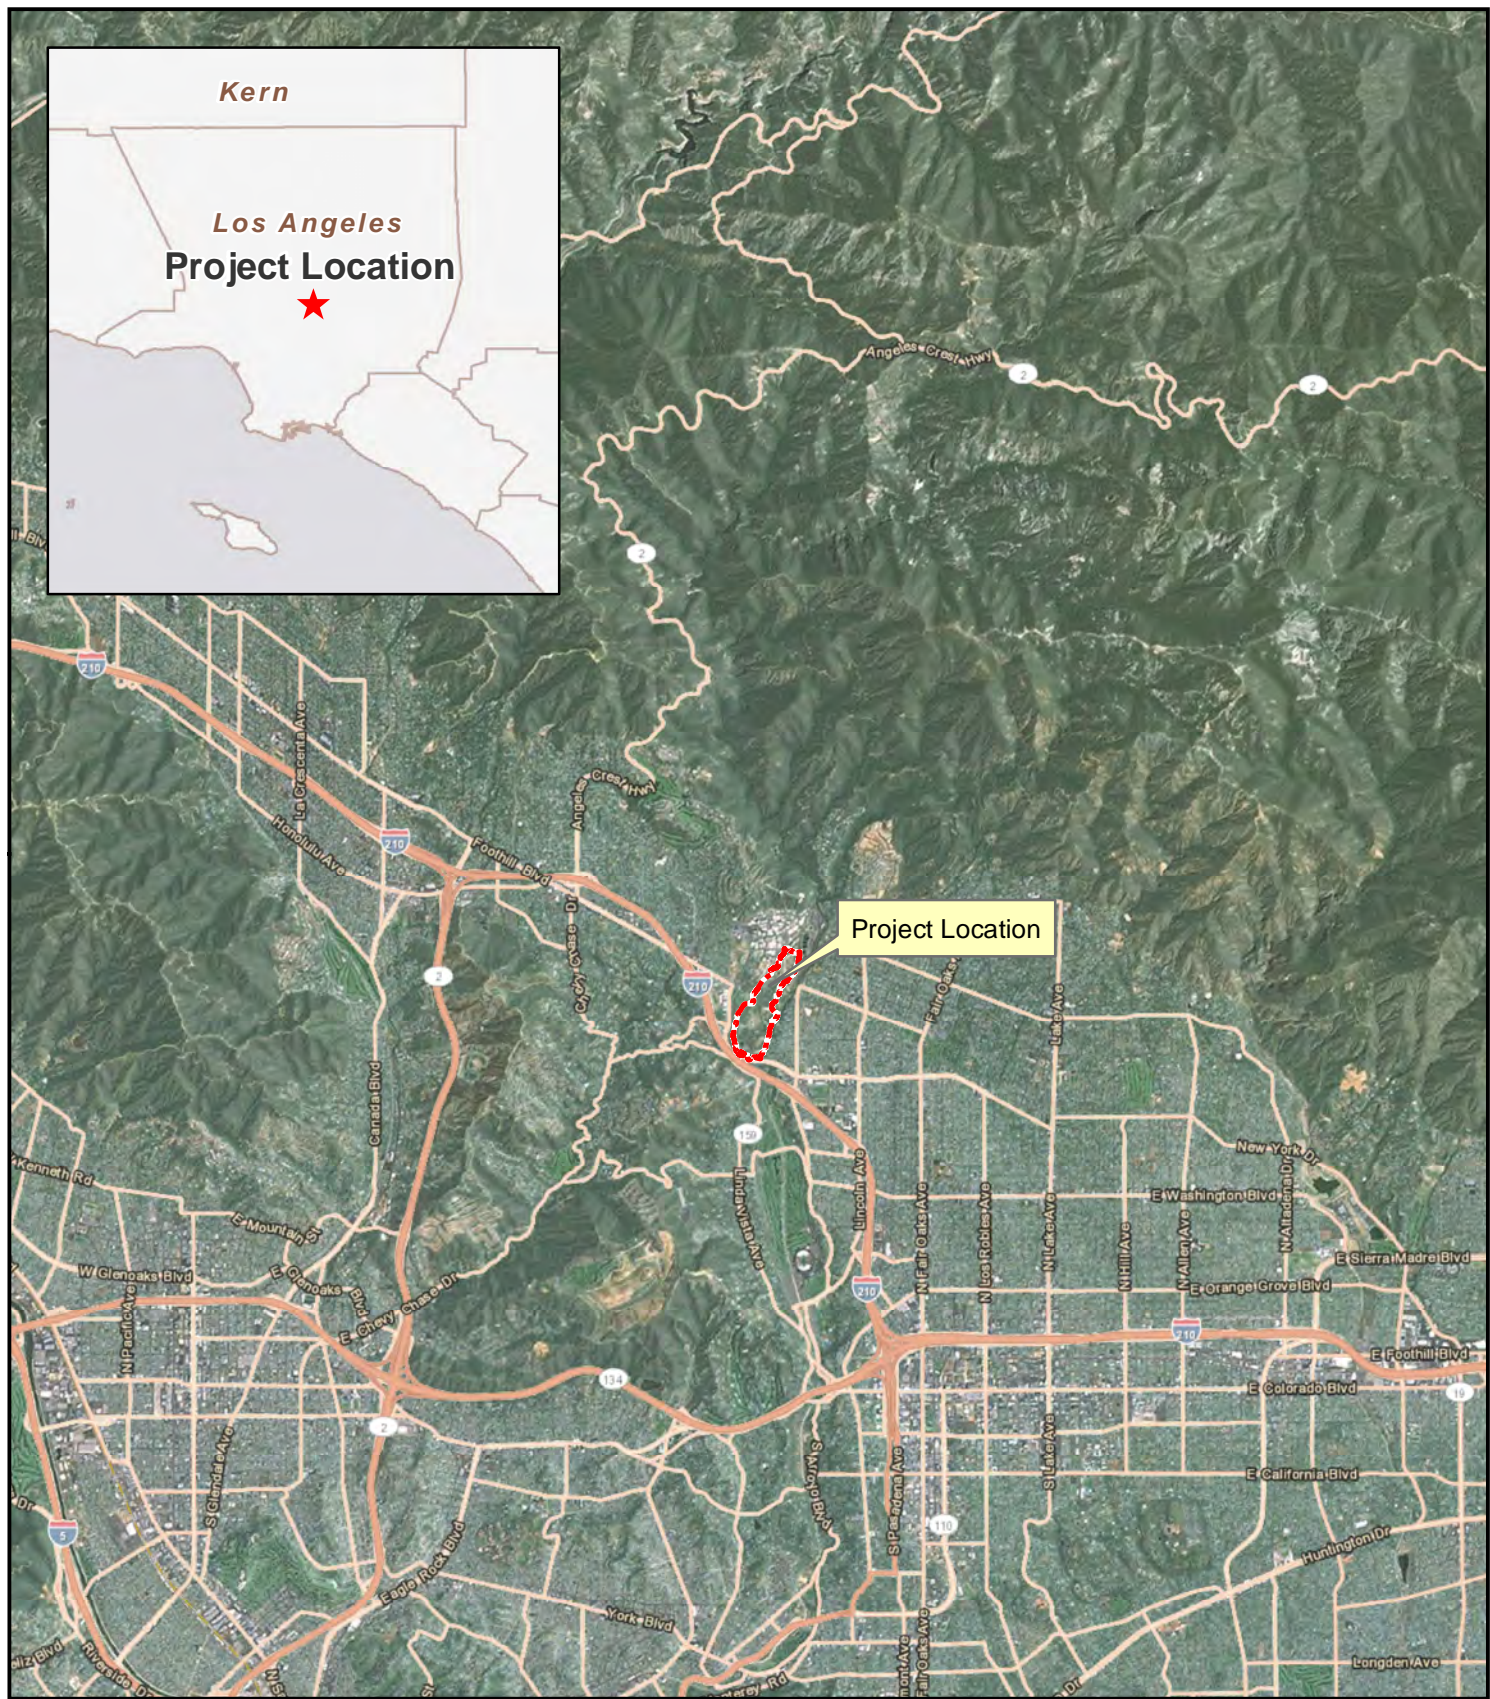
Figure 1
 Devil's Gate Reservoir Sediment Removal
 and Management Project
 Project Vicinity and Location Map

Proposed Project Boundary

The Devil's Gate Reservoir Sediment Removal and Management Project (proposed project) is located in the City of Pasadena, in Los Angeles County approximately 14 miles north of downtown Los Angeles (see Figure 1, Project Vicinity Map). The City of La Cañada Flintridge and the community of Altadena are located near the proposed project site to the west and east, respectively. Lying south of the San Gabriel Mountains, the proposed project site is located in the middle portion of the Arroyo Seco watershed. The Arroyo Seco extends approximately 11 miles from the border of the Angeles National Forest to its confluence with the Los Angeles River. Approximately 20,416 acres (39.1 square miles) of both residential and undeveloped land drain into Devil's Gate Reservoir.

The proposed project site (see Figure 1) includes the Devil's Gate Dam and Reservoir and covers approximately 120 acres. The Devil's Gate Reservoir captures stormwater, sediment, and debris during storm events and retains stormwater to prevent high flow rates from overwhelming the downstream flood control channel.

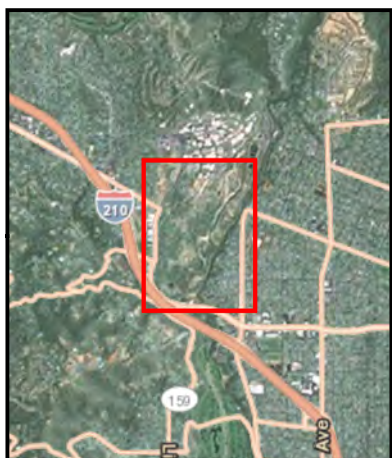
Figure 2
Devil's Gate Reservoir Sediment Removal
and Management Project
Vegetation Communities Map

- Proposed Project Boundary
- Sediment Removal Excavation Limit
- ▲ Coast Live Oak

Vegetation in the Devil's Gate Reservoir is typical of wetlands, with mature riparian trees, pockets of mule fat scrub, and emergent riparian herbaceous communities growing along scoured areas. The riparian areas consisted of Riparian Woodland, Mule Fat Scrub, Coast Live Oak Woodland, and Riparian Herbaceous. Upland vegetation communities also exist within the proposed project boundaries and include Riversidean Alluvial Fan Sage Scrub, Coastal Sage Scrub, Scoured, Ornamental Landscaping and Ruderal areas. The vegetation communities within the proposed project boundary are shown in detail in Figure 2.

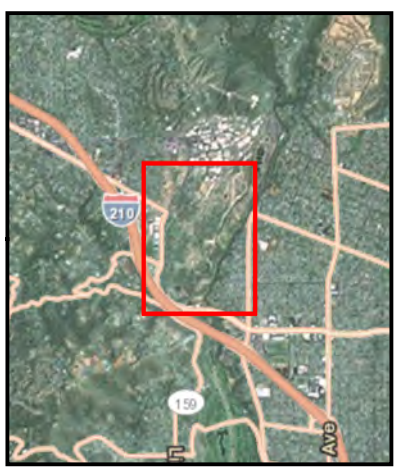
- Proposed Project Boundary
 - Access Road
 - Sediment Removal Excavation Limit
 - Inundation Line
 - Soil Test Pit
 - Photo Points
- | Waters | |

| | Wetland Area (11.2 acres) |

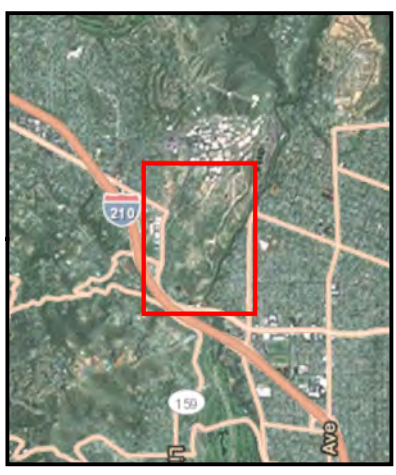
- Proposed Project Boundary
 - Access Road
 - Sediment Removal Excavation Limit
 - Inundation Line
 - Soil Test Pit
 - Photo Points
- Riparian Vegetation**
- Riparian Woodland (45 acres)
 - Mule Fat Scrub (9.3 acres)
 - Riparian Herbaceous (0.03 acre)

- Waters**
- Wetland Area (11.2 acres)
 - Drainage (6.7 acres)
 - Braided Channel (28.9 acres)

The RWQCB jurisdiction includes all USACE jurisdictional areas, Ordinary High Water Marks (OHWMs) or High Water Marks (HWMs) in non-Relatively Permanent Waters (RPWs), isolated wetlands, and any other feature that have an effect on surface or subsurface water quality within California. The CDFW takes jurisdiction to the top of the bank on either side of the drainage or to the outer edge of all riparian vegetation, whichever measurement is greater. Vegetation communities were mapped within the survey area (proposed project boundary) and are displayed on the Vegetation Communities Map (Figure 2). Typically, for reservoir projects, the limit of jurisdiction is determined by the total capacity of the infrastructure (removal area within the reservoir), or HWM. However, Devil's Gate Reservoir does not capture and retain water to total capacity of the reservoir. For Devil's Gate Reservoir, water is typically retained up to 1020 elevation line (contour). Therefore, the 1020 contour is considered the OHWM for this study. The proposed project footprint is located up to the 1070 contour. Therefore, 1070 contour line is considered the HWM for this study. Reference photographs were taken during this survey and are included as Appendix A. Photo points were reproduced using Geographic Information System (GIS) software and displayed on the Delineation Map (Figure 3).

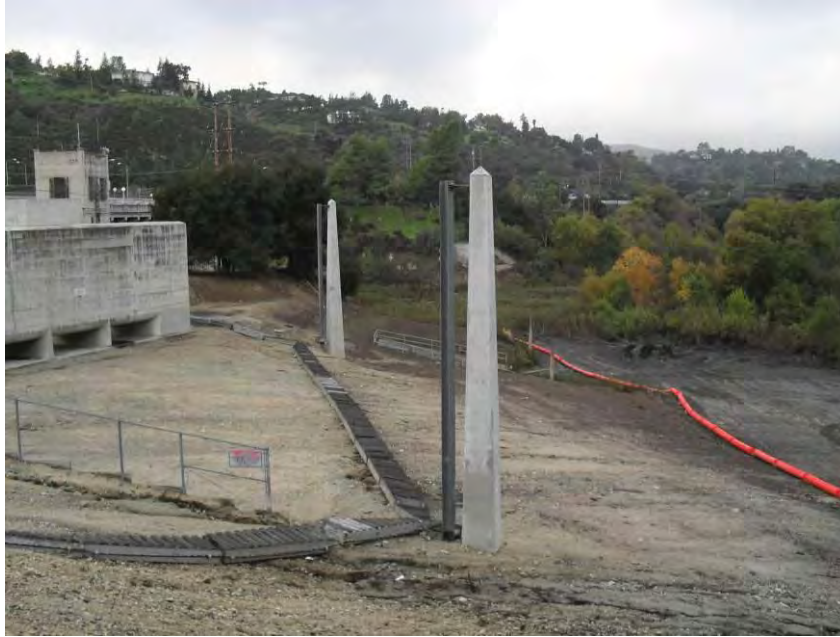
Photo 1: Photo taken from Photo Point 1 looking west depicting the spillway of the reservoir with Black Willow Series on the right and Sage Scrub and Oak Woodland at the back. The orange blockage devices are used to prevent debris from building up behind the dam.

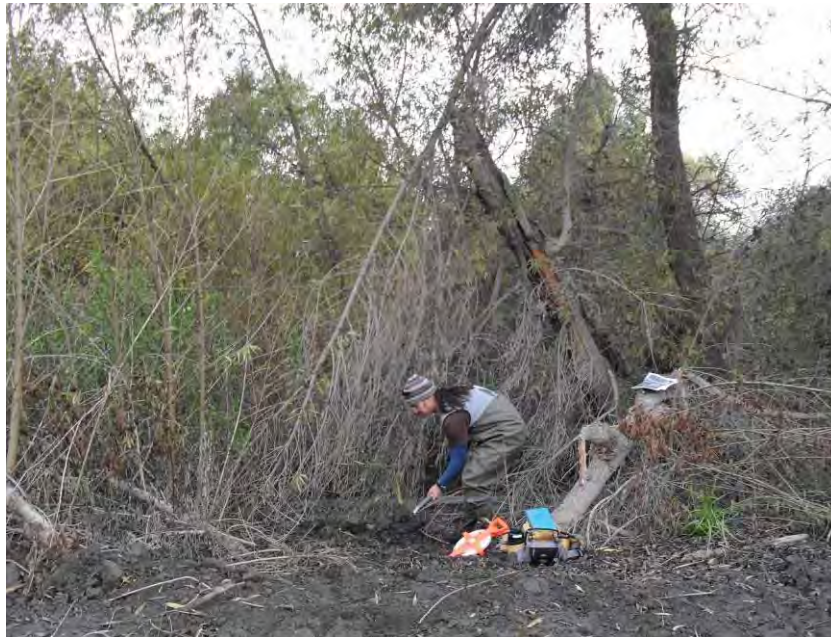
Photo 2: Photo taken from Photo Point 2 depicting the area where Soil Pit #1 was dug. Vegetation in the area included black willow, mule fat, and cattails.

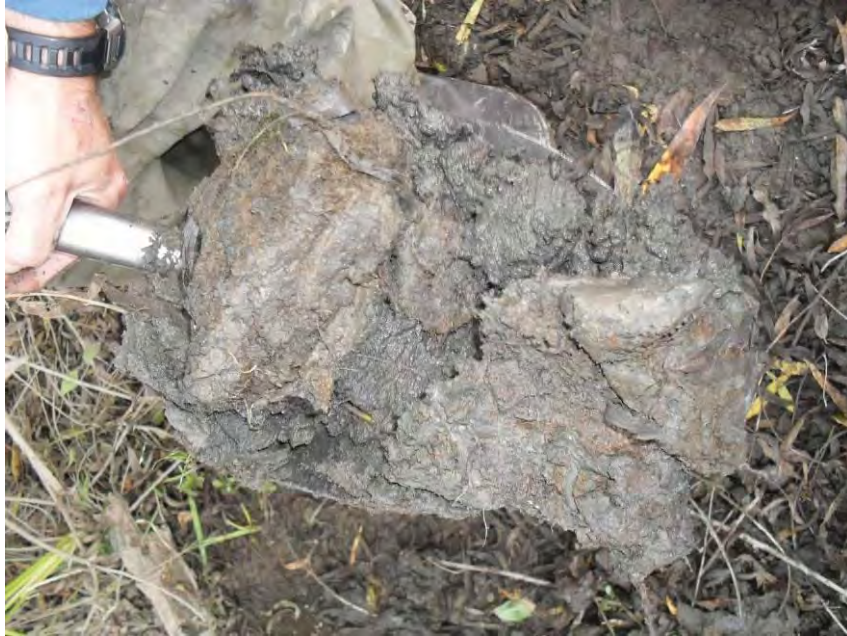
Photo 3: Photo taken from Photo Point 2 looking at soils from Soil Pit # 1. Soils at Pit #1 contained hydric soil indicators including a loamy gleyed matrix with redoximorphic features.

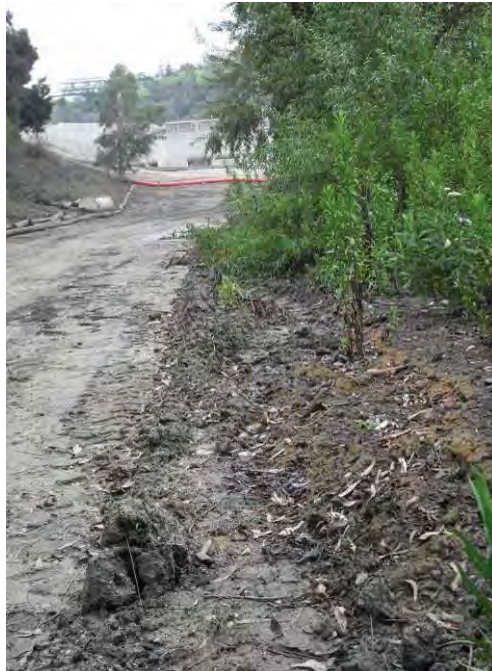
Photo 4: Photo taken from Photo Point 3 depicting orange rusty redoximorphic features on the surface of soils along the banks of the road (on the right). This was typical in areas throughout the reservoir.

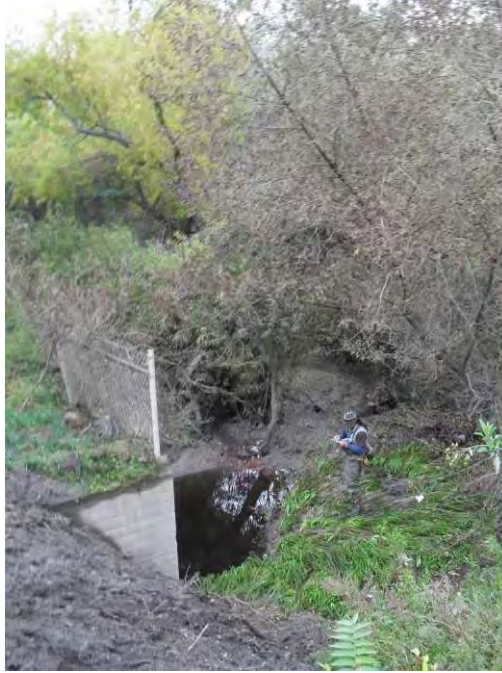
Photo 5: Photo taken from Photo Point 4 looking west depicting a culvert that enters the reservoir on the east side directing neighborhood runoff to the reservoir. A pond existed at the opening of the culvert at the time of the survey with little running water.

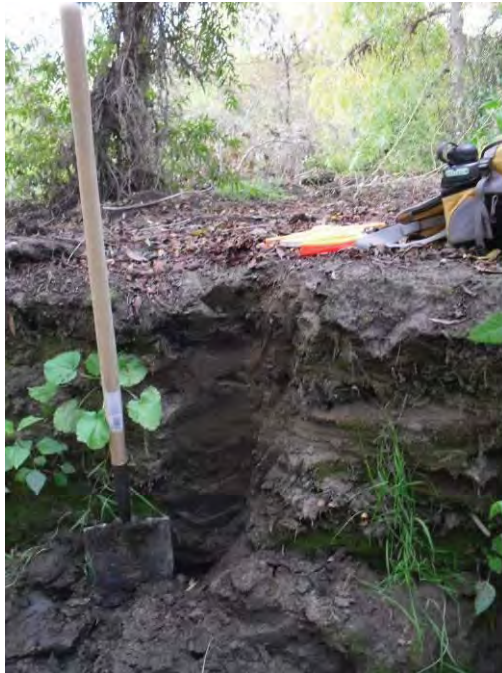
Photo 6: Photo from Photo Point 5 depicting Soil Pit #3. This eroded bank gave a soil profile of 3 feet. Sediment build up was very high at this location as well as with most other soil pit locations. Due to sediment build up following rain events, top soil does not have time to mature in a reservoir like it would under natural conditions (problematic soils).

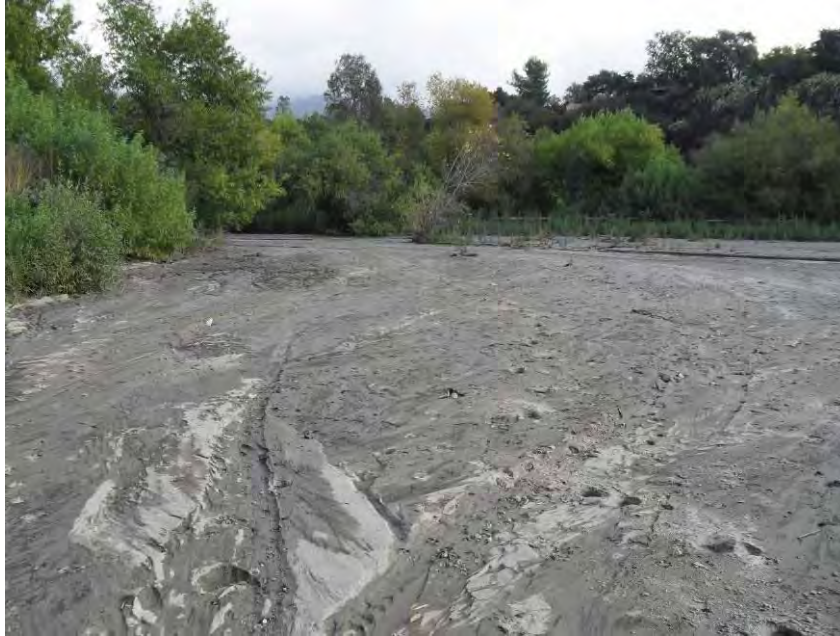
Photo 7: Photo taken from Photo Point 6 looking northeast depicting a large scoured area near the center of the site. Water flows seasonally through this area and is surrounded by Riparian Woodland.

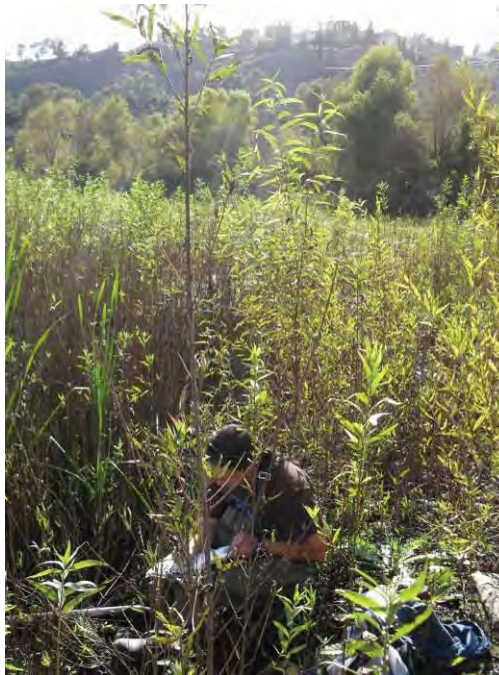
Photo 8: Photo taken from Photo Point 7 depicting the area where Soil Pit # 7 was dug. Vegetation was dominated by mule fat and also included black willow, white alder, California sycamore, and cattails.

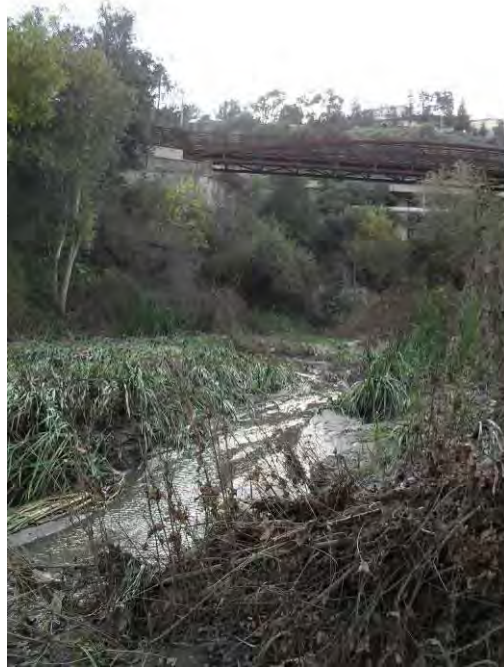
Photo 9: Photo taken from Photo Point 8 looking west depicting water flowing from Flint Wash which empties into the reservoir on the west side.

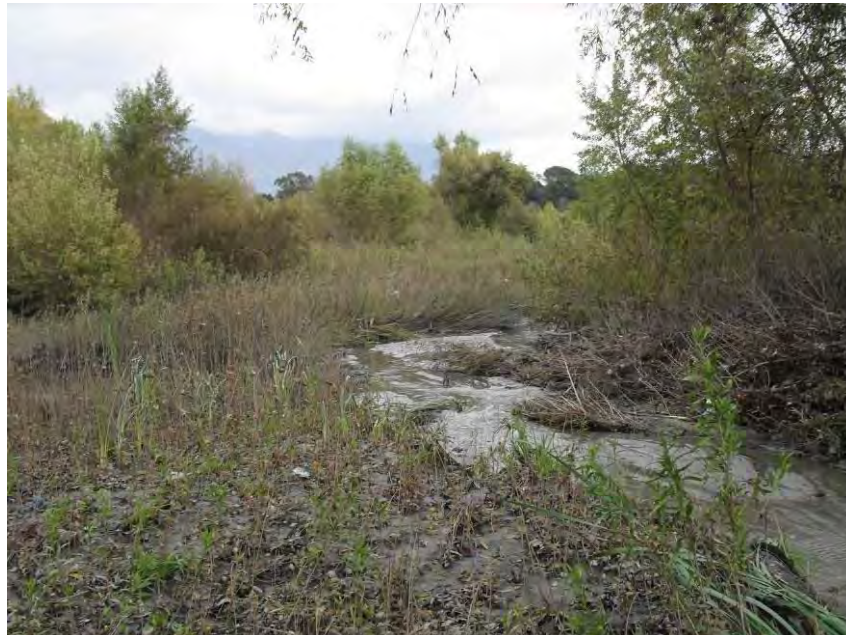
Photo 10: Photo taken from Photo Point 8 looking southeast depicting water flowing from Flint Wash on the west side of the reservoir to the spillway. This area is near Soil Pit #8. Vegetation in this area was dominated by black willows, cattails, and mule fat.

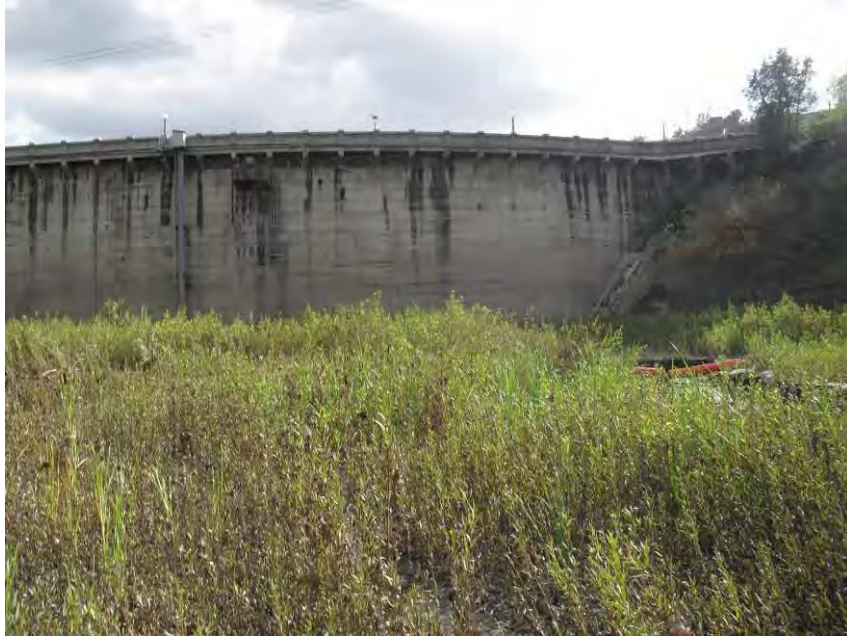
Photo 11: Photo taken from Photo Point 9 looking south depicting the dam wall with emergent riparian vegetation in front of the wall.

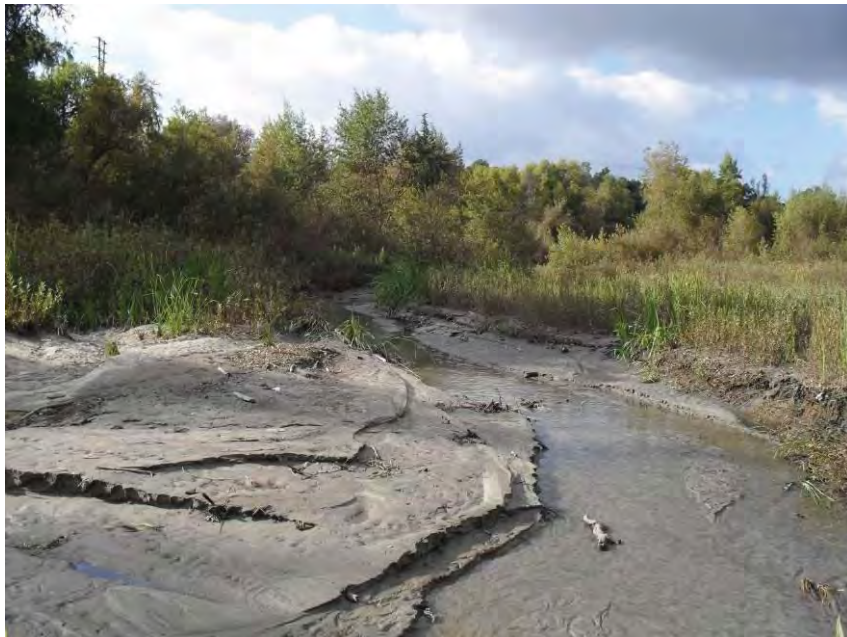
Photo 12: Photo taken from Photo Point 9, south of Soil Pit # 8, depicting water continuing to flow to spillway.
