APPENDIX D – Biological Resources Reports

APPENDIX D 1– Biological Technical Report

**BIOLOGICAL TECHNICAL REPORT FOR THE
DEVIL'S GATE RESERVOIR PROJECT SITE IN
THE CITY OF PASADENA,
LOS ANGELES COUNTY, CALIFORNIA**

November 2010

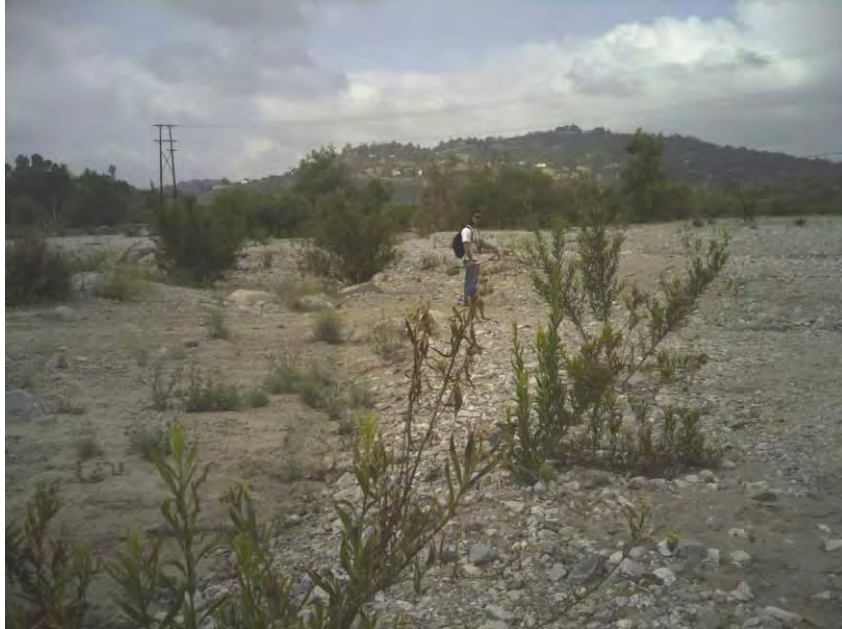
Photo 13: Photo taken from Photo Point 10 looking south depicting the scattered vegetation growing along the channel at the northern extent of the project boundary outside the wetland boundary.

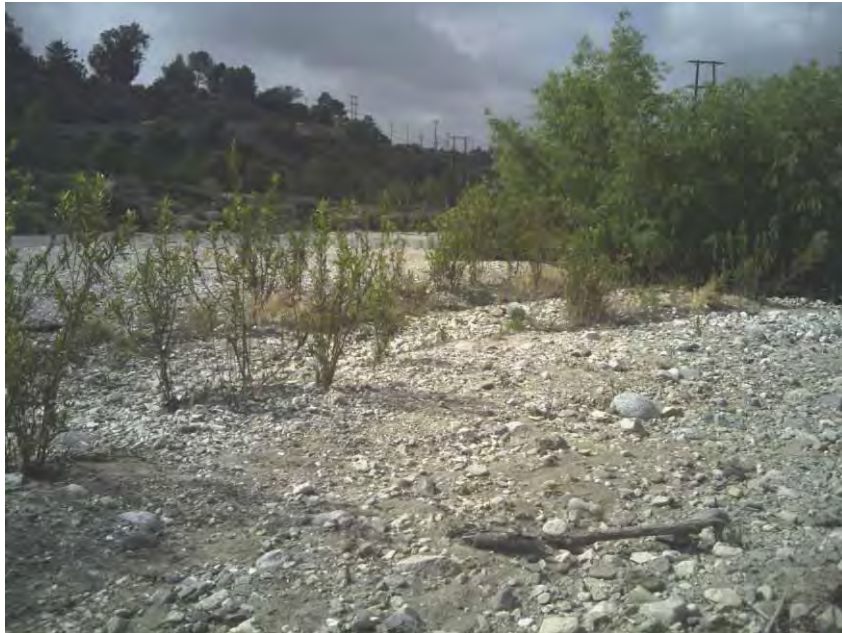
Photo 14: Photo taken from Photo Point 11 looking east depicting the mostly scoured channel with patches of mule fat and dense patches of willow.

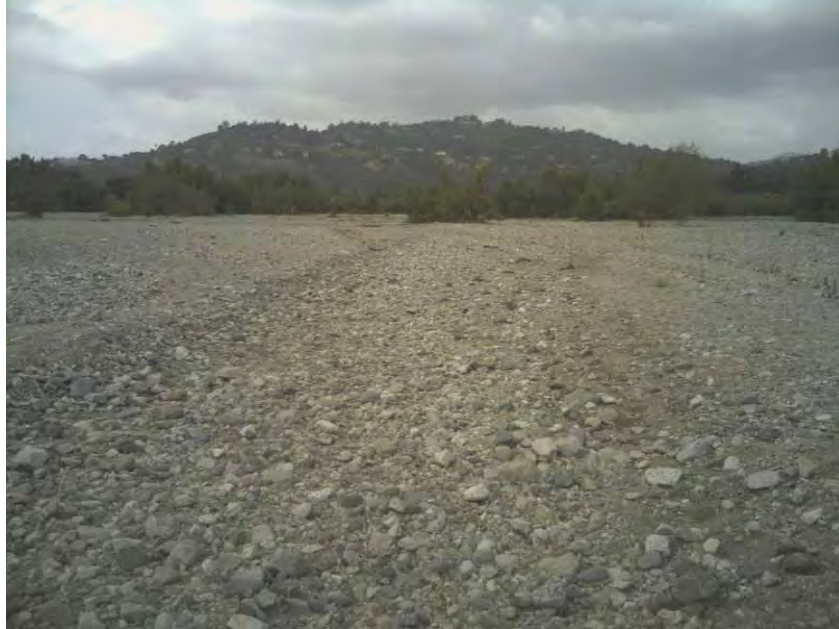
Photo 15: Photo taken from Photo Point 12 looking southwest depicting the scoured plain with scattered willows. The channel meanders from rain event to rain event and year to year throughout the northern reaches of the project site.

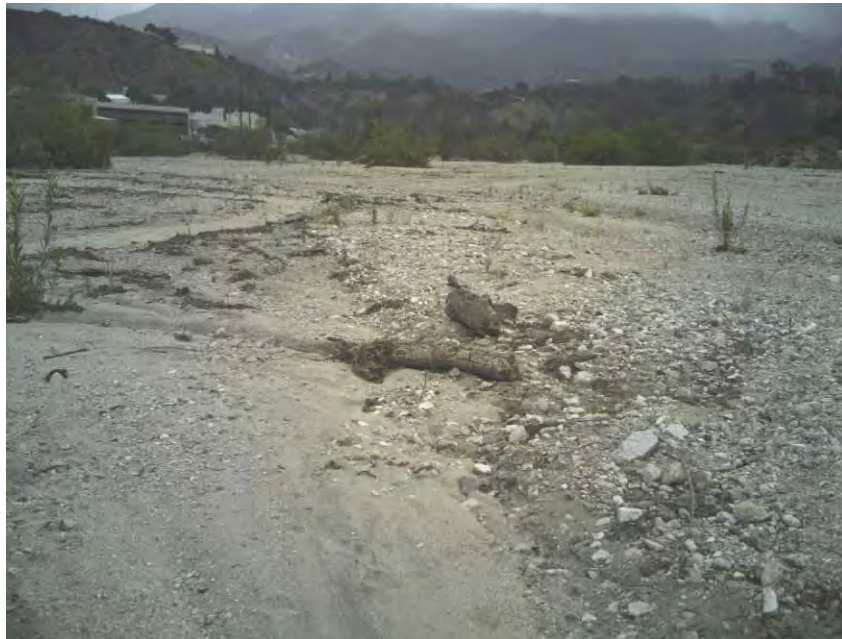
Photo 16: Photo taken from Photo Point 13 looking northeast depicting the braided features throughout the northern section of the project site.

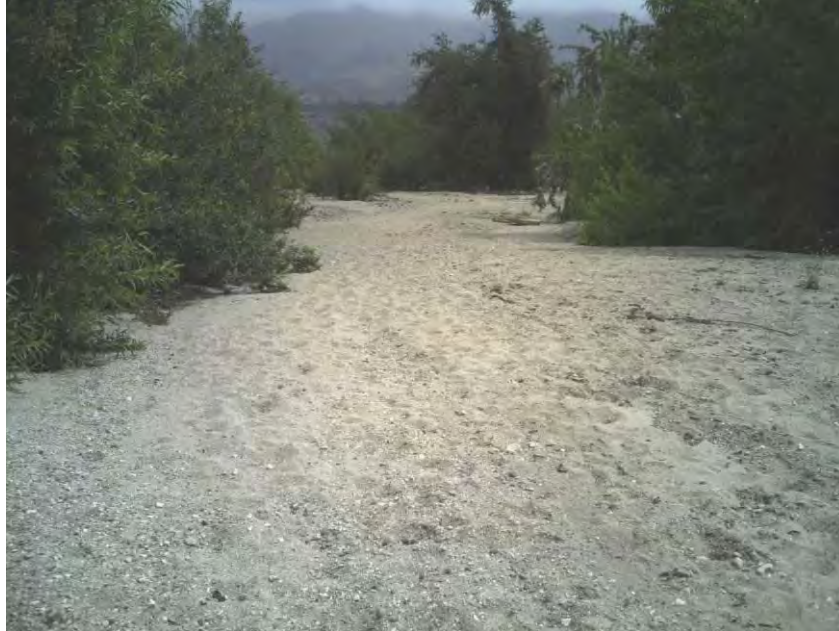
Photo 17: Photo taken from Photo Point 14 looking north depicting the drainage flowing through heavy sandy deposits bordered by dense willows.

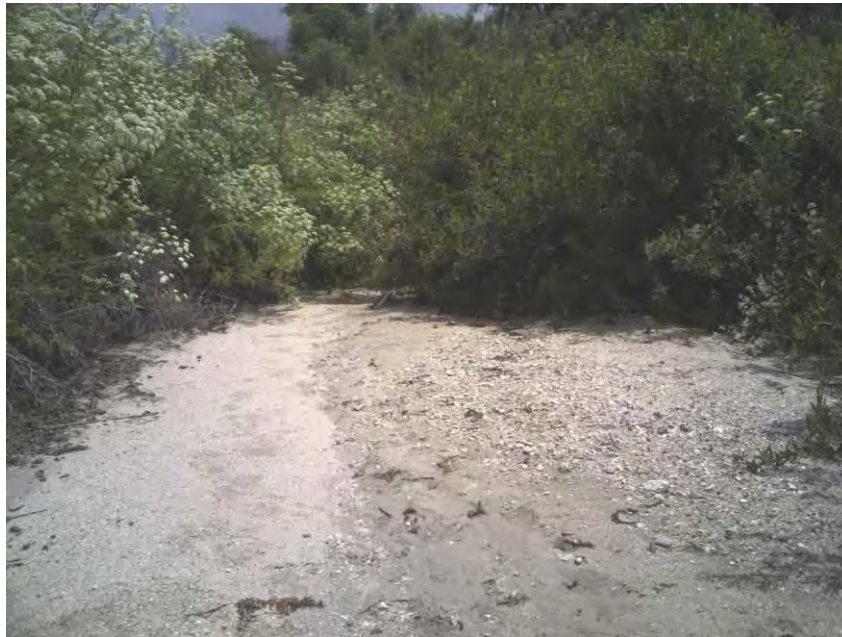
Photo 18: Photo taken from Photo Point 15 looking east depicting the dense riparian vegetation growing along the main channel.

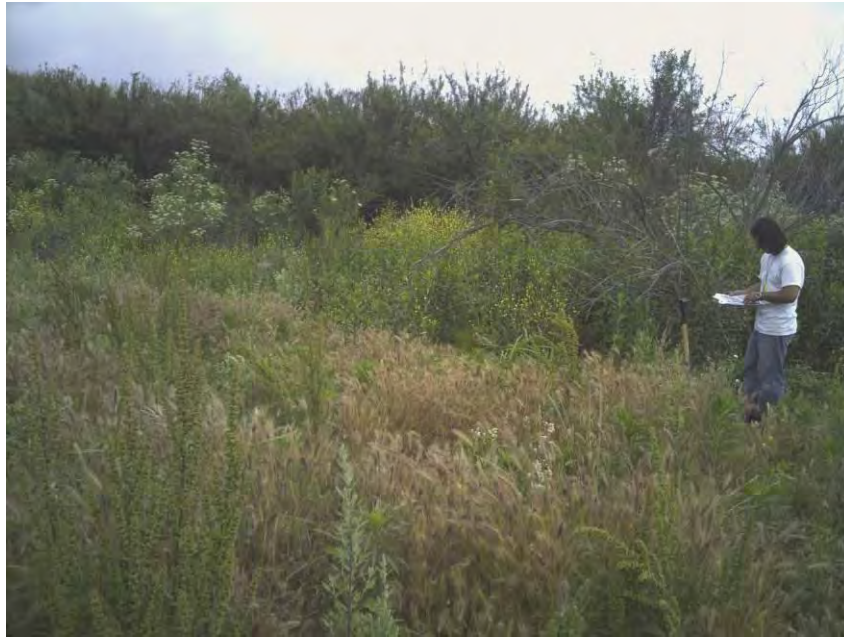
Photo 19: Photo taken from Photo Point 16 looking northeast towards Soil Pit 10 depicting non-native grasses and dominant exotic vegetation in the foreground and native mule fat scrub in the background.

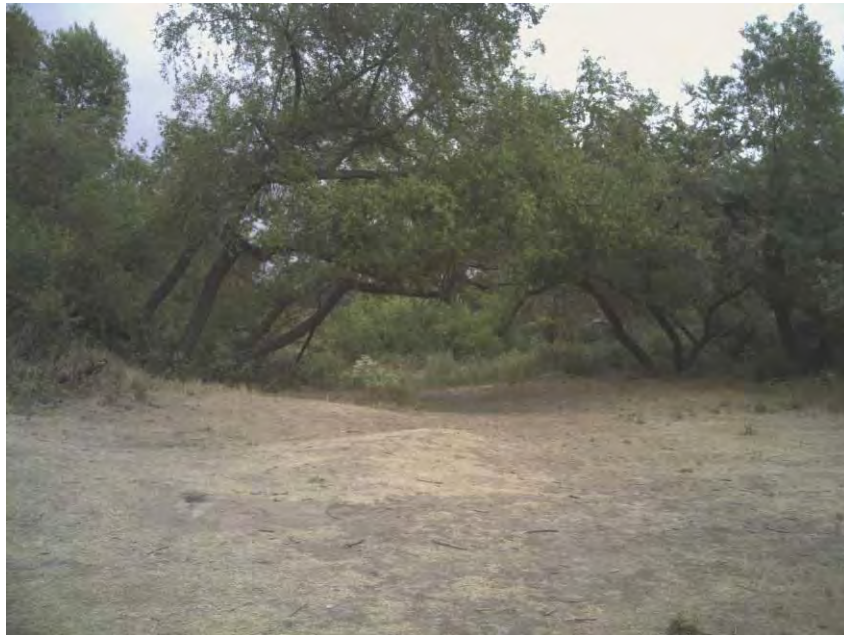
Photo 20: Photo taken from Photo Point 17 facing east depicting willow woodland in the background. Photo taken from the disturbed area to the west of wetland boundary.

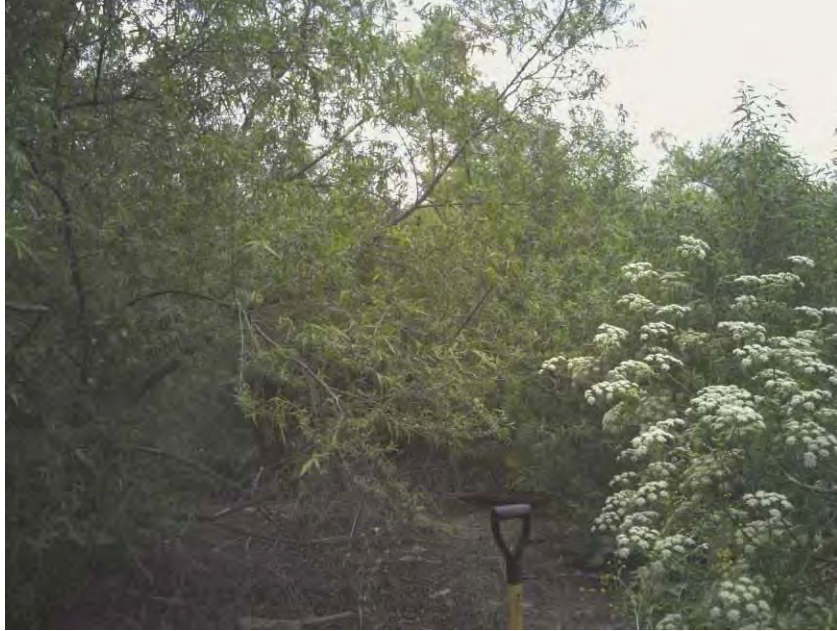
Photo 21: Photo taken from Photo Point 18 looking west depicting a test soil pit with poison hemlock and willows in the background.
