# Substrate Enhancements and Botanical Diversity for Successful Oak Habitat Creation

Richard B. Lewis III, ENV SP  
Senior Restoration Ecologist, Psomas

This is a PDF-version of the slide show that accompanied Psomas' oral presentation at the University of California Agriculture & Natural Resources' 8<sup>th</sup> California Oak Symposium in San Luis Obispo, California, on November 1, 2022. The narration from that presentation has been added via text boxes to this PDF version.

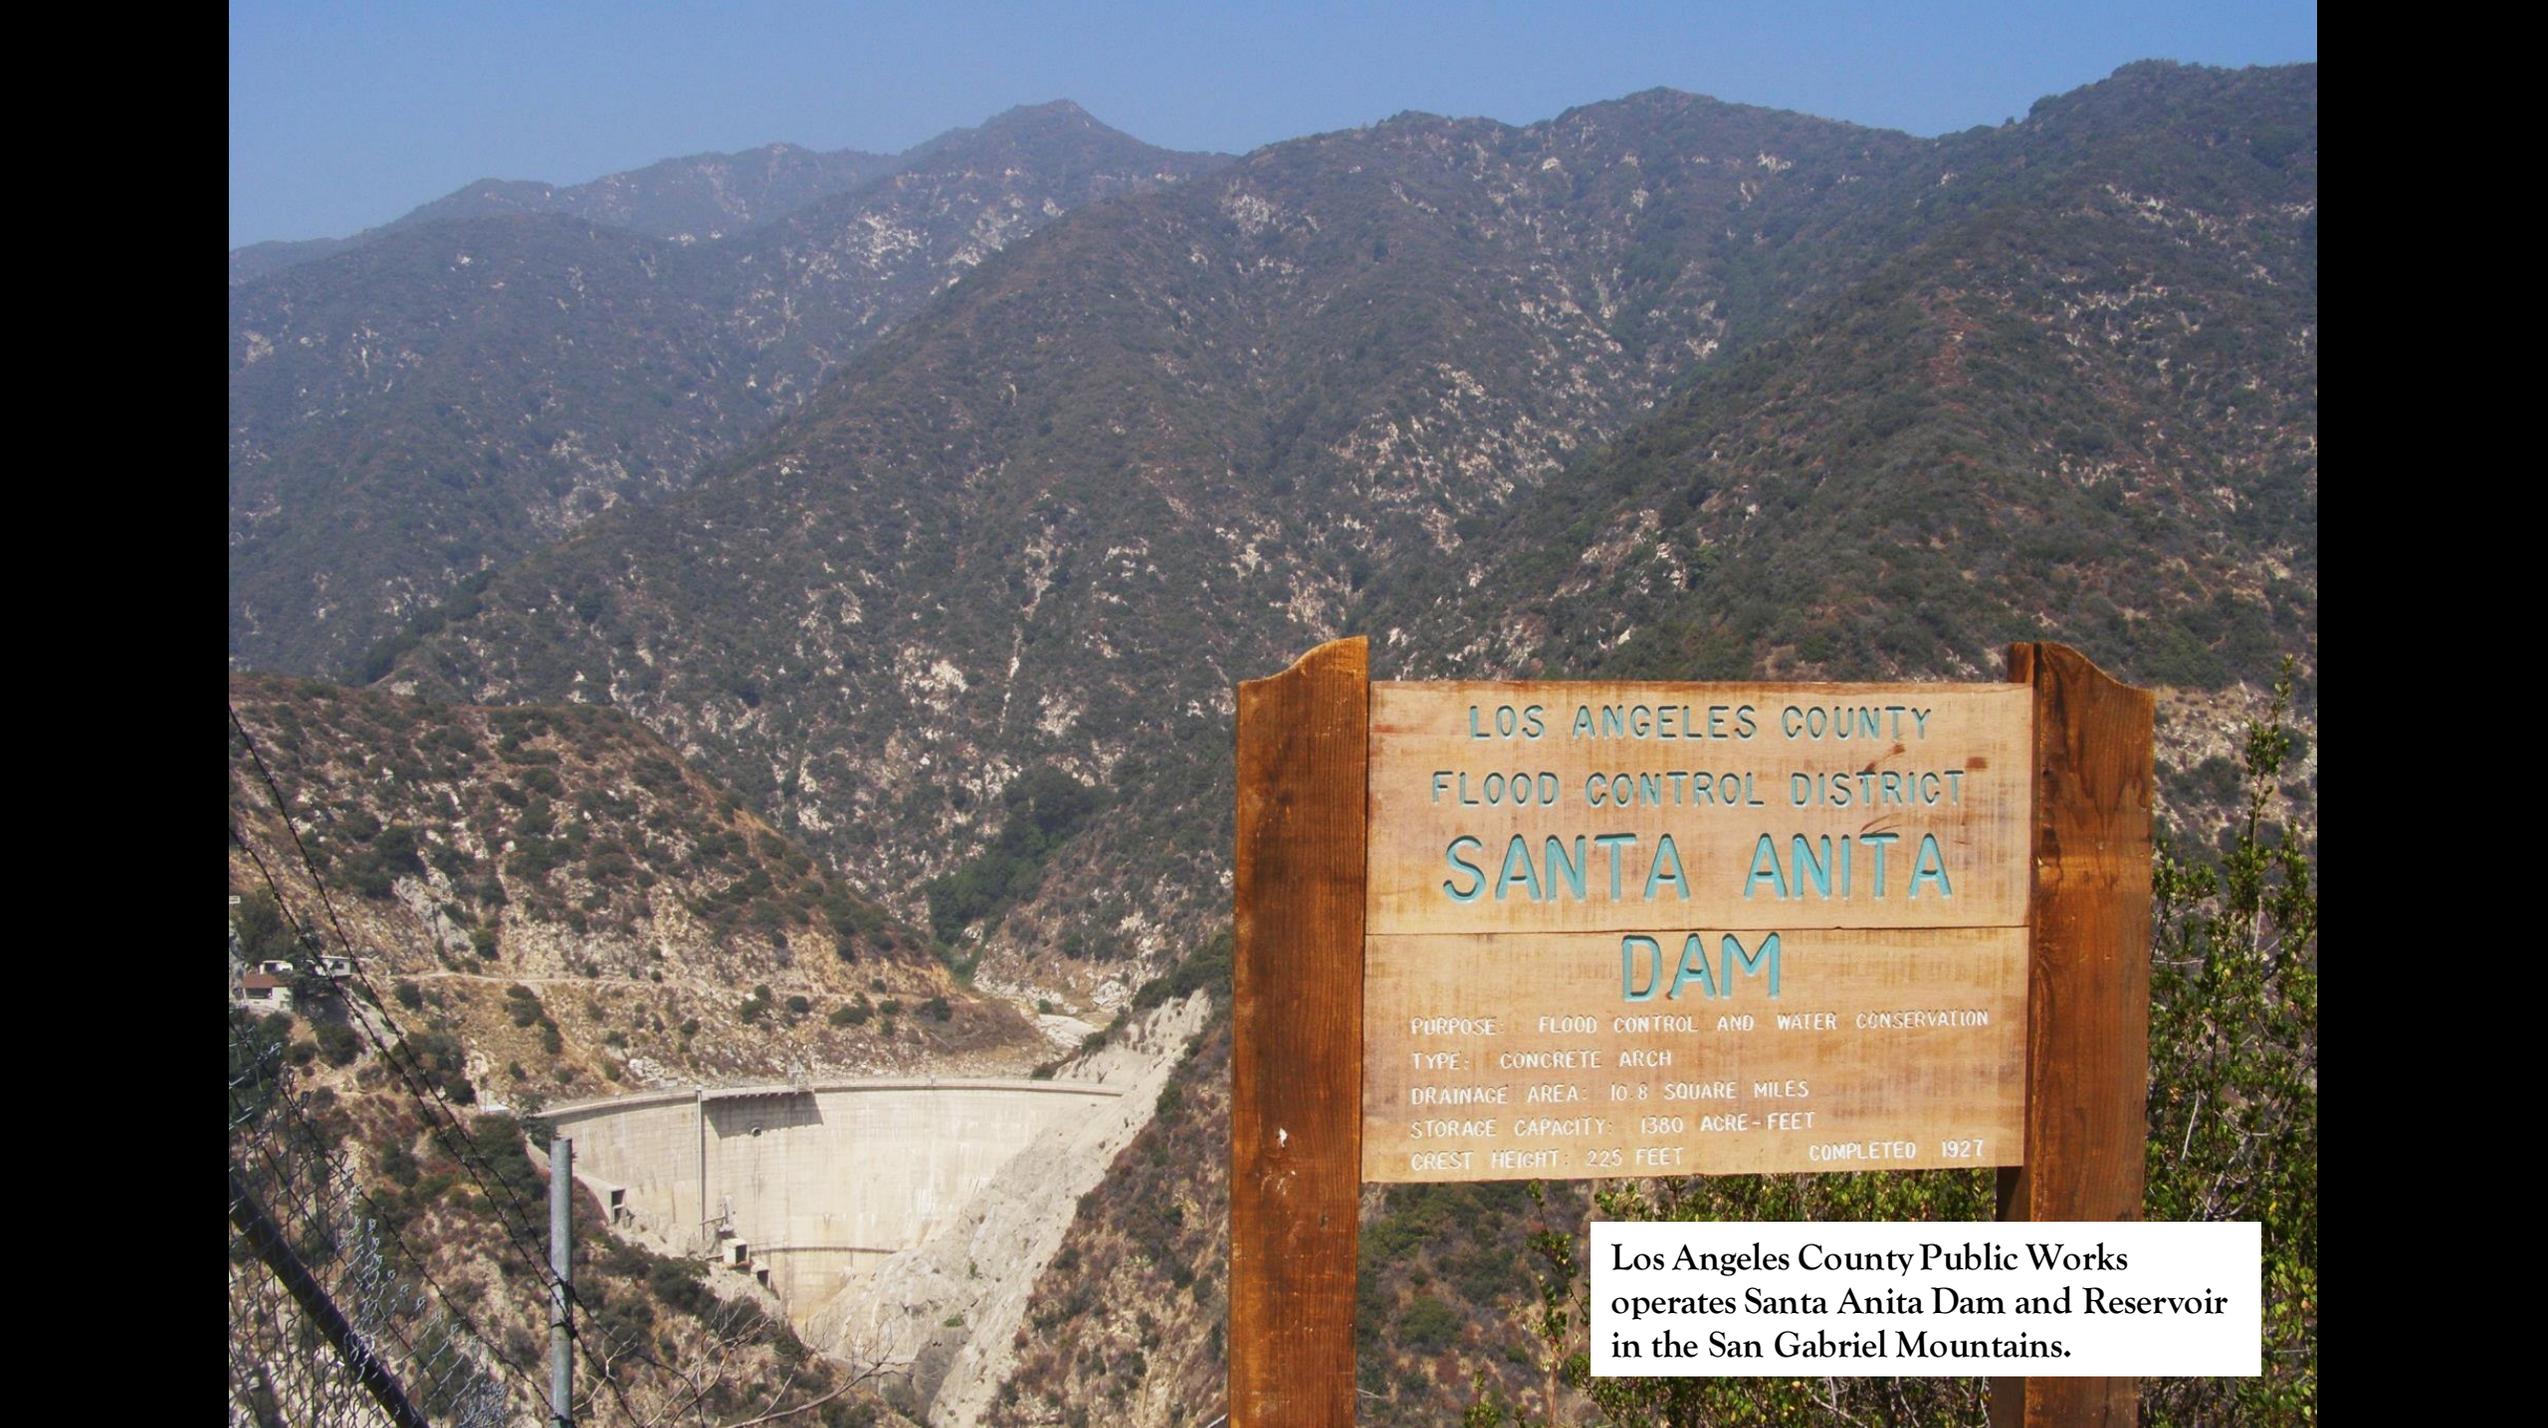
LOS ANGELES COUNTY  
FLOOD CONTROL DISTRICT  
SANTA ANITA  
DAM

PURPOSE: FLOOD CONTROL AND WATER CONSERVATION  
TYPE: CONCRETE ARCH  
DRAINAGE AREA: 10.8 SQUARE MILES  
STORAGE CAPACITY: 1380 ACRE- FEET  
CREST HEIGHT: 225 FEET                      COMPLETED 1927

Los Angeles County Public Works  
operates Santa Anita Dam and Reservoir  
in the San Gabriel Mountains.

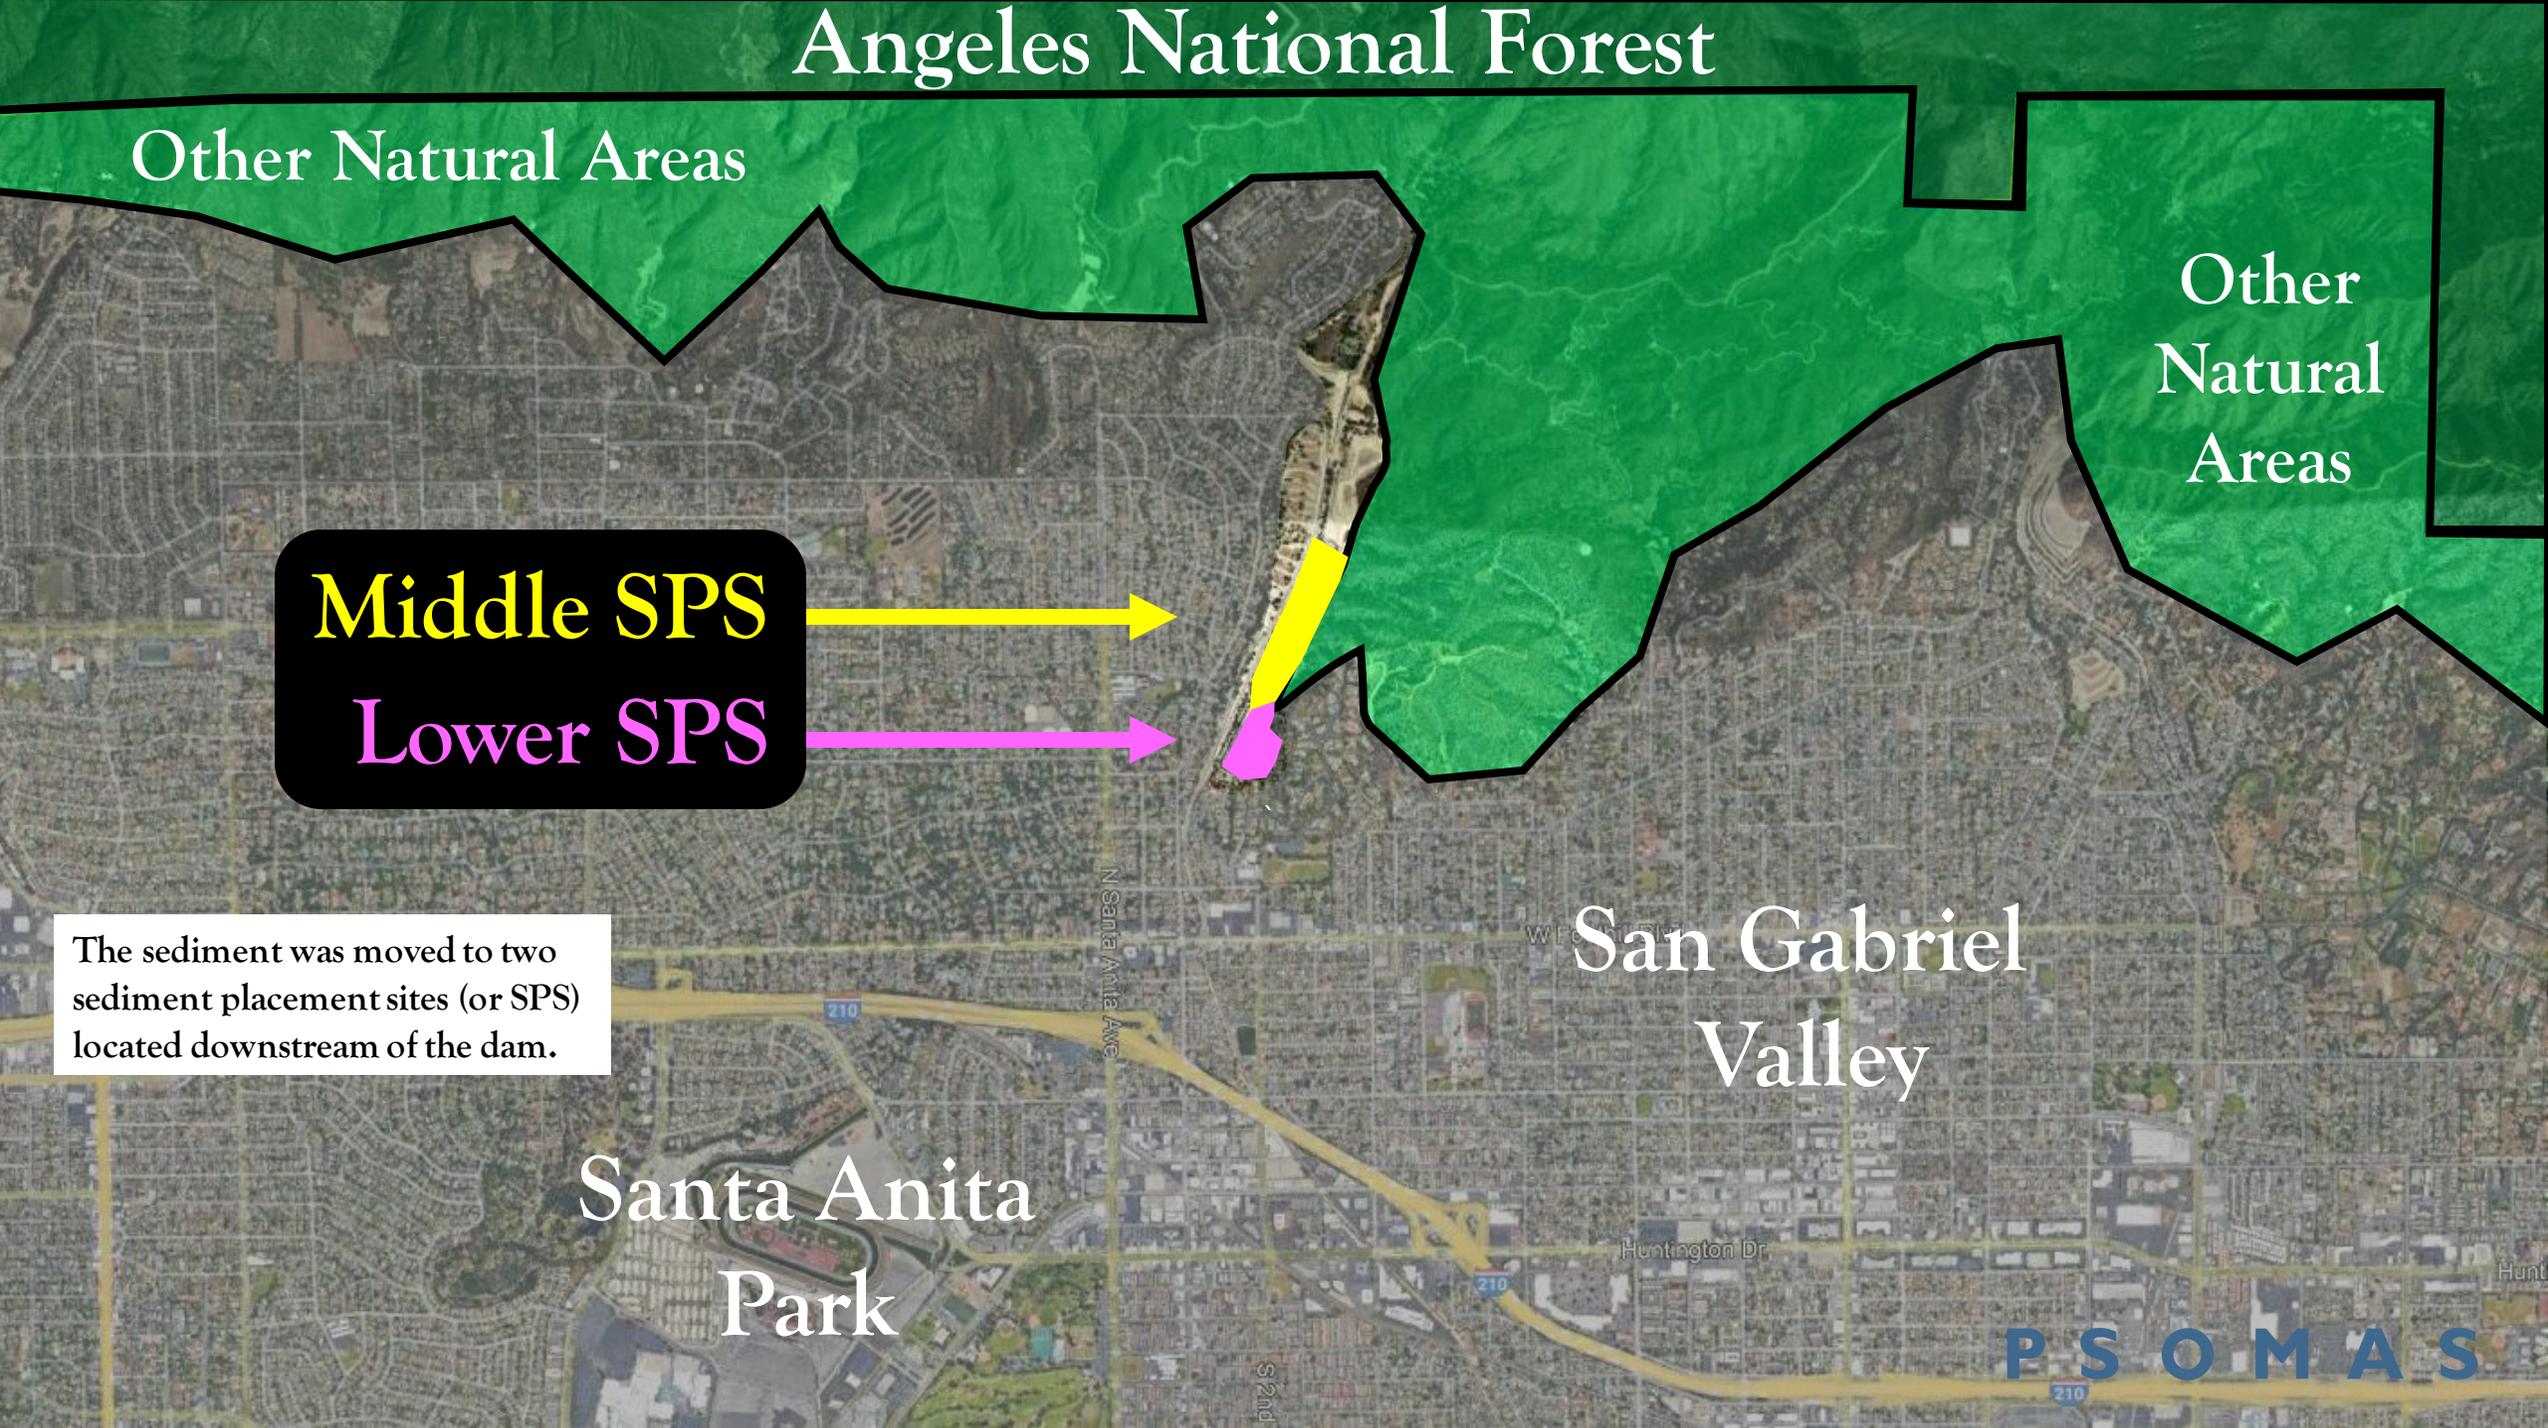
The Lower SPS is the habitat creation site. It is located at the tip of a wedge of open space that extends into the urban grid. It can be visualized as the 'middle fingernail' on a hand extending southwest from Angeles National Forest—mostly surrounded by residential development. This is relevant for the later discussion herein on plant pathogens.

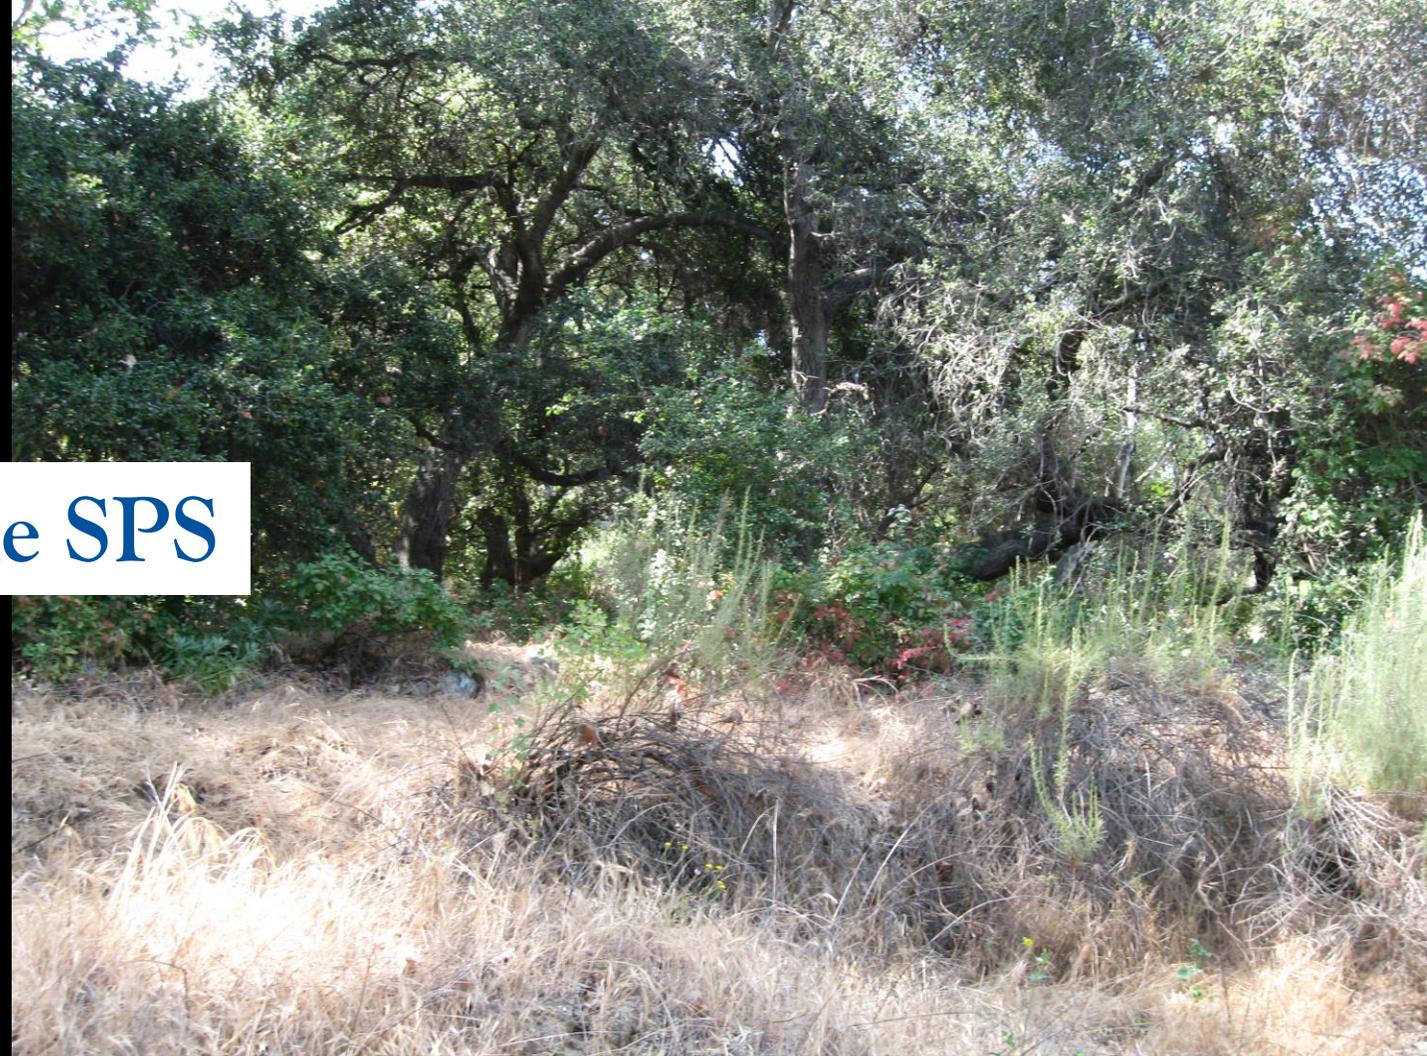
## Middle SPS

The Middle SPS was the vegetation impact site. Note that the understory vegetation is badly degraded by invasive herbs, similar to other regional woodlands. Public Works retained Psomas in 2009 to prepare the habitat mitigation plan.

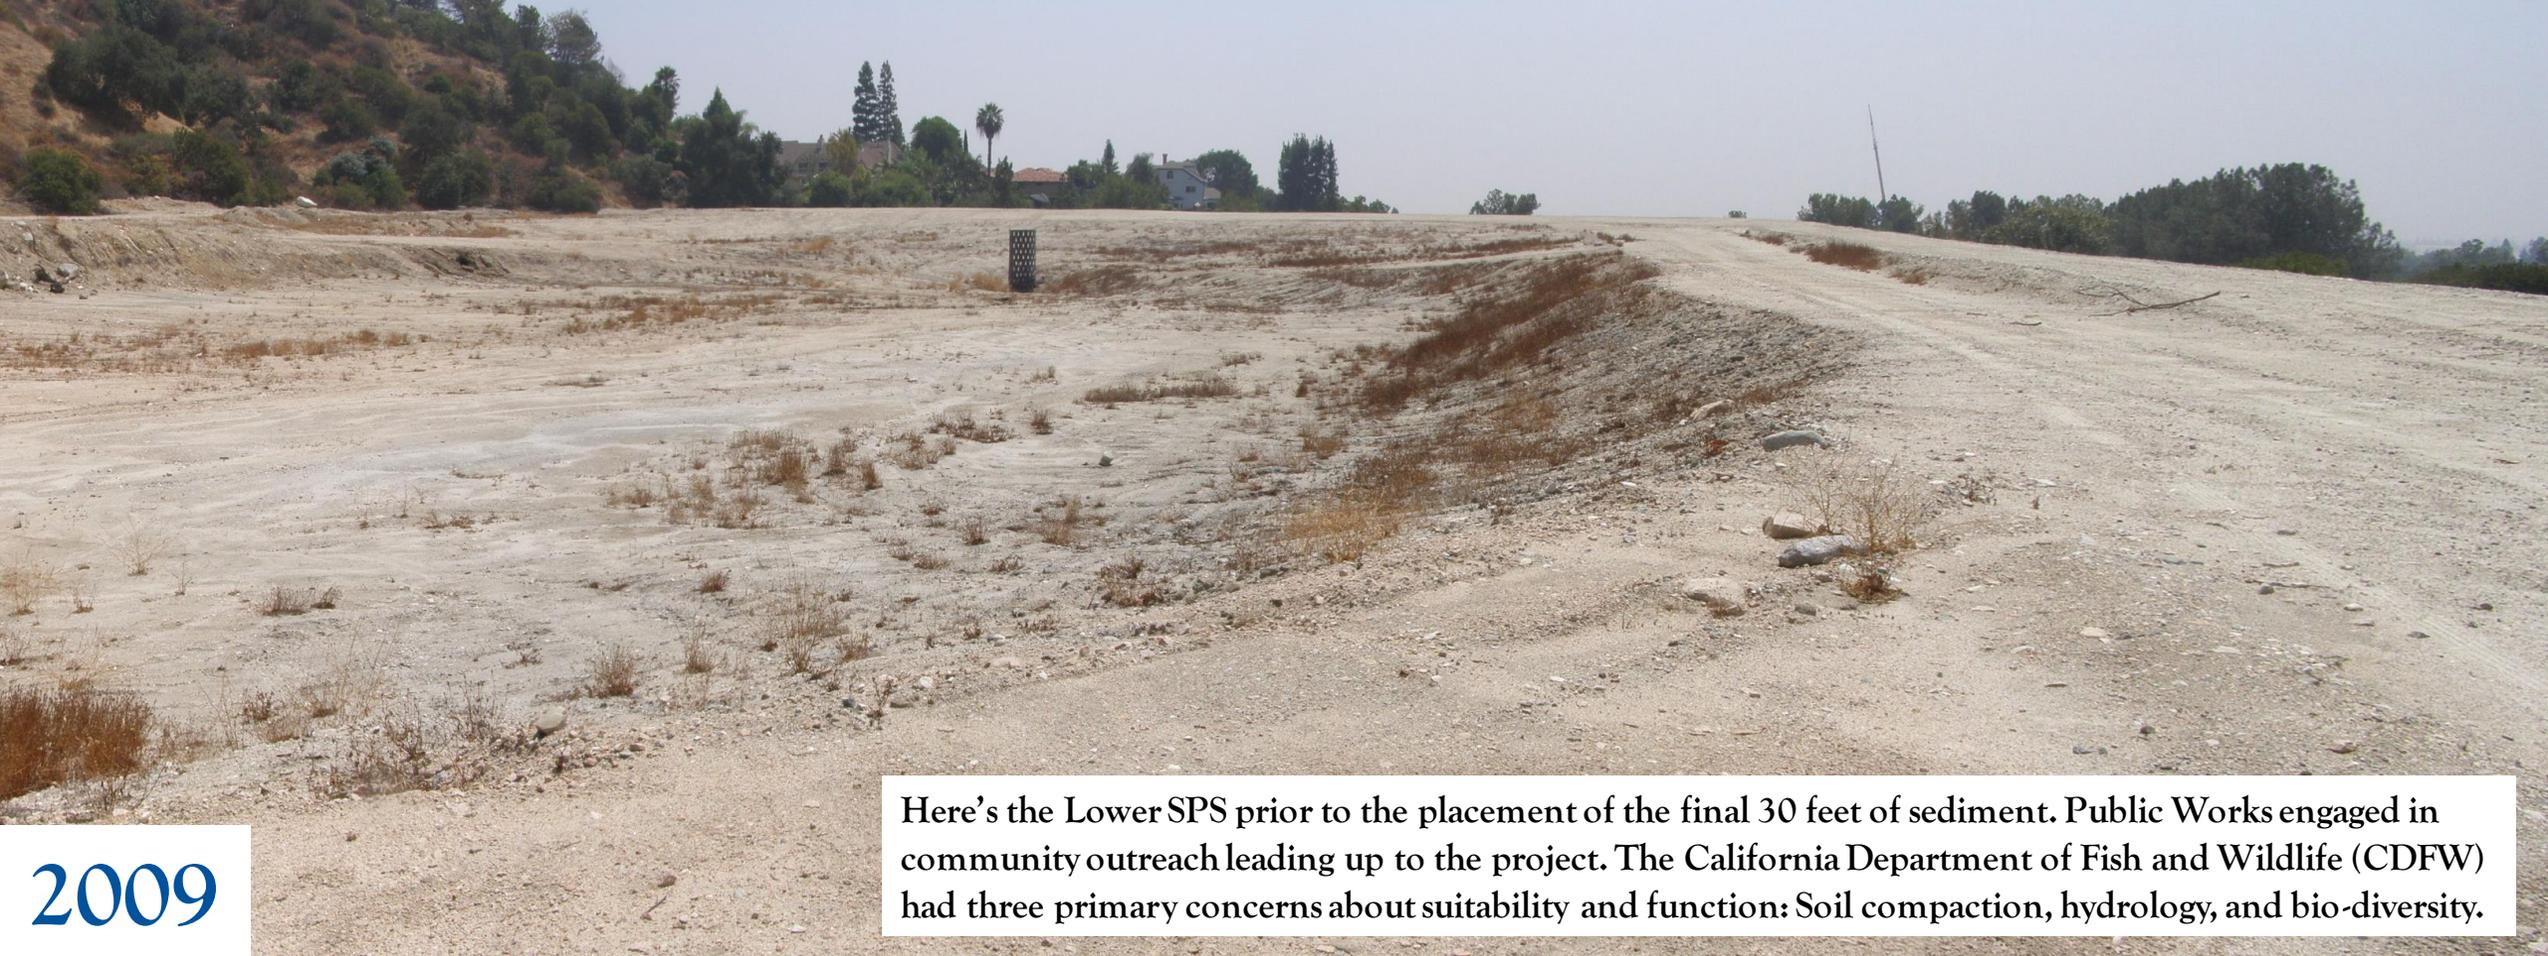
Here's the Lower SPS prior to the placement of the final 30 feet of sediment. Public Works engaged in community outreach leading up to the project. The California Department of Fish and Wildlife (CDFW) had three primary concerns about suitability and function: Soil compaction, hydrology, and bio-diversity.

- Lower SPS prior to final 30' sediment placement
- Public Works' performs community outreach to constituents
- **CDFW: Soil compaction / hydrology / bio-diversity**

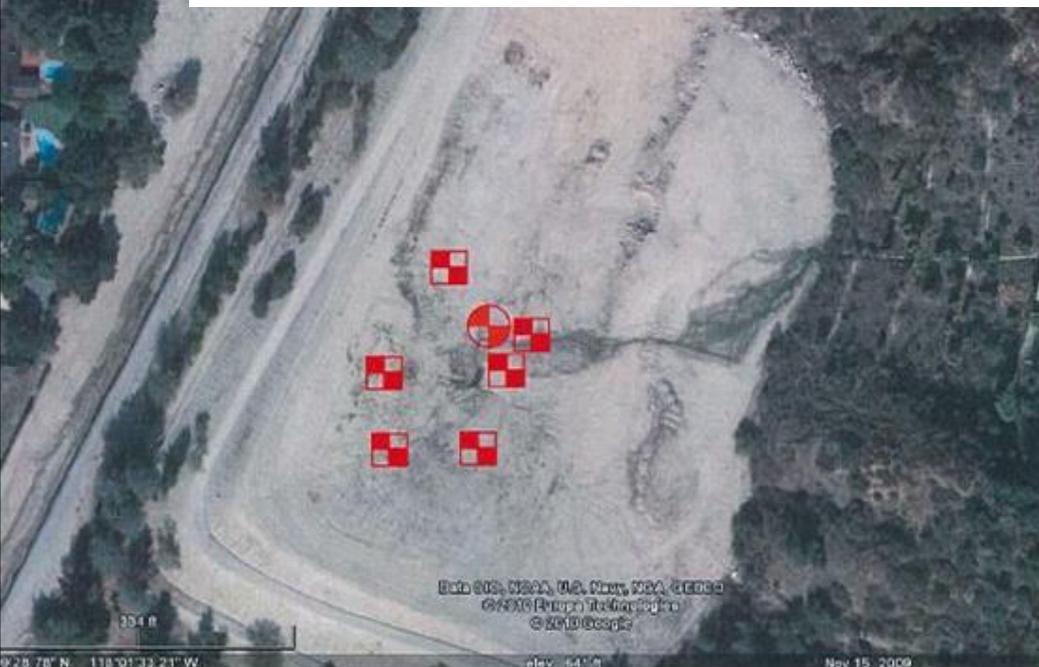
Geo-technical analysis indicated that the existing sediment was somewhat compacted. However, the final sediment would have less than 80% compaction.

- Pre-Existing 78% to 90% Compaction Gradient (0 to 53')
- 30' of New Sediment to Complete Lower SPS
- **New Sediment Compaction < 80% (Deck)**
- Slope Compaction at Least 80% for Stability

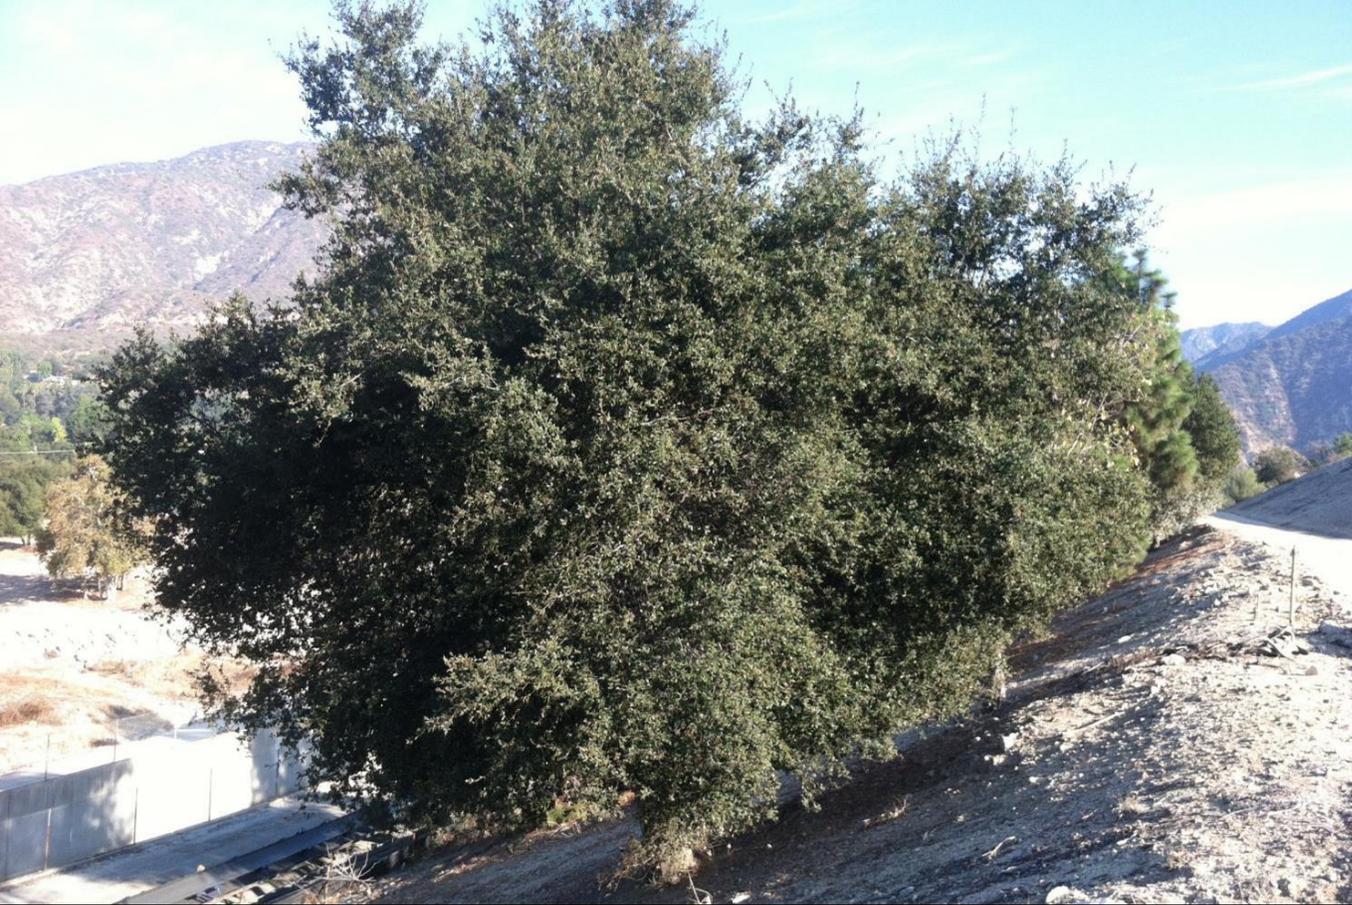
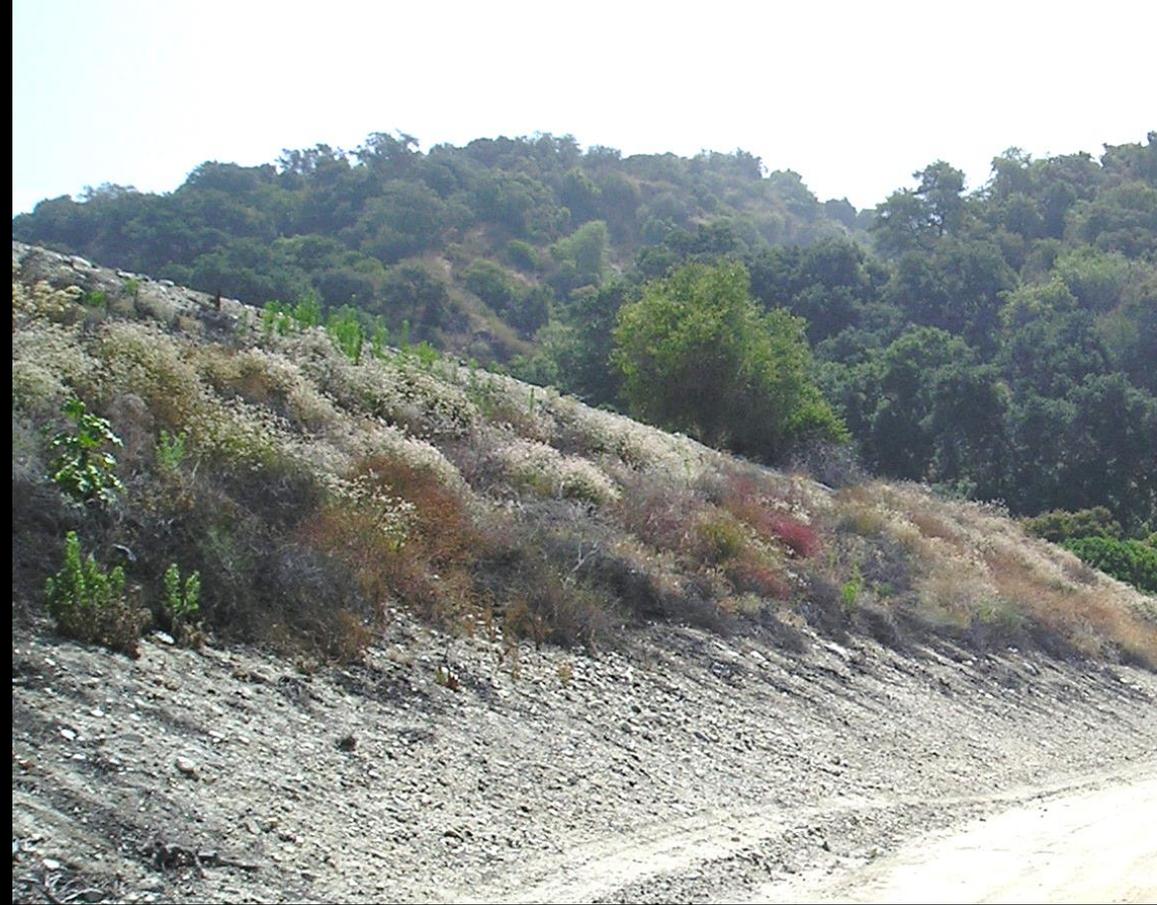
- Upper SPS: Coast live oaks and coastal sage scrub
- Non-irrigated / south- and west-facing slopes

Several large coast live oaks (*Quercus agrifolia* var. *agrifolia*) in good condition, and sage scrub vegetation, occur on the nearby Upper SPS, growing in placed sediment from the same source (Santa Anita Reservoir).

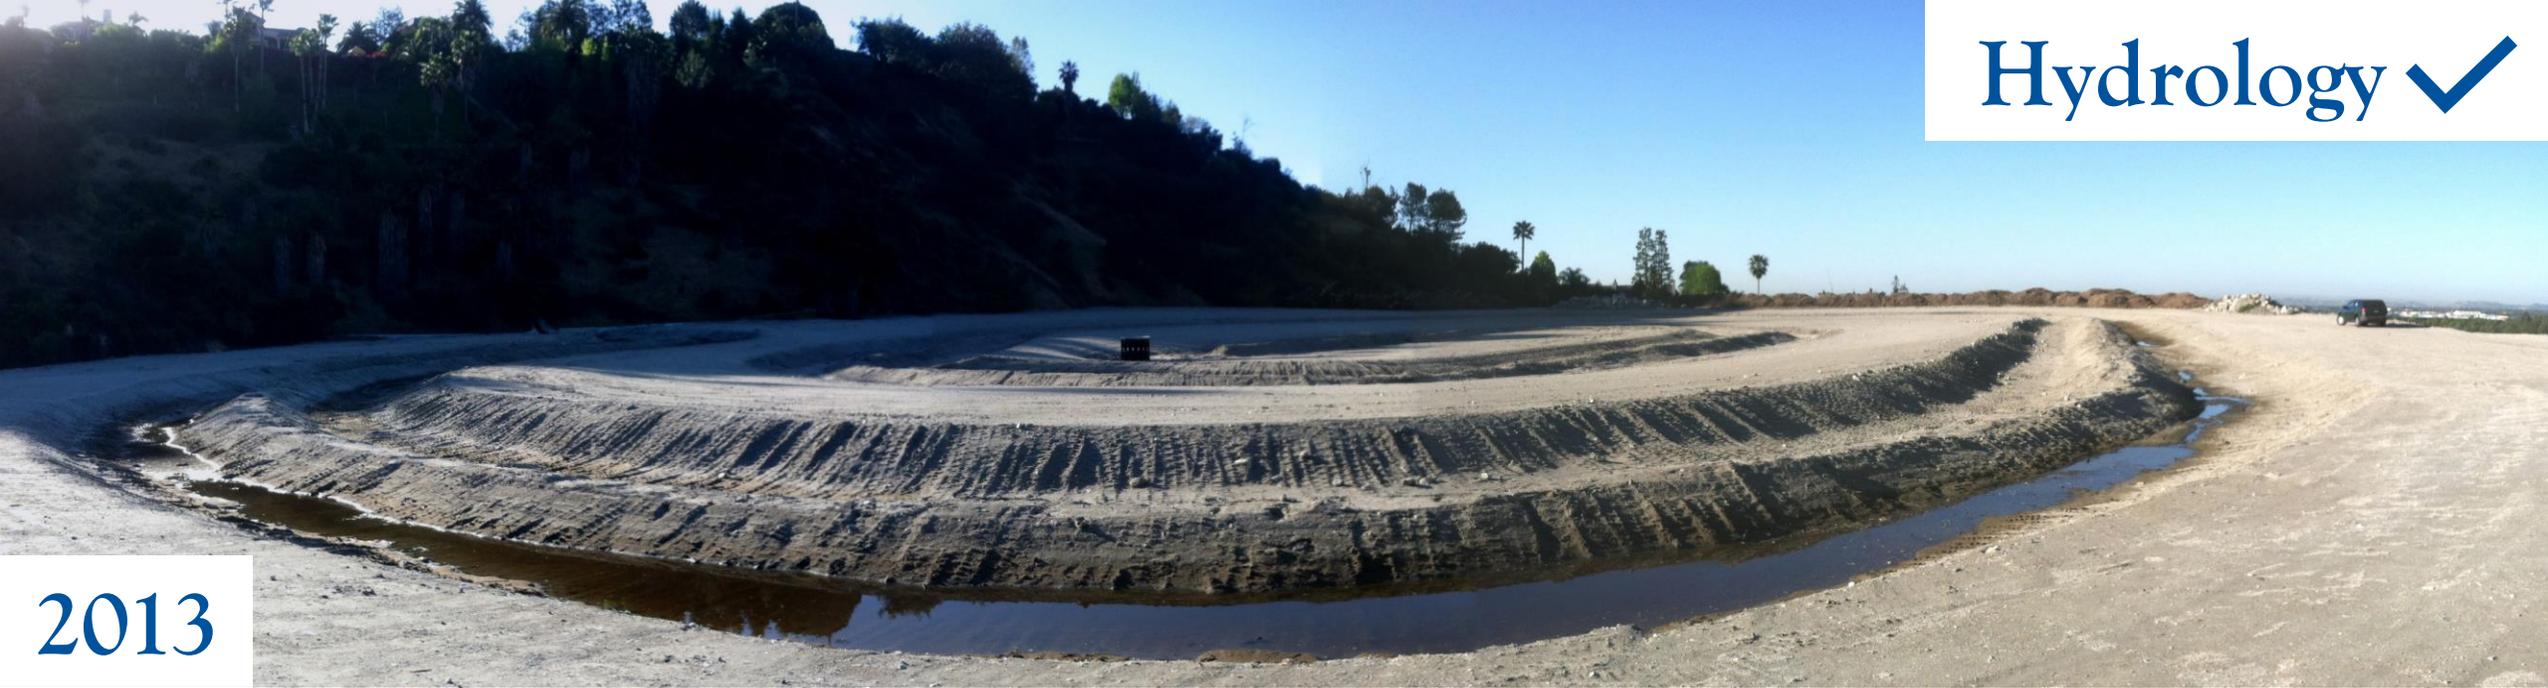
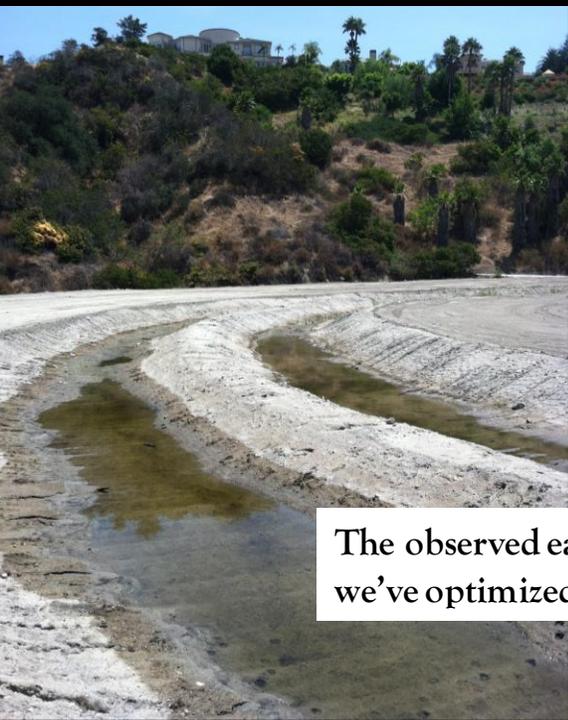
The observed early flows in the drainages indicated that we've optimized the hydrology on the mitigation site.

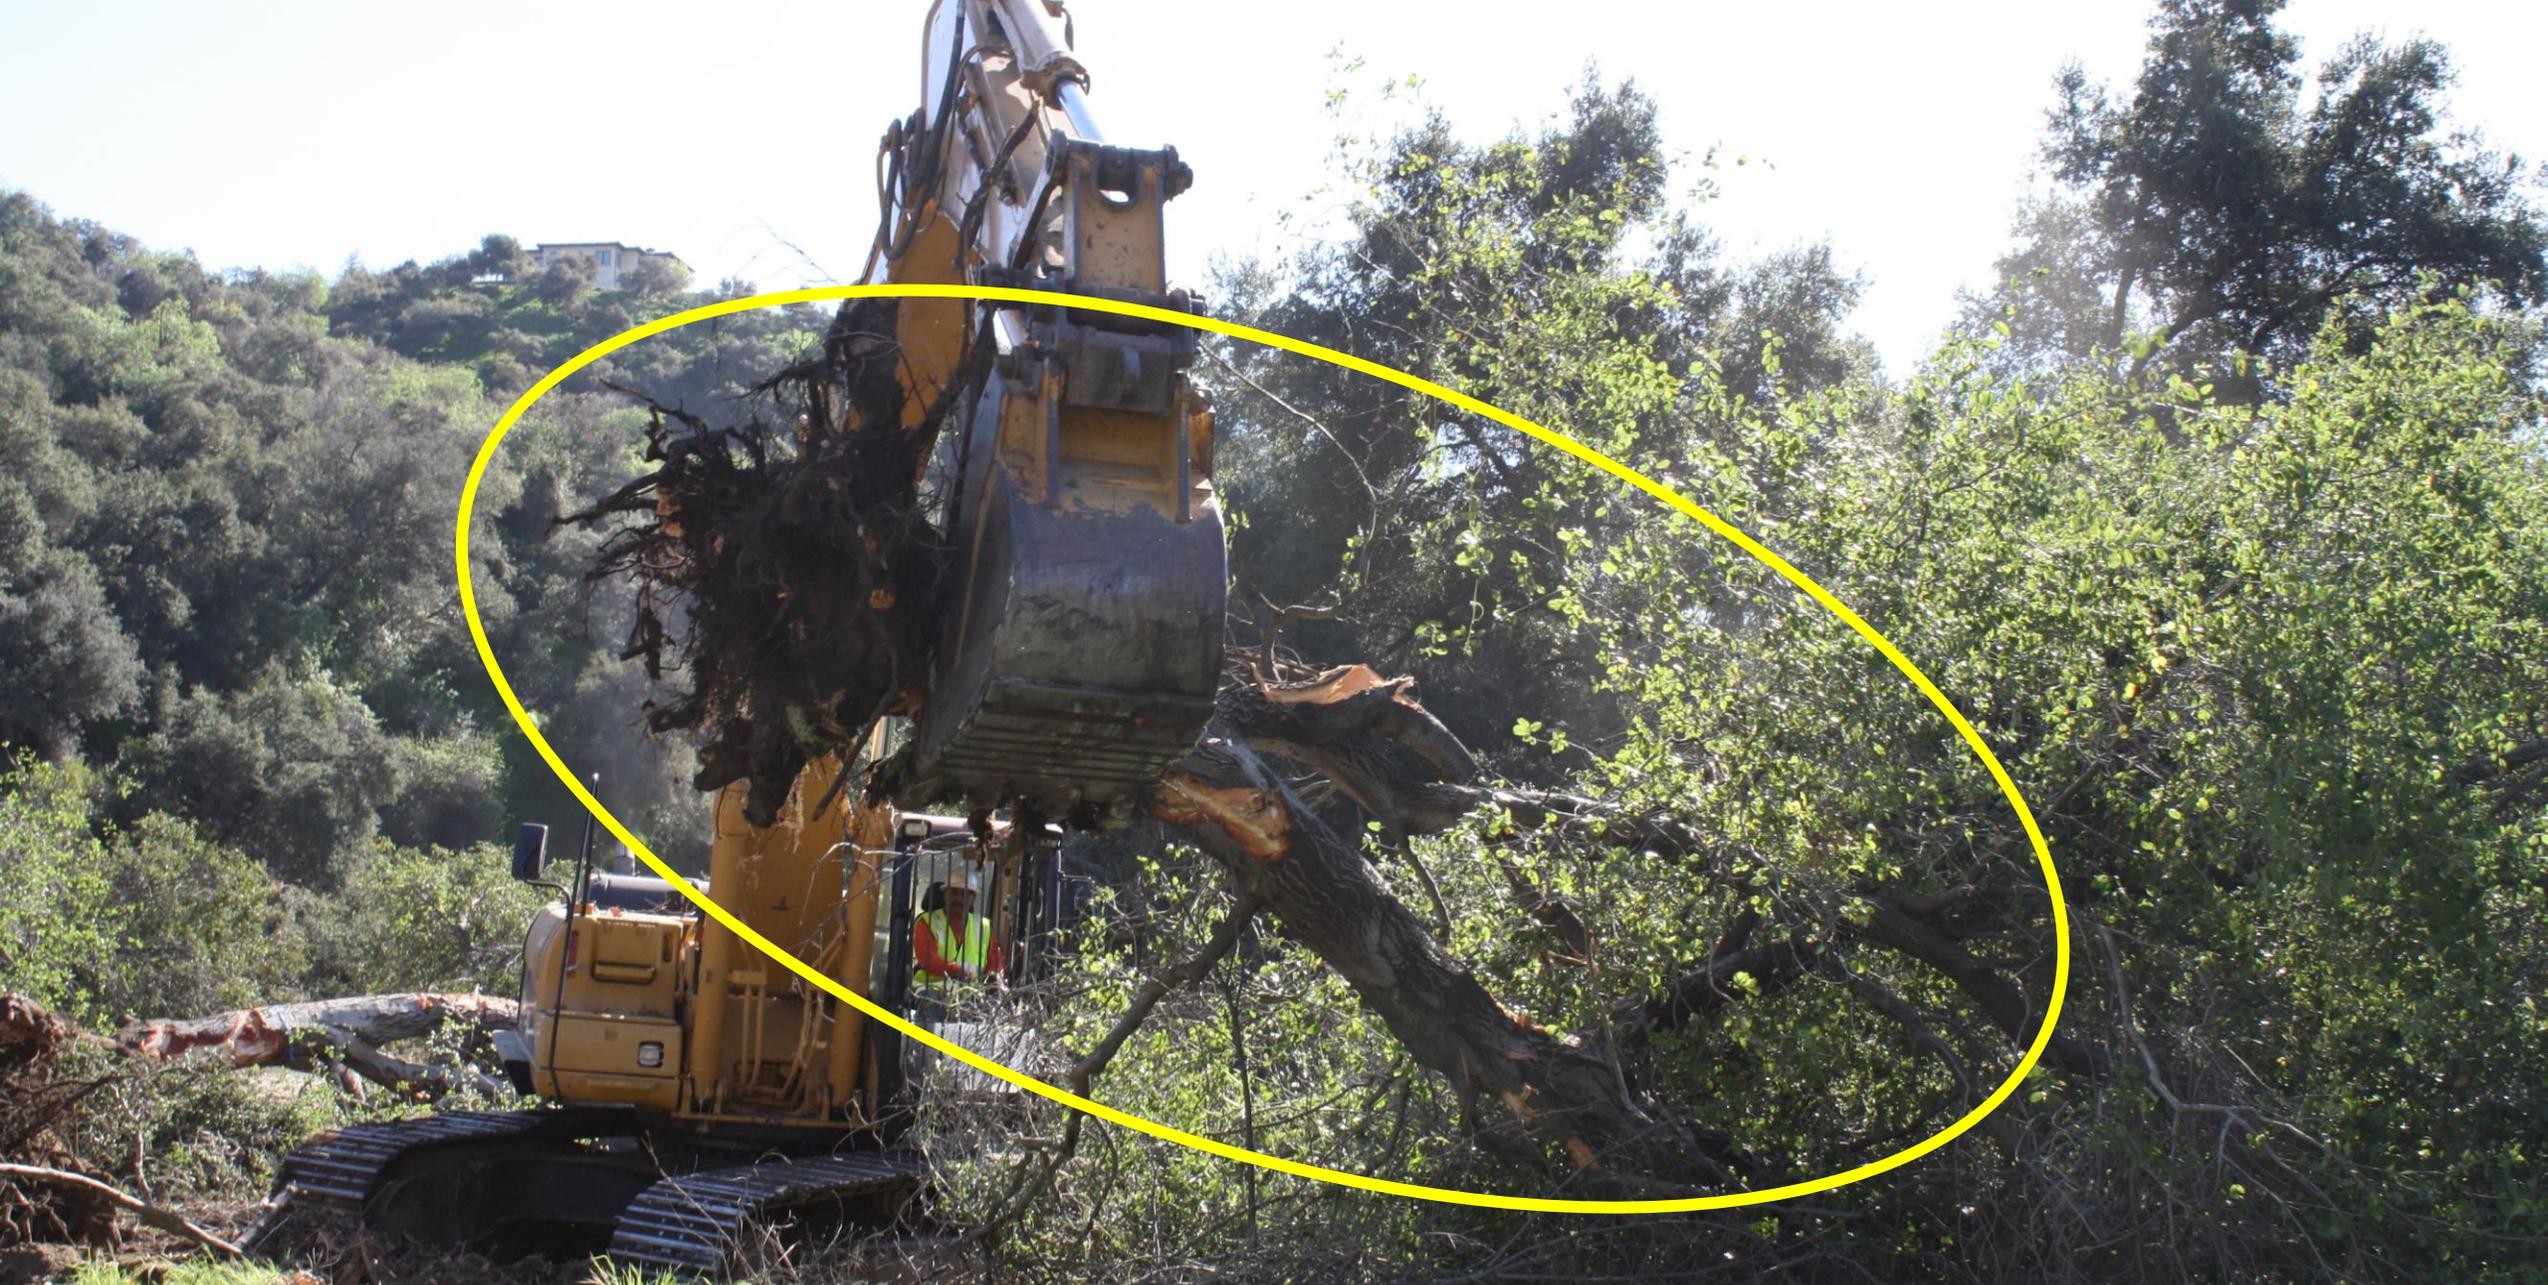
During the habitat impact phase, Psomas worked with Public Works and their General Contractor to salvage and stockpile a huge volume of removed debris—trunks, stumps, brush piles, including some trunks with root masses attached for installation as natural snags.
