# Substrate Enhancements and Botanical Diversity for Successful Oak Habitat Creation

Richard B. Lewis III, ENV SP  
Senior Restoration Ecologist, Psomas

This is a PDF-version of the slide show that accompanied Psomas' oral presentation at the University of California Agriculture & Natural Resources' 8<sup>th</sup> California Oak Symposium in San Luis Obispo, California, on November 1, 2022. The narration from that presentation has been added via text boxes to this PDF version.

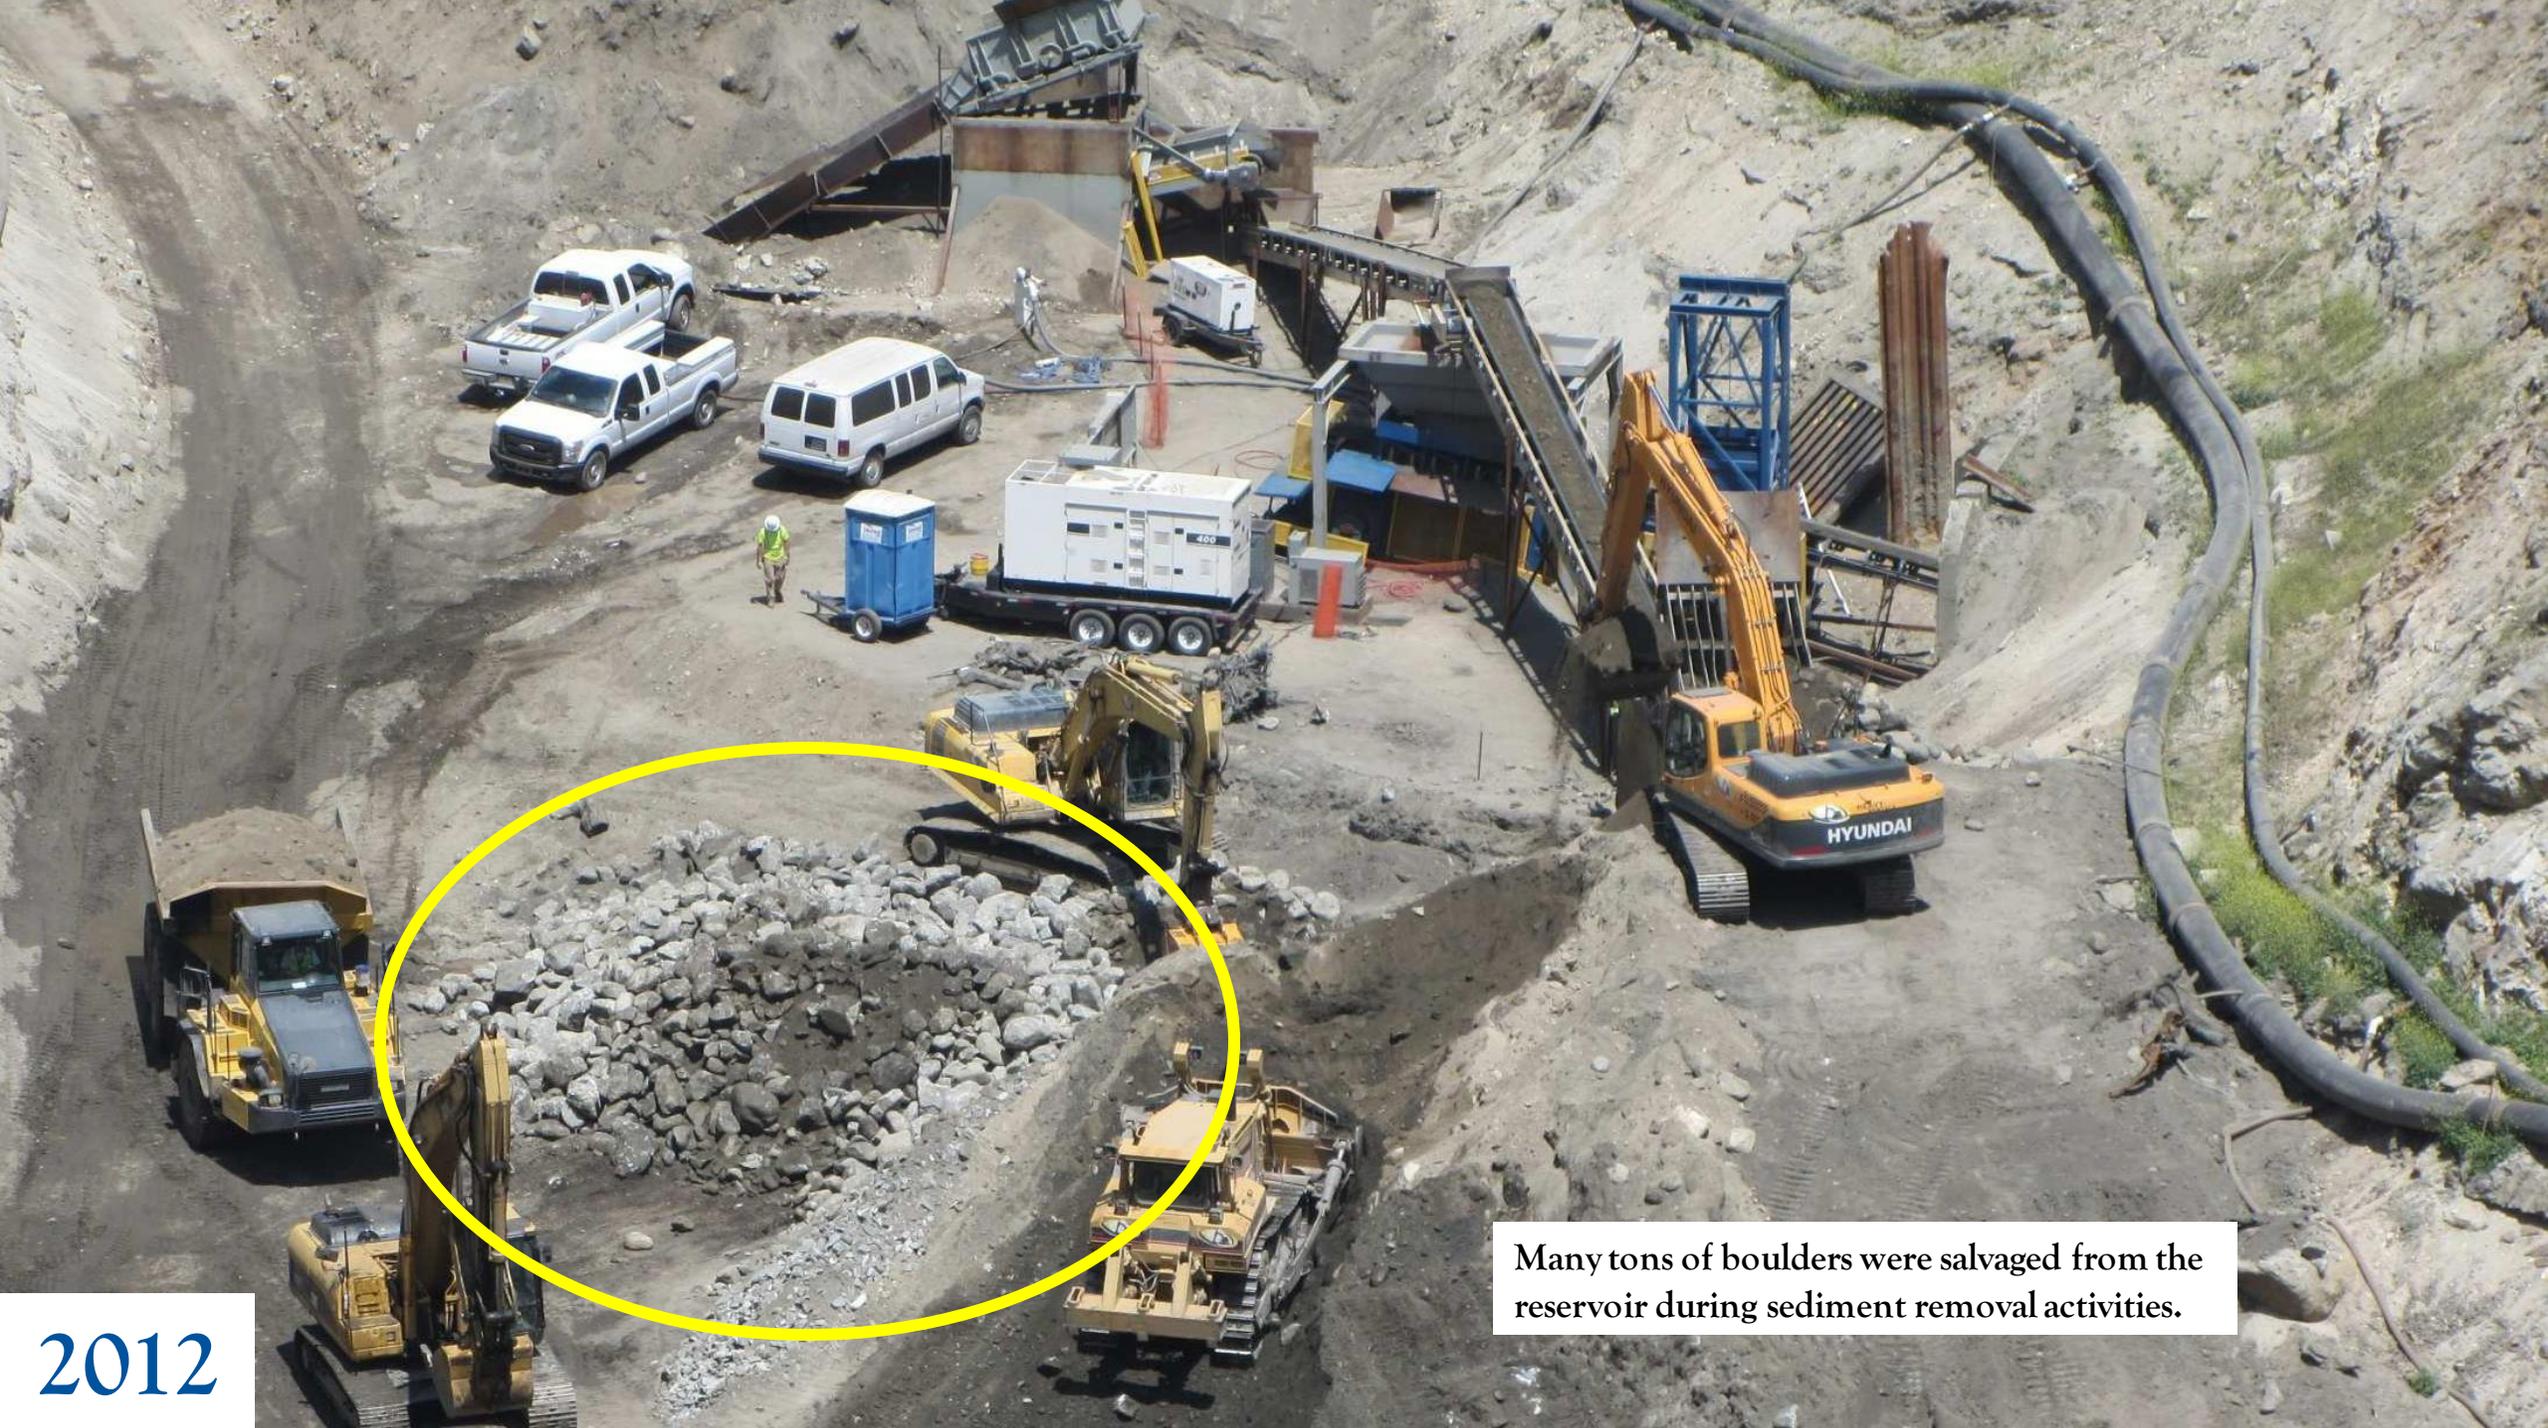
Many tons of boulders were salvaged from the reservoir during sediment removal activities.

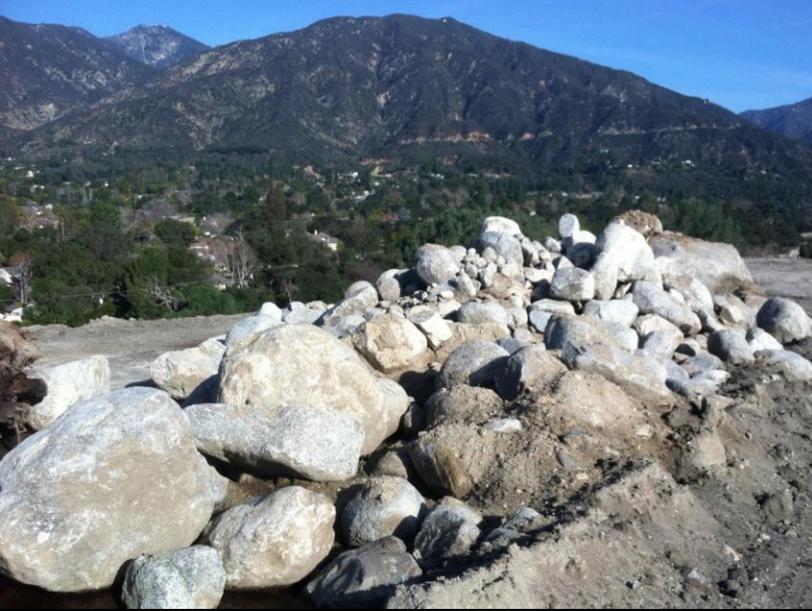
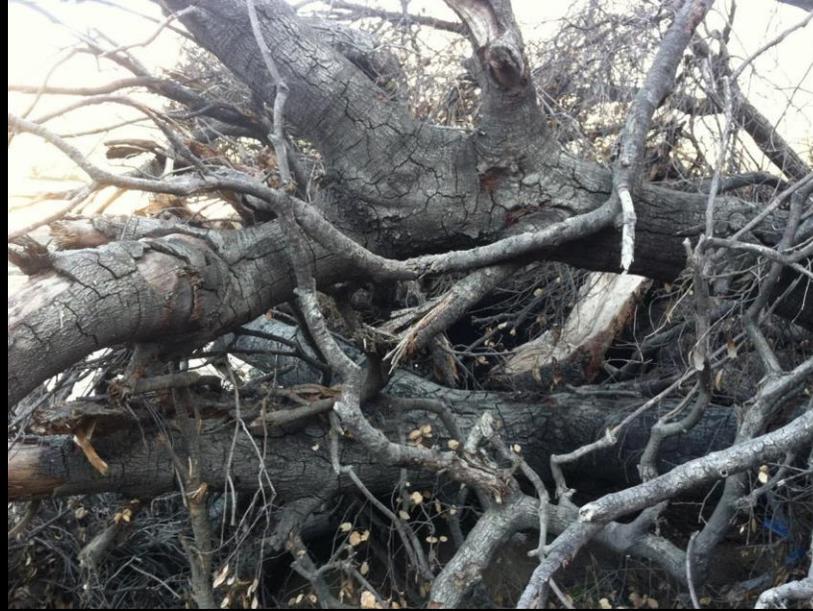
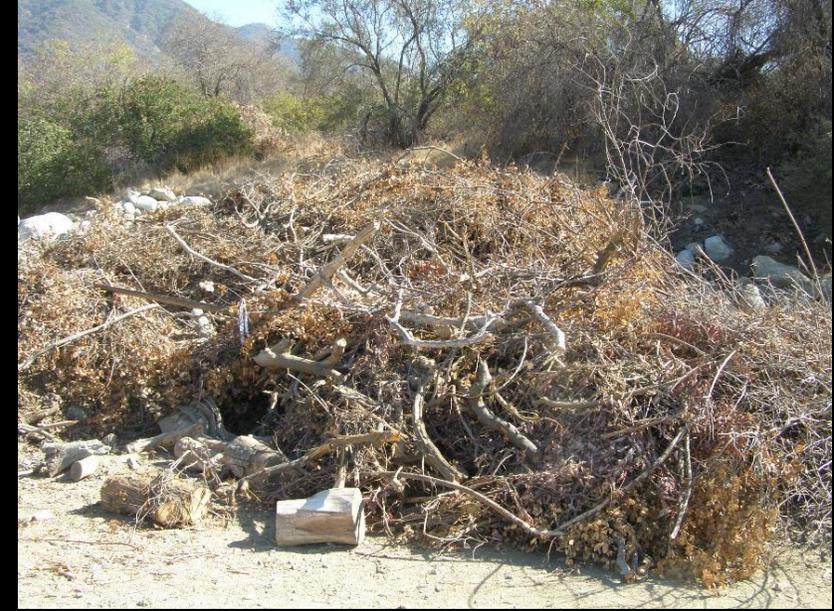
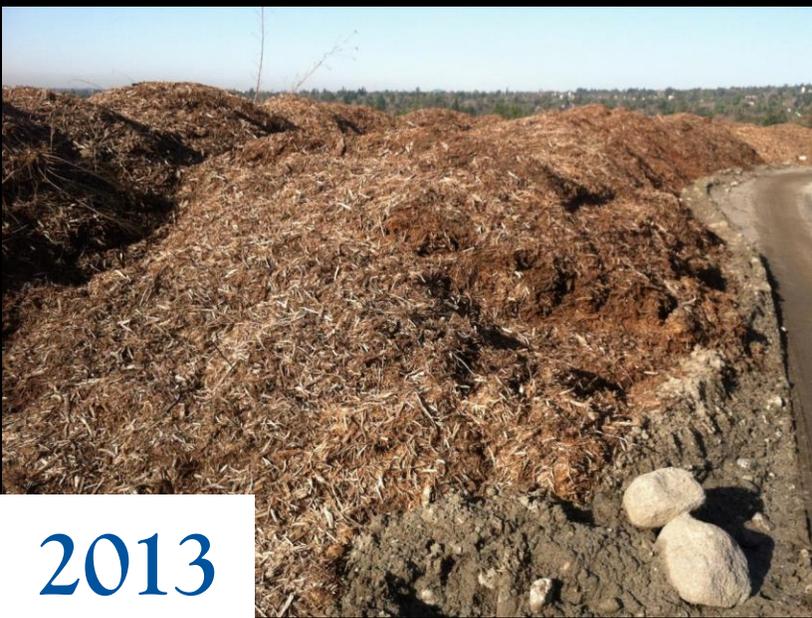
Here are some of the stockpiled natural materials. Whatever trunks/stems were not retained whole, were mulched for use in conditioning the placed sediment. We essentially used 'the whole animal' in terms of woody vegetation from the Middle SPS.

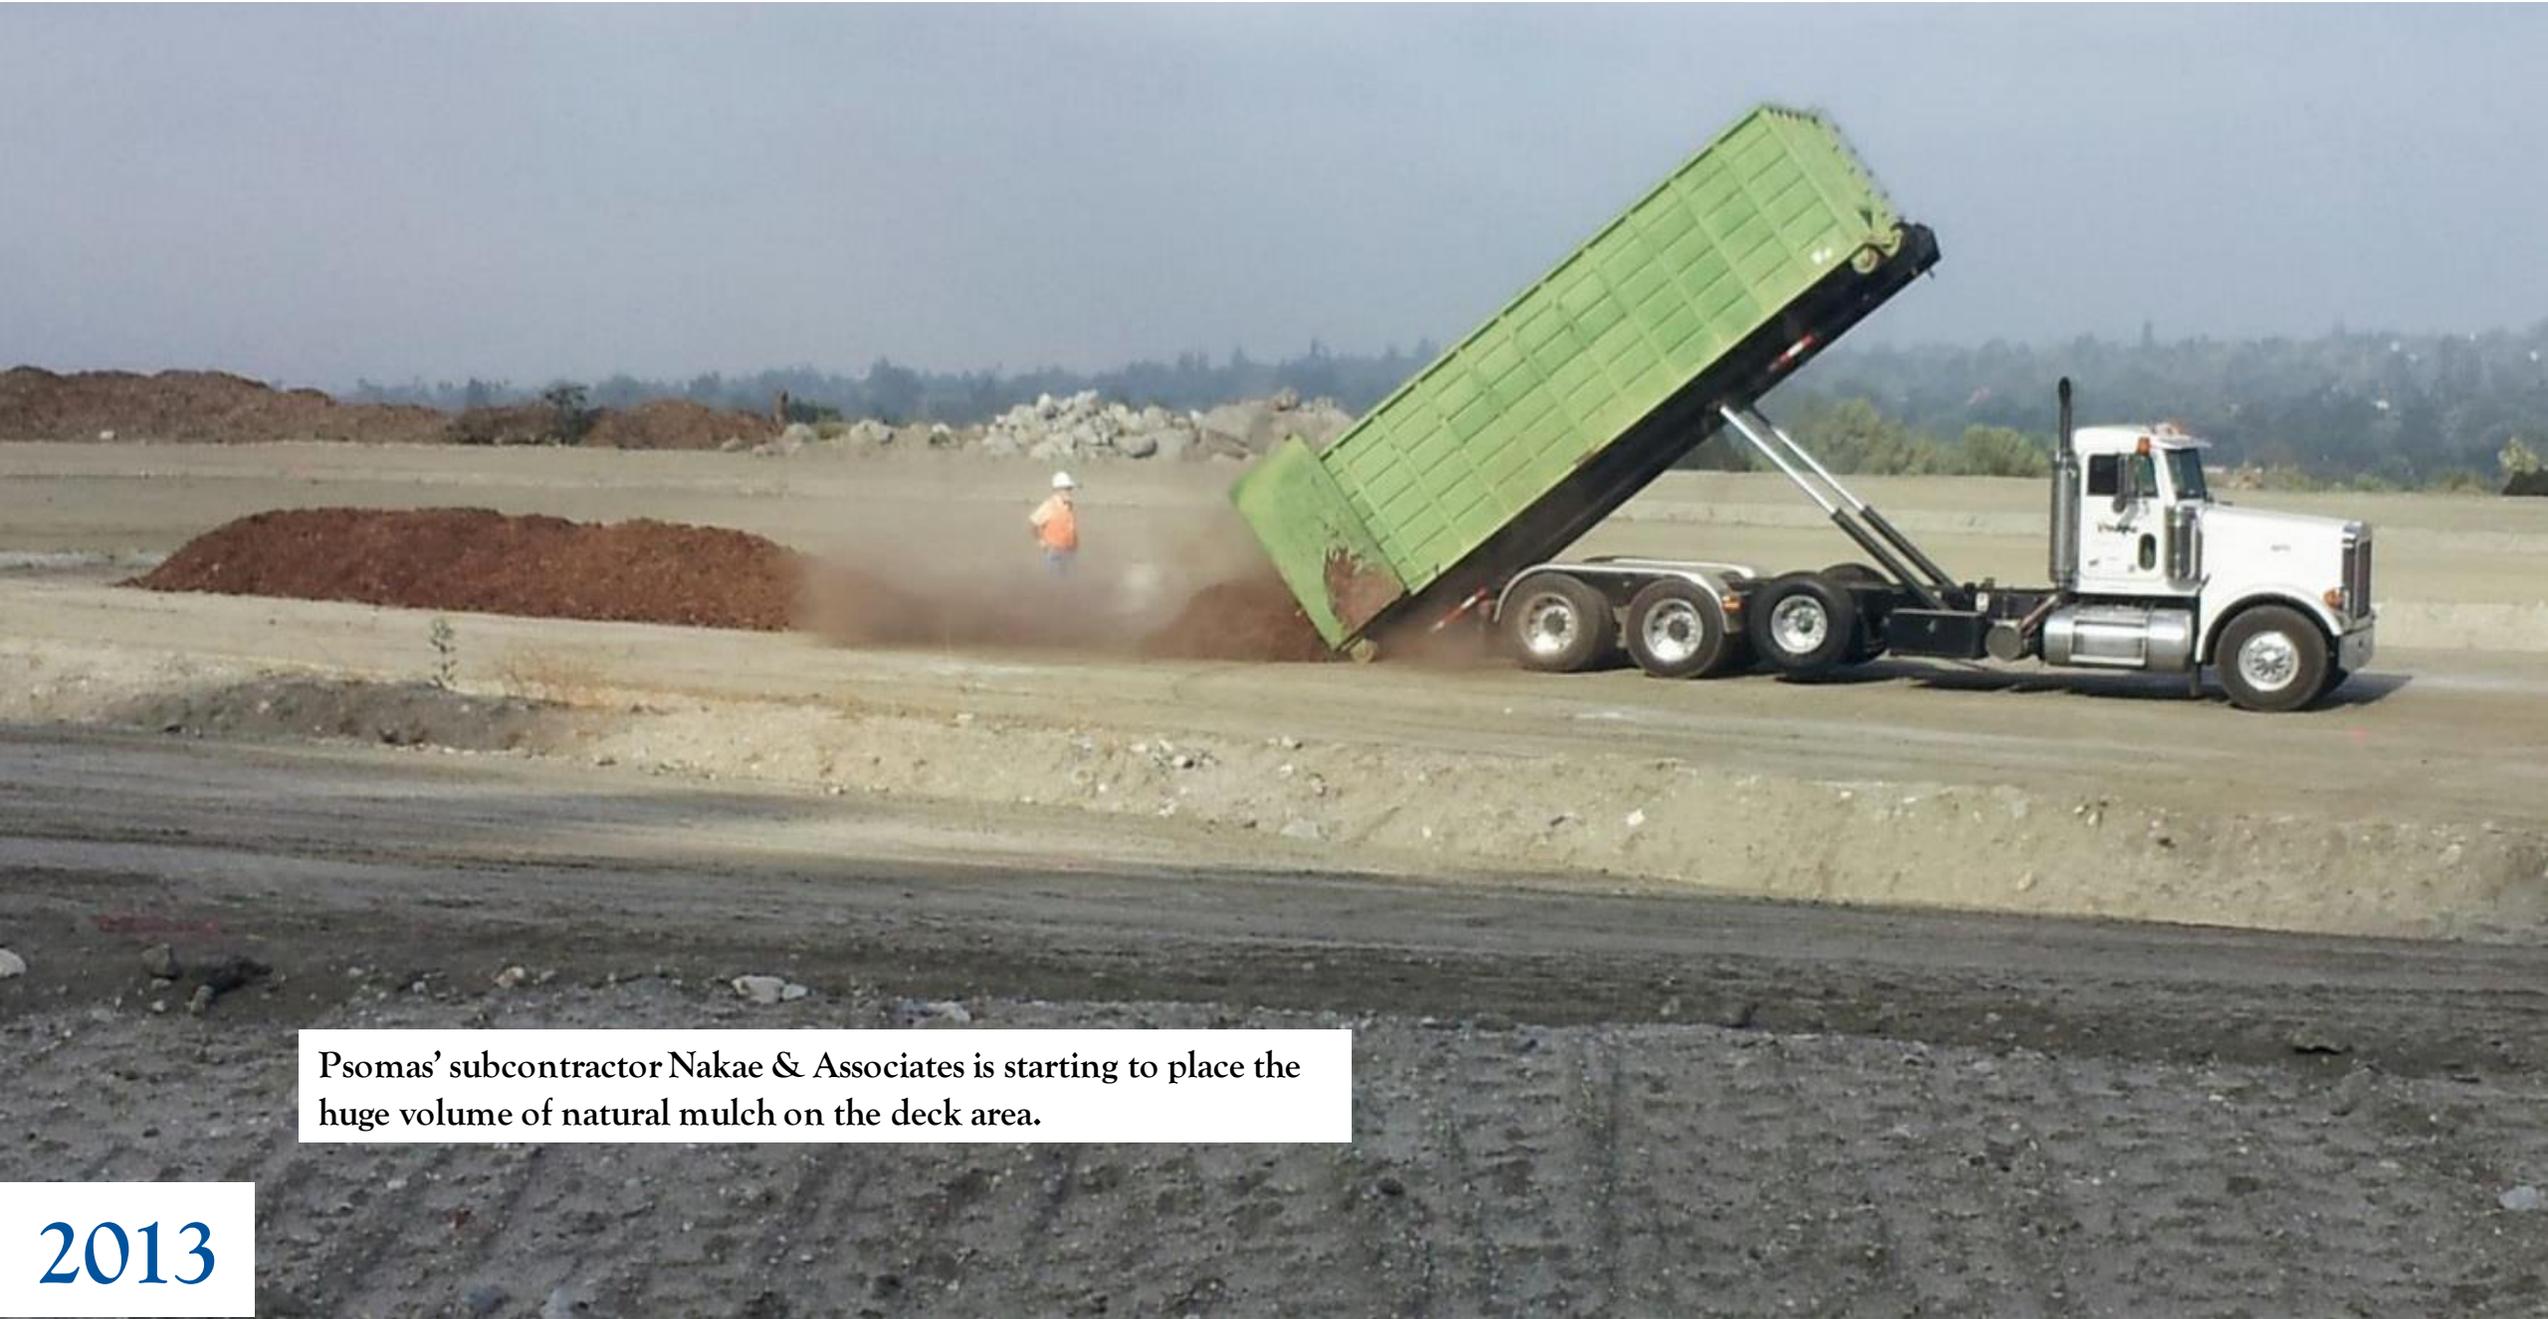
Psomas' subcontractor Nakae & Associates is starting to place the huge volume of natural mulch on the deck area.

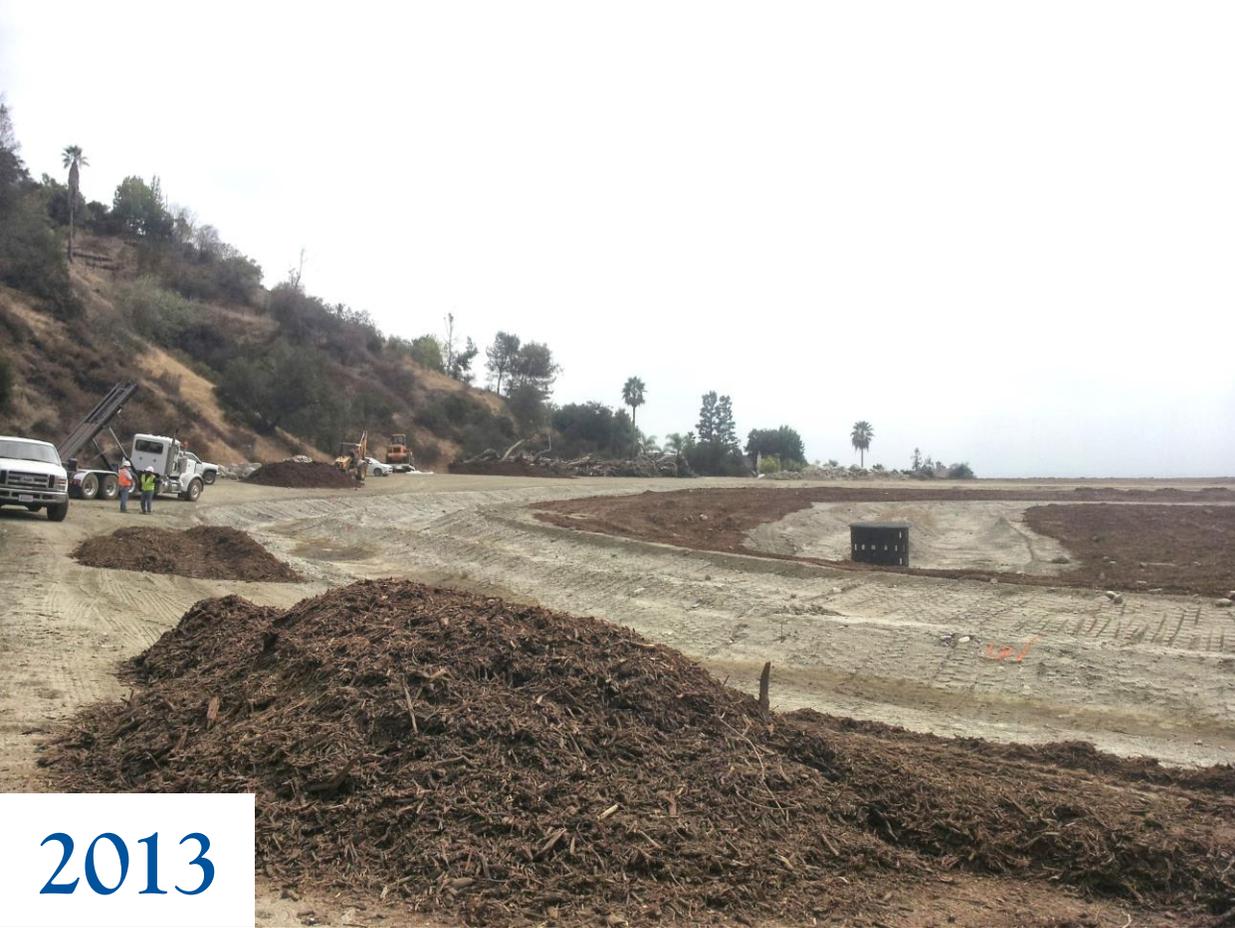
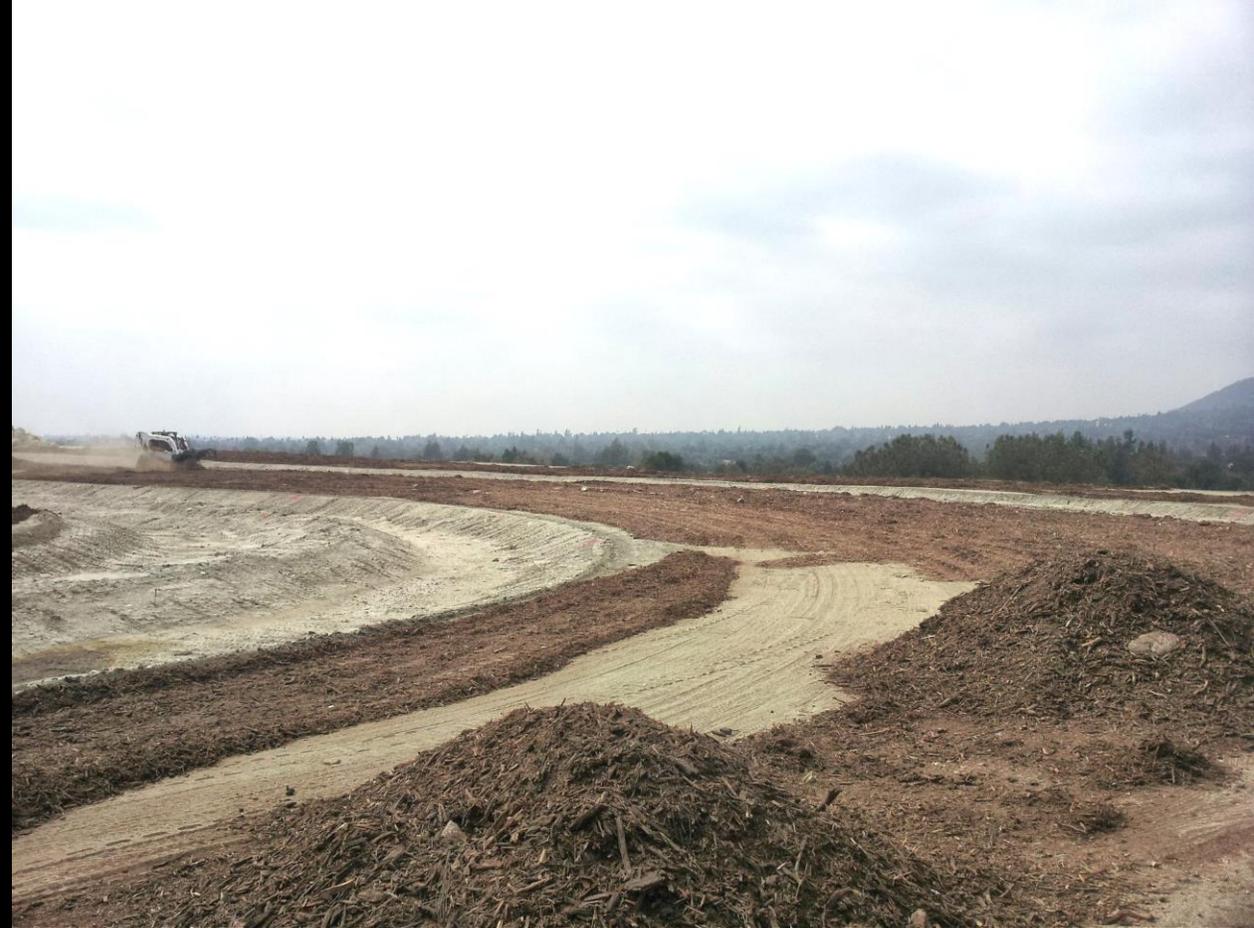
- Large volume of salvaged mulch ripped to minimum 2-foot depth
- Urea added for nitrogen balance

The mulch was ripped to a minimum depth of 2 feet using a bulldozer, and urea was added for nitrogen balance.

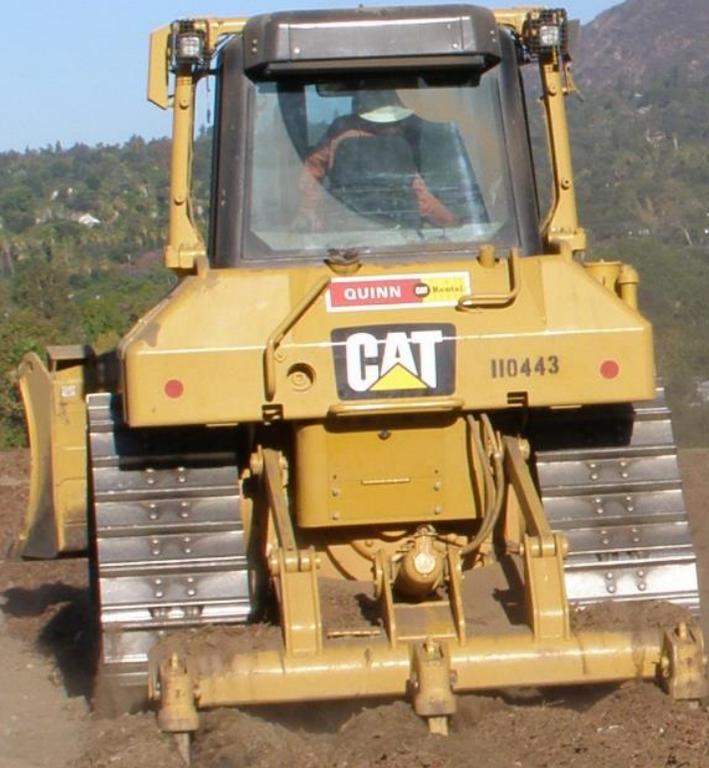
# Compaction ✓

Here, we think we've addressed CDFW's concerns about soil compaction.

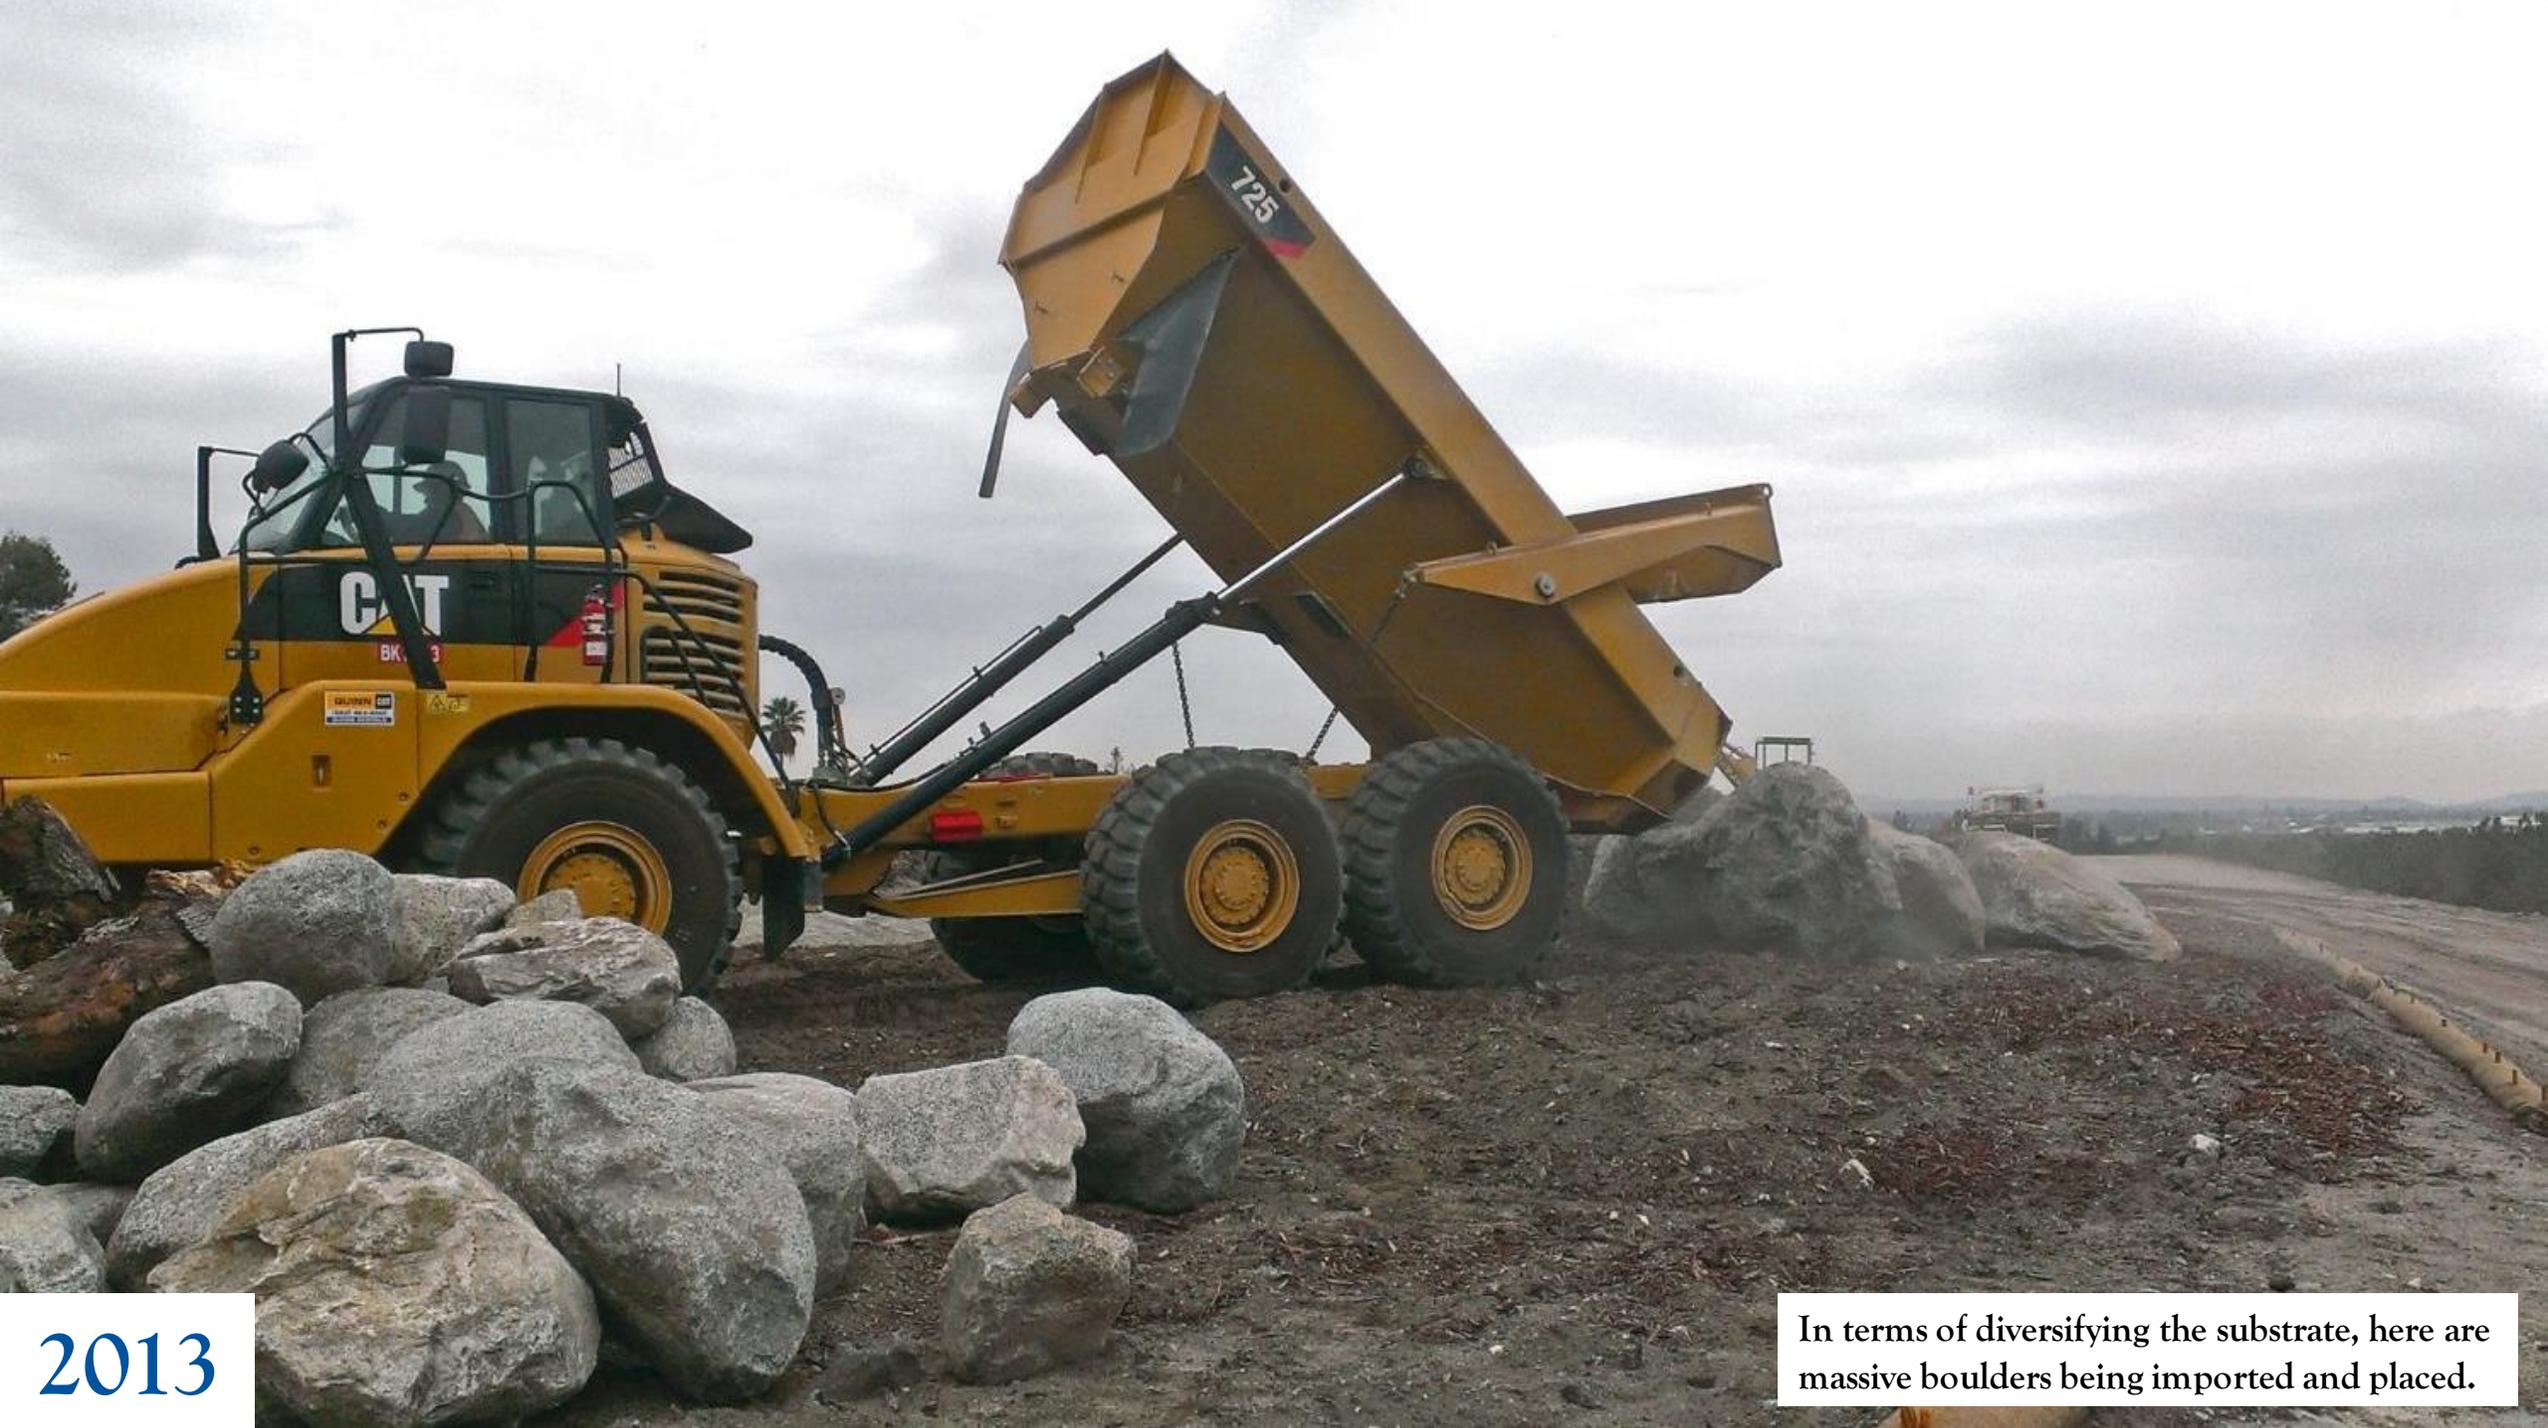
In terms of diversifying the substrate, here are massive boulders being imported and placed.

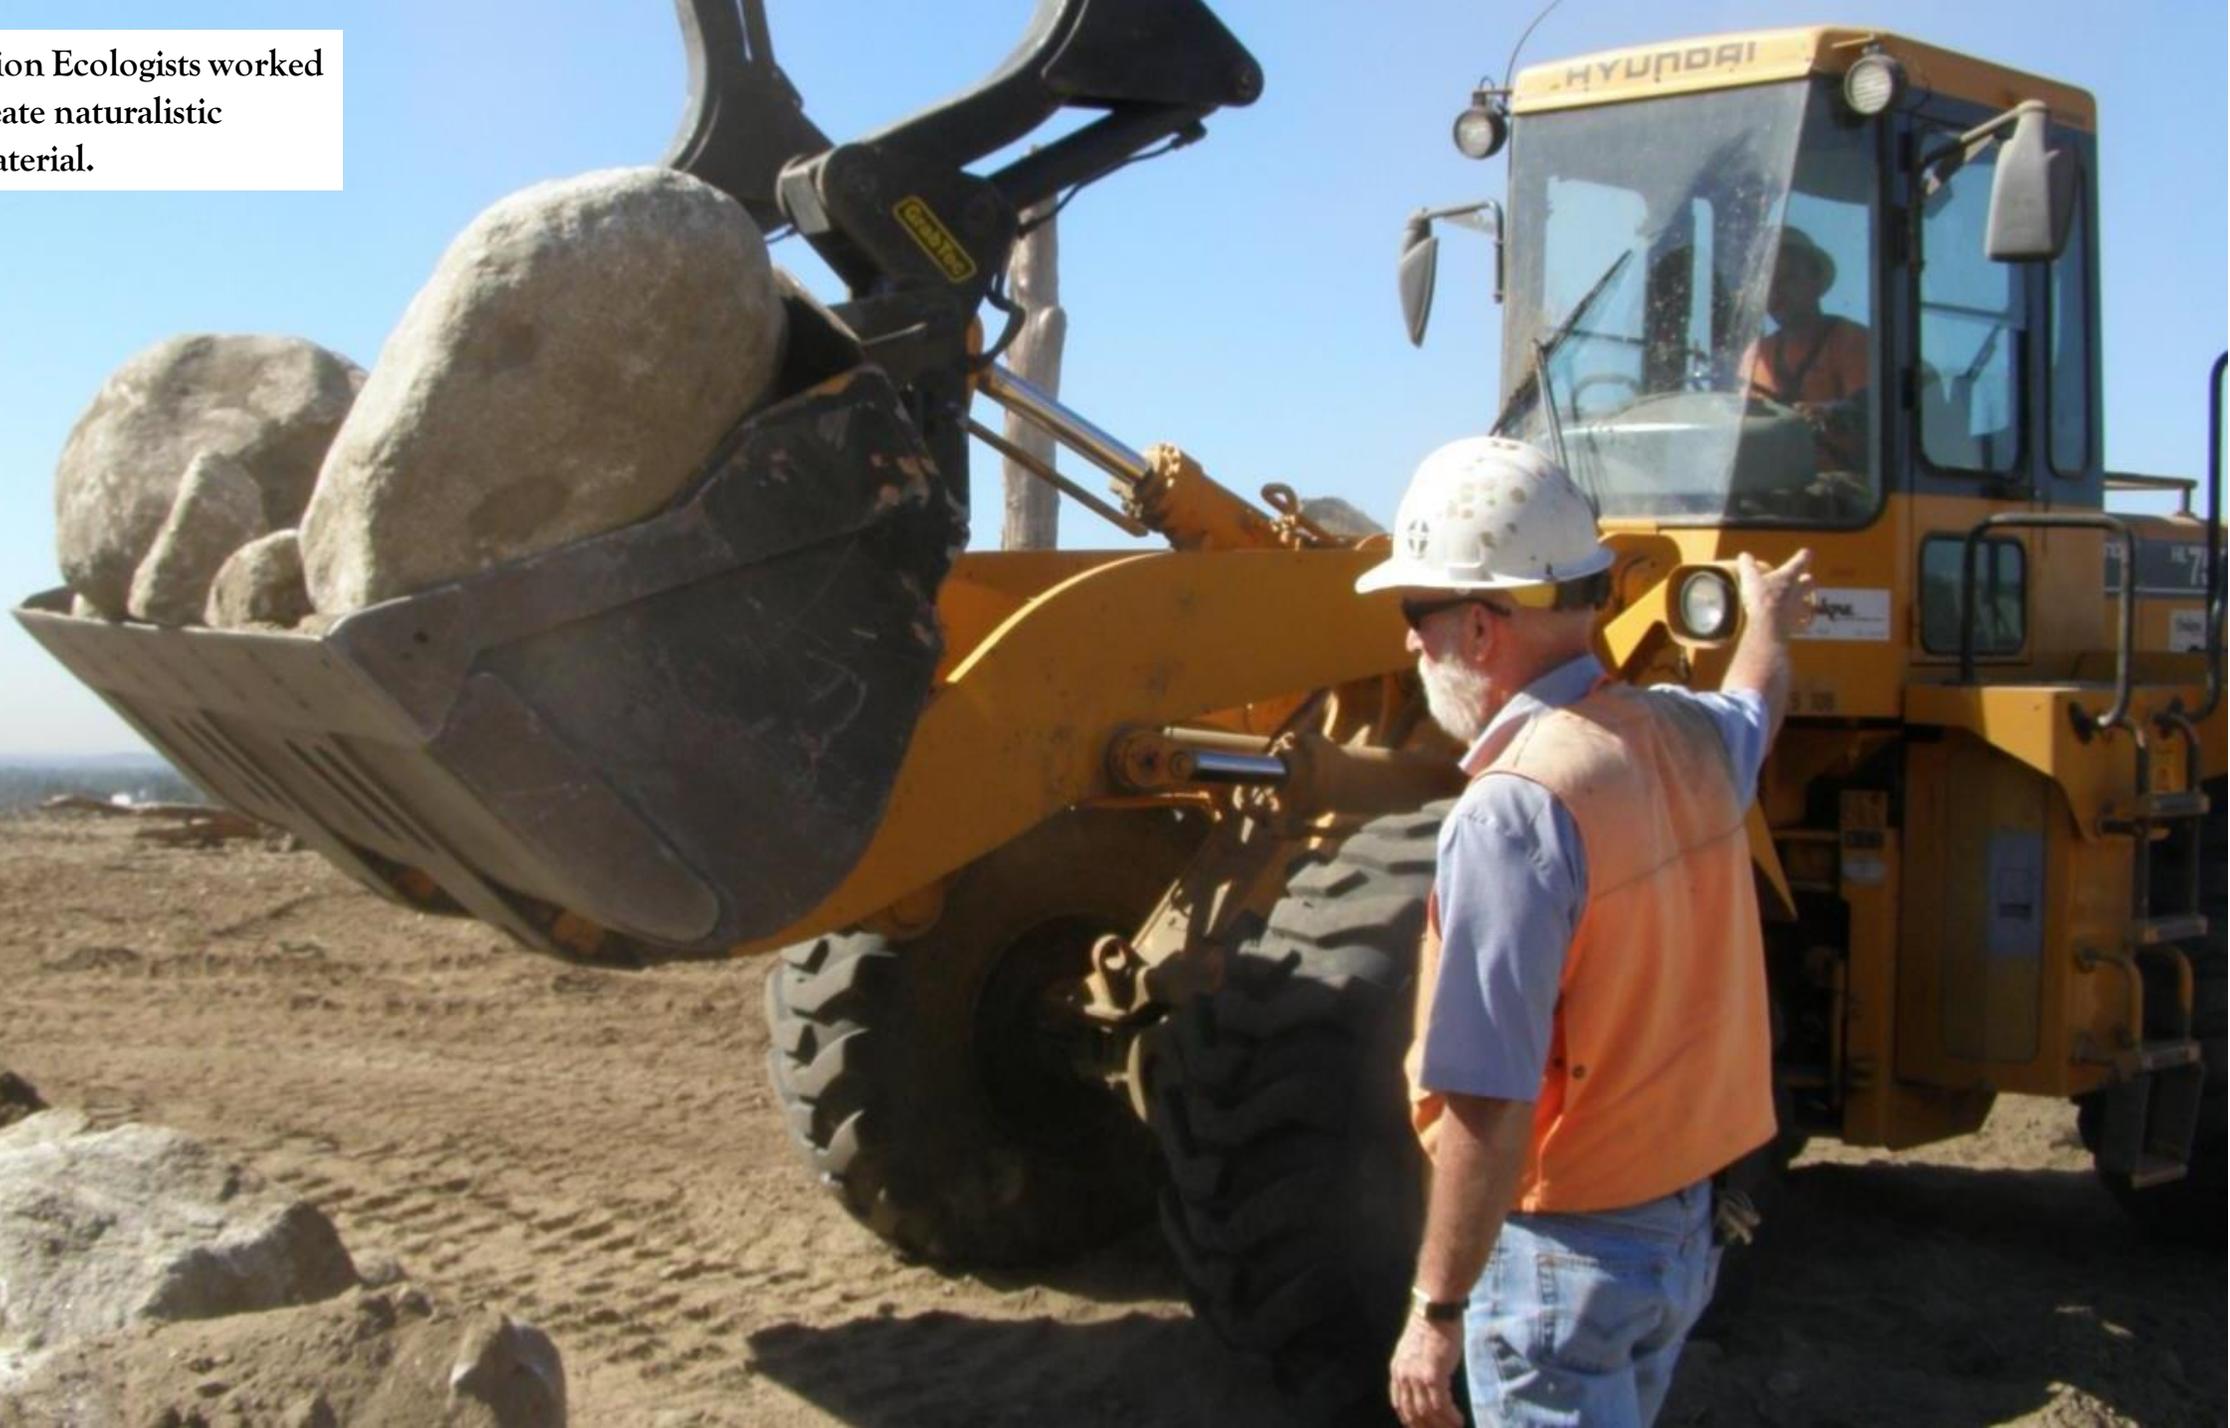
Psomas' Restoration Ecologists worked with Nakae to create naturalistic assemblages of material.

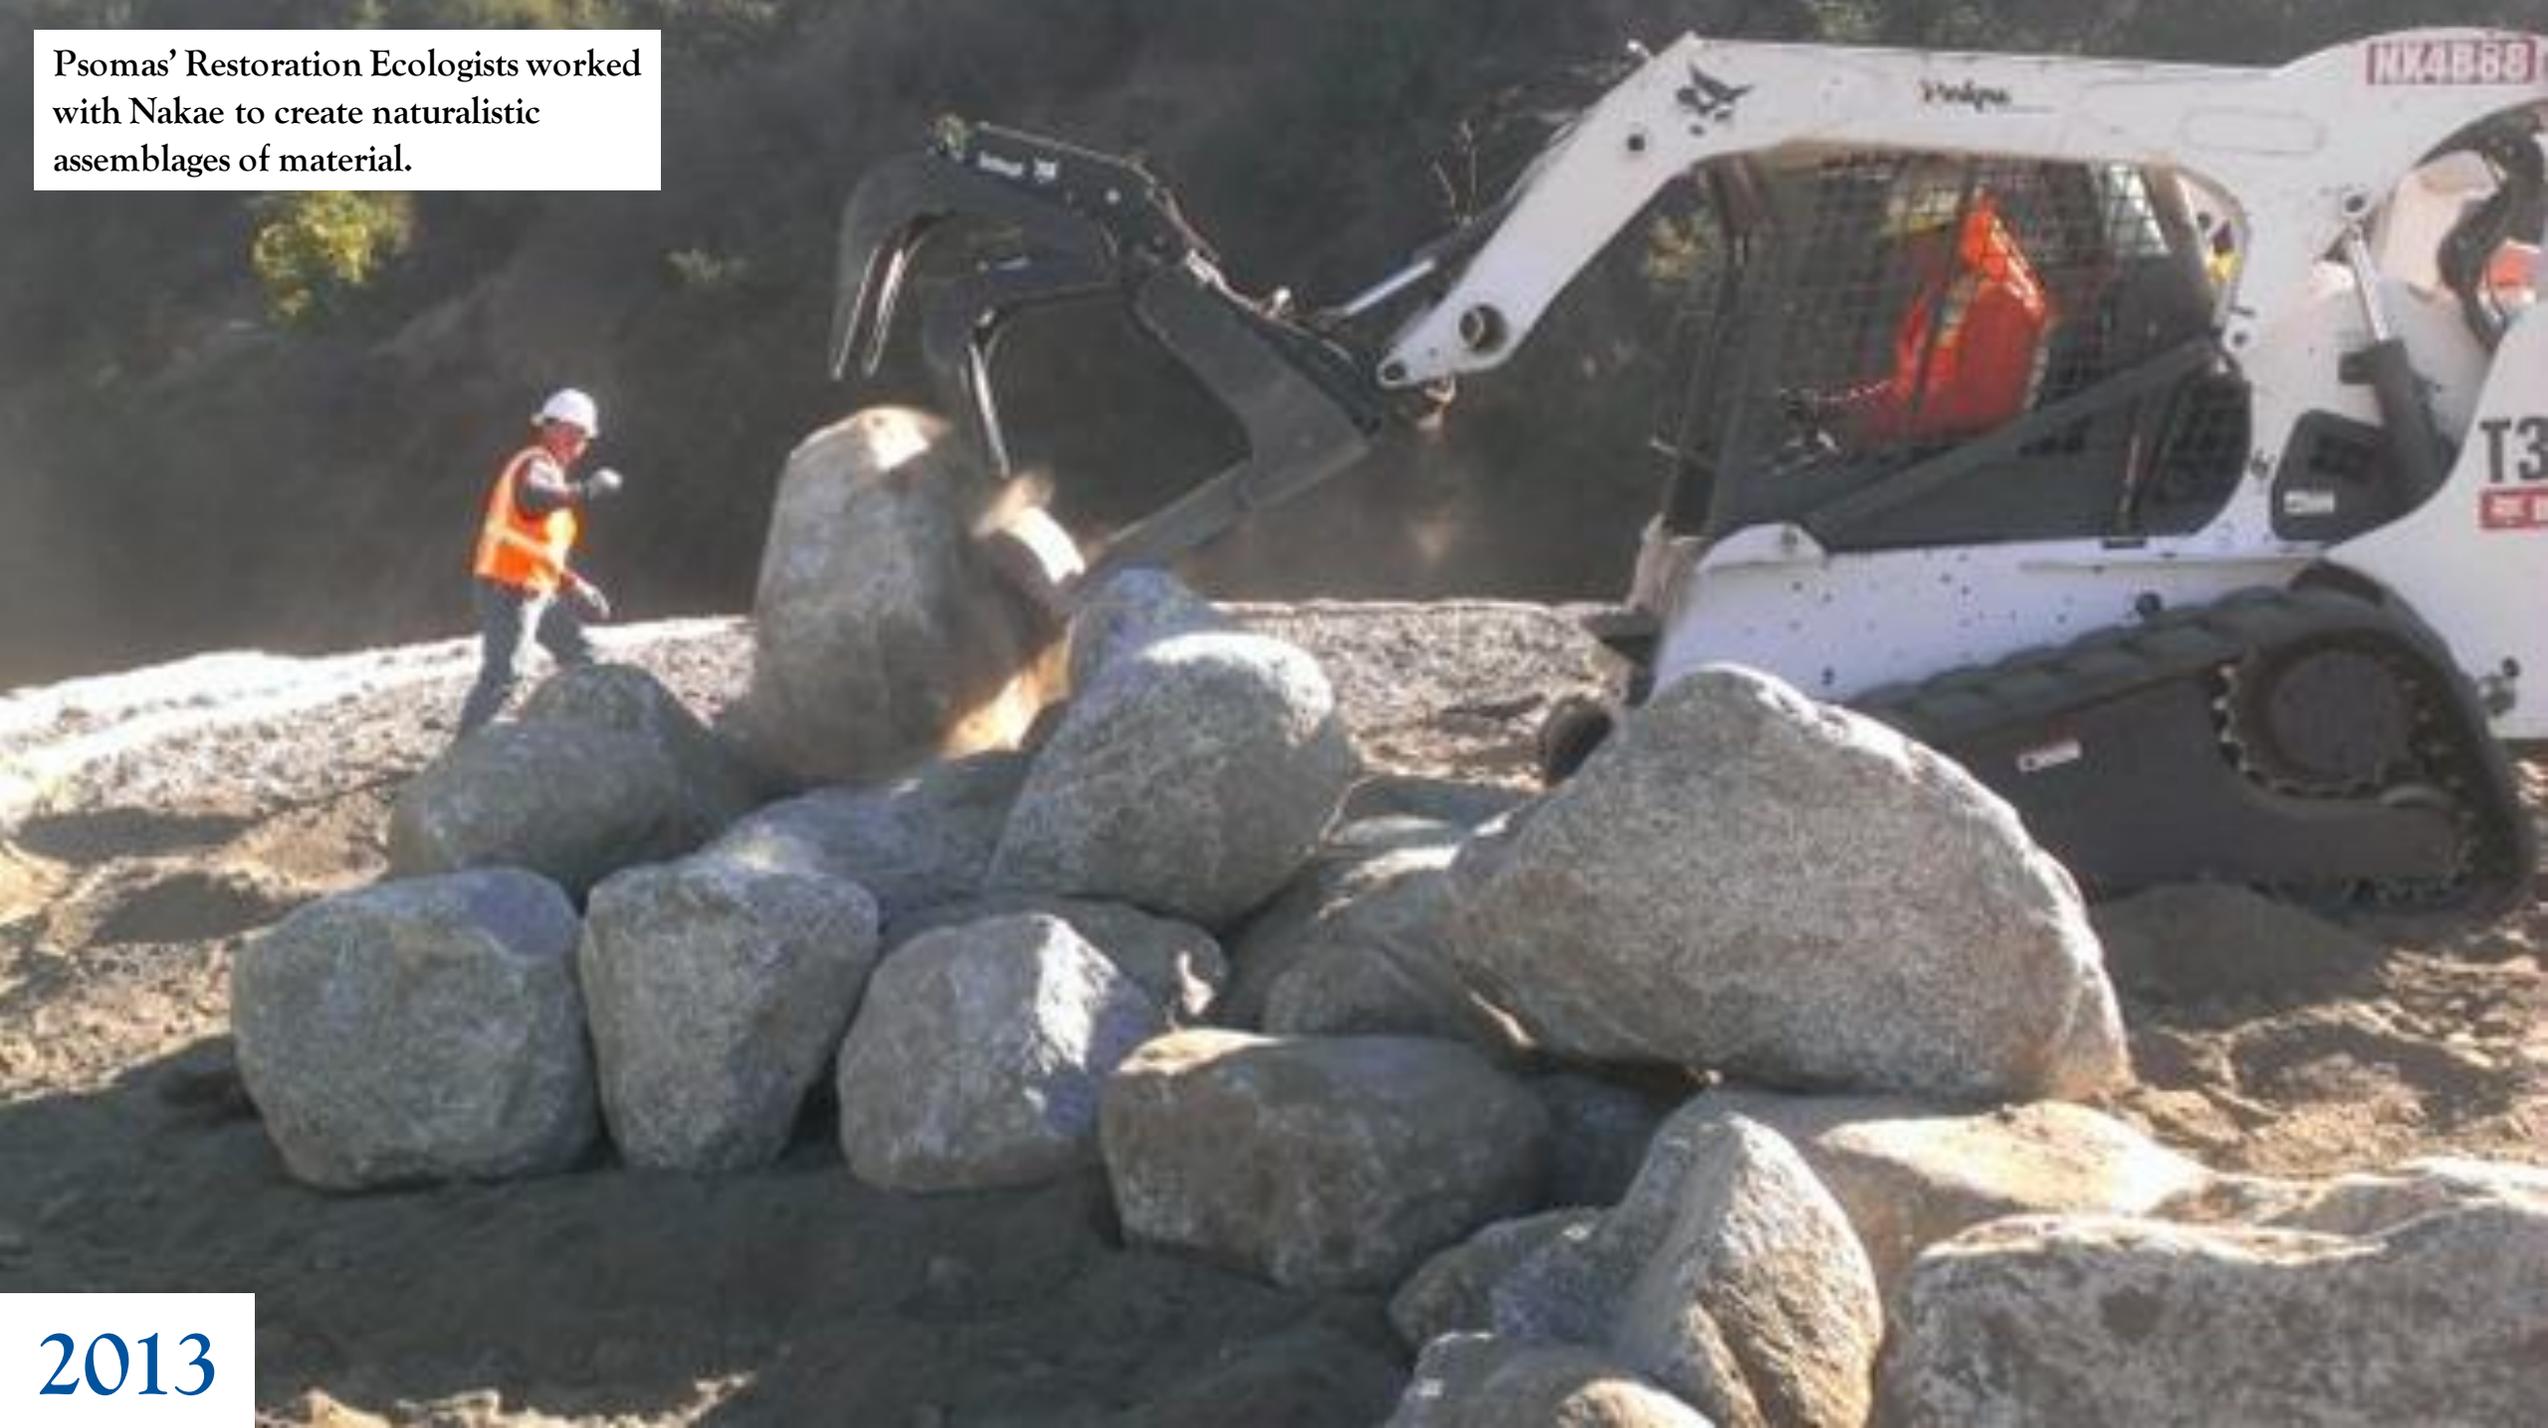
Psomas' Restoration Ecologists worked with Nakae to create naturalistic assemblages of material.
