# Substrate Enhancements and Botanical Diversity for Successful Oak Habitat Creation

Richard B. Lewis III, ENV SP  
Senior Restoration Ecologist, Psomas

This is a PDF-version of the slide show that accompanied Psomas' oral presentation at the University of California Agriculture & Natural Resources' 8<sup>th</sup> California Oak Symposium in San Luis Obispo, California, on November 1, 2022. The narration from that presentation has been added via text boxes to this PDF version.

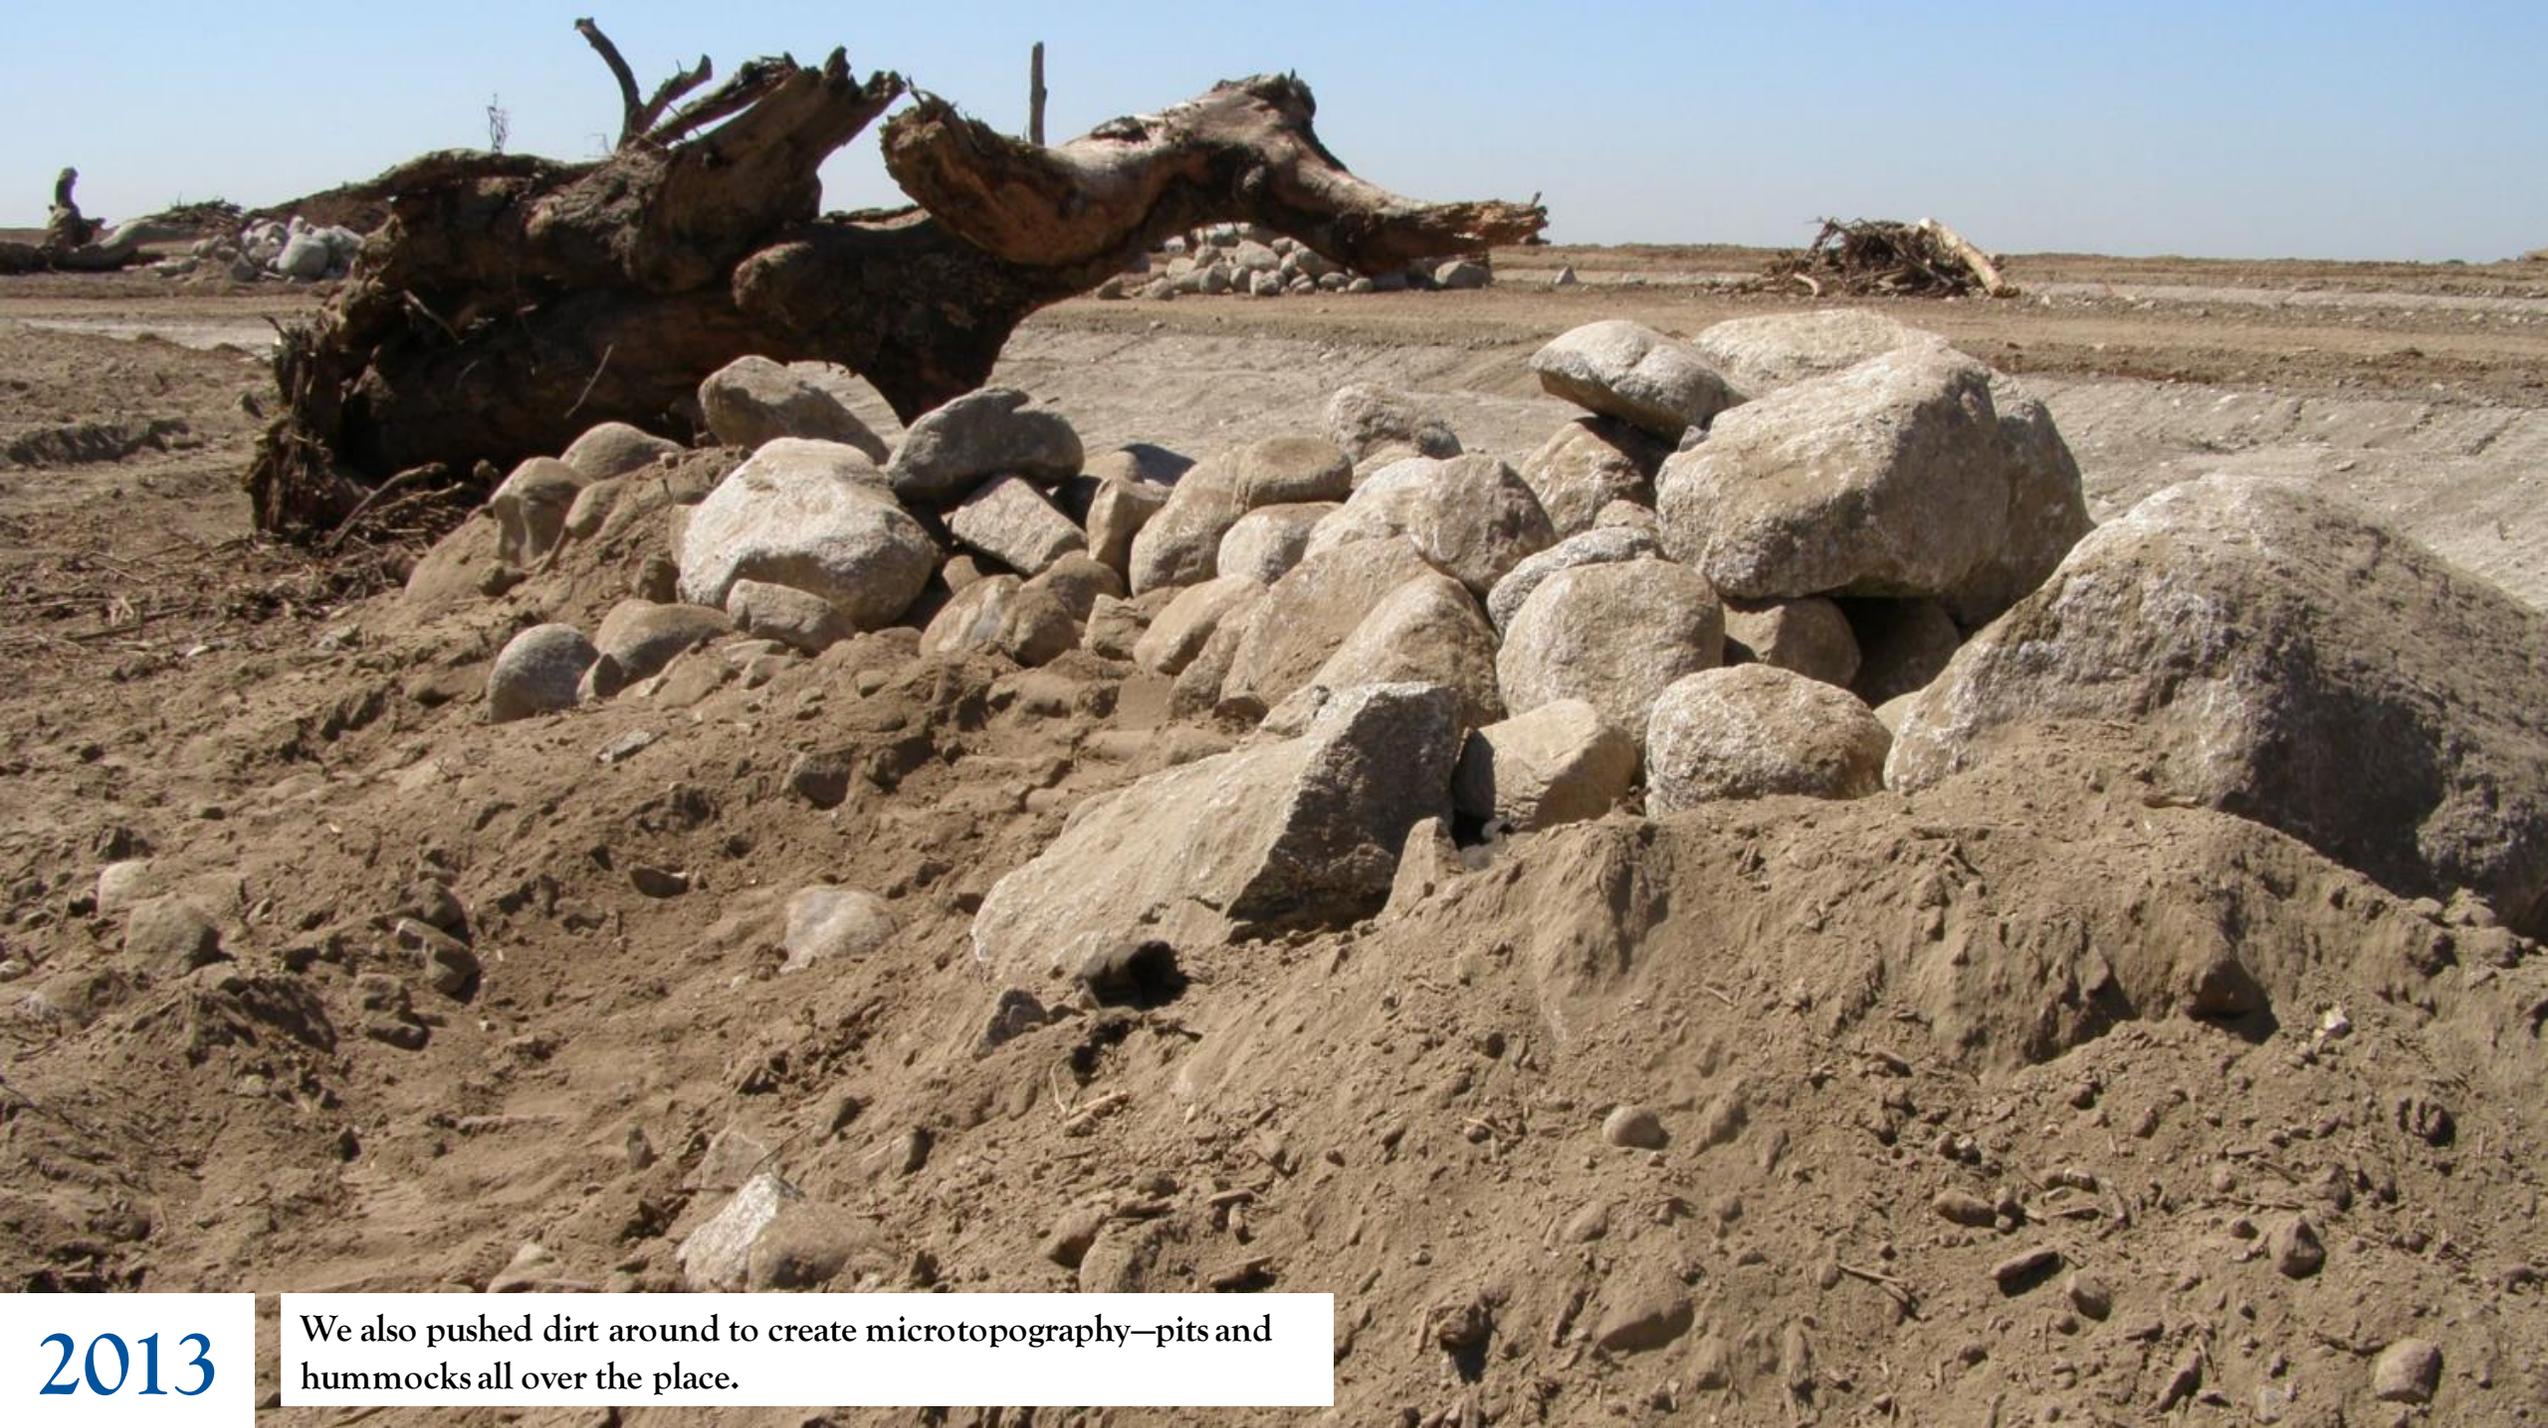
We also pushed dirt around to create microtopography—pits and hummocks all over the place.

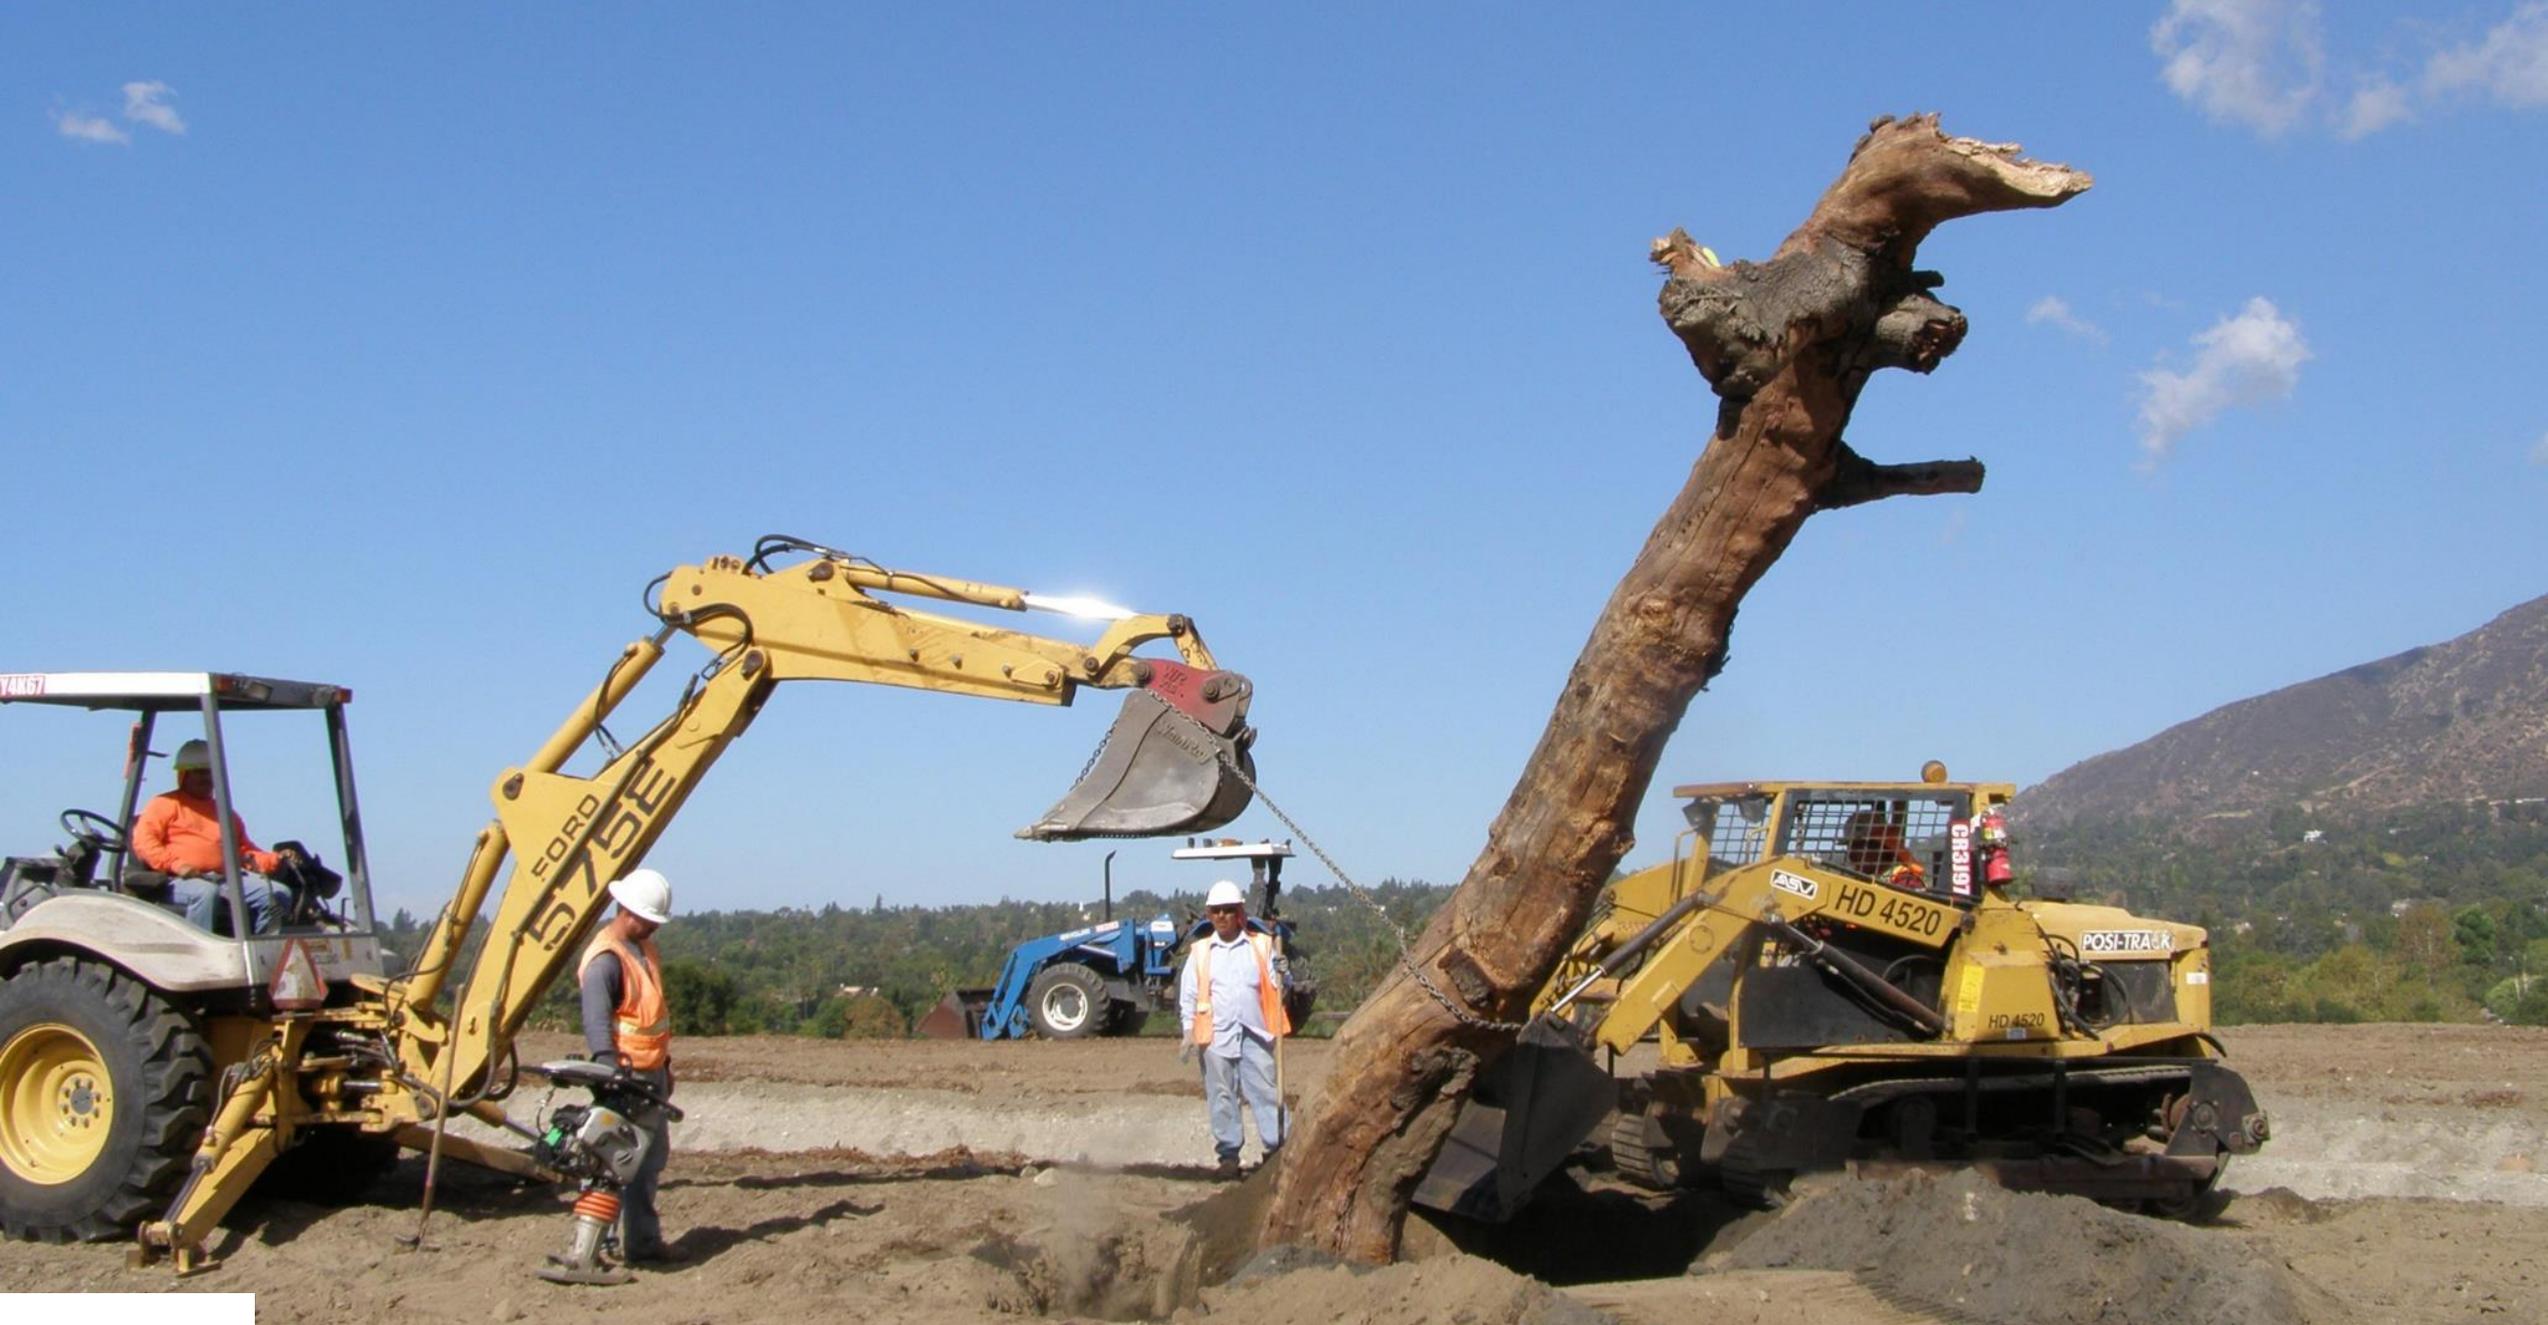
A total of 14 natural snags were erected, and you can see the scale of these. Within minutes these features were being used by raptors and songbirds.

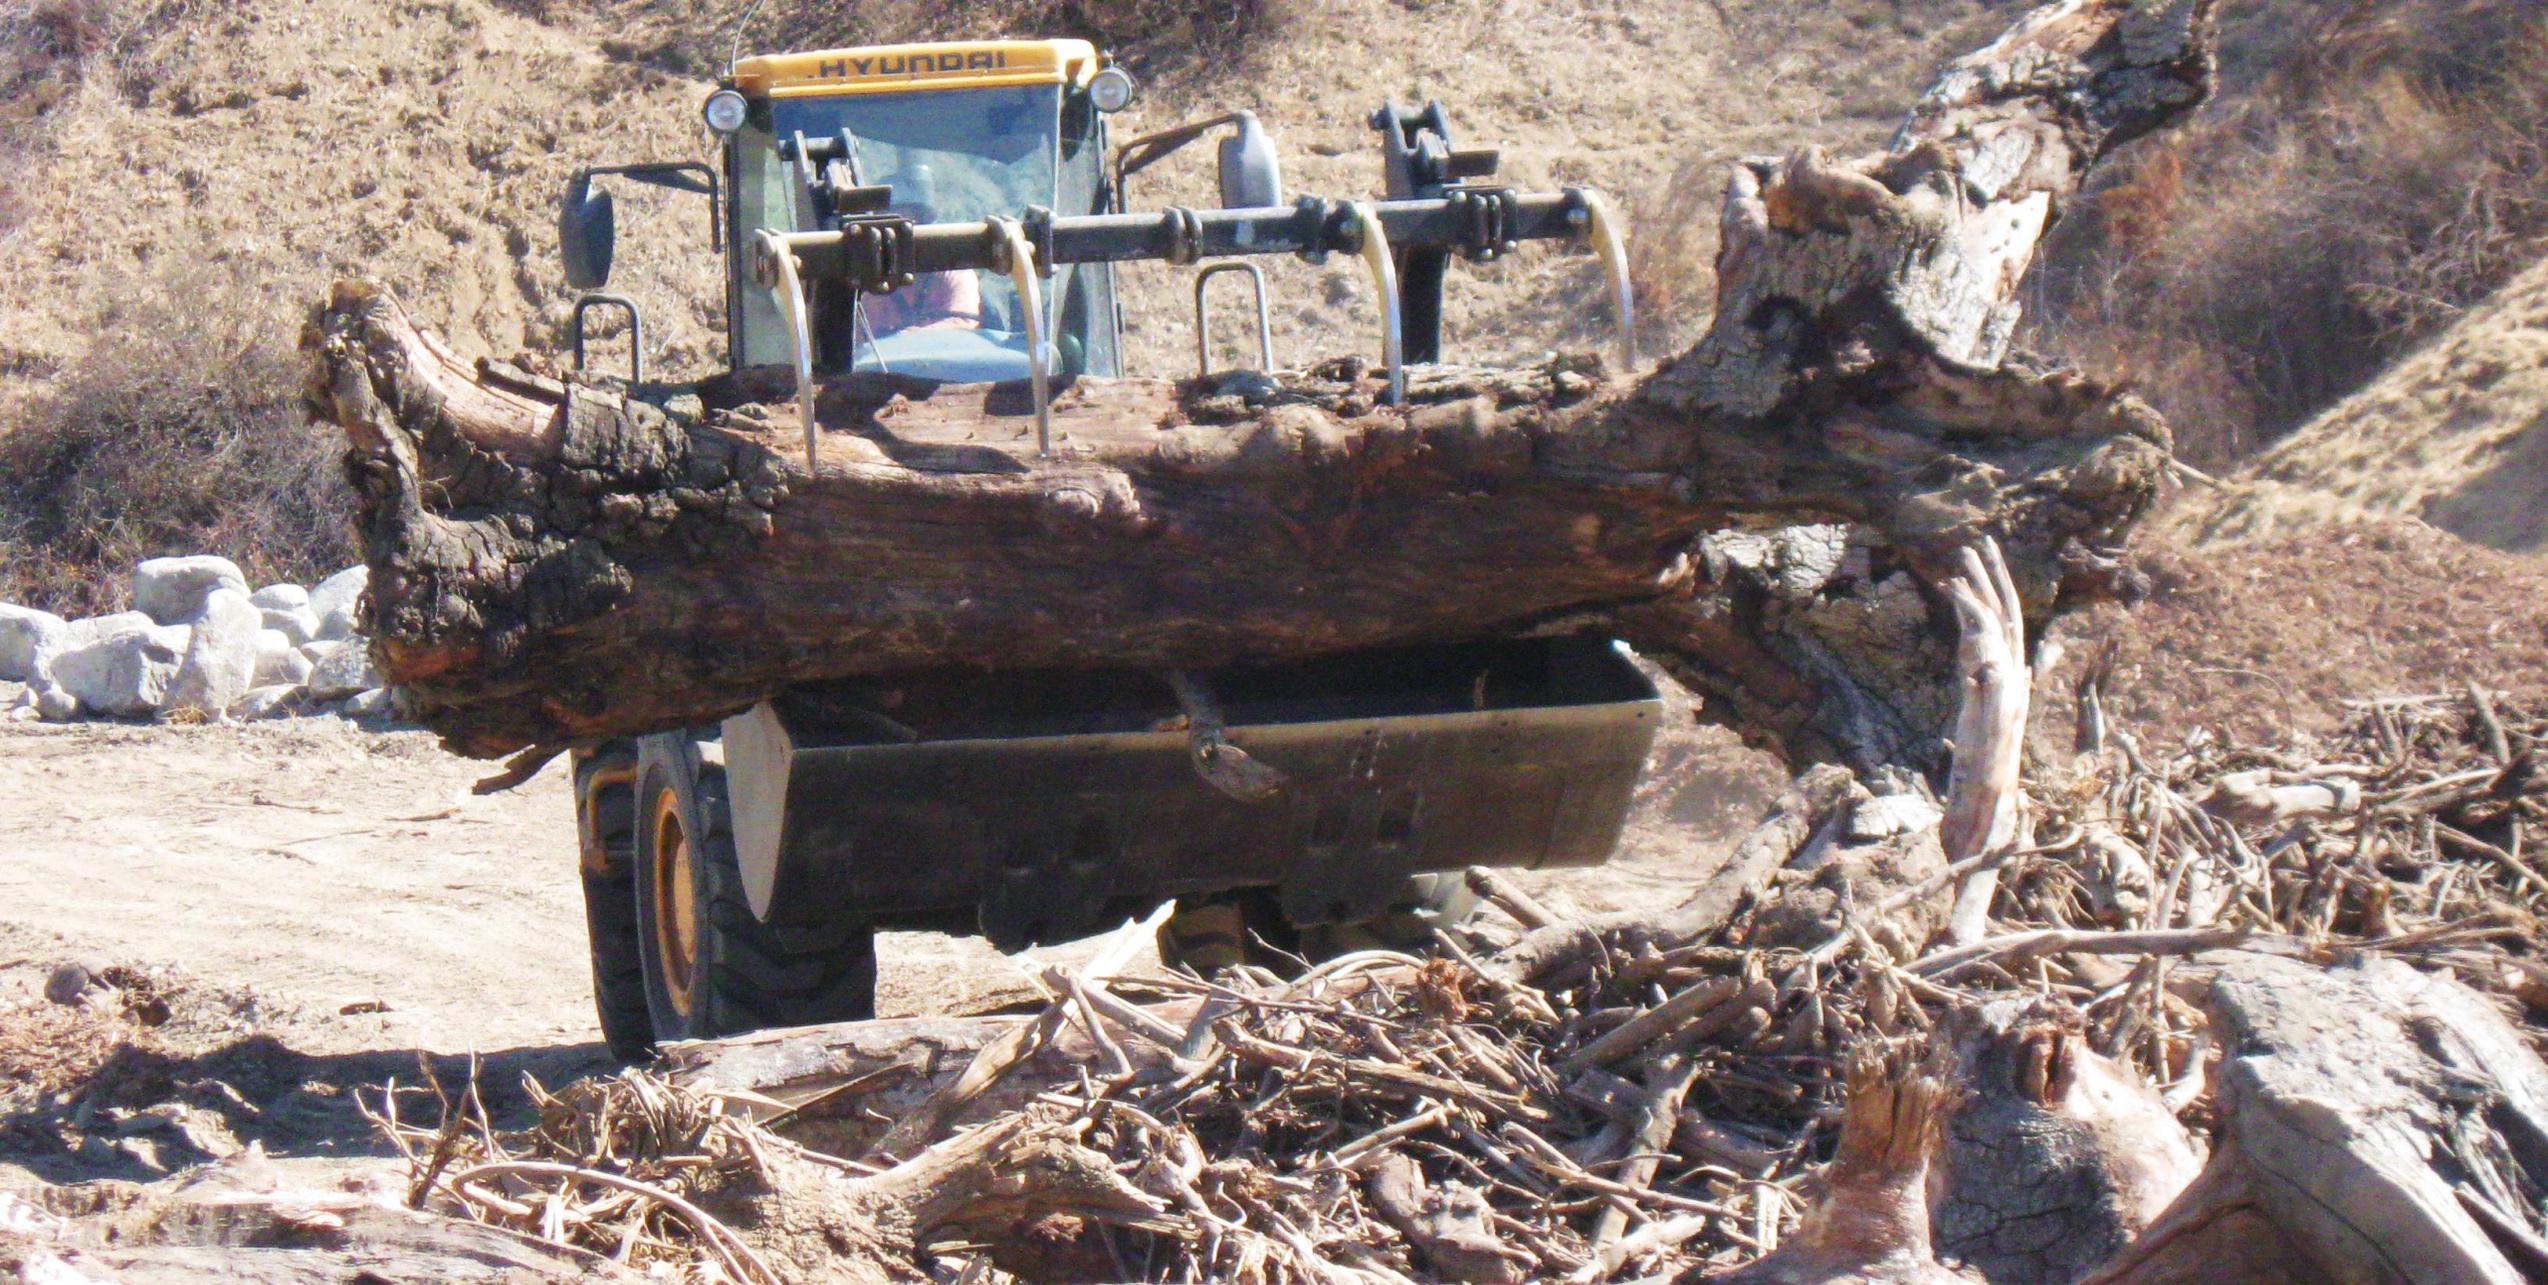
Many kinds of equipment were used for the CWD placement including these grapple attachments.

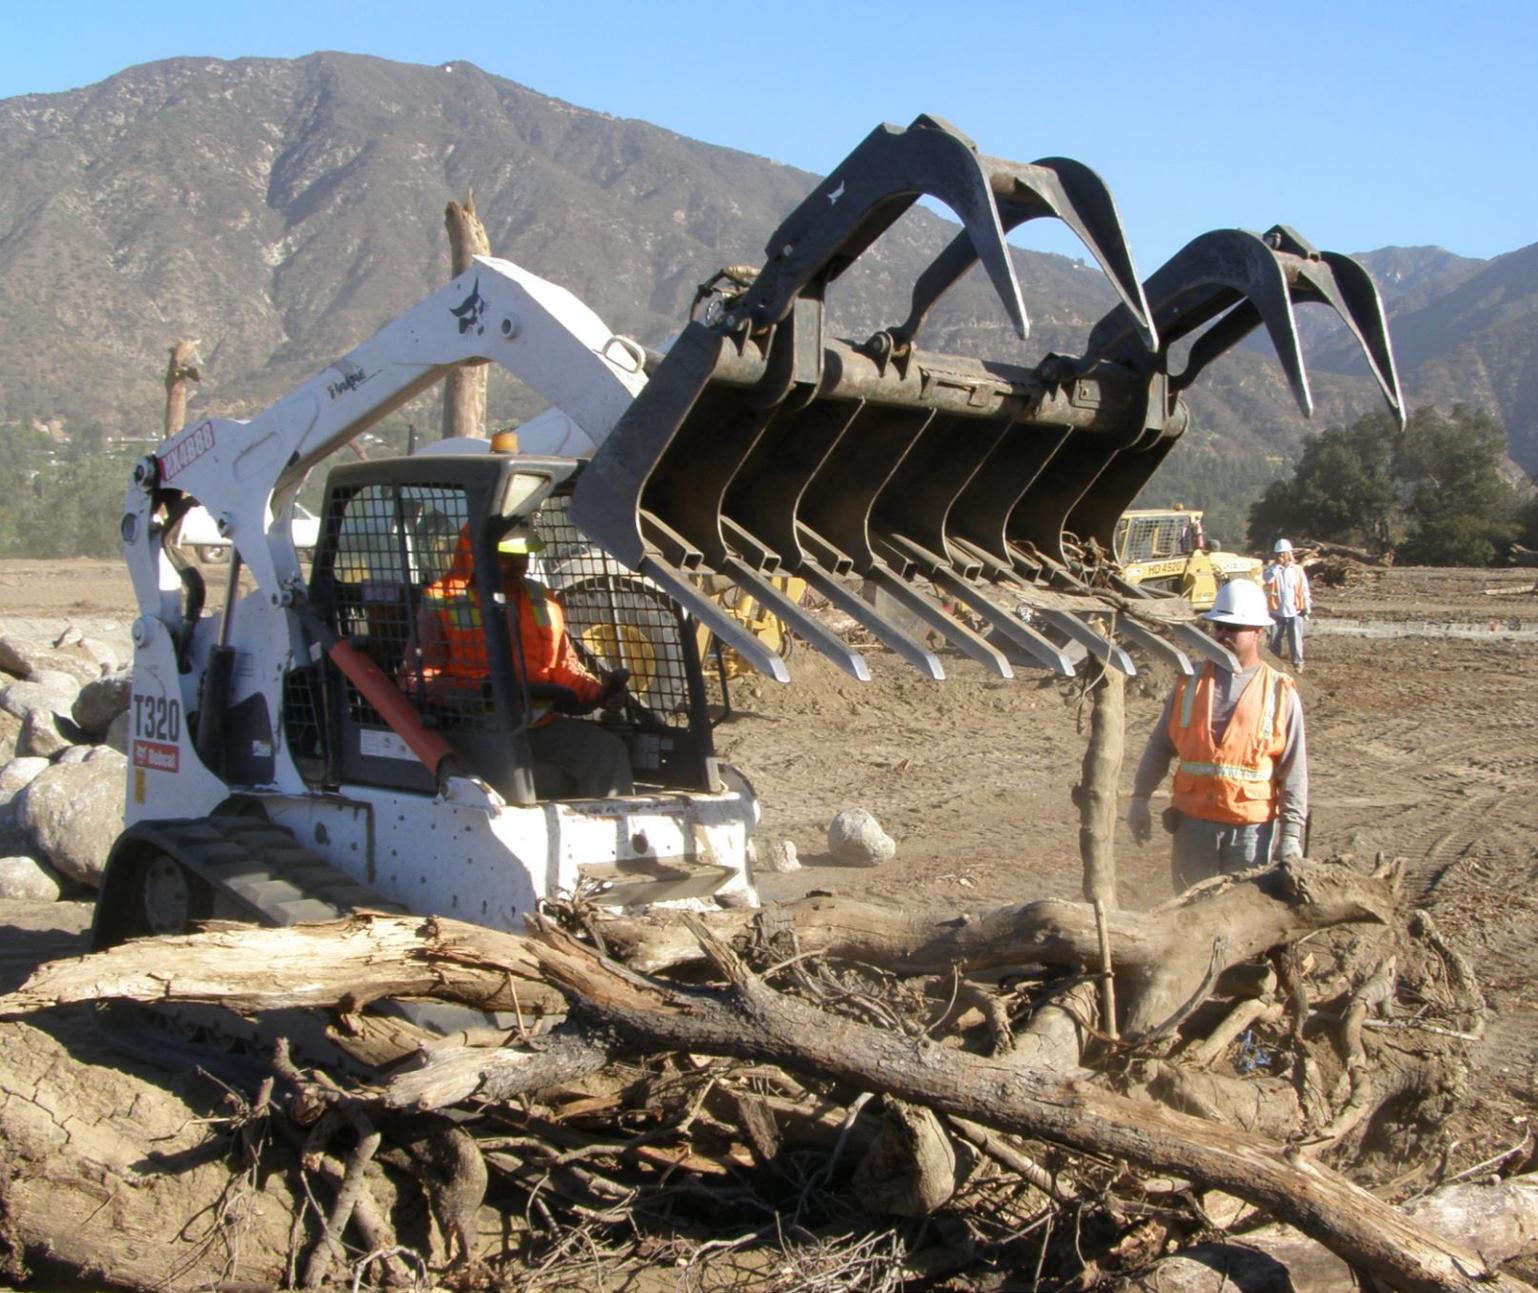
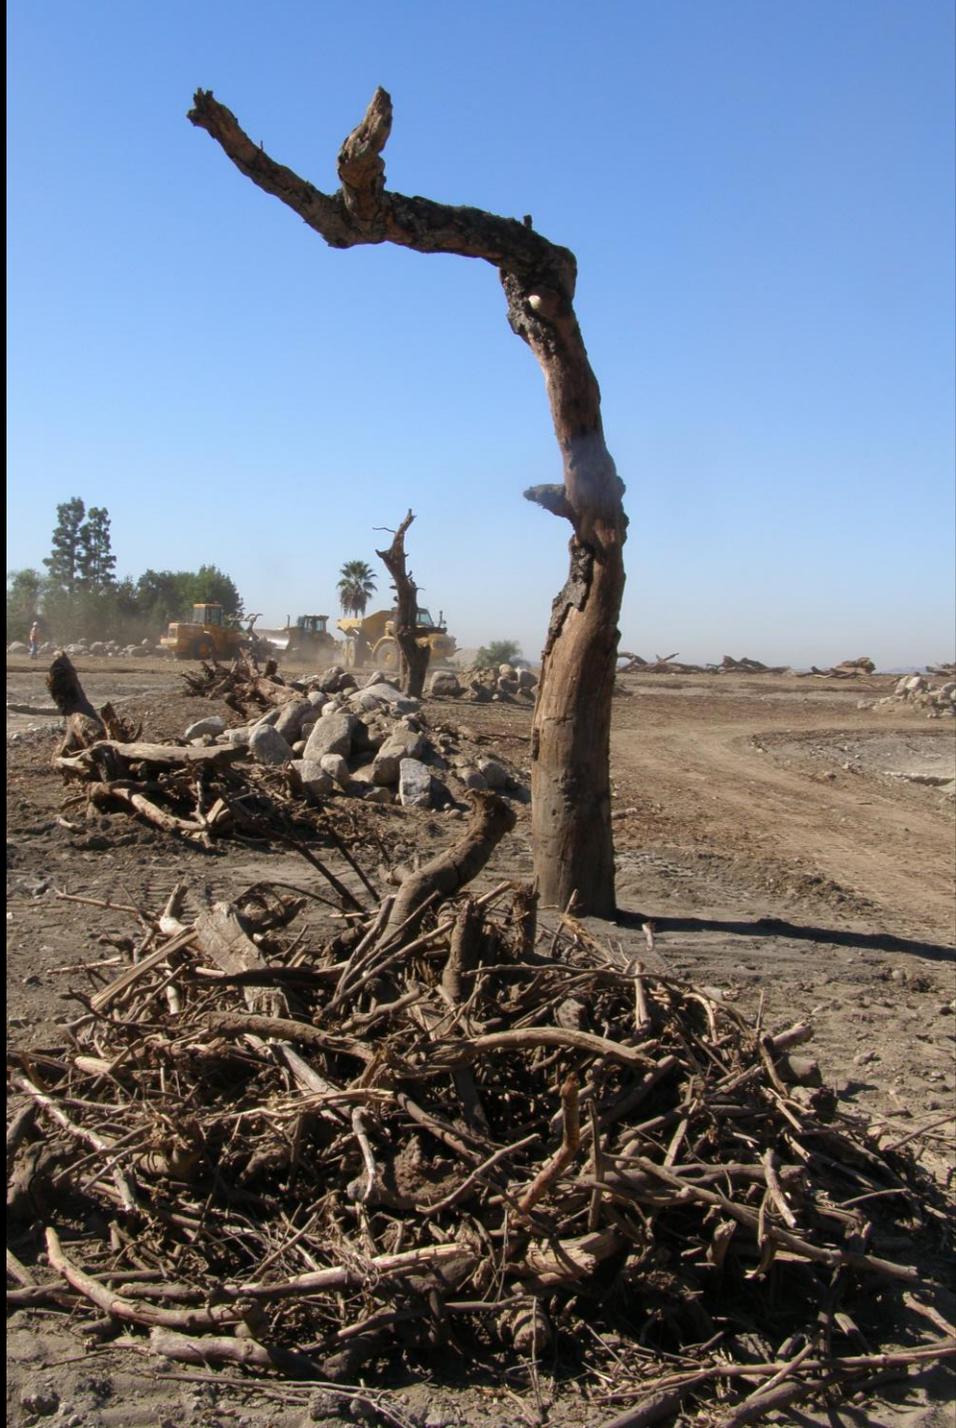
Many kinds of equipment were used for the CWD placement including these grapple attachments.

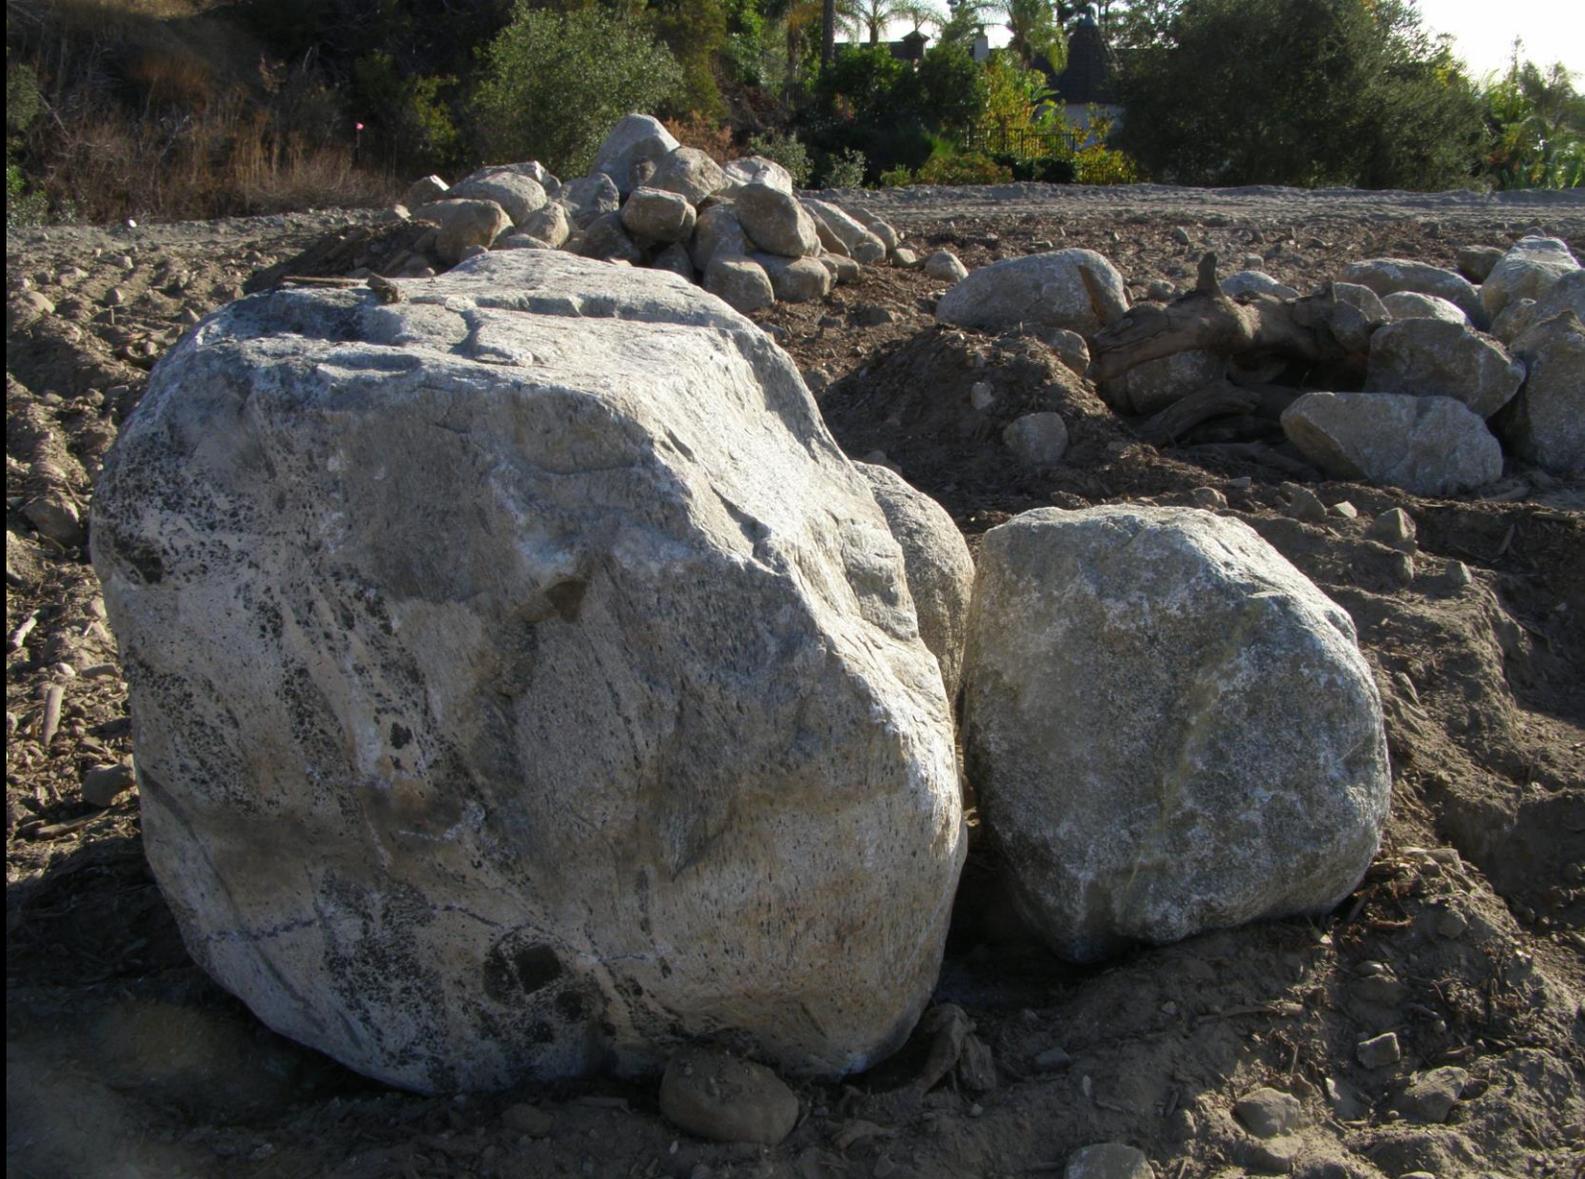
Here are some of the boulders and scatters of woody debris.

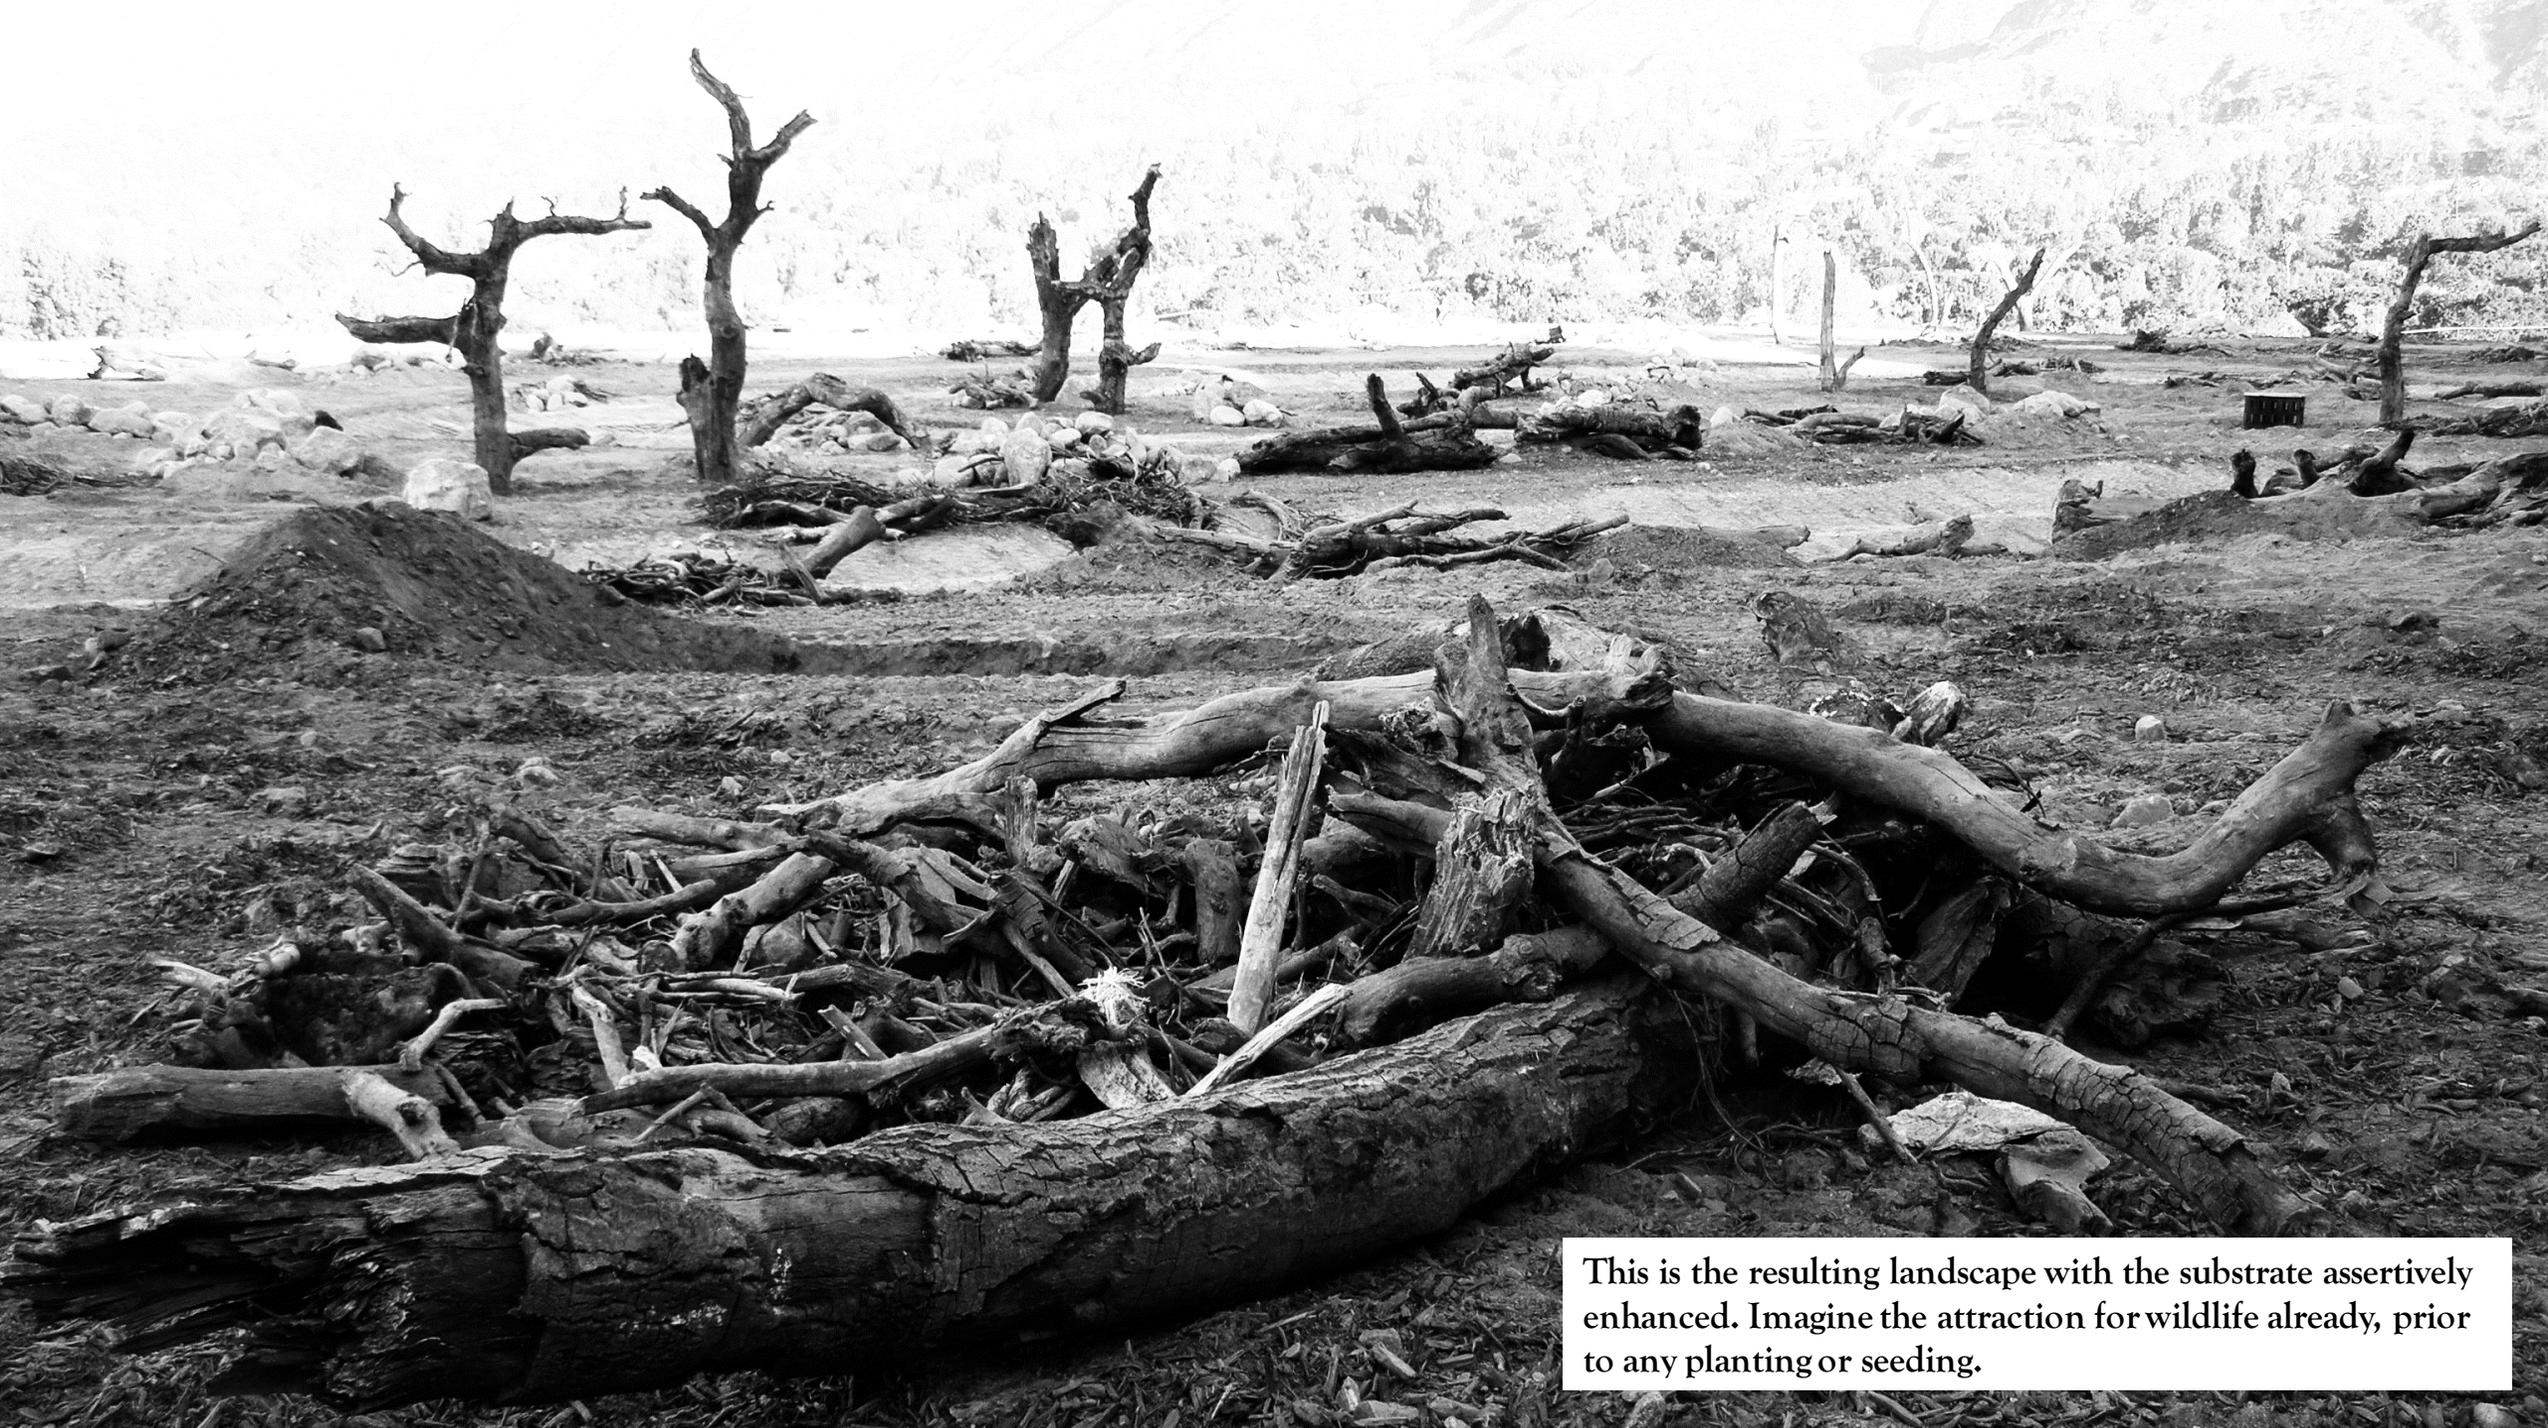
This is the resulting landscape with the substrate assertively enhanced. Imagine the attraction for wildlife already, prior to any planting or seeding.

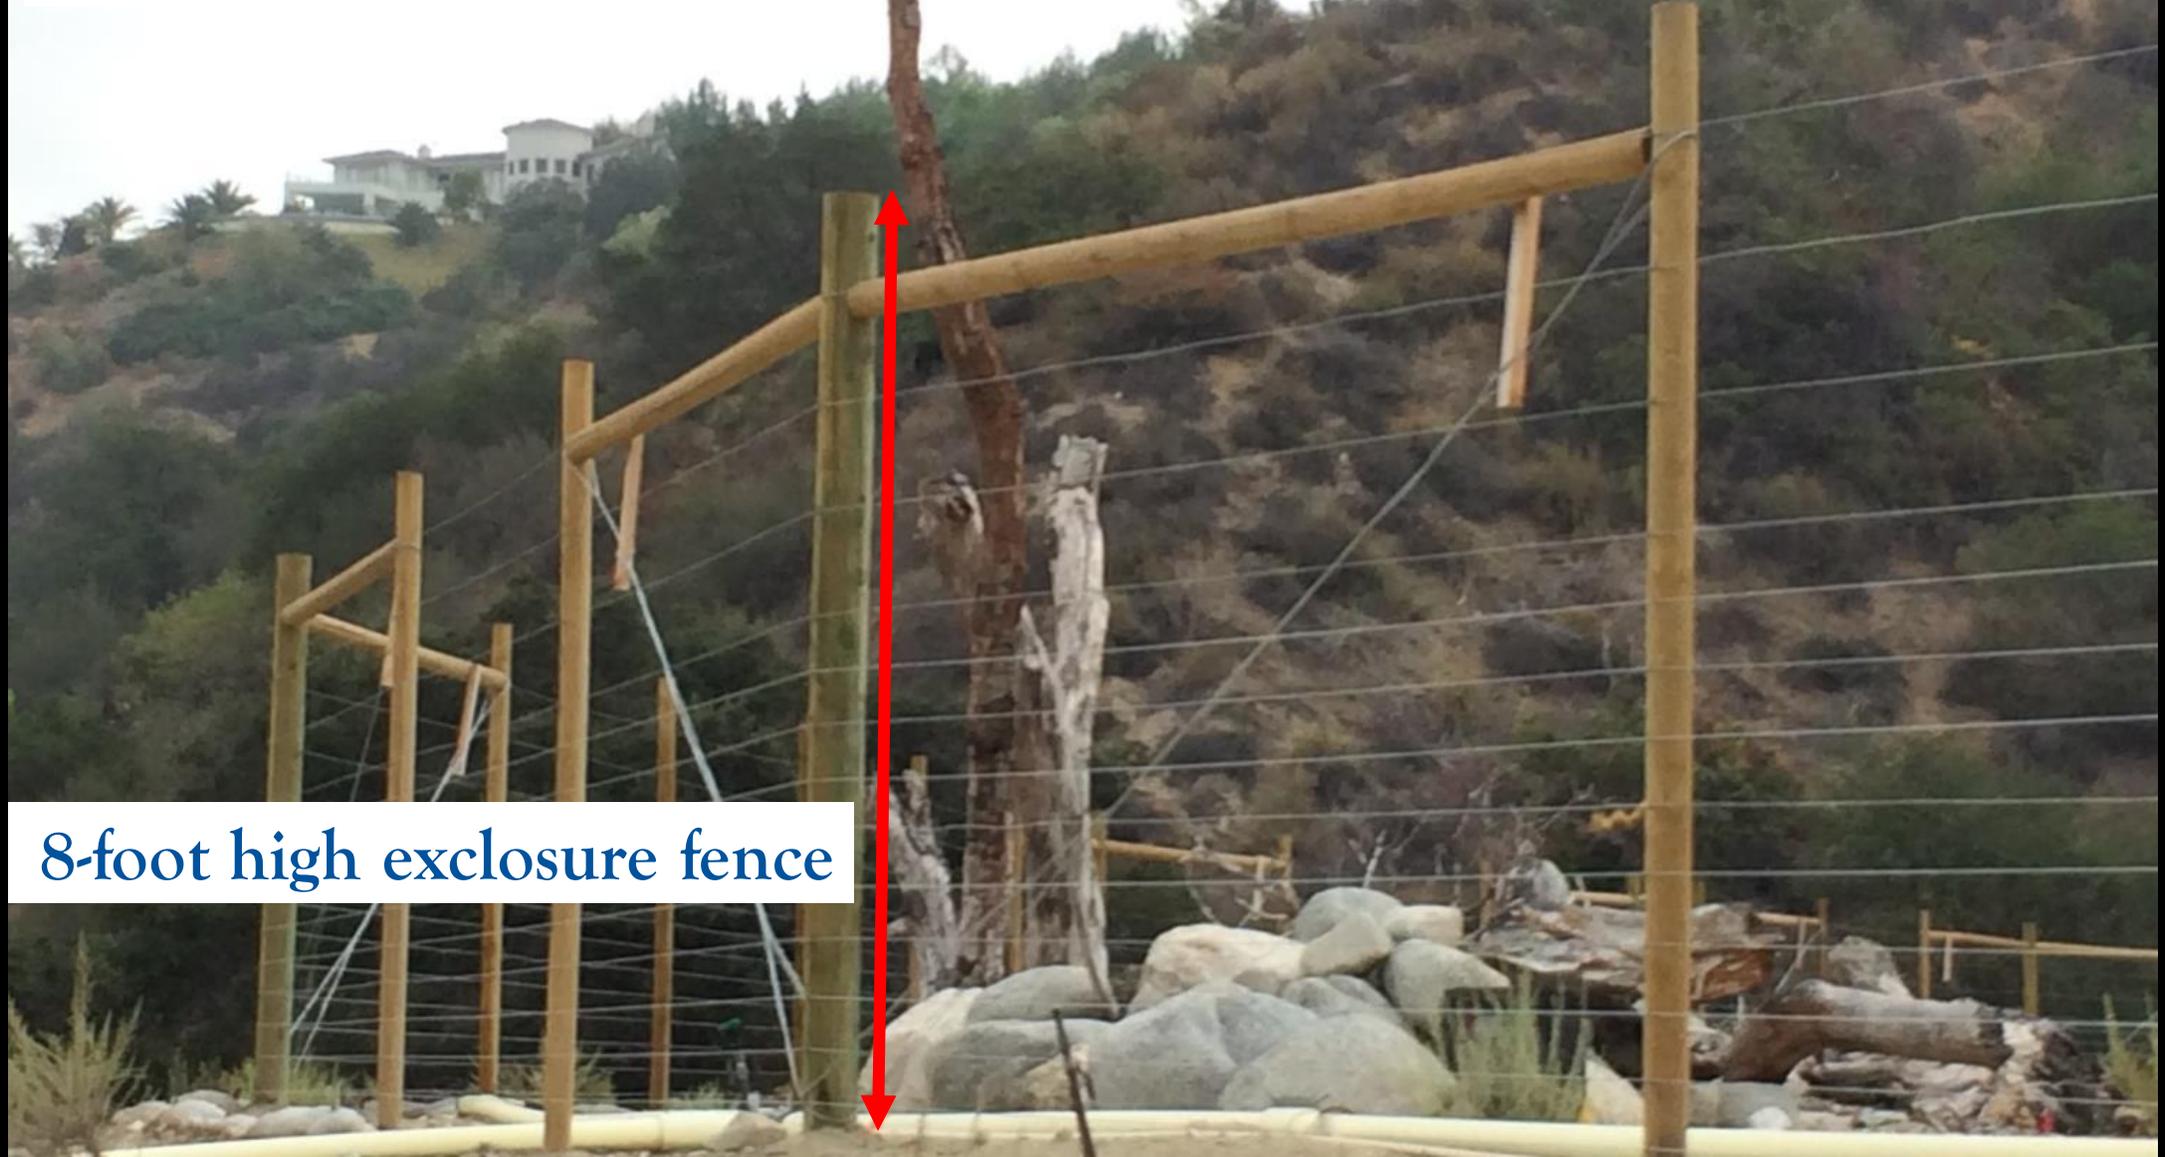
8-foot high exclosure fence

An eight-foot perimeter fence (shown here mid-construction) was installed to temporary exclude large mammals—especially mule deer (*Odocoileus hemionus*)—to avoid excessive herbivory or trampling of the establishing vegetation, oak seedlings, etc.
