# Substrate Enhancements and Botanical Diversity for Successful Oak Habitat Creation

Richard B. Lewis III, ENV SP  
Senior Restoration Ecologist, Psomas

This is a PDF-version of the slide show that accompanied Psomas' oral presentation at the University of California Agriculture & Natural Resources' 8<sup>th</sup> California Oak Symposium in San Luis Obispo, California, on November 1, 2022. The narration from that presentation has been added via text boxes to this PDF version.

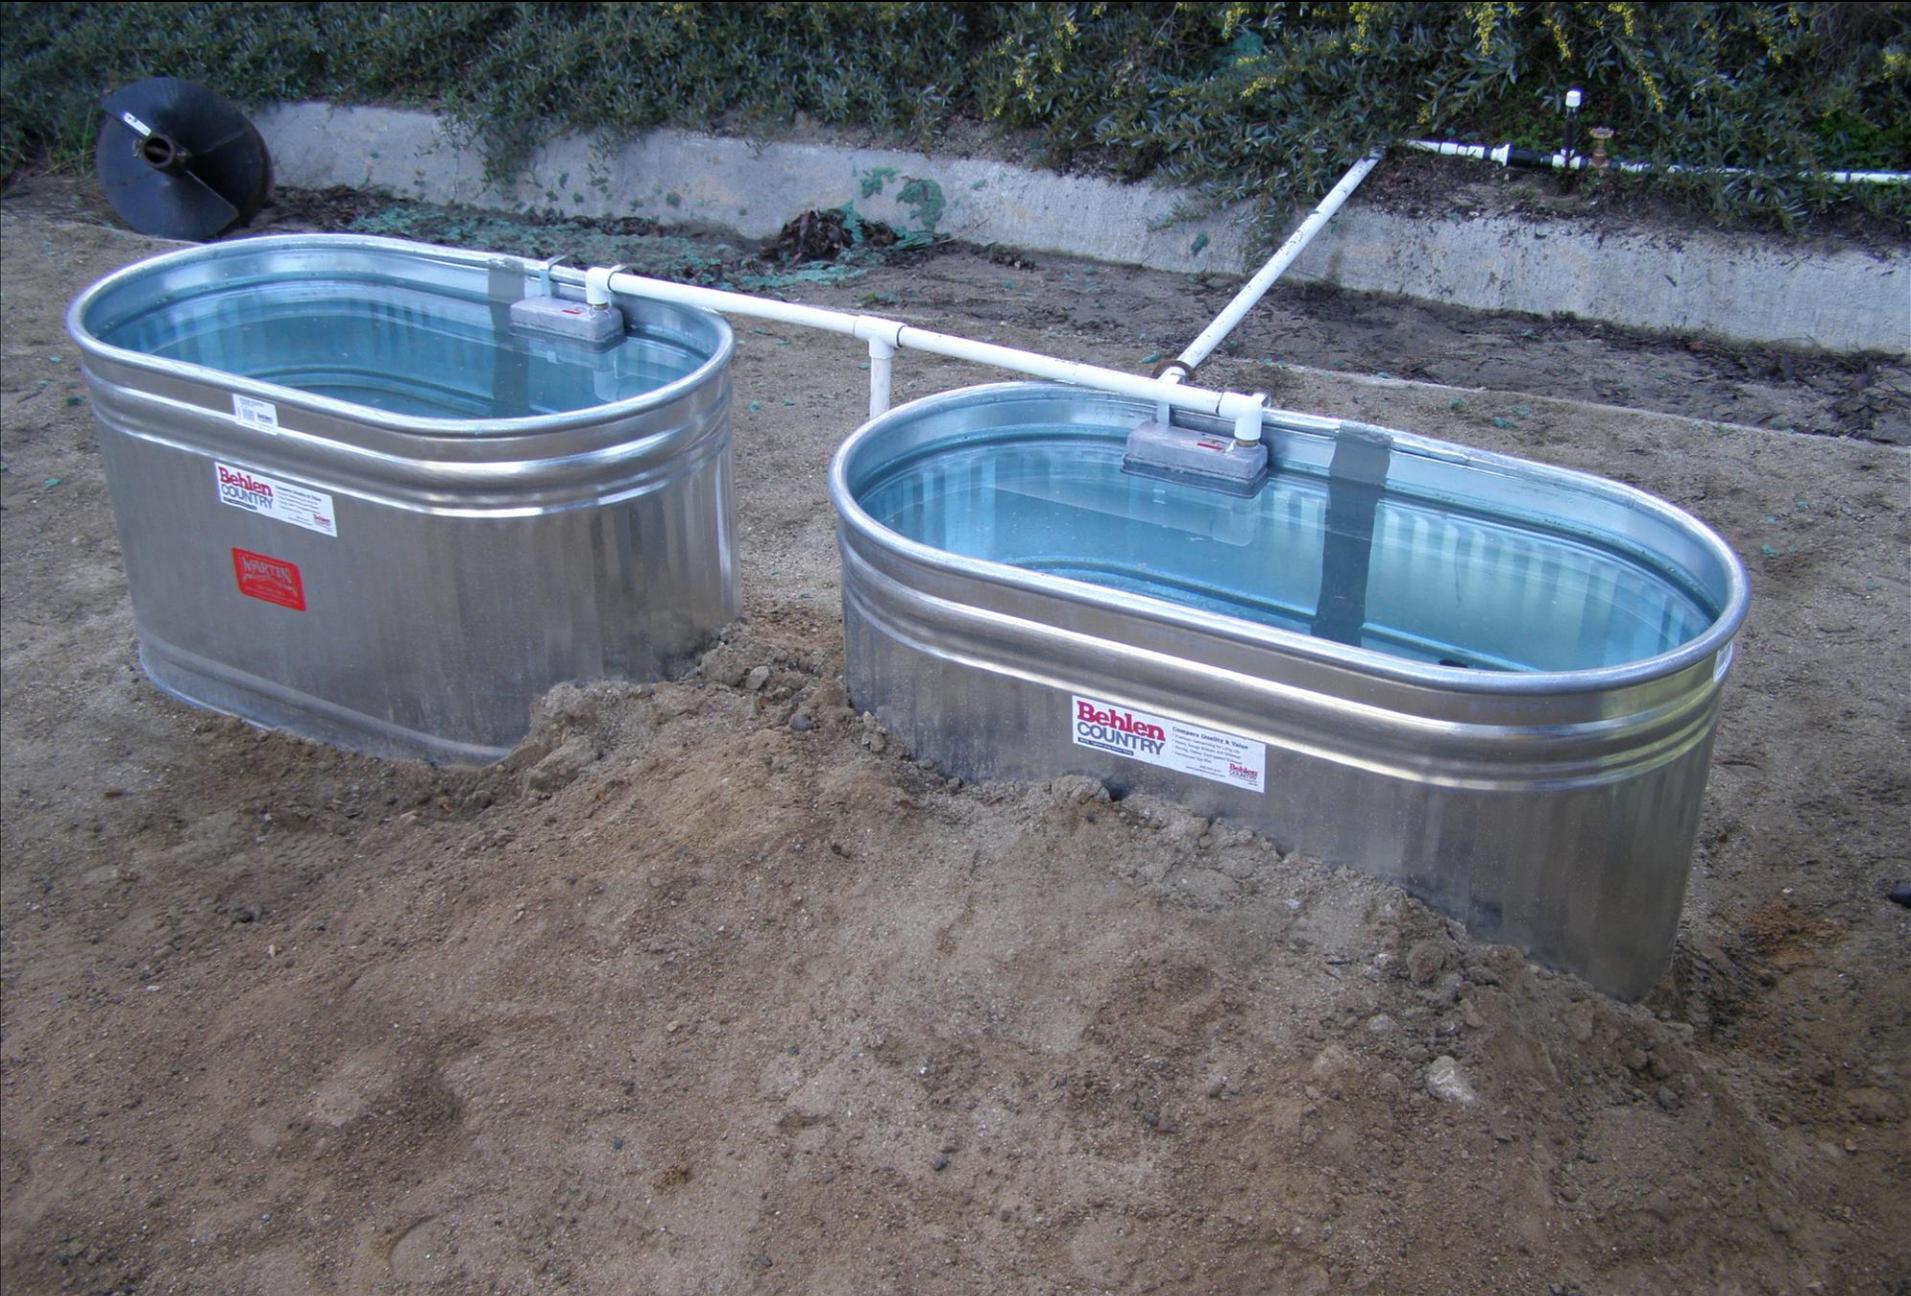
Because we temporarily fenced-off some water resources, we installed some temporary 'drinker tanks' for wildlife, and these have been heavily used.

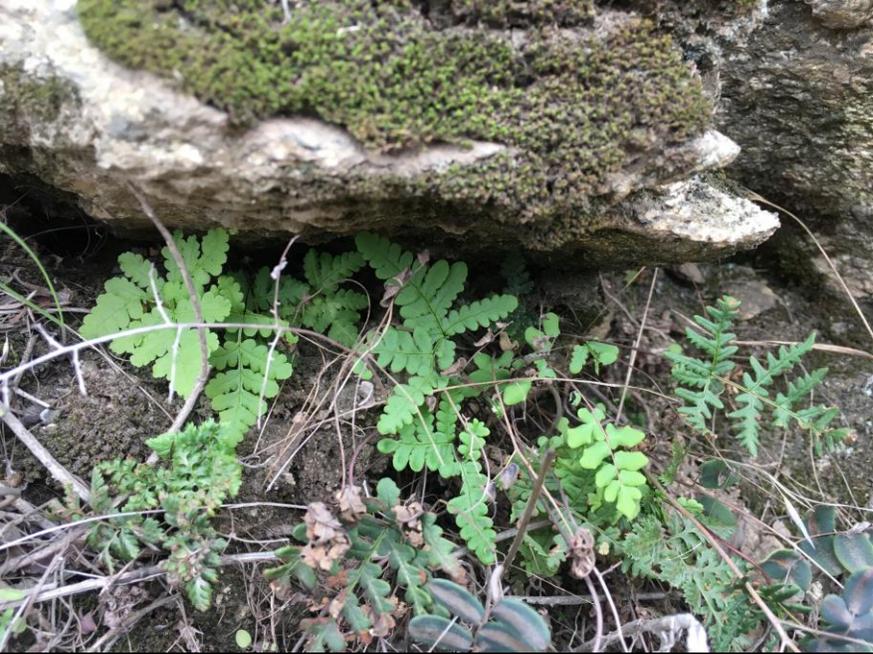
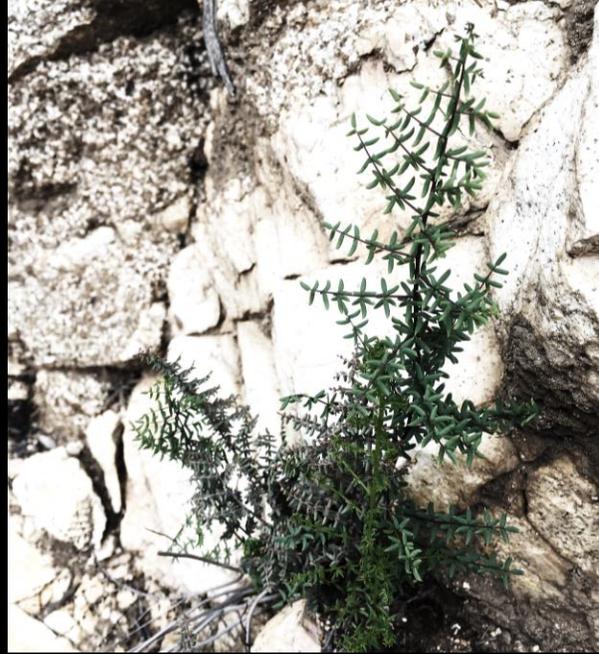
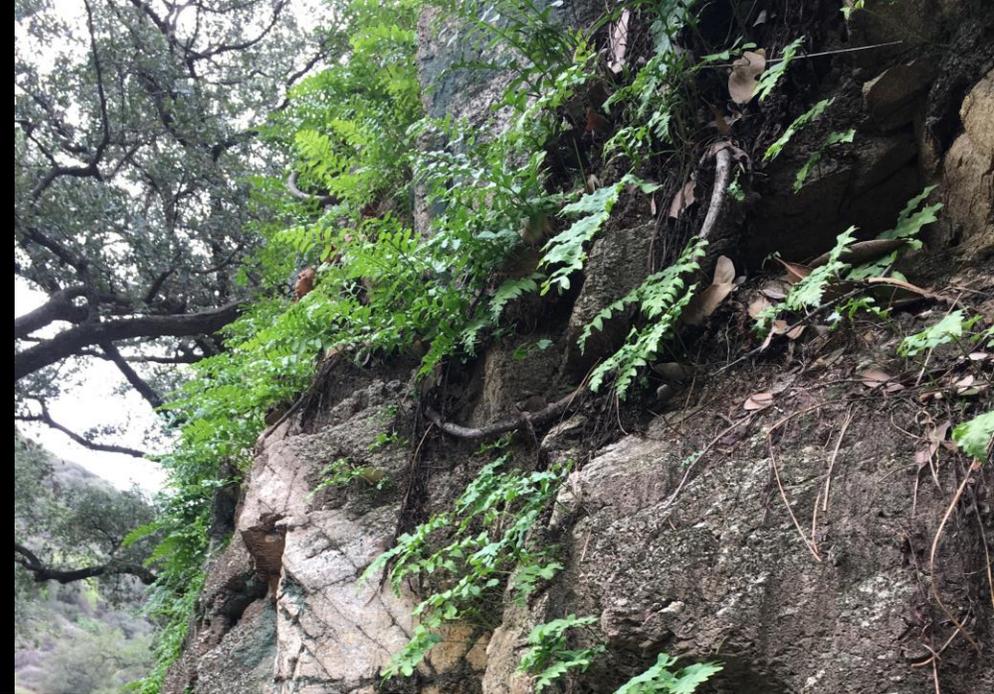
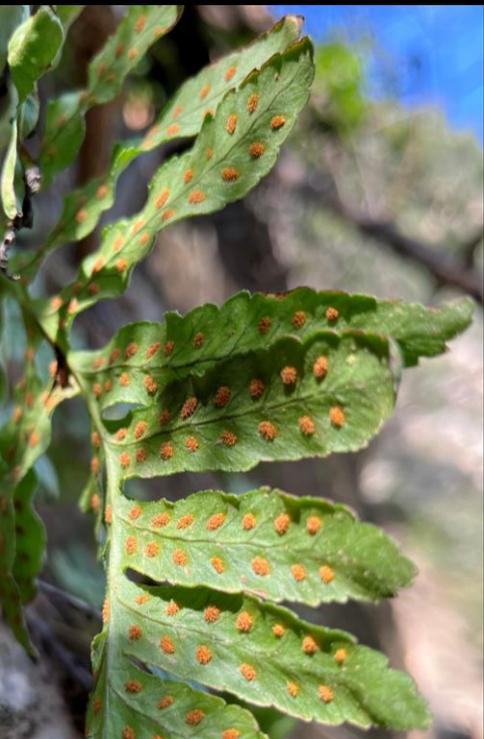
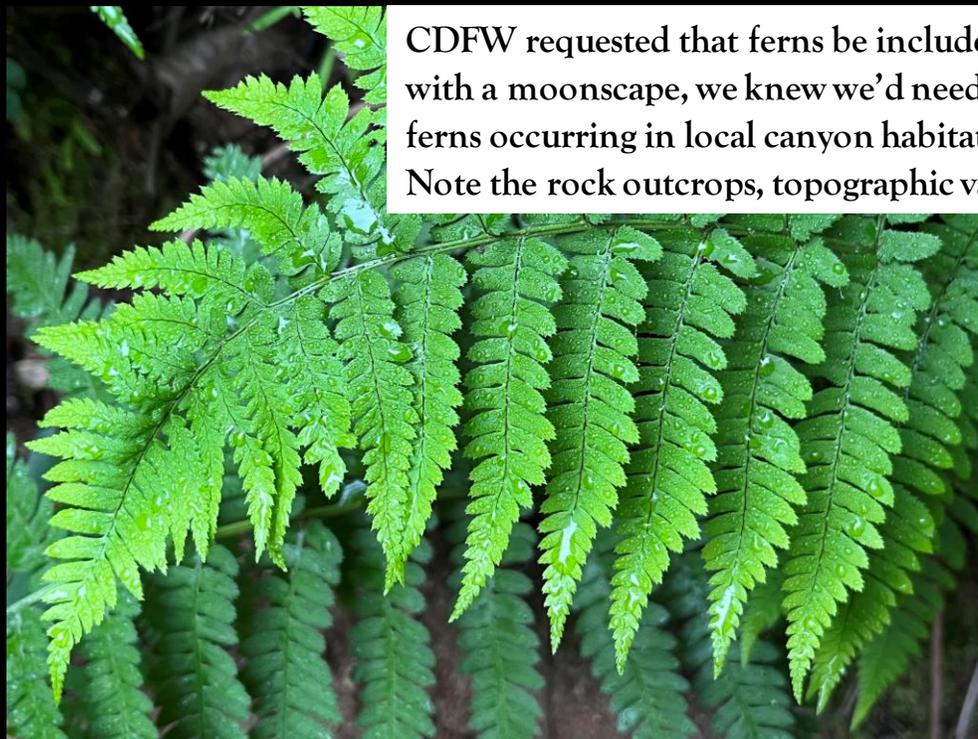
CDFW requested that ferns be included in the palette. Starting with a moonscape, we knew we'd need some similar substrate as ferns occurring in local canyon habitats, as you see in these photos. Note the rock outcrops, topographic variation, and woody debris.

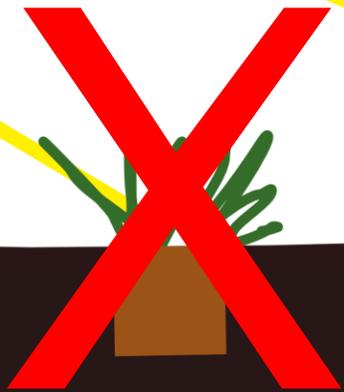
Fern Planting

We did not plant our ferns with a fully concentric basin—too much exposure to sun and wind.

Instead, we dug beneath placed boulders and CWD, beneath overhang as possible, and this has worked well.

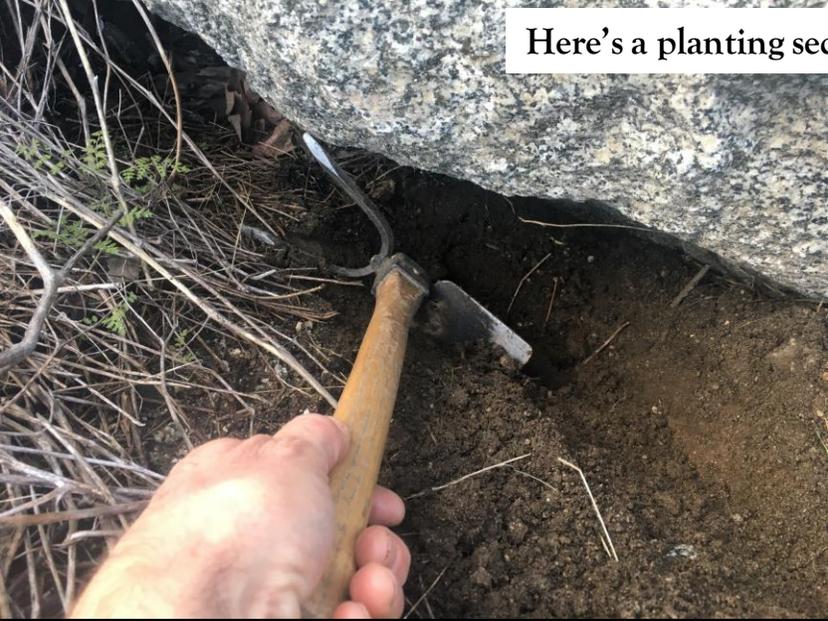
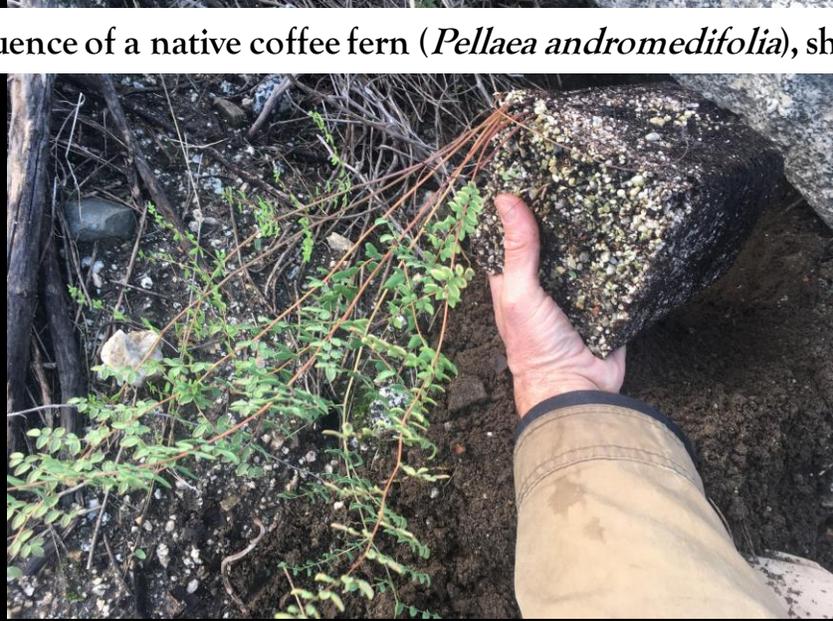
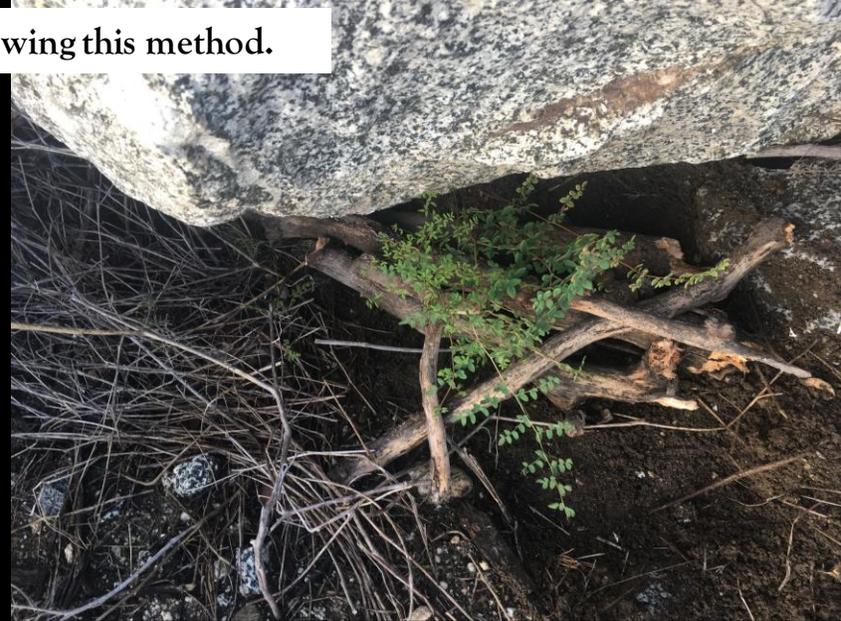
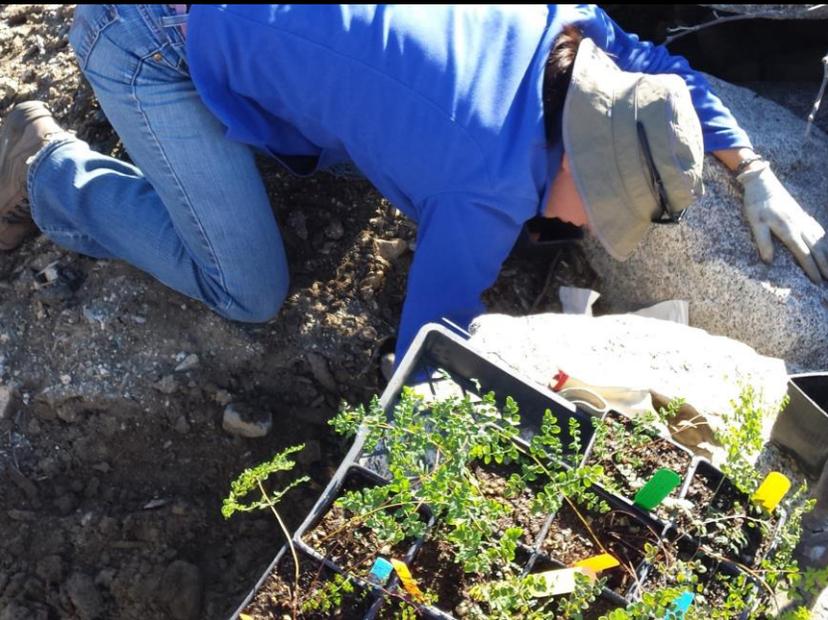
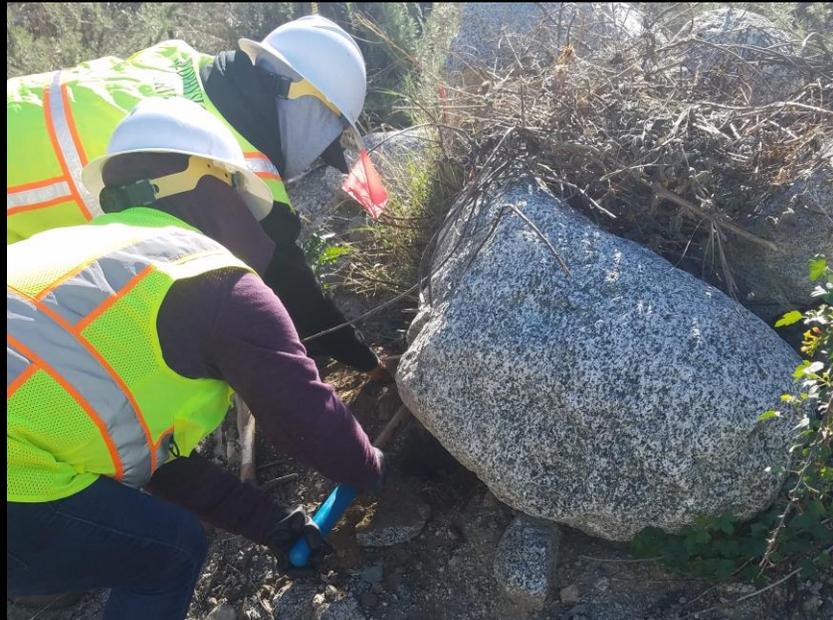
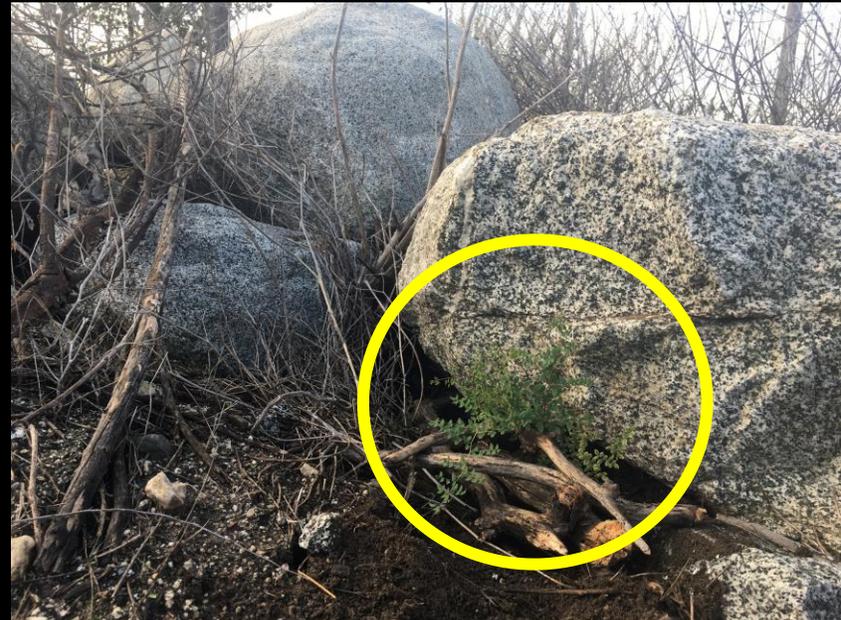
Here's a planting sequence of a native coffee fern (*Pellaea andromedifolia*), showing this method.

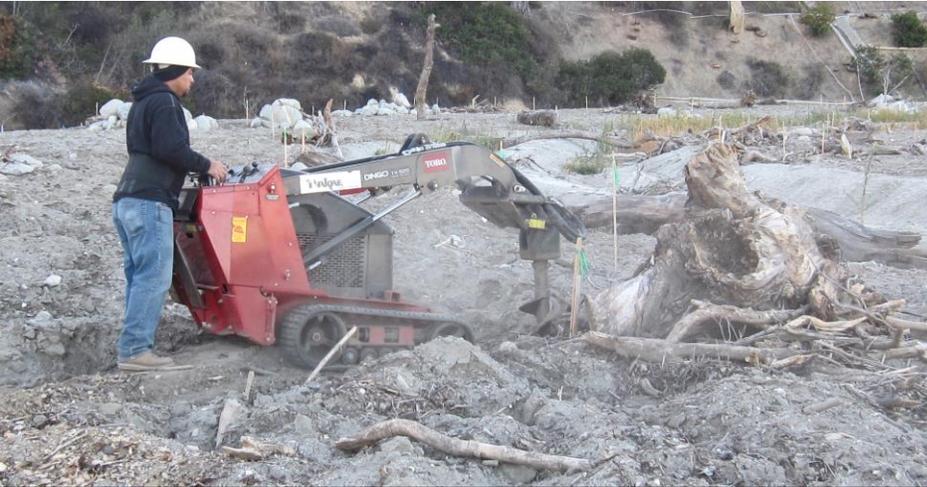
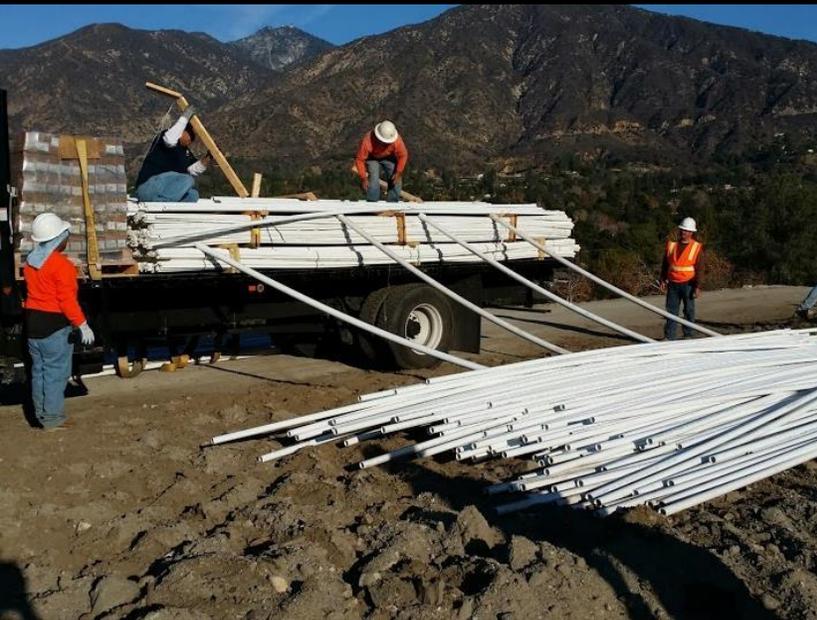
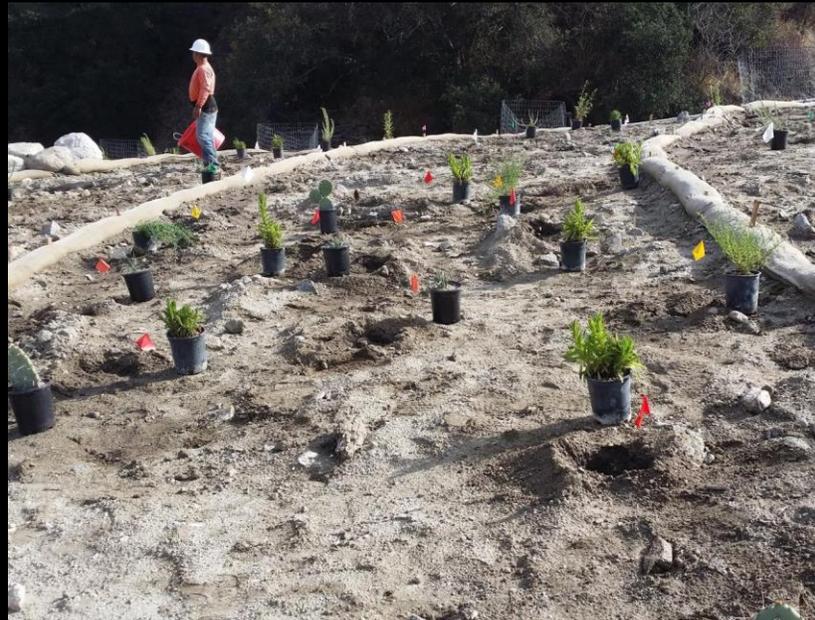
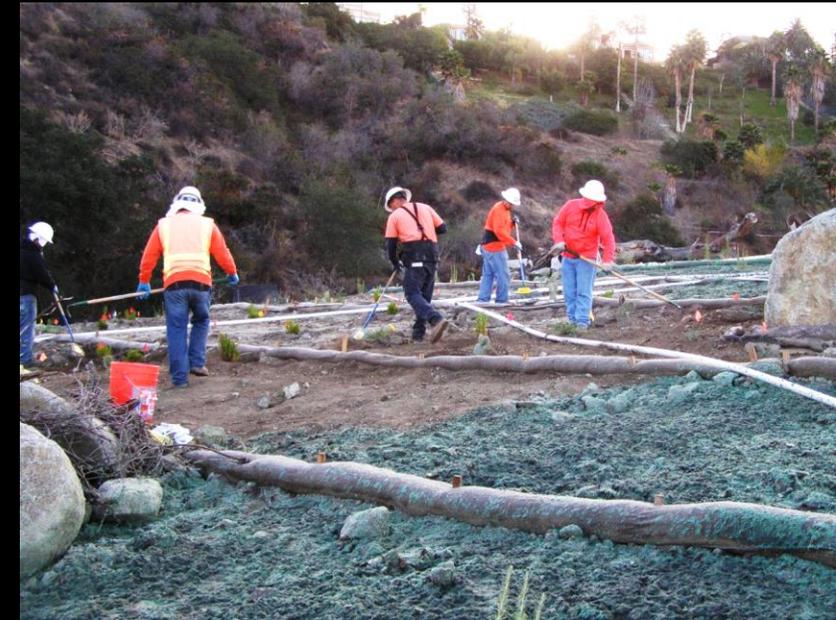
Initial Planting / Seeding

A Dingo™ was used to auger the oak planting holes. The seedlings were caged and mostly positioned adjacent to rock and CWD. This was to provide protection from sun and wind, and so the oaks roots could benefit from cooler and moist soils under these features.

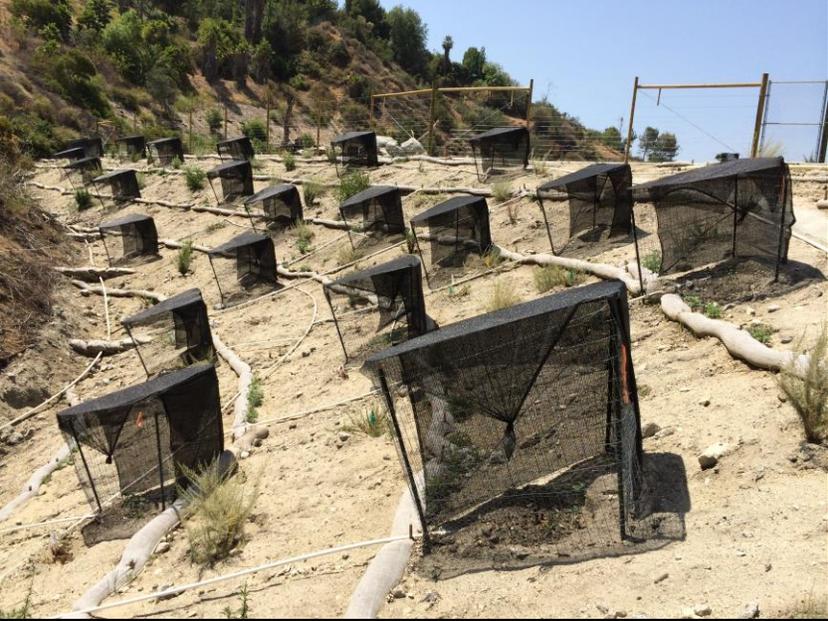
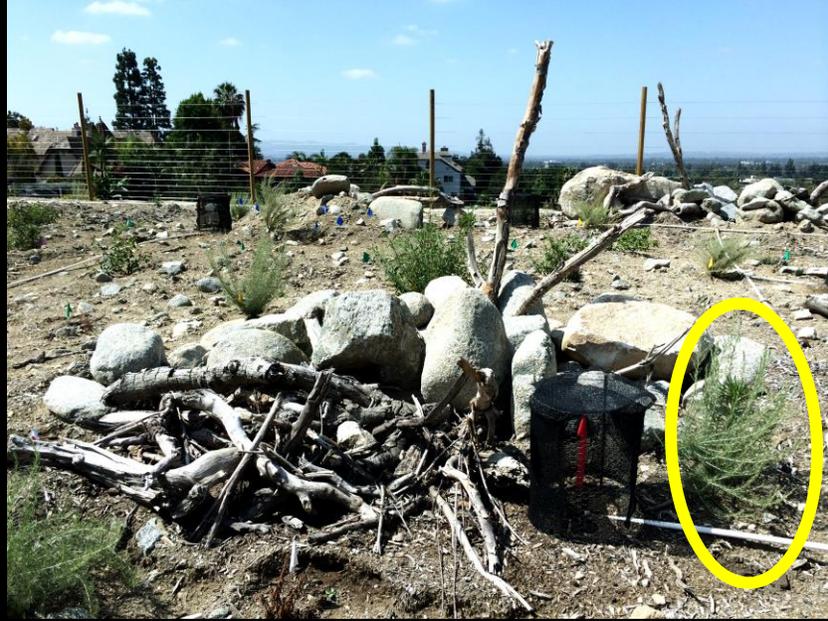
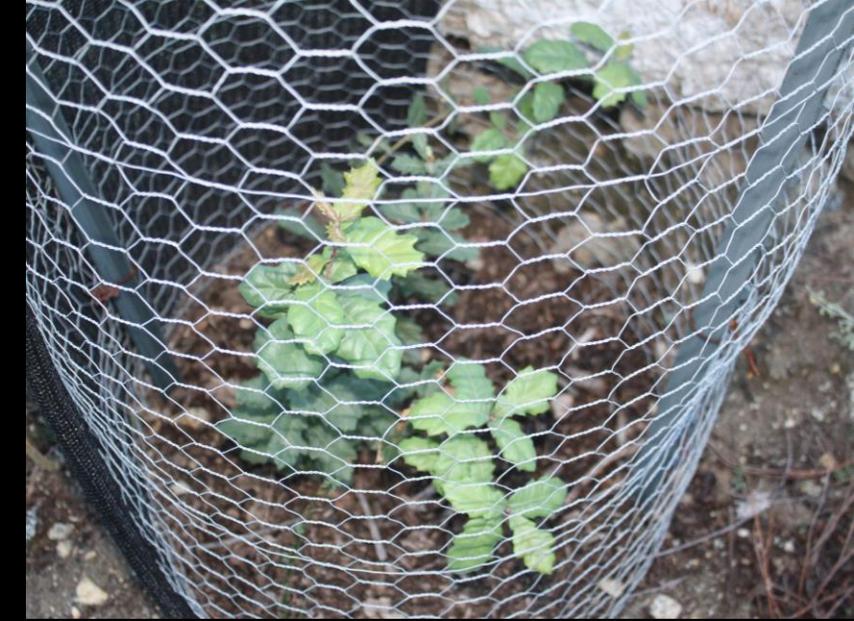
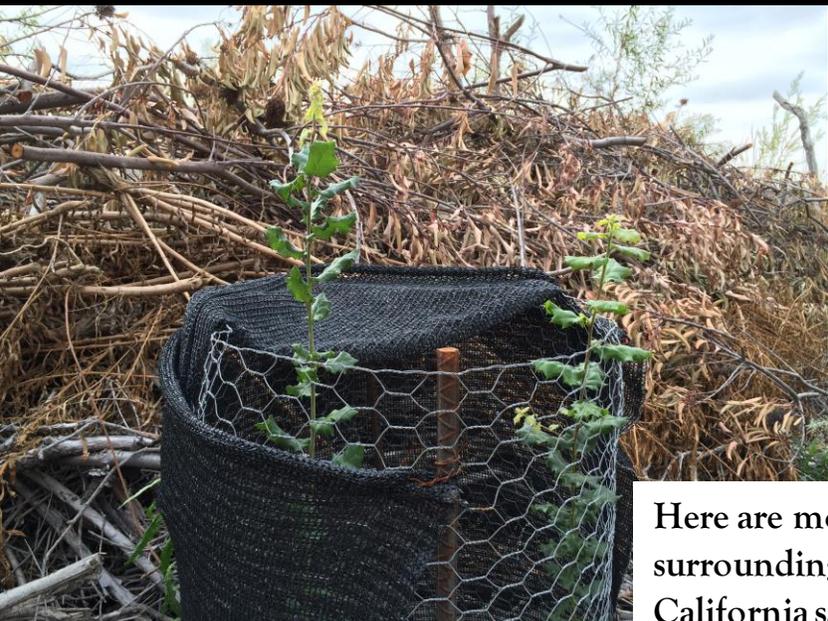
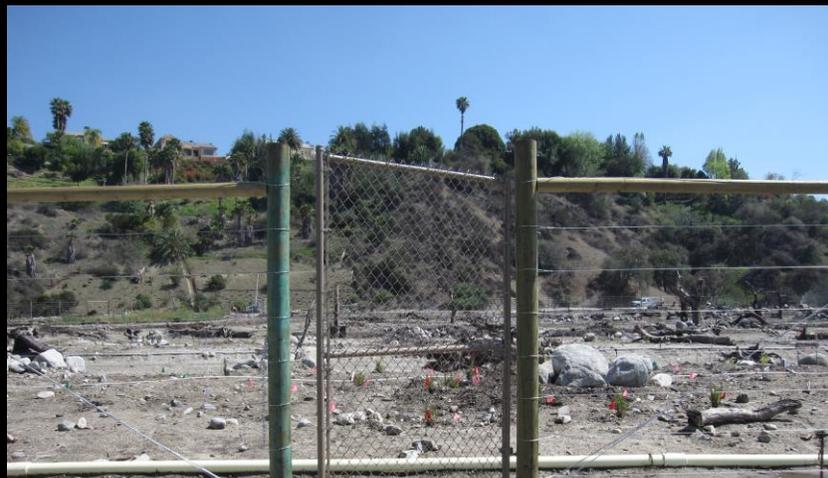
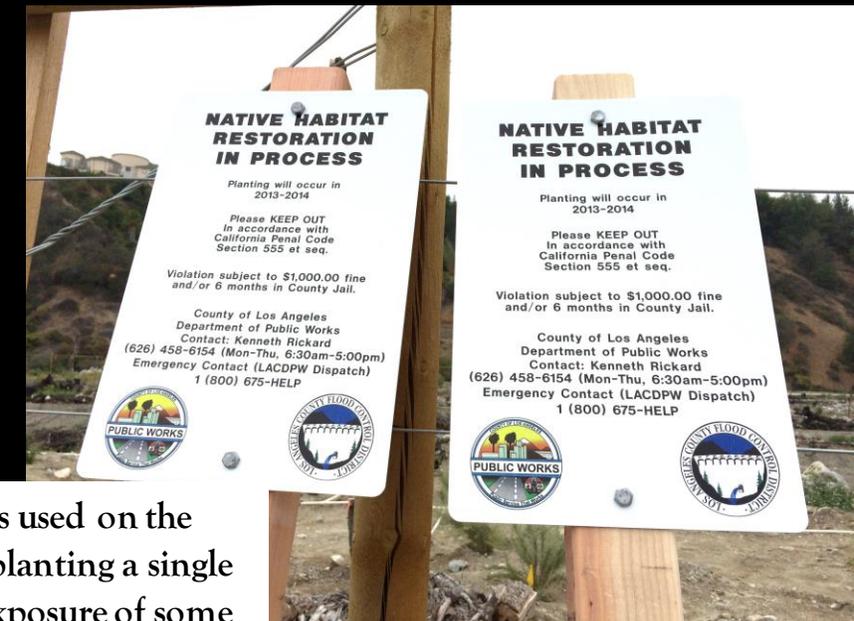
# Oak Protection

Here are more of the oak cages, including a more robust type that was used on the surrounding slopes, outside the 8-foot fence. We experimented with planting a single California sagebrush (*Artemisia californica*) plant on the southwest exposure of some oak plantings to serve as a kind of nurse plant. A combination of interpretive signs, and warning signs (shown here), were installed to deter trespassing.

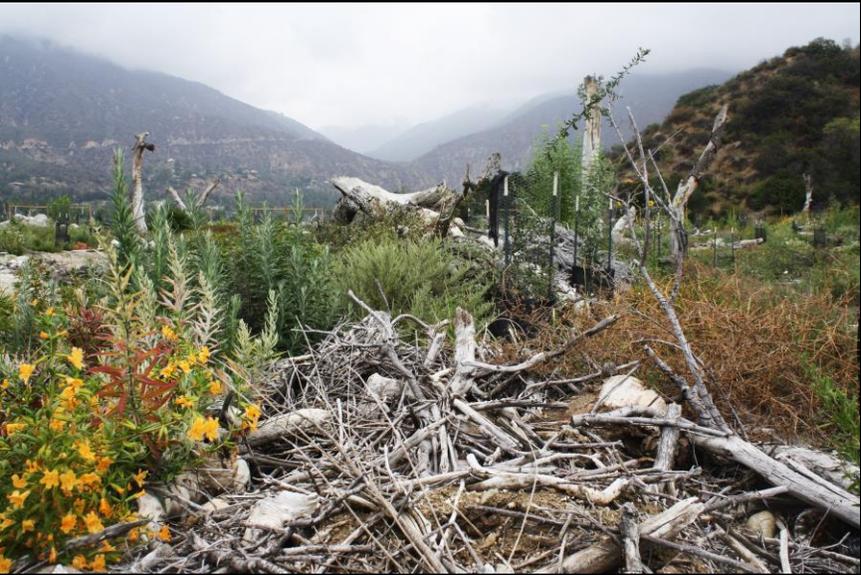
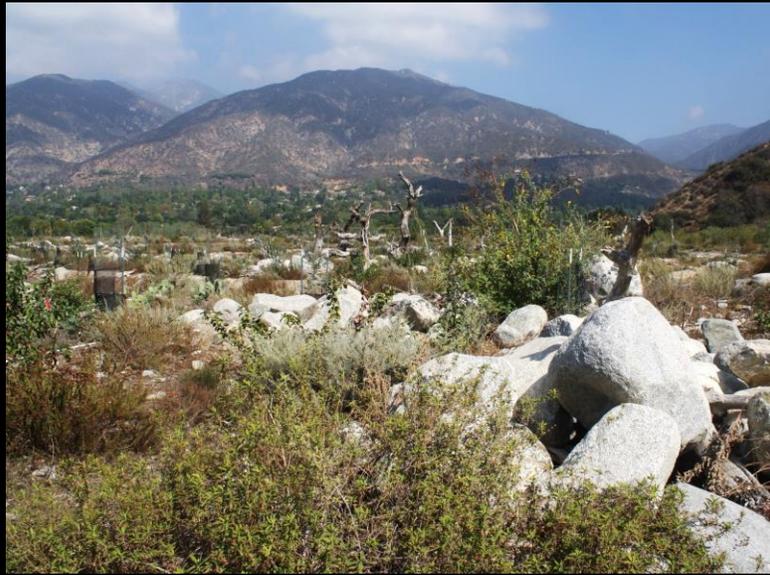
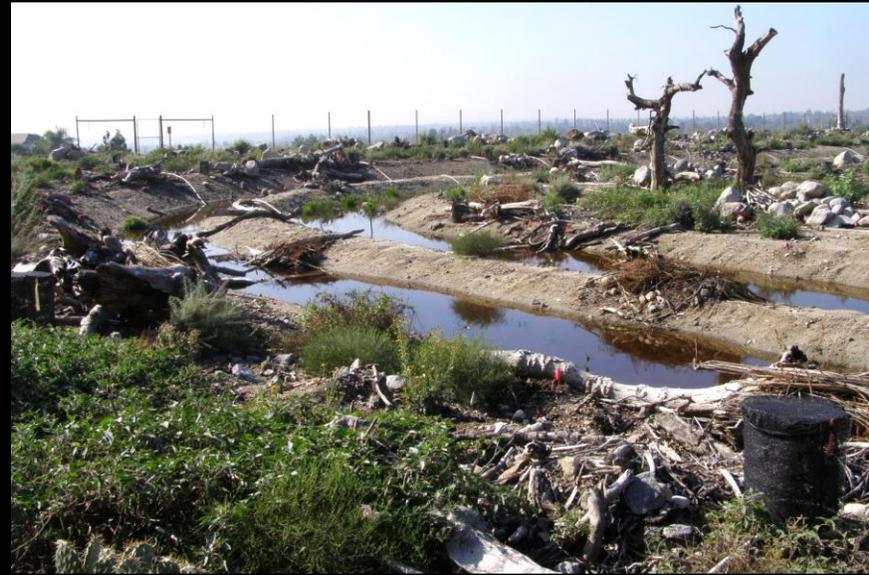
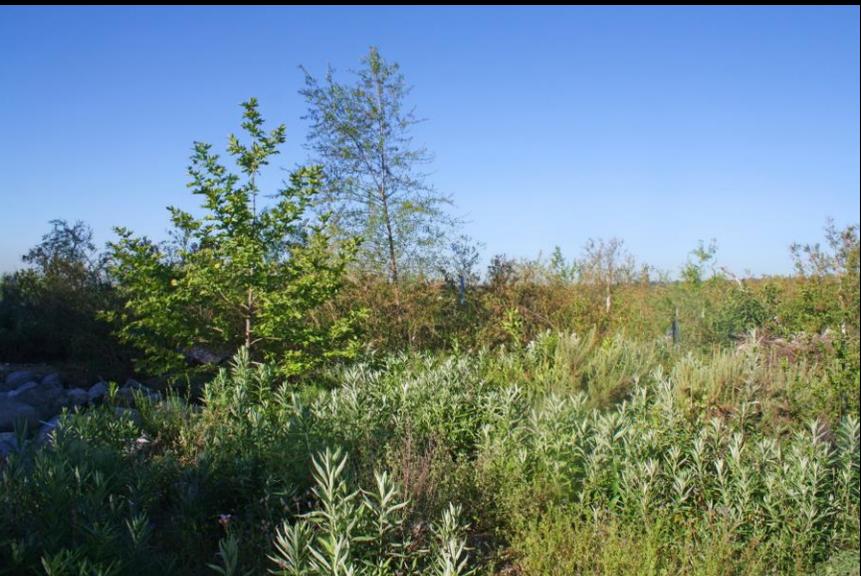
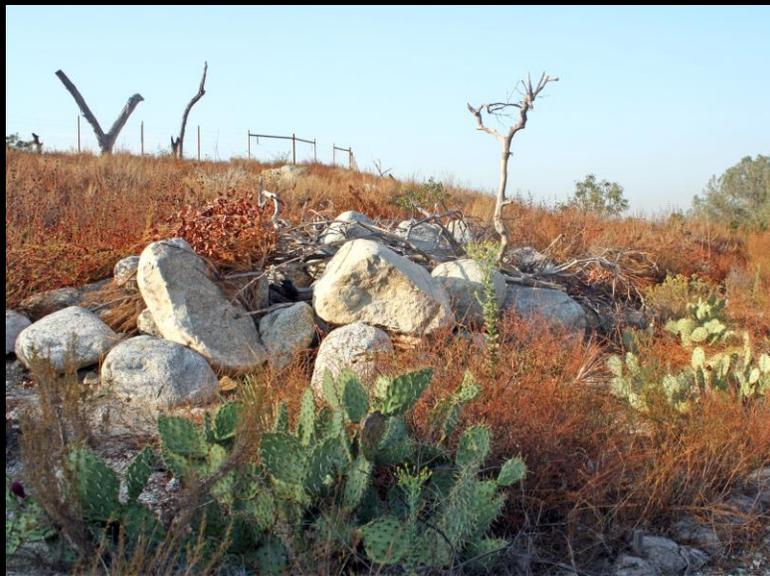
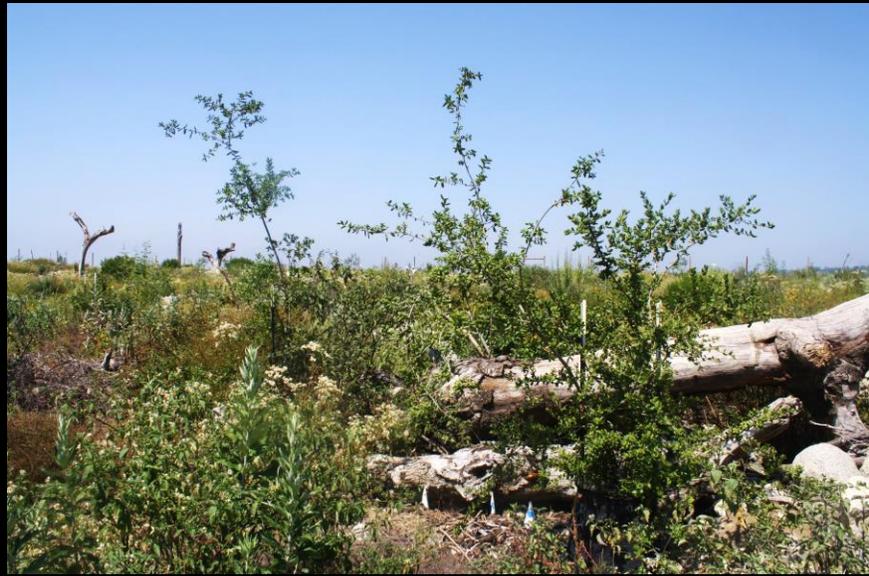
More of the interim conditions. Some oak saplings to the lower right, and some temporary ponding in the drainages (top right).

The wood and rocks also support vines and vining shrubs that would have had a harder time otherwise.

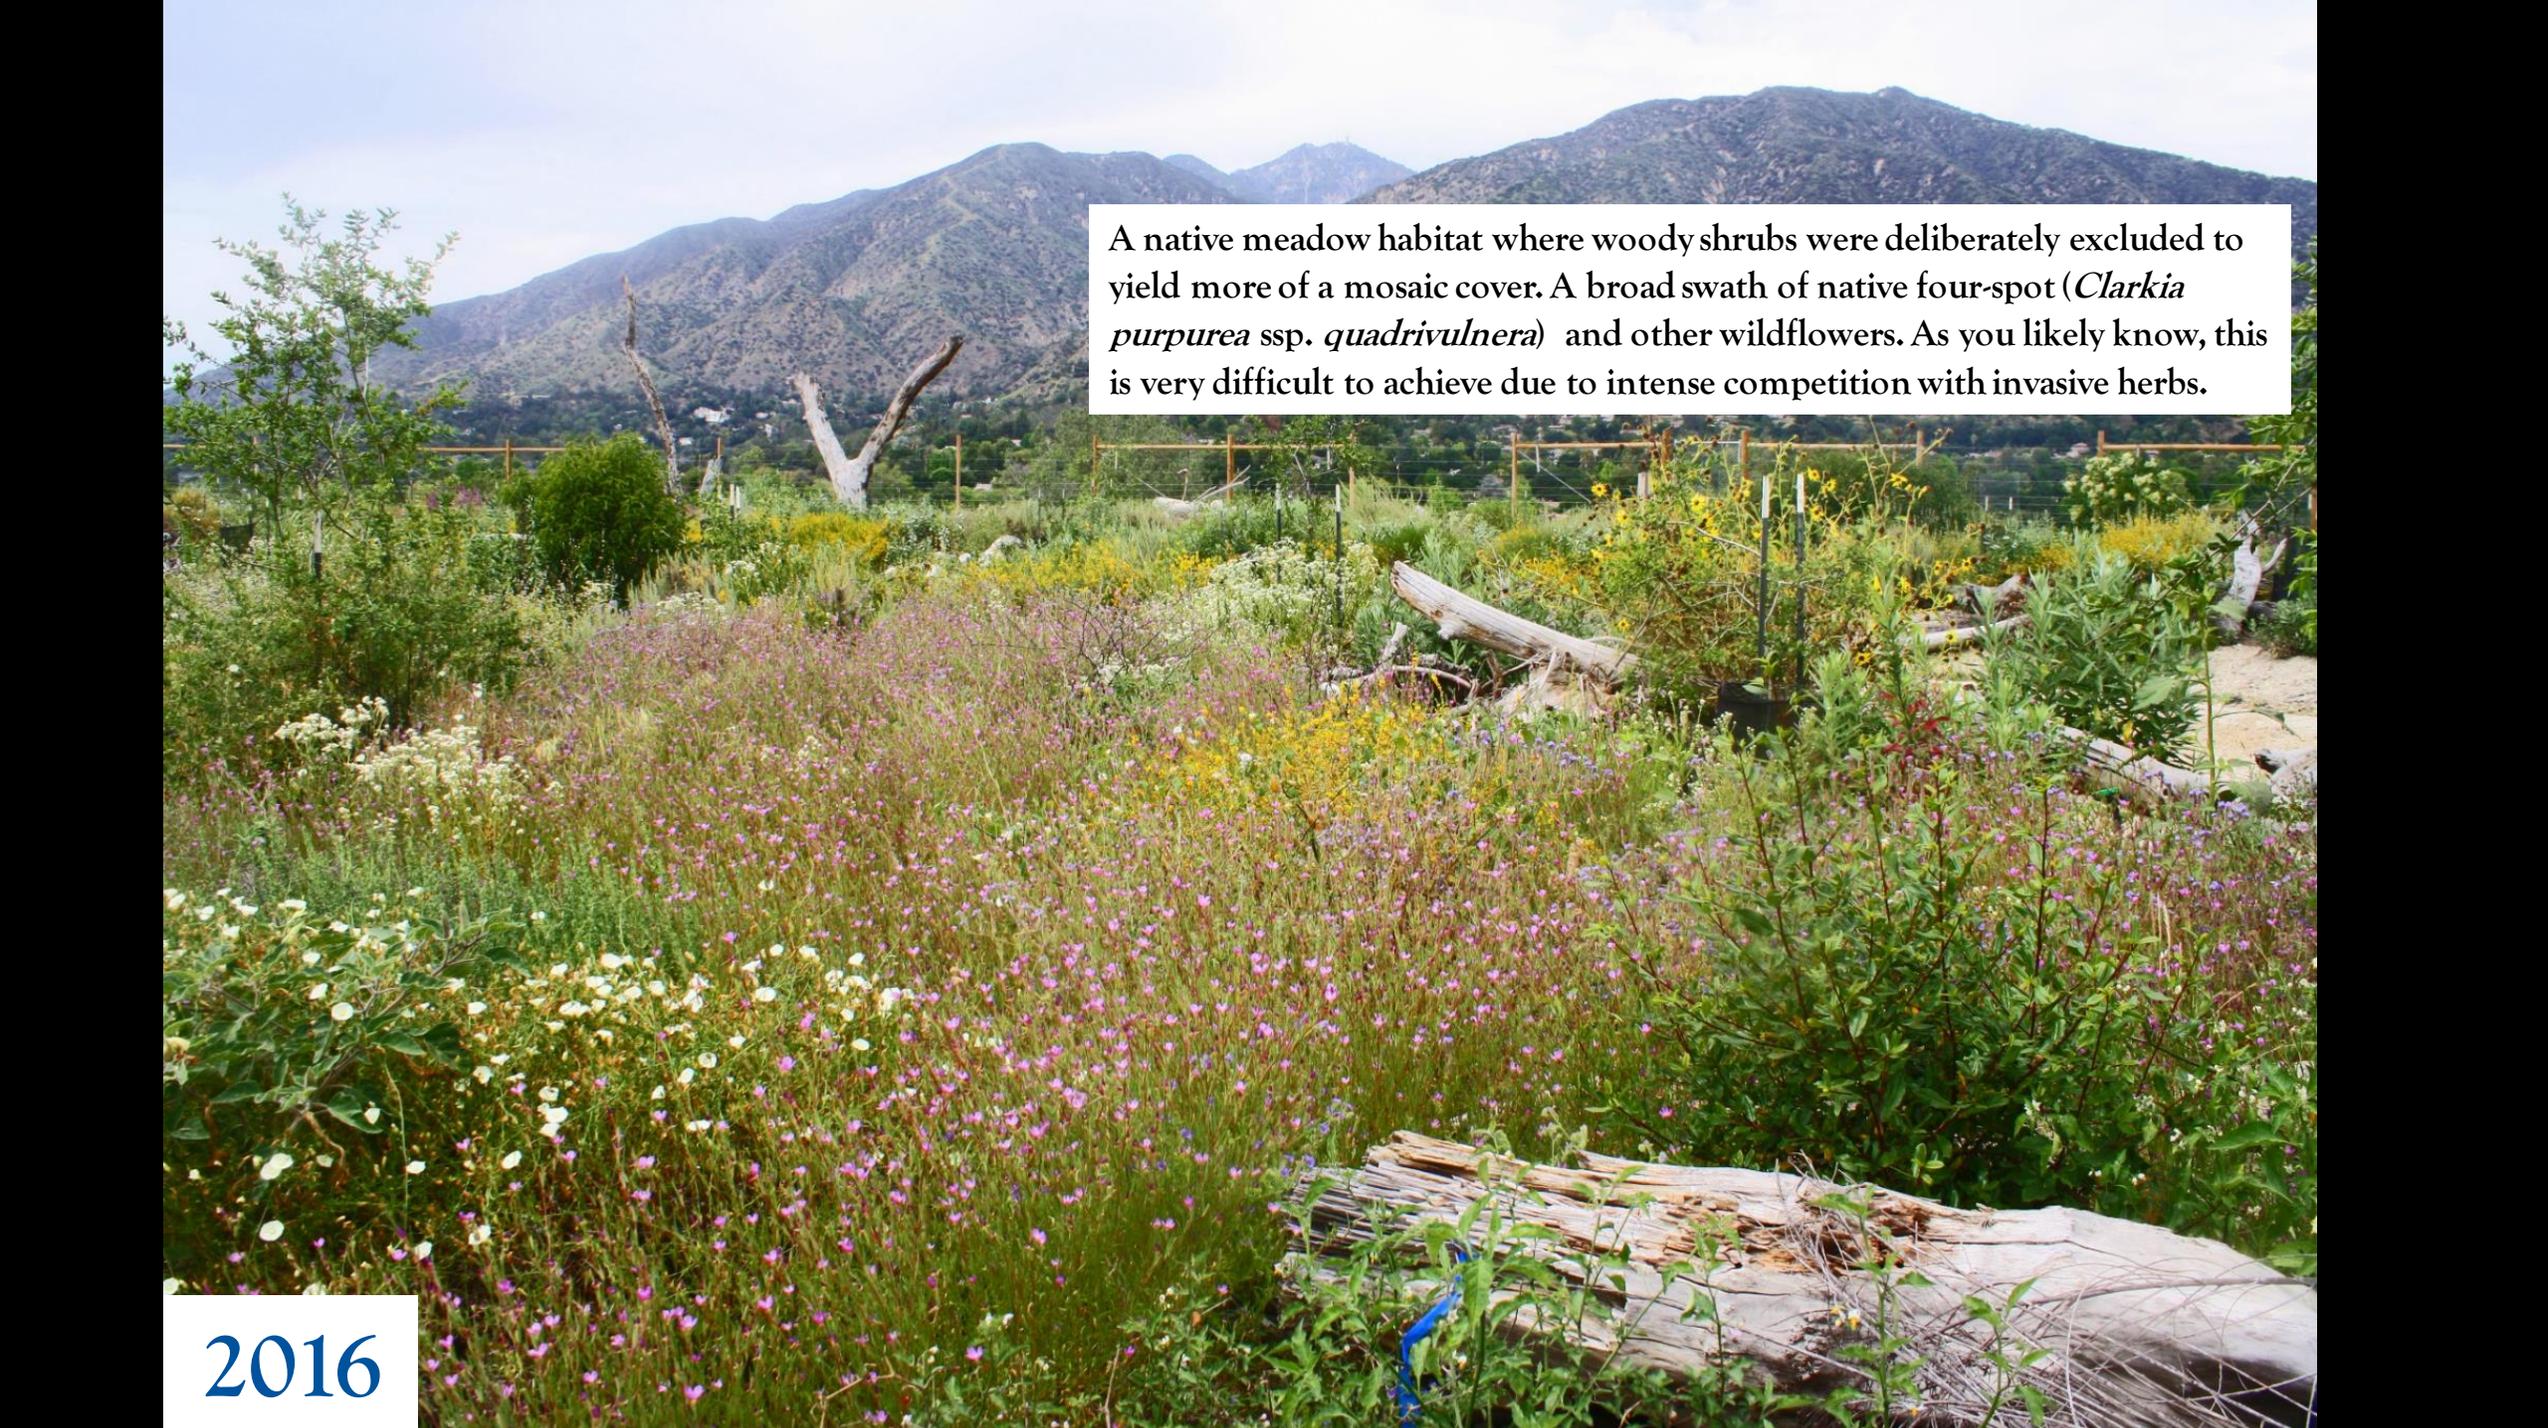
A photograph of a native meadow habitat. The foreground is filled with a dense, colorful mosaic of wildflowers, including purple, yellow, and white blooms. Several large pieces of weathered driftwood are scattered throughout the field. In the background, a wire fence runs across the middle ground, and beyond that, a range of rugged, brownish mountains stretches across the horizon under a clear sky.

A native meadow habitat where woody shrubs were deliberately excluded to yield more of a mosaic cover. A broad swath of native four-spot (*Clarkia purpurea* ssp. *quadrivulnera*) and other wildflowers. As you likely know, this is very difficult to achieve due to intense competition with invasive herbs.
