# Substrate Enhancements and Botanical Diversity for Successful Oak Habitat Creation

Richard B. Lewis III, ENV SP  
Senior Restoration Ecologist, Psomas

This is a PDF-version of the slide show that accompanied Psomas' oral presentation at the University of California Agriculture & Natural Resources' 8<sup>th</sup> California Oak Symposium in San Luis Obispo, California, on November 1, 2022. The narration from that presentation has been added via text boxes to this PDF version.

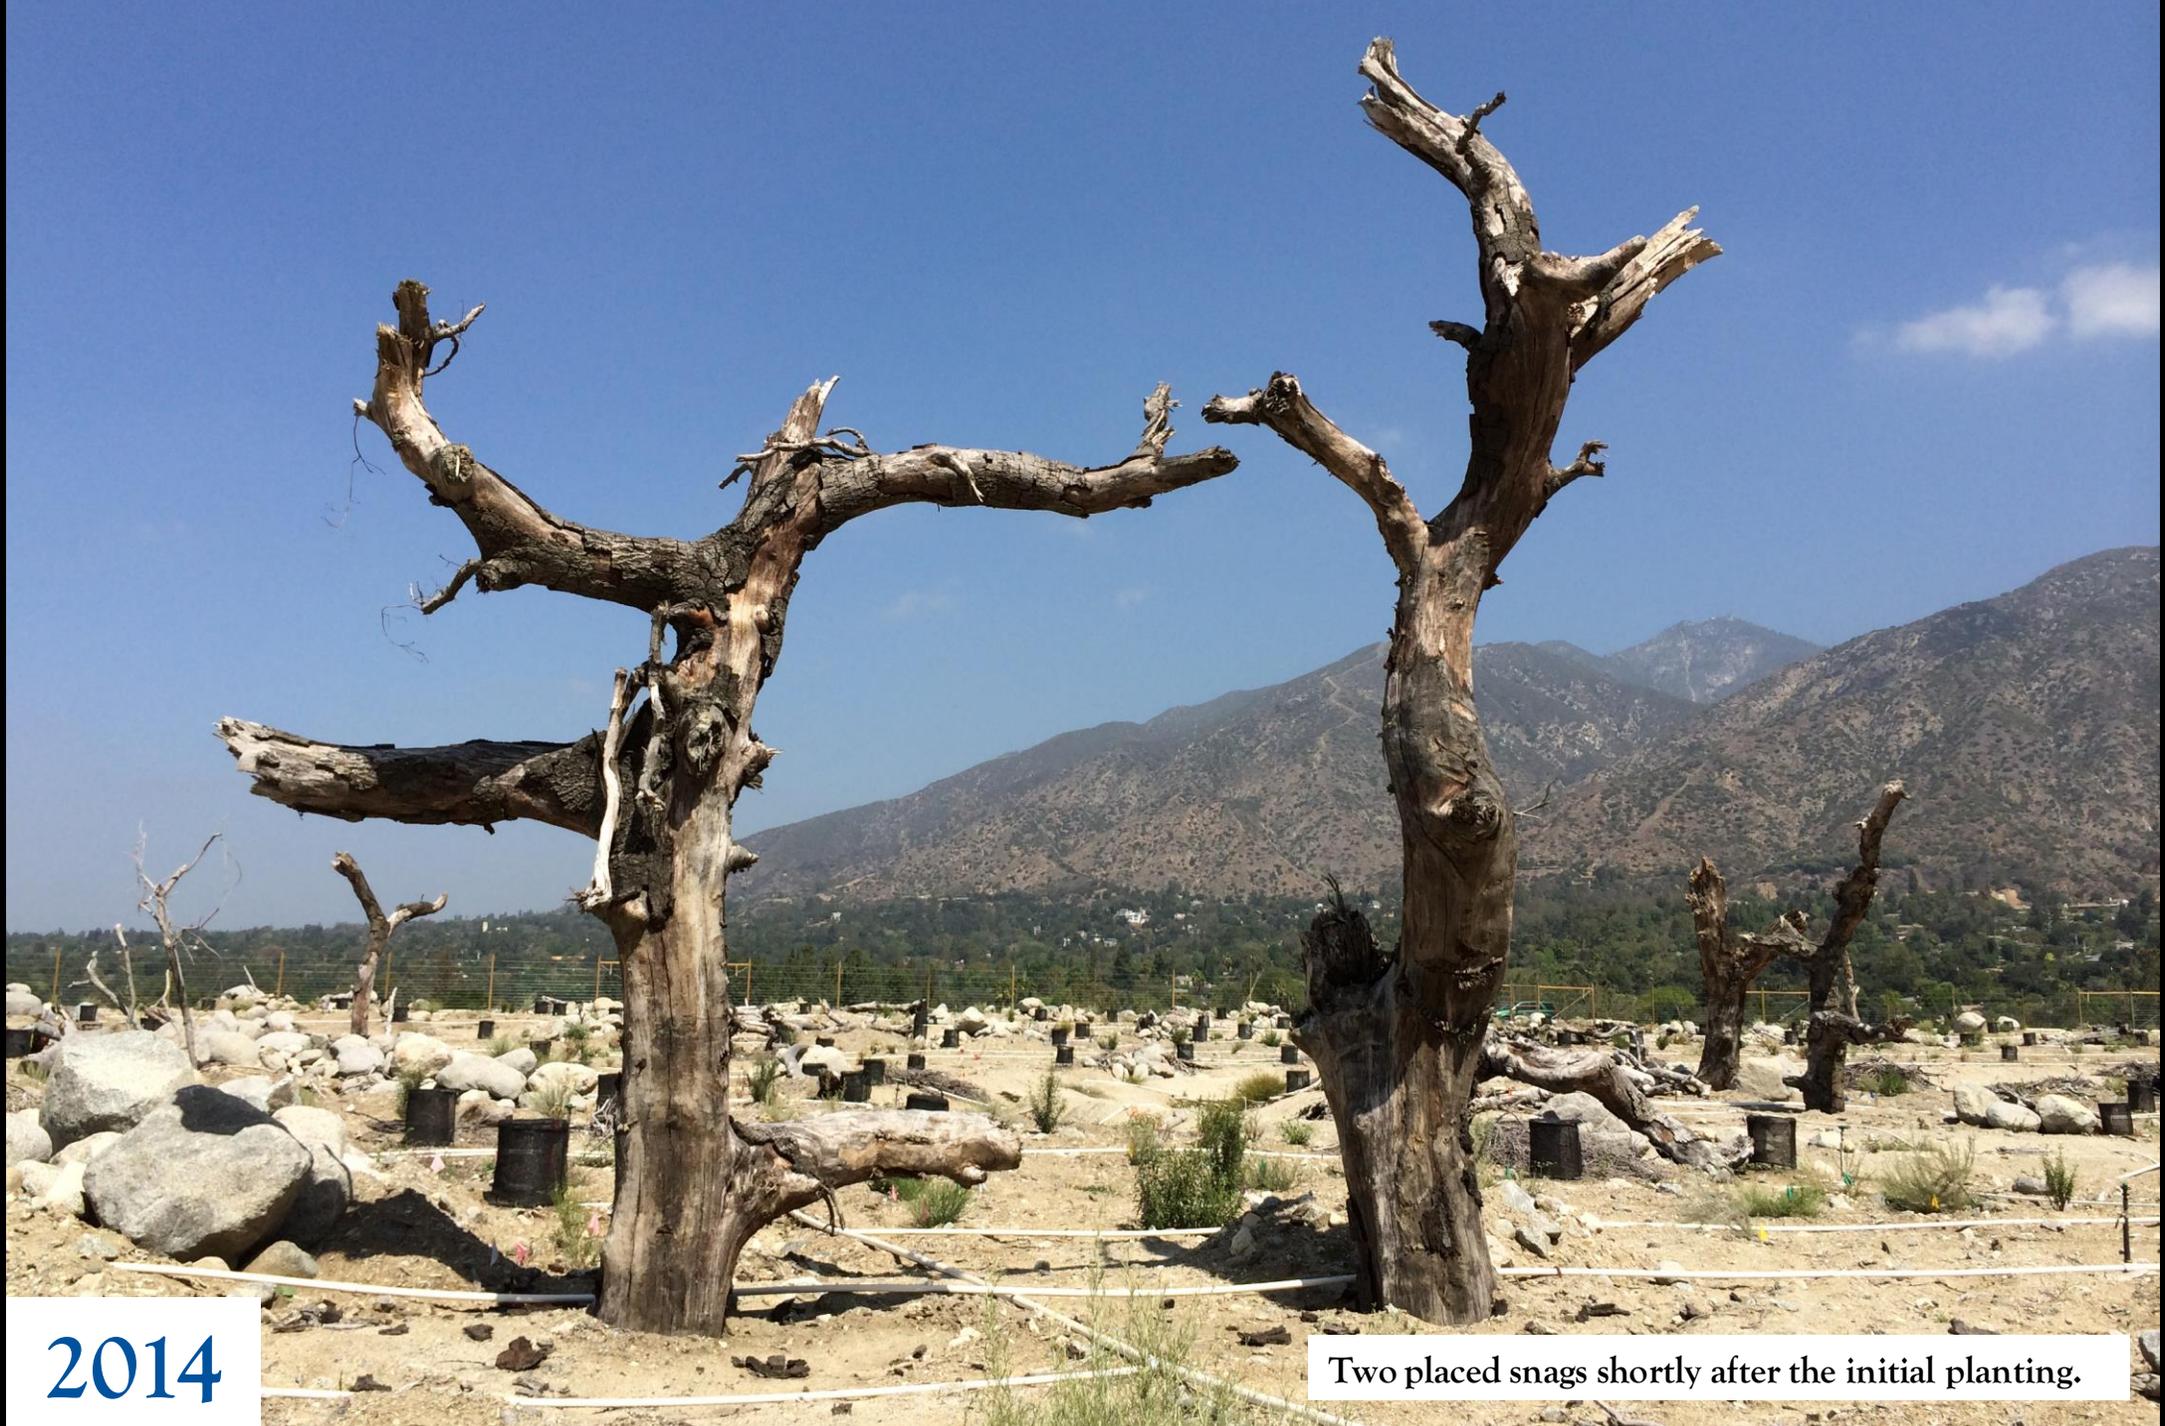
2014

Two placed snags shortly after the initial planting.

And the same snags a few years later showing the diverse planted and seeded vegetation. Think of the time required for an oak to germinate, mature, begin to senesce, die-back and disarticulate, and we're pre-emptively providing habitat values that would not otherwise exist for many years.

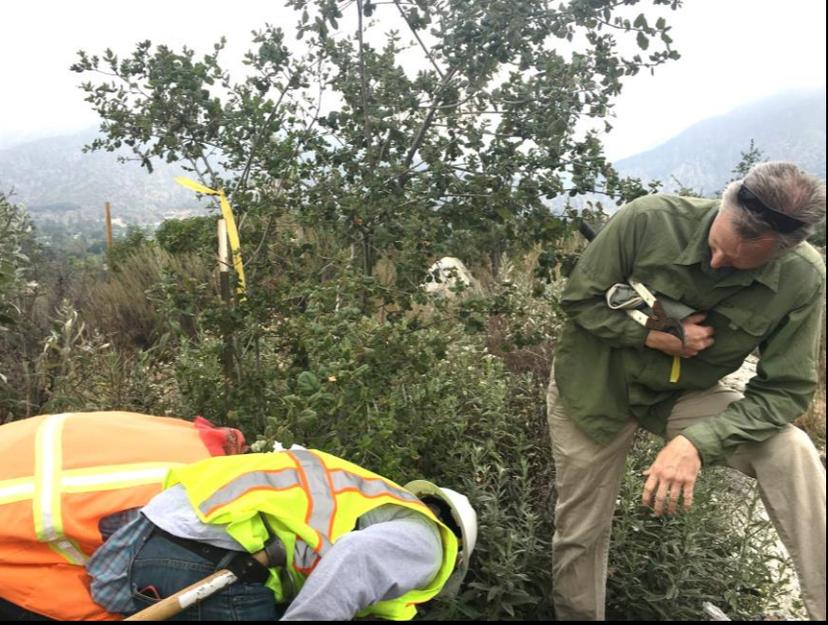
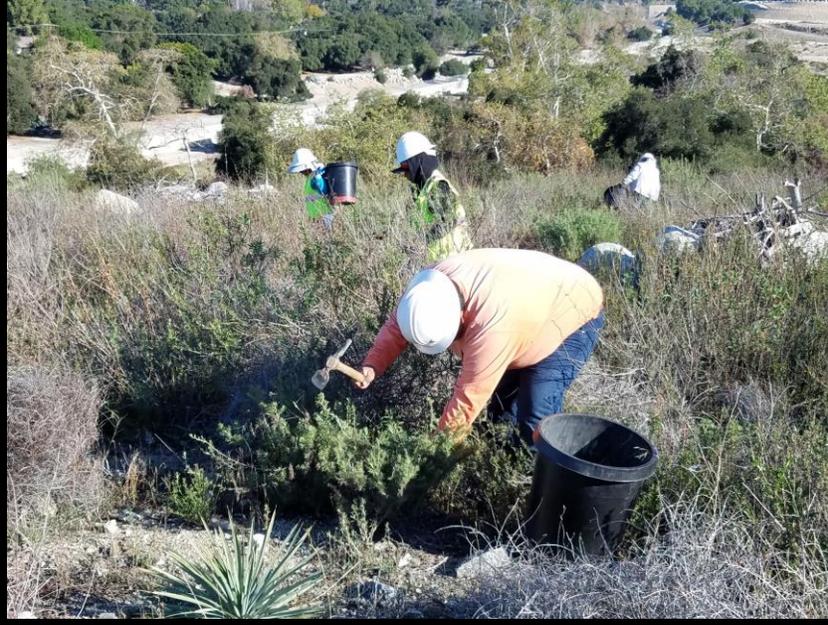
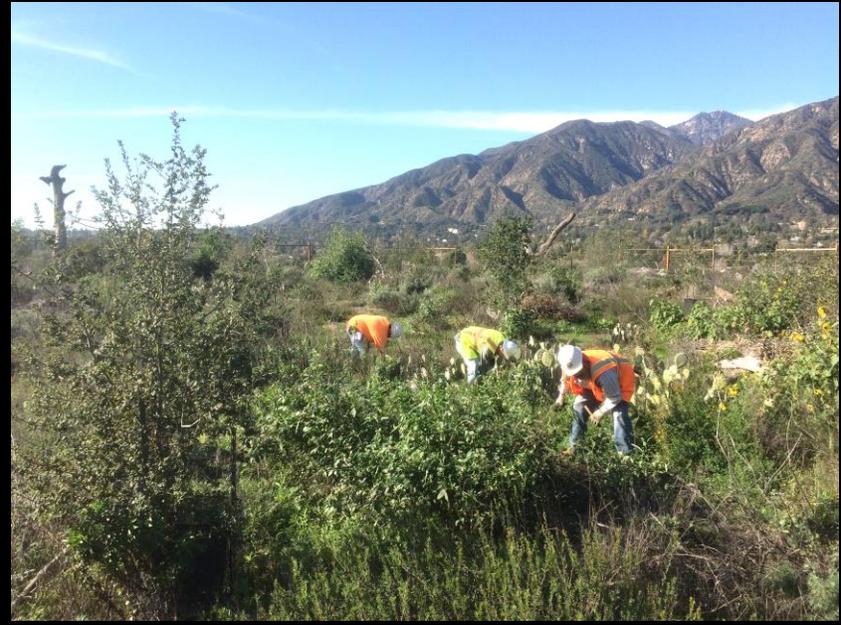
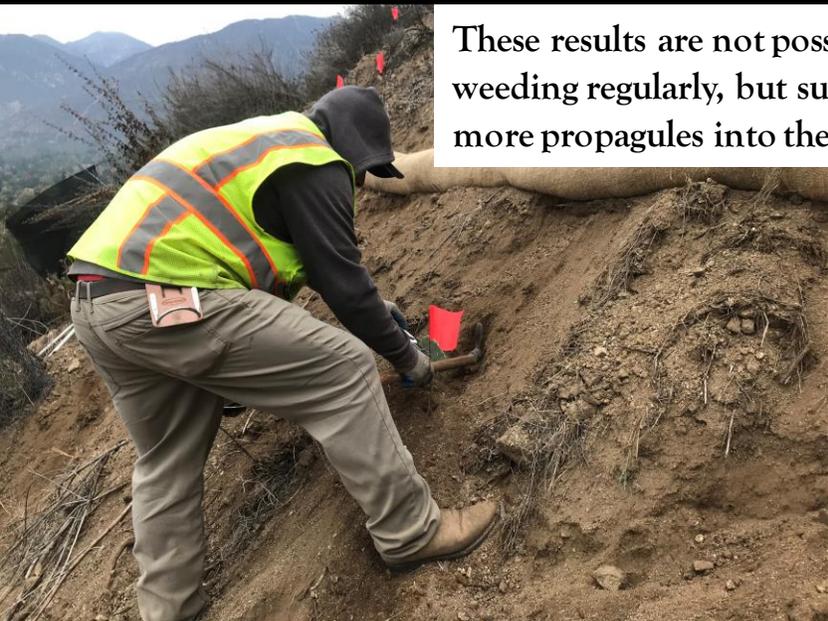
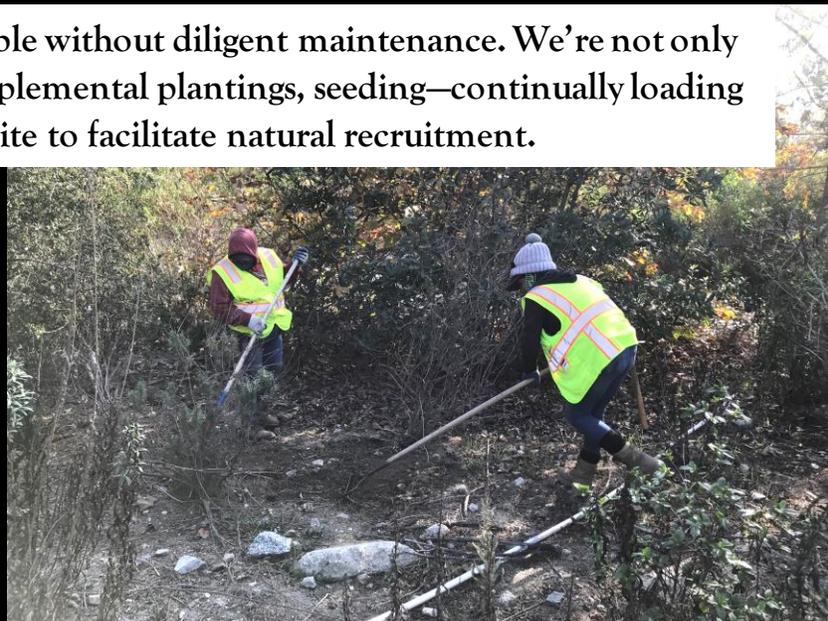
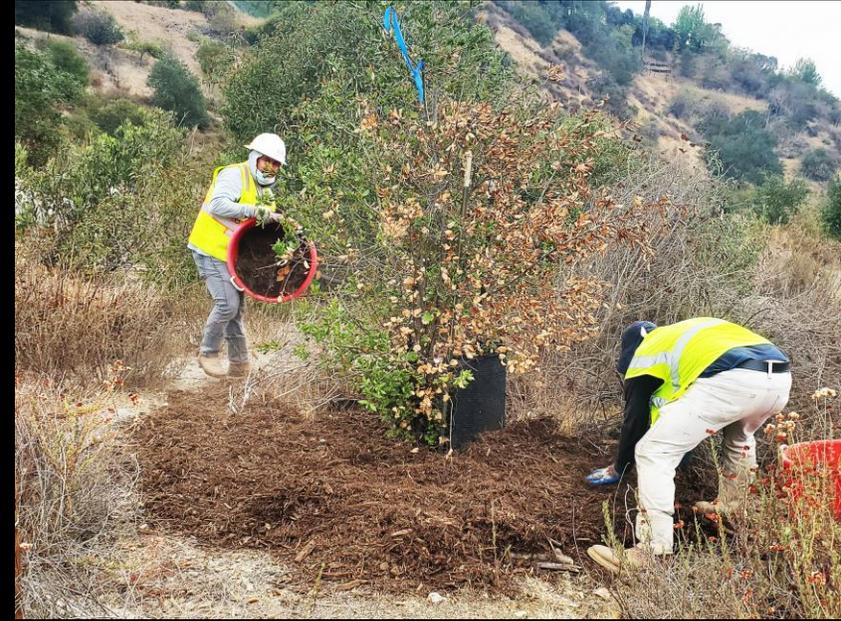
Maintenance / Enhancement

These results are not possible without diligent maintenance. We're not only weeding regularly, but supplemental plantings, seeding—continually loading more propagules into the site to facilitate natural recruitment.

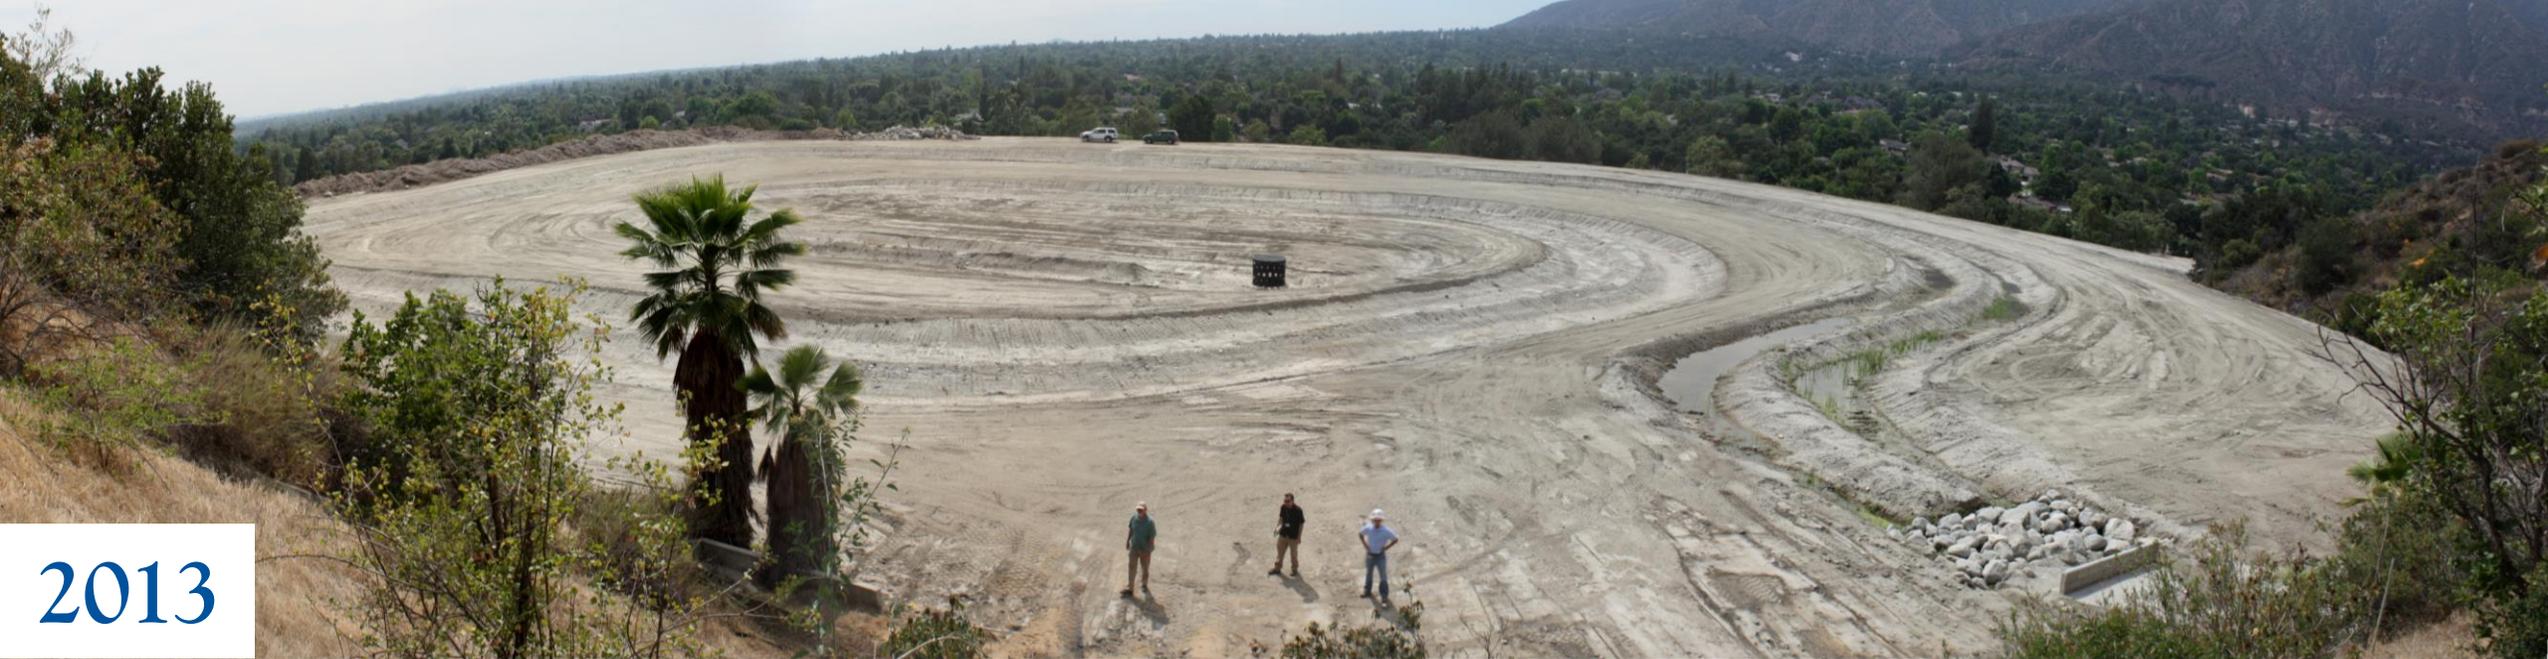
2013

These panoramas show the progress at a landscape level.

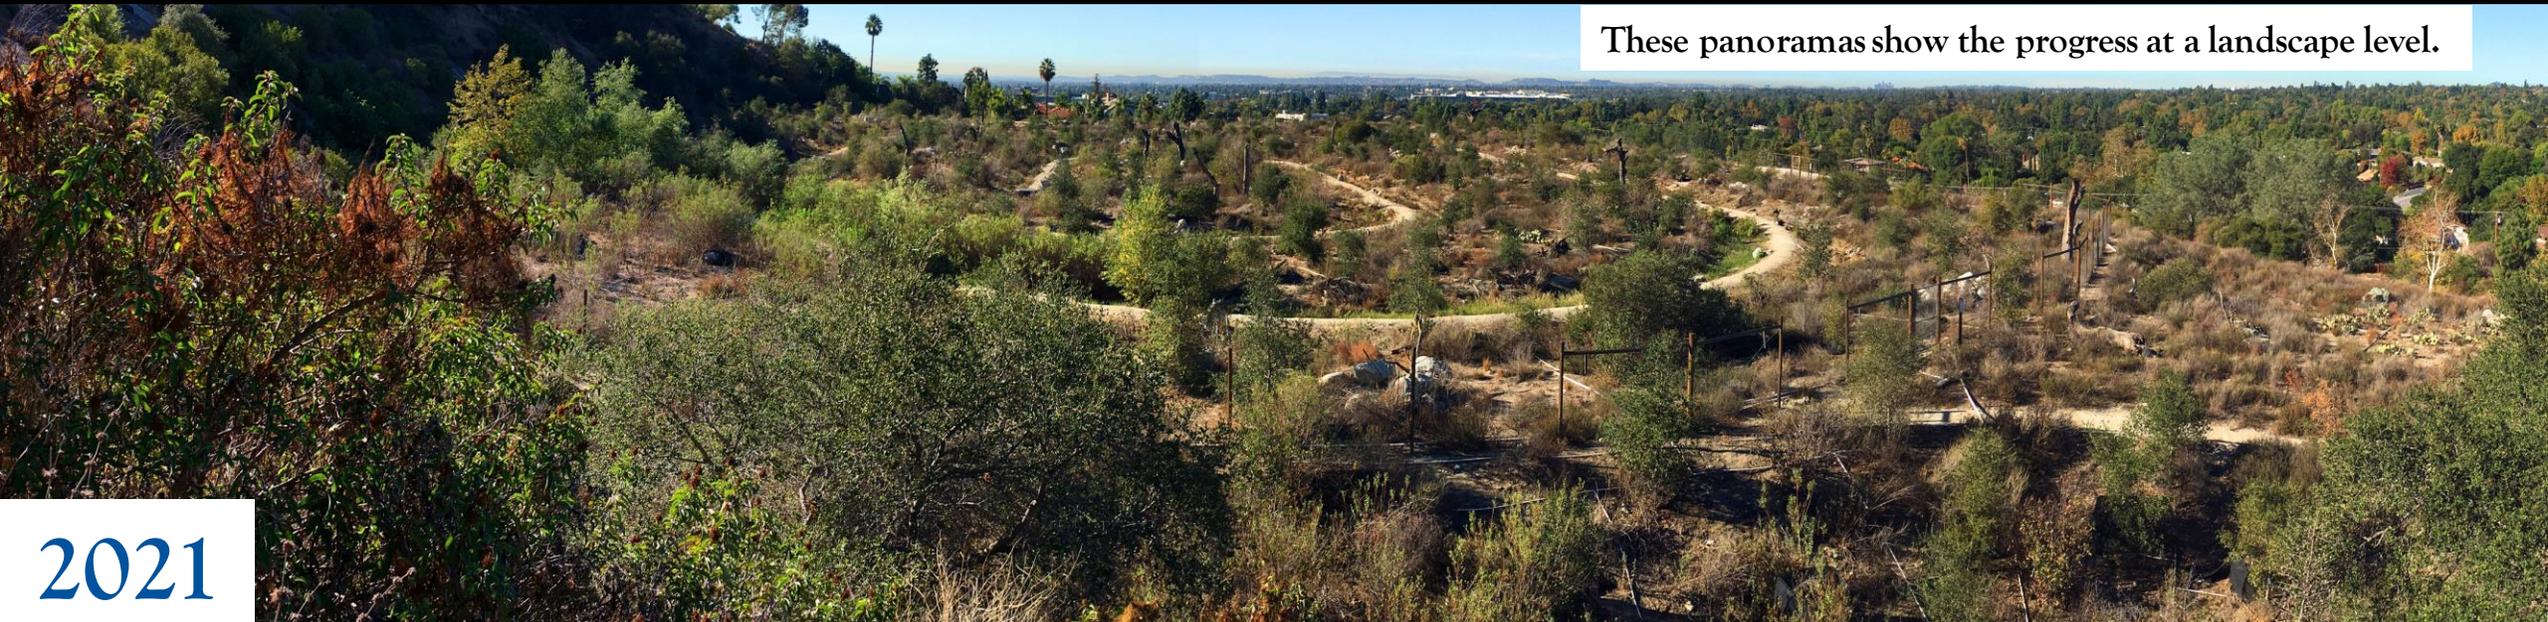
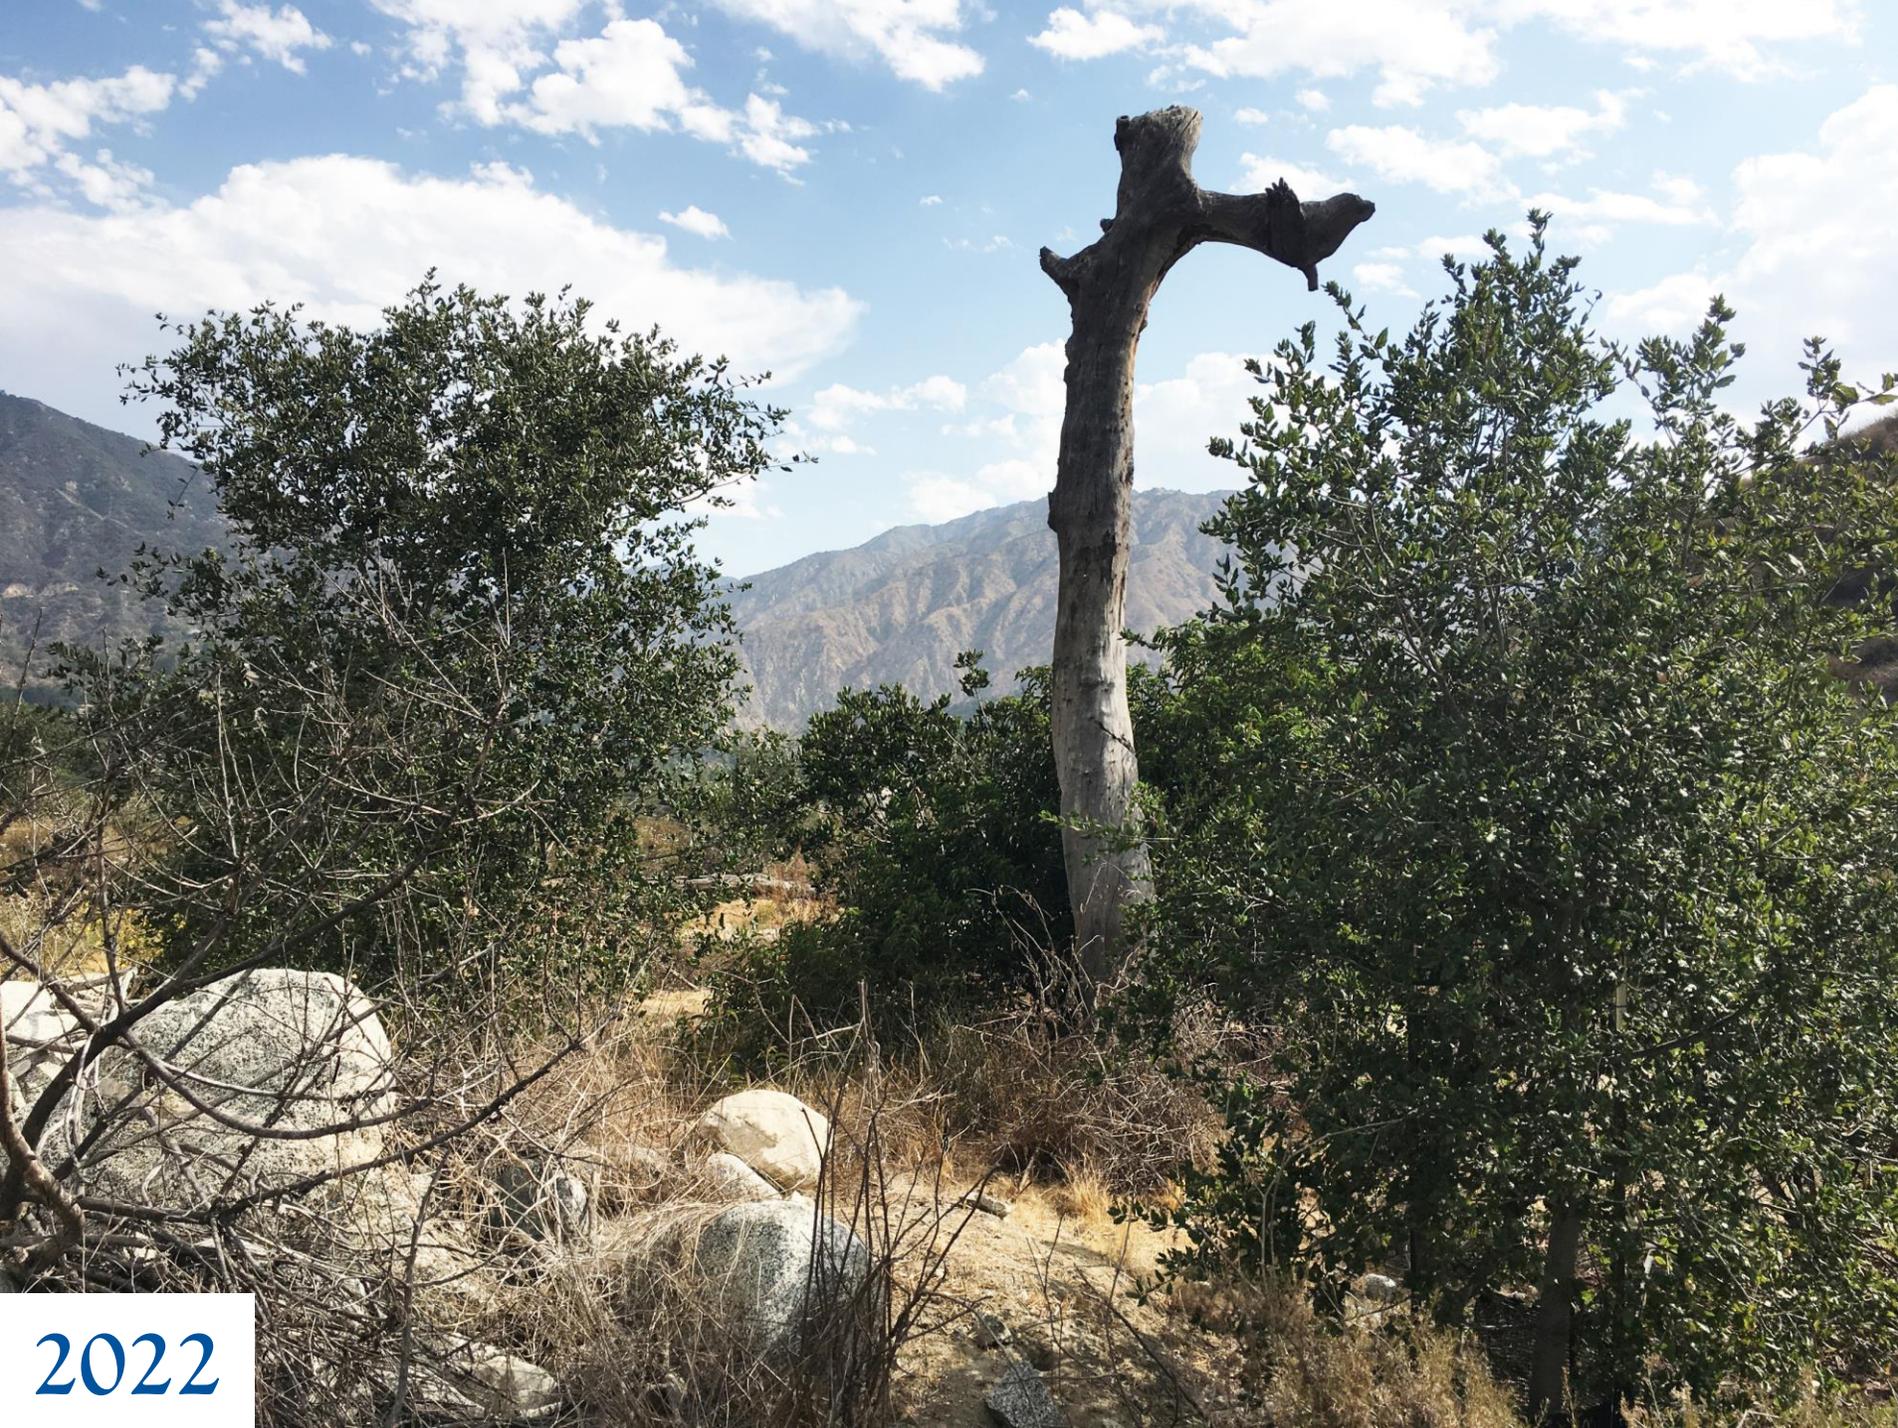
These panoramas show the progress at a landscape level.

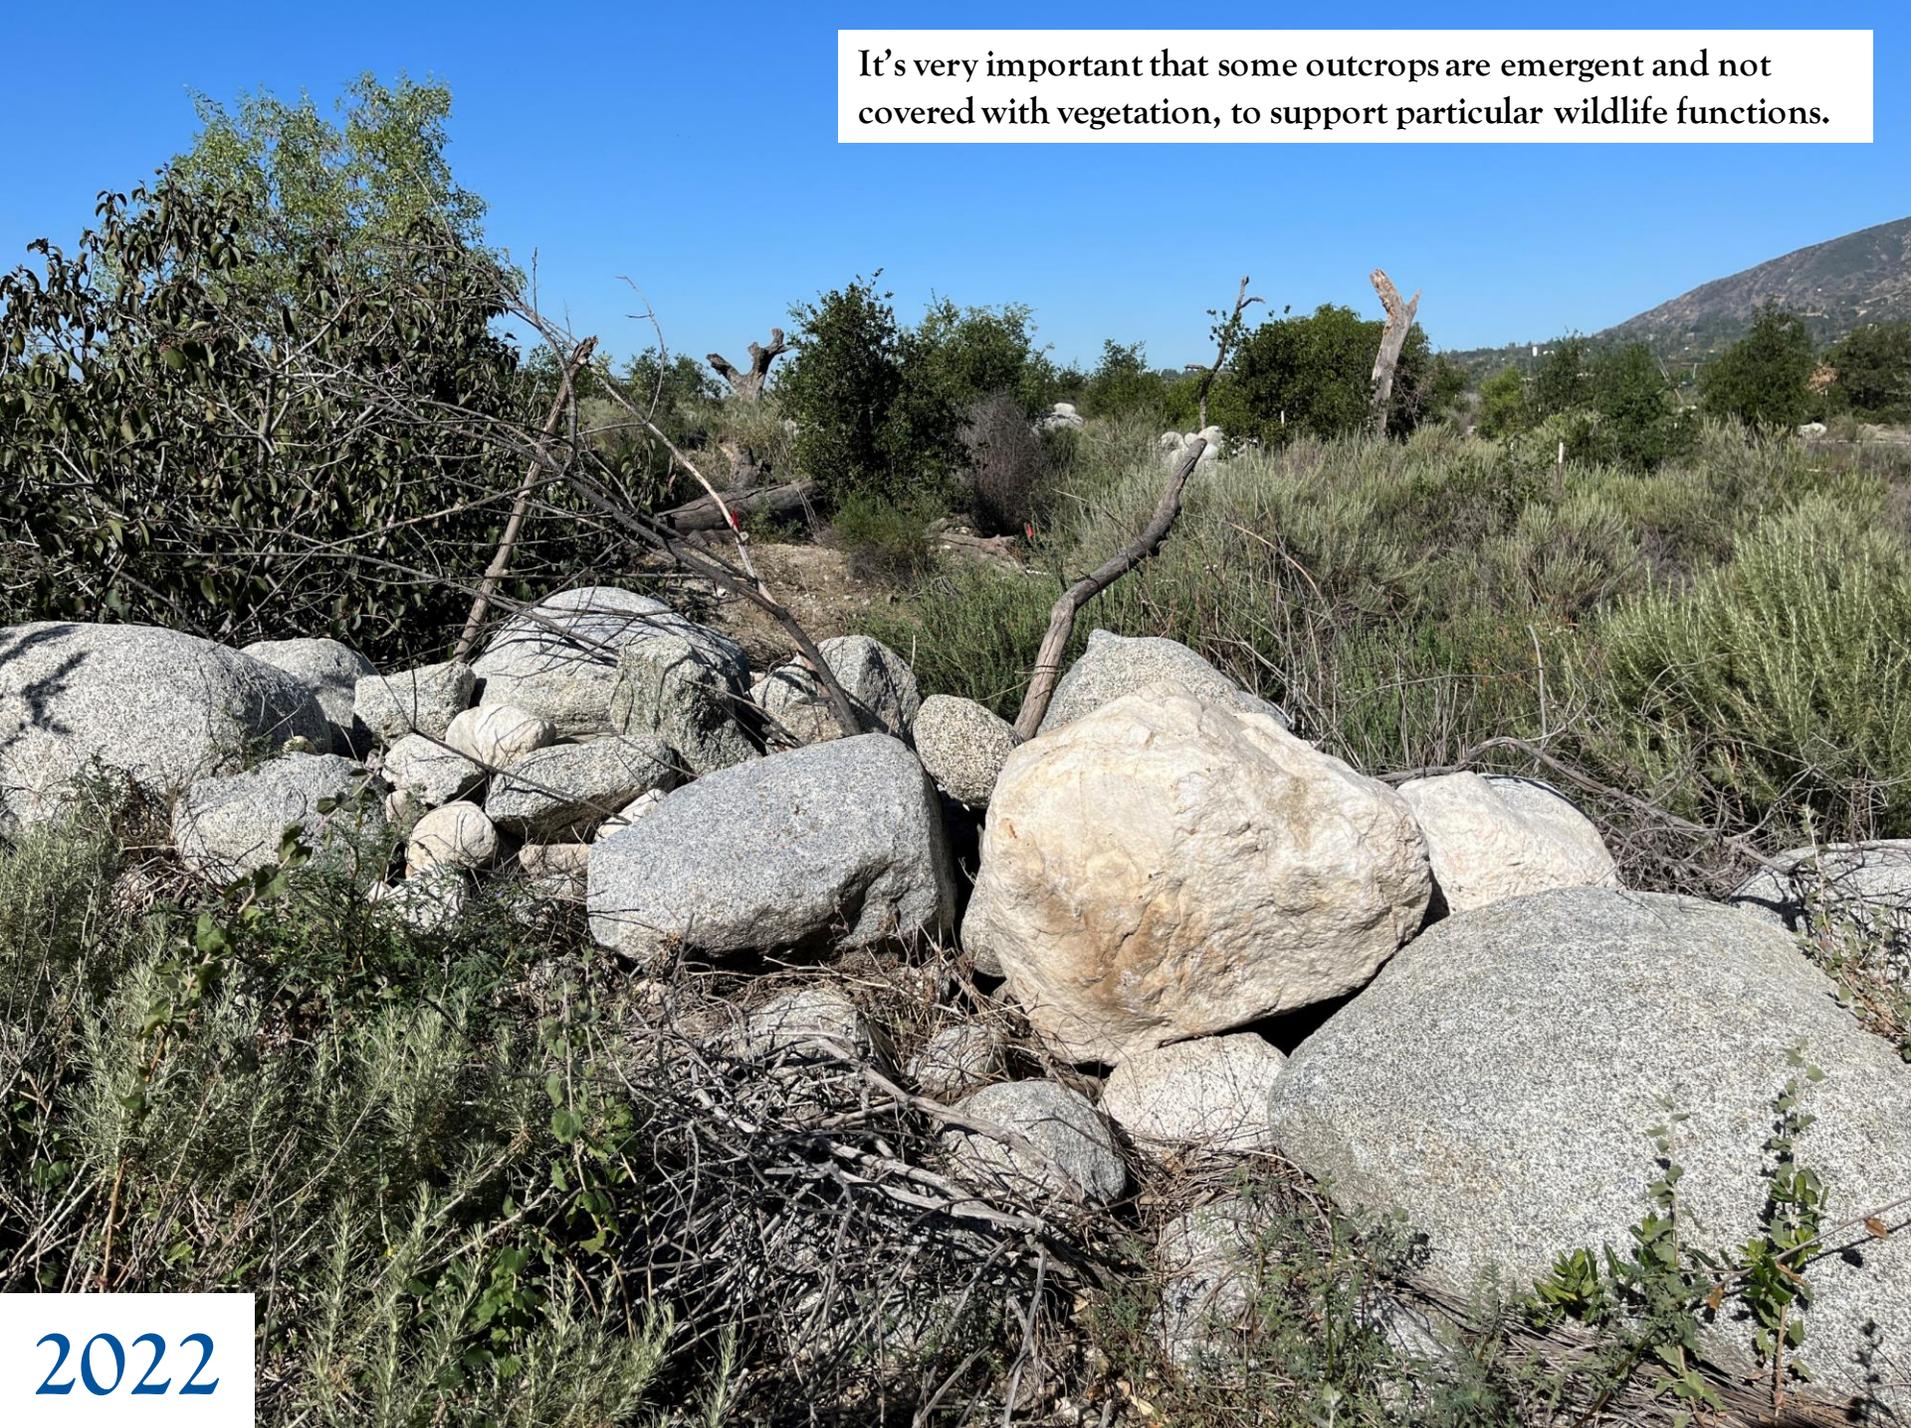
It's very important that some outcrops are emergent and not covered with vegetation, to support particular wildlife functions.

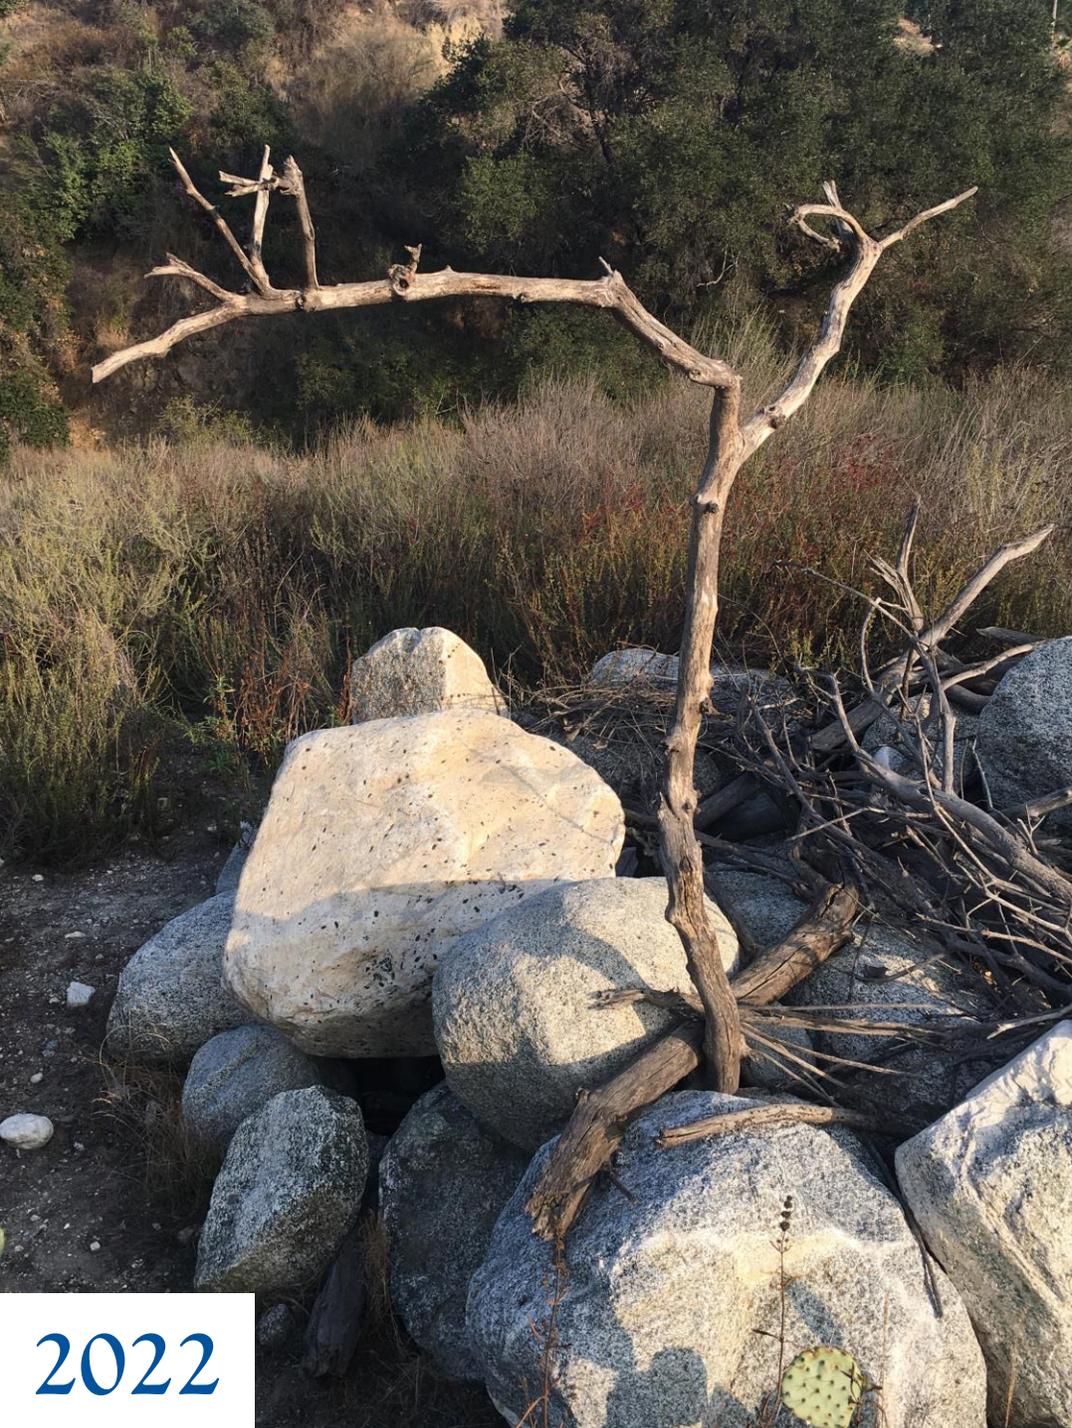
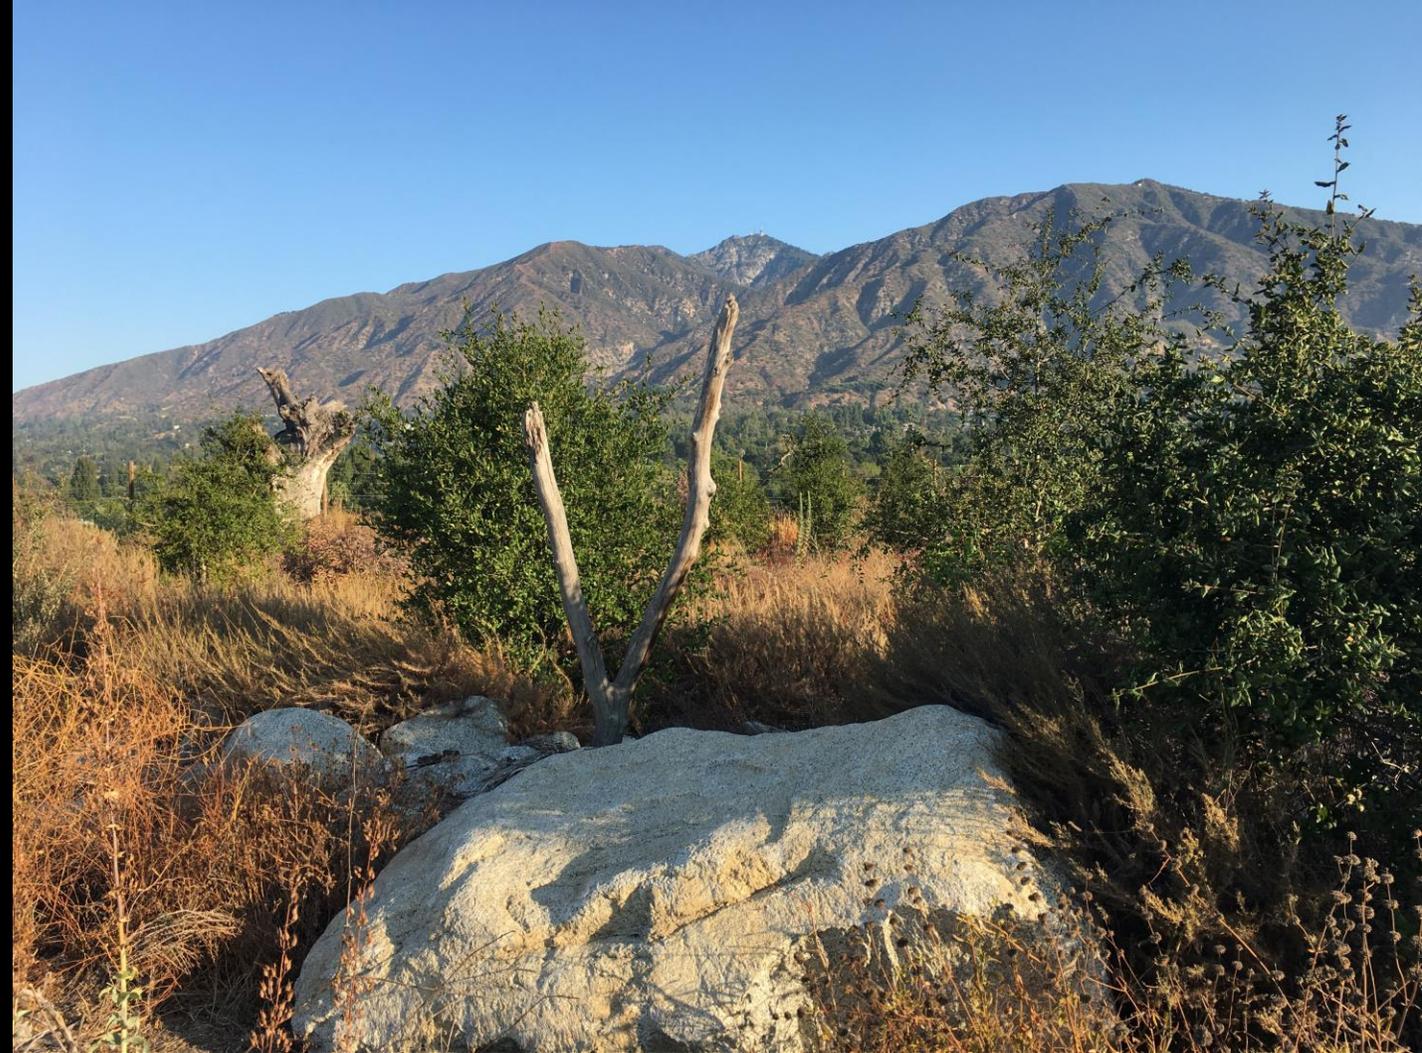
In addition to the large snags, we often place smaller branches among the assemblages, and these are heavily used by critters.

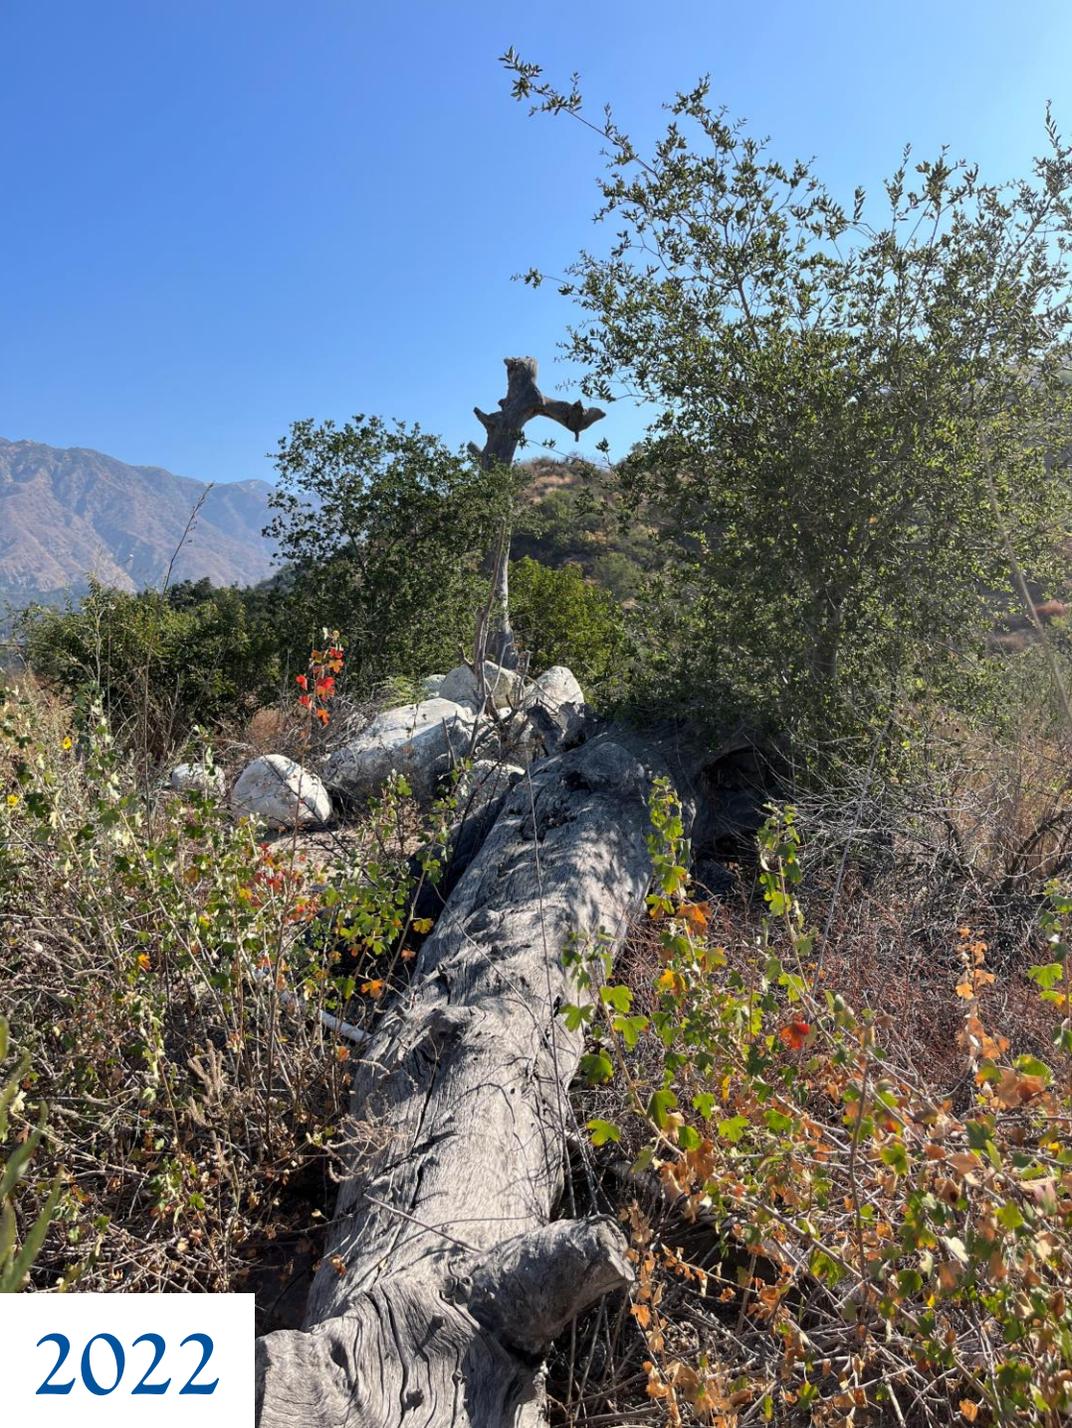
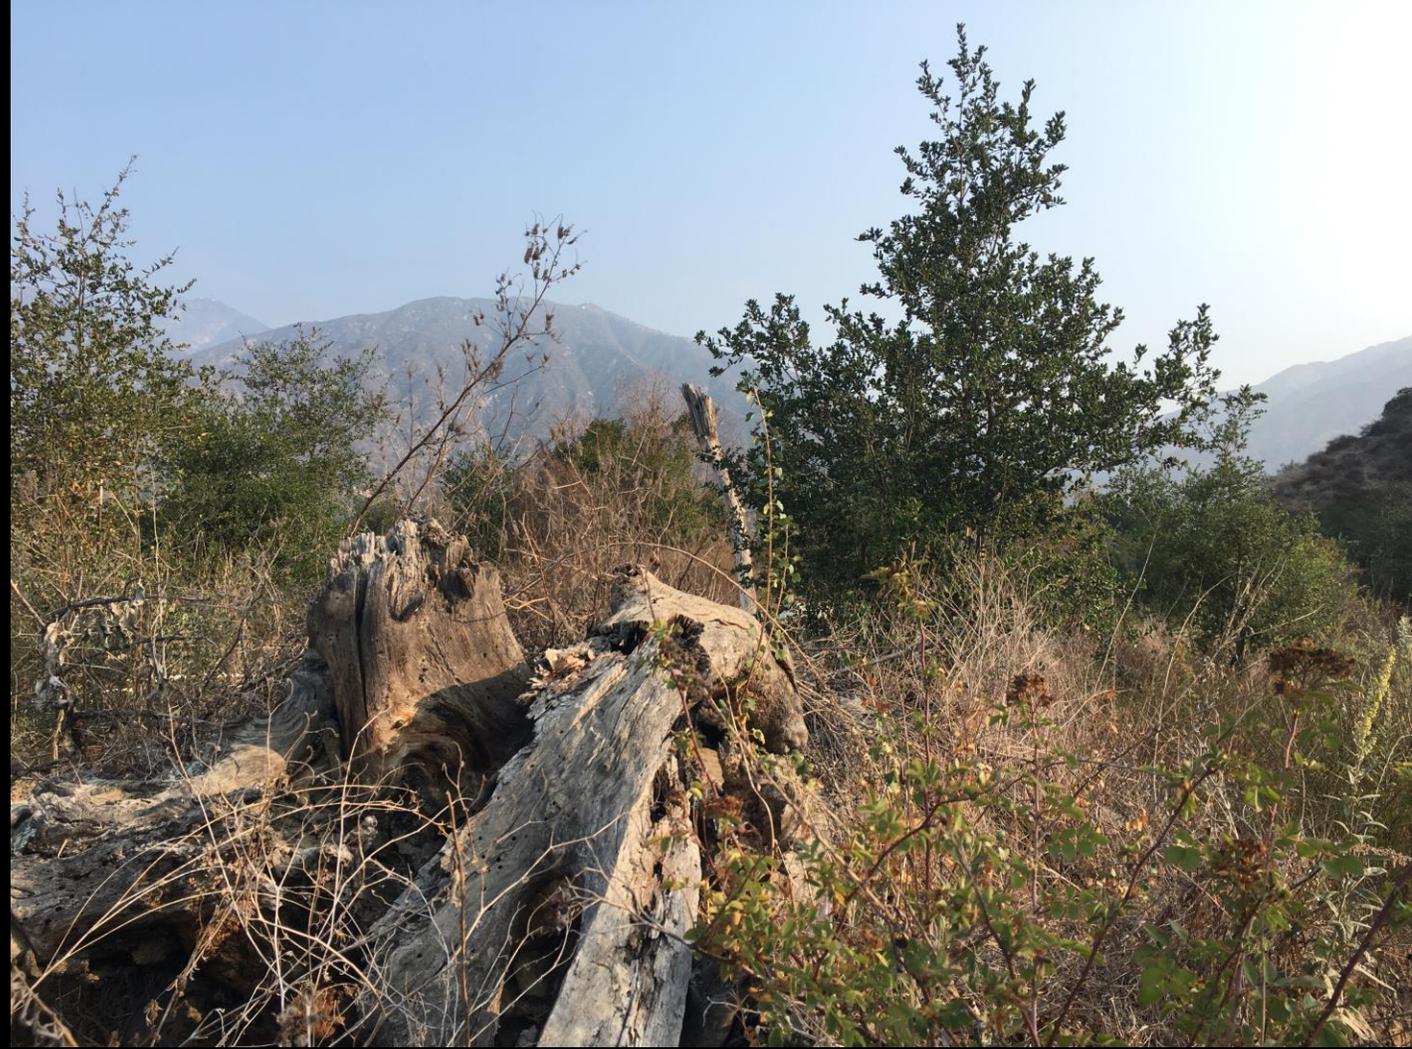
The placed CWD continues to weather and decay.
