# Substrate Enhancements and Botanical Diversity for Successful Oak Habitat Creation

Richard B. Lewis III, ENV SP  
Senior Restoration Ecologist, Psomas

This is a PDF-version of the slide show that accompanied Psomas' oral presentation at the University of California Agriculture & Natural Resources' 8<sup>th</sup> California Oak Symposium in San Luis Obispo, California, on November 1, 2022. The narration from that presentation has been added via text boxes to this PDF version.

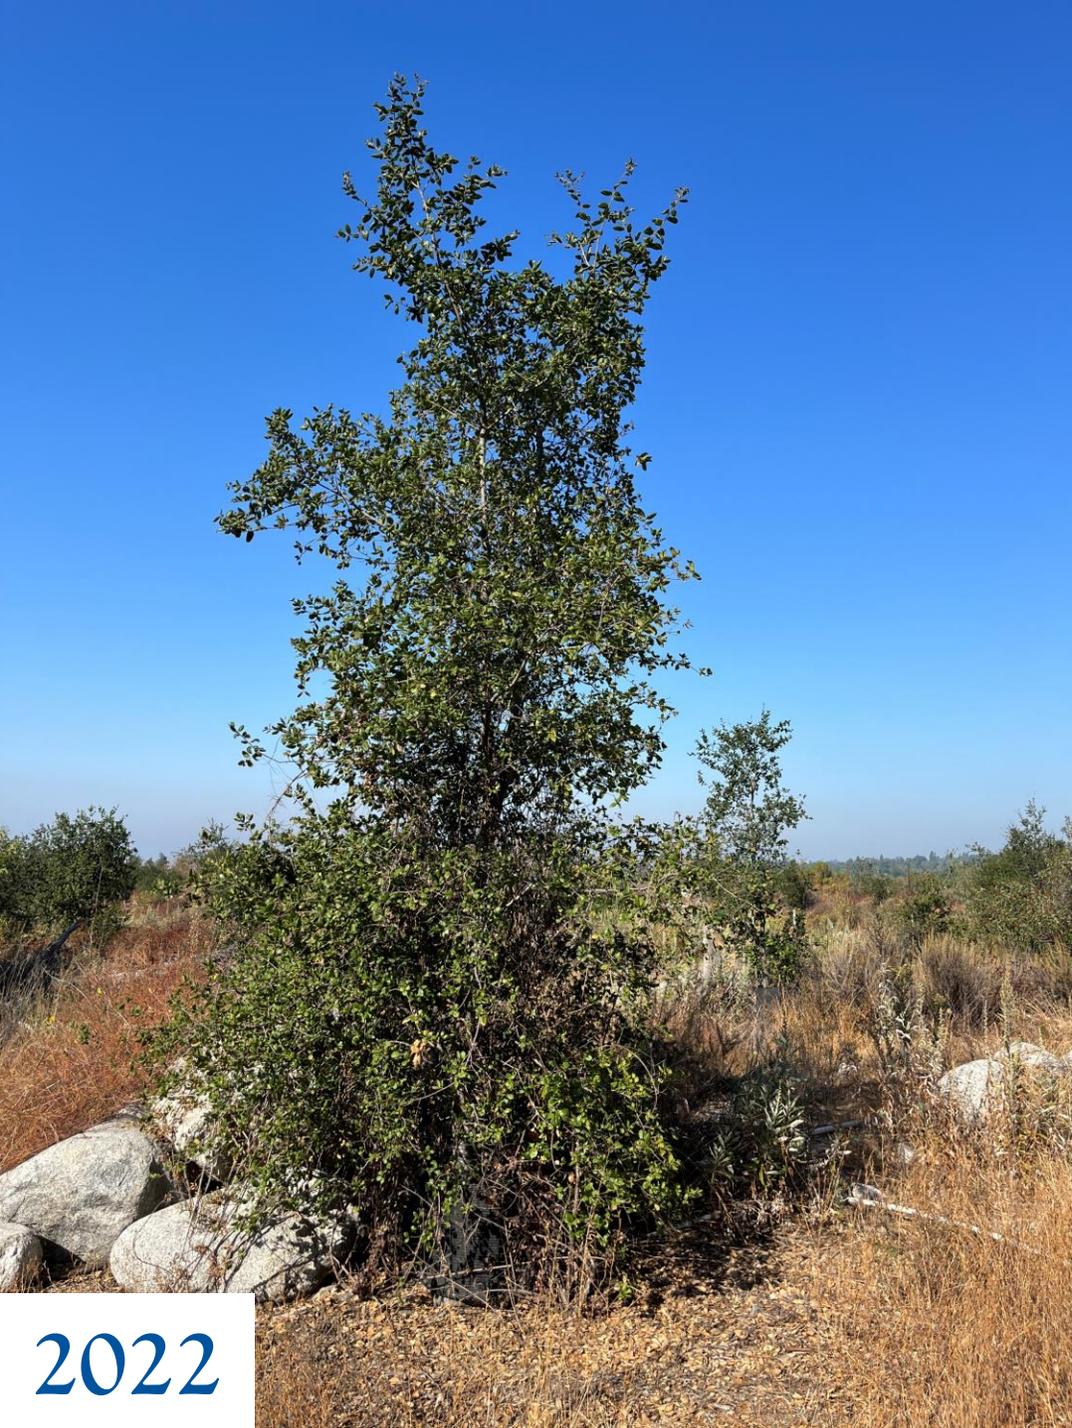
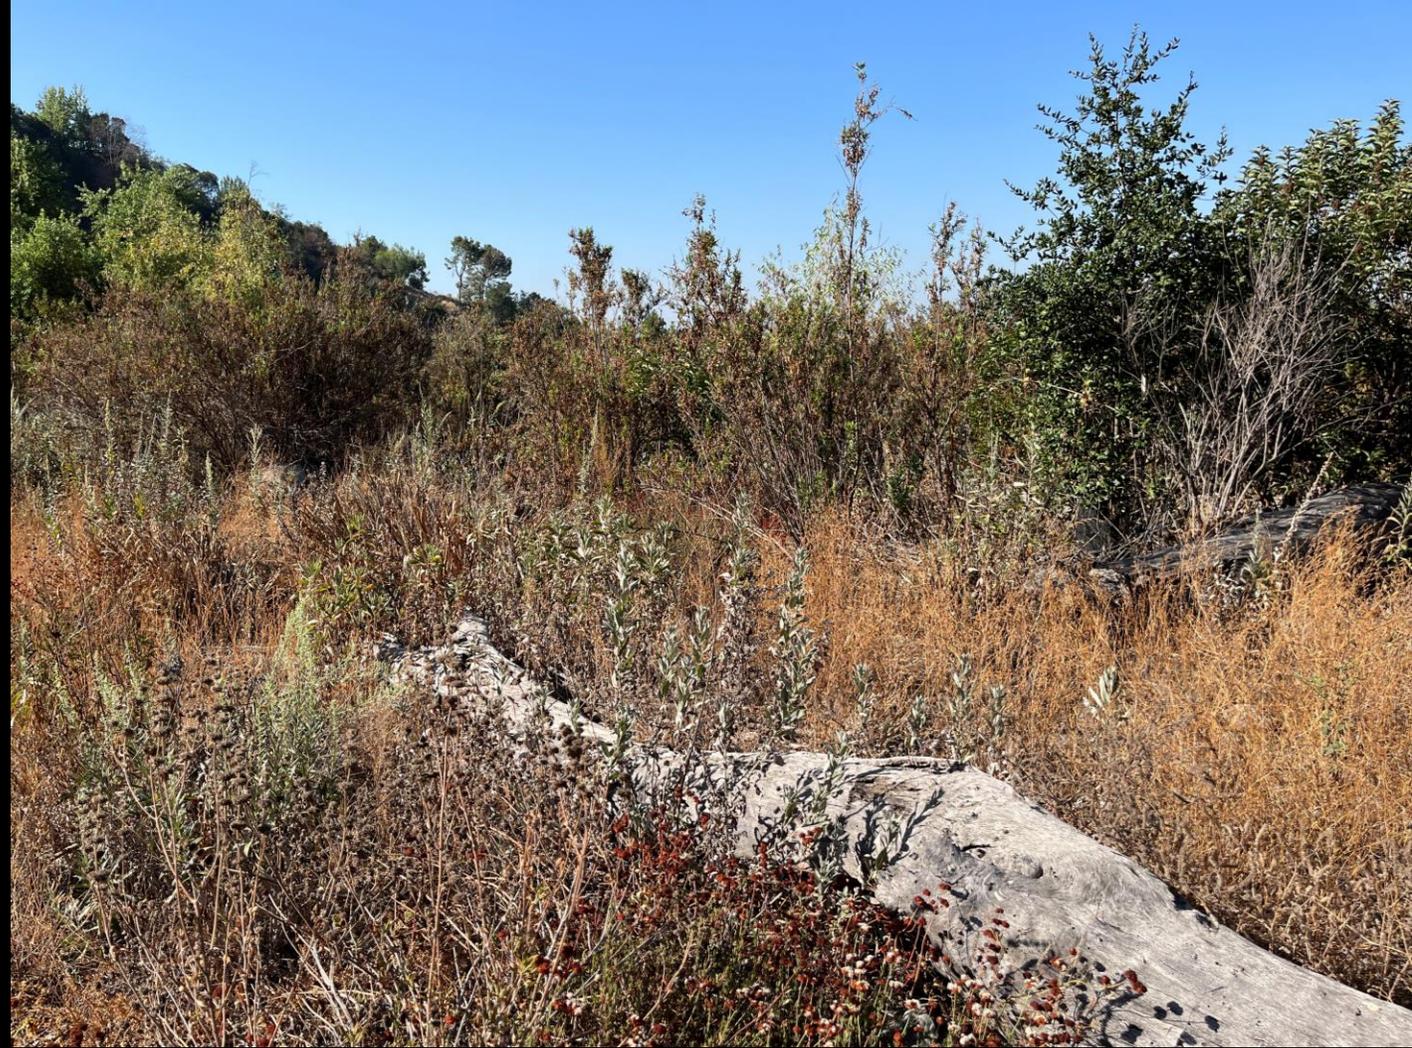
The oaks are resilient despite ongoing drought. The oak habitat has not been irrigated since 2018, and the CSS areas not since 2015. We only received 3/4 of average rainfall in the prior year, and 1/3 of average in the year before that—really some acute drought.

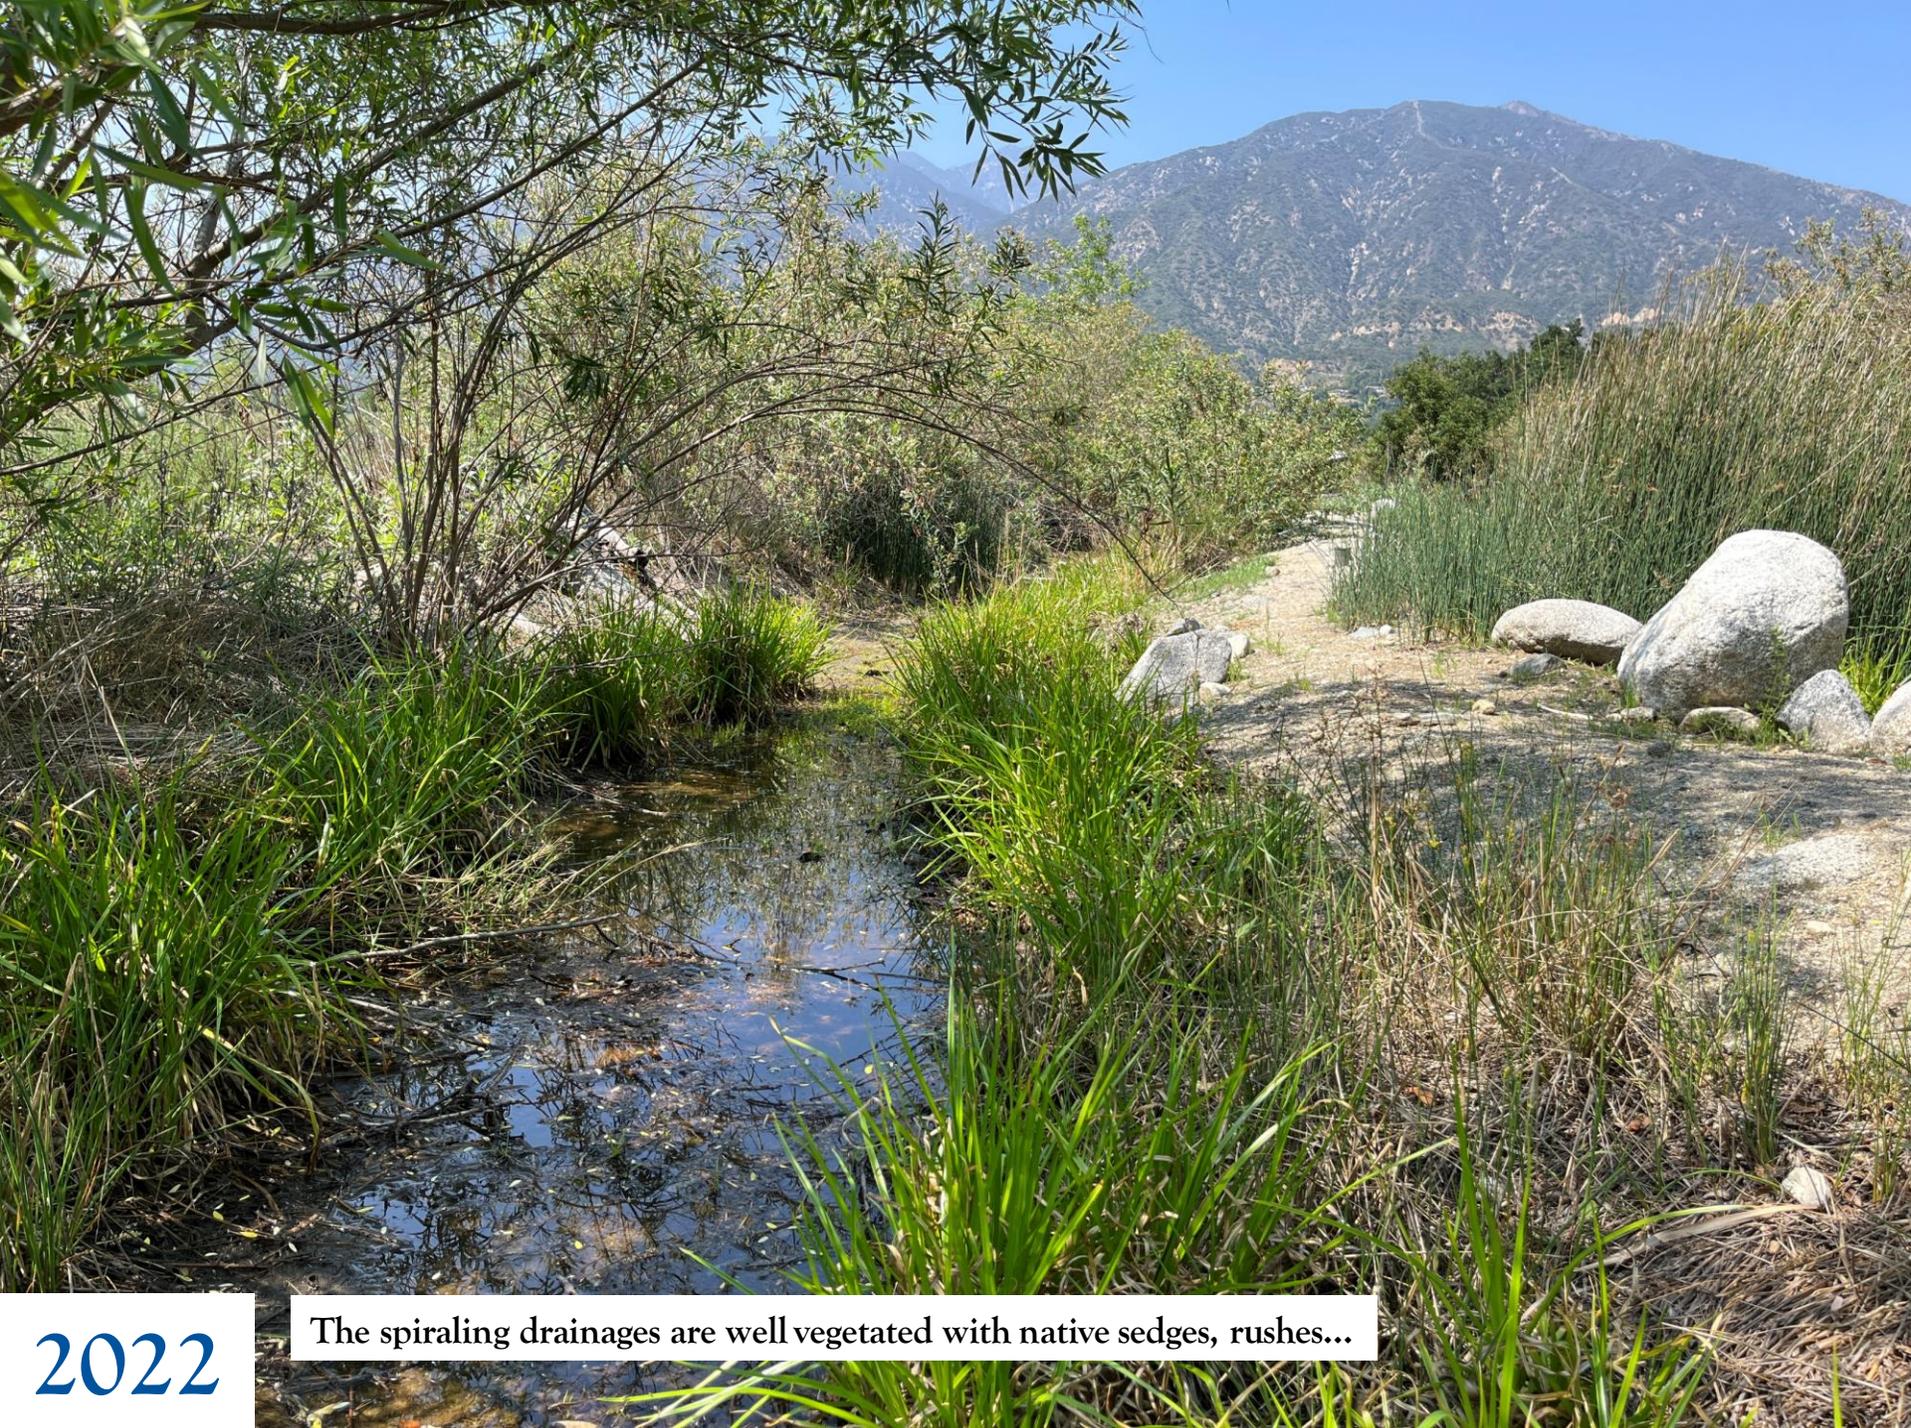
The spiraling drainages are well vegetated with native sedges, rushes...

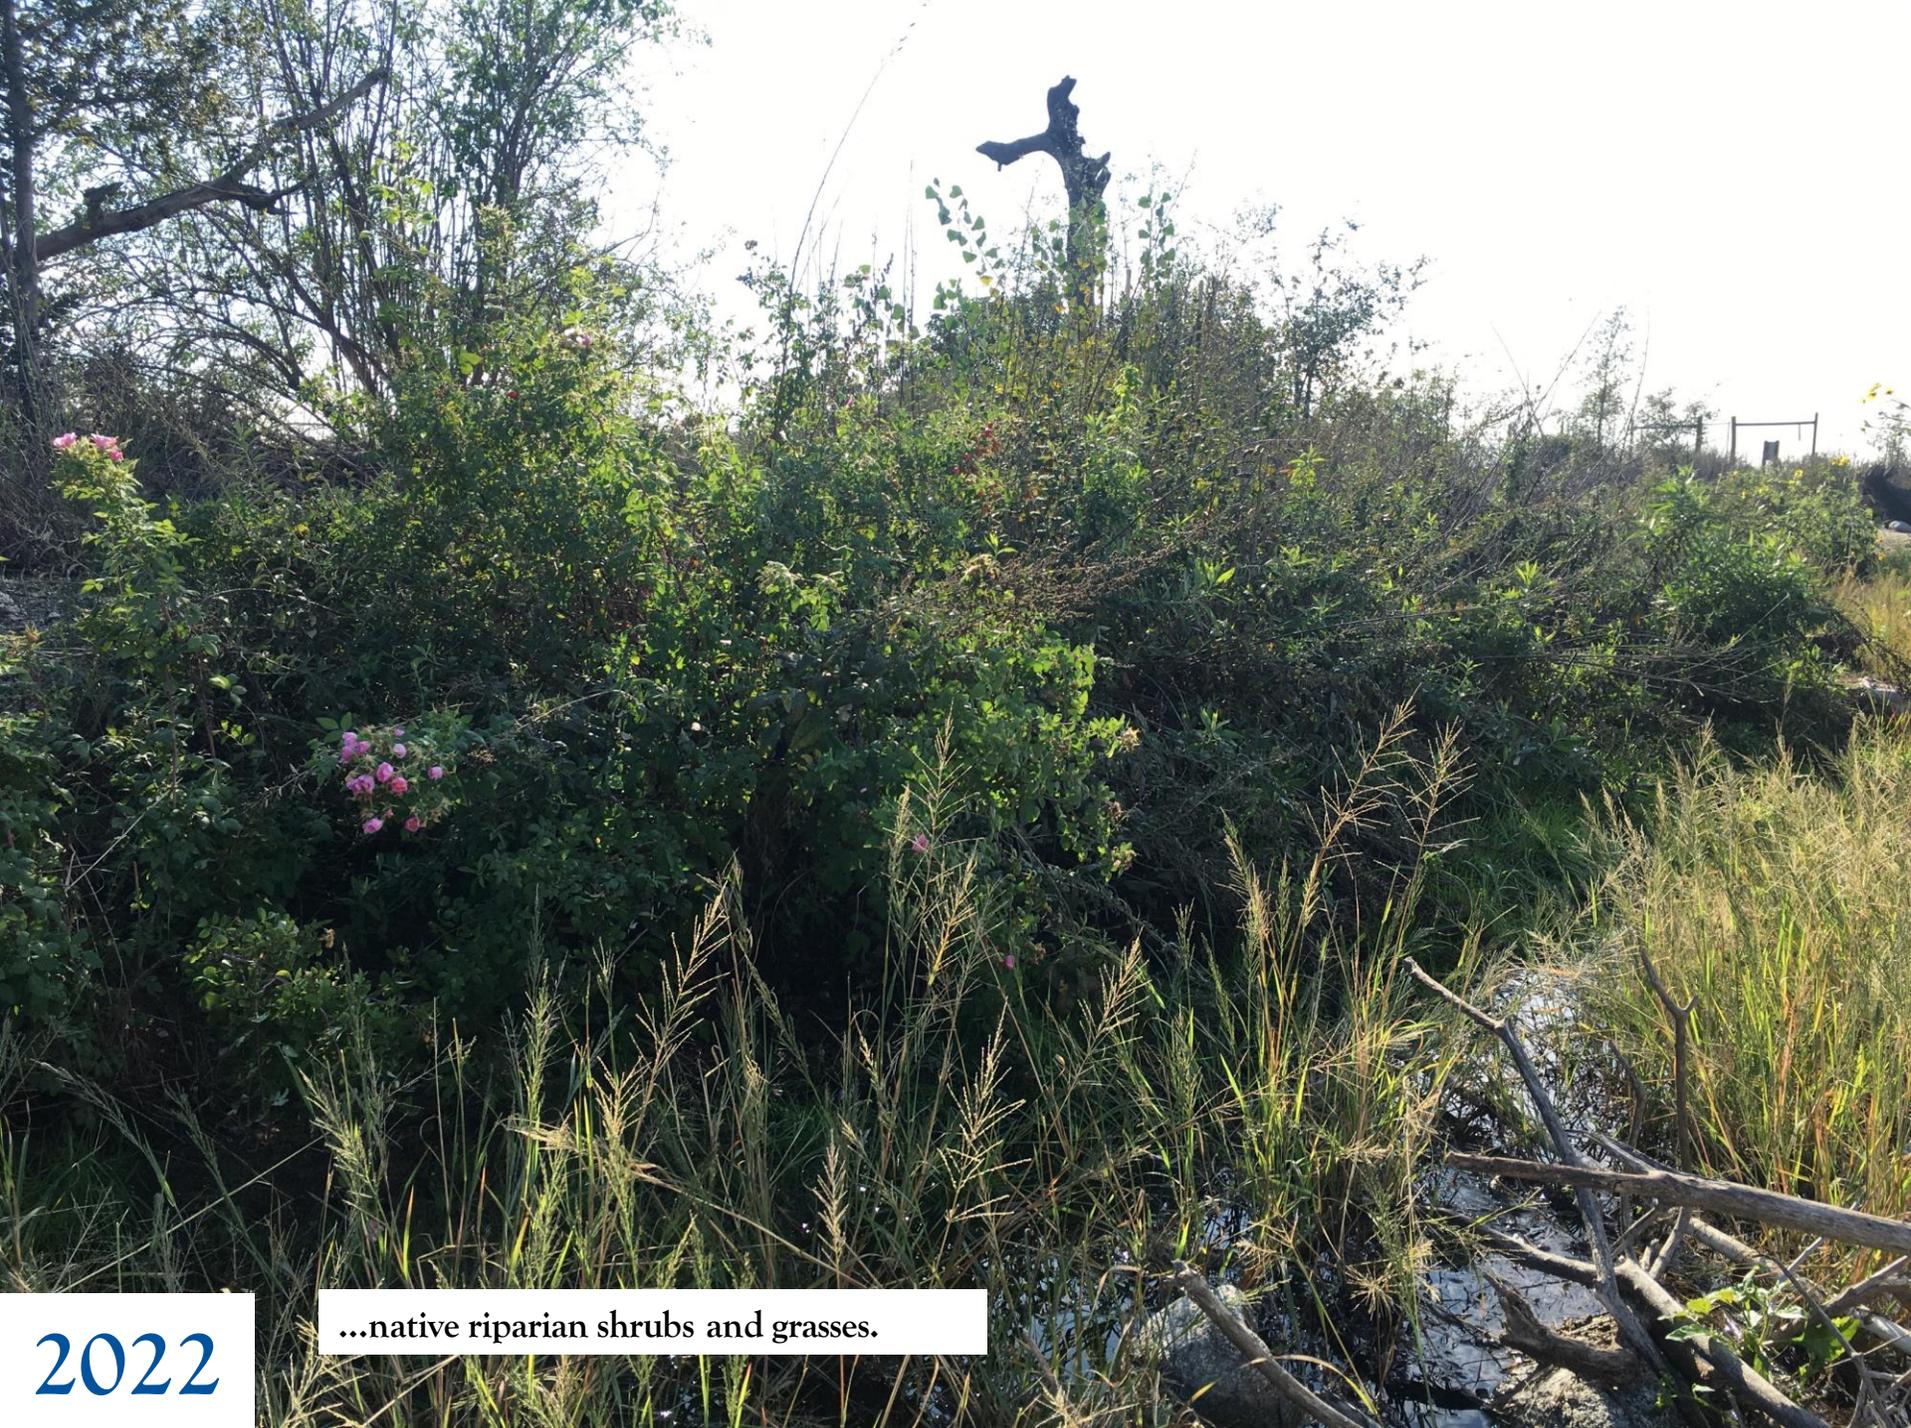
...native riparian shrubs and grasses.

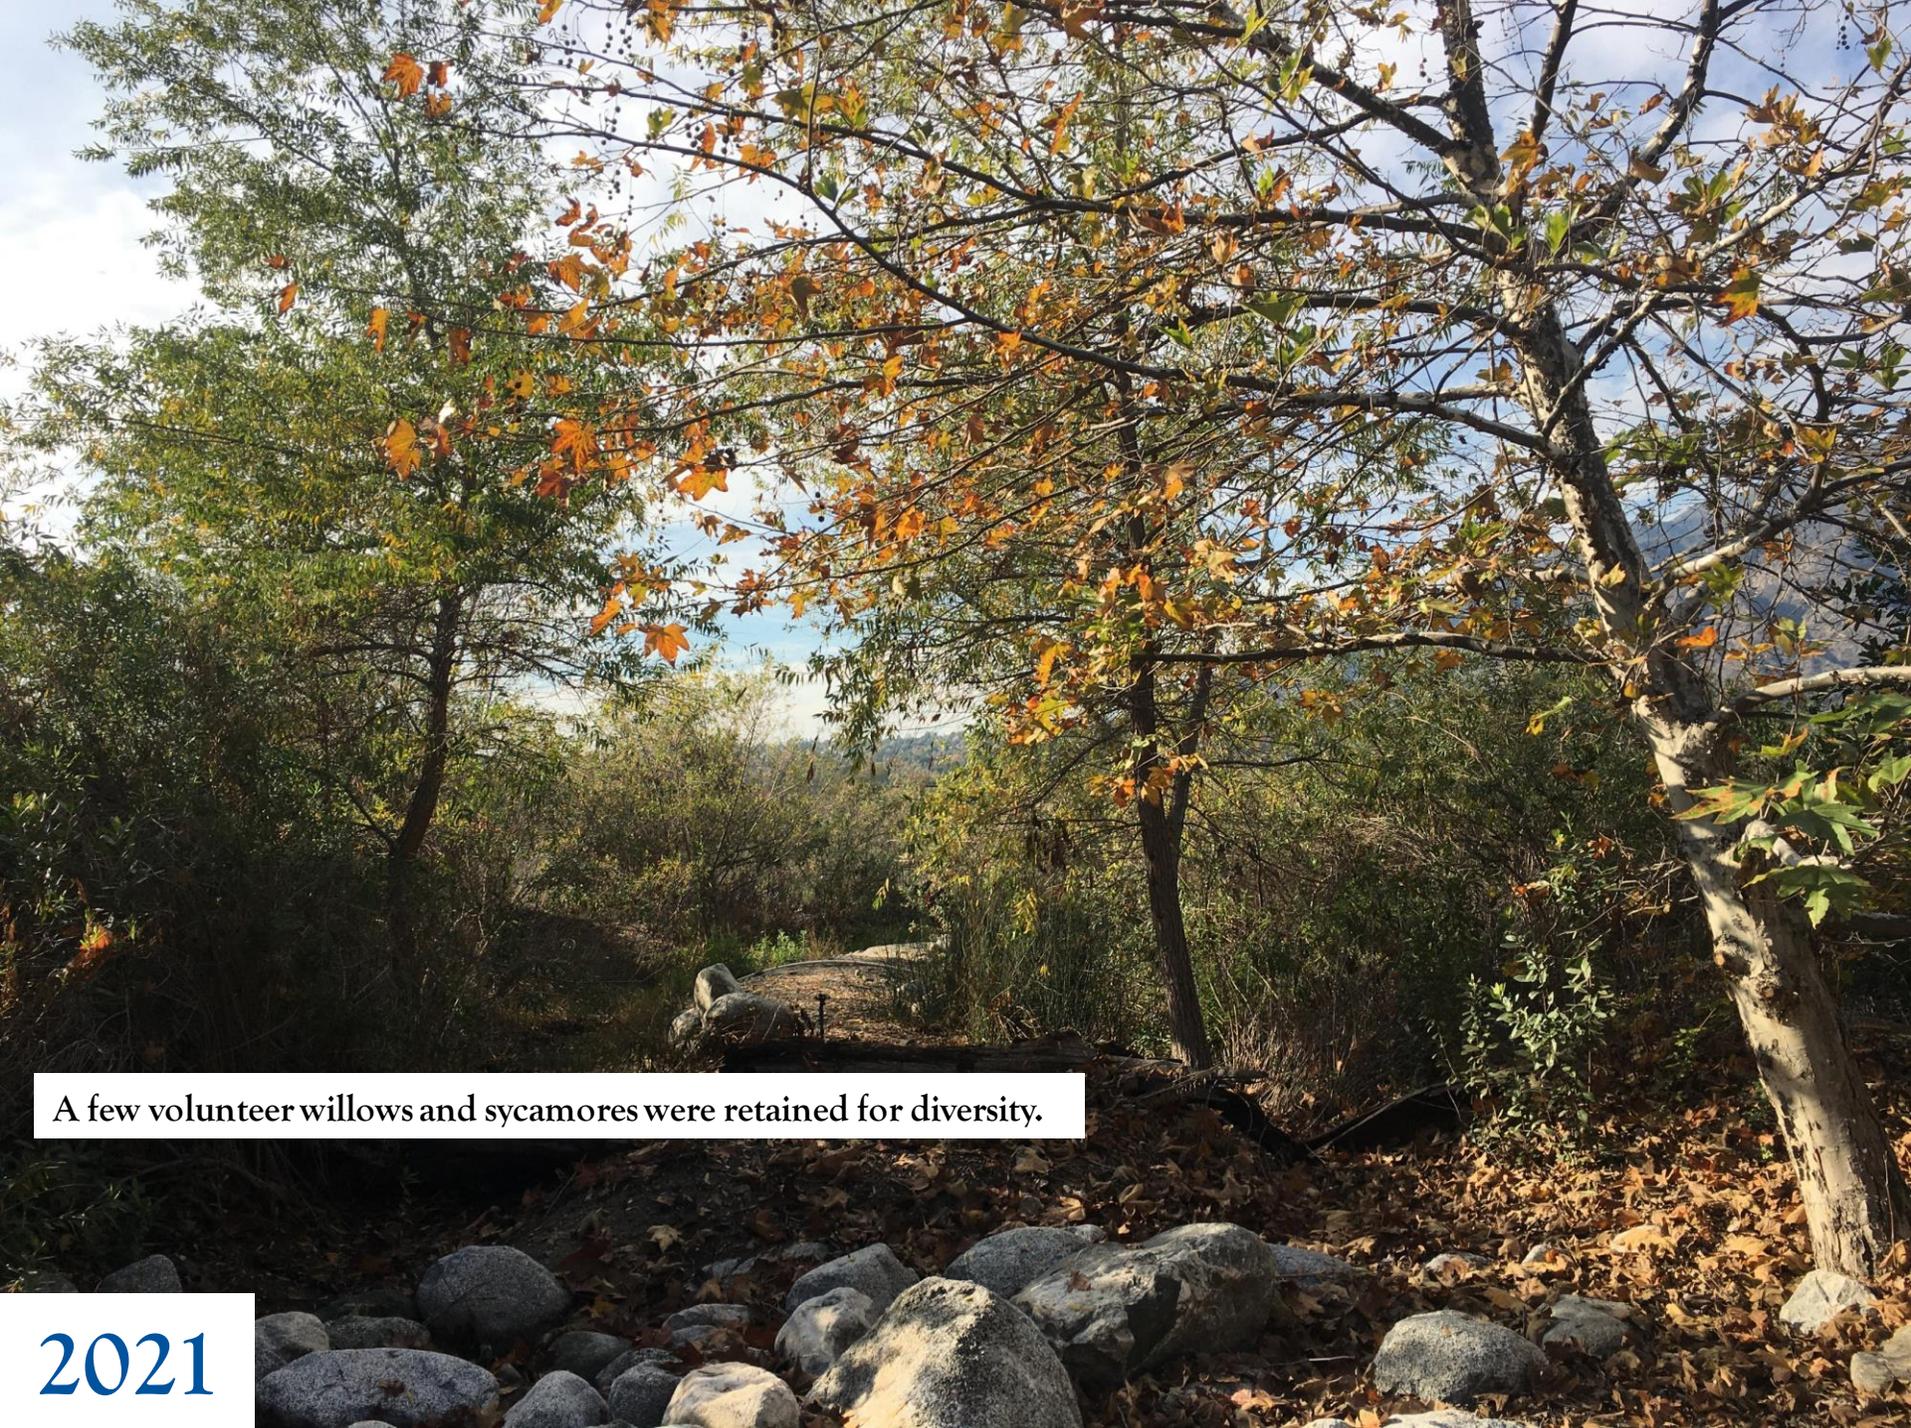
A few volunteer willows and sycamores were retained for diversity.

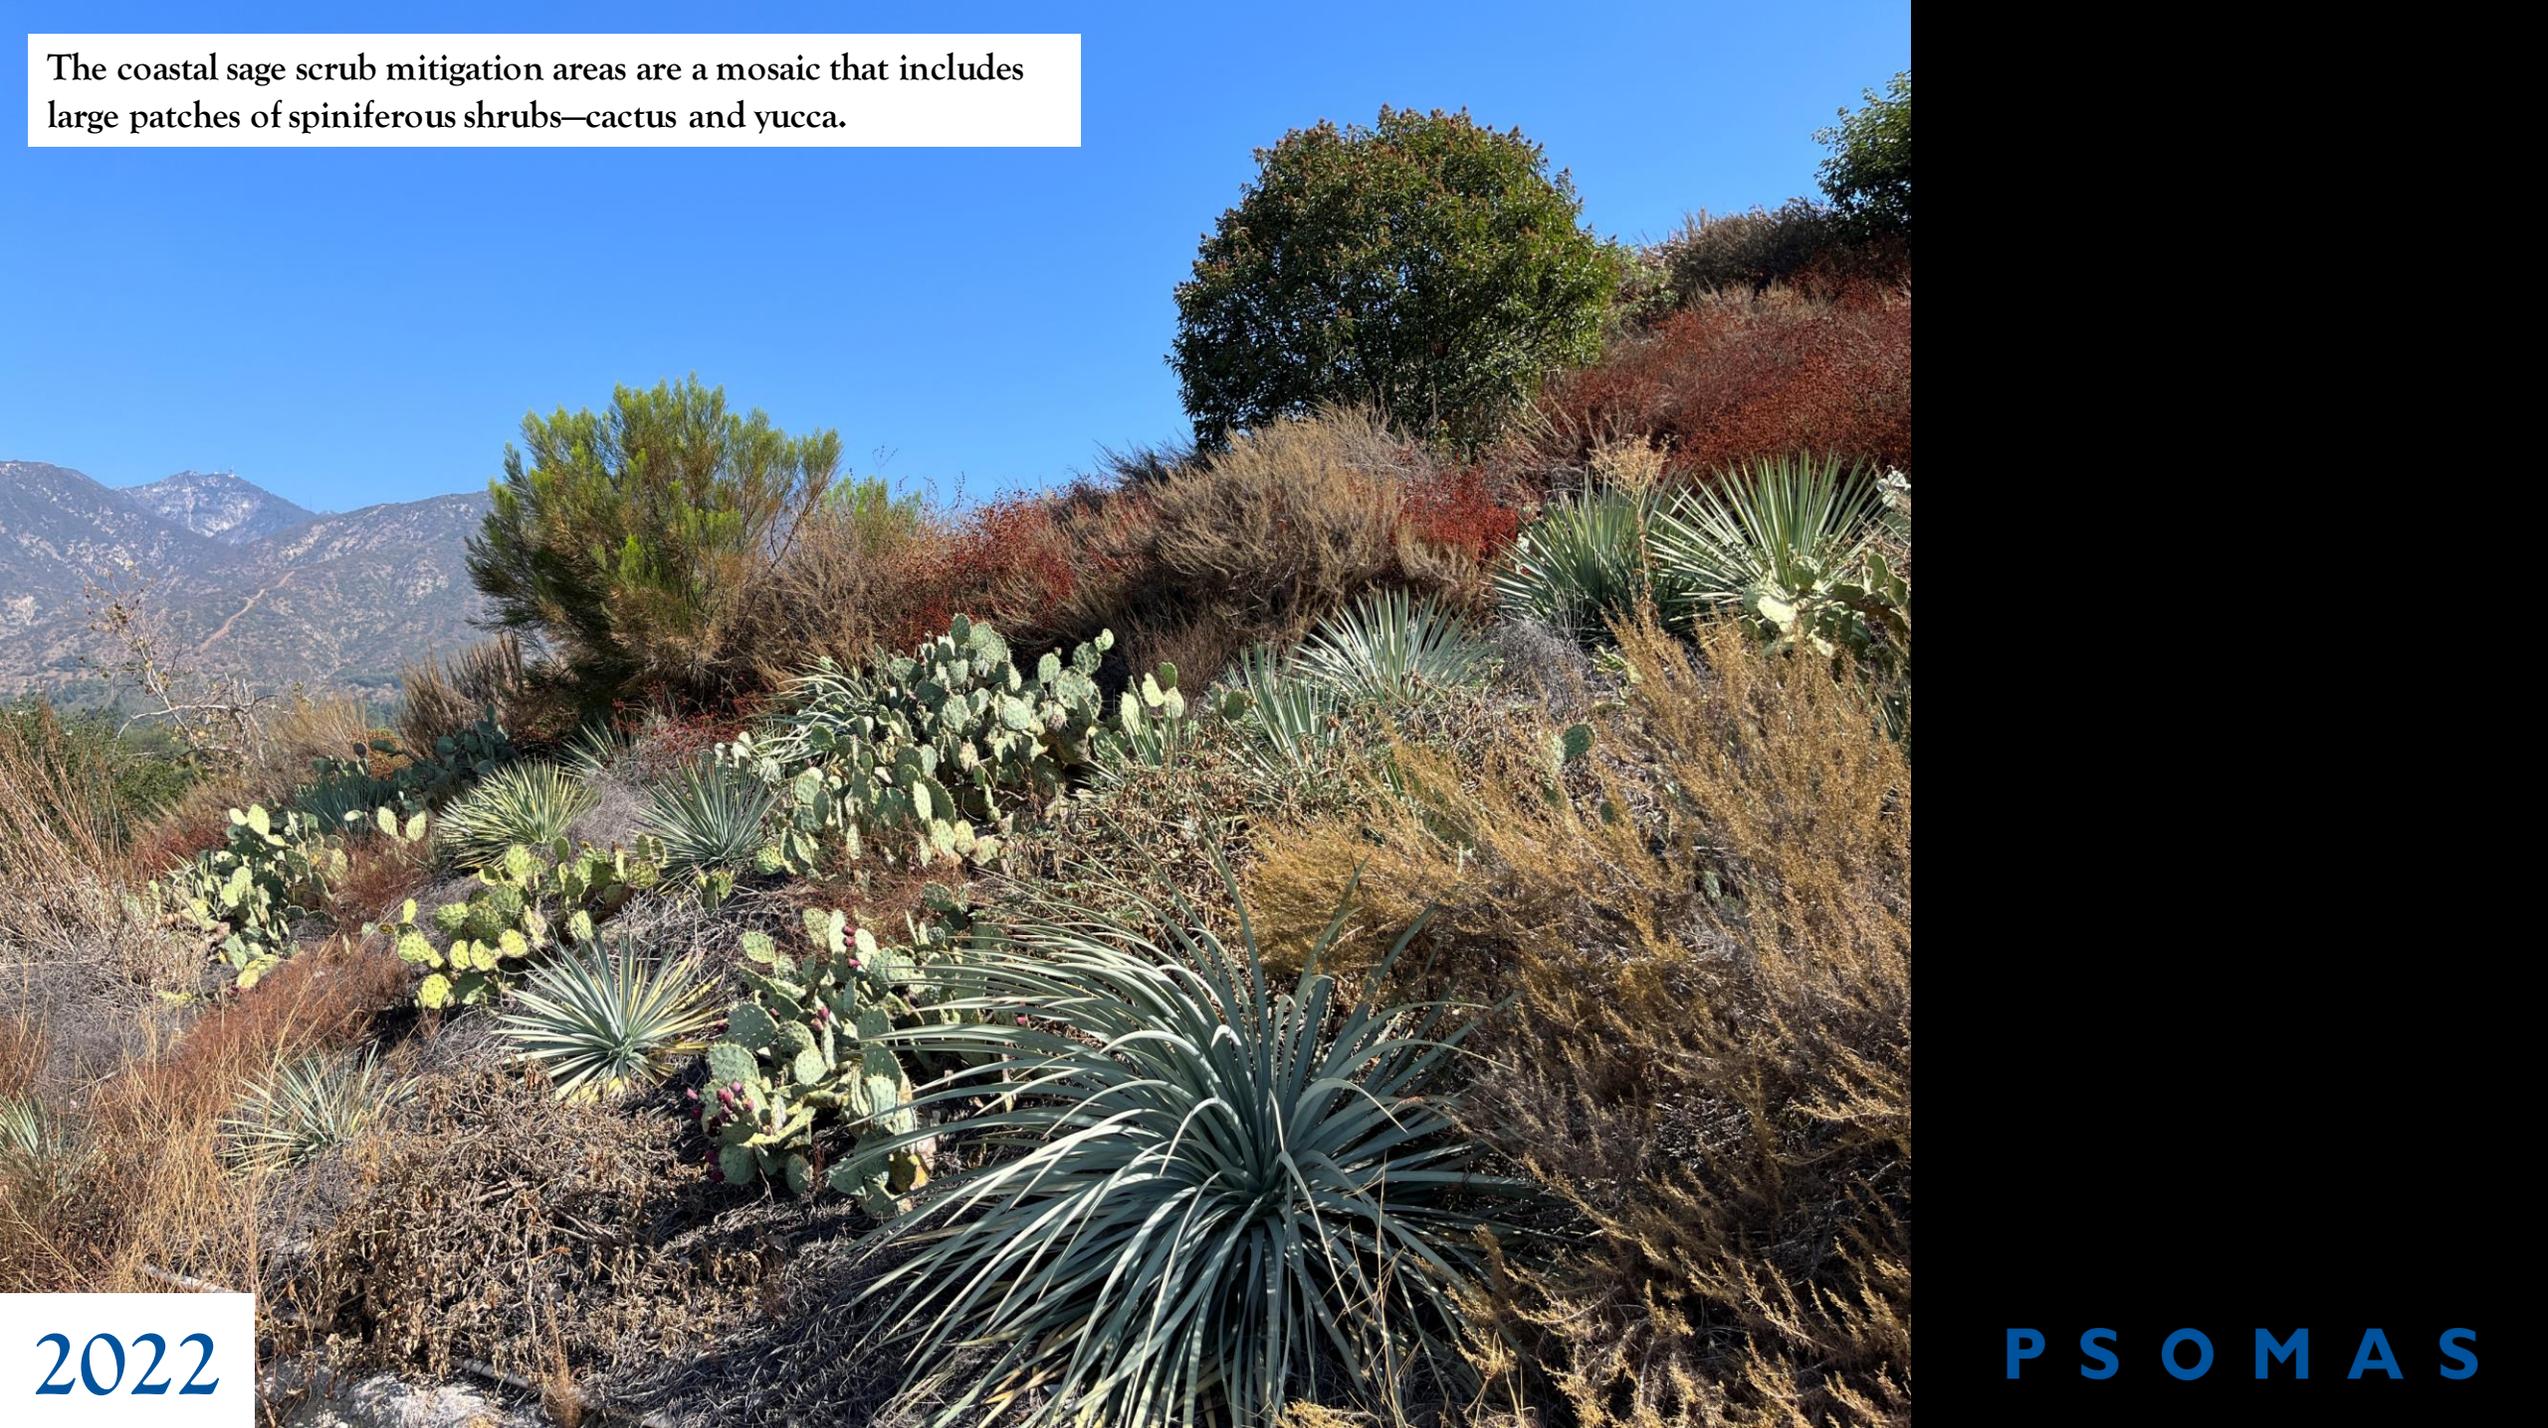
The coastal sage scrub mitigation areas are a mosaic that includes large patches of spiniferous shrubs—cactus and yucca.

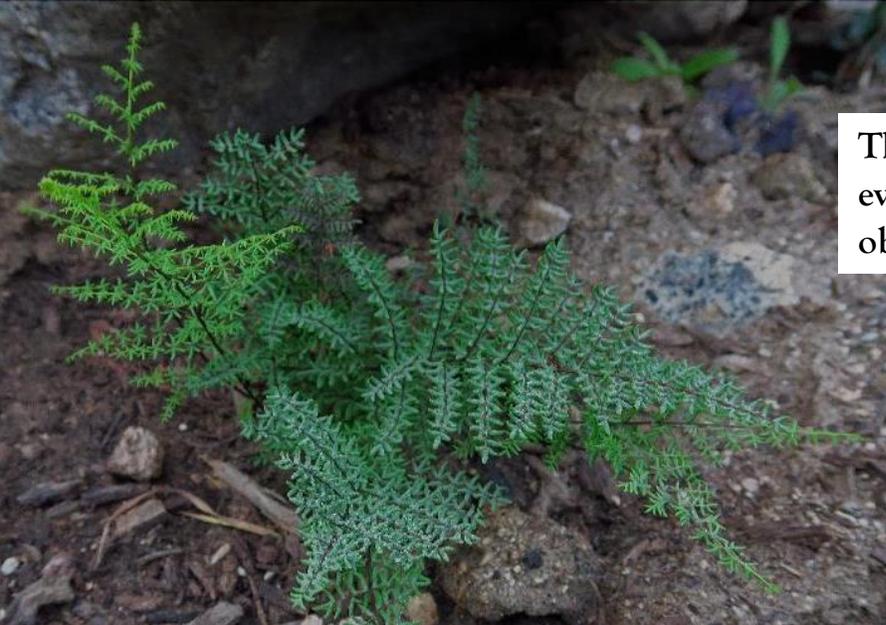
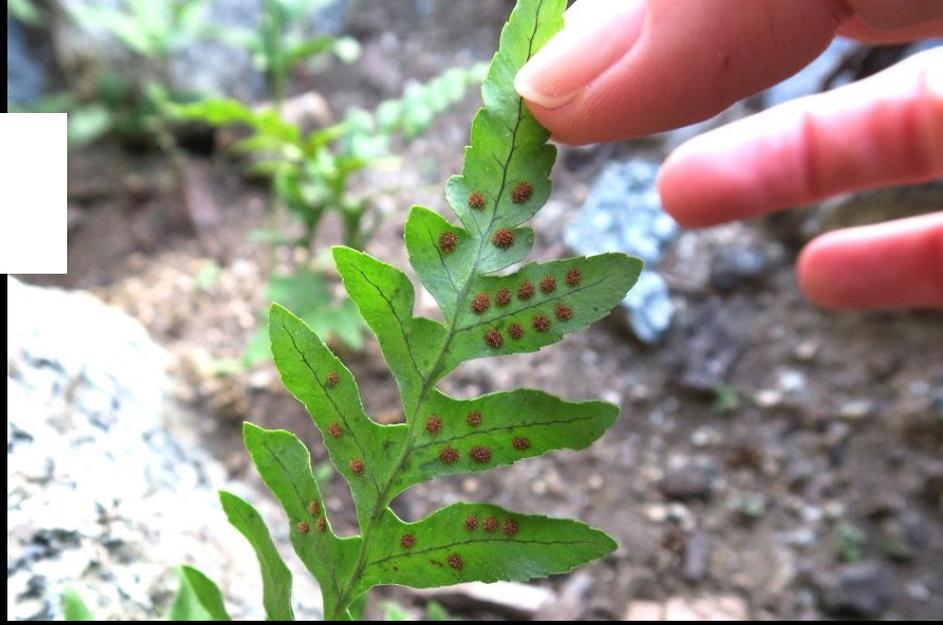
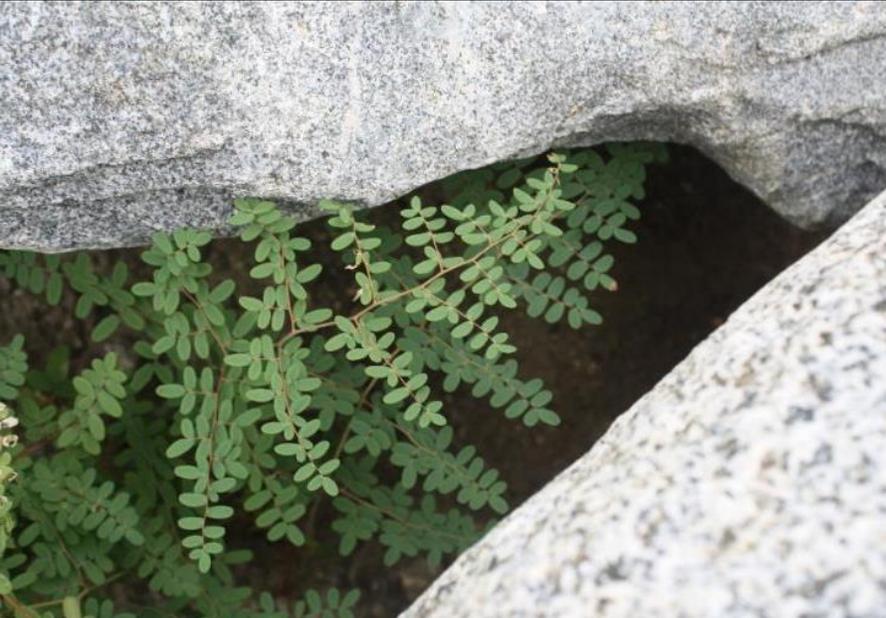
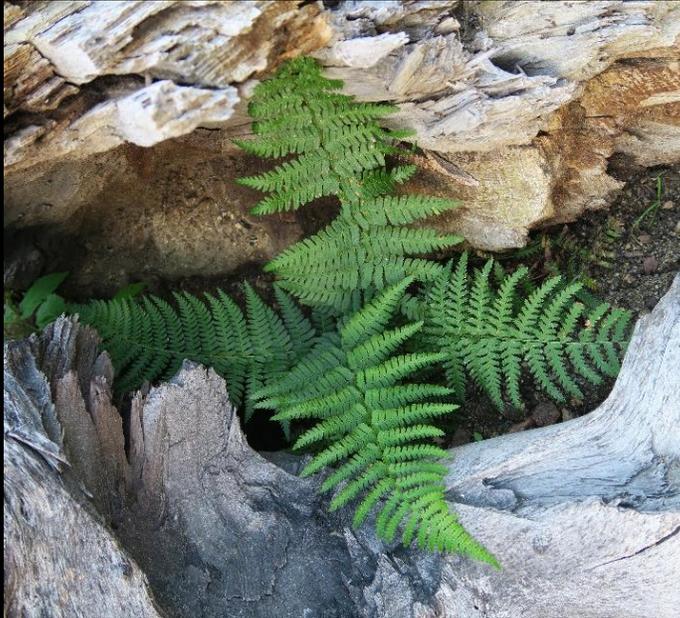
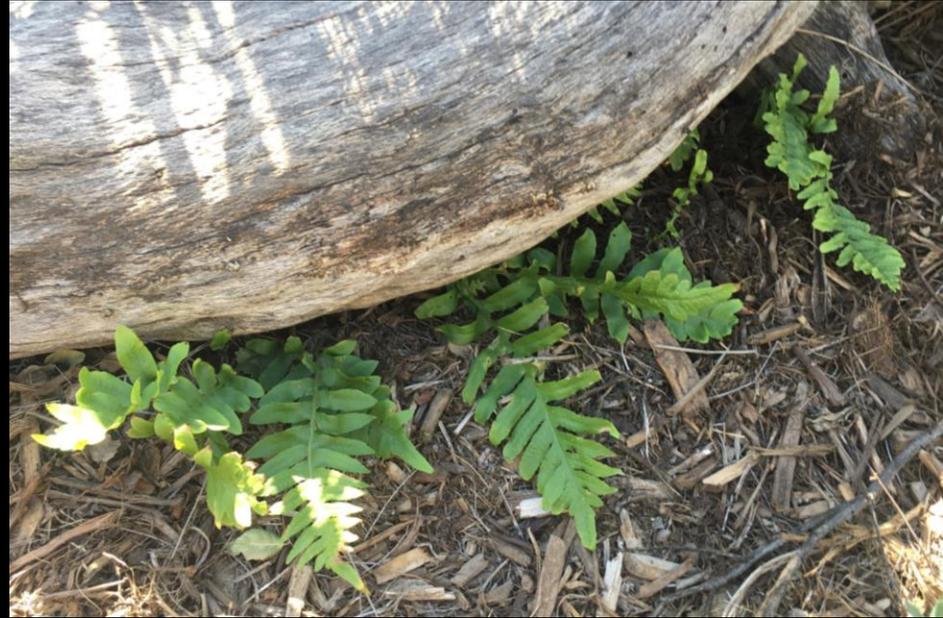
Fern growth and *regeneration*

There are planted ferns hiding under just about every assemblage, and they are regenerating with observed sporangia and clonal growth.

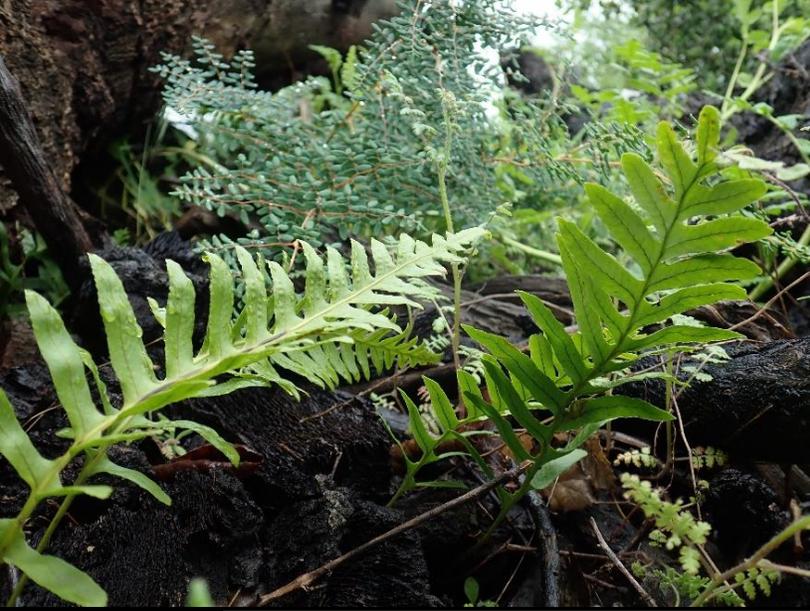
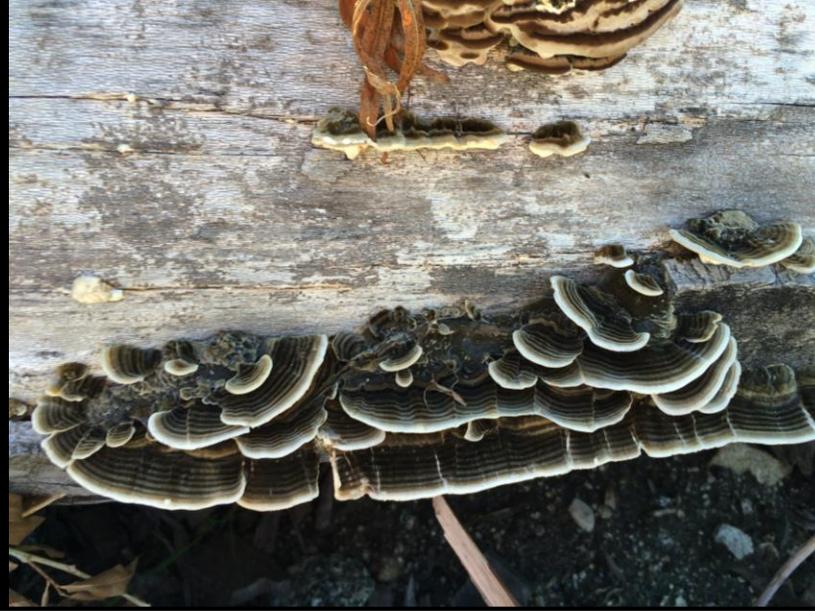
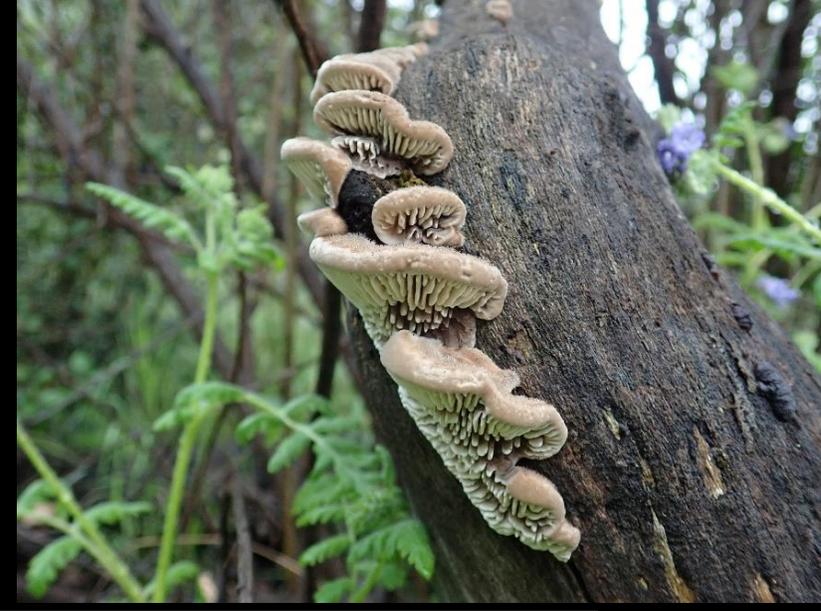
Beneficial decay processes

The placed CWD enables a beneficial decomposition food web that would have otherwise taken many years to establish.

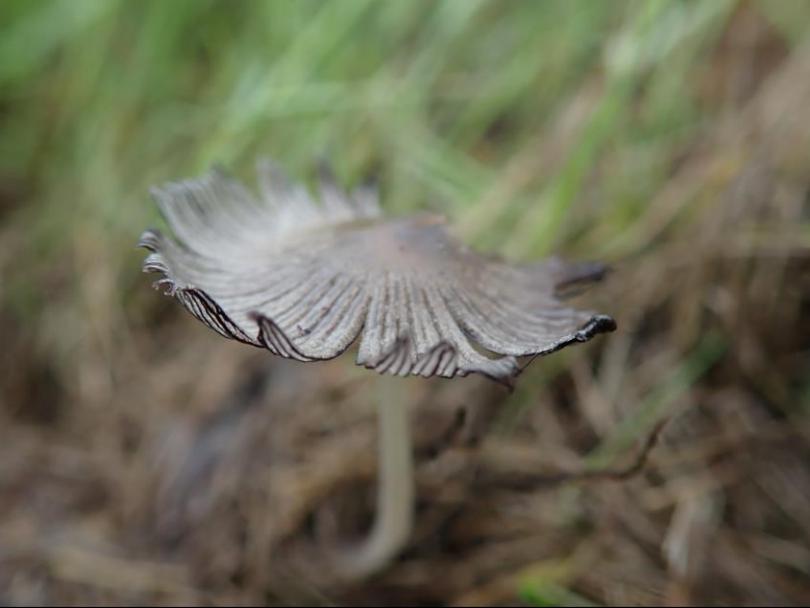
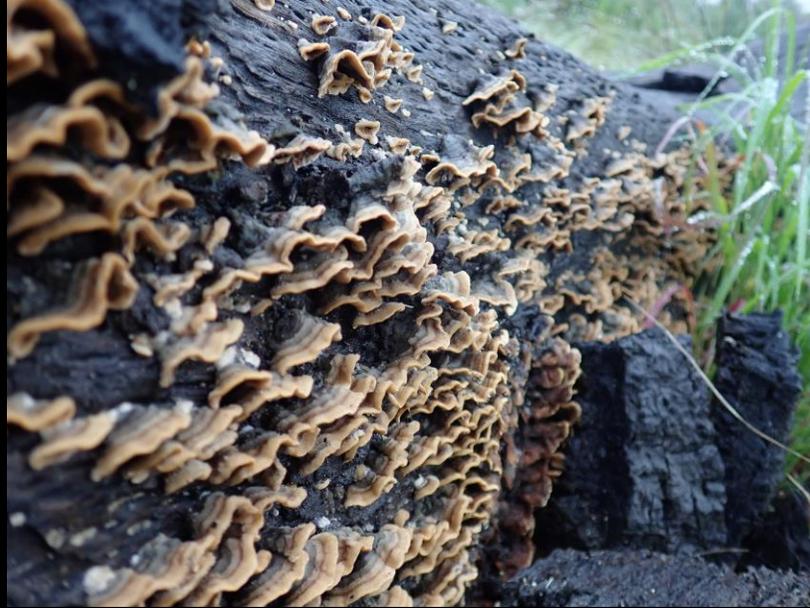
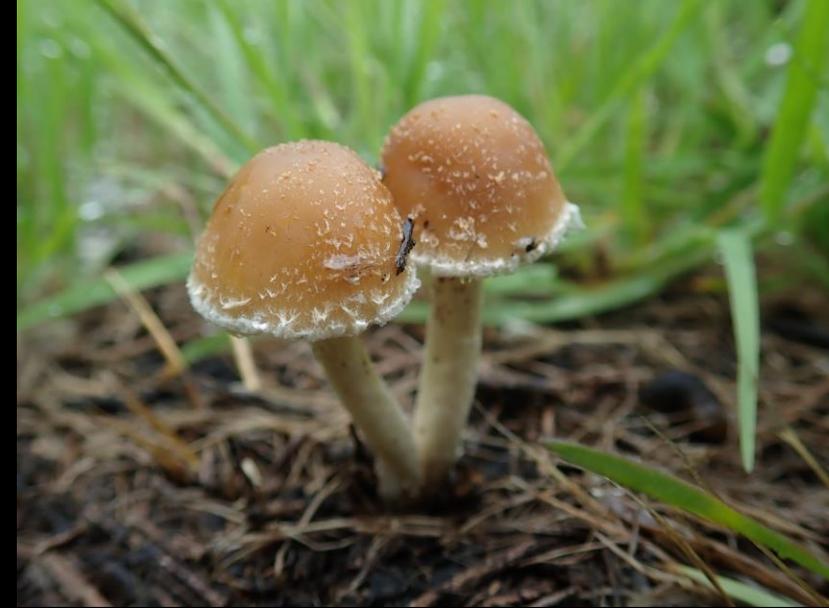
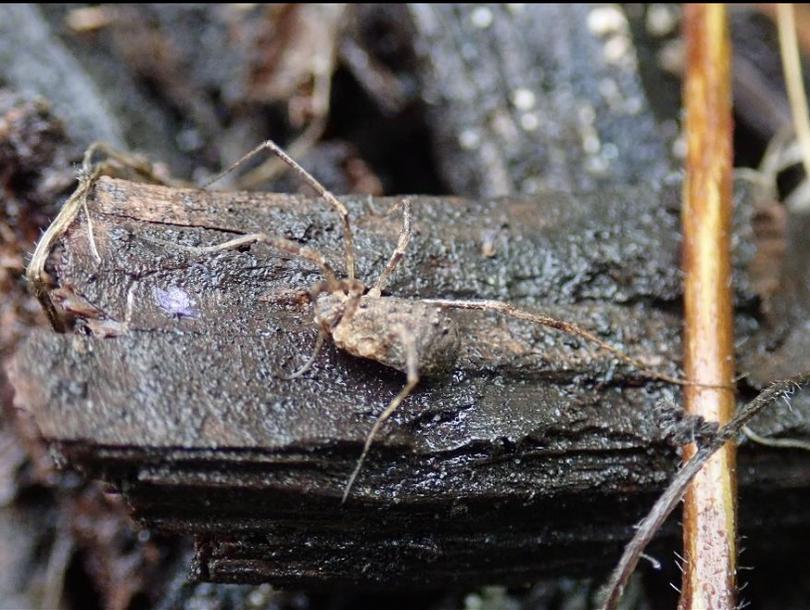
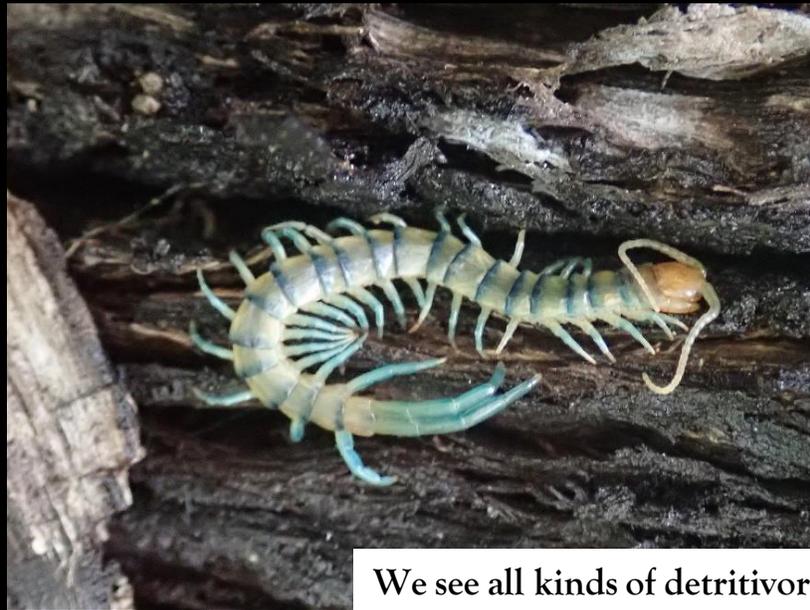
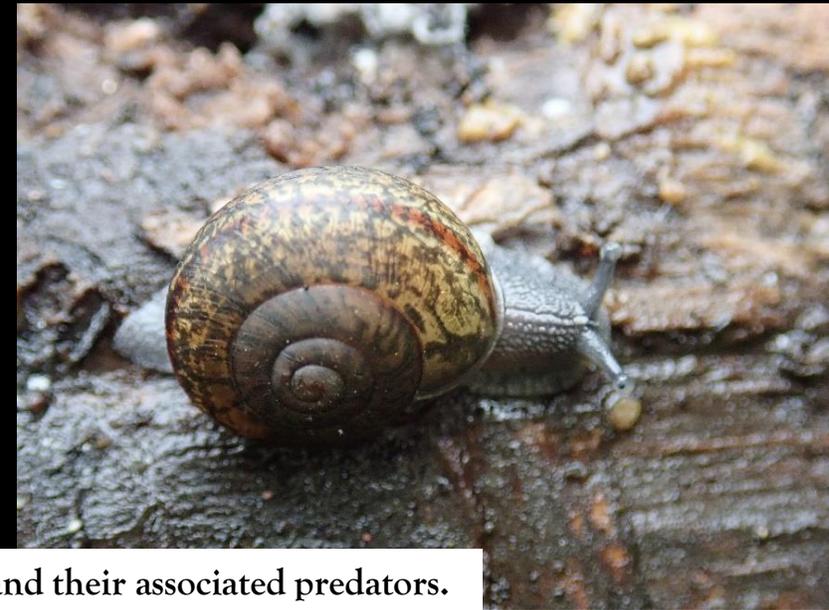
# Decomposition food web

We see all kinds of detritivores and their associated predators.
