# Substrate Enhancements and Botanical Diversity for Successful Oak Habitat Creation

Richard B. Lewis III, ENV SP  
Senior Restoration Ecologist, Psomas

This is a PDF-version of the slide show that accompanied Psomas' oral presentation at the University of California Agriculture & Natural Resources' 8<sup>th</sup> California Oak Symposium in San Luis Obispo, California, on November 1, 2022. The narration from that presentation has been added via text boxes to this PDF version.

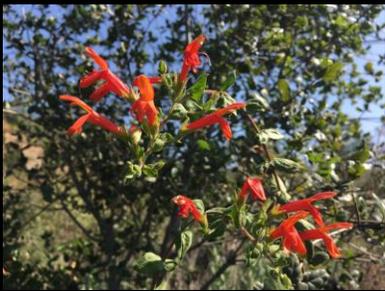
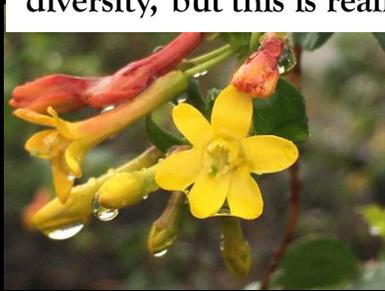
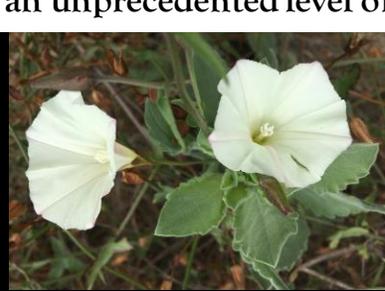
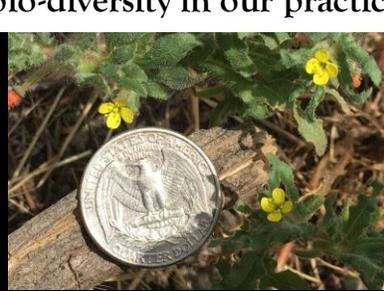
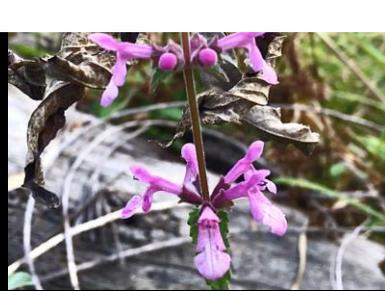
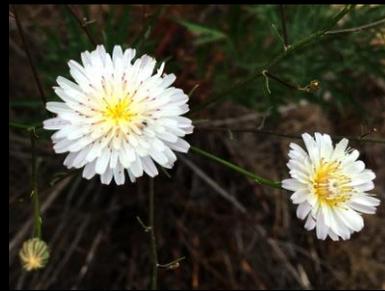
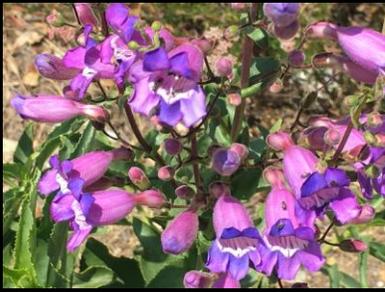
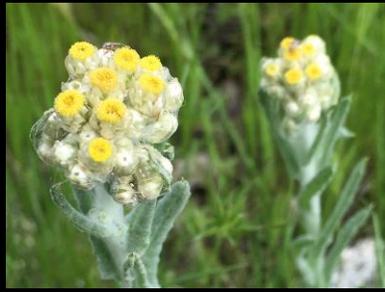
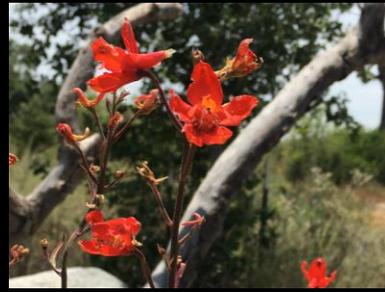
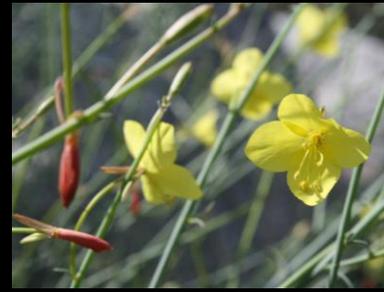
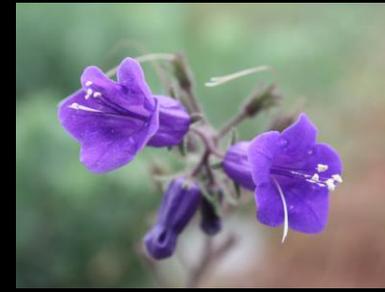
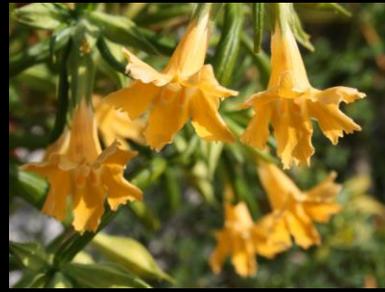
151 native vascular plant taxa

The botanical diversity is very high, with over 150 native vascular plant species. Our work emphasizes bio-diversity, but this is really an unprecedented level of bio-diversity in our practice.

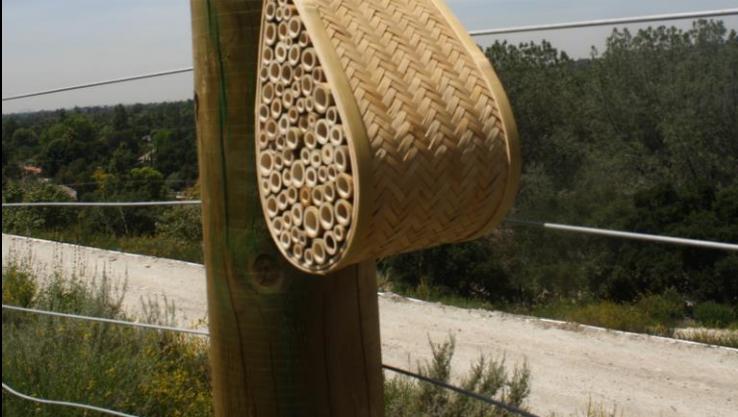
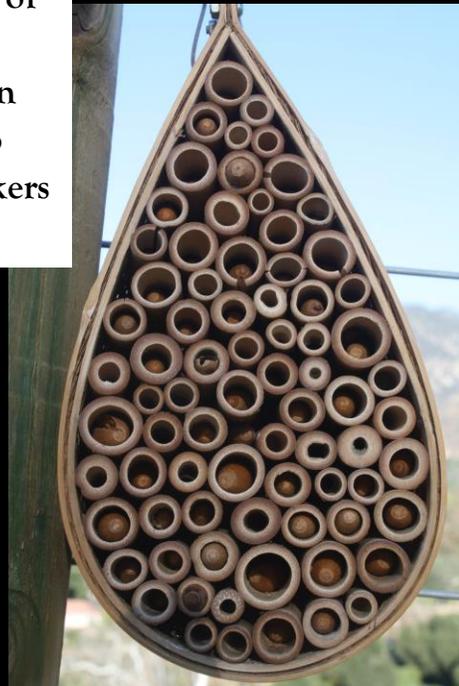
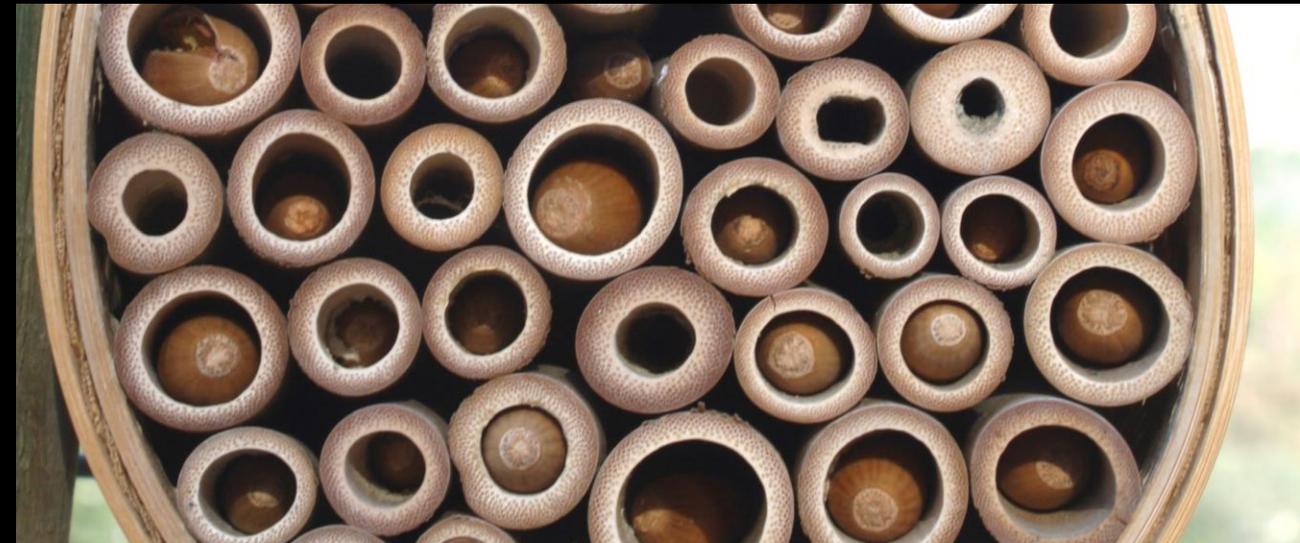
We observed an abundance of volunteer, short-fruited willowherb (*Epilobium brachycarpum*) on the site and protected it. Later, we saw hundreds of sphinx moth (*Hyles lineata*) larvae using this as their host plant, and later the adults nectaring on the site. We placed some carpenter bee houses to see what would happen, but the acorn woodpeckers (*Melanerpes formicivorus*) had other plans...

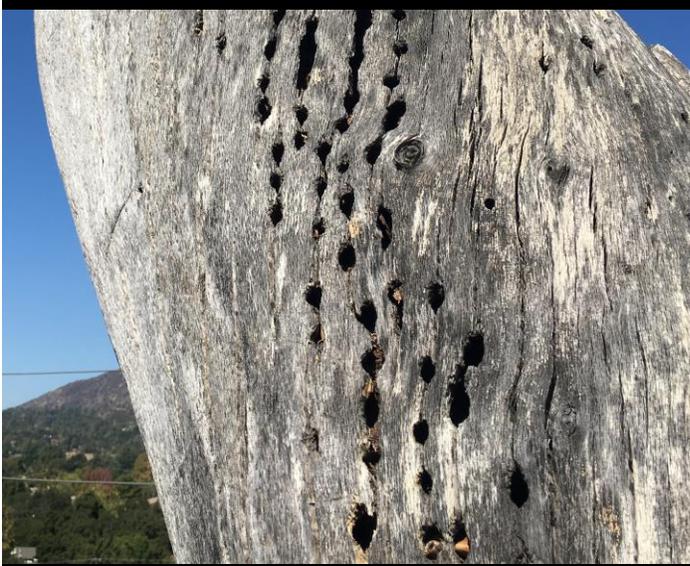
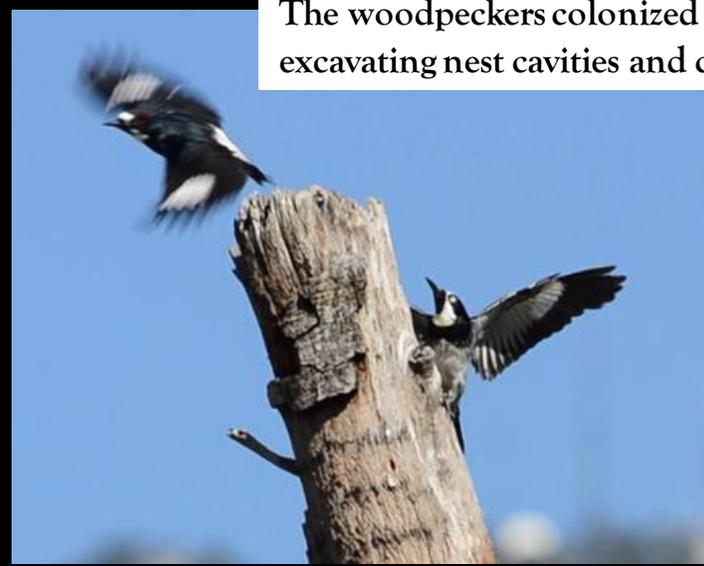
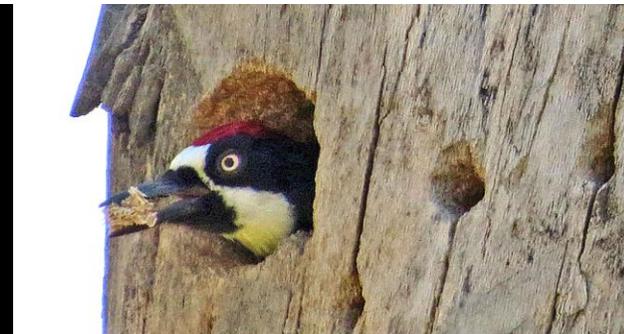
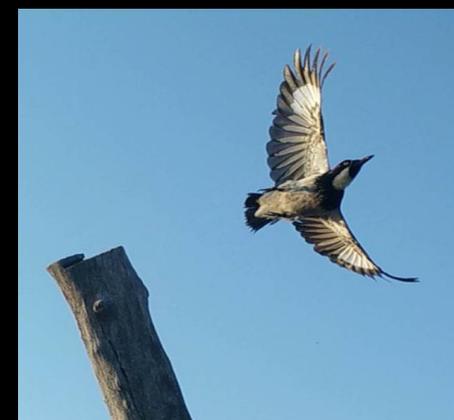
The woodpeckers colonized our snags pretty much overnight, excavating nest cavities and caching acorns to create valuable granaries.

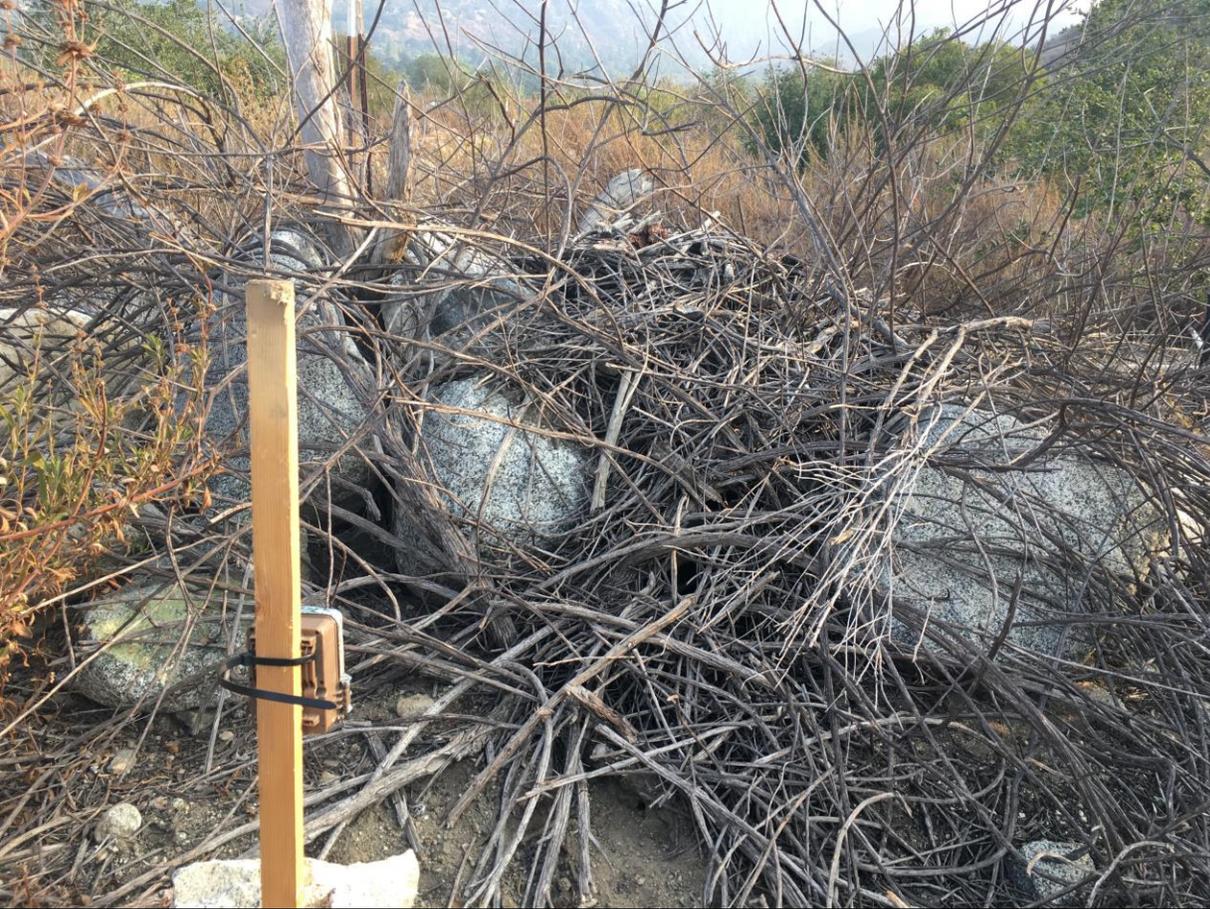
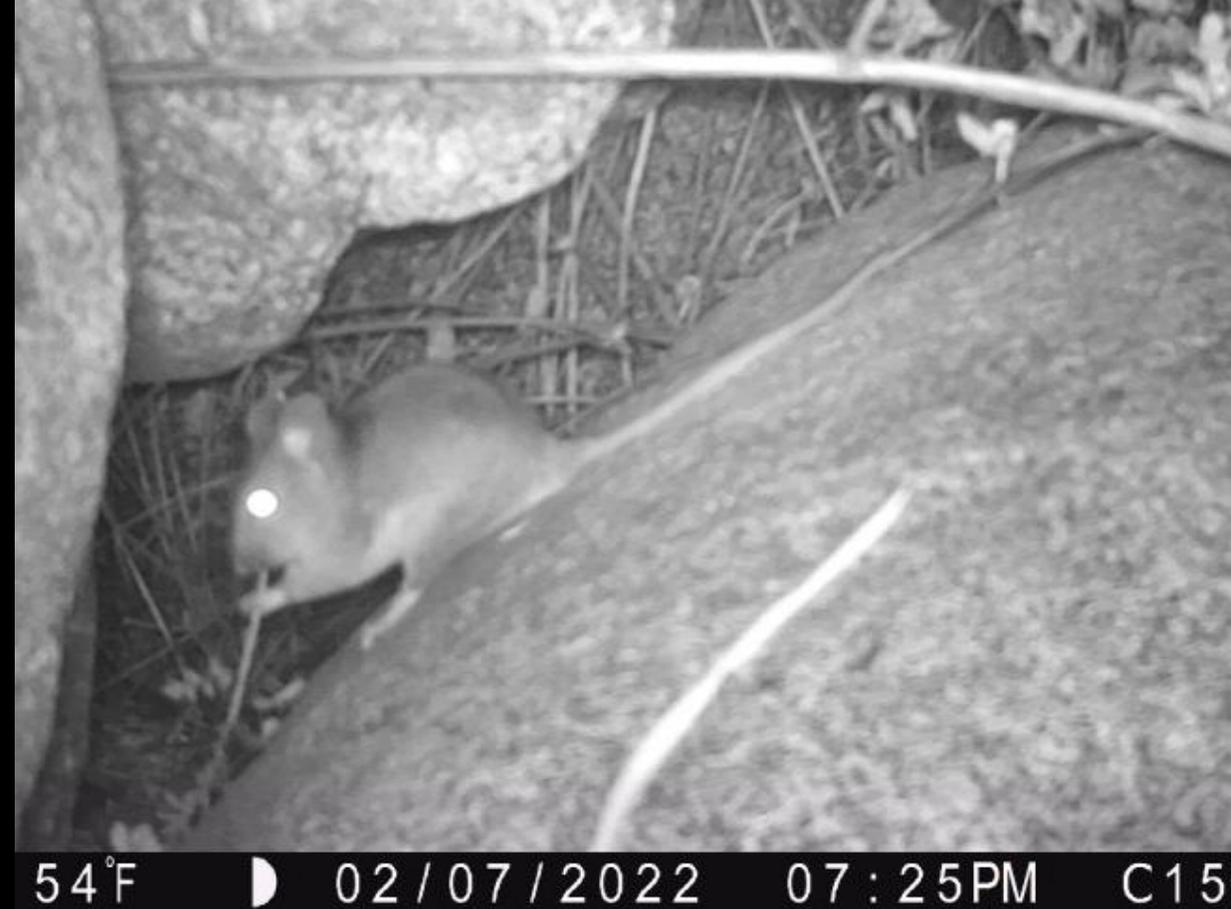
**Bryant's woodrat: California Species of Special Concern**

Wildlife camera placed at suspected woodrat nest

I saw some telltale signs of woodrats, so we placed wildlife cameras at several assemblages and confirmed Bryant's woodrat (*Neotoma bryanti intermedia*), a California Species of Special Concern.

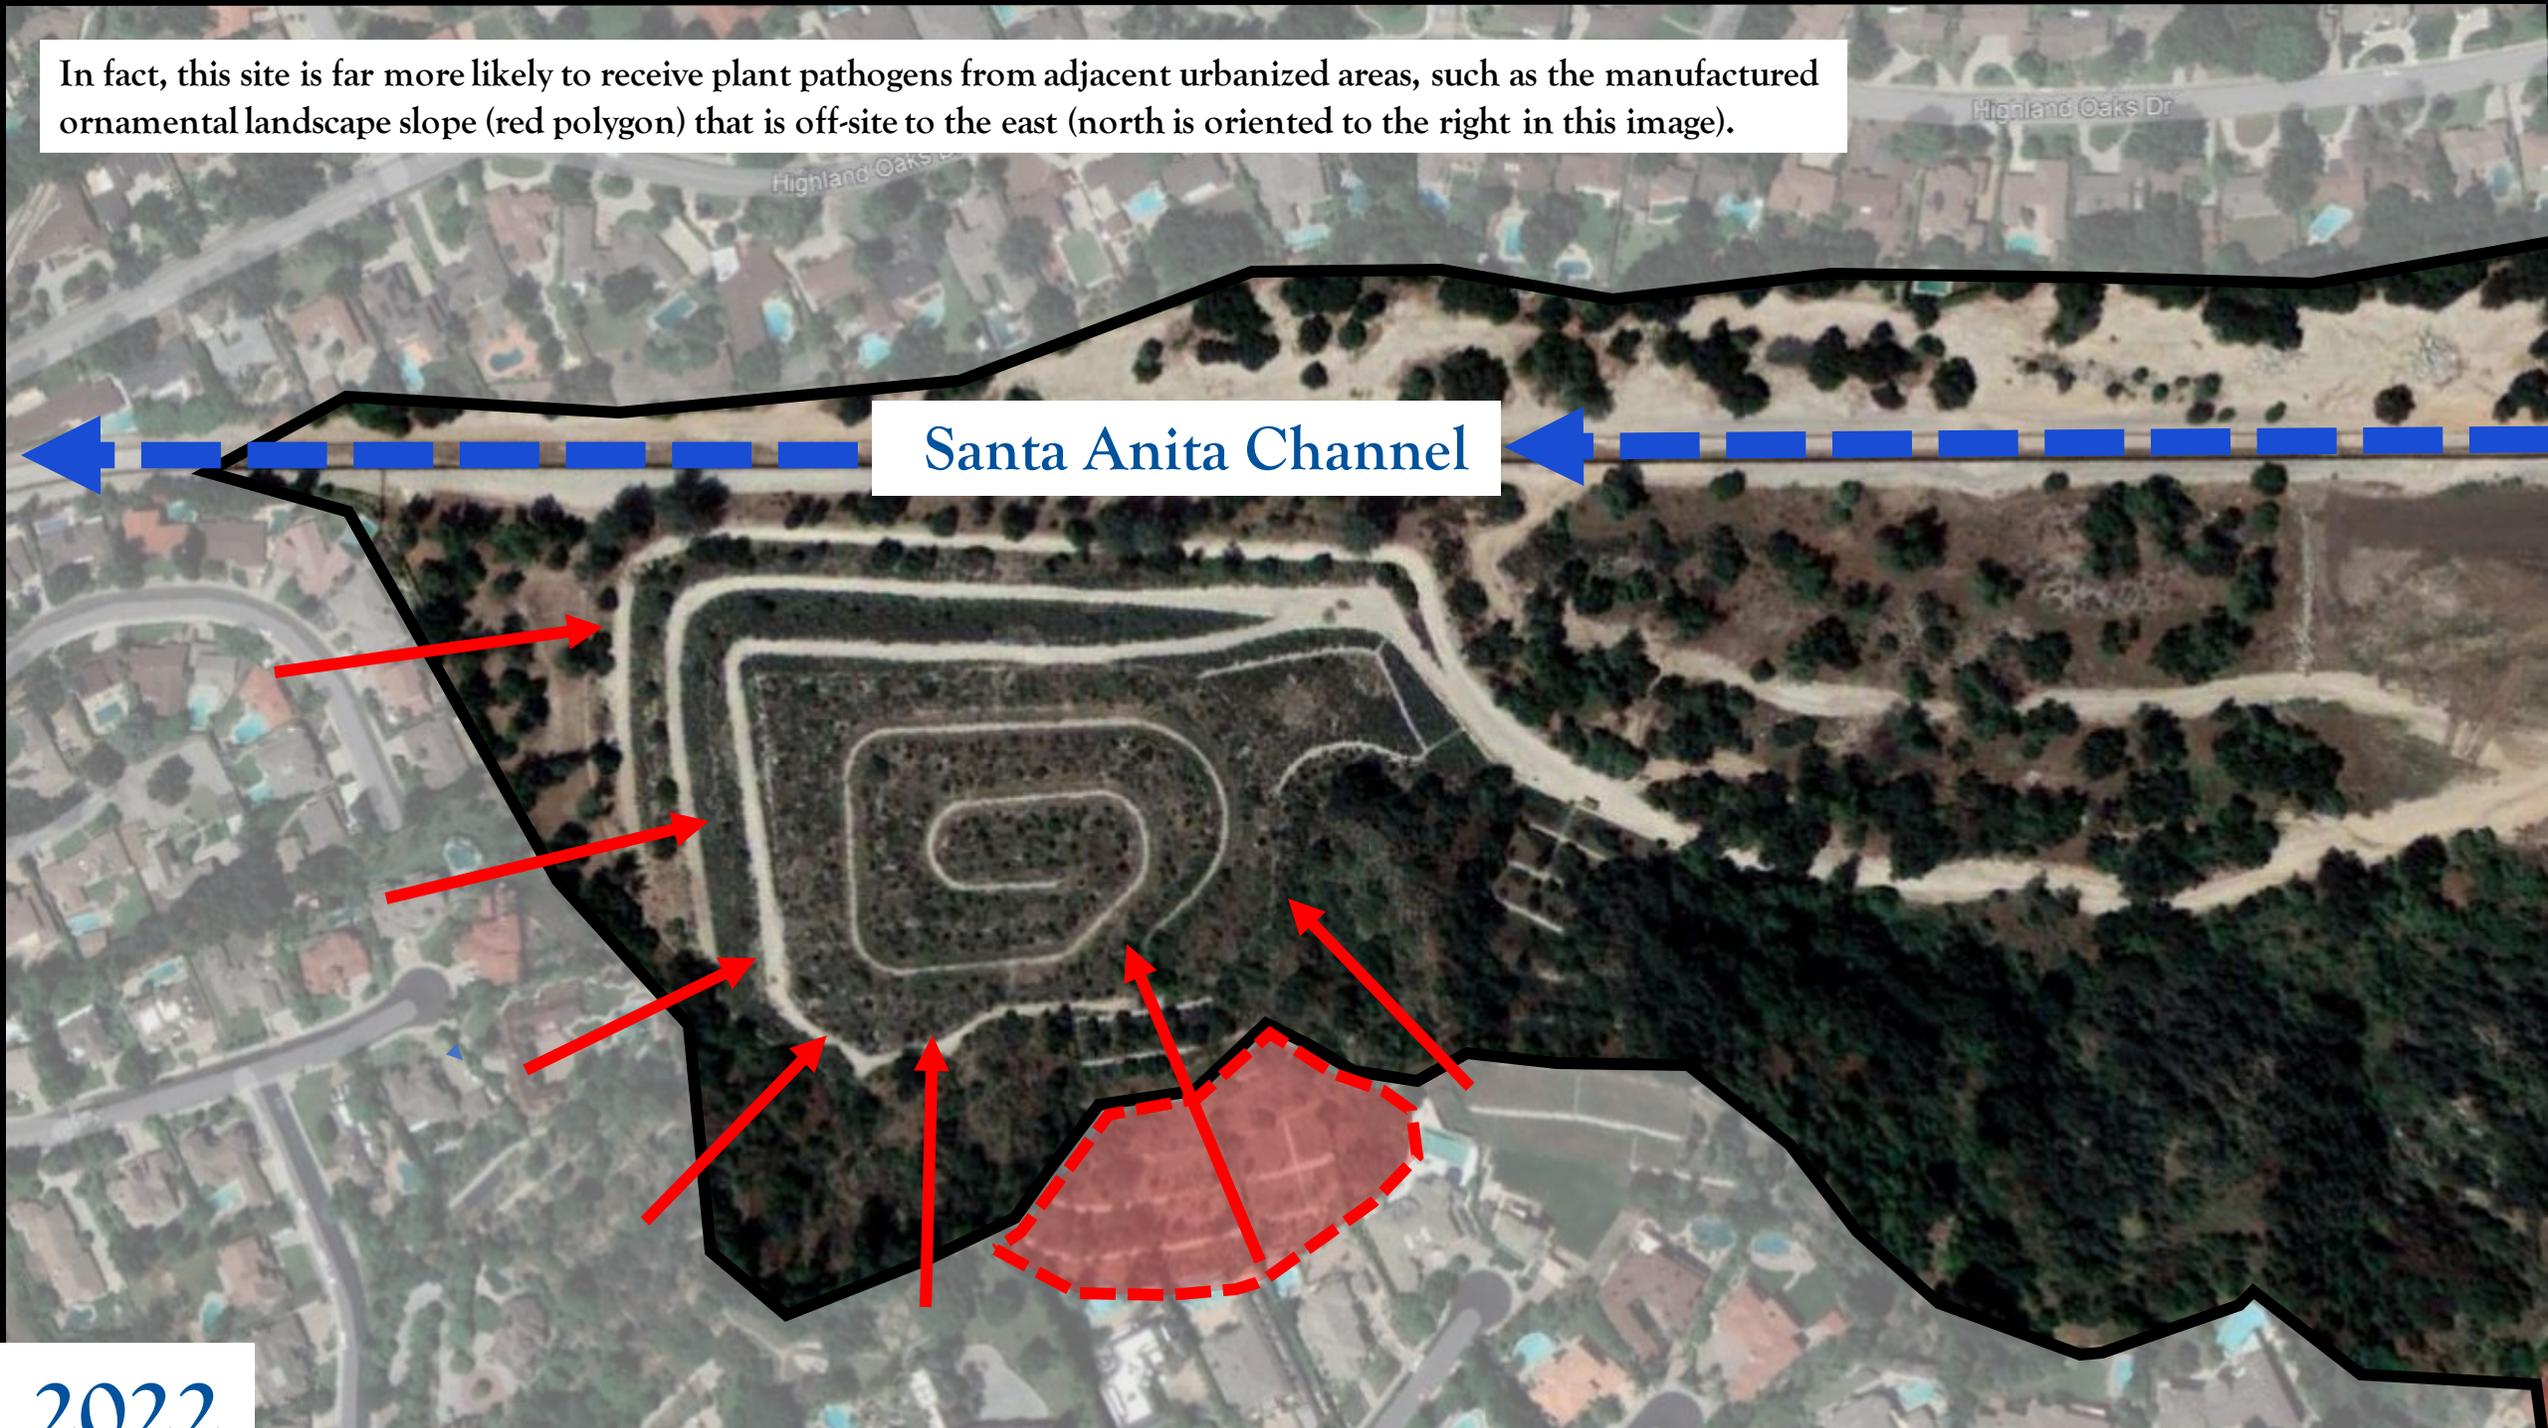
The specific location and configuration of this site, at the tip of a wedge of habitat surrounded by development, make it a good candidate for experimentation without risking the contamination of sensitive natural areas.

In fact, this site is far more likely to receive plant pathogens from adjacent urbanized areas, such as the manufactured ornamental landscape slope (red polygon) that is off-site to the east (north is oriented to the right in this image).
