### **CONSOLIDATED SEWER MAINTENANCE DISTRICT SERVICES TO THE CITY OF LAKEWOOD**

**ENCLOSURE 2**  
**QUICK MAINTENANCE RATING REPORT PRIORITY LIST**  
**CITY OF LAKEWOOD**

Infrastructure Inspection Reports  
for Grades 4 and 5

# Periodics Report for City of Lakewood

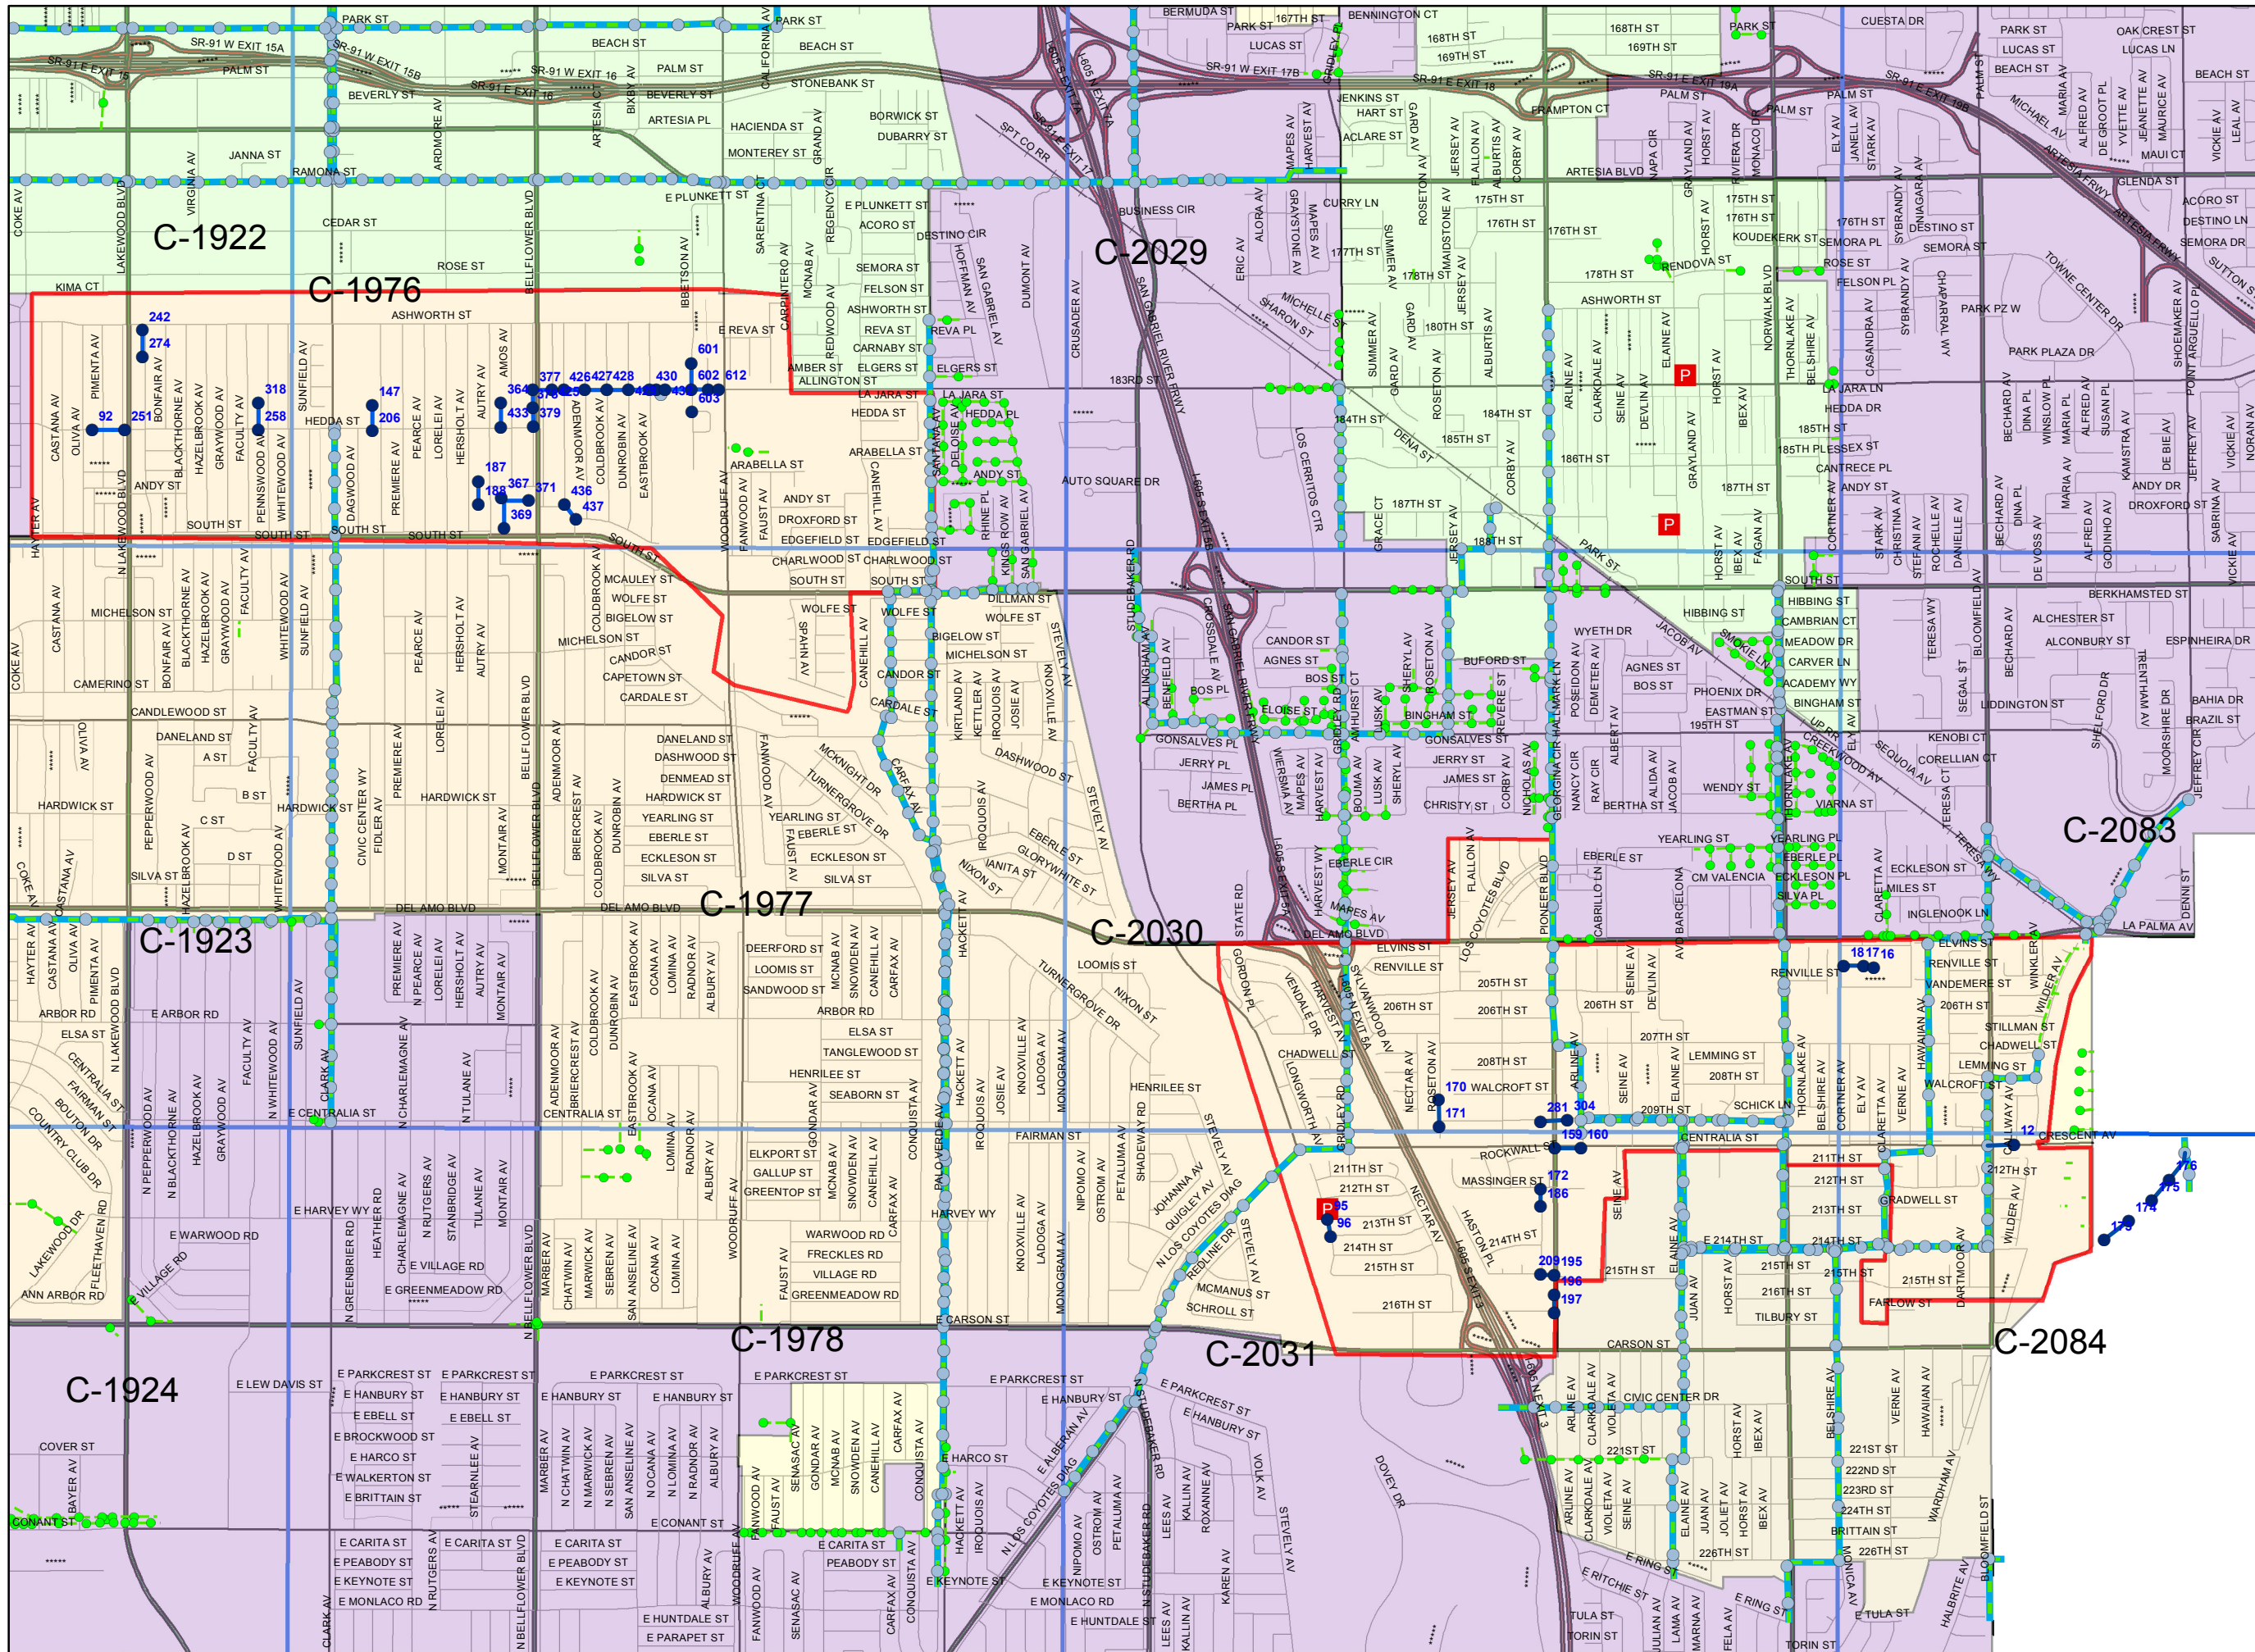
#### HIGH WATER LEVELS

Item No.	QMR	START MH	END MH	STREET	OBSERVATION	PERCENT CAPACITY: LOCATION
1	5200	1976-0610	1976-0611	ALLEY	Water mark	90%
2	5141	1976-0602	1976-0603	IBBETSON AV	Camera underwater due to lift station	(70%'-100%'): 147'-End MH
3	5116	1976-0187	1976-0188	EASEMENT	Water mark	75%
4	5100	1976-0429	1976-0430	ALLINGTON ST	Water mark	80%
5	5100	1976-0377	1976-0378	BELLFLOWER BV	Water mark	80%
6	5100	1976-0377	1976-0425	ALLINGTON ST	Water mark	80%
7	5100	1976-0378	1976-0379	BELLFLOWER BV	Water mark	80%
8	5100	1976-0425	1976-0426	ALLINGTON ST	Water mark	80%
9	5100	1976-0426	1976-0427	ALLINGTON ST	Water mark	80%
10	5100	1976-0427	1976-0428	ALLINGTON ST	Water mark	80%
11	5100	1976-0428	1976-0429	ALLINGTON ST	Water mark	80%
12	5100	1976-0601	1976-0602	IBBETSON AV	Water mark	100%
13	5100	1976-0602	1976-0611	ALLINGTON ST	Water mark	100%
14	5100	1976-0611	1976-0612	ALLINGTON ST	Water mark	100%
15	5100	1976-0432	1976-0602	ALLINGTON ST	Water mark	100%

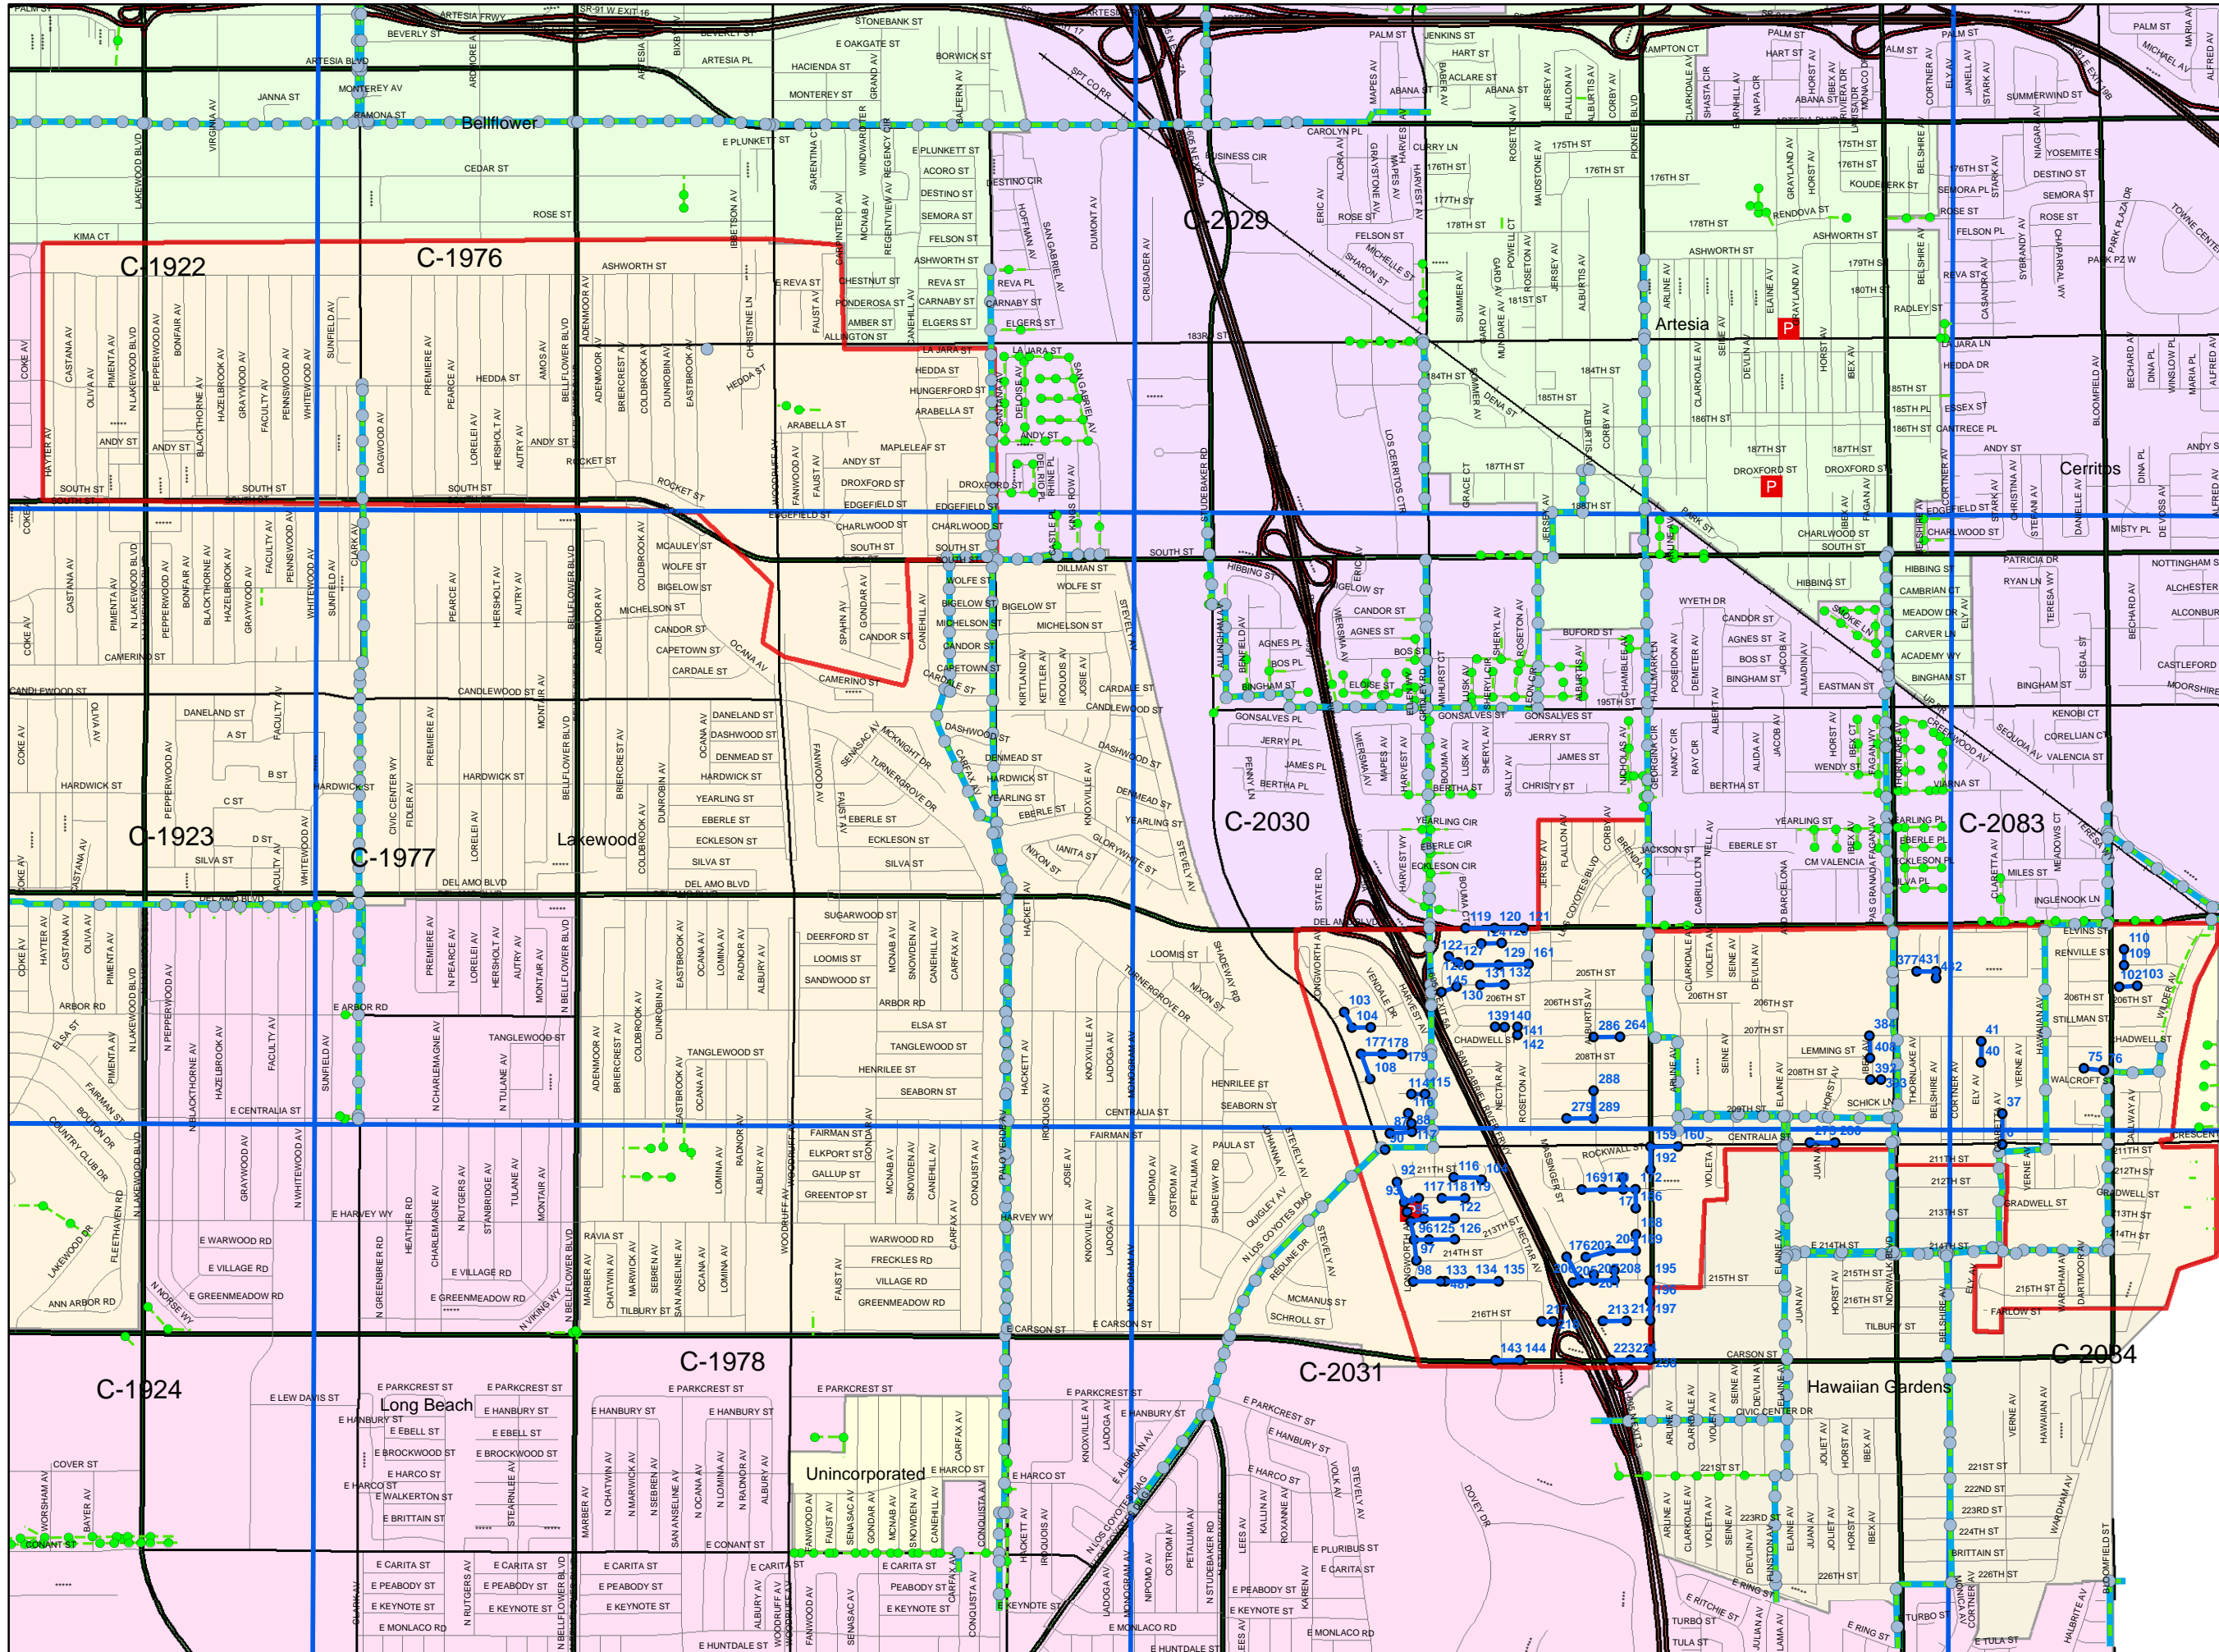
#### INFILTRATION

ITEM NO.	QMR	START MH	END MH	STREET	OBSERVATION	PROPOSED CORRECTIVE METHOD	LENGTH OF REPAIR (FT)
1	5234	2031-0093	2031-0092	LONGWORTH AV	Infiltration dripper: 44'	Infiltration is minimal. No action needed.	
2	5142	2031-0133	2031-0098	215TH ST	Infiltration dripper: 66', 59' (reverse), 149' (reverse)	Infiltration is minimal. No action needed.	
3	5132	2030-0178	2030-0177	CHADWELL ST	Infiltration dripper: 18'	Infiltration is minimal. No action needed.	
4	5131	2030-0122	2030-0127	RENVILLE ST	Infiltration dripper: 20'	Infiltration is minimal. No action needed.	
5	5131	2083-0103	2083-0102	VANDEMERE ST	Infiltration dripper: 7'	Infiltration is minimal. No action needed.	
6	4832	2031-0176	2031-0206	HASTON PL	Infiltration runner: 89', 119', 152', 249', 296', 300', 306', 330'	Lining: MH to MH	355
7	4538	2031-0135	2031-0134	215TH ST	Infiltration runner: 25', 67', 105'	Lining: MH to MH	352
8	4333	2031-0196	2031-0197	PIONEER AV	Infiltration runner: 68'; dripper: 124'	Lining: MH to MH	216
