**CONSOLIDATED SEWER MAINTENANCE DISTRICT
CONDITION ASSESSMENT PROGRAM REPORT
PROJECT Y0TV0910A**

**CONDITION ASSESSMENT REPORT
COUNTY OF LOS ANGELES DEPARTMENT OF PUBLIC WORKS
CONSOLIDATED SEWER MAINTENANCE DISTRICT**

PROJECT NAME:	Y0TV910A	PROJECT MGR:	Eric Liu
PROJECT DATE:	07/23/10	CONTACT NO:	(626) 300-3369
SUP. DISTRICT(s):	1 & 4	MAP PAGE(S):	1654,1709,1753,1754 1808 &1809
Report By:	Hanna Kebede	Report Date:	05/13/2013

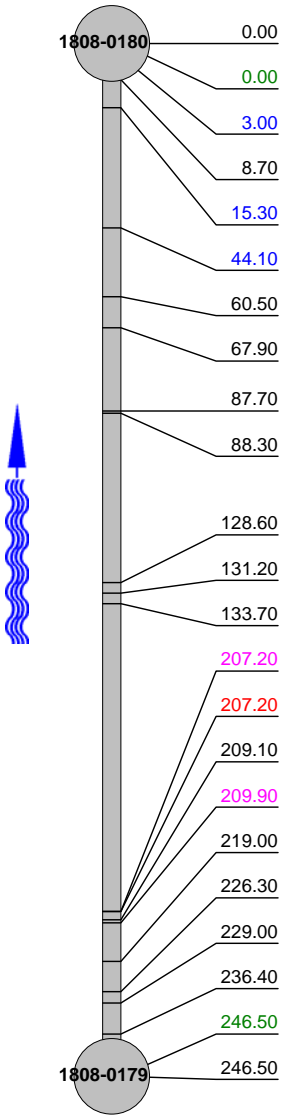
229.00	Tap Factory Active, at 3 o'clock, 6", within 8 inch: NO	00:15:31	3897	
	236.40	Tap Factory Active, at 3 o'clock, 6", within 8 inch: NO	00:15:56	3898

246.50	Vermin Cockroach, within 8 inch: NO	00:16:32	3899	M 1
	246.50	Manhole, within 8 inch: NO, Remarks: 1808-0179	00:16:42	3900

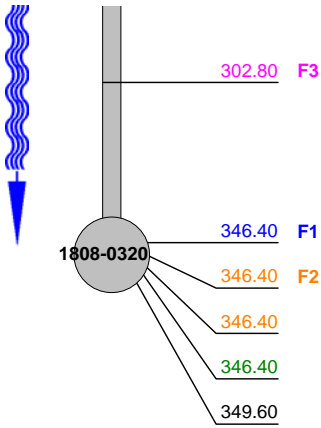
Date: 20100422	P.O.#: Y0TV0910A	Weather: Dry	Surveyed By: Gilbert Contreras	section number: 1762	PSR: 59411
Total Pipe Length: 281.00	Survey Customer: LACDPW	System Owner: ZLAS	Clean Date: 04/21/2010	Pre-Cleaned: Jetting	Map Grid #: 1808

1:627	position	observation	MPEG	photo	grade
	302.80	F3 Fracture Multiple, from 7 to 5 o'clock, within 8 inch: YES, End	00:16:25	12655	S 4
	346.40	F1 Surface Spalling Other, from 7 to 5 o'clock, within 8 inch: YES, End	00:17:29	12656	S 2
	346.40	F2 Surface Aggregate Visible Unknown, from 3 to 5 o'clock, within 8 inch: YES, End	00:17:40	12657	S 3
	346.40	Fracture Longitudinal, at 1 o'clock, within 8 inch: YES	00:18:07	12658, b	S 3
	346.40	Crack Circumferential, from 8 to 9 o'clock, within 8 inch: YES	00:18:24	12660, b	S 1
	349.60	Manhole, within 8 inch: NO, Remarks: 1808-0320	00:19:00	12662

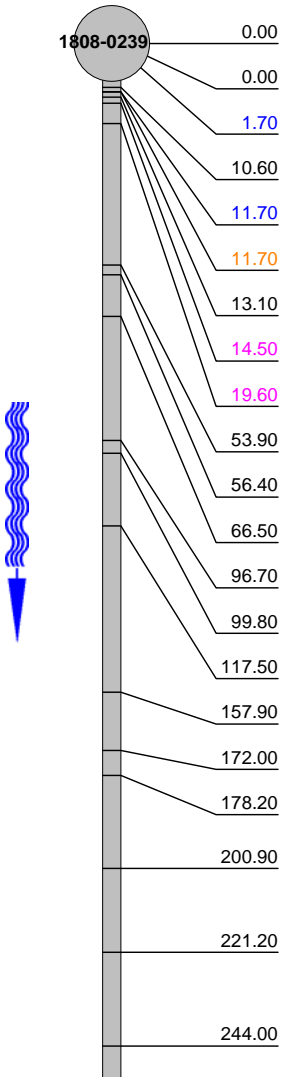
11.70	Obstacle Pipe Material, from 8 to 10 o'clock, 10 %, within 8 inch: NO	00:03:06	13290, b	M 2
	11.70 S2	Crack Multiple, from 7 to 5 o'clock, within 8 inch: YES, Start	00:03:17	13292, b	S 3

13.10	Tap Factory Active, at 9 o'clock, 6", within 8 inch: NO	00:03:52	13294	
	14.50	Broken, from 7 to 9 o'clock, within 8 inch: YES	00:04:19	13295, b	S 4

19.60 S3	Surface Aggregate Missing Unknown, from 4 to 9 o'clock, within 8 inch: YES, Start	00:05:04	13297, b	S 4
	53.90	Tap Factory Active, at 9 o'clock, 6", within 8 inch: NO	00:06:43	13301

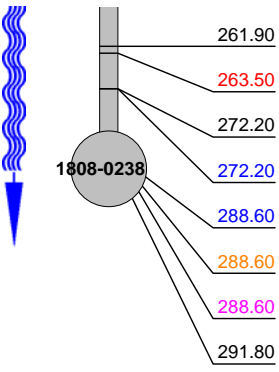
Date: 20100423	P.O.#: Y0TV0910A	Weather: Dry	Surveyed By: Gilbert Contreras	section number: 1781	PSR: 59362
Total Pipe Length: 281.00	Survey Customer: LACDPW	System Owner: ZLAS	Clean Date: 04/22/2010	Pre-Cleaned: Jetting	Map Grid #: 1808

1:561	position	observation	MPEG	photo	grade
	261.90	Tap Factory Capped, at 9 o'clock, 6", within 8 inch: NO	00:18:38	13313	
	263.50	Broken, from 6 to 9 o'clock, within 8 inch: YES	00:19:12	13314, b	S 5
	272.20	Tap Factory Active, at 3 o'clock, 6", within 8 inch: NO	00:19:51	13316	
	272.20	Crack Longitudinal, at 3 o'clock, within 8 inch: YES	00:20:14	13317, b	S 2
	288.60 F1	Surface Spalling Other, from 7 to 5 o'clock, within 8 inch: YES, End	00:22:03	13319	S 2
	288.60 F2	Crack Multiple, from 7 to 5 o'clock, within 8 inch: YES, End	00:22:17	13320	S 3
	288.60 F3	Surface Aggregate Missing Unknown, from 4 to 9 o'clock, within 8 inch: YES, End	00:22:31	13321	S 4
	291.80	Manhole, within 8 inch: NO, Remarks: 1808-0238	00:23:23	13322

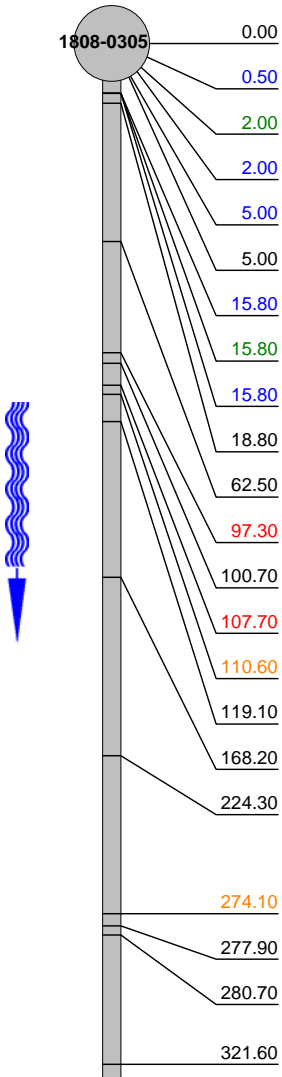
62.50	Tap Factory Active, at 12 o'clock, 6", within 8 inch: NO	00:06:32	11662	
	97.30	Broken Void Visible, from 7 to 5 o'clock, within 8 inch: YES	00:07:51	11663, b	S 5

100.70	Tap Factory Active, at 12 o'clock, 6", within 8 inch: NO	00:08:28	11665	
	107.70	Broken Void Visible, from 7 to 5 o'clock, within 8 inch: YES	00:9:10	11666, b	S 5

110.60 S3	Crack Multiple, from 7 to 5 o'clock, within 8 inch: YES, Start	00:09:55	11668, b	S 3
	119.10	Tap Factory Active, at 12 o'clock, 6", within 8 inch: NO	00:10:35	11670

274.10 F3	Crack Multiple, from 7 to 5 o'clock, within 8 inch: YES, End	00:15:01	11673	S 3
	277.90	Tap Factory Capped, at 9 o'clock, 6", within 8 inch: NO	00:15:23	11674

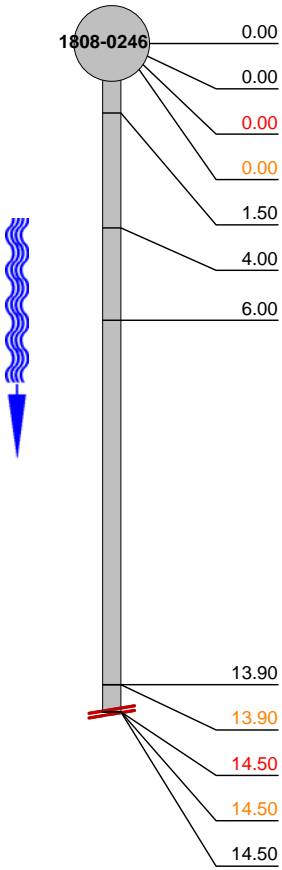
14.50 F1	Broken Soil Visible, from 5 to 7 o'clock, within 8 inch: NO, End	00:05:51	12676	S 5
	14.50 F2	Deposits Ingressed Other, from 5 to 7 o'clock, 15 %, within 8 inch: NO, Remarks: SAND, End	00:06:01	12677	M 3

14.50	Abandoned Survey, within 8 inch: NO, Remarks: DUE TO BROKEN PIPE	00:06:22	12678

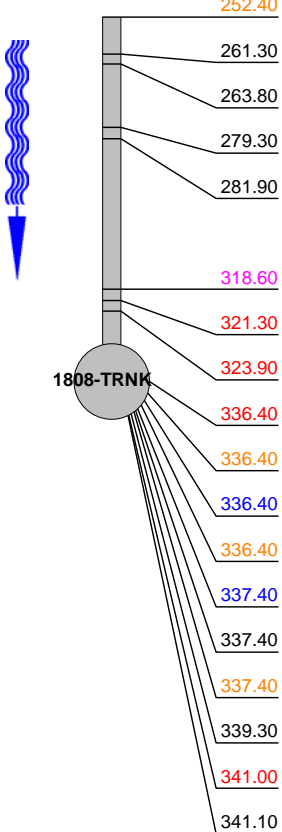
339.30	Tap Factory Active, at 6 o'clock, 6", within 8 inch: NO, Remarks: DROP LATERAL	00:30:54	13570	
	341.00	Broken, from 10 to 2 o'clock, within 8 inch: NO	00:31:34	13571, b	S 5

341.10	Manhole, within 8 inch: NO, Remarks: 1808-TRNK	00:32:22	13573

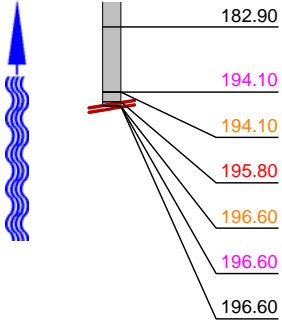
Date: 20100422	P.O.#: Y0TV0910A	Weather: Dry	Surveyed By: Gilbert Contreras	section number: 1761	PSR: 59410
Total Pipe Length: 311.00	Survey Customer: LACDPW	System Owner: ZLAS	Clean Date: 04/21/2010	Pre-Cleaned: Jetting	Map Grid #: 1808

1:396	position	observation	MPEG	photo	grade
	182.90	Tap Factory Active, at 3 o'clock, 6", within 8 inch: NO	00:20:16	12619	
	194.10 F6	Surface Aggregate Missing Unknown, from 3 to 9 o'clock, within 8 inch: YES, End	00:22:28	12620	S 4
	194.10 F1	Surface Aggregate Visible Unknown, from 7 to 5 o'clock, within 8 inch: NO, End	00:22:53	12621	S 3
	195.80	Broken Soil Visible, from 3 to 9 o'clock, within 8 inch: YES	00:24:14	12622, b	S 5
	196.60 F3	Crack Multiple, from 7 to 5 o'clock, within 8 inch: YES, End	00:25:16	12624	S 3
	196.60 F4	Broken, from 7 to 9 o'clock, within 8 inch: YES, End	00:25:40	12625	S 4
	196.60	Abandoned Survey, within 8 inch: NO, Remarks: COMPLETES INSPECTION OF E	00:26:08	12626

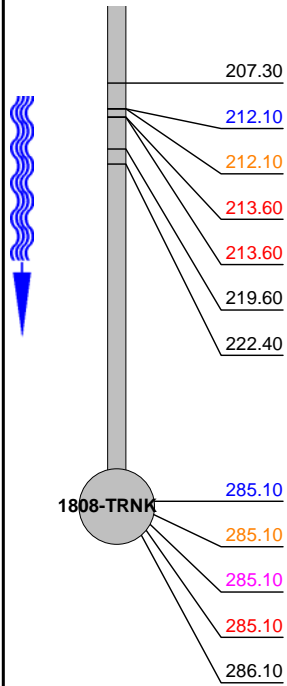
1:429	position	observation	MPEG	photo	grade
	<u>207.30</u>	Tap Factory Active, at 9 o'clock, 6", within 8 inch: NO	00:22:33	13359	
	<u>212.10</u>	Tap Factory Defective, at 3 o'clock, 6", 2, within 8 inch: NO	00:23:10	13360, b	M 2
	<u>212.10</u>	Fracture Longitudinal, at 3 o'clock, within 8 inch: NO	00:23:24	13362, b	S 3
	<u>213.60</u> F4	Broken Soil Visible, from 7 to 5 o'clock, within 8 inch: YES, End	00:24:04	13364	S 5
	<u>213.60</u> S5	Broken, from 7 to 5 o'clock, within 8 inch: YES, Start	00:24:21	13365, b	S 5
	<u>219.60</u>	Tap Factory Active, at 9 o'clock, 6", within 8 inch: NO	00:25:05	13367	
	<u>222.40</u>	Tap Factory Capped, at 3 o'clock, 6", within 8 inch: NO	00:25:32	13368	
	<u>285.10</u> F1	Surface Spalling Other, from 7 to 5 o'clock, within 8 inch: YES, End	00:27:57	13369	S 2
	<u>285.10</u> F2	Surface Aggregate Visible Unknown, from 3 to 9 o'clock, within 8 inch: YES, End	00:28:13	13370	S 3

<u>285.10</u> F3	Fracture Multiple, from 7 to 5 o'clock, within 8 inch: YES, End	00:28:27	13371	S 4
	<u>285.10</u> F5	Broken, from 7 to 5 o'clock, within 8 inch: YES, End	00:28:40	13372	S 5
	<u>286.10</u>	Manhole, within 8 inch: NO, Remarks: 1808-TRNK	00:29:25	13373
