Devil's Gate Reservoir Restoration Project First Quarter Compliance Report Activities Occurring Between January 2019 and March 2019

Appendix A: Construction Monitoring Logs

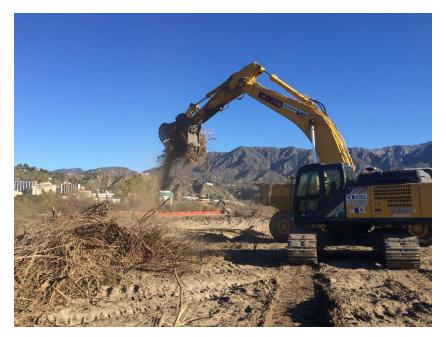
Log Entry #2 Photo A

1030- monitored loading of vegetation spoils into dump truck. 3 wood rats safely flushed. 1 Woodrat mortality. All work within ESA. Working northward.

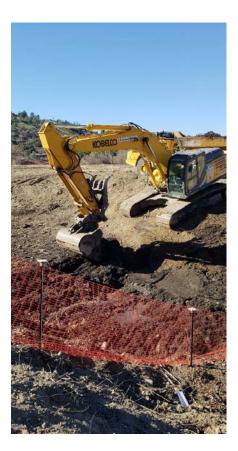
Log Entry #5 Photo A

0750 observed woodrat carcass. Appears to be from previous day.

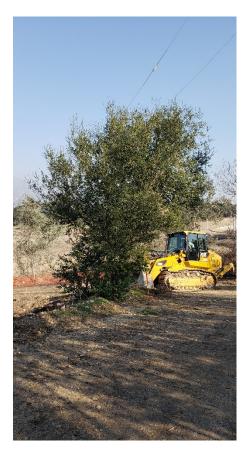
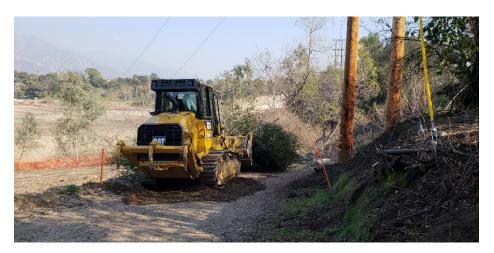
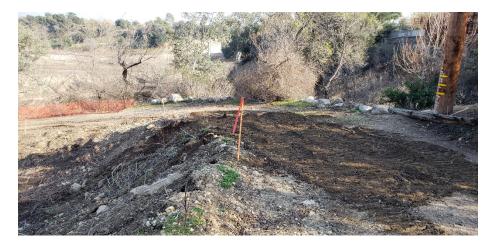
Log Entry #7 Photo A

1354 observed old alligator lizard carcass. Likely result of crushing/runover.

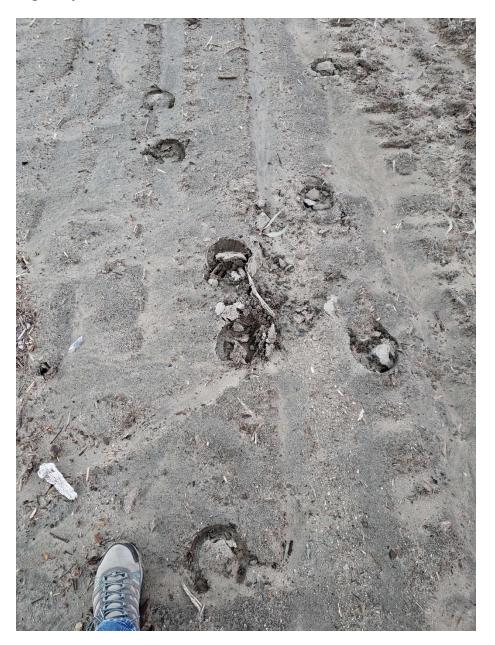
Log Entry #2 Photo A

Observed horse tracks in construction site

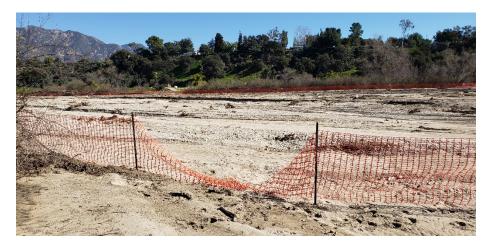
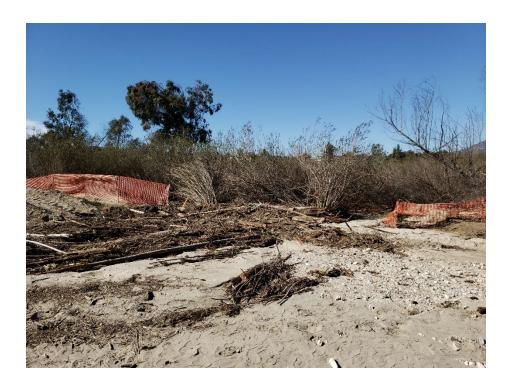
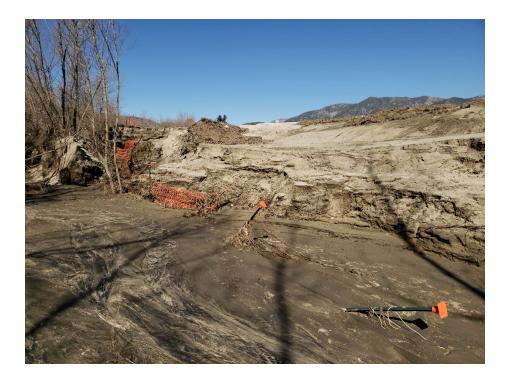
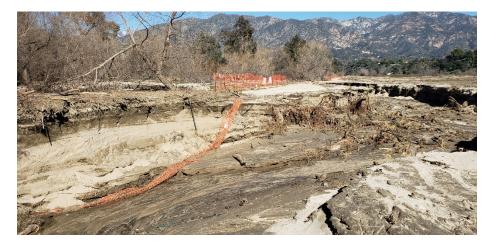
Fence is need of repair/replacement.

Multiple areas of downed fence, particularly on western boundary. A major section along the southwestern boundary is missing/washed out and is in need of replacement. Appears to be in same state as site check on Wednesday.

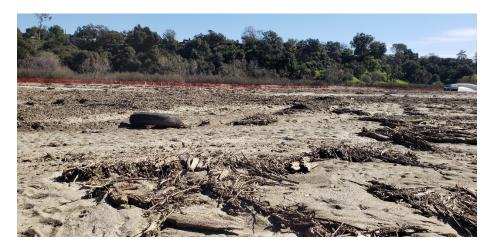
Log Entry #2 Photo A

Debris (natural and human trash) washed into site from high flows and storm from the previous week. Even tire, metal poles, woody debris...

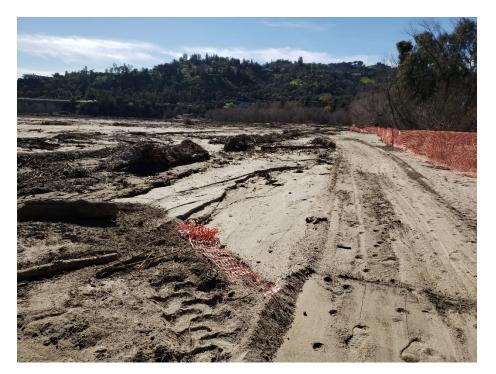
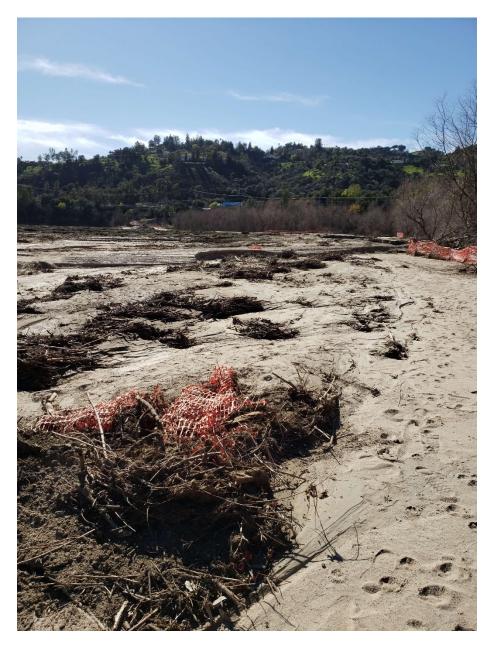
Fence reminants littering site.

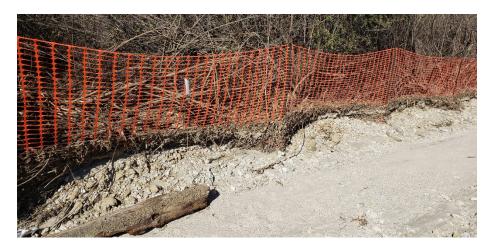
Log Entry #4 Photo A

certain areas of the fence are so clogged with debris it may prevent wildlife from moving freely through it.

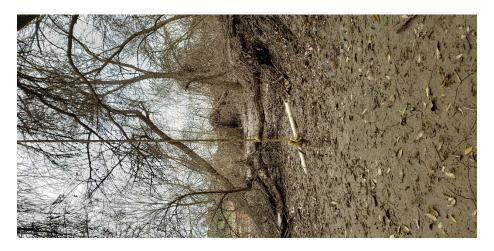
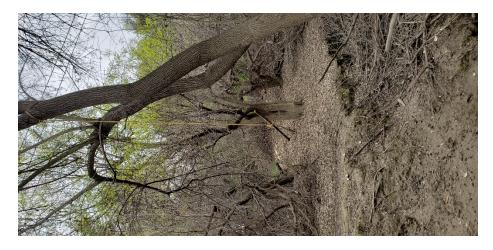
Log Entry #2

Observed 2 swings in restoration area alobg west side and near Berkshire creek. Also observed recreationists walking on project site.

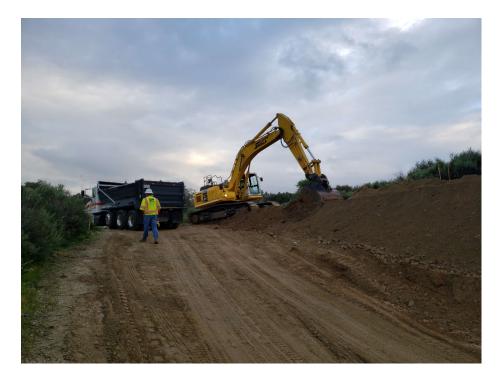
Log Entry #3 Photo A

Griffith crew smoothing newly transported dirt with sheep's toe roller and filling eastern access road area.

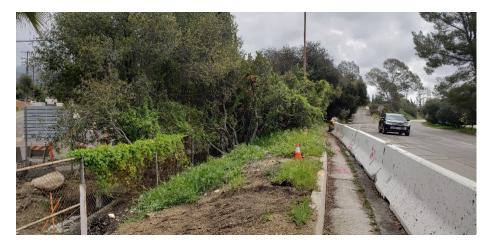
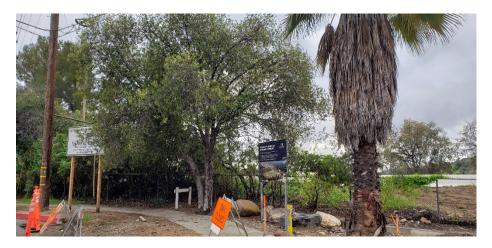
1013-1044 Joe asked if an area between the eastern access road and Oak Grove Dr. could be checked as they plan to clear it tomorrow or Monday. Area only contained newly sprouted low cover vegetation that was almost entirely nonnative. Adjacent to oak tree #21 but it was anticipated to be partially impacted in the Tree Report. Joe said they would not be removing any of the adjacent native vegetation. No nests or nesting birds detected in the area immediately adjacent however a BLPH continued to collect mud inside the work area as construction activities continued. Photos looking east, and then south (of oak tree #21).

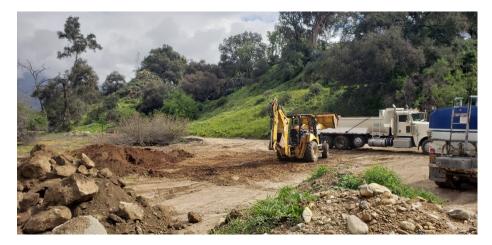
Log Entry #6 Photo A

1050 Griffith crew loading previously stockpiled dirt into haul trucks with backhoe in lower staging area east of sediment removal area and north of construction/trailer yard. Crew (excavator and spotter) done working on western access road. Dirt hauled to fill eastern access road.

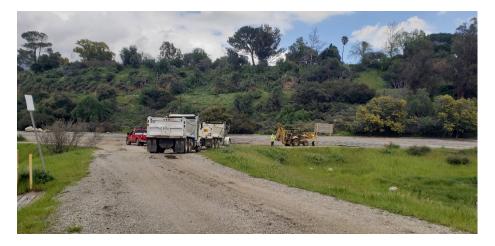
Log Entry #7 Photo A

1327 Crew done on eastern access road and in lower staging area. They moved to northern access road entrance to work on shaker plates. Confirmed with Joe that no other work was planned that required a monitor and then left the site.

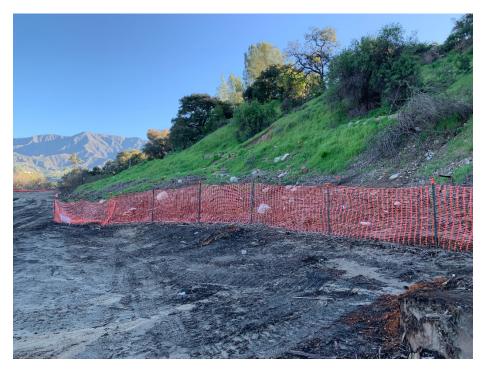
Log Entry #1 Photo A

0750- monitored weed spraying in DG-3A. No sensitive species or nesting birds observed.

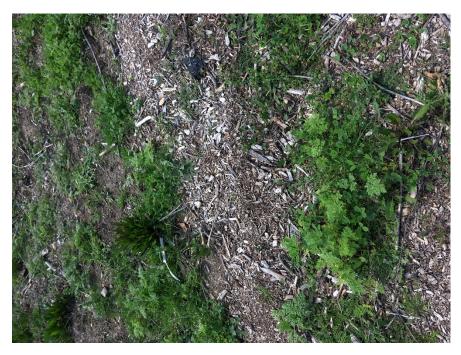
Log Entry #4 Photo A

1030, noticed that one crew member was overspraying onto rocks. Discussed spot treatment procedure and the need to avoid spraying anything other than target species.
