CONSOLIDATED SEWER MAINTENANCE DISTRICT CONDITION ASSESSMENT PROGRAM REPORT UNINCORPORATED COUNTY

CONDITION ASSESSMENT REPORT LOS ANGELES COUNTY PUBLIC WORKS CONSOLIDATED SEWER MAINTENANCE DISTRICT

| PROJECT | Y0TV1314A2 | PROJECT | Eric Liu |

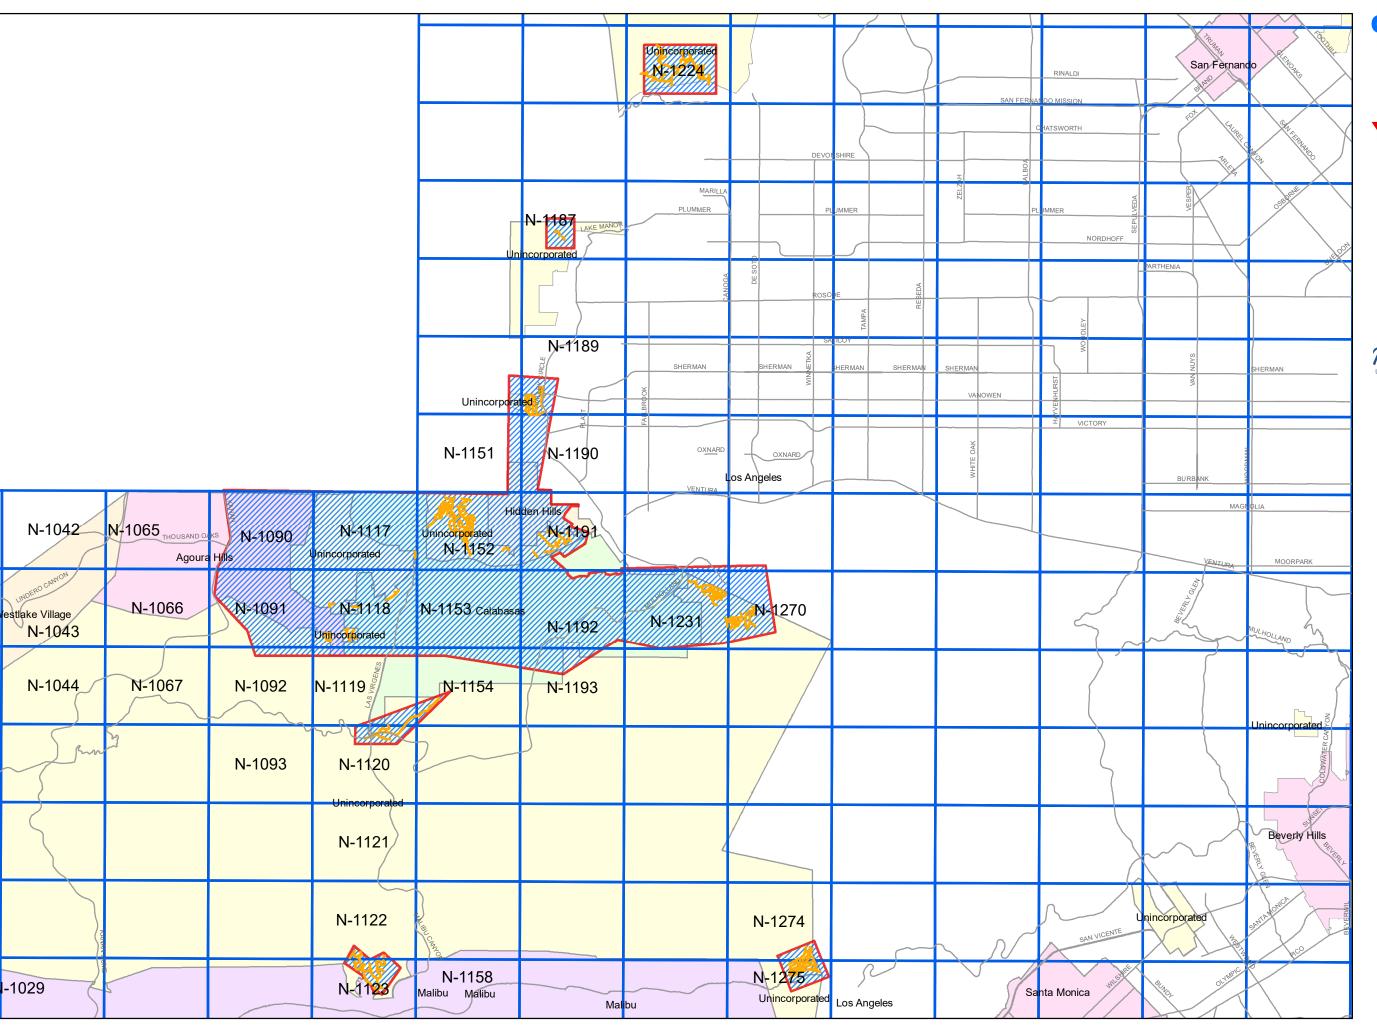
Project Overview Map

OVERVIEW MAP

CCTV PROJECT Y0TV1314A2

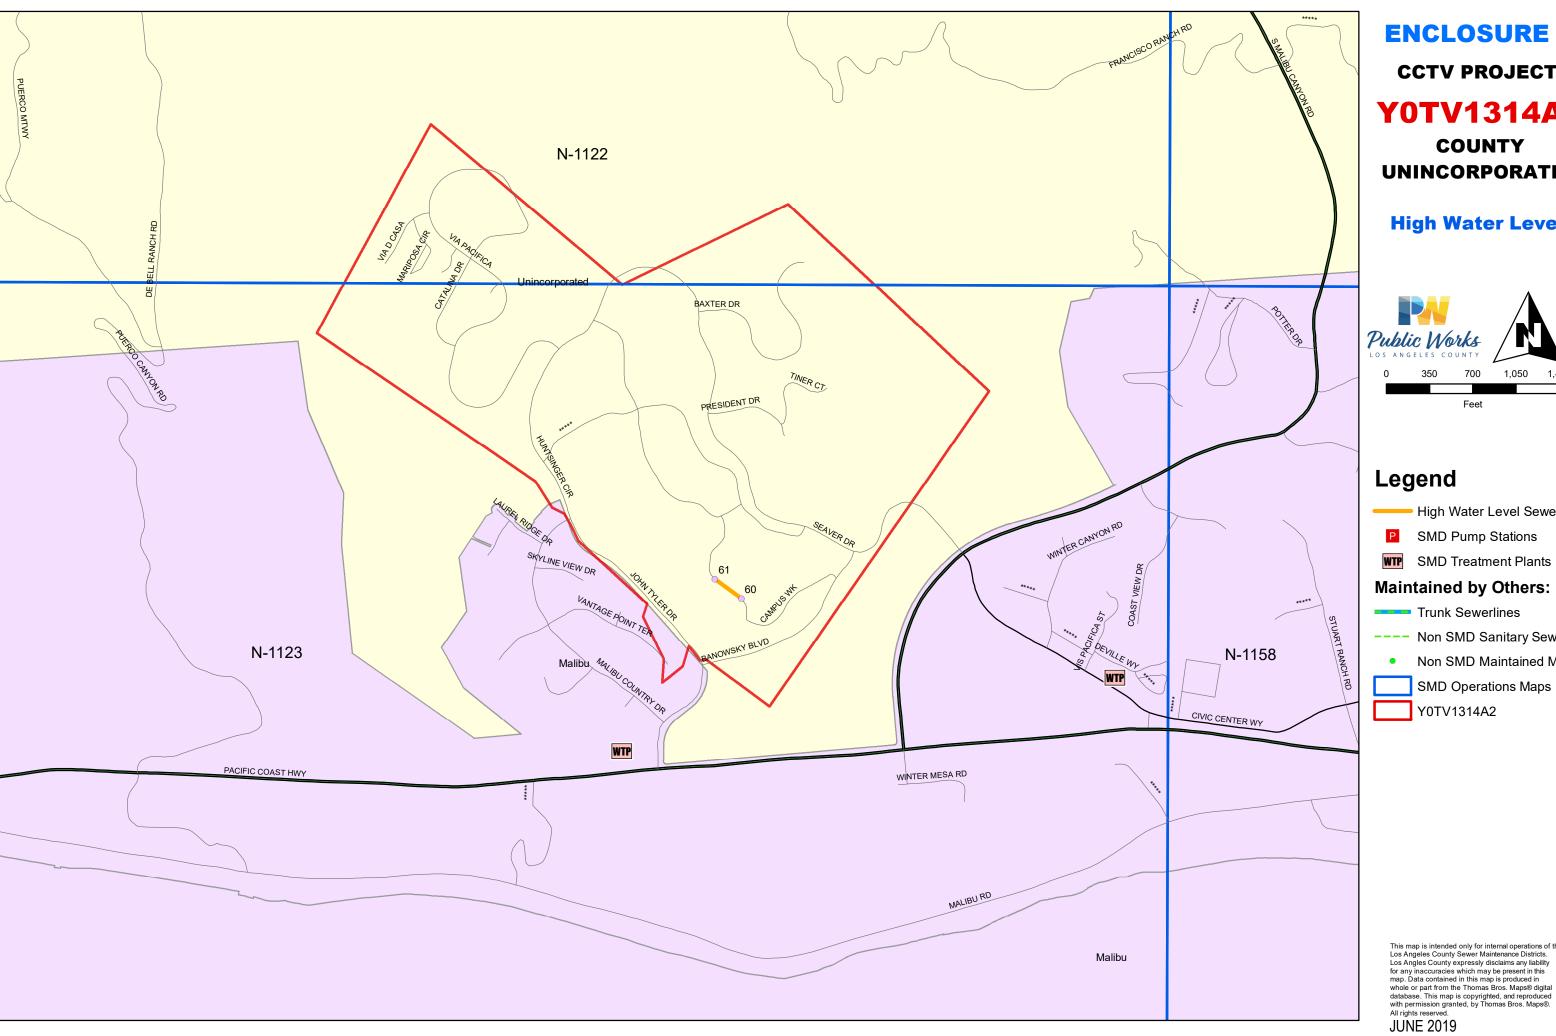
CCTV PROJECT

Y0TV1314A2

- Quick Maintenance Rating Map
- High Water Levels List
- High Water Levels Map
- Sample Lateral Notice Letter

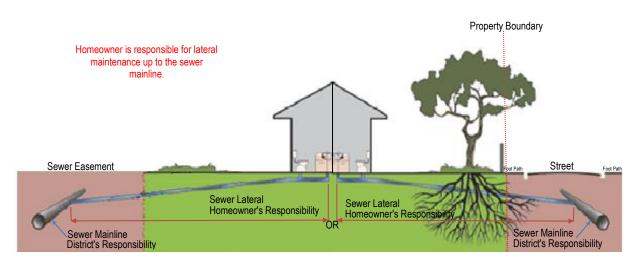
The sewer system within the District is comprised of a series of underground pipes. Many are publicly owned; however, the sewer laterals are entirely owned by the private property owner they serve. The laterals extend from the building to the mainline within the street (or within an easement at the rear of your home). The laterals are typically four inches in diameter while the District's mainline is typically at least eight inches in diameter. The private property owner is responsible for the entire length of the lateral, which includes the portion that may be located within the public right of way (under the asphalt and street landscaping).

SEWER LATERALS - AREAS OF RESPONSIBILITY
