**Year 1 Annual Monitoring Report  
for the  
Devil's Gate Reservoir Restoration Project  
(Phase 2) Onsite Habitat Mitigation**

**Pasadena, Los Angeles County, California**

Los Angeles County Public Works

**December 17, 2021**

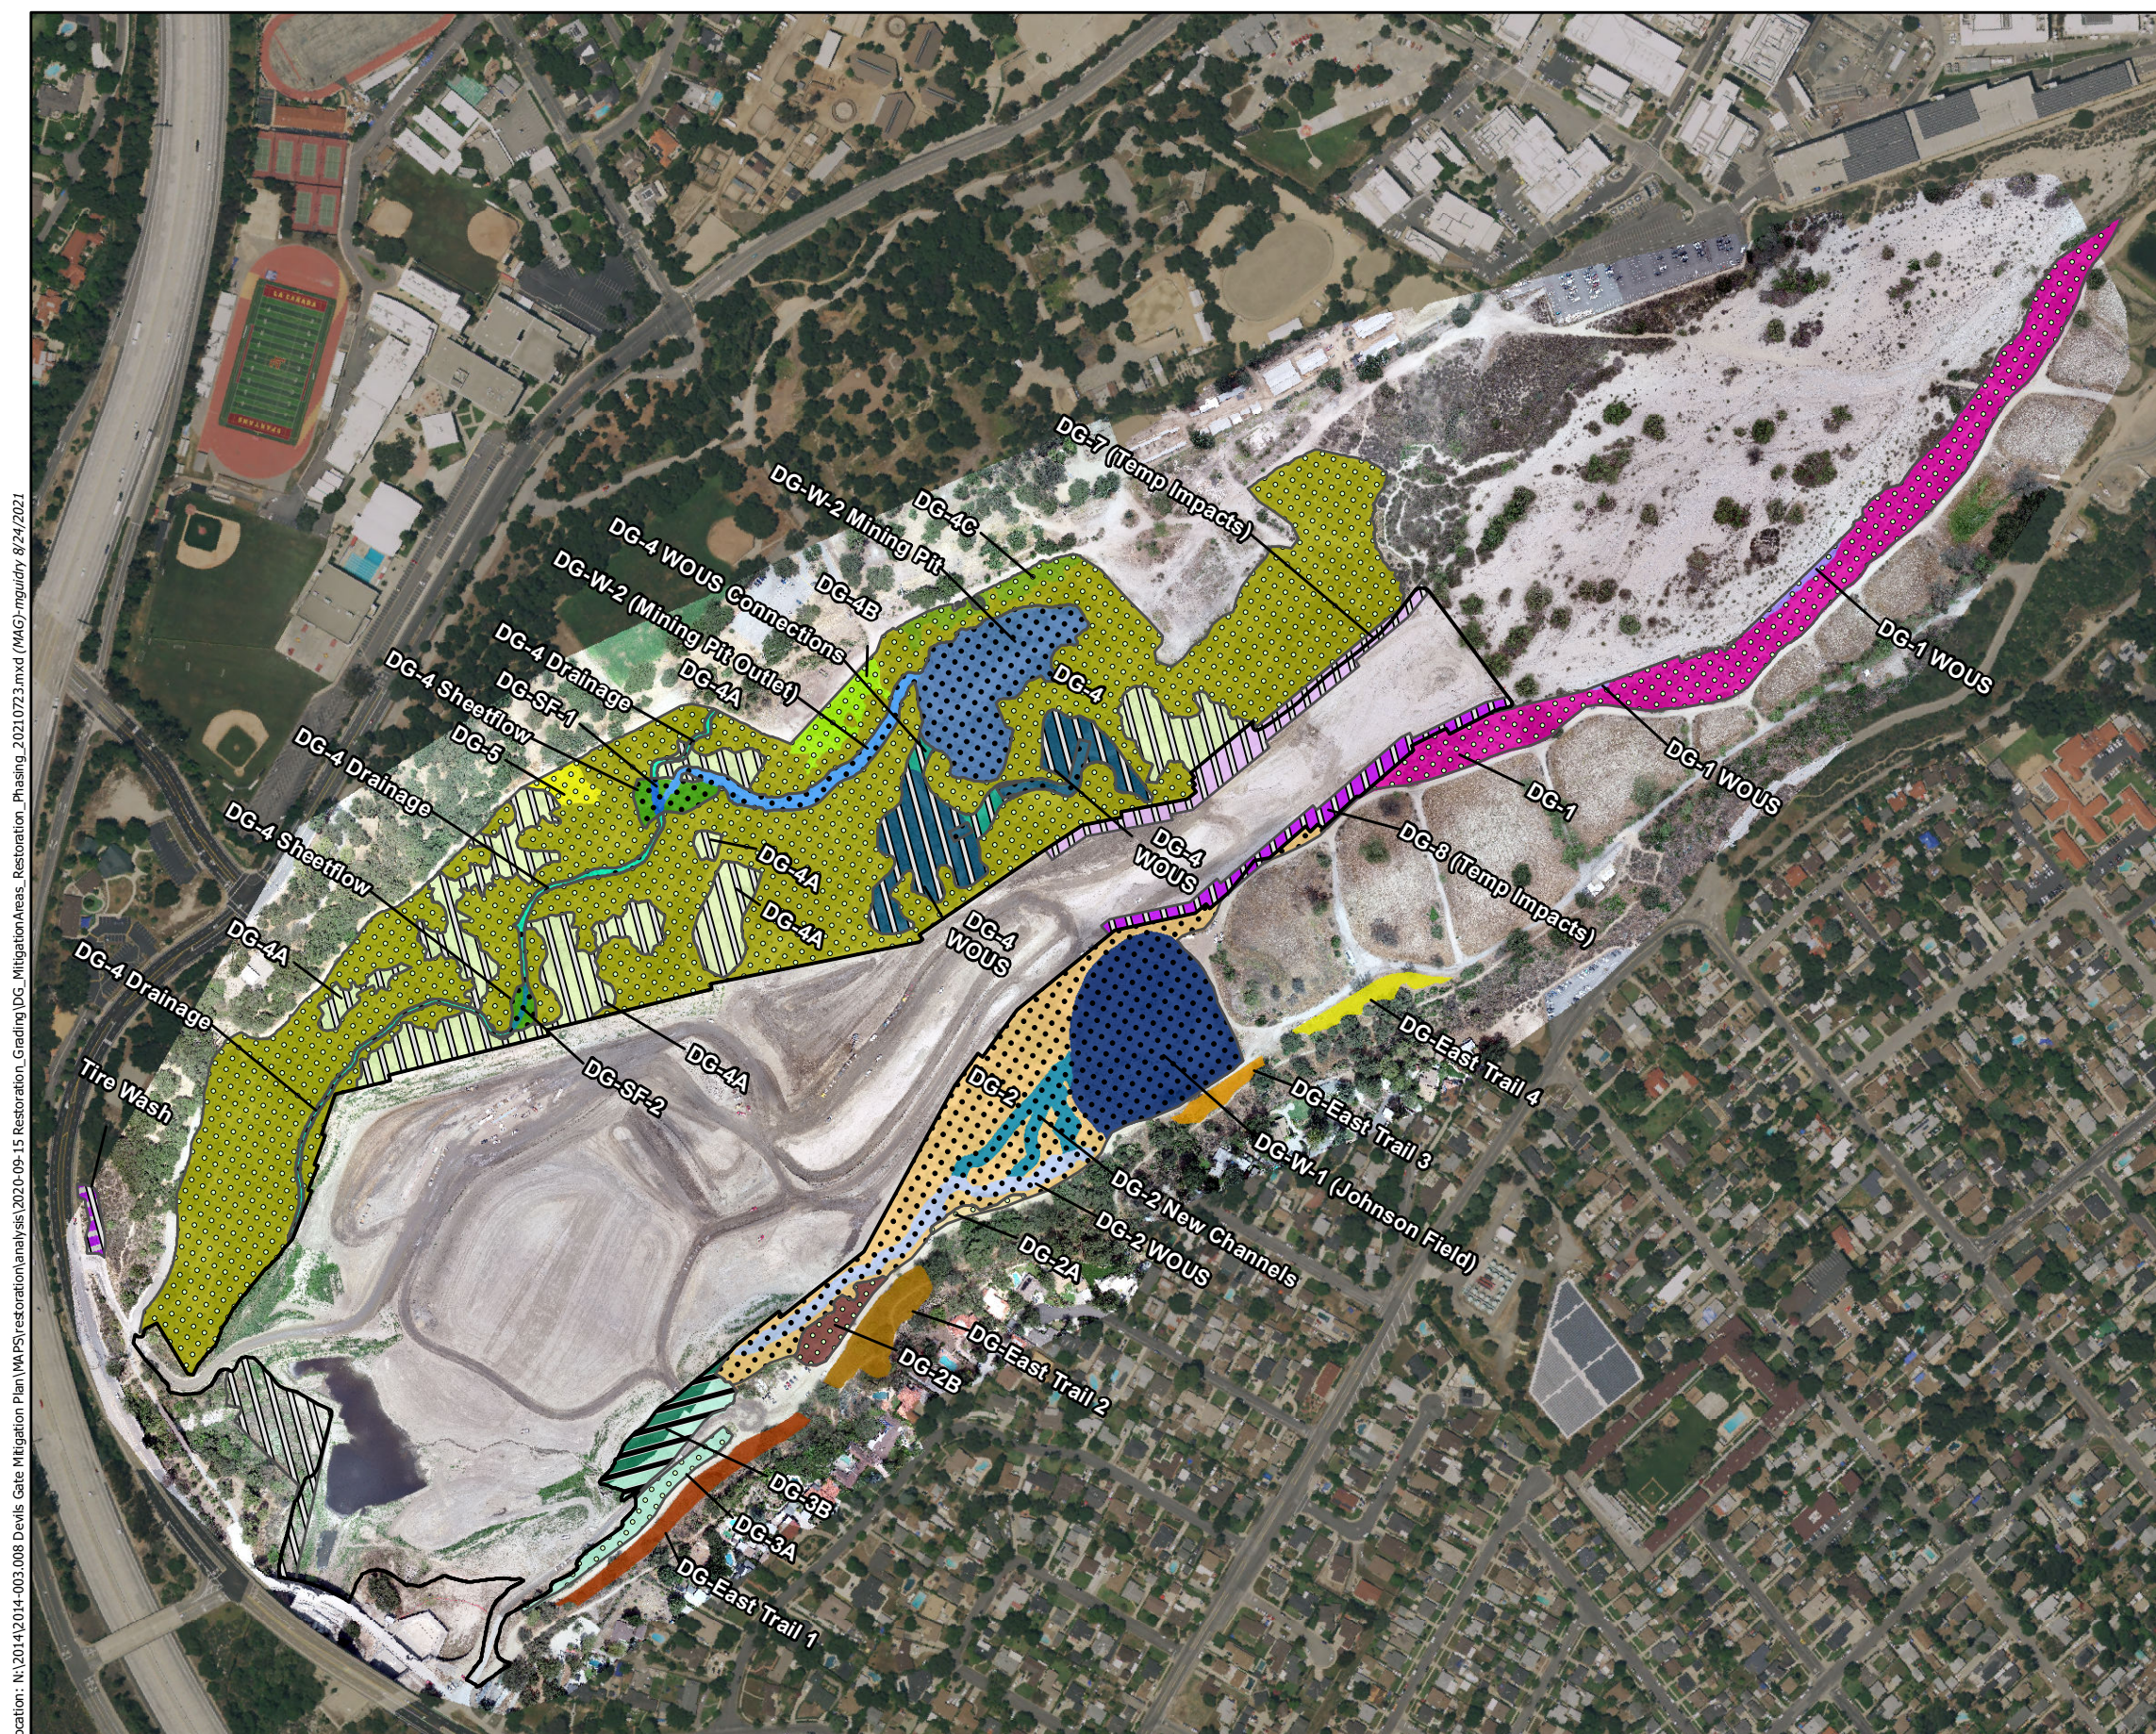
**Figure 3.**  
**Onsite Habitat Mitigation Areas**

The Phase 2 onsite habitat mitigation areas (hereafter referred to as mitigation areas) are located to the east and west of the Devil's Gate Reservoir (Reservoir) just outside of the PMA for the Project (Figure 3). Mitigation areas DG-W-1 (Johnson Field), DG-2, DG-2 New Channels, and DG-2 WOUS, are located on the east side of the Reservoir and mitigation areas DG-W-2 (Mining Pit), DG-W-2 Outlet, DG-4 Sheet Flow (northern), and DG-SF-1 are located on the west side of the Reservoir. The mitigation areas are encompassed by the Hahamongna Watershed Park, which is heavily used for recreational activities, such as hiking, bird watching, horseback riding, and disc golf.

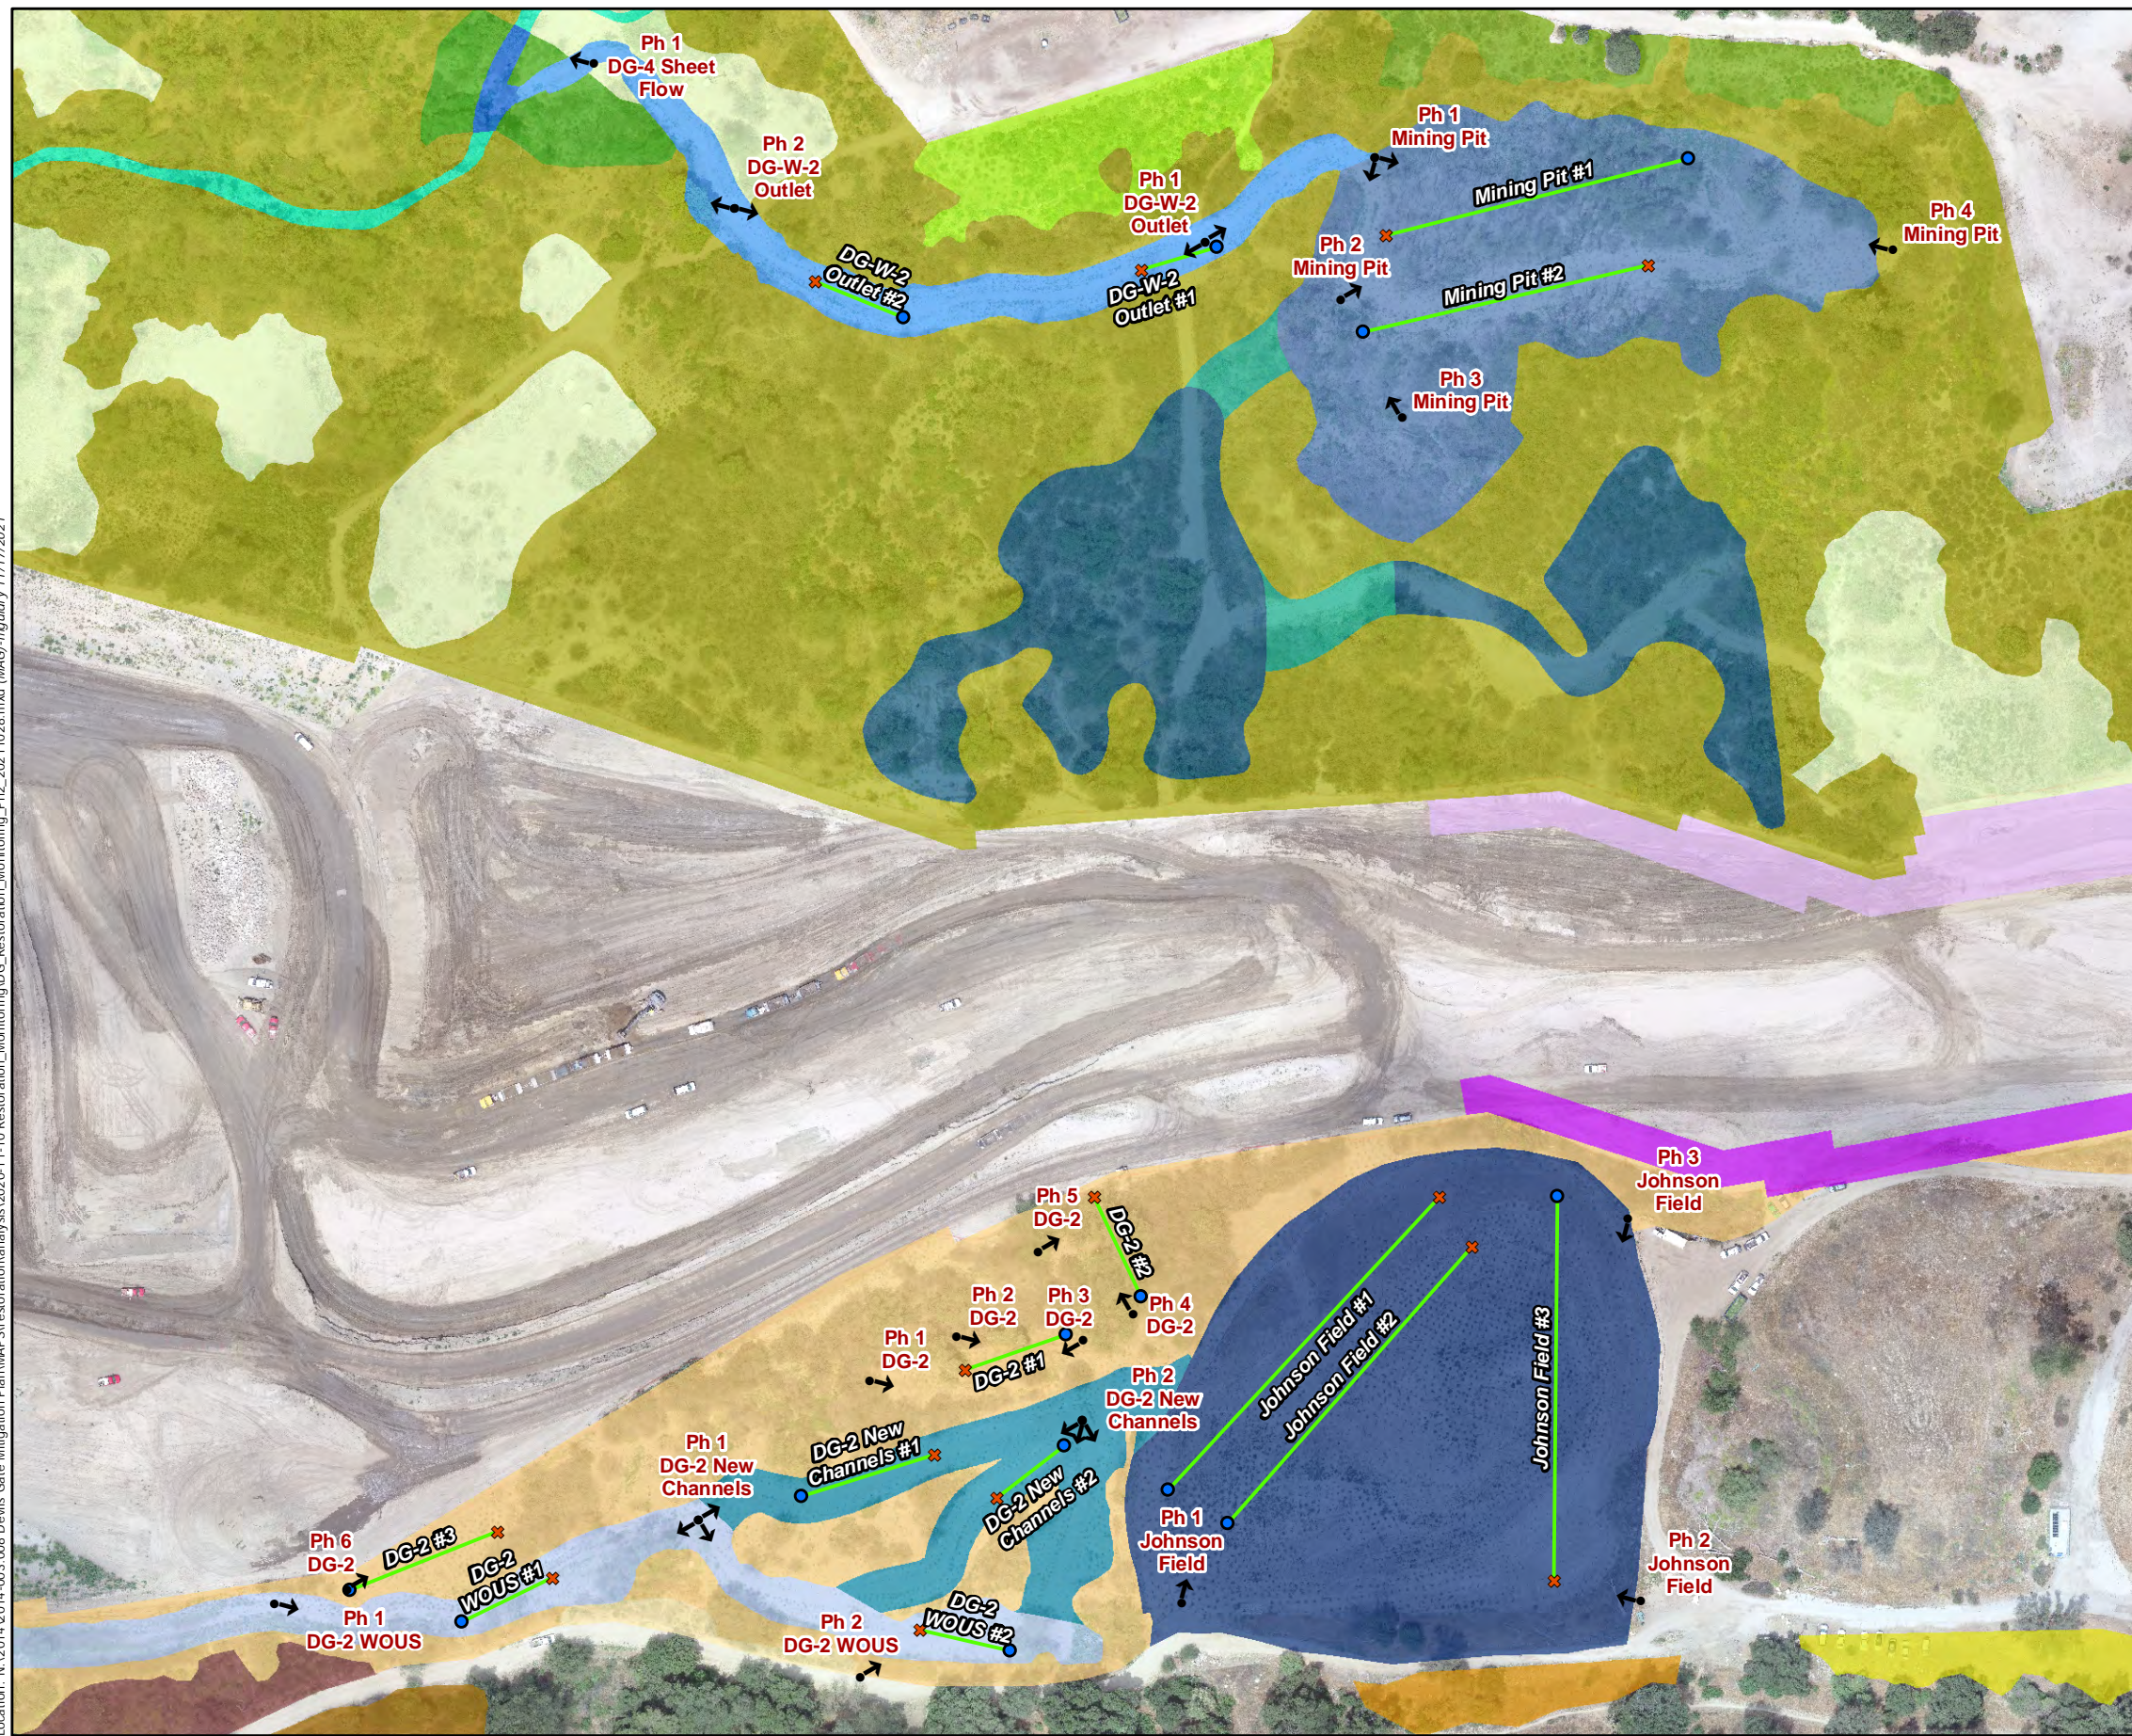
**Figure 5. Transect Locations Mitigation Areas**

Data was collected along each transect at every 0.5 m (sampling location), starting at 0.5 m. Each plant species that intersected the transect tape at each sampling location was recorded. A sampling dowel was used to assist in determining which plant species intersected the transect tape at each sampling location. In situations where the canopy of a plant intersected the transect tape at a sampling location, that species

Bare ground, rock, and litter were also recorded along each transect in areas that had no plant overlap. Species occurrence along each transect line was totaled and divided by the number of sampling points and multiplied by 100 to derive the percent cover (total cover) along each transect. Species richness was determined for each mitigation area and reference site by documenting all of the native species that occurred within a belt transect. The belt transects extended one meter to the left and right of each of the 14 transects within the mitigation areas, and the 4 transects within the reference sites.
