As we discussed over the phone on August 9, 2016, it is my understanding that the County is preparing a habitat restoration and management plan for impacts associated with the Devil's Gate Sediment Removal Plan. We are concerned that the proposed sediment removal will alter the hydrology in the reservoir in a manner that may impede restoration of riparian habitat outside the project footprint. I have reviewed the information provided by the County (Veronica Mardis) on April 20, 2016 (*Devil's Gate Sediment Removal and Management Plan On-Site Mitigation Hydrology Justification*, Justification) in support of establishing riparian vegetation on the west side of the reservoir (attached). This message is to request clarification regarding the information provided and to recommend that specific information is included as part of the restoration and management plan to ensure habitat created for the vireo will be viable over the long term.

**DEVIL'S GATE DAM RESERVOIR
DEVIL'S GATE RESERVOIR SEDIMENT REMOVAL PROJECT**

Devil's Gate Sediment Removal and Management Plan
On-Site Mitigation Hydrology Justification

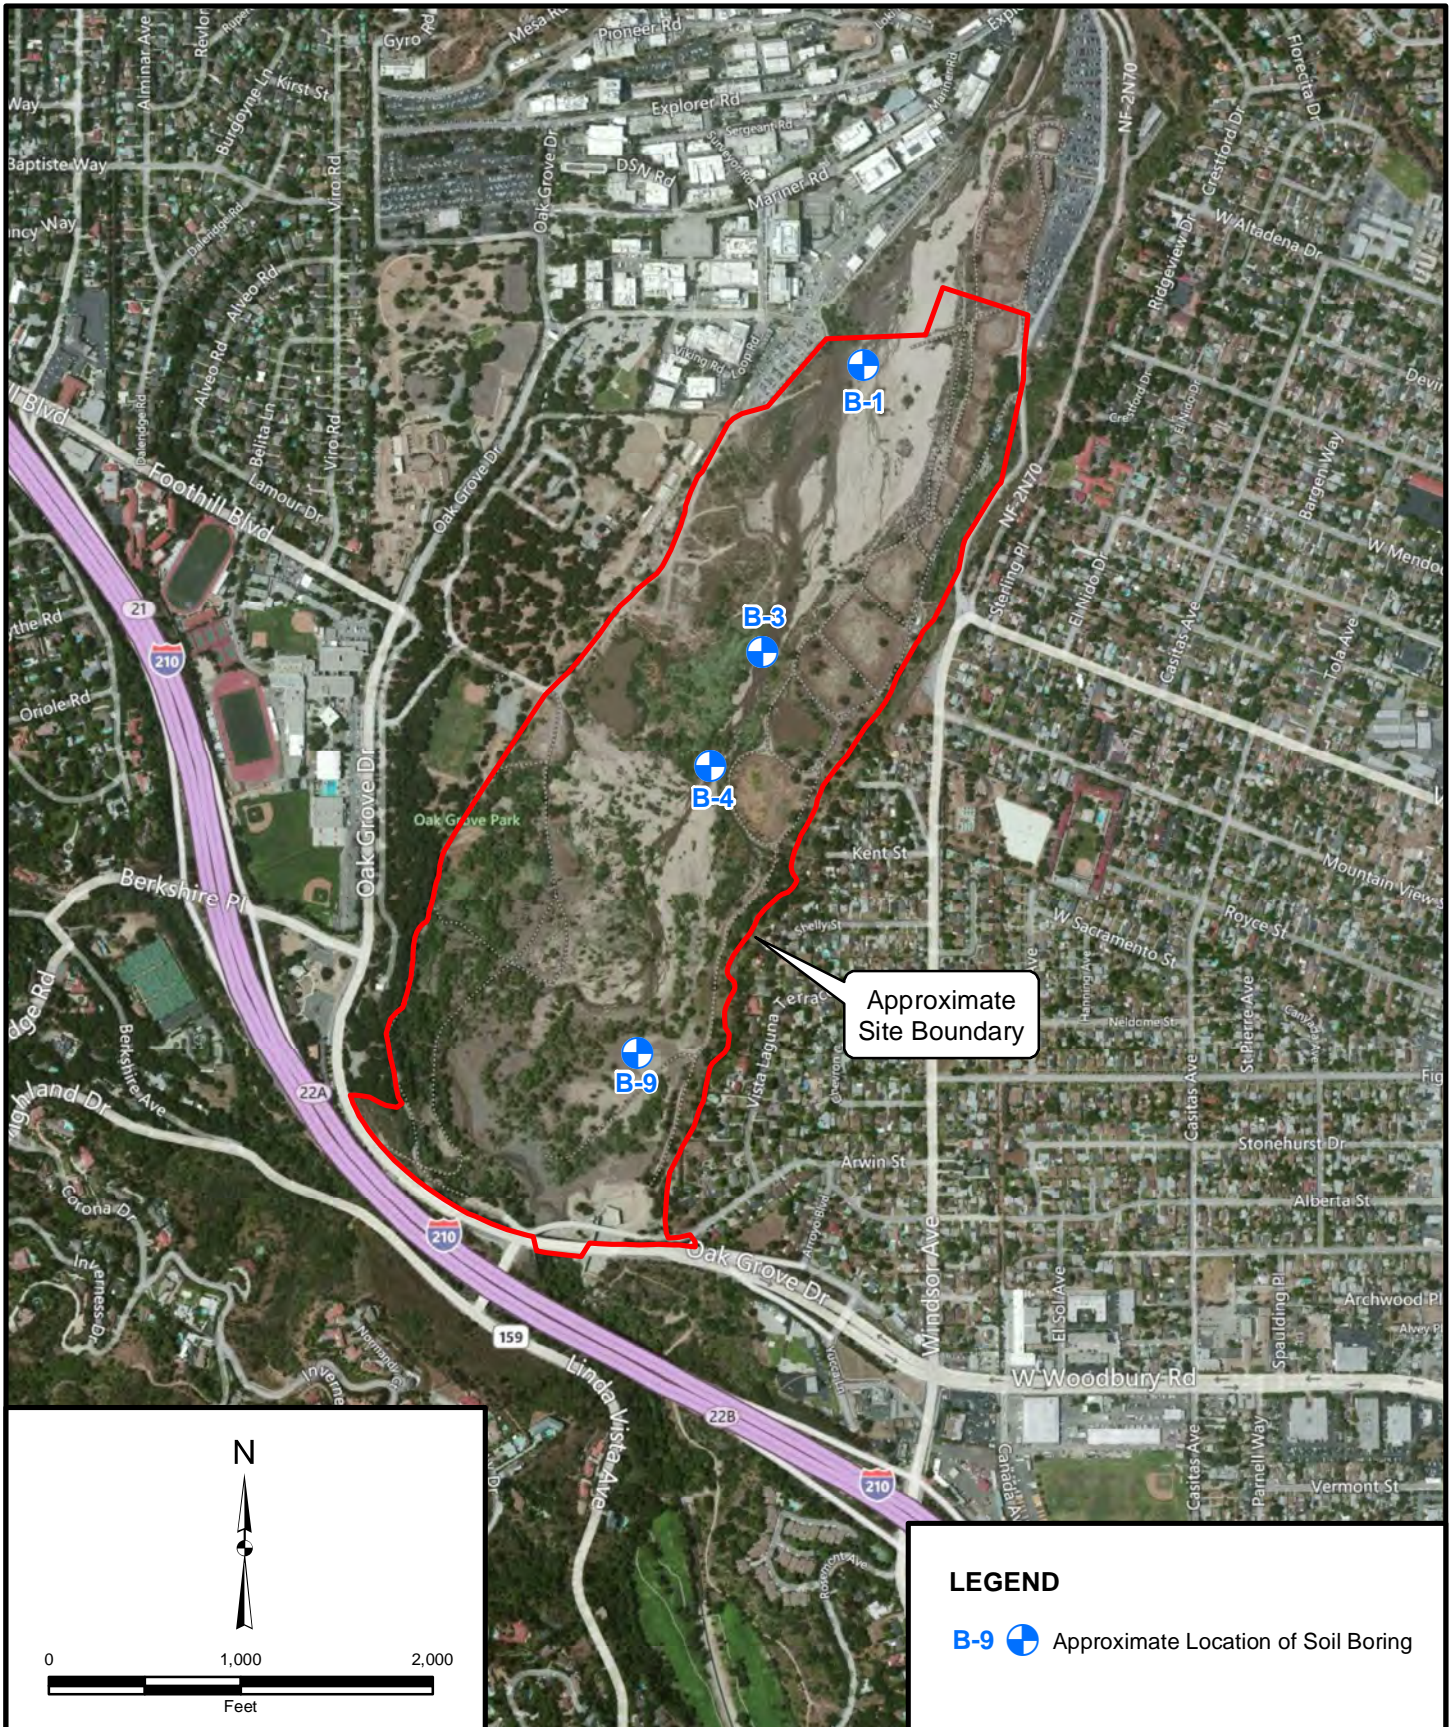
BORING LOCATION MAP

B-9 Approximate Location of Soil Boring

Devil's Gate Reservoir Pasadena, California

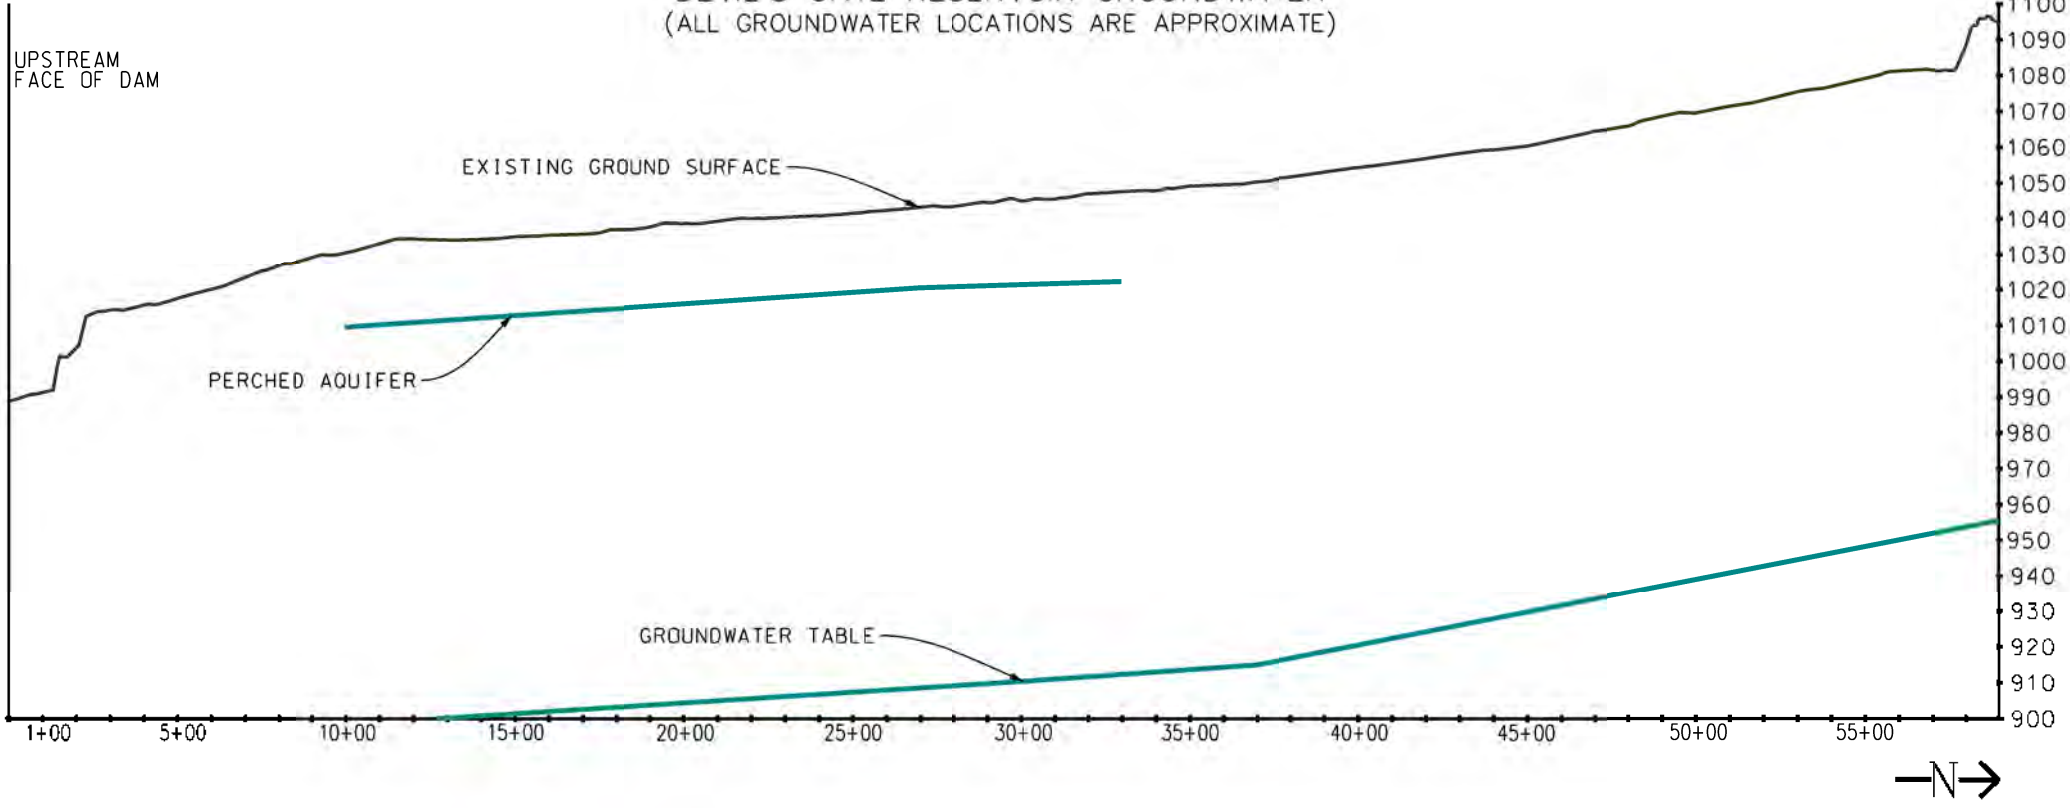
Well Monitoring Locations

DEVIL'S GATE RESERVOIR GROUNDWATER
(ALL GROUNDWATER LOCATIONS ARE APPROXIMATE)

LACFCD has several groundwater monitoring wells adjacent to Devil's Gate Reservoir, which have data dating back to the 1920s, approximate locations of these wells are shown in Attachment 4. Attachment 5 is a graph showing the historic groundwater elevations from a monitoring well on the east side of the reservoir. The groundwater levels in Devil's Gate Reservoir have been fairly consistent over the life of the dam. The groundwater levels do fluctuate over time, but typically keep within the 900 to 1,000-foot amsl. This is consistent with the dynamics of a reservoir system, as the amount of rainfall received and water impounded in the reservoir can affect the level of the groundwater table. For example, water impounded in the reservoir will permeate into the ground, thus raising the groundwater table in the surrounding area. Similarly, when little rainfall is received, and water is still being extracted from the groundwater table, the elevation of the groundwater over the entire basin will drop.

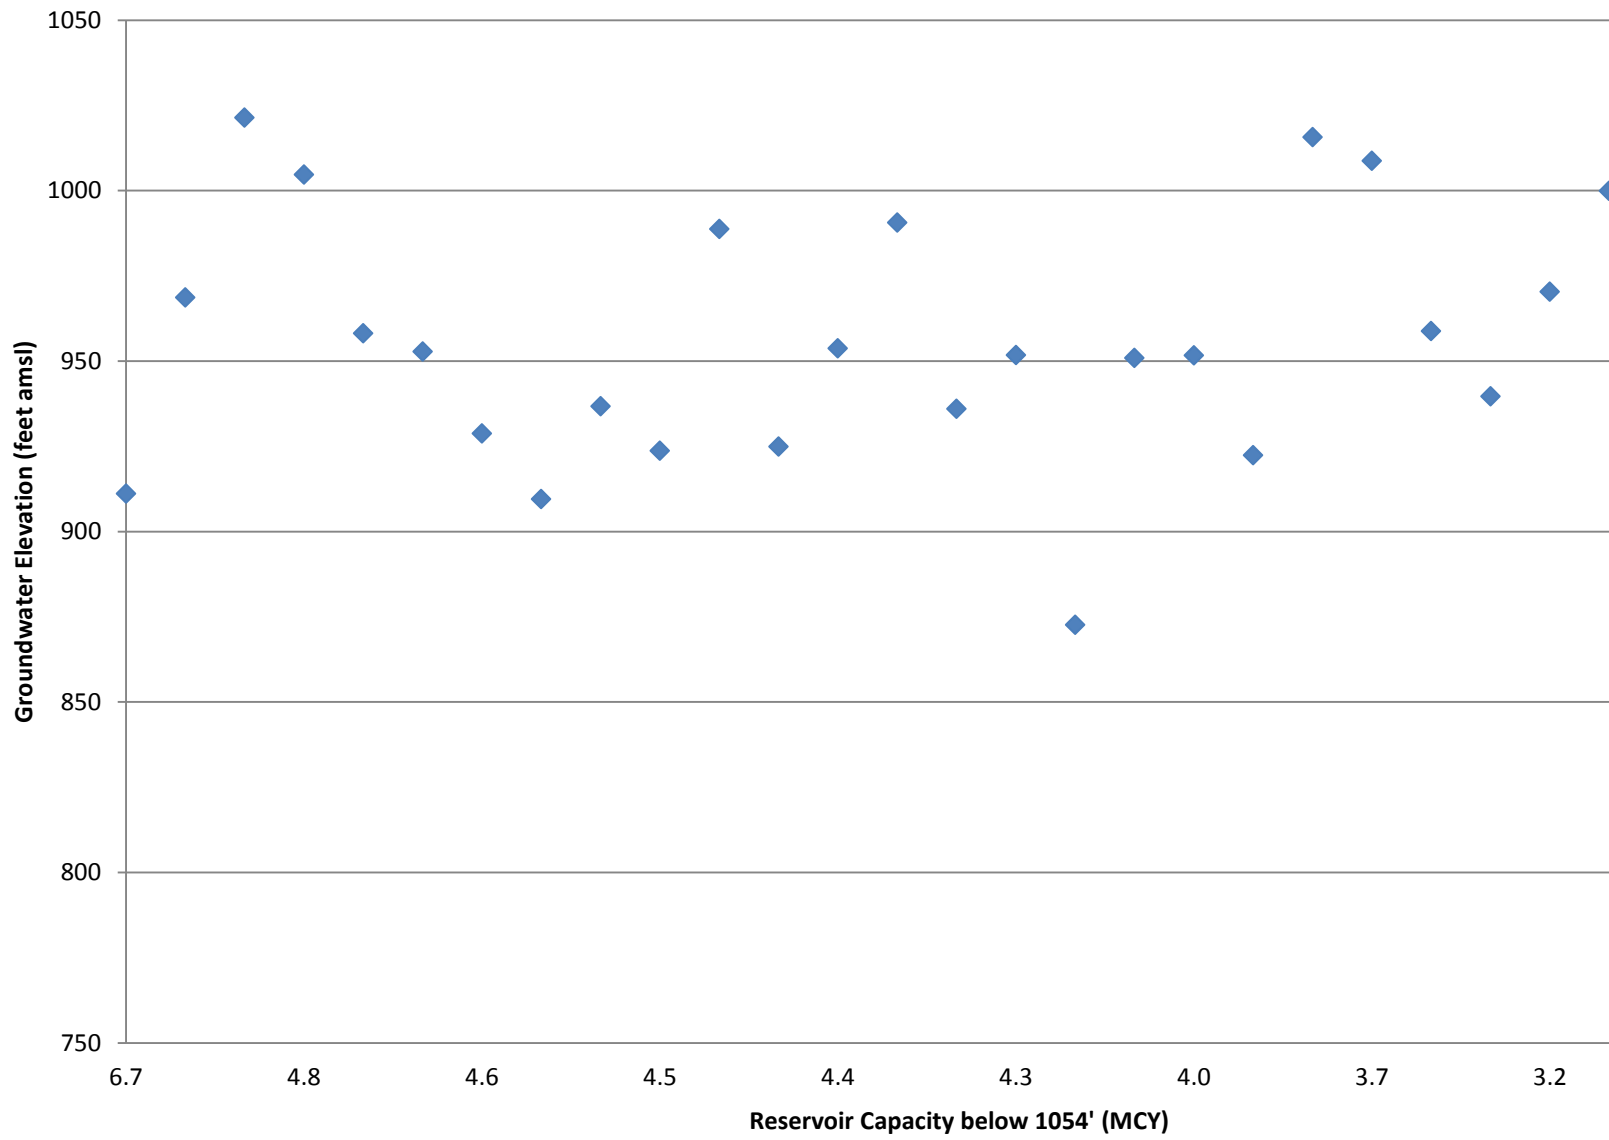
Reservoir Capacity vs. Groundwater Levels

Increase in Sediment Levels

- 2) Information provided in Attachments 5 and 6 of the Justification compares groundwater elevations over time and at various sediment levels within the reservoir. What is the source of the data provided in these graphs? Monitoring wells located on the east side of the reservoir are depicted in Attachment 4 but it is not clear if these wells were used to generate the graphs in Attachments 5 and 6. Is it possible that wells located on the east side of the spreading basins record artificially high groundwater levels due to the adjacent City of Pasadena spreading basins that are located above the elevation of the reservoir? If so, these wells may not detect changes in groundwater levels compared to sediment levels in the Reservoir. It appears the spreading basins are regularly maintained so the elevation of adjacent groundwater should be fairly stable.

Attachment 6 is a graph showing the groundwater levels at various reservoir capacities. A decrease in reservoir capacity represents an increase in sediment levels. As can be seen from Attachment 6, the historic groundwater levels in the reservoir show no correlation between sediment levels and groundwater elevation. Rather, the correlation between rainfall received, water entering the reservoir, and groundwater levels indicates that water within the reservoir dictates the groundwater elevations.

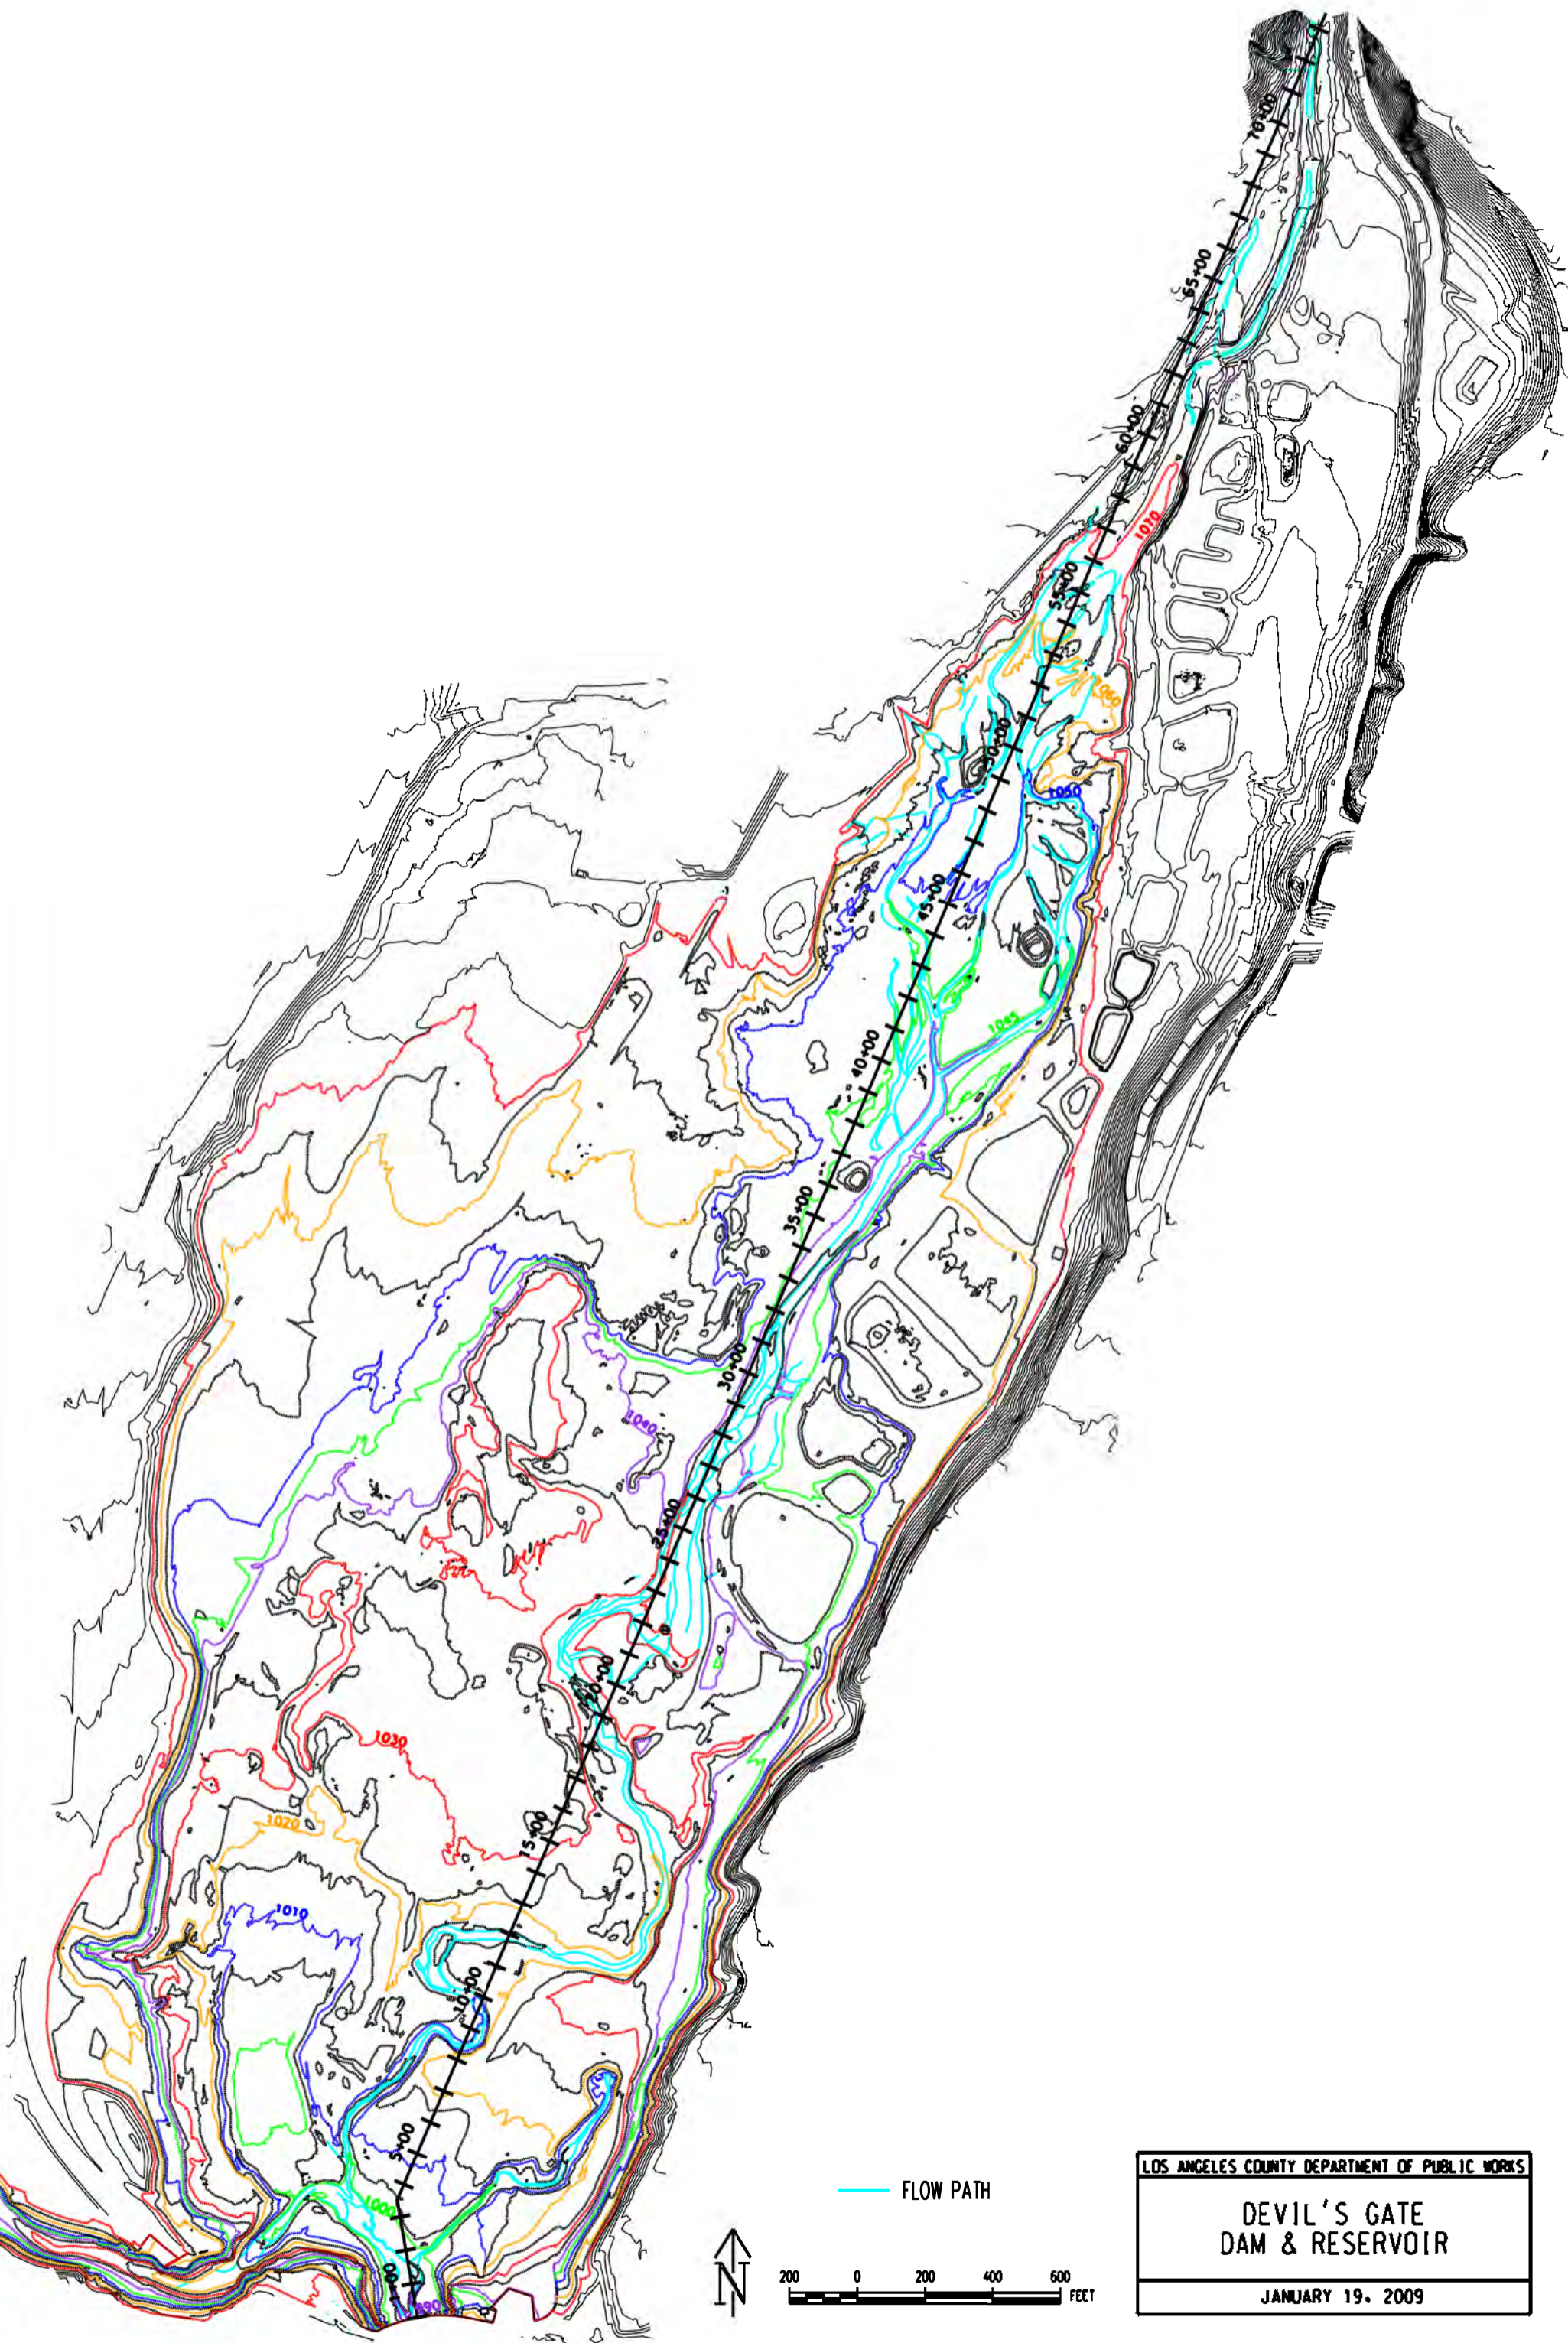
LOS ANGELES COUNTY DEPARTMENT OF PUBLIC WORKS
DEVIL'S GATE
DAM & RESERVOIR
JANUARY 19, 2009

Attachment 10 shows the contours and estimated flow path of Devil's Gate Reservoir in January 2009, pre-Station Fire. Pre-Station Fire conditions show water flowing from the north end of the reservoir towards the face of the dam through channels that were cut by storm flows. The contours in Attachment 10 show several braided channels within the north end of the reservoir that converge into one main channel that flows toward the dam, all within the proposed project boundary. Attachment 11 shows the proposed configuration post-project. After the completion of the Devil's Gate Sediment Removal Project, the water will flow through a path similar to the pre-Station Fire. Even though the reservoir will be evenly graded during construction within the project boundary, the water flowing into the permanent maintenance area will continue to meander and braid through the sediment deposited during storms.

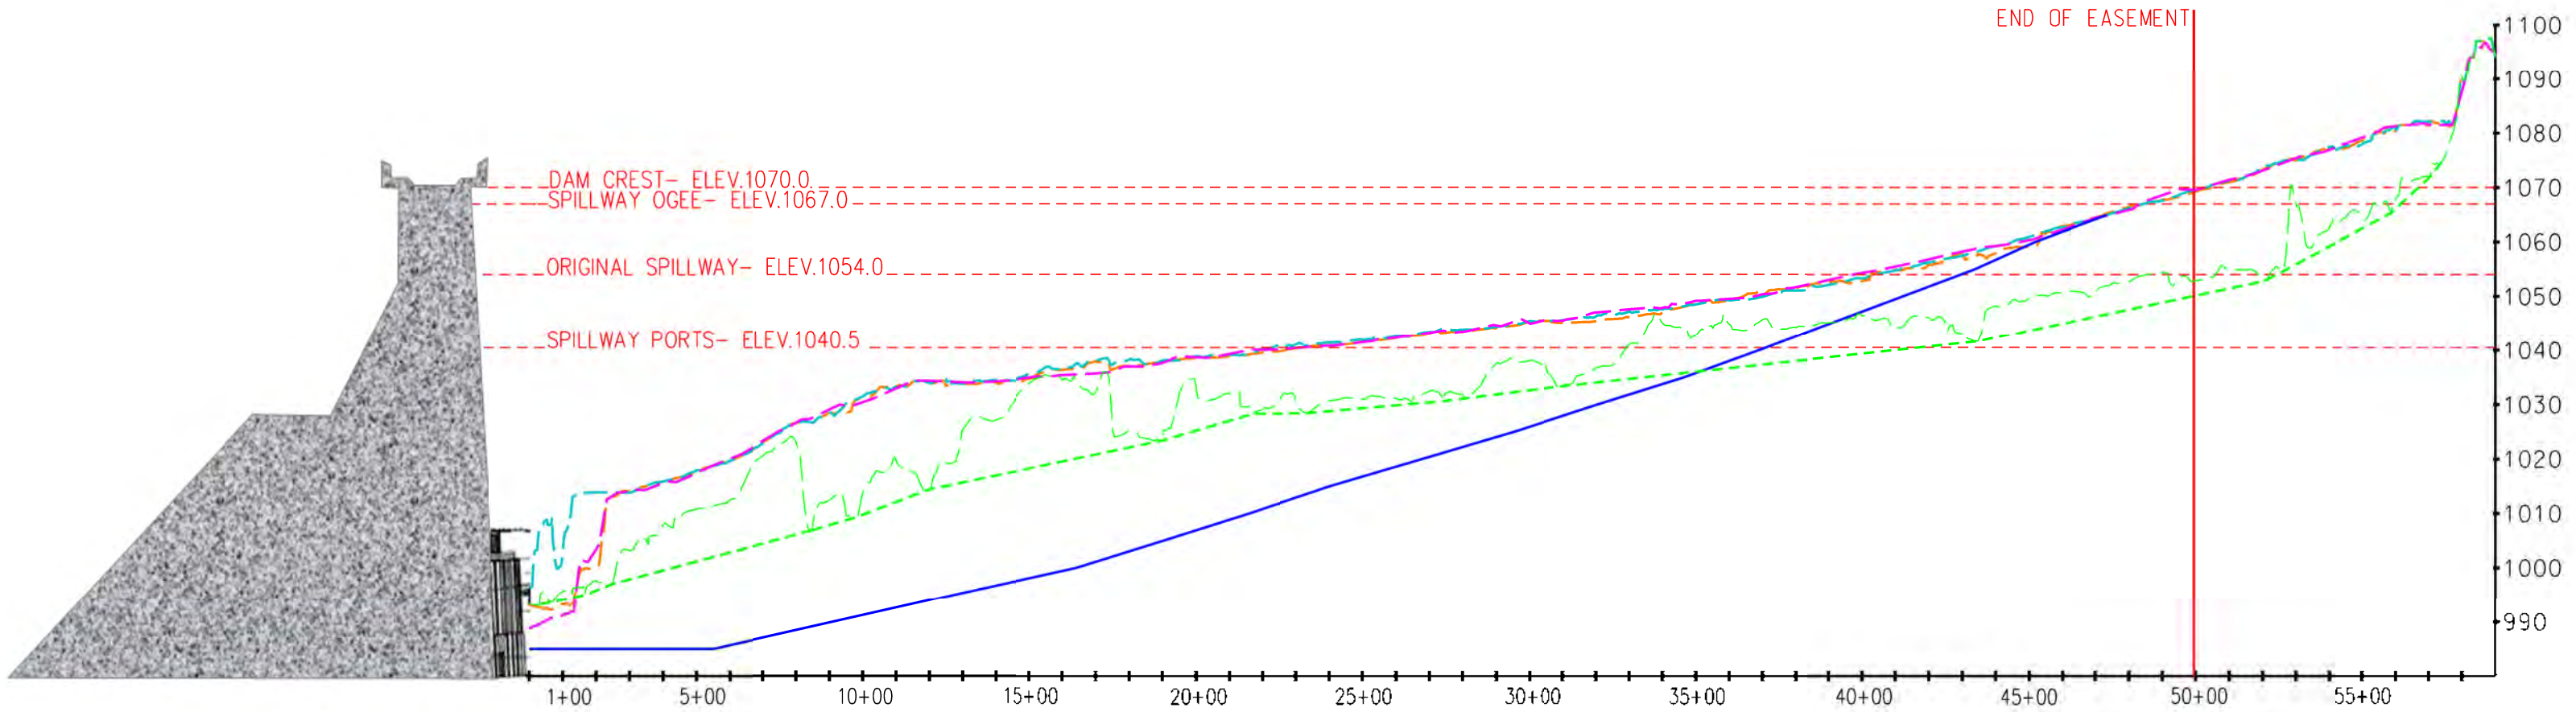
DEVIL'S GATE RESERVOIR PROFILE

LEGEND	
—	JANUARY 2009
- - -	JAN. 2009 APPROX. FLOW PATH
—	MARCH 2011
—	MARCH 2012
—	MAY 2014
—	APPROVED PROJECT

10) Attachment 12 compares the slope of the low flow channel over time with the proposed project. While the streambed elevation increased between 2009 and 2014, the slope appears to remain about the same. The proposed project will increase the slope substantially relative to the 2009/2014 slope. Will this cause a headcut upstream? How far upstream do you anticipate the headcut to extend as a result of increasing the gradient of the streambed? Does the proposed annual maintenance account for erosion of the bed and banks associated with the headcut?

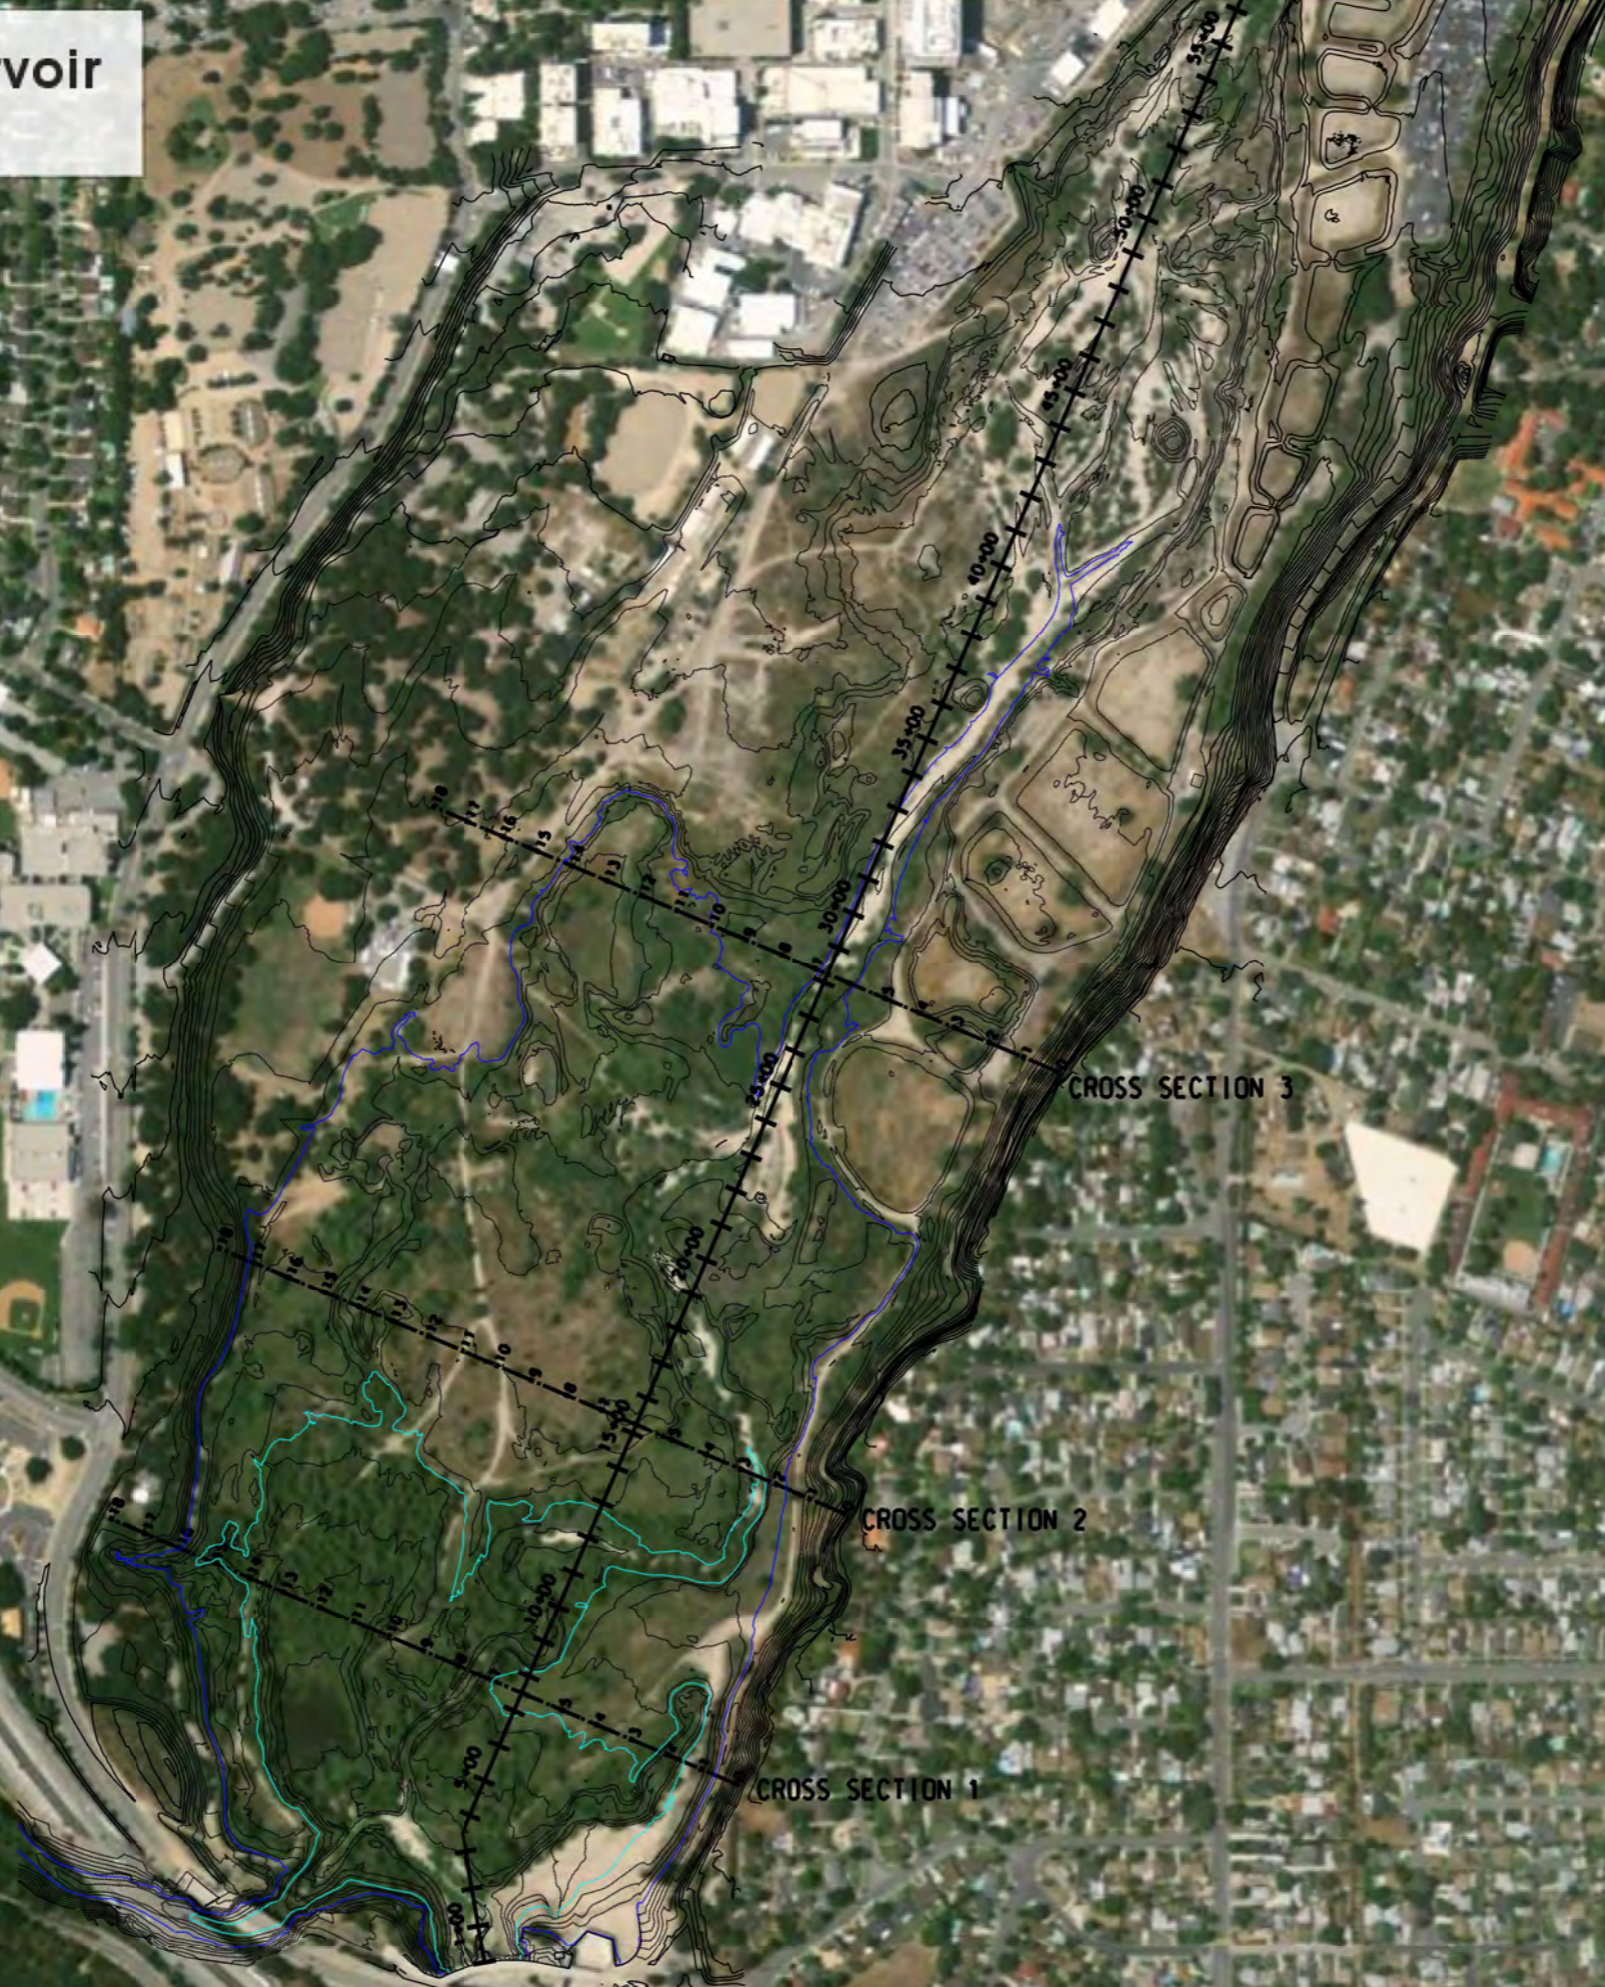
— 1040-FT WATER SURFACE ELEVATION
— 1020-FT WATER SURFACE ELEVATION

LOS ANGELES COUNTY DEPARTMENT OF PUBLIC WORKS
**DEVIL'S GATE
DAM & RESERVOIR**
JANUARY 19, 2009

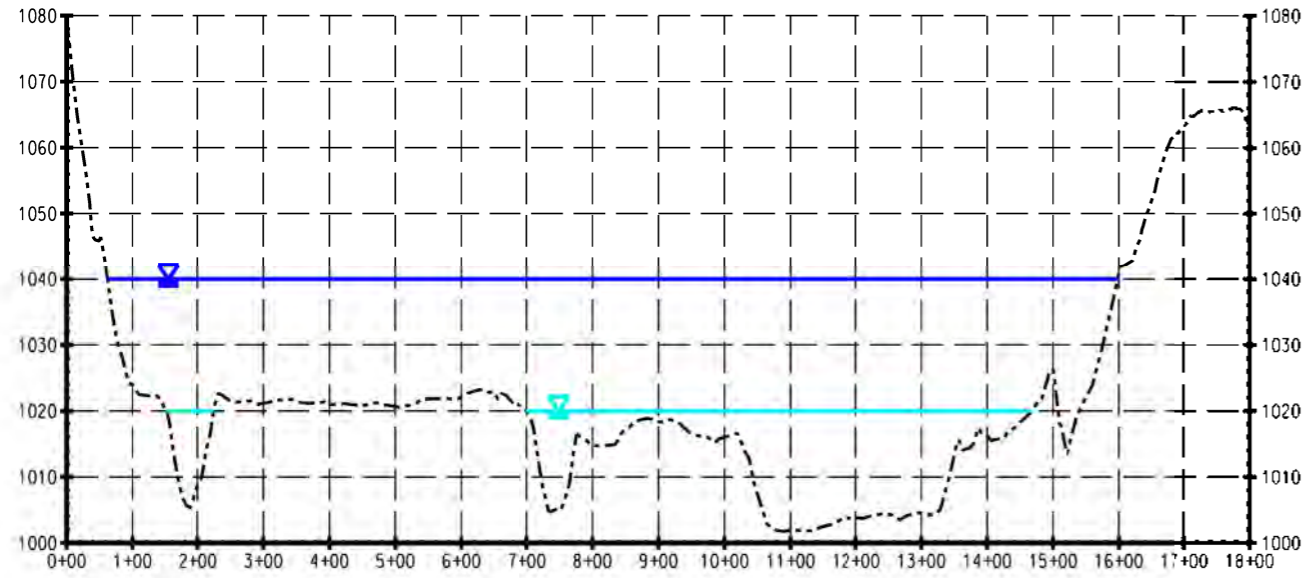
CROSS SECTION 1

- 1040-FT WATER SURFACE ELEVATION
- 1020-FT WATER SURFACE ELEVATION

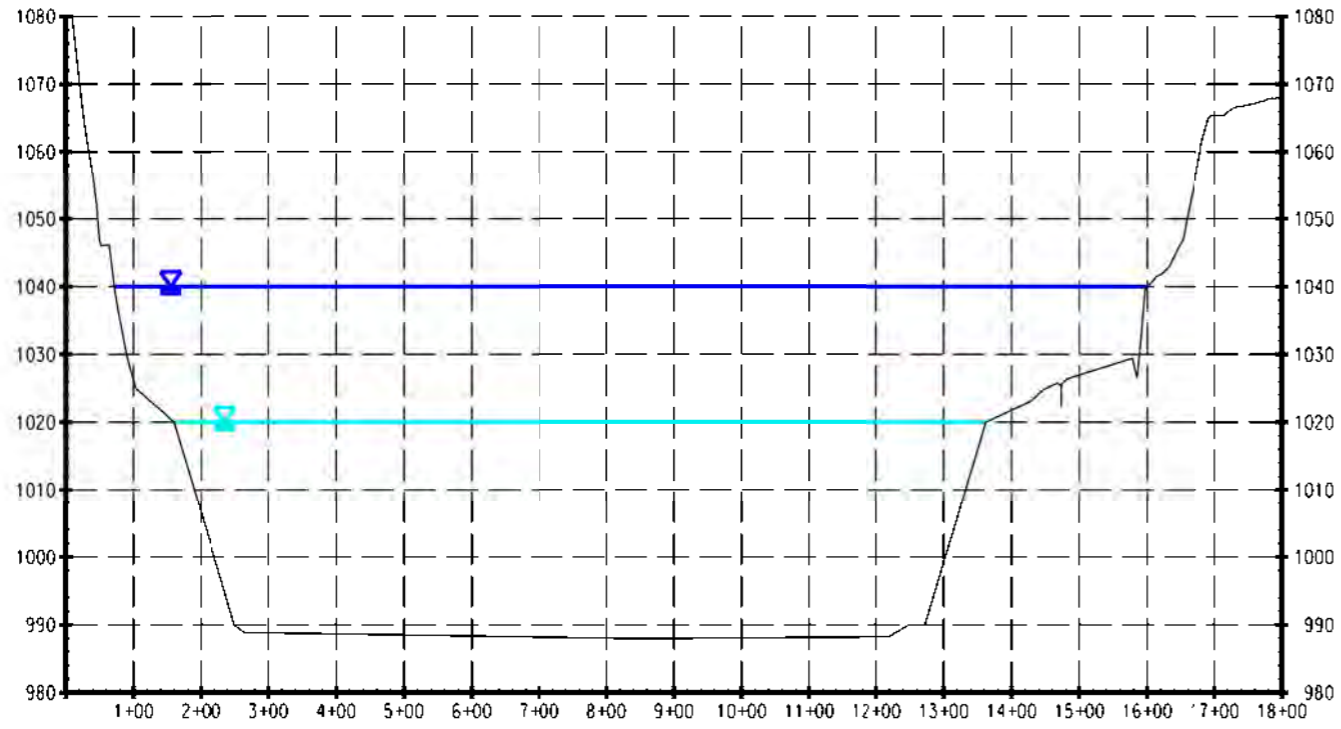
CROSS SECTION 1

- 1040-FT WATER SURFACE ELEVATION
- 1020-FT WATER SURFACE ELEVATION
