# Memorandum

To: Christine Medak, USFWS  
Project: Devil's Gate Reservoir Restoration Project  
From: Lauren Simpson  
Date: June 11, 2020

**Subject: Weekly Least Bell's Vireo Survey and Noise Monitoring Summary for the Devil's Gate Reservoir Restoration Project; Week of June 1 – June 5, 2020**

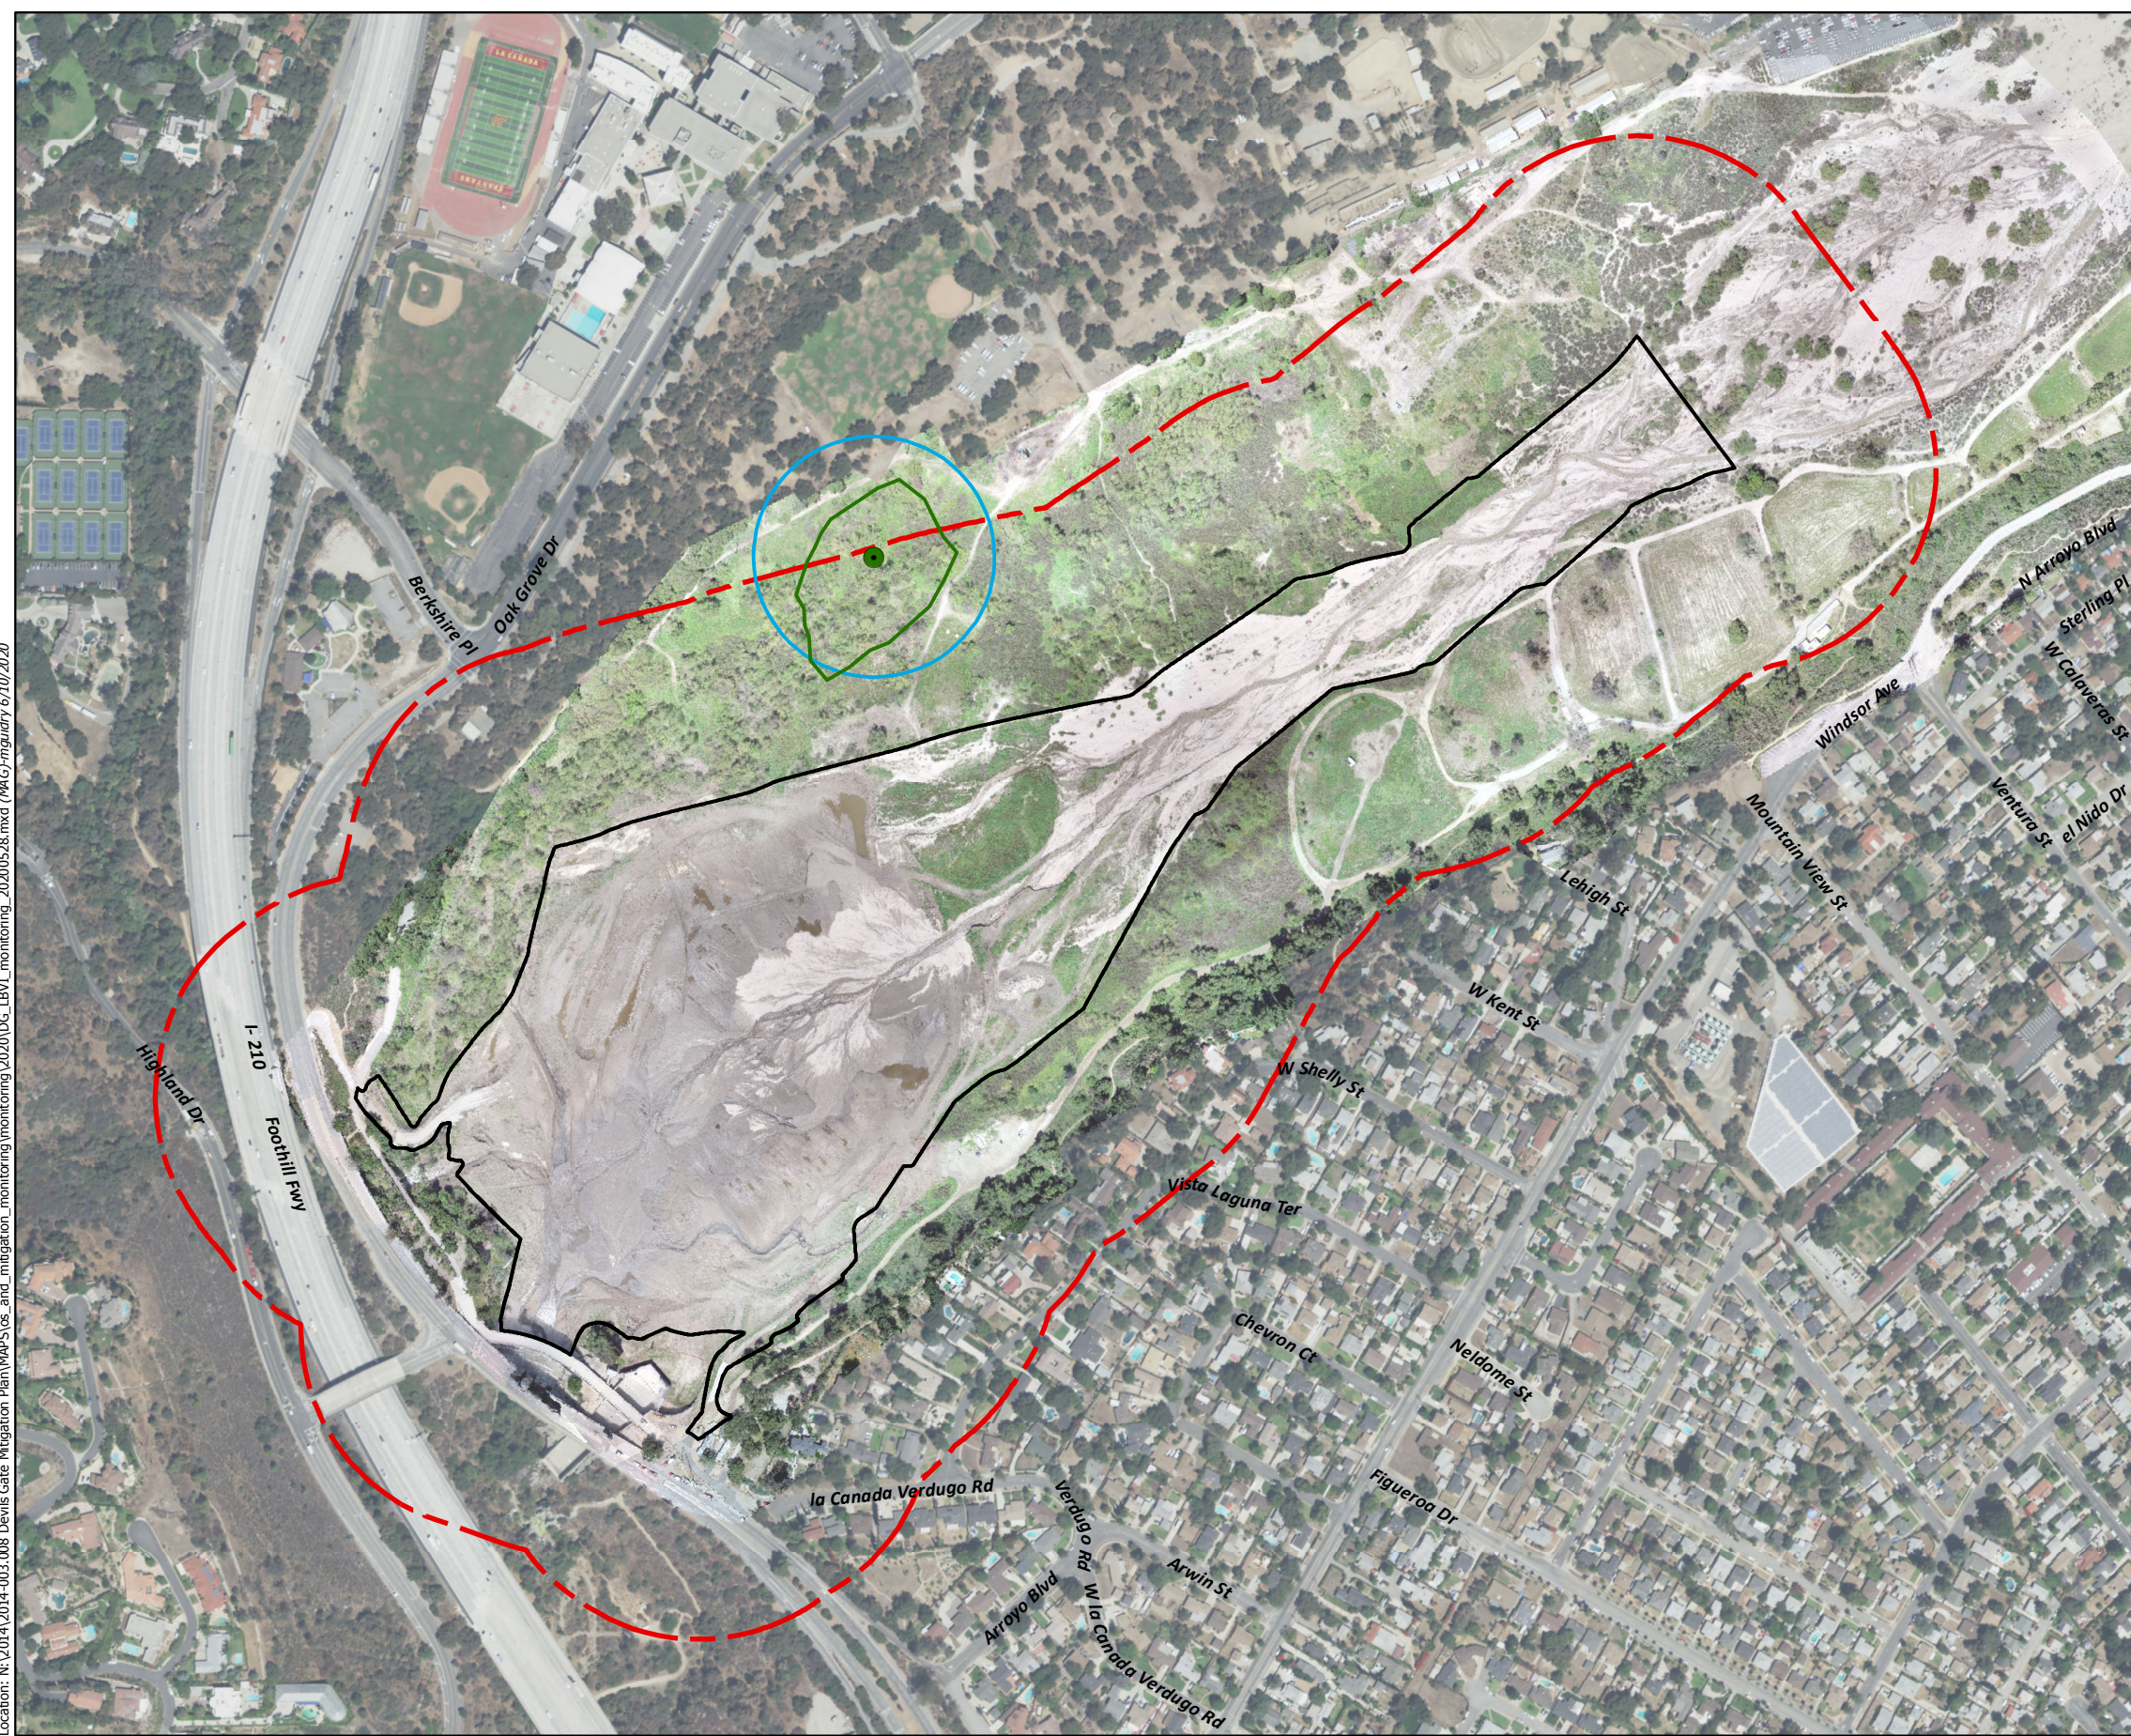
### Figure 1. Least Bell's Vireo Monitoring June 1 - 5, 2020

The least Bell's vireos were documented during both surveys conducted during the week of June 1, 2020. The location of the least Bell's vireo nest and territory are depicted in Attachment A. The male was observed singing within the previously documented territory as well as further north than was previously documented. The territory size was expanded to reflect these observations. The female was observed sitting on the nest on June 5, 2020. Based on the initial observation of incubation on May 21, 2020, the nest may be in the final days of incubation or the female may have been brooding nestlings.

Location of Least Bell's Vireo Nest and Territory
